**Re: Haines Junction Refinery  
Remediation Assessment**

**HAINES JUNCTION REFINERY  
REMEDIATION ASSESSMENT**

J.R. Paine & Associates Ltd. was retained by the Department of Indian Affairs and Northern Development, Action On Waste program, to determine the extent of soil and groundwater contamination present at the abandoned oil refinery site in Haines Junction, Yukon.

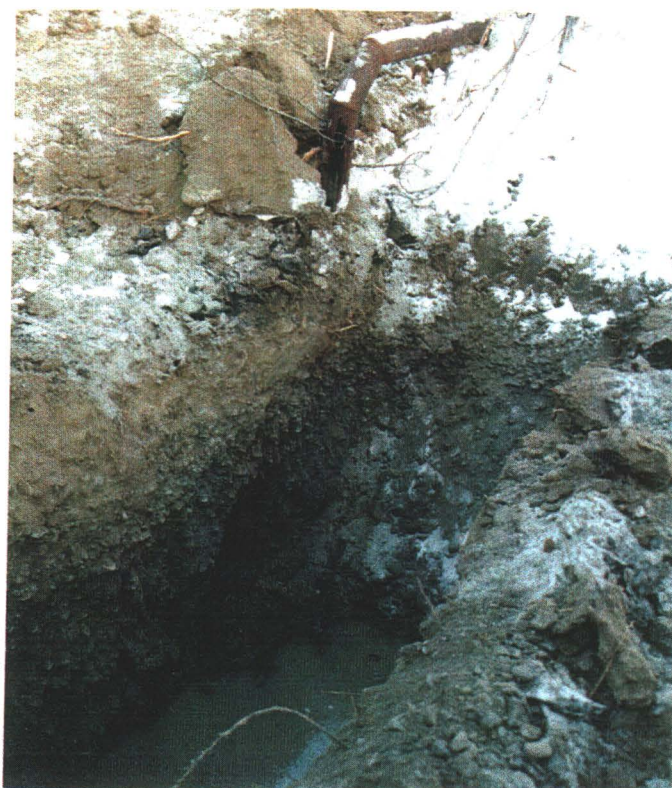
Photo #5

| Photo No. | Description |
|---|---|
| #5 | •TP#16-94 located near F5, note outlet pipe leading into disposal pit (ends at surface) |

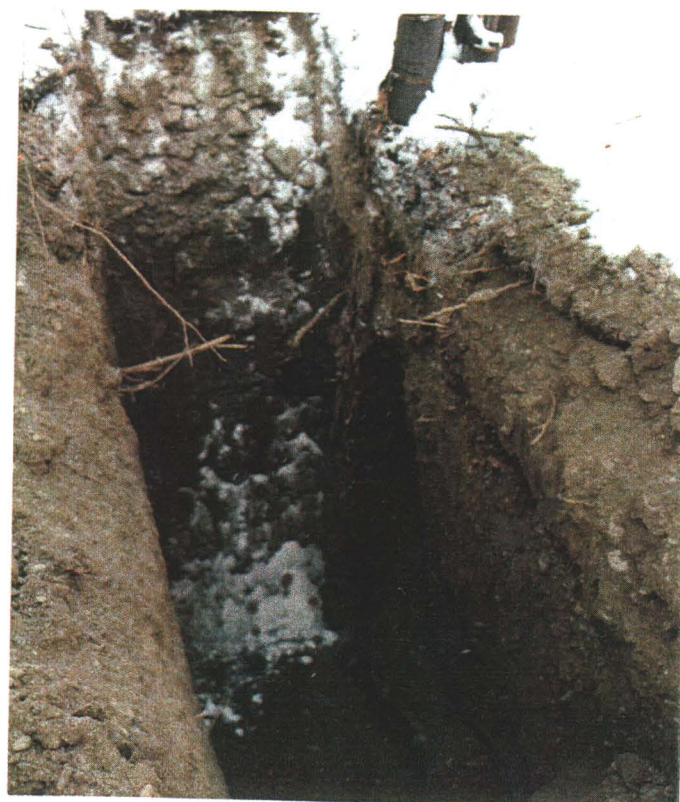
Photo #6

| Photo No. | Description |
|---|---|
| #6 | •TP#3-94 located adjacent to pipe leading into ground; at 1.2 metre depth, pipe begins to lead south |

Several notes which were taken as part of the environmental survey component of the work program are provided in Table One in Appendix A. An example includes tar staining around the south pitch tank and near TP#3-94. Also, several 45 gallon drums were encountered in various locations throughout the study area. One of the drums had a DOW Chemical insignia with warning label printed on the side. Upon contacting DOW, they could not provide details with respect to its previous contents. Based on the information contained on the drum label, they did speculate that it may have been a glycol formulation. Both soil and water samples retrieved from this area were tested for glycols, however, no such impurities were present at detectable levels.
