**Environmental Site Assessment
Whitehorse, Yukon
Teslin to Morley River**

Te 27, 30, 32, 33, 34, 35, 36

Prepared for:
Yukon Arctic Environmental Services
Action On Waste
345, 300 Main Street
Whitehorse, Yukon
Y1A 2B5

Prepared by:
Groundtrax (Yukon) Inc.
P.O. Box 5105
Whitehorse, Yukon
Y1a 4S3

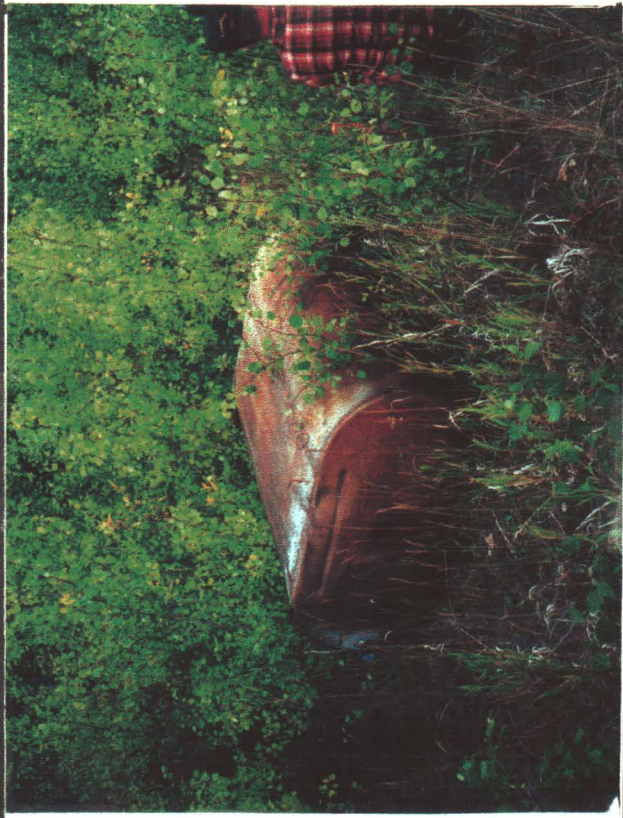
P - 4 A second 900 litre fuel tank again in close proximity to the log cabin. Approximate distance 30 feetnorth/east.

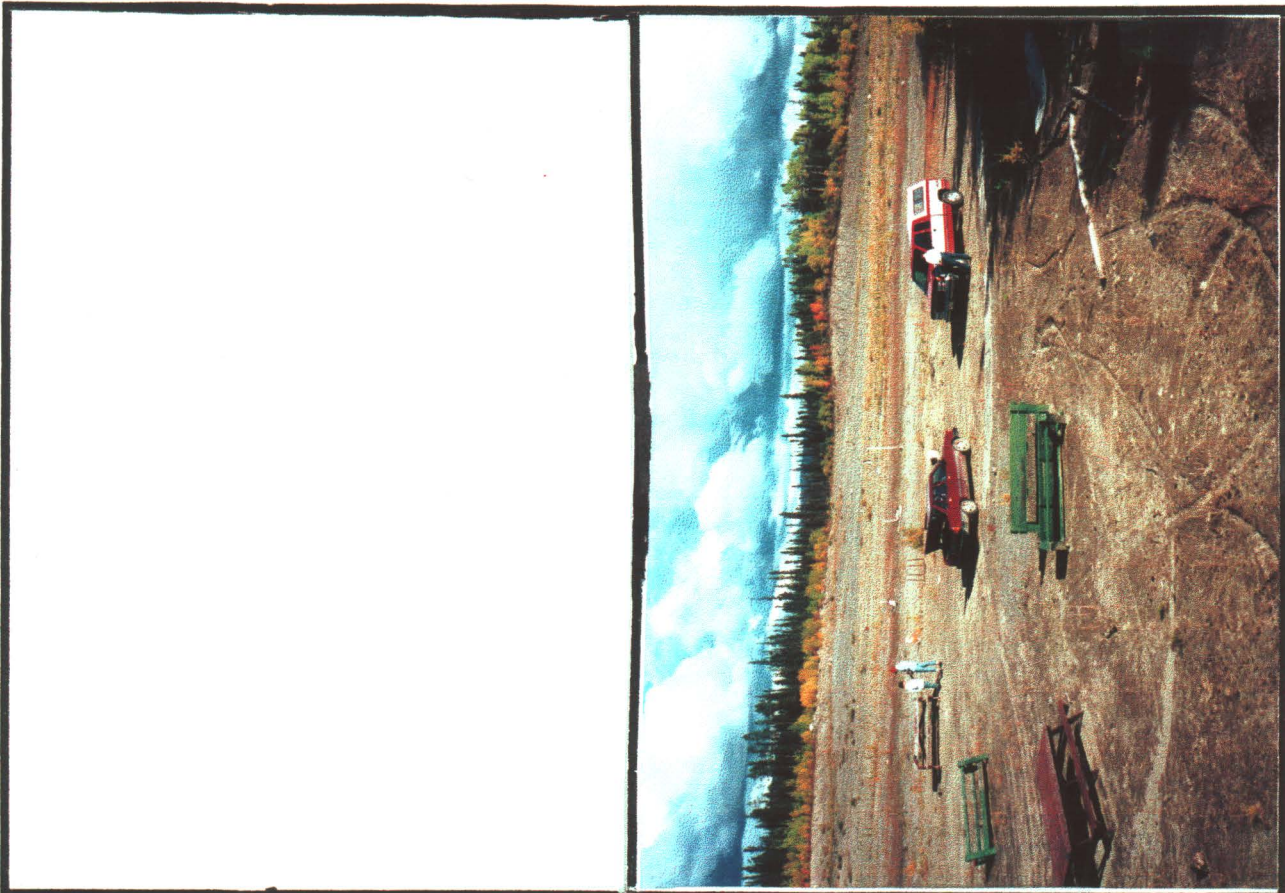
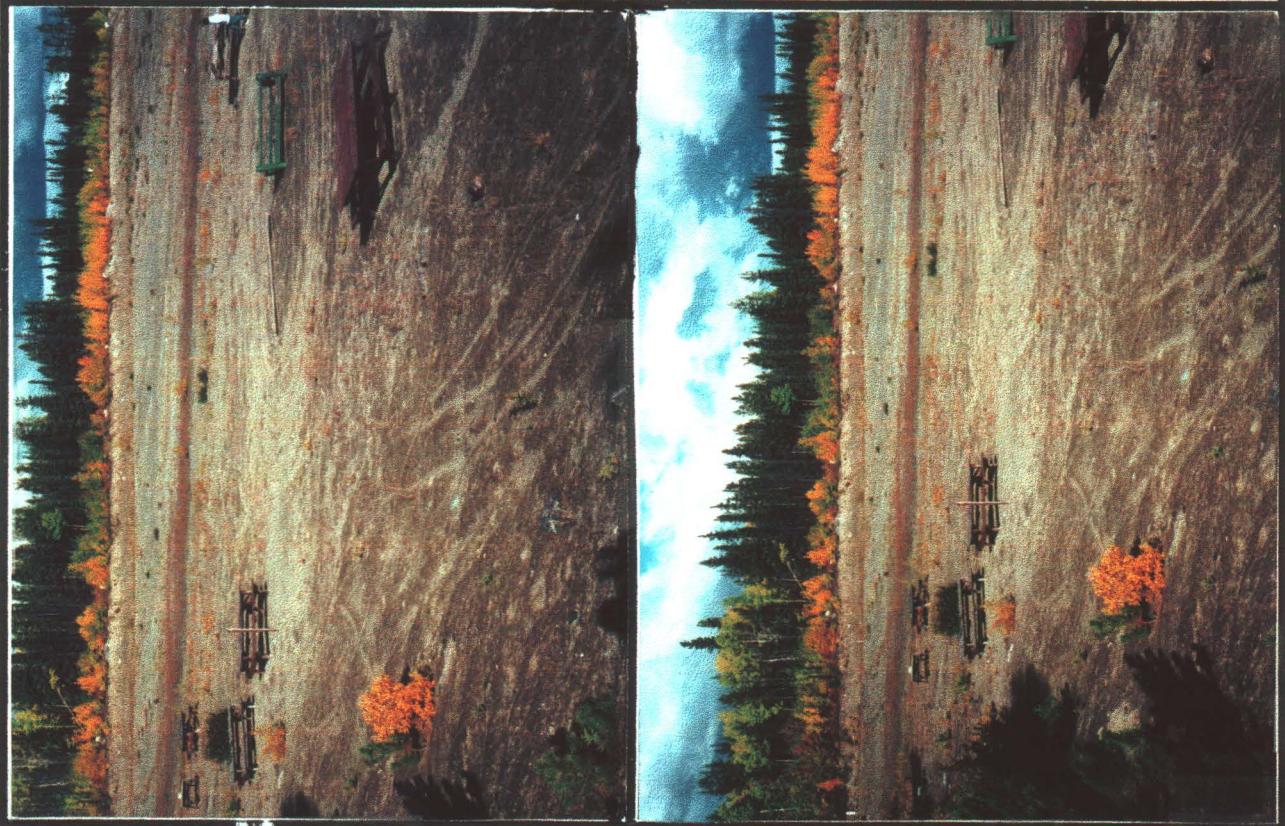
Appendix A 2
Photos Site No 2
Teslin Gun Club

Photo P1, P2 and P3 All photos were taken from the top of the embankment at the south west end of this site. These photos are views of the investigation area looking from the south/west. The area to the left of the picnic tables in p1 and the area showing at the top of P2 in the open expanse were the investigation areas.

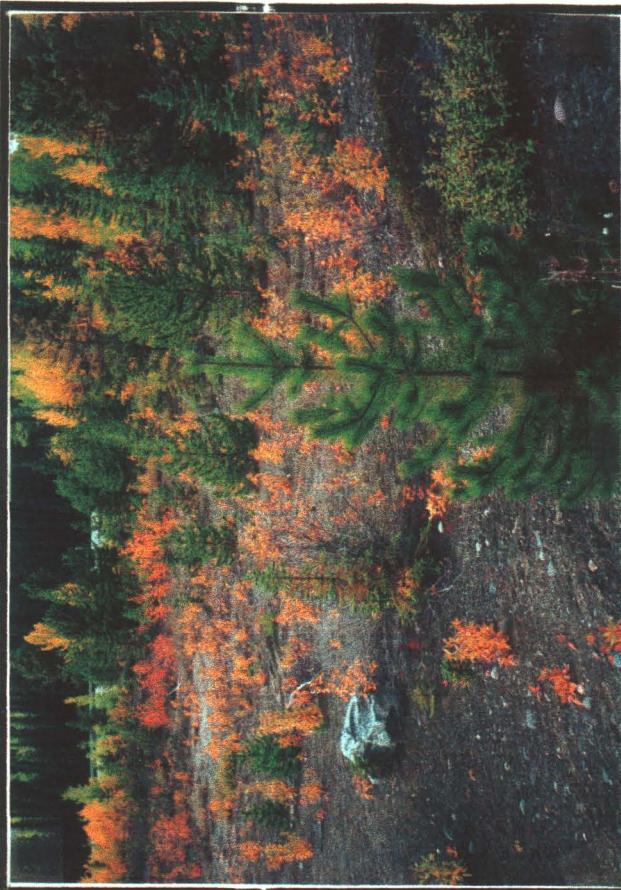
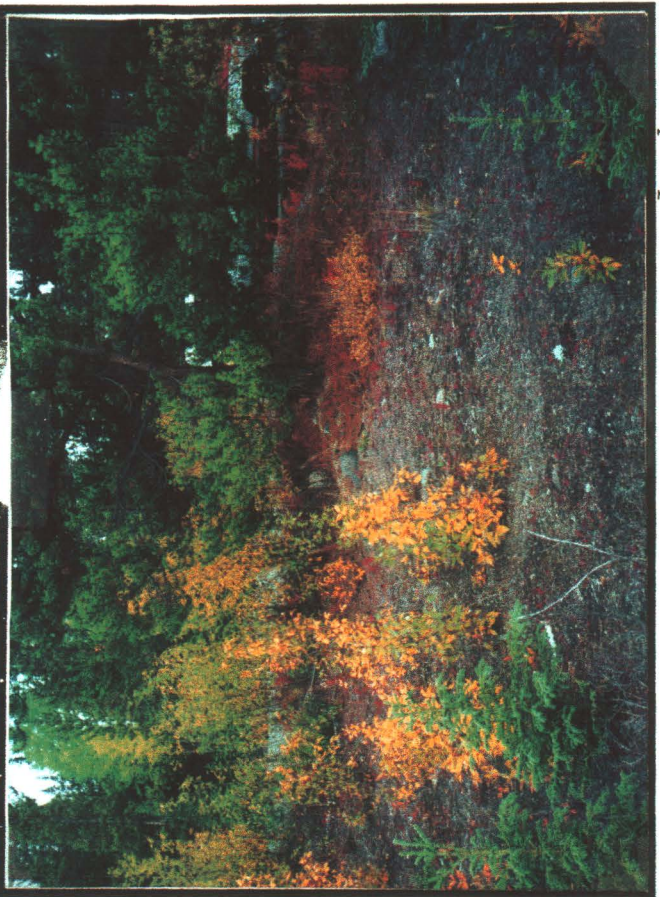
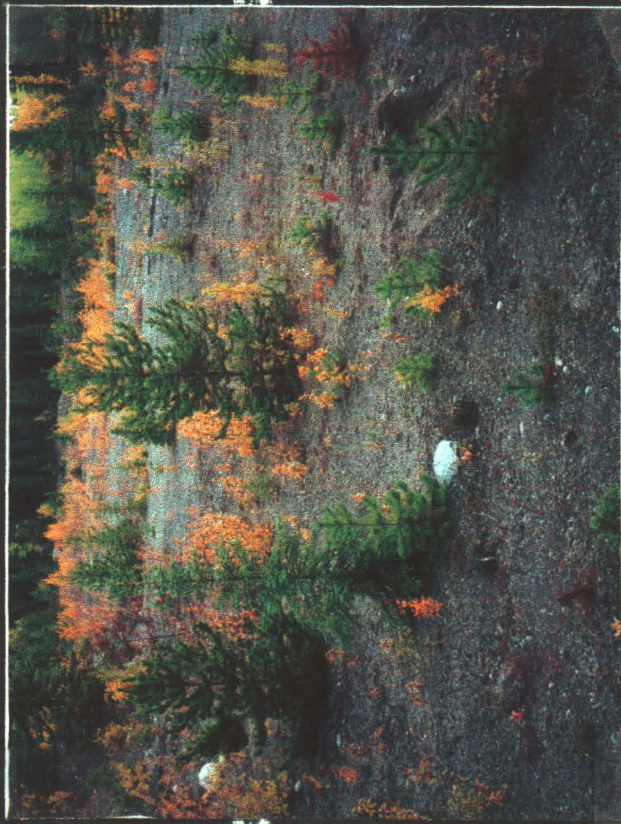
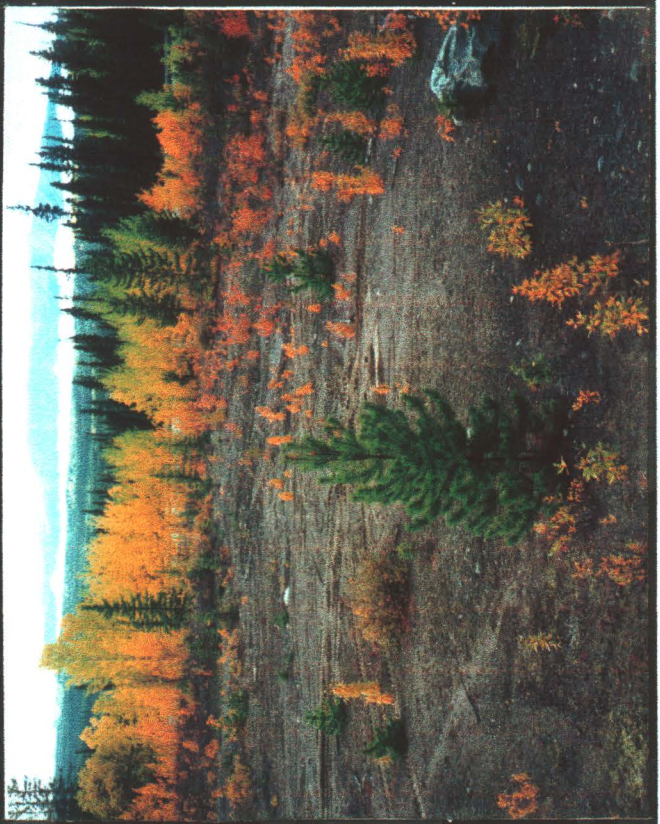
Appendix A 3
Photos Site No 3
Oil Tank Station

P2,P3 and P4 The three of these photos are of the actual investigation site. P2 is a view of the site, as you look to the south/west of the area. You can also see the Alaska highway at the top of this photo, between the trees. P3 is a second view of this site taken from the north/east end. This photo is directed to the south where a steep embankment slopes down to a gully. The highway is also very visible in this photo. The last photo P4 is a shot of the investigation site taken from the west end..

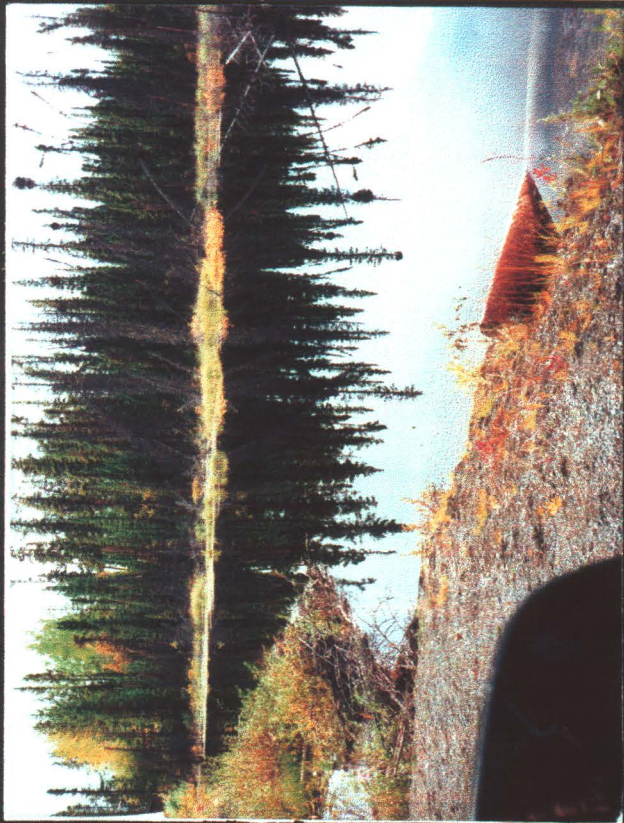
P - 4 A

Photo P - 4A This photo was taken at a location south/west of the site and approximately one kilometre away. This picture shows where the road has been washed out and a beaver has constructed a dam at the site.

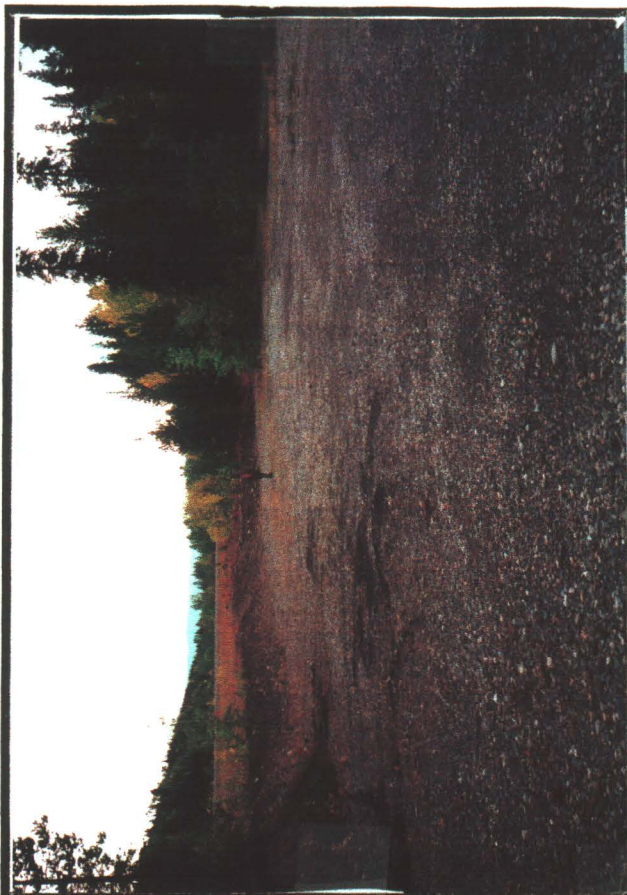
P - 3 A second look at the site from the west end. This photo shows an area of staining in the foreground and to the left of the photo. Probable cause, vehicles parking in the camping area.

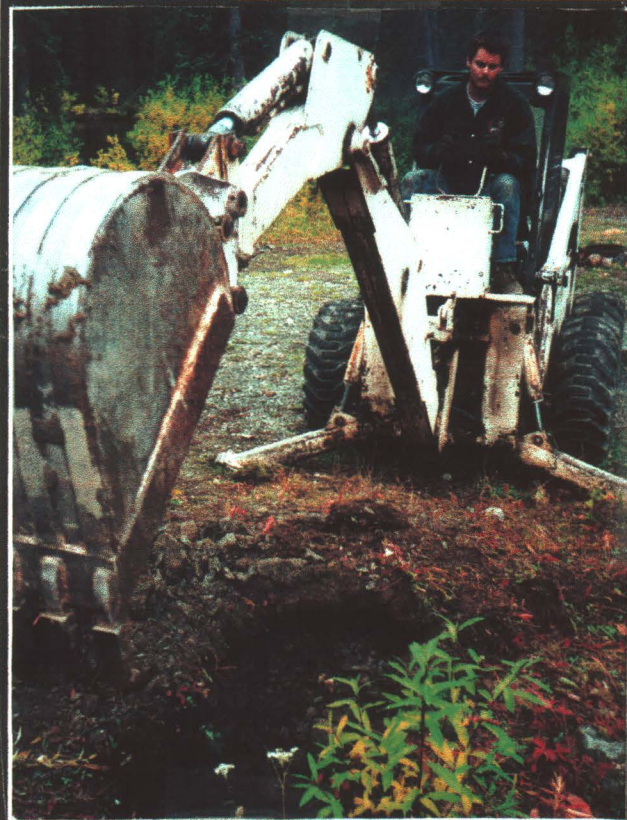
P - 4 This last picture was taken during the excavation of one of the test pits at this site.

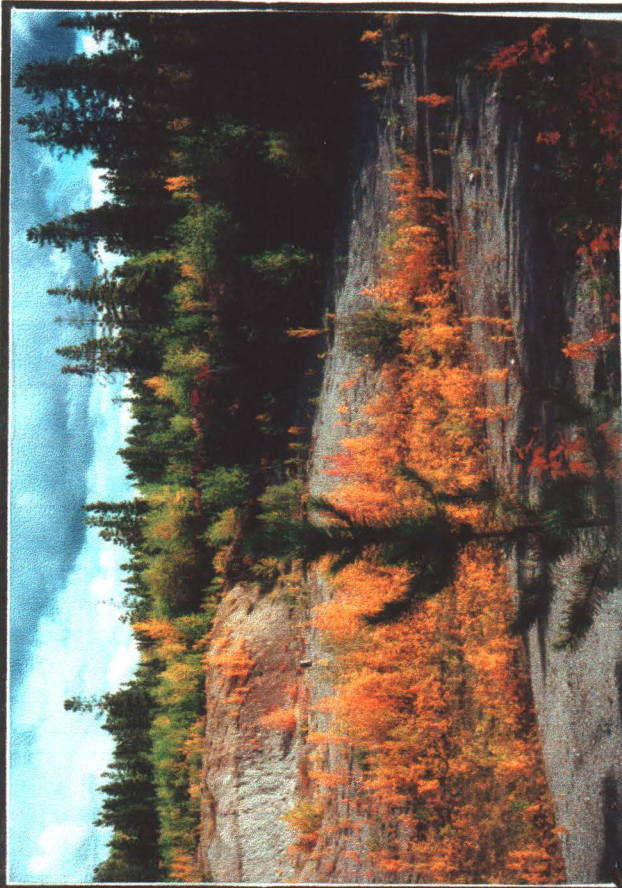
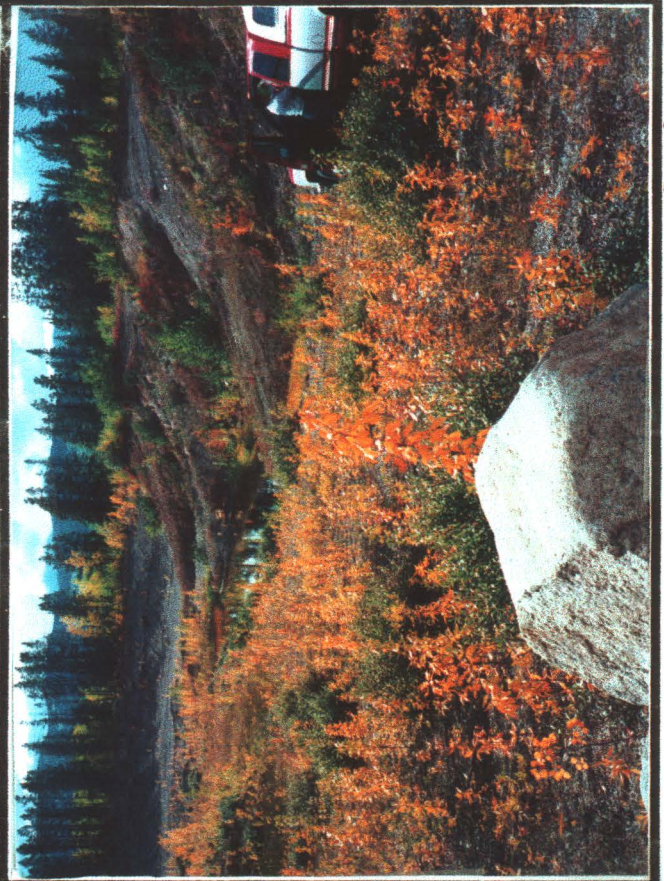
P - 3 P3 was taken from the south/west end of the investigation site and identifies the back portion of the site and also shows a 45 gallon fuel drum that was disposed of at this site. This drum did have product in it, that had leaked into the soil.

It is the recommendation of Groundtrax Inc. that no remediation is required at this site as a result of the Alaska Highway construction but it is suggested that the area located at SGS No 1 be excavated and the contaminated soil from that location be removed and disposed of at a certified disposal site. Also the three barrels located at the southern end of the site be removed and disposed. It should also be kept in

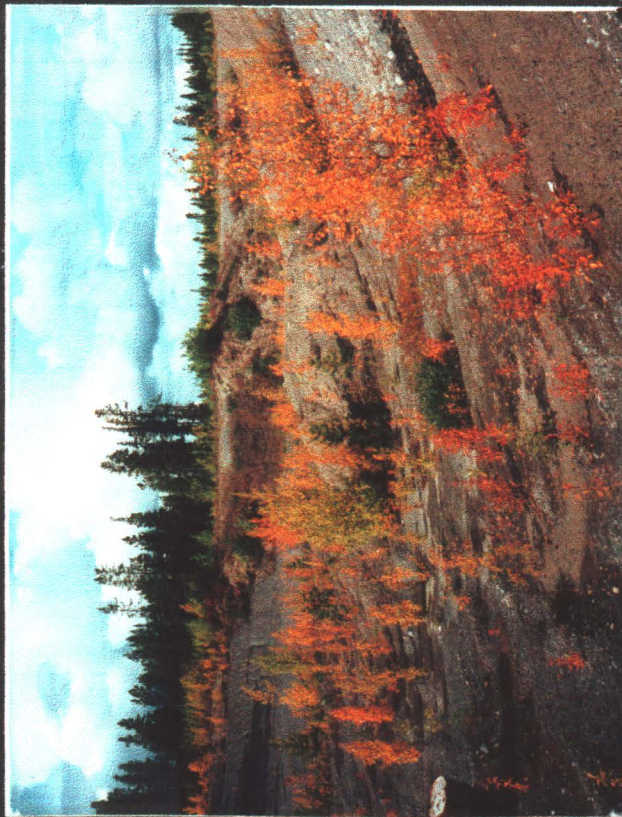
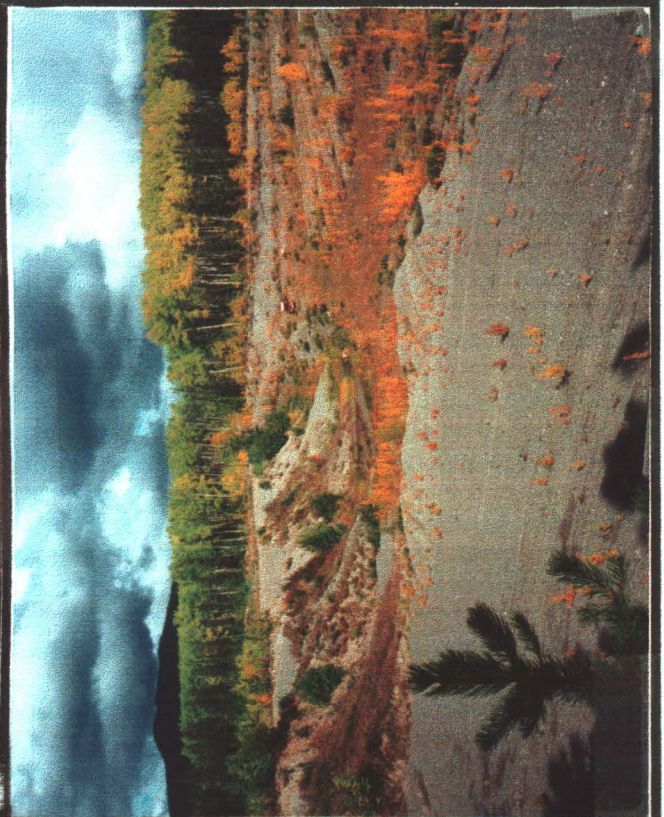
P - 4 A second shot of the fuel drum, this time from the south/east end of the site.

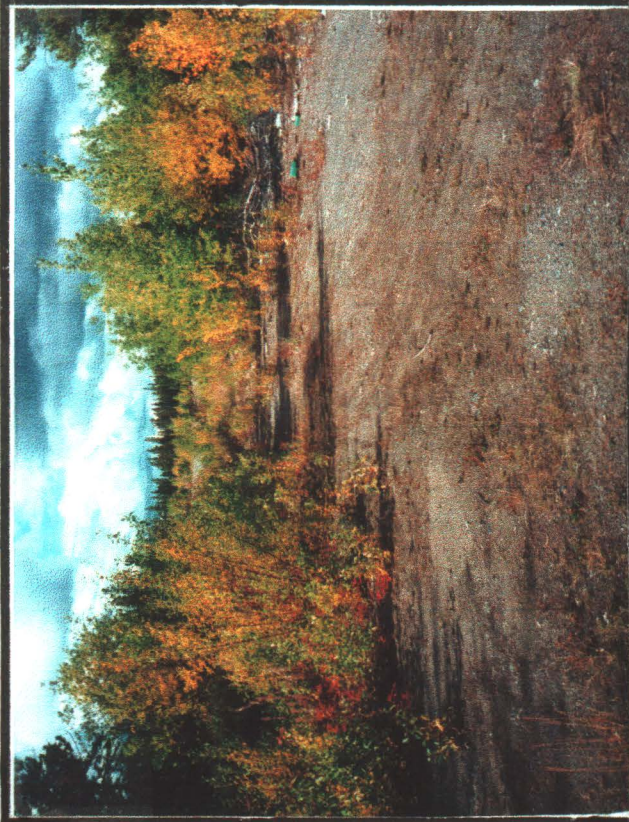
P - 4 This photo was taken of the area to the west of the dump site is the general direction to the gravel pit to the west.
