An Environmental Assessment of Snag Airstrip Yukon Territory

Environmental Sciences Group
Royal Military College
Kingston, Ontario

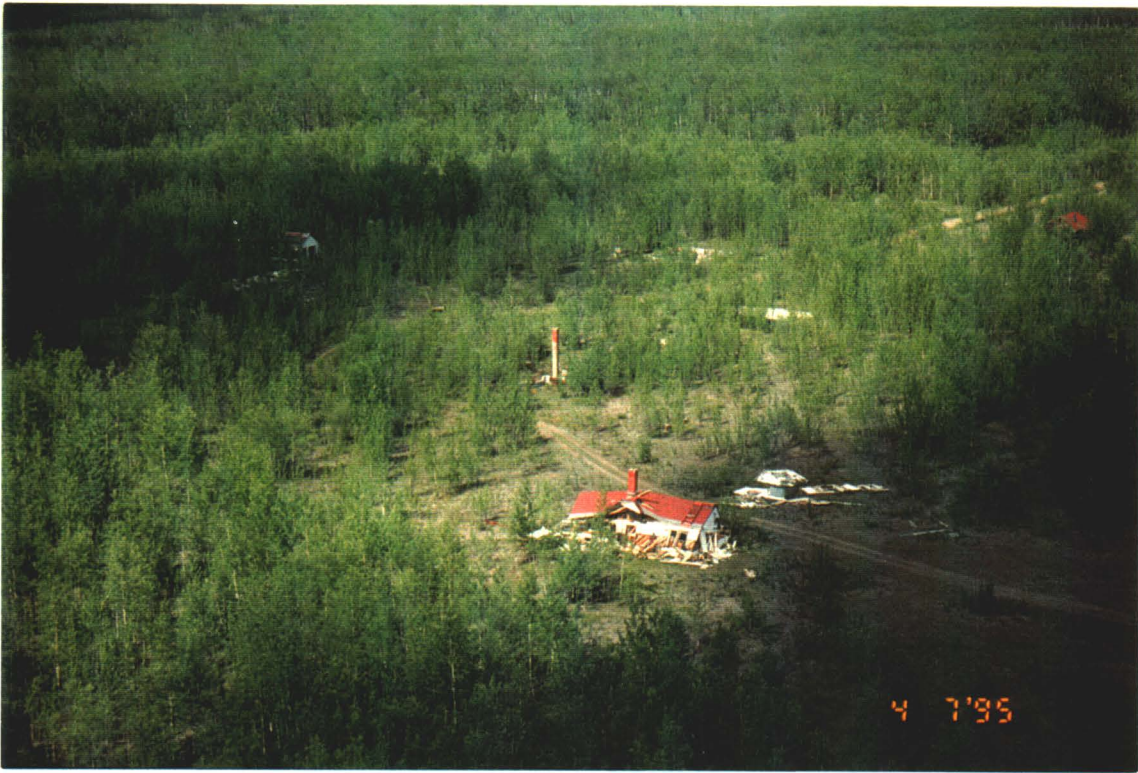
Photograph III-1: Aerial view from the south of the tower building.

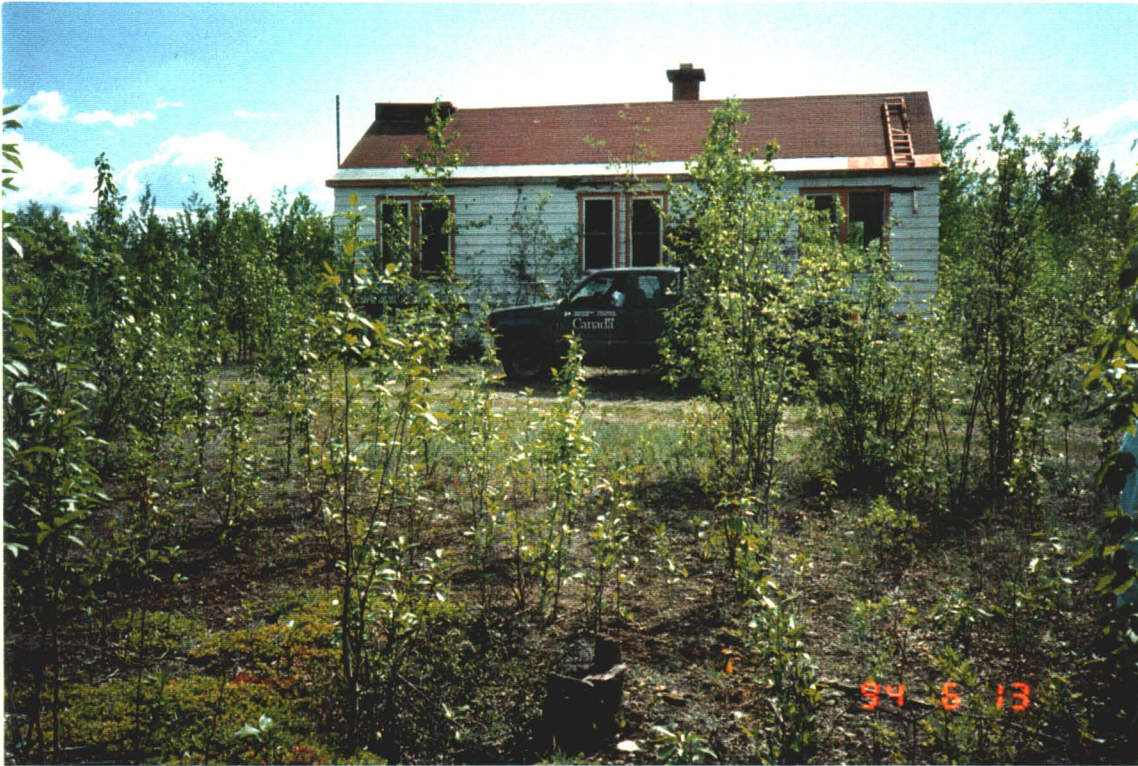
Photograph III-2: The tower building as it appeared during the preliminary investigation of Snag Airstrip in 1994.

Two paint chip samples, including a field duplicate, collected from the interior walls of the tower building were analyzed for inorganic elements. Cobalt, lead, zinc, chromium and arsenic were detected in the paint and could represent a human health hazard during demolition activities.

Soils in six locations around the tower building were found to contain at least one contaminant at a concentration exceeding the CCME R/P Remediation Criteria. The inorganic elements lead, zinc and copper were the main contaminants of concern detected in soils near the tower building. Delineation of one area affected by elevated levels of inorganic contaminants through the collection of 23 gridded soil samples was only partly successful, hence further delineation will be required in order to make an accurate estimate of the volume of soil requiring removal. Biota, in the form of plants growing near the tower building, have been shown to be impacted by the presence of high concentrations of lead and zinc. Elevated concentrations of PCBs in all the plant samples collected from the tower building area, but not in the corresponding soils, hint at the great

mobility of these compounds. The paint in the tower building also contains inorganic elements, in particular lead, and PCBs. Recommendations for the demolition of the building remains will be based on the potential for human health impact which this represents. Removal of soils containing elevated concentrations of inorganic elements should effectively remediate the areas affected by elevated concentrations of PCBs and pesticides.

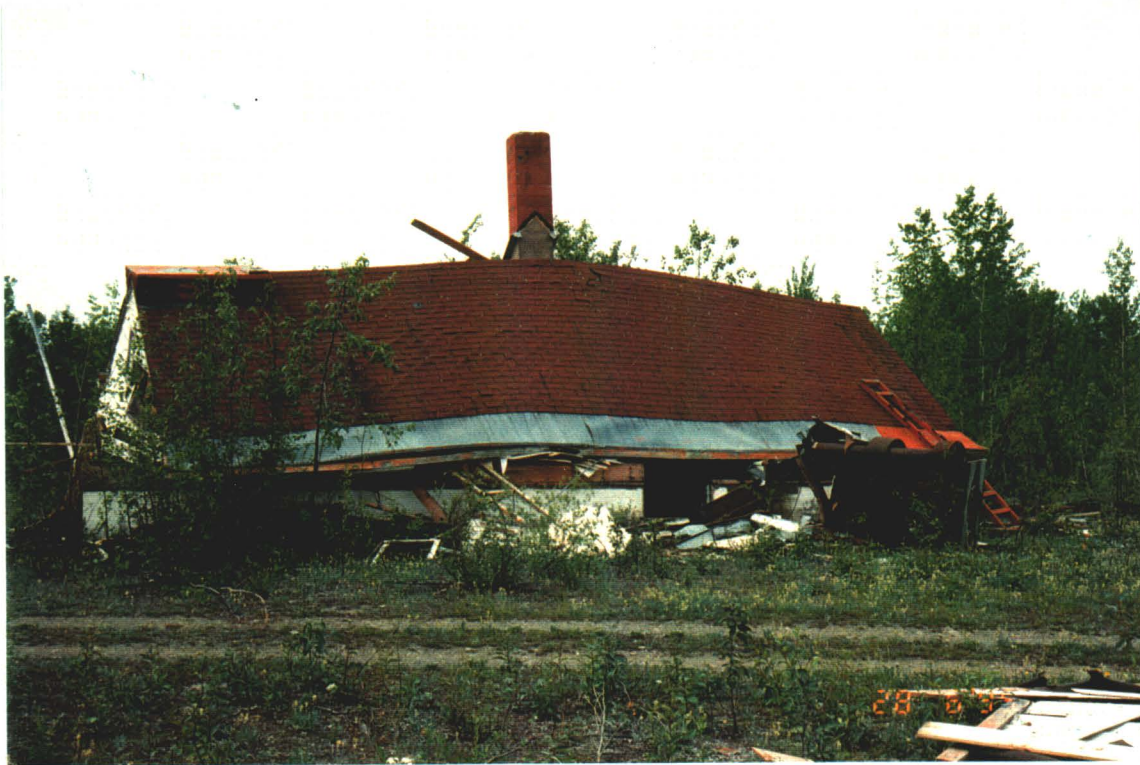
Photograph III-3: View from the south of the tower building in 1995 following its partial demolition.

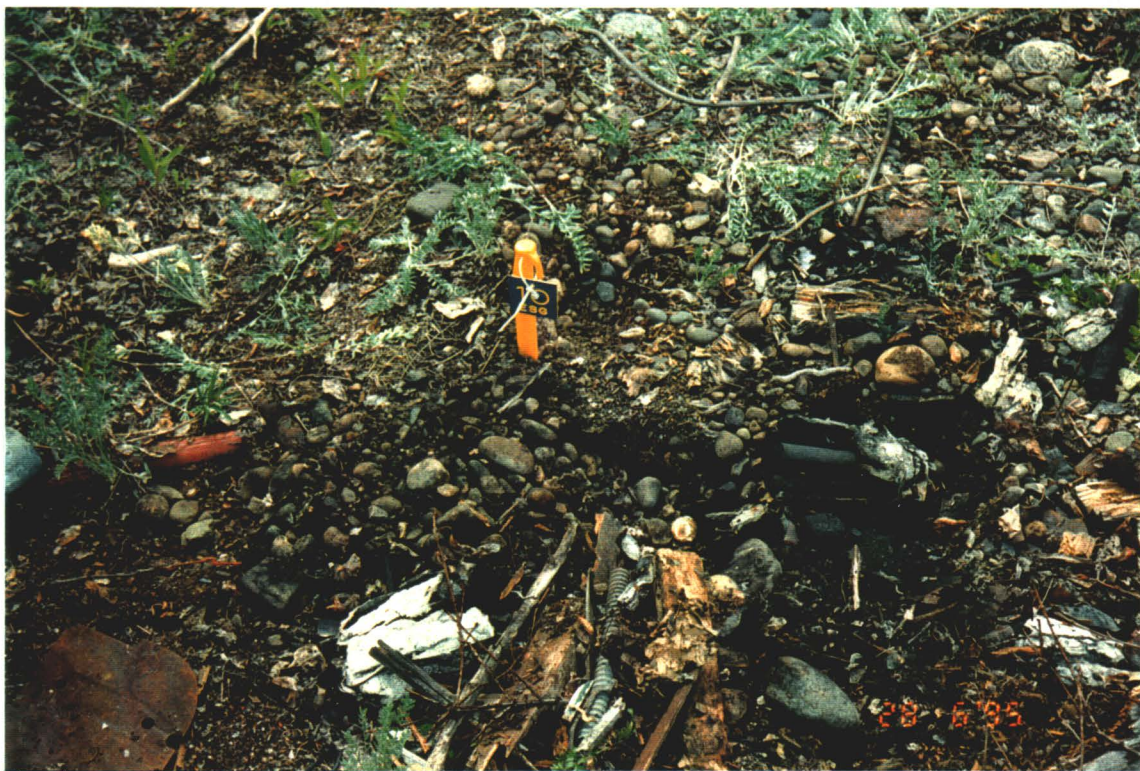
Photograph III-4: G6109 contained copper, lead, zinc, cadmium and pesticides at concentrations exceeding the criteria.

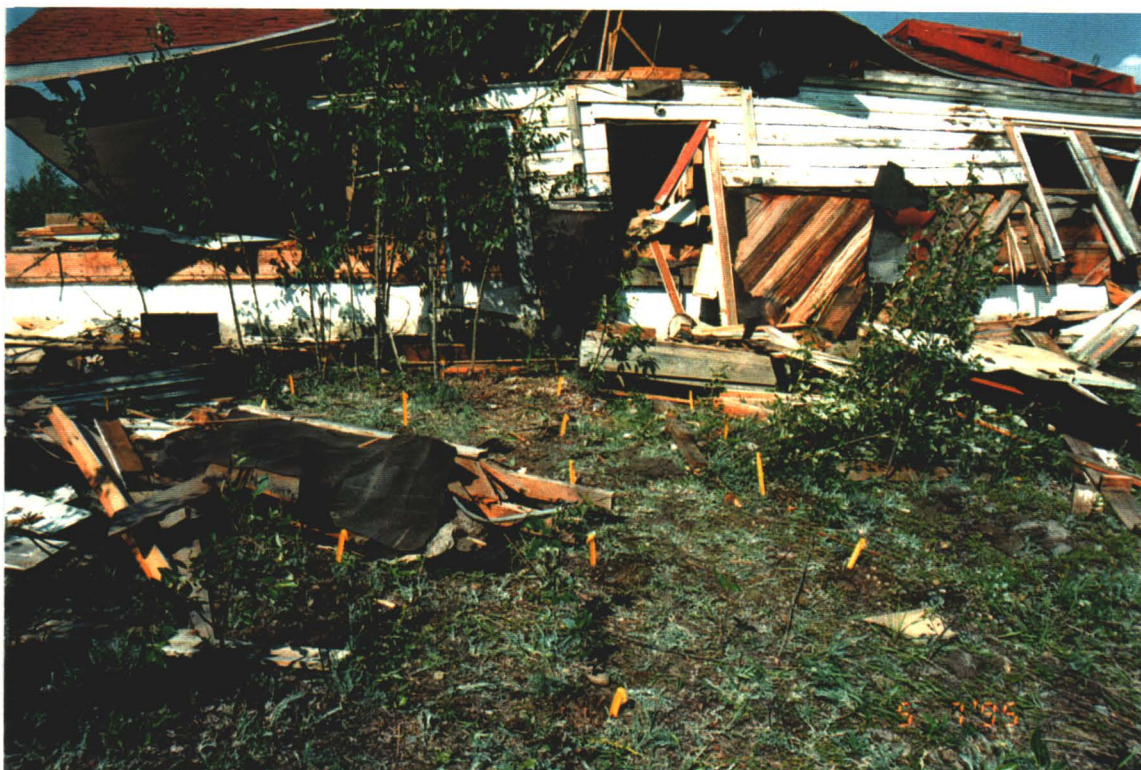
Photograph III-5: Delineation soil samples collected around G6100 which contained elevated concentrations of copper, lead and zinc.

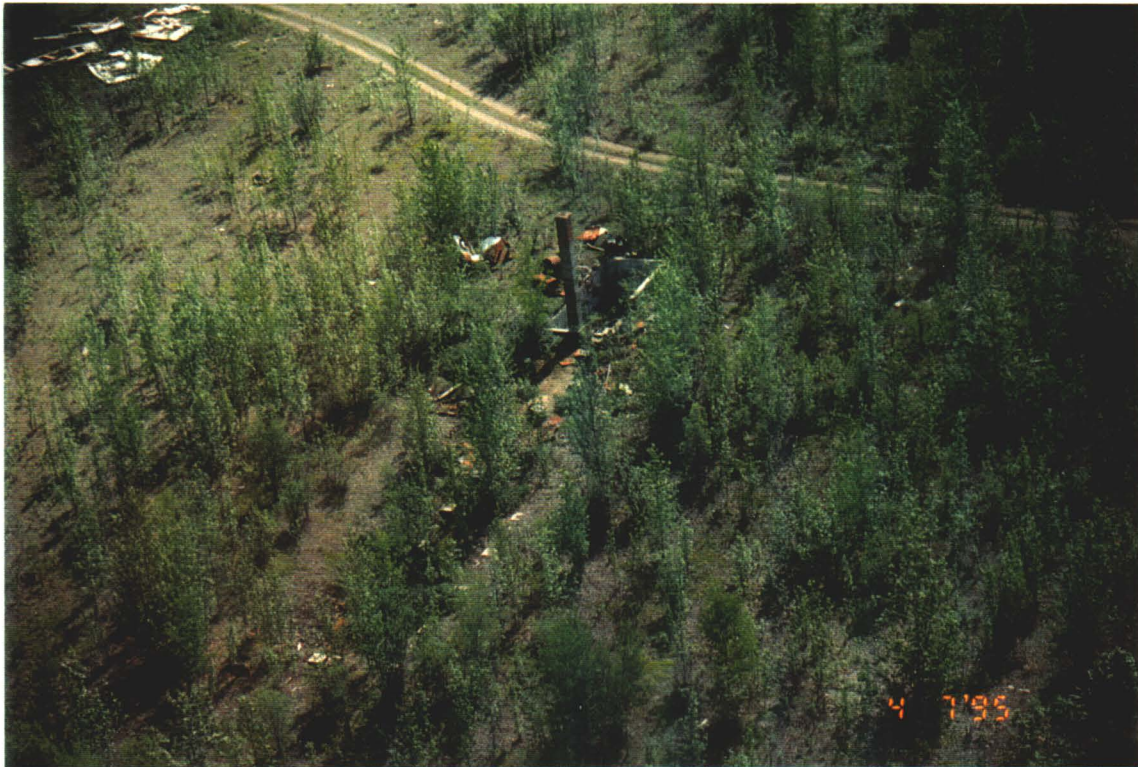
Photograph III-6: Aerial view of the concrete foundation, chimney and pairs of concrete supports marking the former site of the DOT barracks building.

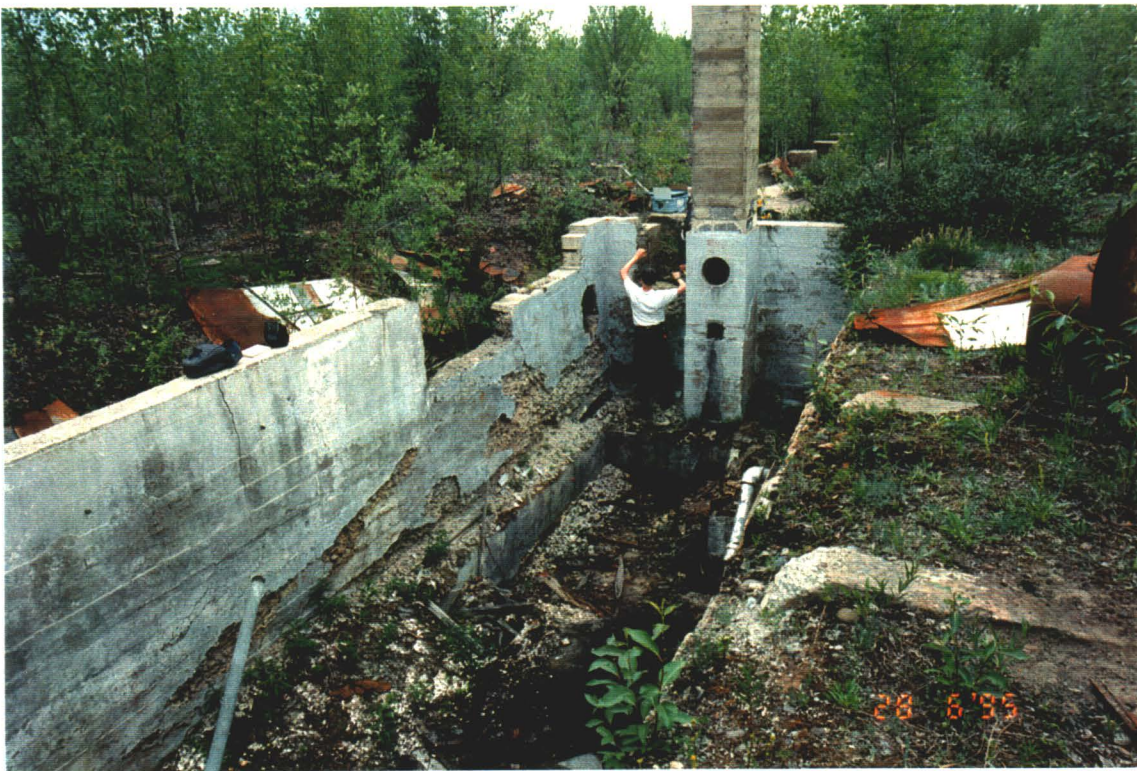
Photograph III-7: DOT Barracks Building basement as viewed from the south.

The DOT barracks building was located in the southern half of the site, north of the tower building approximately 50 m (see Map II-1), marked by a large brick chimney and a concrete foundation (Photograph III-6) forming what would have been a basement (Photograph III-7). Pairs of concrete supports extended out from the foundation to the northeast and may represent the extent of the building when it was intact. Debris was scattered extensively around the building area and included domestic items like tin cans as well as building materials including sheet metal, tar shingles, insulation, piping, wood and pressboard. Much of the debris around the building was partially or completely buried suggesting the area had been worked to some extent. In addition, there was a layer of ash on the substrate surface in the vicinity of the building, suggesting that its demolition may have included burning. The substrate in the vicinity of the barracks building consisted of fine to medium textured sand mixed with rocks and building materials like wood and pressboard. The soil also had an organic component consisting of dried leaves, roots and detritus. In many areas there was a layer of ash over the soil. Vegetation in the vicinity of the building was of moderate density and consisted primarily of early successional species including shrubs like poplars (*Populus balsamifera*, *P. tremuloides*) and willows (*Salix* spp.), and some herbs (*Solidago decumbens*, *Arctostaphylos uva-ursi*). A thin layer of soil supporting growth by moss and fireweed (*Epilobium angustifolium*) has covered the floor of the basement (Photograph III-7).

The debris and moss on the floor of the barracks building basement is contaminated with PCBs at a level exceeding that regulated by CEPA. Soil PCB concentrations in the general vicinity of the building foundation exceed background concentrations but not applicable criteria. Elevated concentrations of PCBs in vegetation collected near the barracks building suggest that the impact of soil contamination on local biota is significant and is not limited to plants growing directly in contaminated soil.

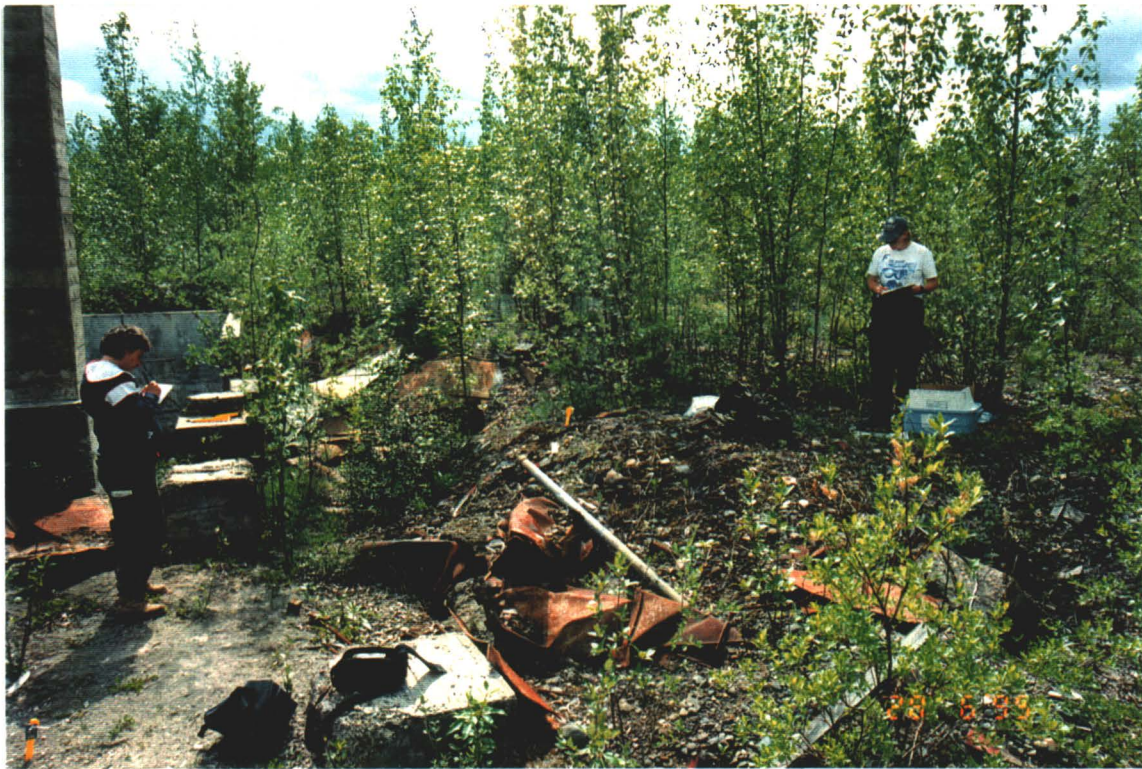
Photograph III-8: Samples collected off the west side of the barracks building foundation (G6116, G6117A/B) contained elevated levels of nickel, zinc and arsenic.

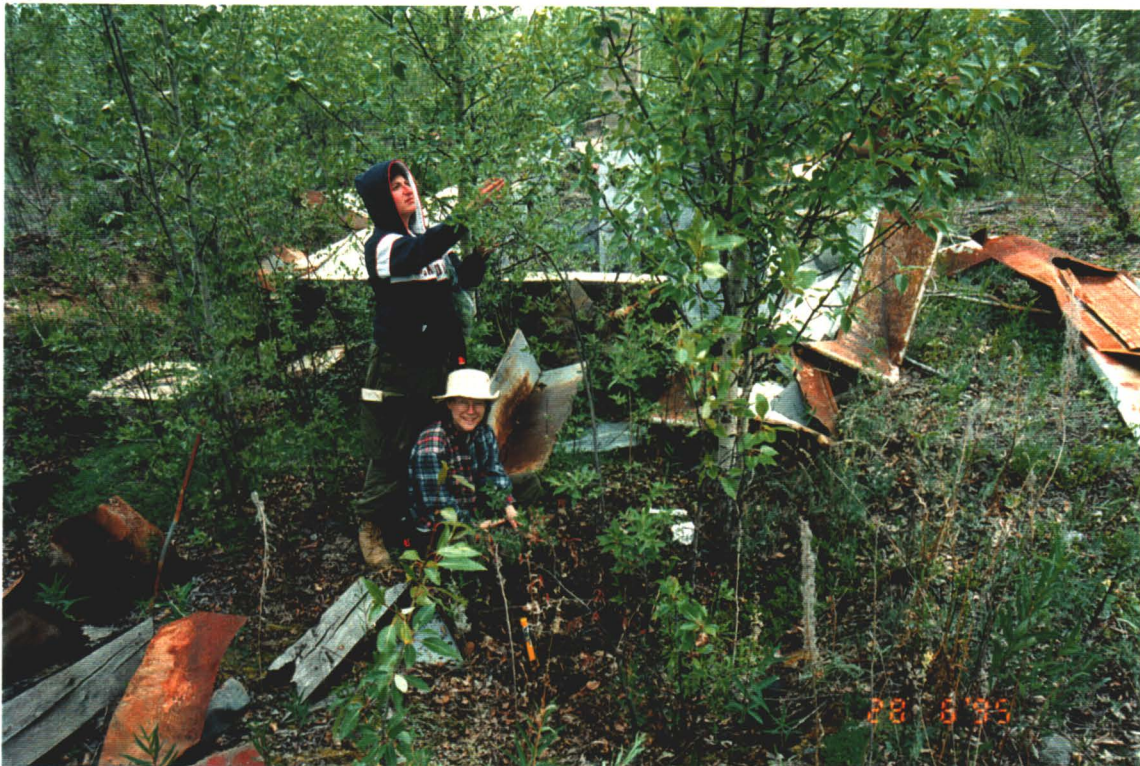
Photograph III-9: Soil sample G6118, collected in a depression at the south end of the barracks, contained lead and zinc at concentrations exceeding the criteria.

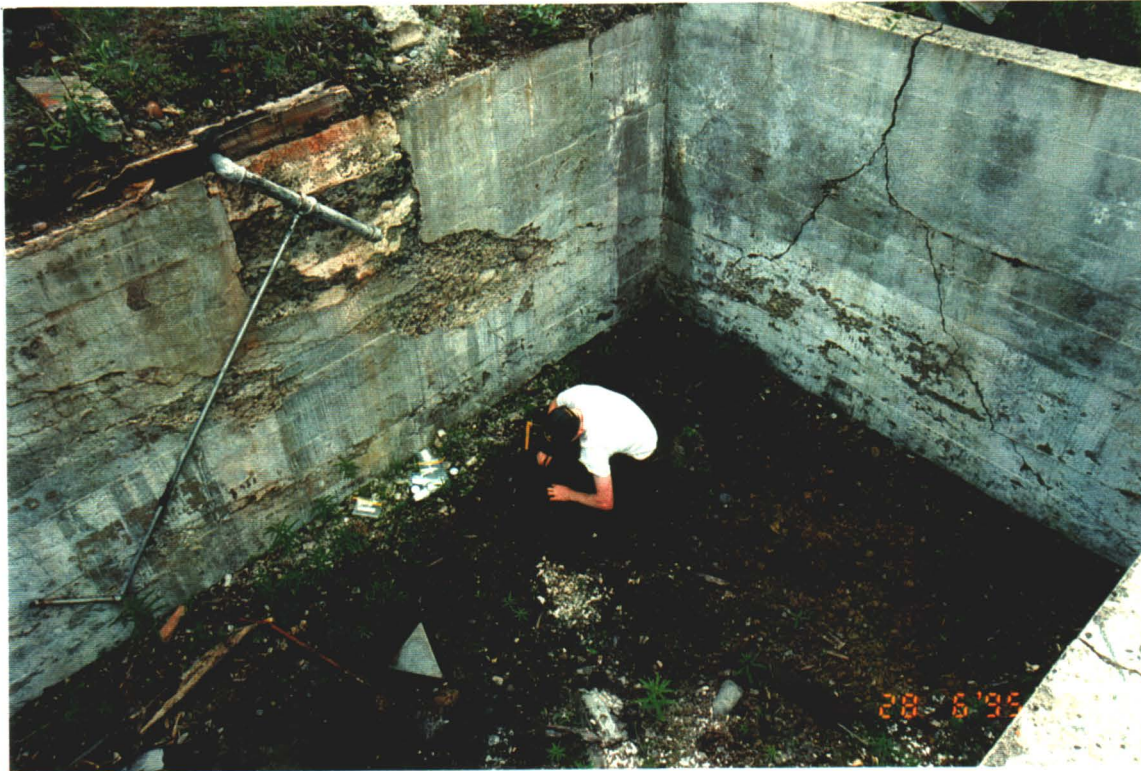
Photograph III-10: PCB concentrations in violation of CEPA and high levels of dioxins were found in soils collected in the barracks basement (G6119A/B).

The assessment soil sample collected in the barracks building basement (G6119A) was analyzed for pesticides in duplicate. The high concentration of PCBs in this sample interfered significantly with the analyses, resulting in very high detection limits. Hence the presence of pesticides in soils from the barracks basement could not be confirmed. This soil will be removed, however, because it contains PCB levels in violation of CEPA.

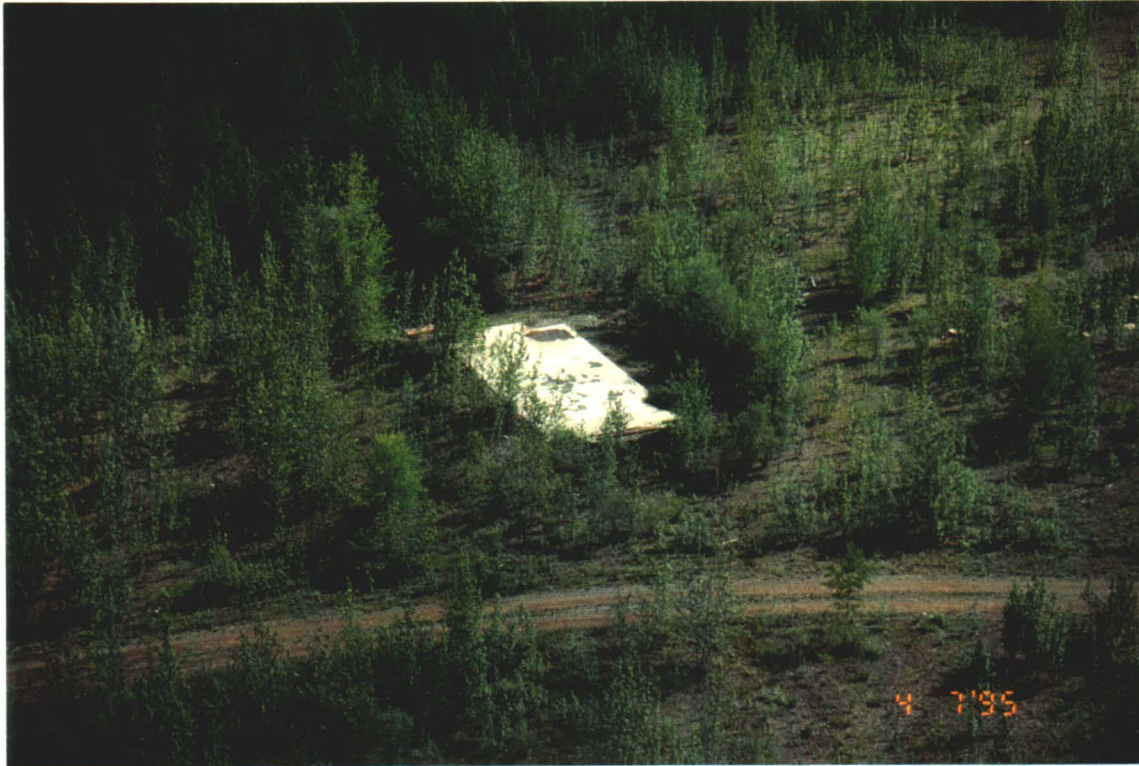
Photograph III-11: Aerial view from the north of the warehouse foundation with Snag Road in the foreground.

The warehouse was located between the DOT barracks building and the married quarters on the east side of Snag Road (see Map II-1, Photograph III-11). All that remained was the concrete foundation and a set of stairs extending from the southeast side of it. There was evidence of a bay door at the northwest end facing Snag Road. Debris in the area around the building included a pile of transformer plates south of the south corner of the building, and a small tin can which had a large stain associated with it near the west side of the foundation. Metal filings and a grey powdery substance were scattered over the northwest half of the foundation. There was a wooden platform just southeast of the warehouse stairs that may have been a pallet for the storage of materials (Photograph III-12). Wooden slats running southeast from the platform suggested that this area was the site of a temporary storage building like a Quonset hut, in which case, the wooden platform which was painted orange like the stairs may have served as a door stoop. The substrate in the vicinity of the warehouse consisted of medium to coarse sand with organics and rocks mixed in varying amounts. Vegetation in the vicinity of the building, as with much of the rest of the site, consisted primarily of early successional species including shrubs like poplars (*Populus balsamifera*, *P. tremuloides*) and willows (*Salix* spp.), and some herbs (e.g. *Epilobium angustifolium*, *Oxytropis campestris*).

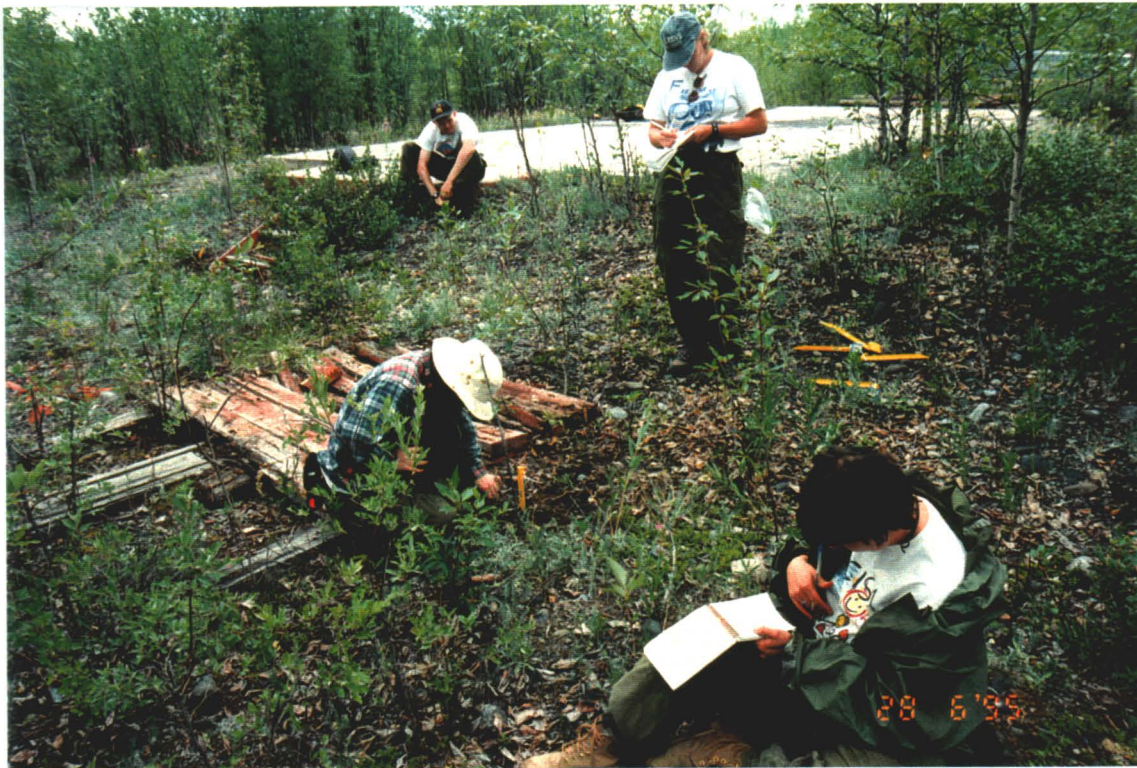
Photograph III-12: View from the east of the warehouse foundation with the orange wooden platform in the foreground.

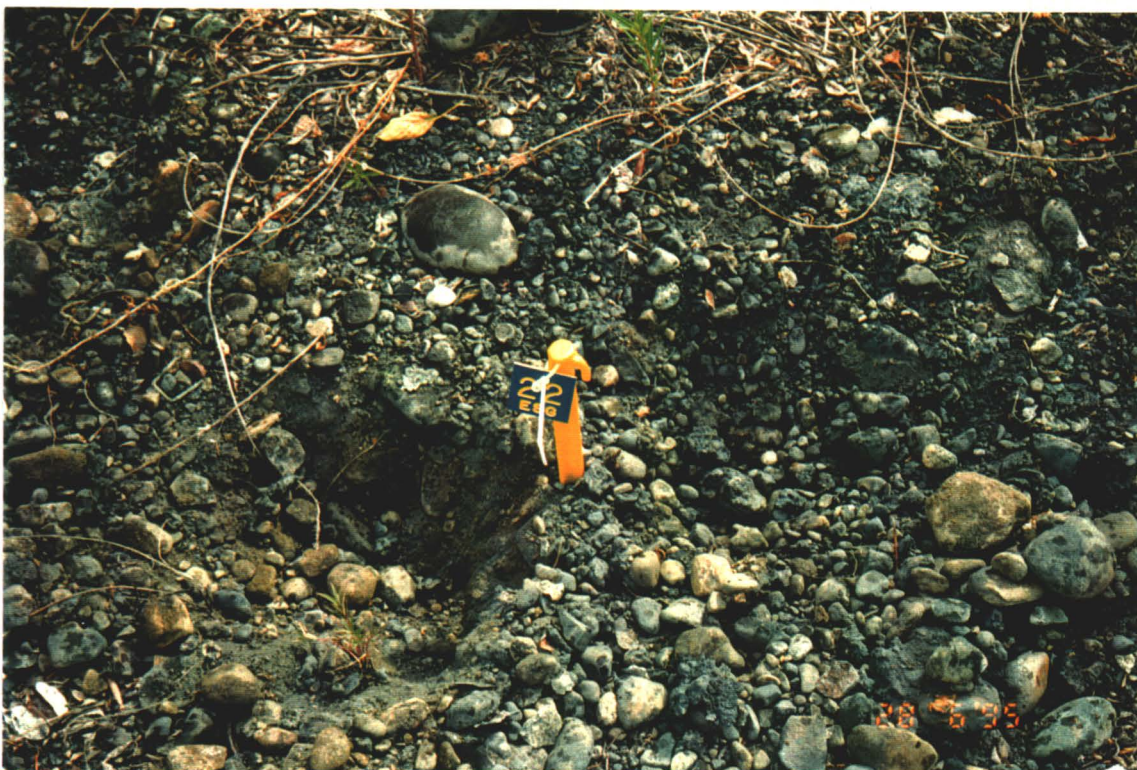
Photograph III-13: Soil sample G6121, collected in this stain on the west side of the warehouse, contained very high levels of copper, zinc and leachable lead.

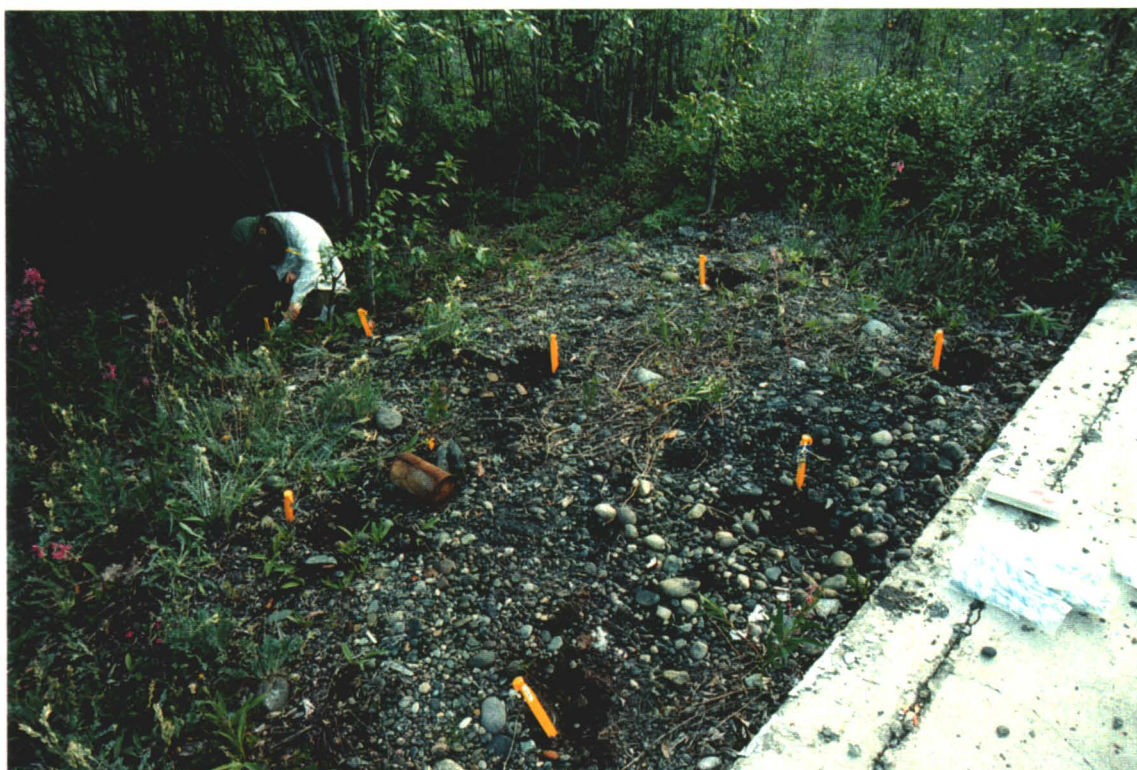
Photograph III-14: Sample pegs indicating the delineation of lead, copper and zinc contamination detected in soil sample G6121 (sample series SN22).

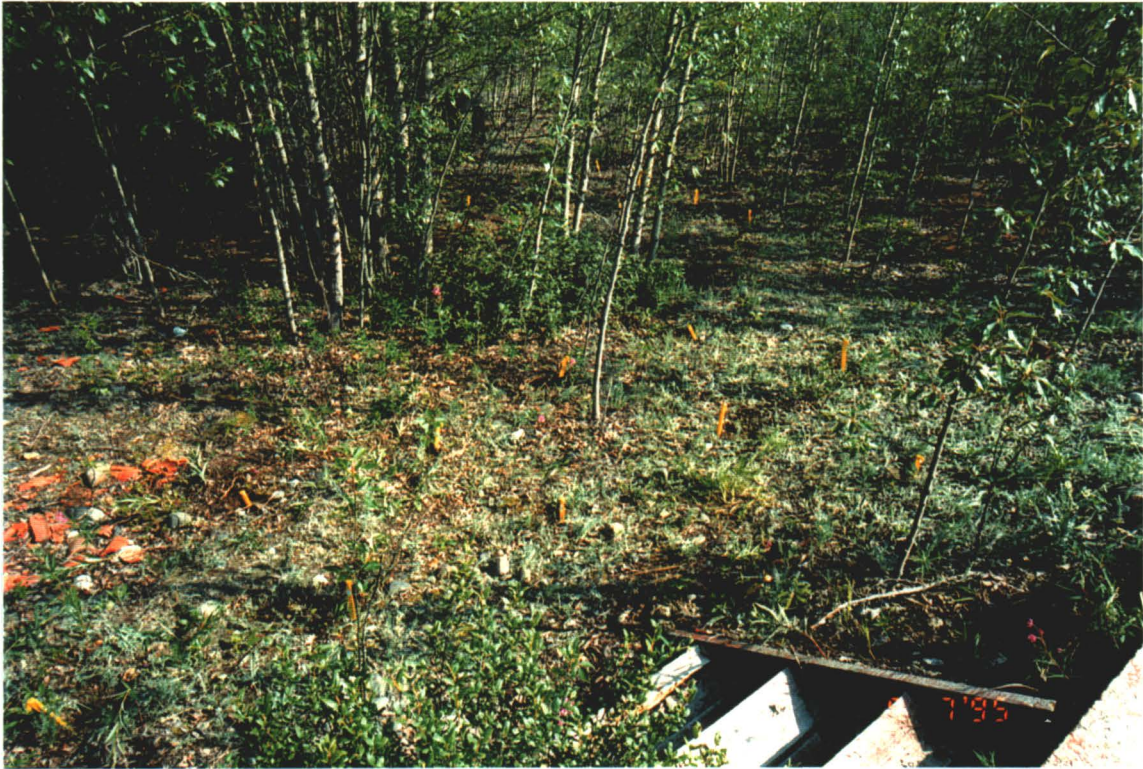
Photograph III-15: Sample pegs indicating the delineation of copper and zinc contamination detected at G6123 (sample series SN24). Delineation sample series SN39 is visible in the background.

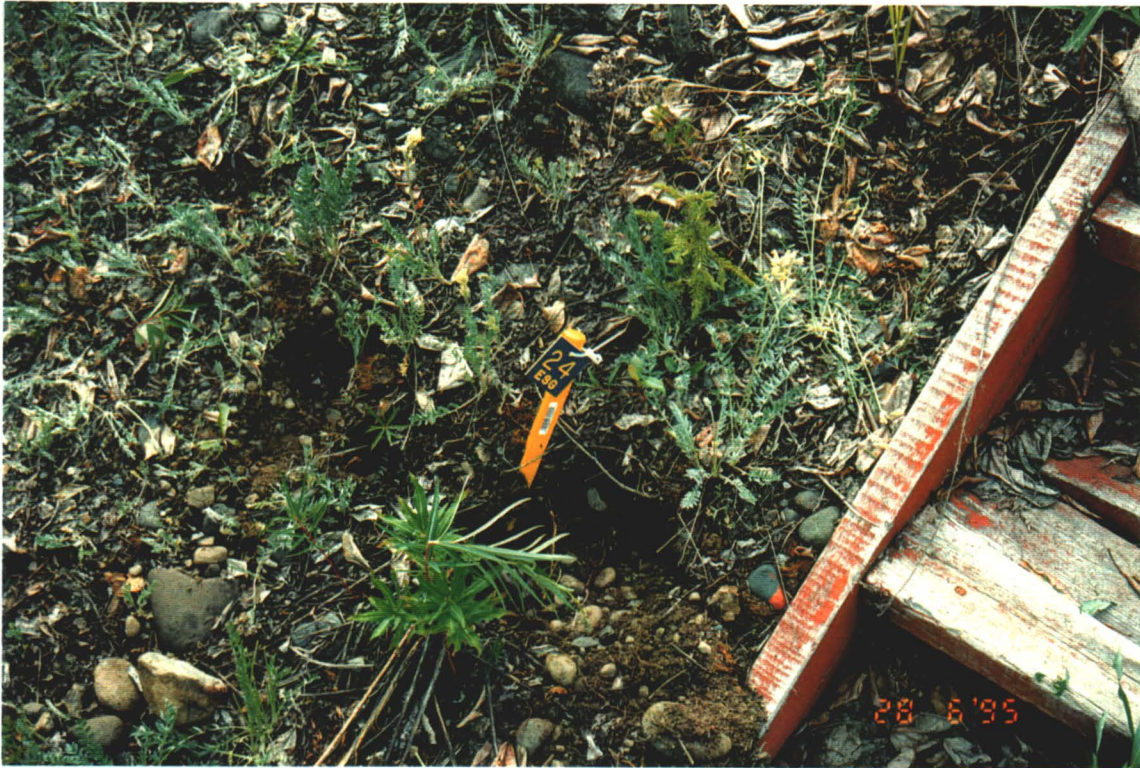
Photograph III-16: Soil sample G6123 contained PCBs, copper and zinc at concentrations exceeding the criteria.

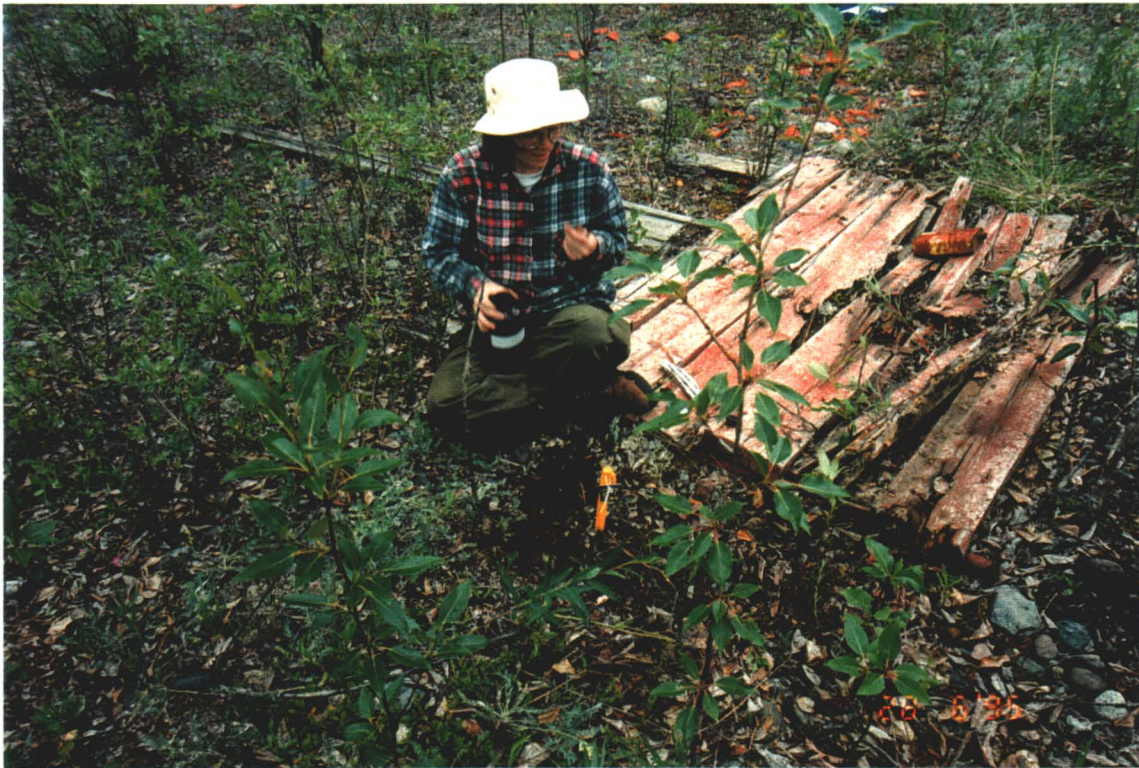
Photograph III-17: Soil sample G6126 contained unidentified chlorinated organic compounds which interfered with PCB analyses.

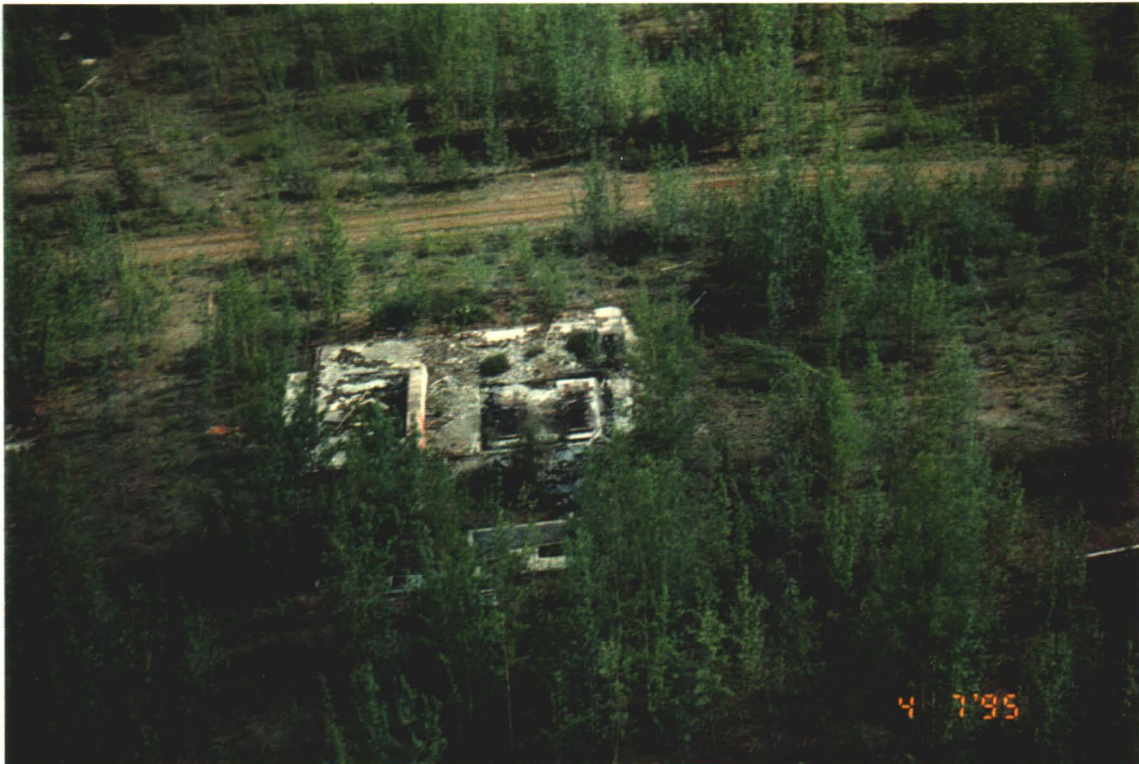
Photograph III-18: Aerial view from the west of the powerhouse and pump house foundations.

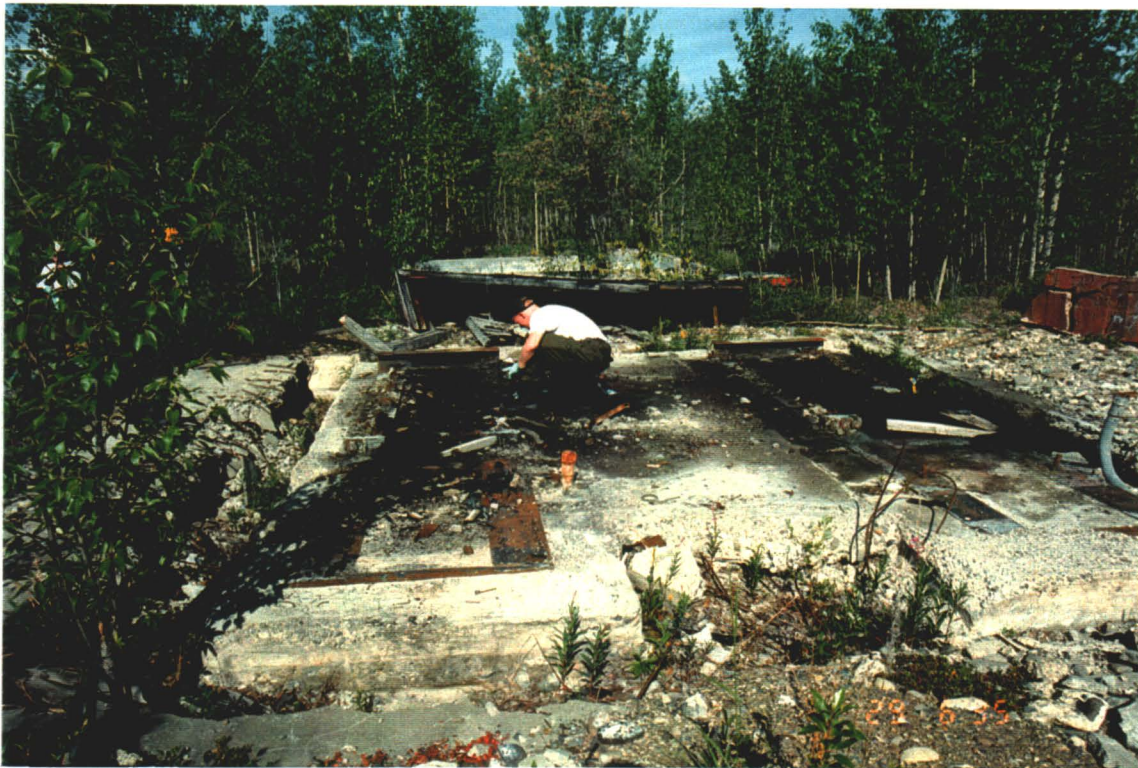
Photograph III-19: The oil-stained south half of the powerhouse foundation as viewed from the east.

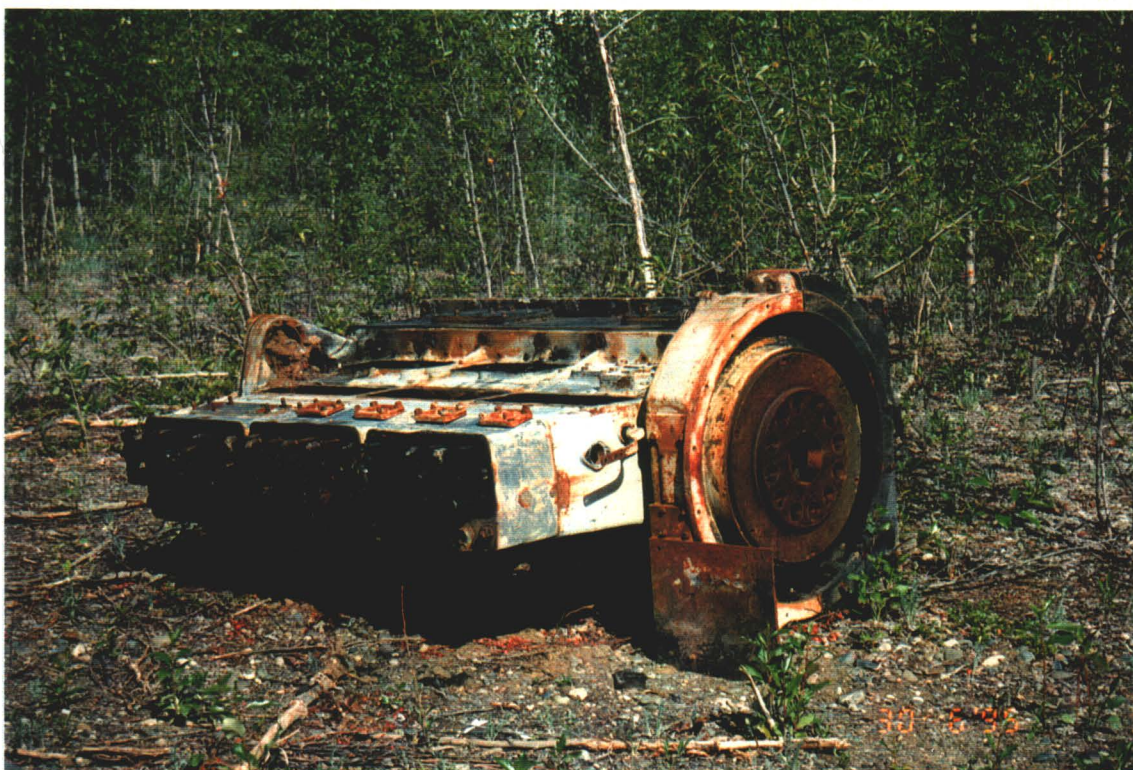
Photograph III-20: Part of one of the generators was found lying on the side of Snag Road just south of the powerhouse.

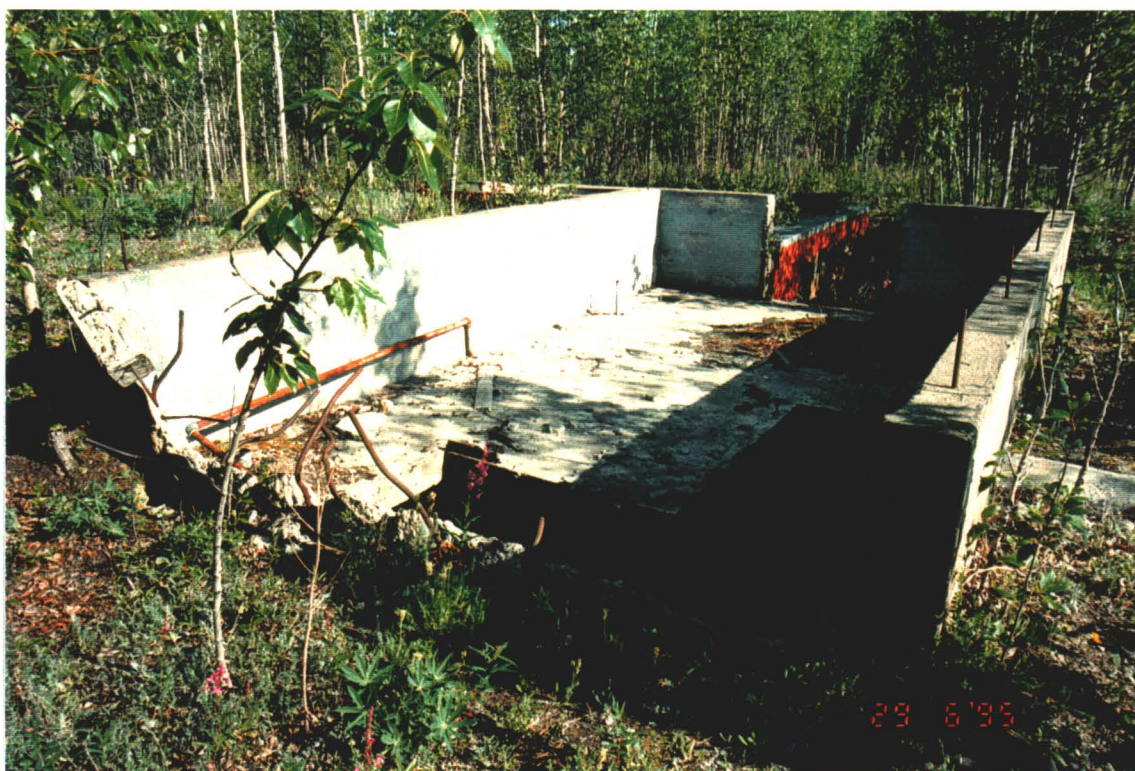
Photograph III-21: The pump house foundation as viewed from the southwest with the opening to its basement visible.

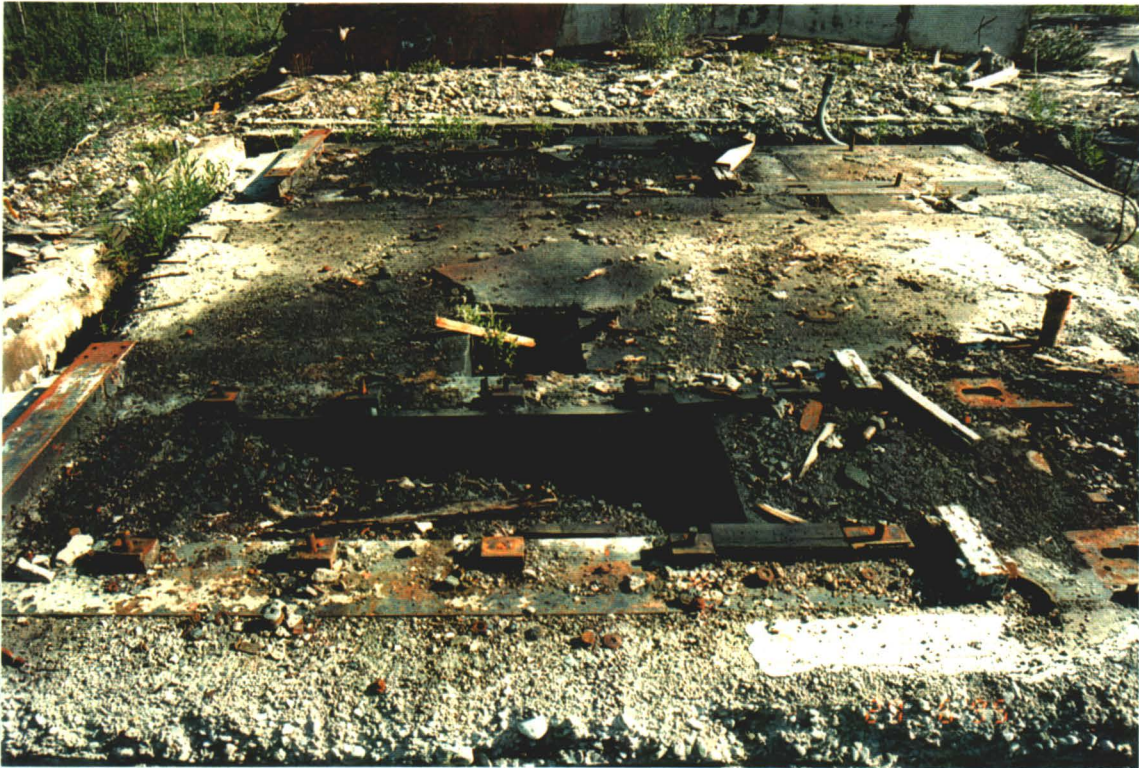
Photograph III-22: Oily sludge on the powerhouse foundation contained PCBs at concentrations exceeding the level regulated by CEPA.

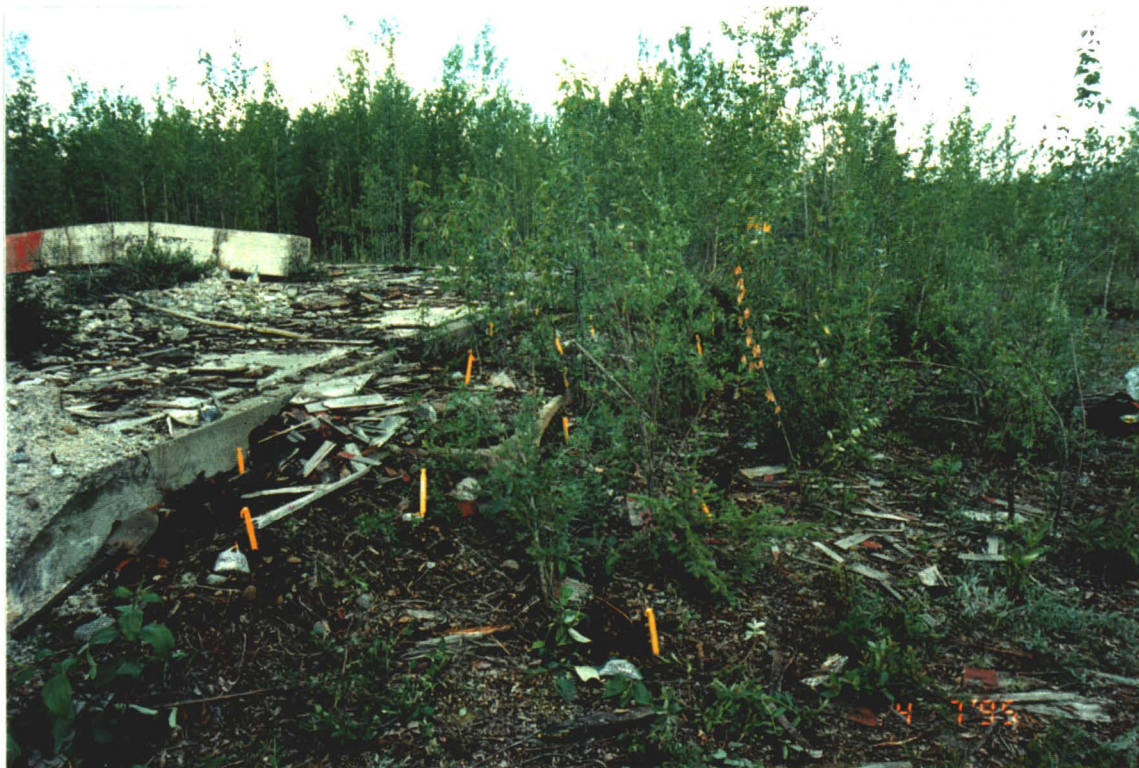
Photograph III-23: Pegs indicating the delineation of contamination on the eastern side of the powerhouse foundation (sample series SN33).
