An Environmental Assessment of Snag Airstrip Yukon Territory

Environmental Sciences Group
Royal Military College
Kingston, Ontario

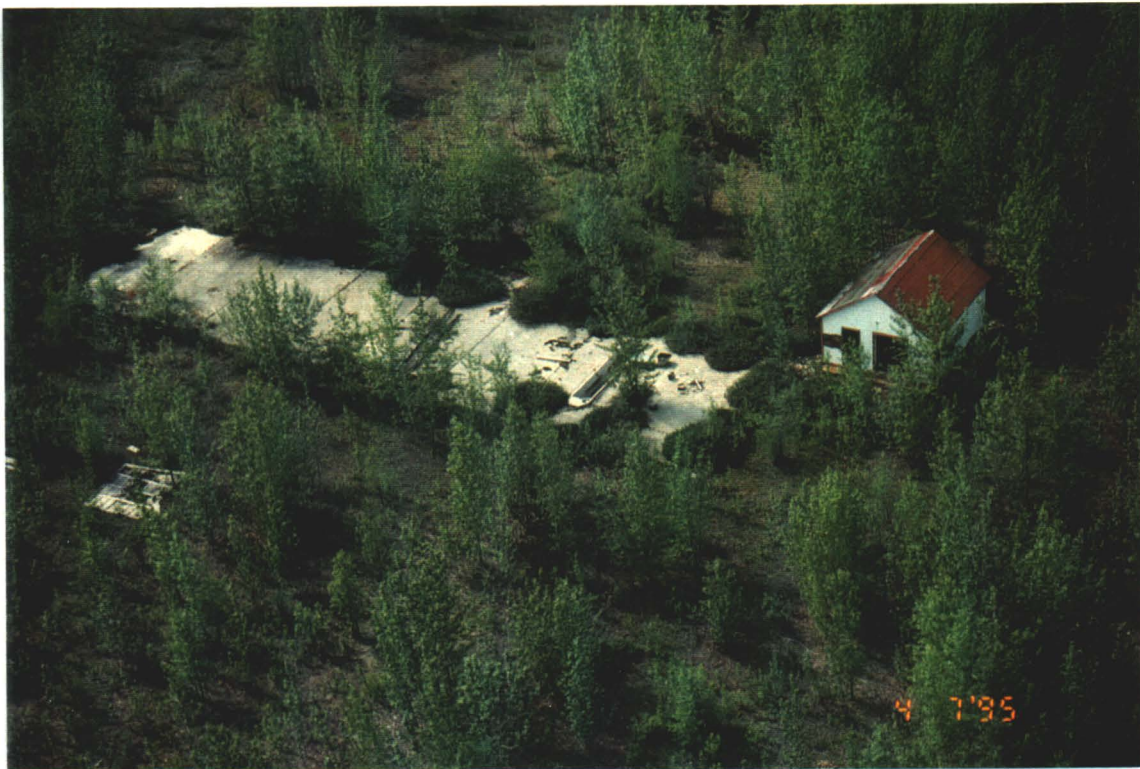
Photograph III-24: Aerial view from the east of the fire hall next to the garage foundation.

Concentrations of PCBs in soils collected around the fire hall did not exceed the CCME R/P Remediation Criterion, but were higher than background soil concentrations. The interior surface of the building walls did not contain detectable extractable amounts of PCBs.

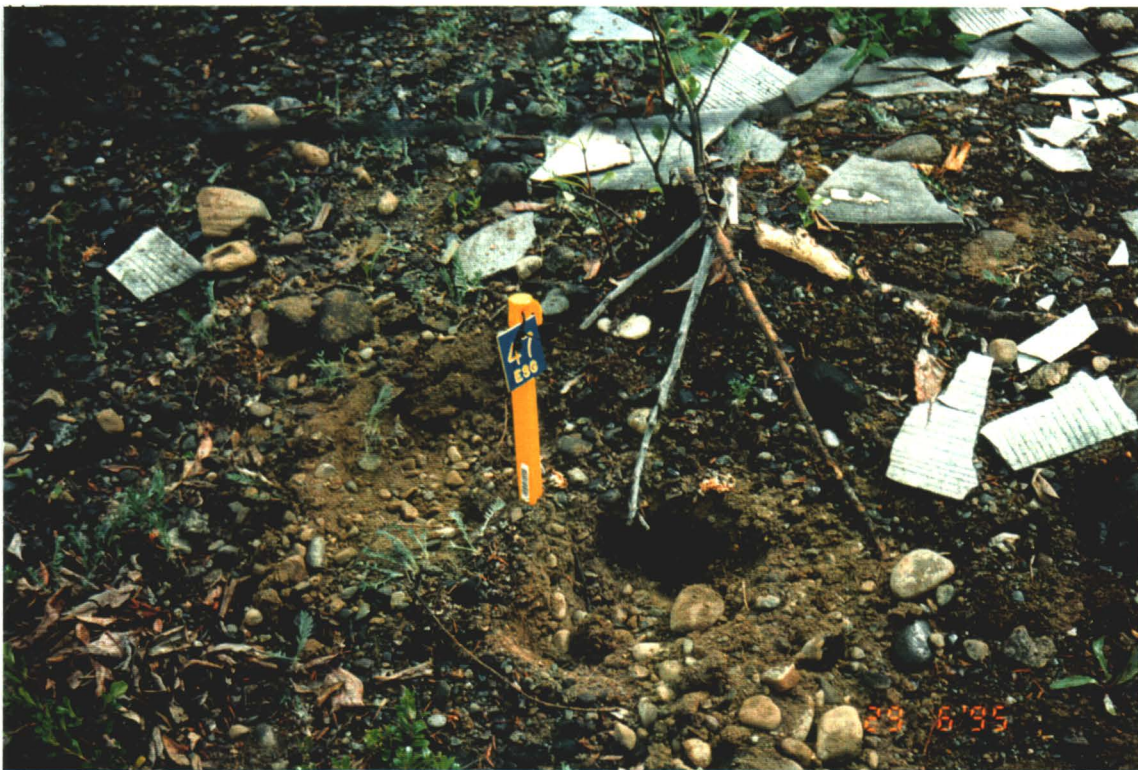
Photograph III-25: The oily sheen on the rocks around the fire hall was evidently caused by balsam dripping off the poplars growing in the area.

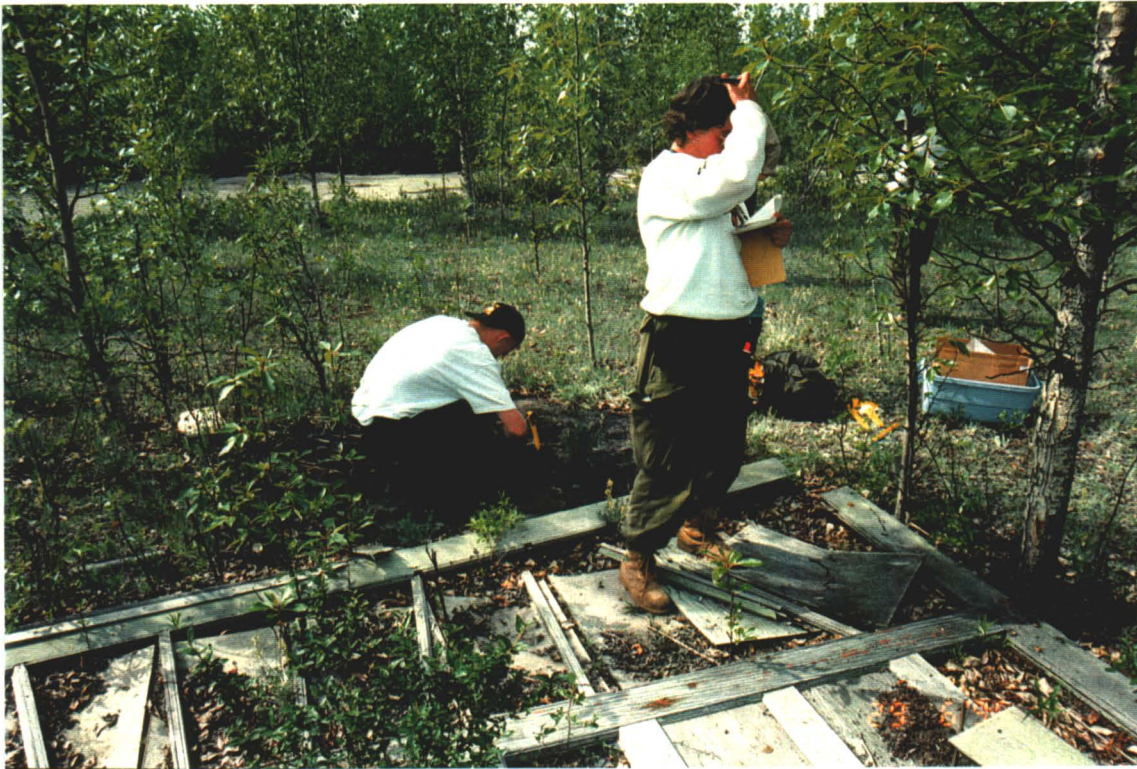
Photograph III-26: A sample of ash and soil collected from beside the garage bay door (G6157) contained lead, zinc, nickel and copper at levels exceeding the criteria.

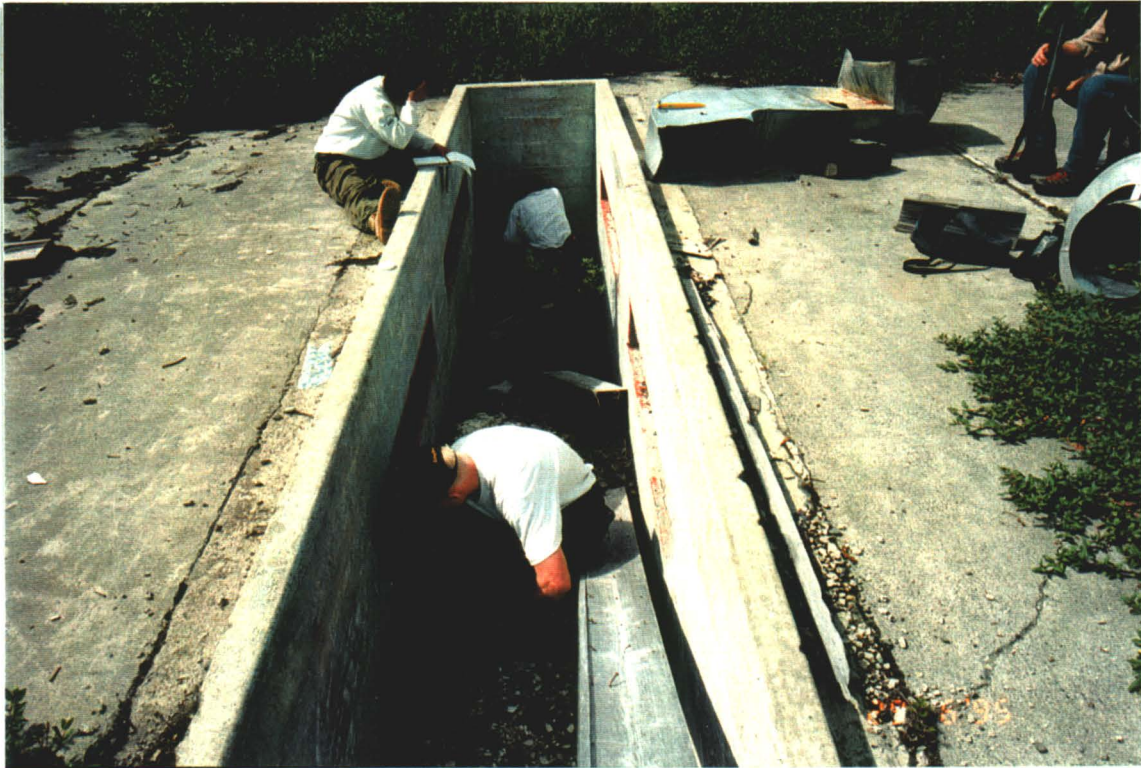
The same sample analyzed for dioxins (G6153) was also analyzed for pesticides. The total concentration of pesticides (5700 ppb) in the sample of material from the bottom of the oil-change pit exceeded the BC (2000 ppb), Québec (2000 ppb) and Netherlands (3000 ppb) Level B remediation criteria. Six of the 22 pesticide analytes were detected in this sample. Five out of six of the compounds detected were part of the DDT family of compounds and constituted 4800 ppb of the detected pesticide compounds. The parent compound *p,p'*-DDT was the most abundant form of pesticide found in the sample (2900 ppb), and its concentration exceeded the Netherlands Level B criterion for individual chlorinated pesticides (500 ppb). The concentration of the DDT metabolic product *p,p'*-DDE (1300 ppb) was 2.6 times the Netherlands criterion.

Photograph III-27: Debris from the larger oil-change pit at the garage (G6153) contained high levels of PCBs, dioxins, pesticides, PAHs and inorganic elements.

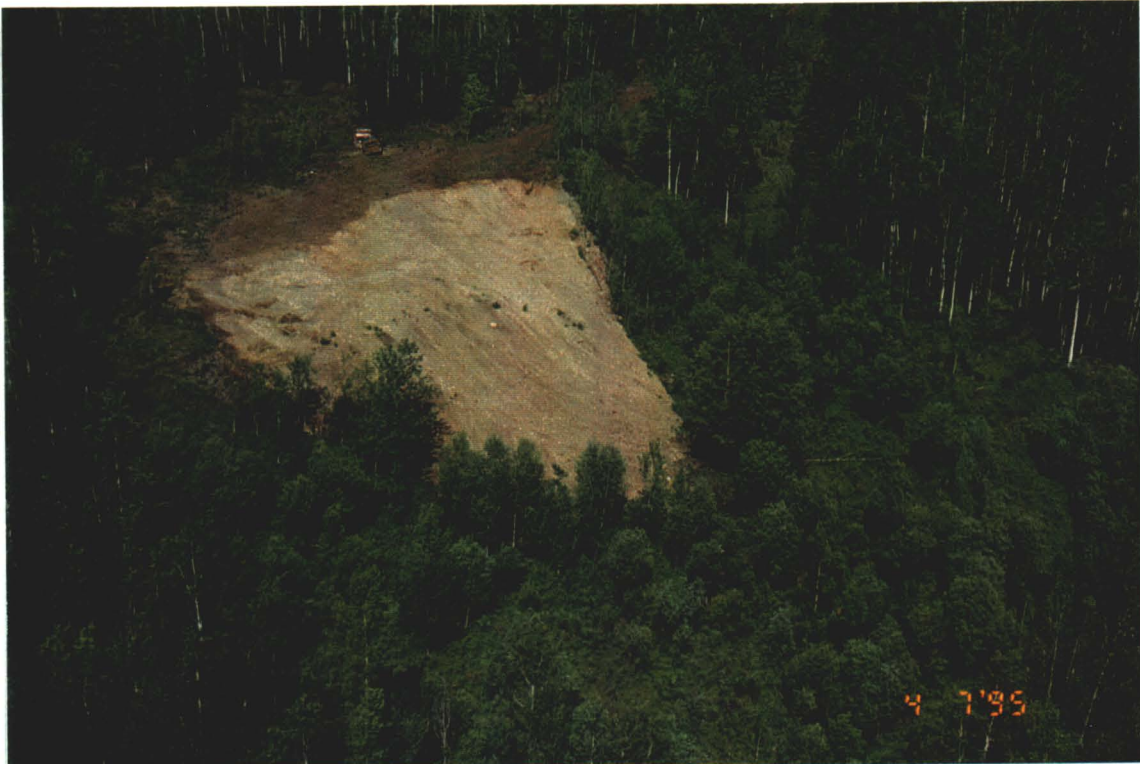
Photograph III-28: Aerial view from the southwest of the Snag Airstrip Dump showing the recently worked dump face.

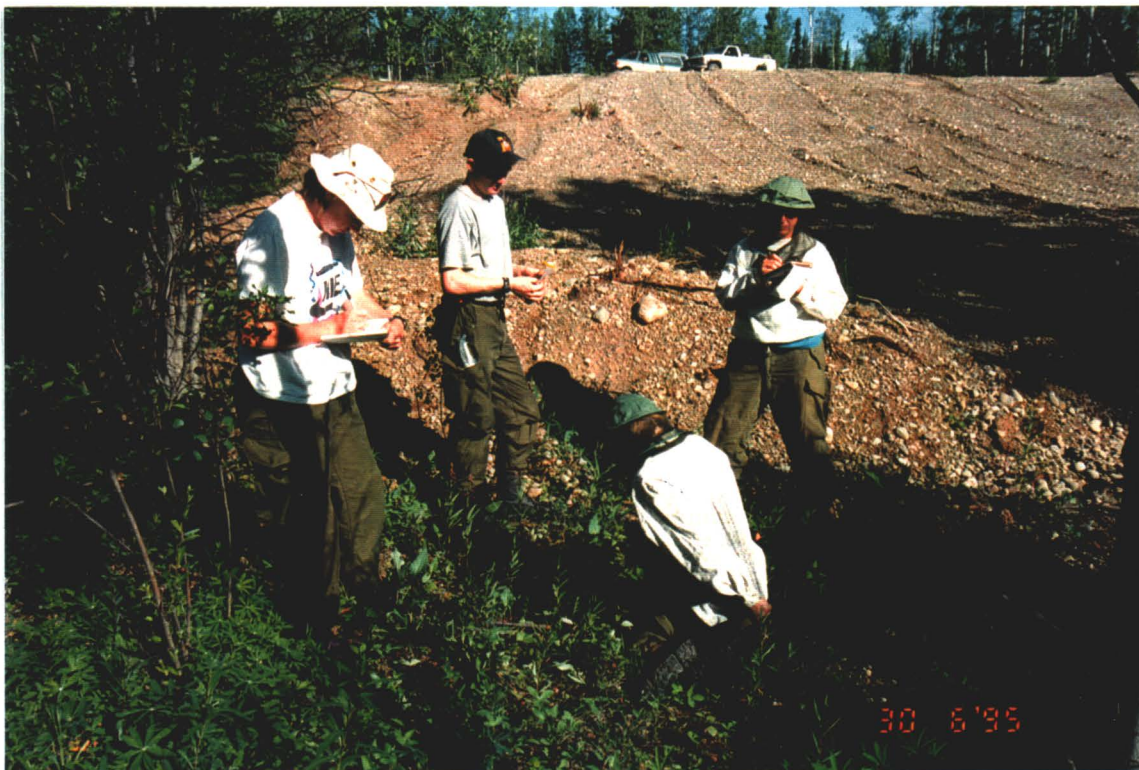
Photograph III-29: View of the recently graded dump face from the toe of the dump.

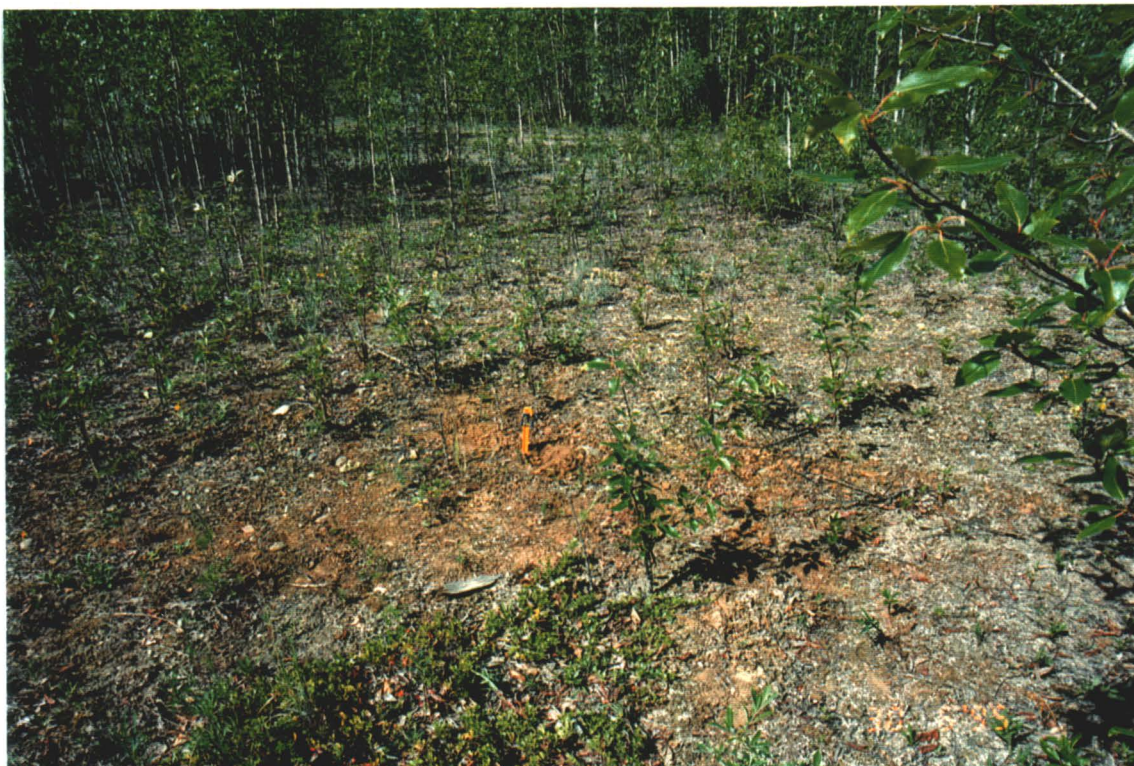
Photograph III-30: Vegetation in the area that may have been the septic field was sparse.

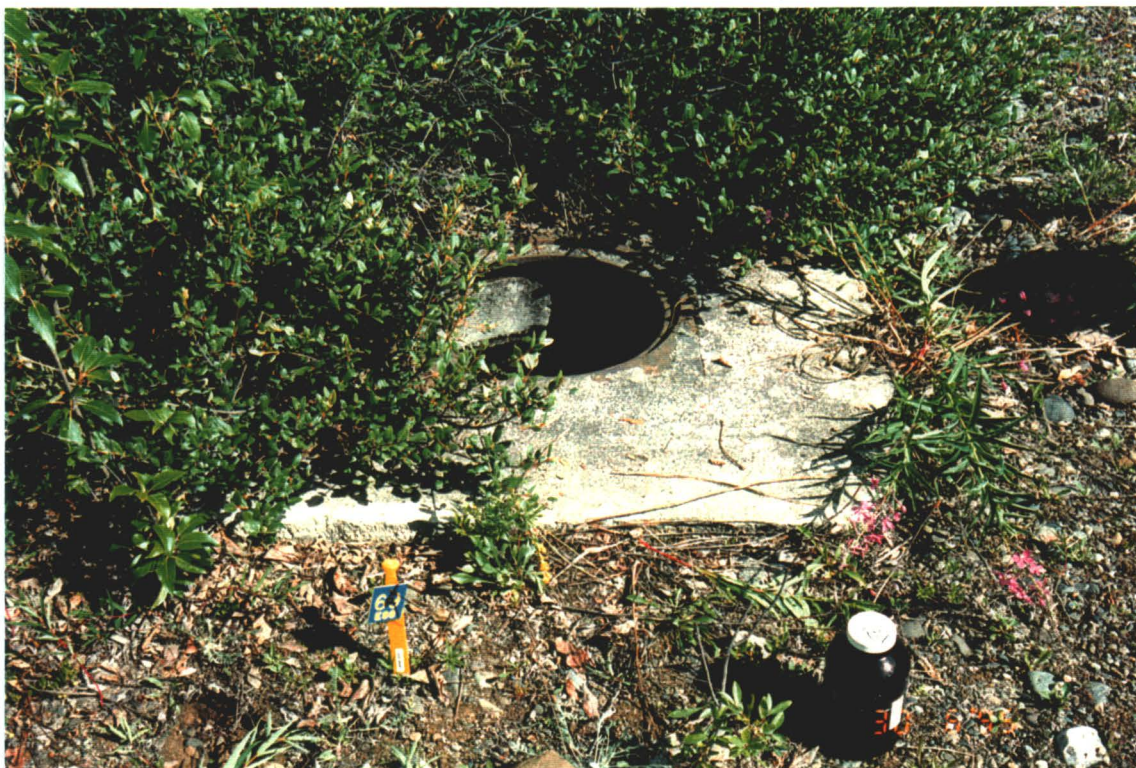
Photograph III-31: Debris collected from the bottom of this manhole (O6104) contained concentrations of copper and zinc which exceeded the criteria.

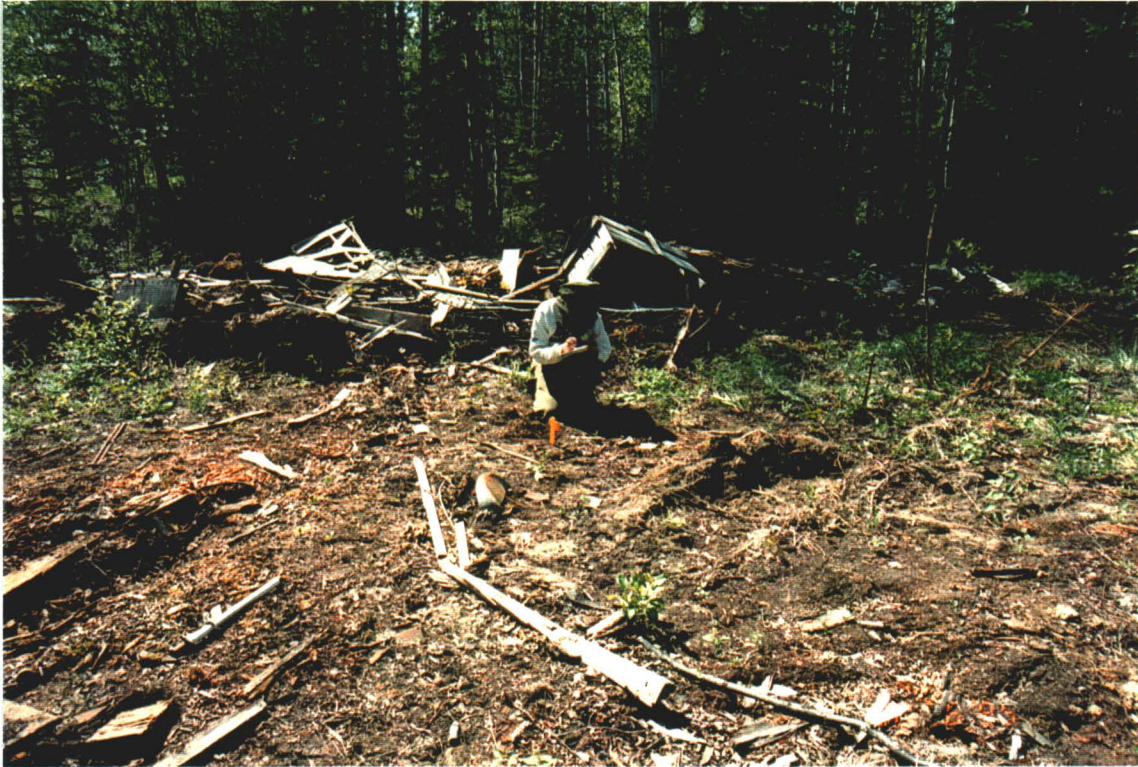
Photograph III-32: The remains of the collapsed storage shack with sample location G6159 in the foreground.

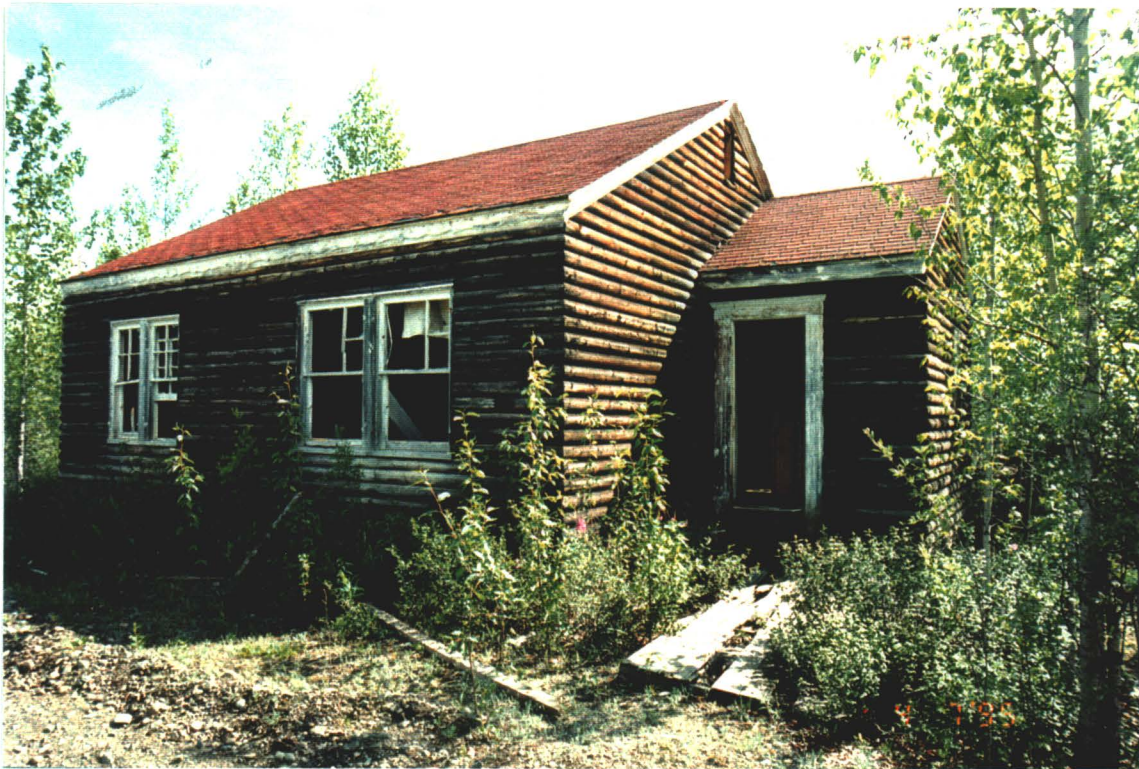
Photograph III-33: The log building which served as one of three married quarters.

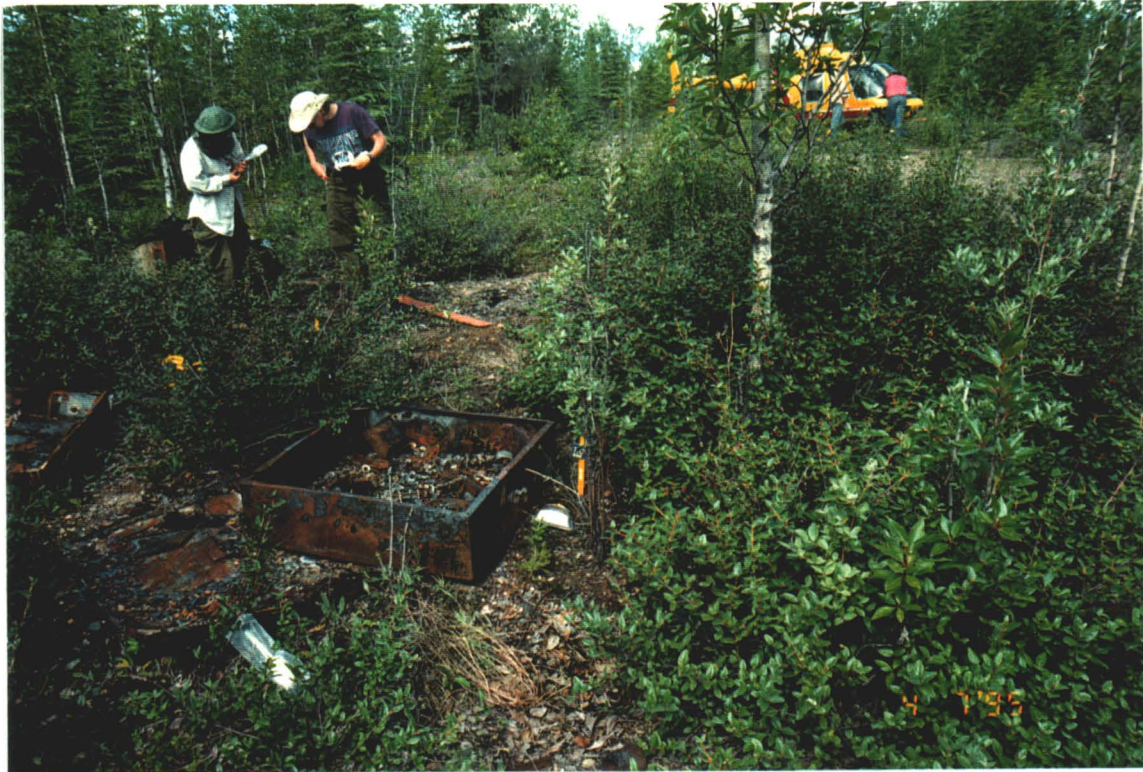
Photograph III-34: Soil sample G6187 and G6186, collected amongst the burnt building remains at the beacon site, contained inorganic elements at concentrations exceeding the criteria.
