Remediation of Aishihik Airstrip Yukon Territory

Environmental Sciences Group
Royal Military College
Kingston, Ontario

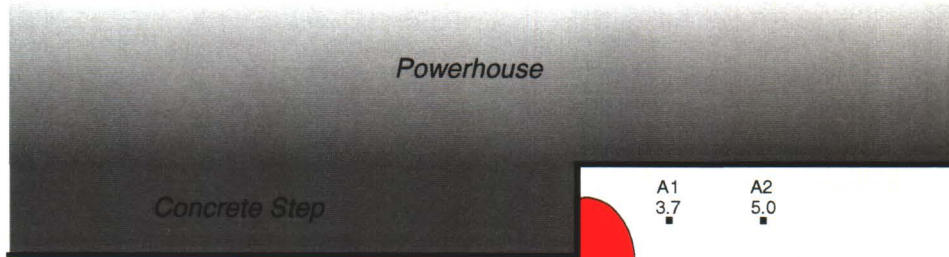
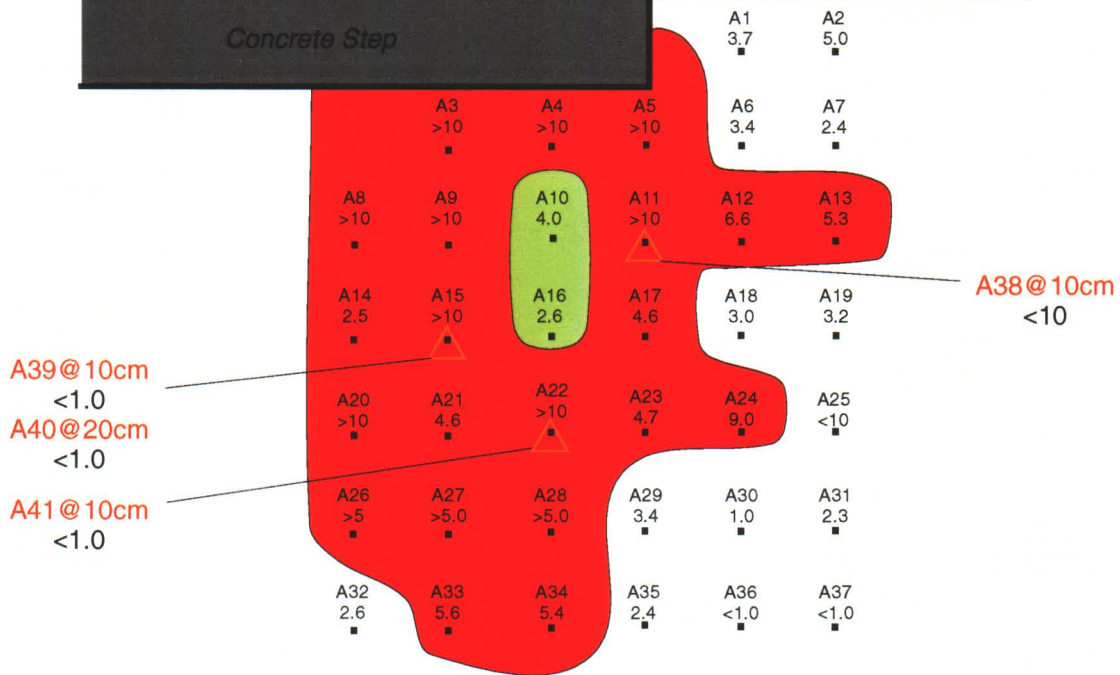
Map III-1: Delineation Sample Locations and PCB Concentrations (ppm) at AA101, the Powerhouse East Stain

Forty-one samples (A1- A41) were taken along a 1 m grid and analyzed with the immunoassay test kit in the Yukon to delineate the extent of contamination at this location. These included four subsurface samples (A38 - A41) taken at depths of up to 20 cm. The sample locations are shown on Map III-1. Based on the results (Table III-1) the area of contamination was marked with pegs and flag tape (Photograph III-1).

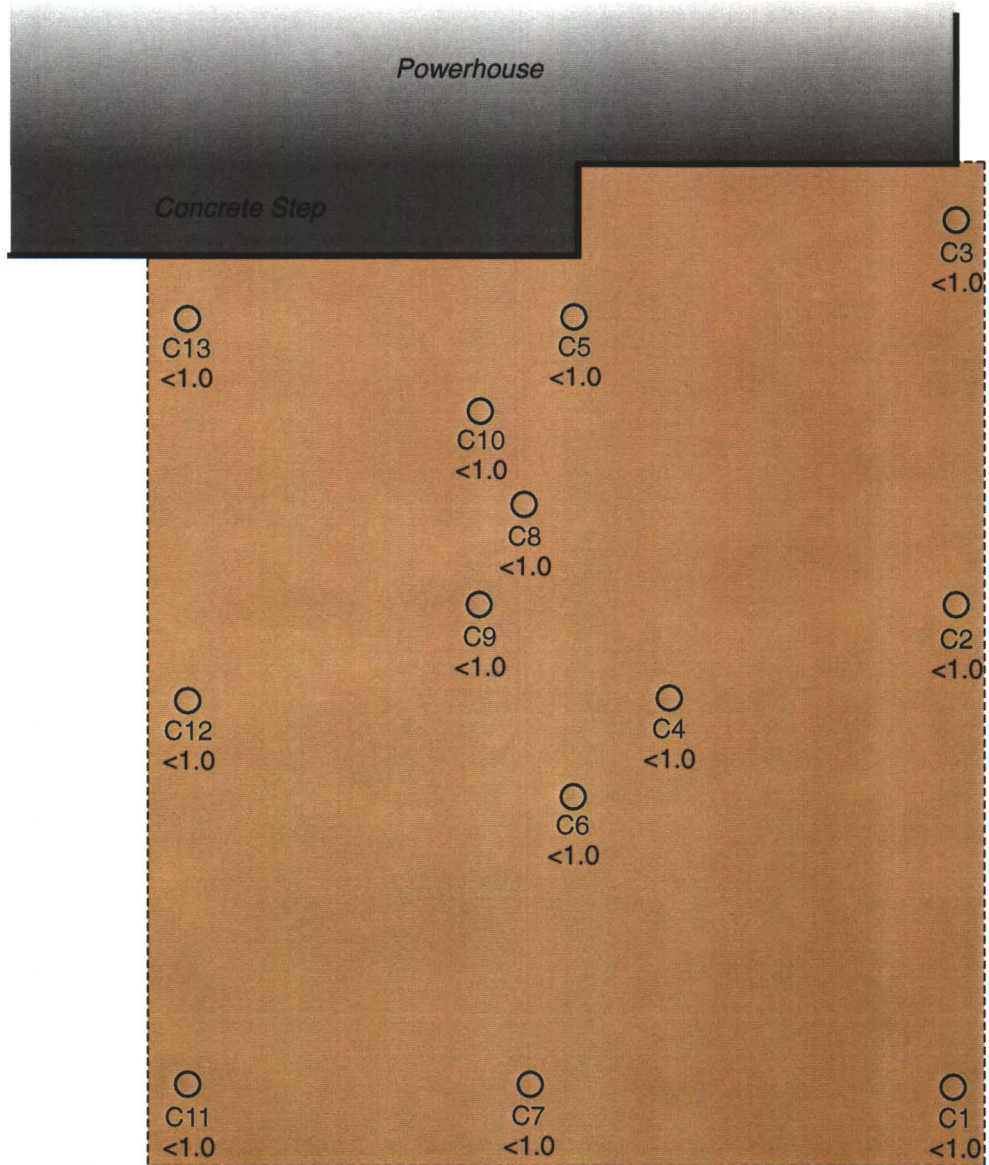
Map III-2: Confirmatory Testing Sample Locations and PCB Concentrations (ppm) at AA101, the Powerhouse East Stain

Sample #	Conc. of PCBs (ppm or $\mu\text{g/g}$)	
	Field Test Kit	GC/ECD
C1	<1.0	
C2	<1.0	<0.1
C3	<1.0	<0.1
C4	<1.0	
C5	<1.0	
C6	<1.0	0.08
C7	<1.0	0.04
C8	<1.0	
C9	<1.0	0.6
C10	<1.0	
C11	<1.0	0.1
C12	<1.0	0.07
C13	<1.0

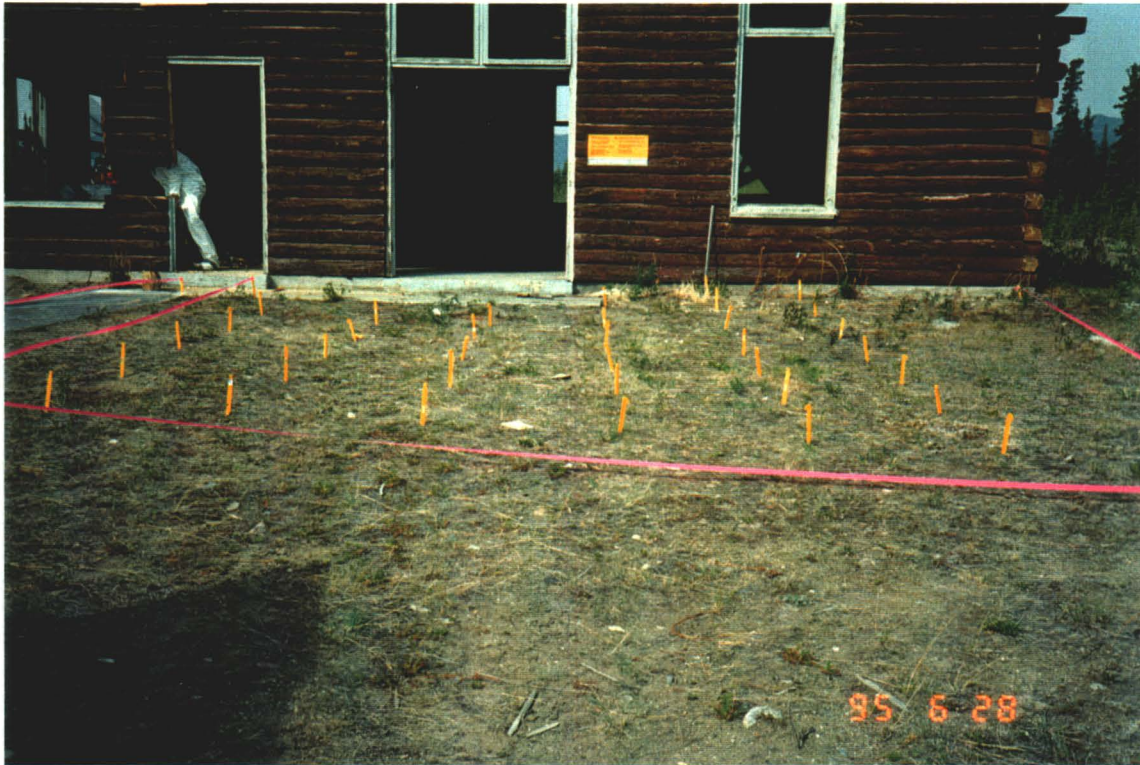
Photograph III-1: Delineation and demarcation of contaminated area at AA101, the powerhouse east stain.

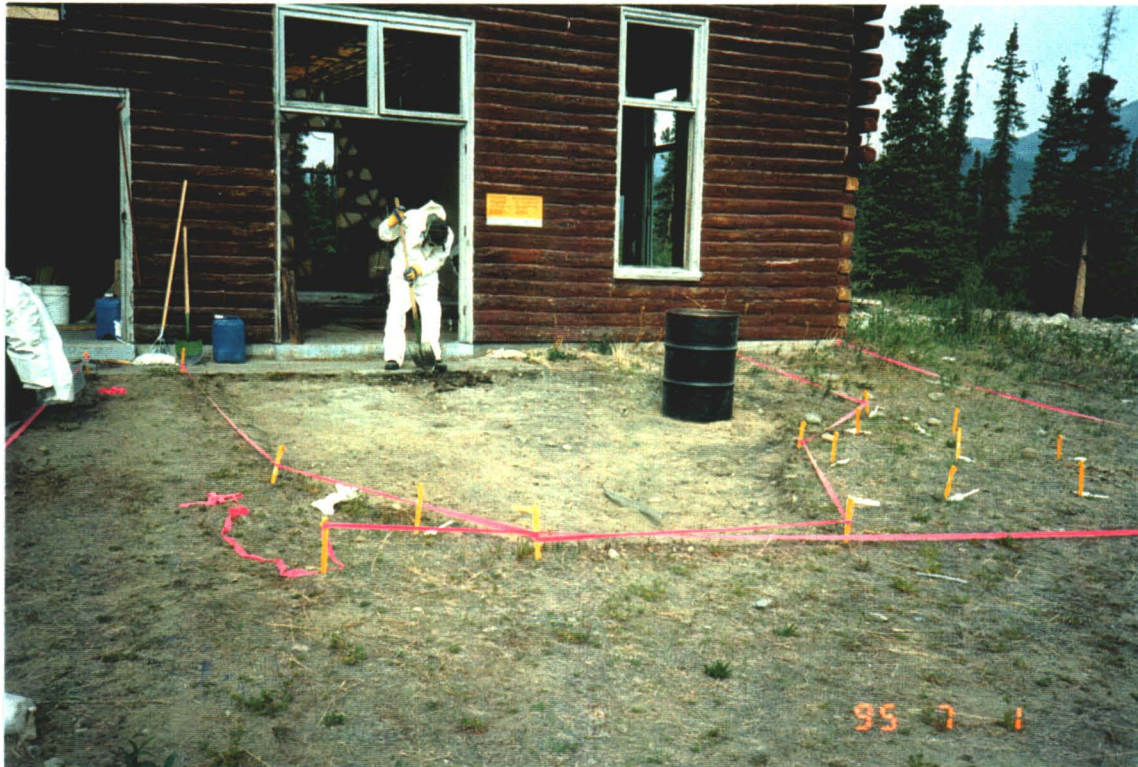
Photograph III-2: Excavation and barrel containment of DCC-II/CCME R/P PCB-contaminated soils at AA101, the powerhouse east stain.

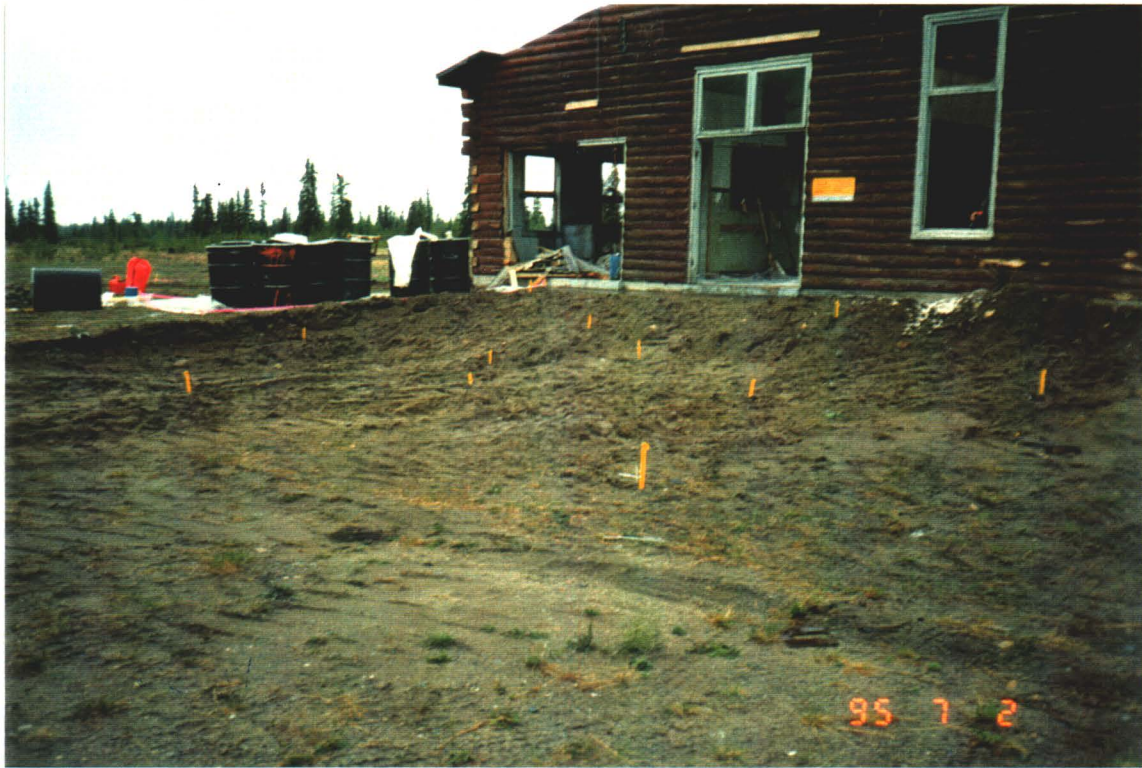
Photograph III-3: Excavated area at AA101, the powerhouse east stain, after removal of DCC-I contaminated soil.

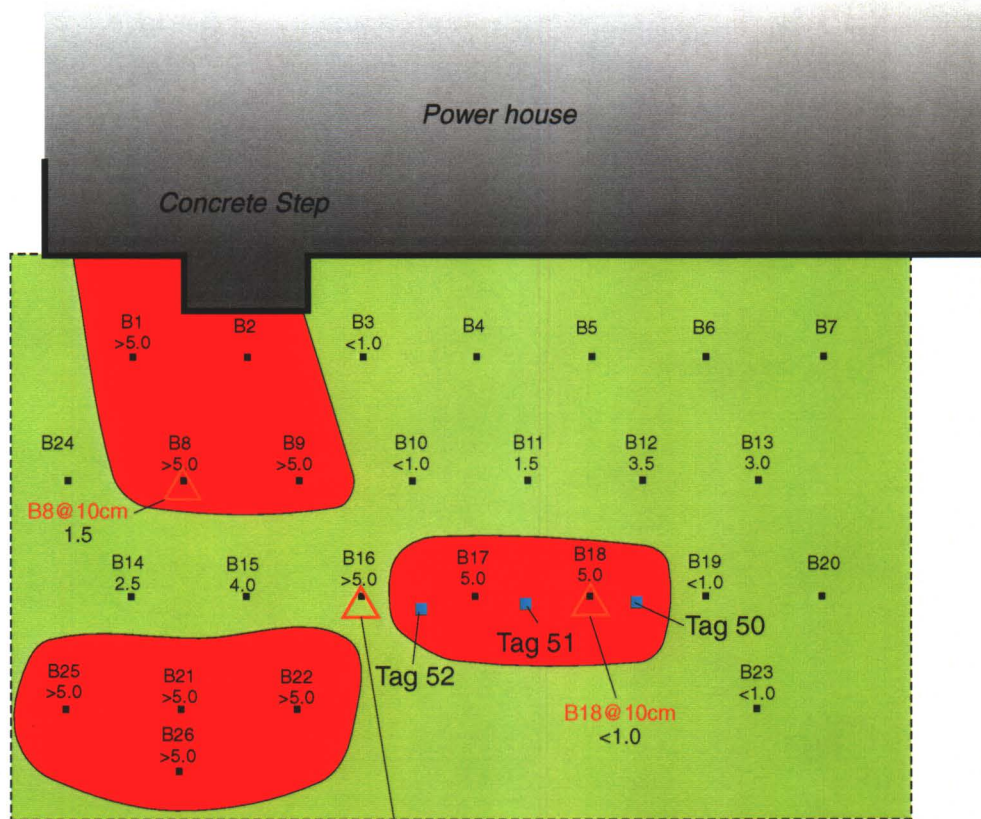
Map III-3: Delineation Sample Locations and PCB Concentrations (ppm) at AA108 and AA115, the Powerhouse South Stain

Samples were collected from a stained area south of the powerhouse, in an area containing eight pole stumps which were previously used for a transformer stand. Three of the samples contained PCBs at concentrations (up to 3.4 ppm) in excess of the DCC-I.

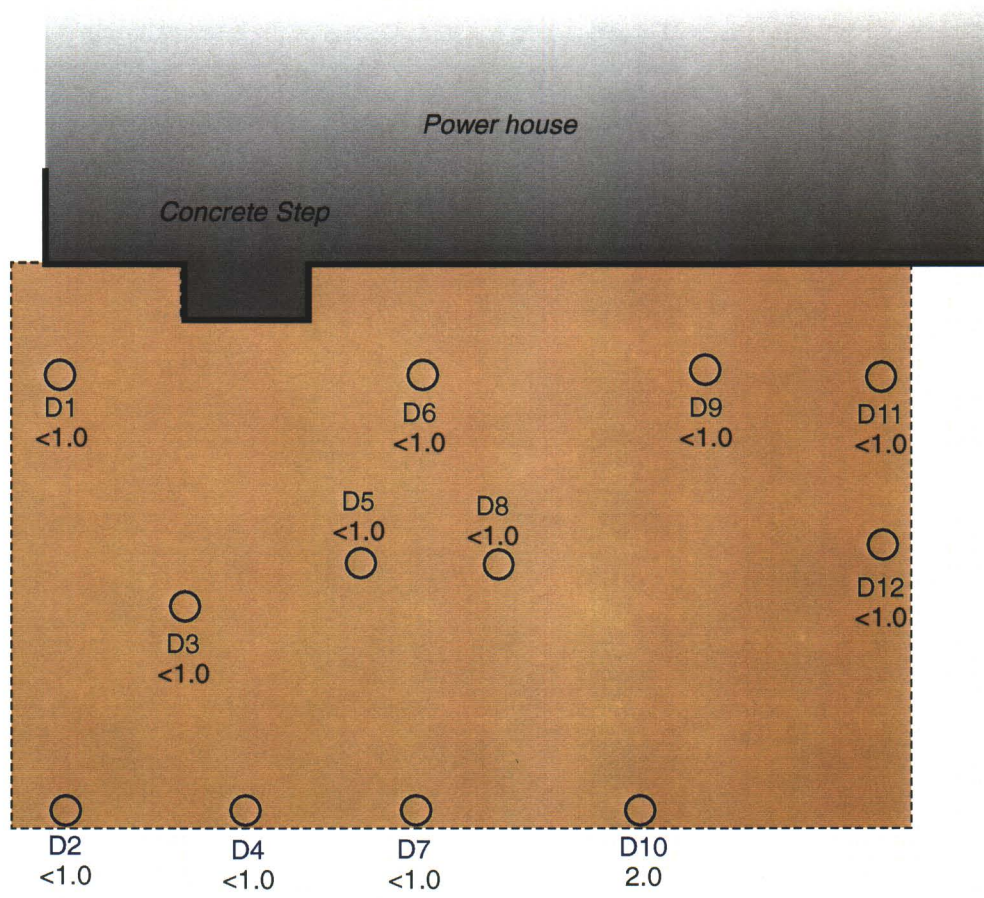
Map III-4: Confirmatory Testing Sample Locations and PCB Concentrations (ppm) at AA108 and AA115, the Powerhouse South Stain

Sample #	Conc. of PCBs (ppm or µg/g)	
	Field Test Kit	GC/ECD
D1	<1.0	
D2	<1.0	<1
D3	<1.0	<1
D4	<1.0	
D5	<1.0	
D6	<1.0	0.2
D7	2.0	
D8	<1.0	<1
D9	<1.0	
D10	2.0	
D11	<1.0	0.1
D12	<1.0	<1

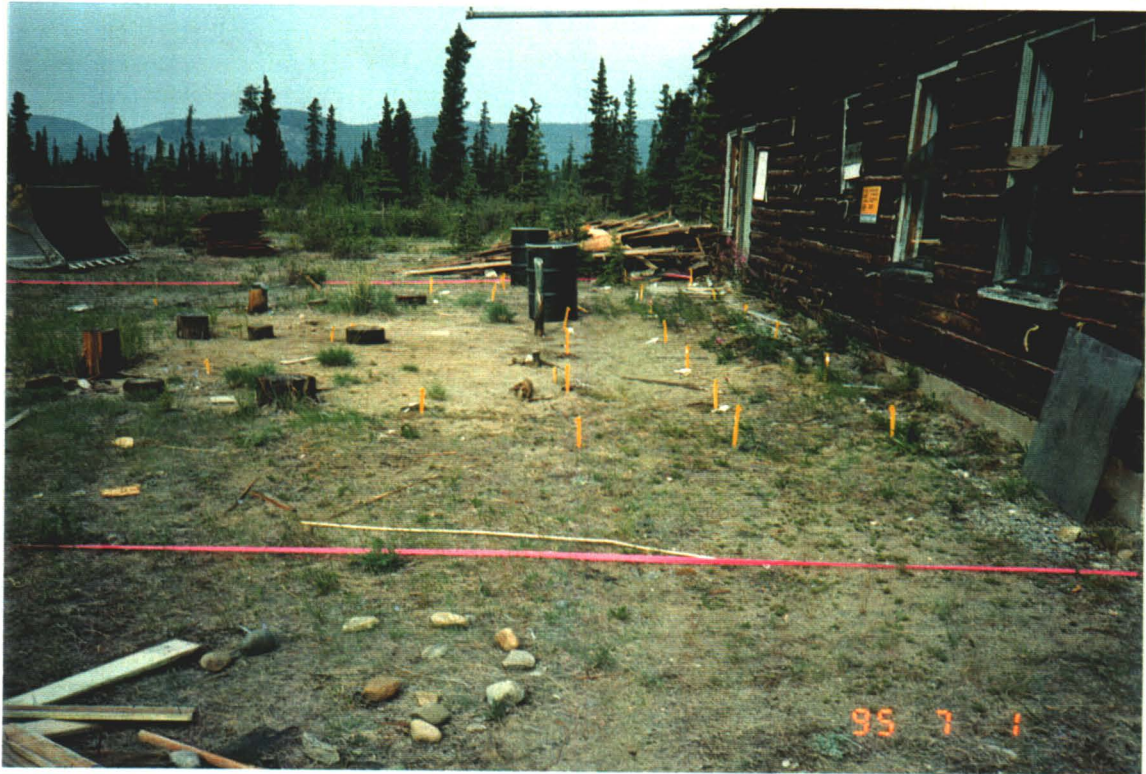
Photograph III-4: Delineation and demarcation of contaminated area at AA108 and AA115 the powerhouse south stain.

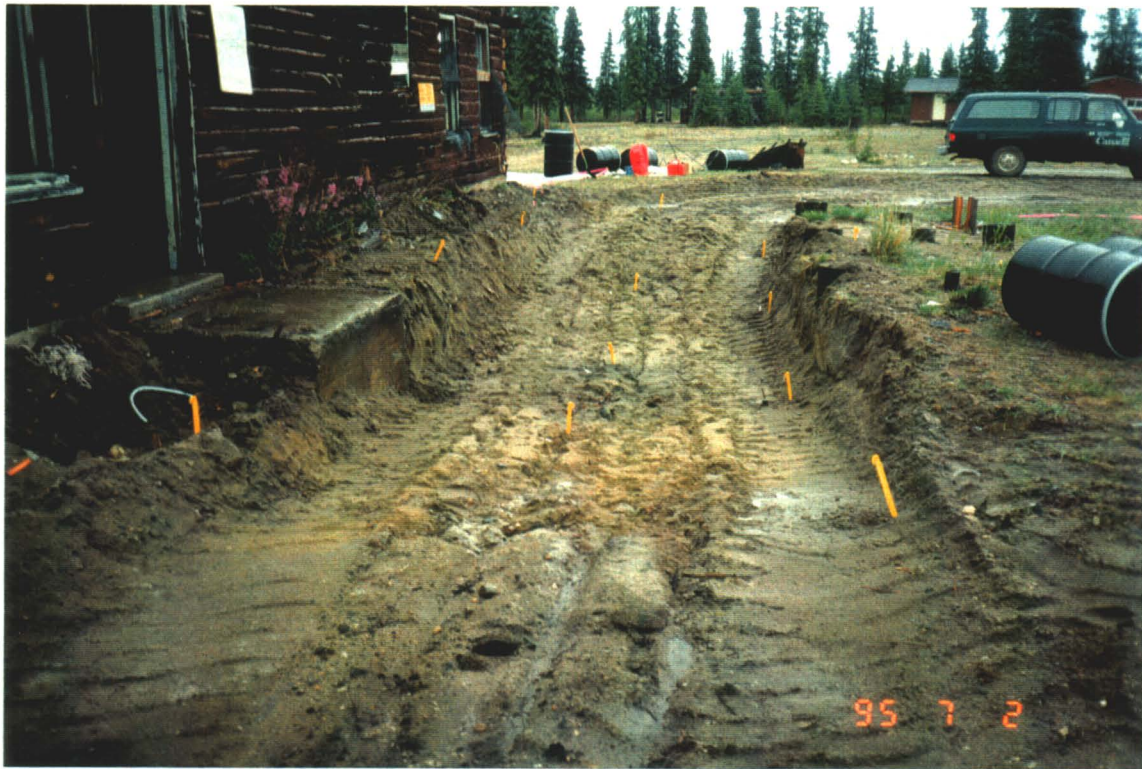
Photograph III-5: Excavated area at AA108 and AA115, the powerhouse south stain after removal of DCC-I contaminated soil.

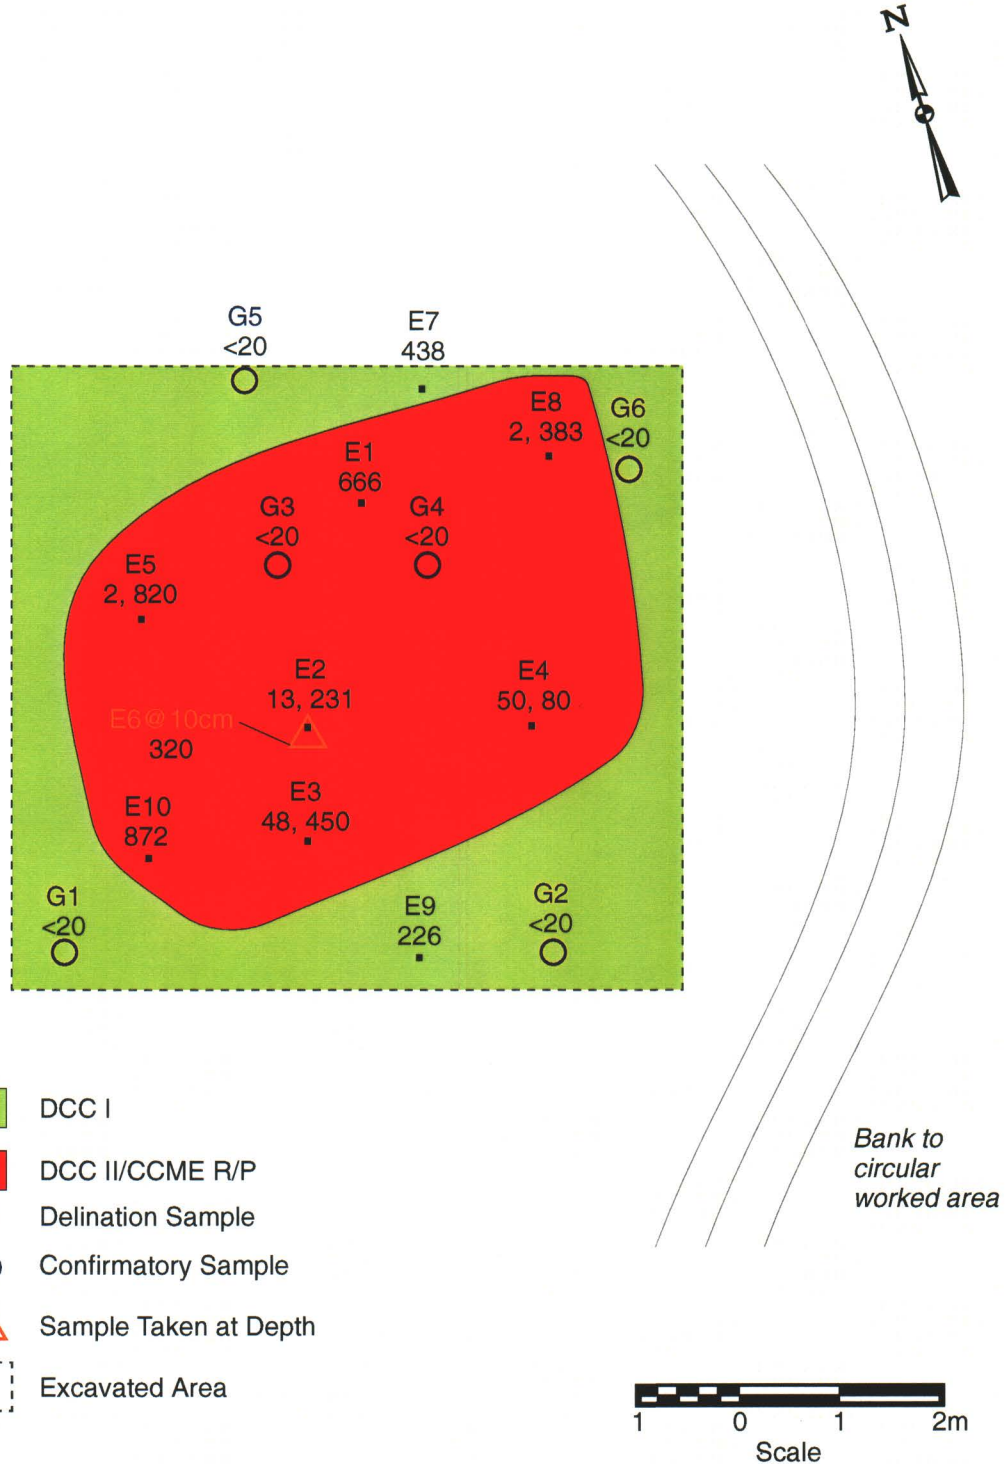
Map III-5: Delineation and Confirmatory Testing Sample Locations and Lead Concentrations (ppm) for West Battery Stain

Ten samples (E1 - E10), including one depth sample, were collected from in and around the area, defined by the scattered battery fragments, at random locations. All the samples were analyzed using the PFXRF at Aishihik. Four samples at the outer edge of the stained area (E6, E7, E7 and E9) had concentrations of lead that exceeded DCC-I. The concentrations of lead in the remaining samples ranged from 666 ppm to 50,080 ppm, all in excess of DCC-II. Sample locations are indicated on Map III-5 and the concentrations of copper, zinc and lead are shown in Table III-5 (Photograph III-8).

The high level DCC-II contaminated soils (1.2 m^3) were placed in barrels with the battery fragments. Contaminated soil was excavated using a front-end loader, from an area 6 m by 6 m to a depth of 0.6 m (22 m^3) and placed in a landfill on site. After excavation of the contaminated soil, six samples (G1 - G6) were taken from the perimeter and bottom of the excavated area and analyzed using the PFXRF. The results (Table III-7) indicated that the lead-contaminated soil in the West Battery Stain area had been successfully removed to below the detection limit (20 ppm). The confirmatory sample

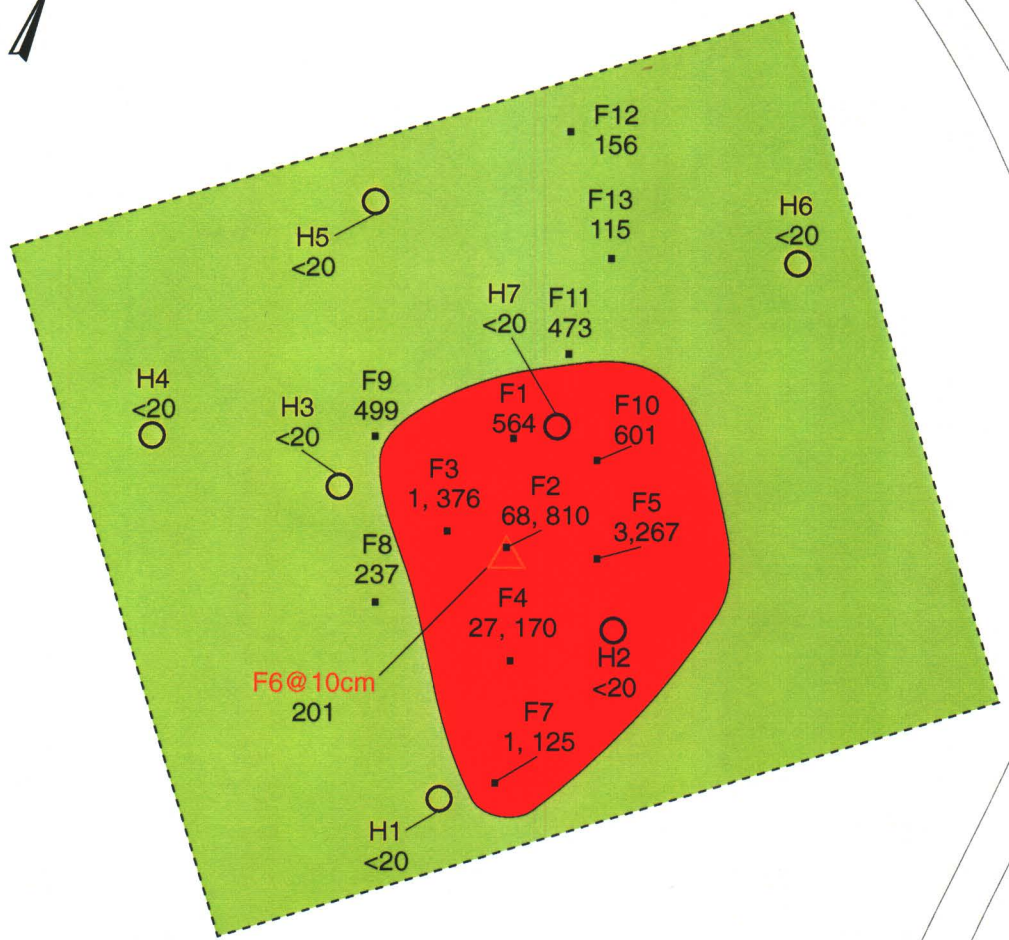
Map III-6: Delineation and Confirmatory Testing Sample Locations and Lead Concentrations (ppm) for East Battery Stain

Thirteen samples (F1 - F13), including one depth sample, were collected from in and around the area, defined by the scattered battery fragments, at random locations. All the samples were analyzed using the PFXRF at Aishihik. Three samples (F12, F12* and F13), located on the edge of the stained area, contained concentrations of lead below DCC-I. Six samples (F1, F6, F8, F8, F9 and F11) had concentrations of lead that exceeded DCC-I. The concentrations of lead in the remaining samples (F1, F2, F3, F4, F5, F7 and F10) ranged from 564 ppm to 68,810 ppm, all in excess of DCC-II. Sample locations are shown on (Map III-6) and the concentrations of copper, zinc and lead are displayed in Table III-6.

The surface layer of DCC-II contaminated soil (0.5 m^3) was placed in barrels with the battery fragments. Contaminated soil was excavated from an area 7 m by 6 m to a depth of 0.6 m (0.5 m^3), using a front-end loader, and placed in a landfill on site. After excavation of the contaminated soil, seven samples (H1 - H7) were taken from the perimeter and bottom of the excavated area and analyzed using the PFXRF. The results (Table III-8) indicated that the lead-contaminated soil in the East Battery Stain area had been successfully removed to below DCC-I in all cases and below the detection limit (20 ppm) in most cases. The confirmatory sample locations and actual area of soil removed are shown in Map III-6 (Photograph III-11). All excavated areas were backfilled.

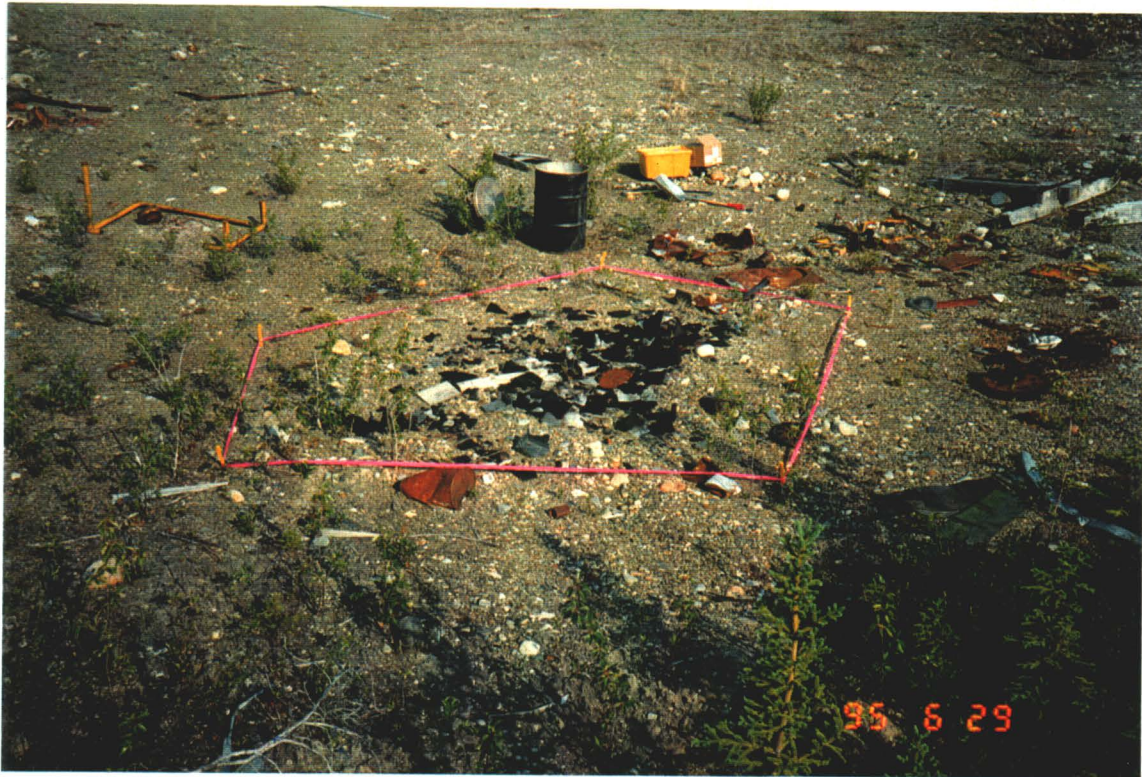
Photograph III-6: West battery stain before containing battery fragments in barrels.

Prior to performing any delineation sampling the visible battery fragments as well as the surface 3 cm of soil was removed from both battery stains and placed in barrels (Photograph III-6 and Photograph III-7).

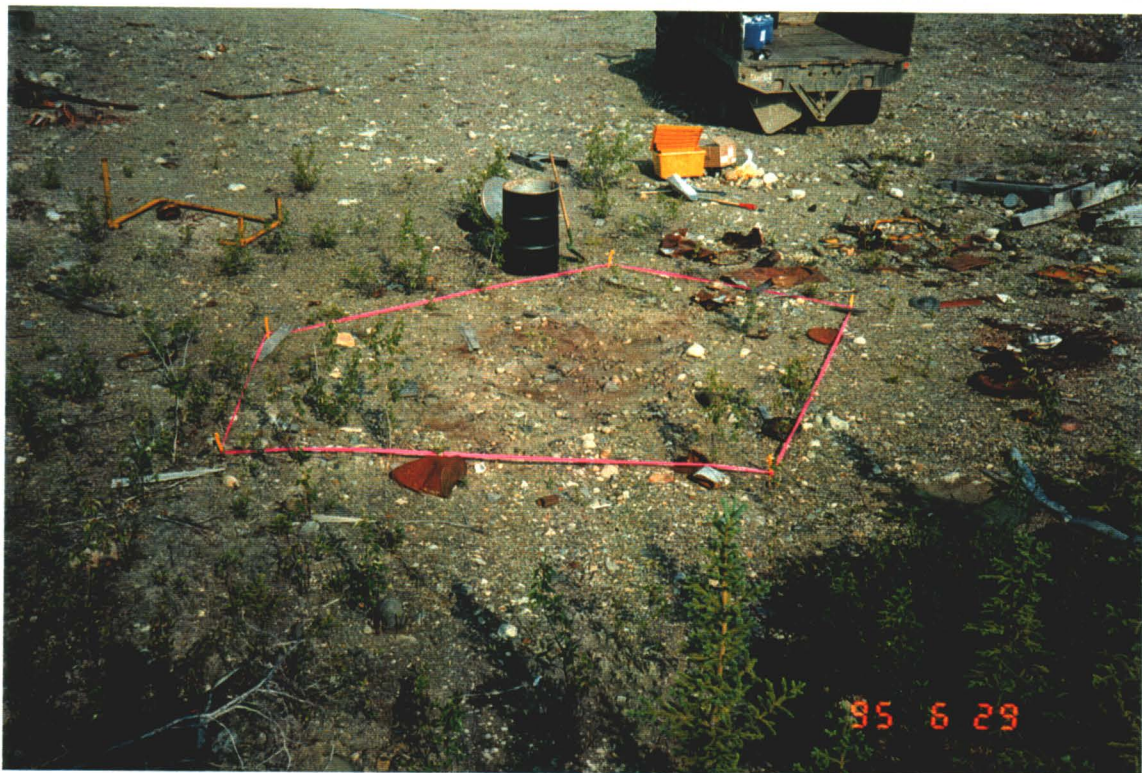
Photograph III-7: West battery stain after containing battery fragments in barrels.

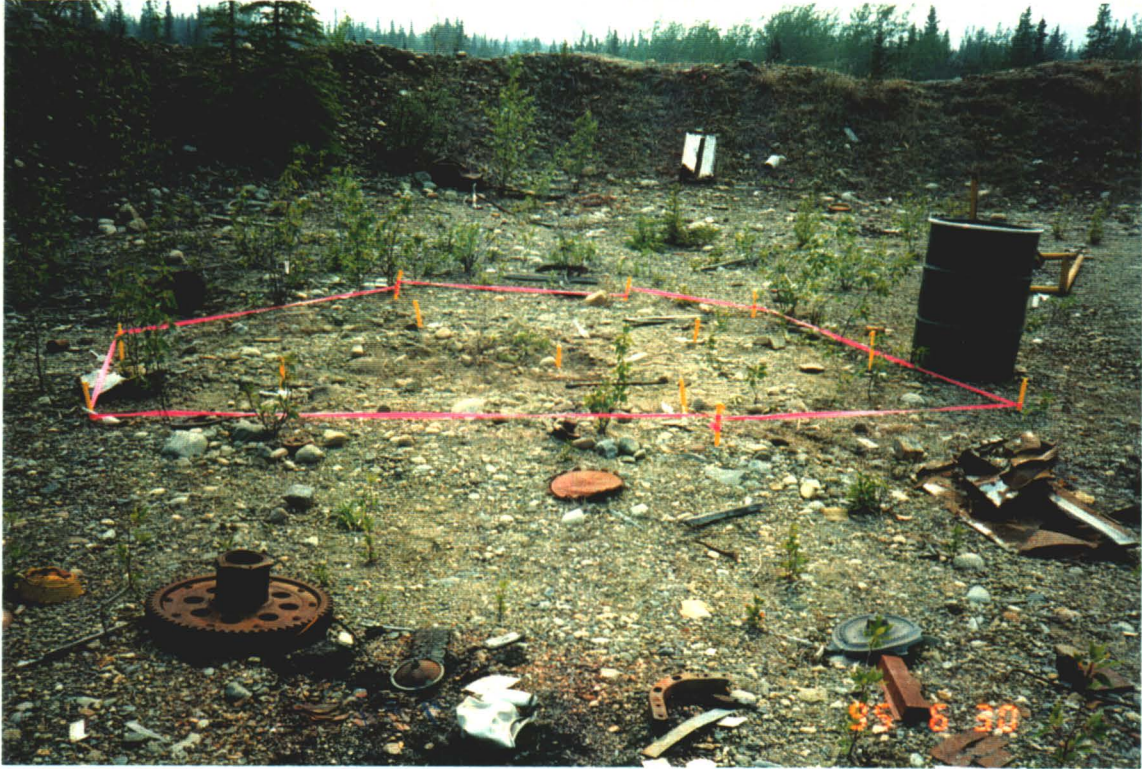
Photograph III-8: Delineation sample locations for the west battery stain.

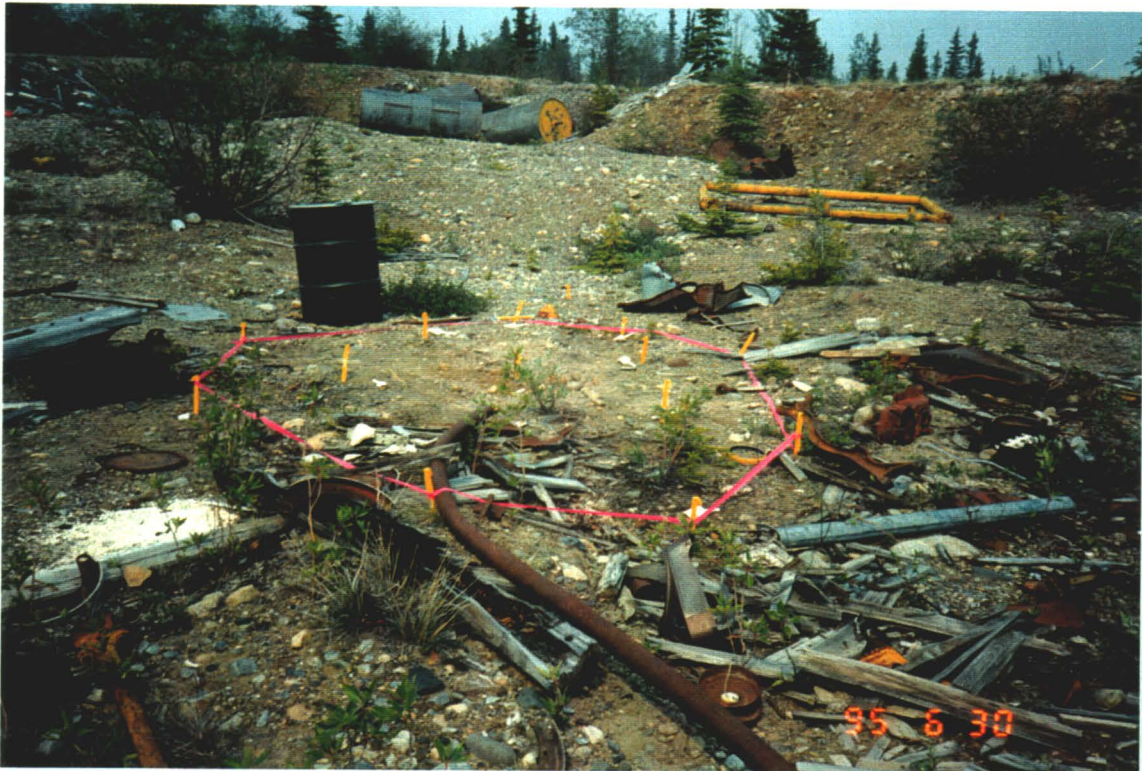
Photograph III-9: Delineation sample locations for east battery stain.

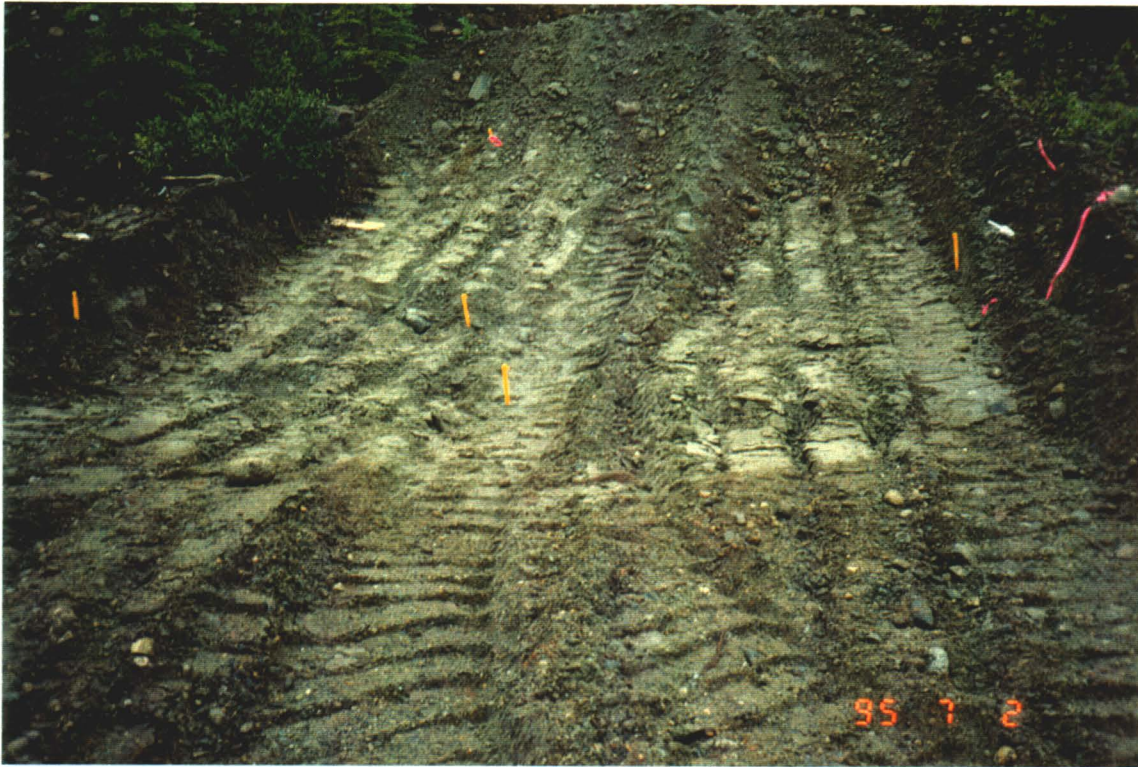
Photograph III-10: Confirmatory sampling at the west battery stain.

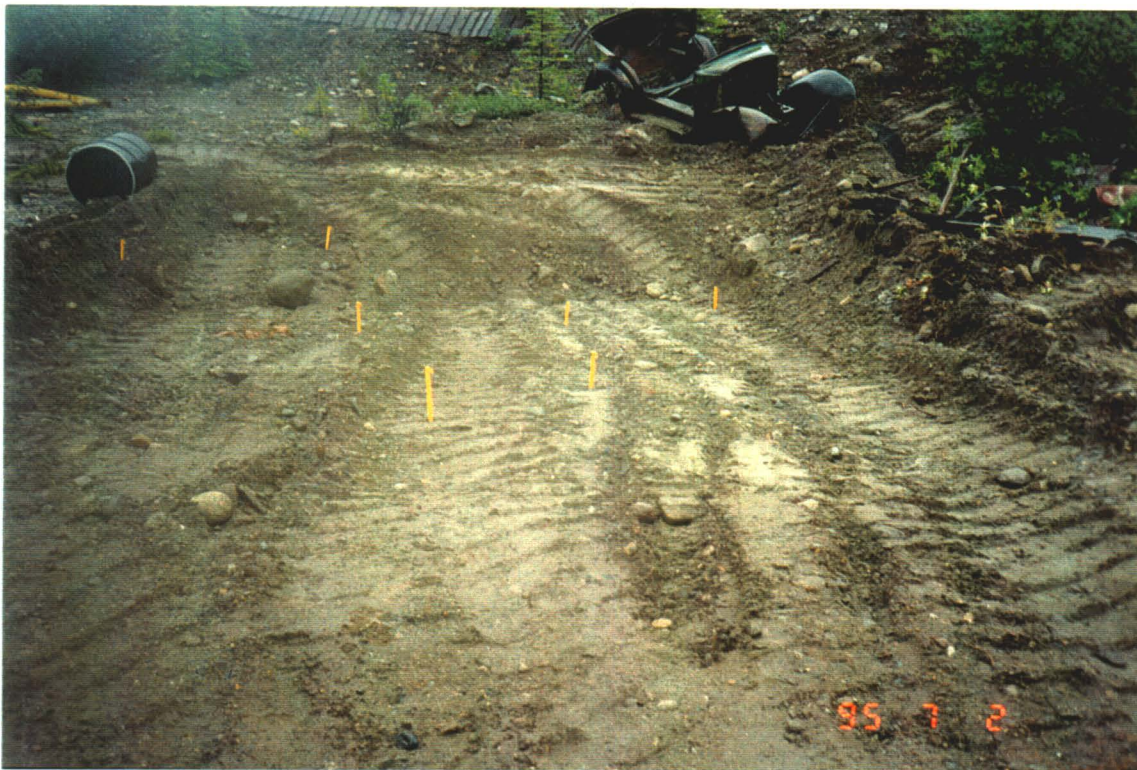
Photograph III-11: Confirmatory sampling at the east battery stain.

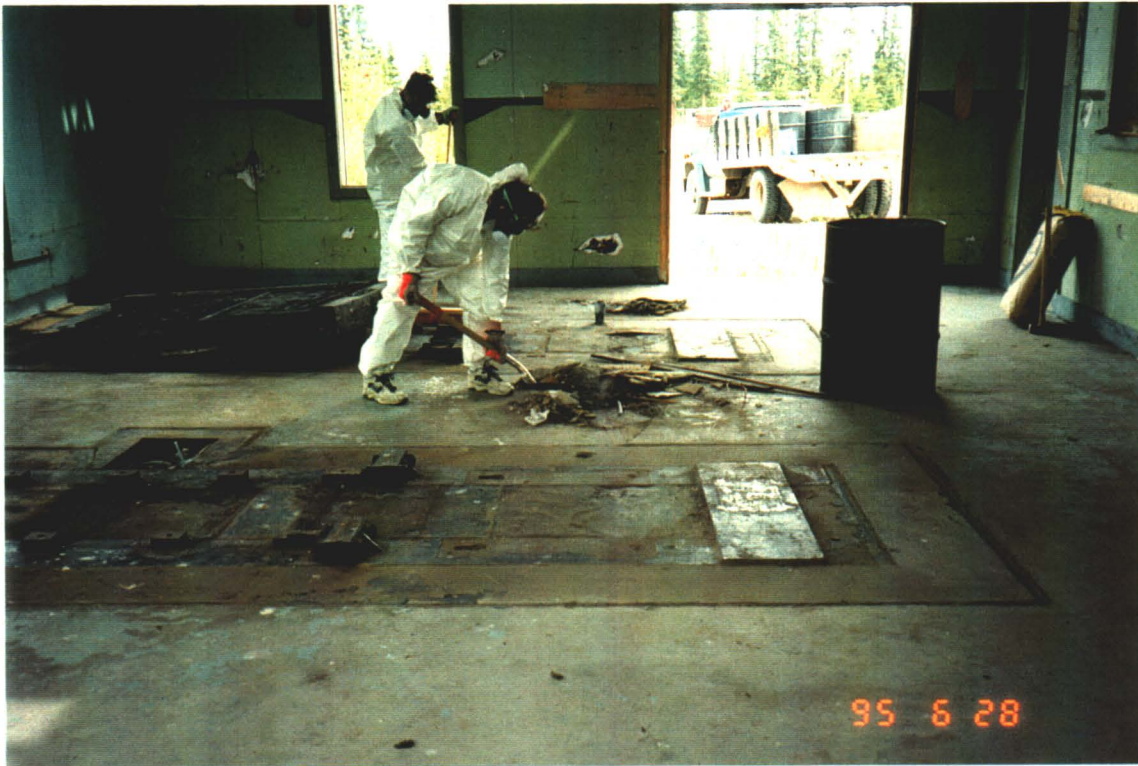
Photograph IV-1: Scattered debris from powerhouse floor containment in barrels.

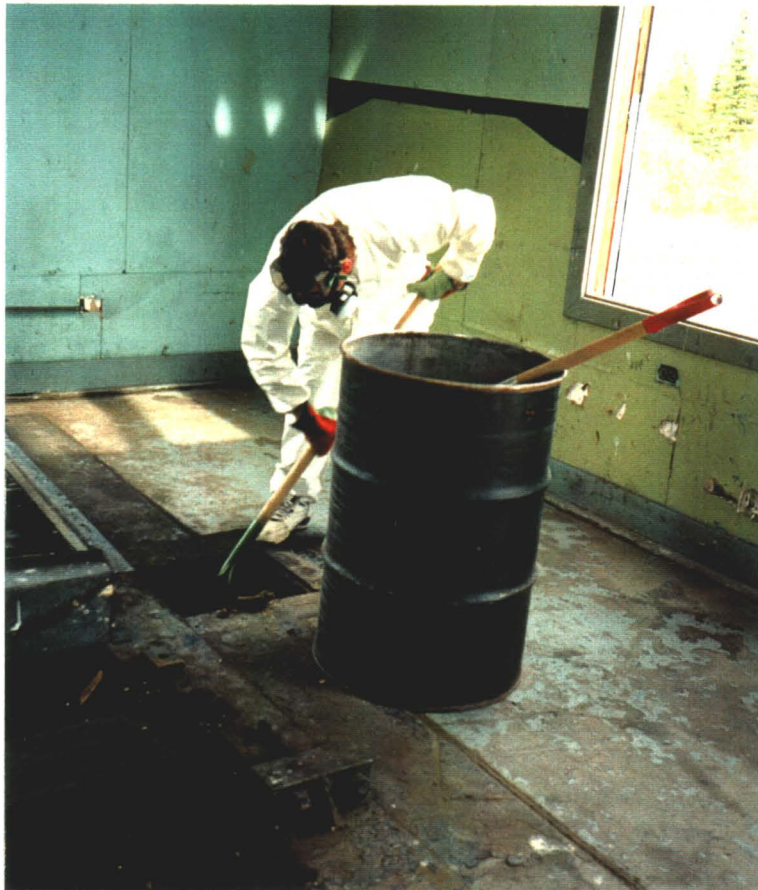
Photograph IV-2: Powerhouse generator sump soil excavation and containment in barrels.

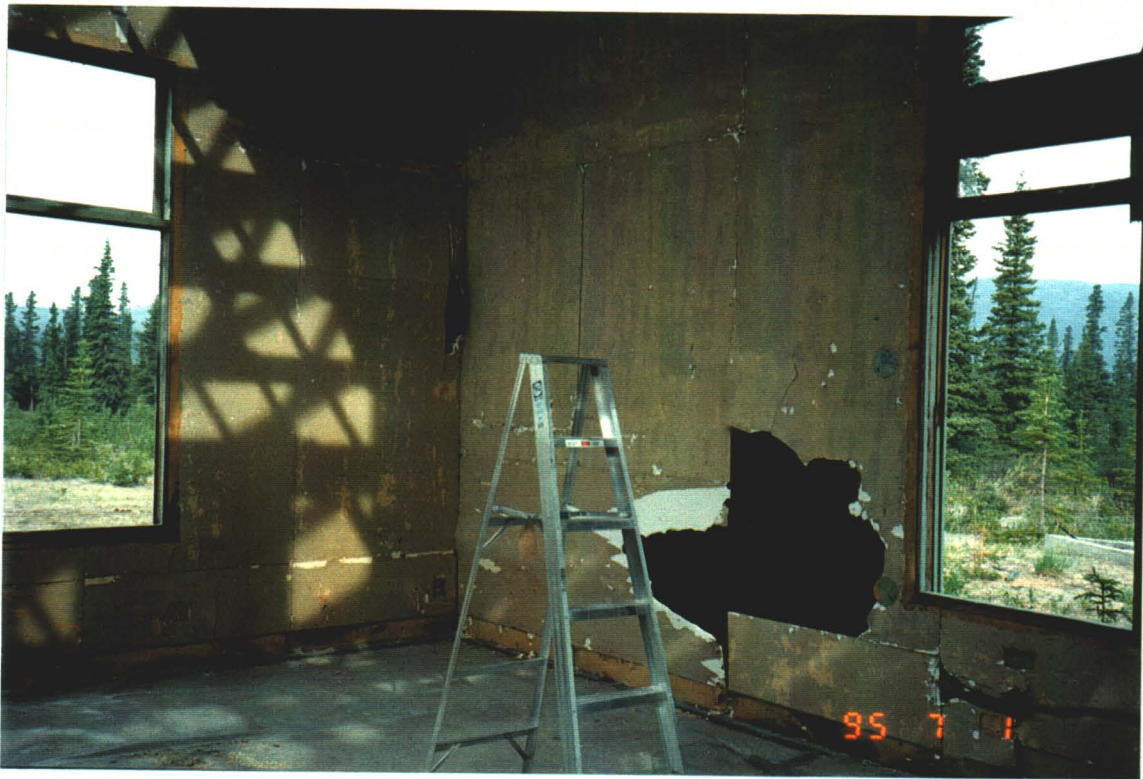
Photograph IV-3: Powerhouse walls after physical paint stripping.

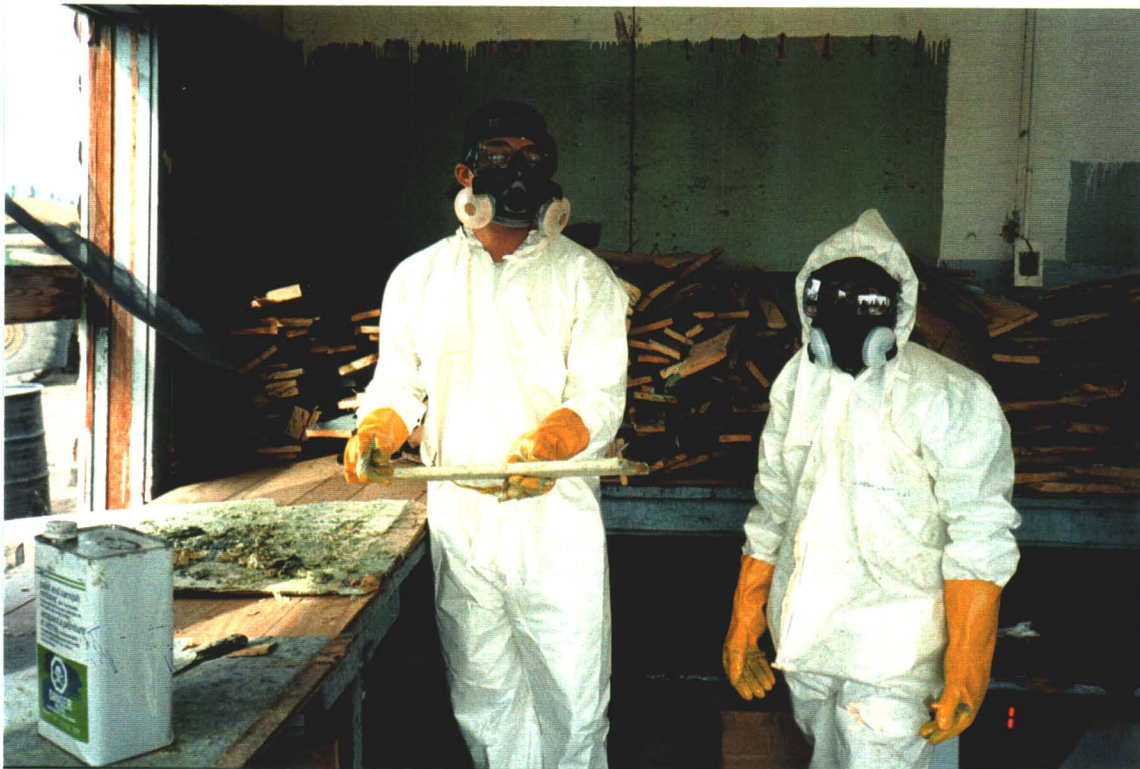
Photograph IV-4: Powerhouse wooden plank during chemical paint stripping.

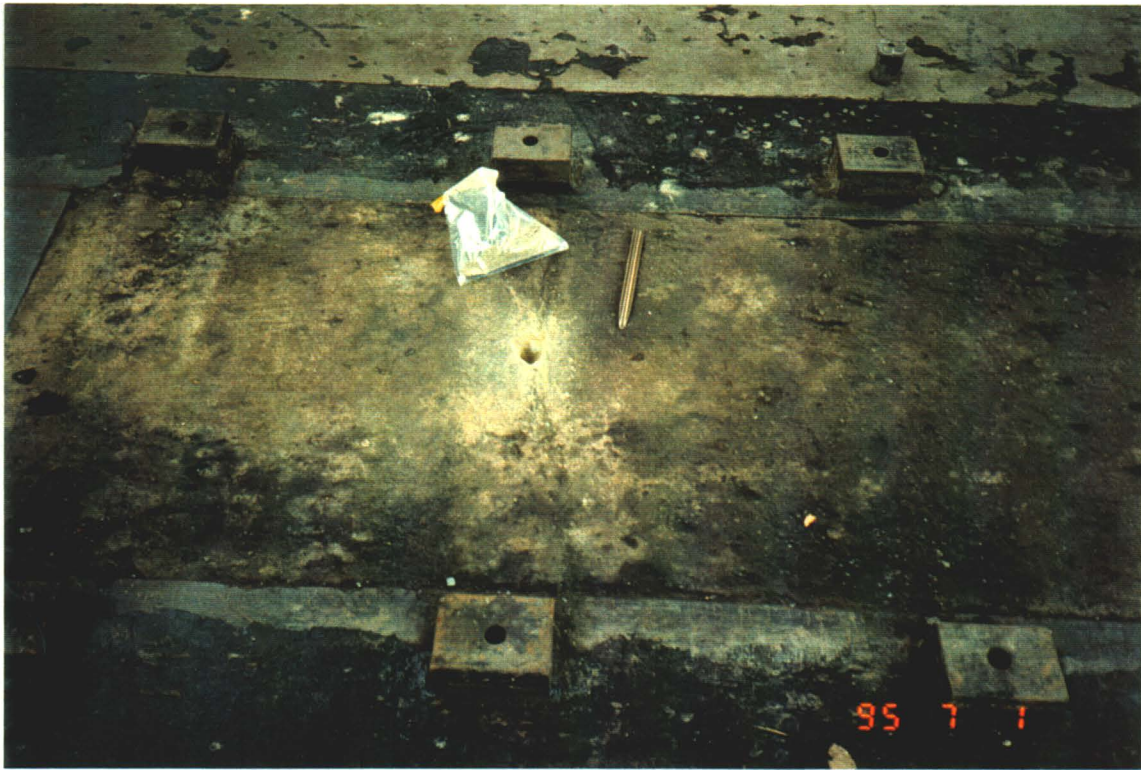
Photograph IV-5: Concrete sample removed from the powerhouse generator foundations.

the surface of the concrete floor with a masonry drill bit, and analyzed in the laboratory for PCBs. The concentrations of PCBs (6.5 ppm and 36 ppm) in these two samples were found to be below CEPA and no further treatment of the concrete surfaces was performed (Photograph IV-5). The concrete bench from the southwest room was removed to the landfill.

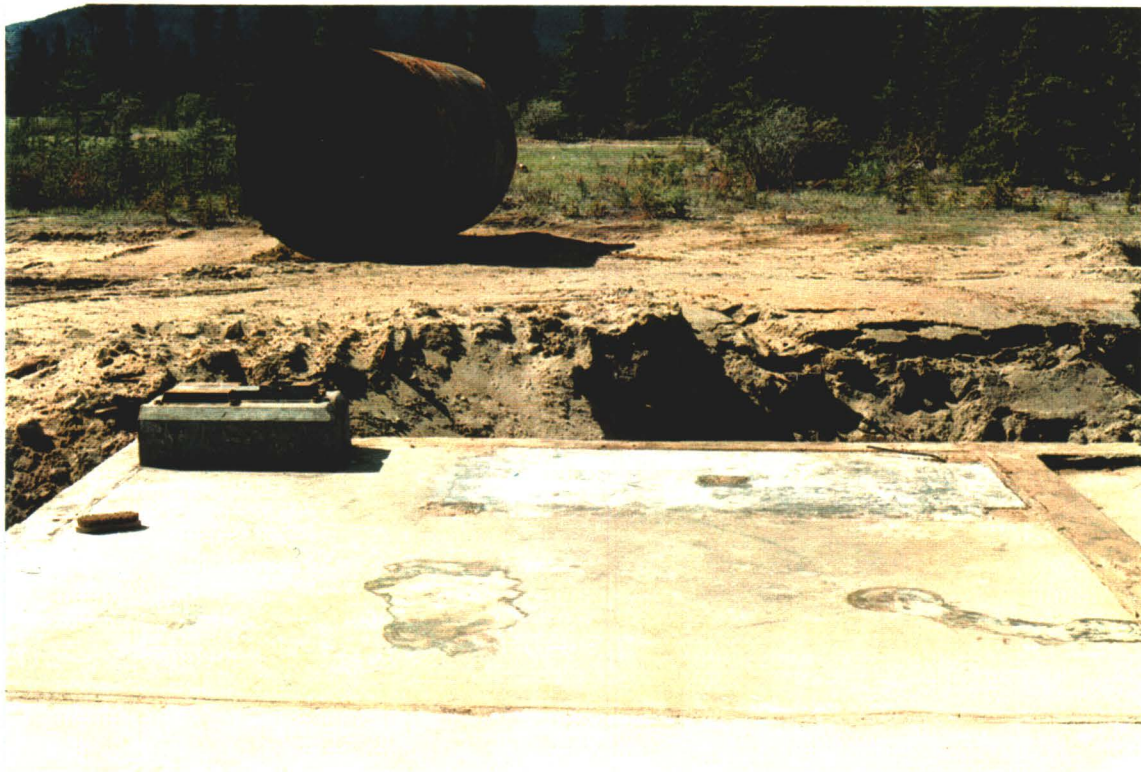
Photograph IV-6: Pit and tank after removal of the powerhouse diesel tank.

The buried diesel fuel tank was removed from the west side of the powerhouse and taken to the landfill. A stain at the bottom of the tank pit was sampled and analyzed for benzene, toluene, ethylbenzene and xylene (BTEX), pesticides and PCBs. Low levels of xylene (p,m-xylene (0.34 ppm) and o-xylene (1.8 ppm)) was detected. None of the other BETX compounds were detected. Pesticide and PCB levels were below the detection limits. These results indicate that the levels and nature of the contamination are not deleterious to the environment. Further, the depth of contamination suggested that back-filling the tank pit with gravel provided a suitable remediation solution (Photograph IV-6 and Photograph IV-7).
