Remediation of Aishihik Airstrip Yukon Territory

Environmental Sciences Group
Royal Military College
Kingston, Ontario

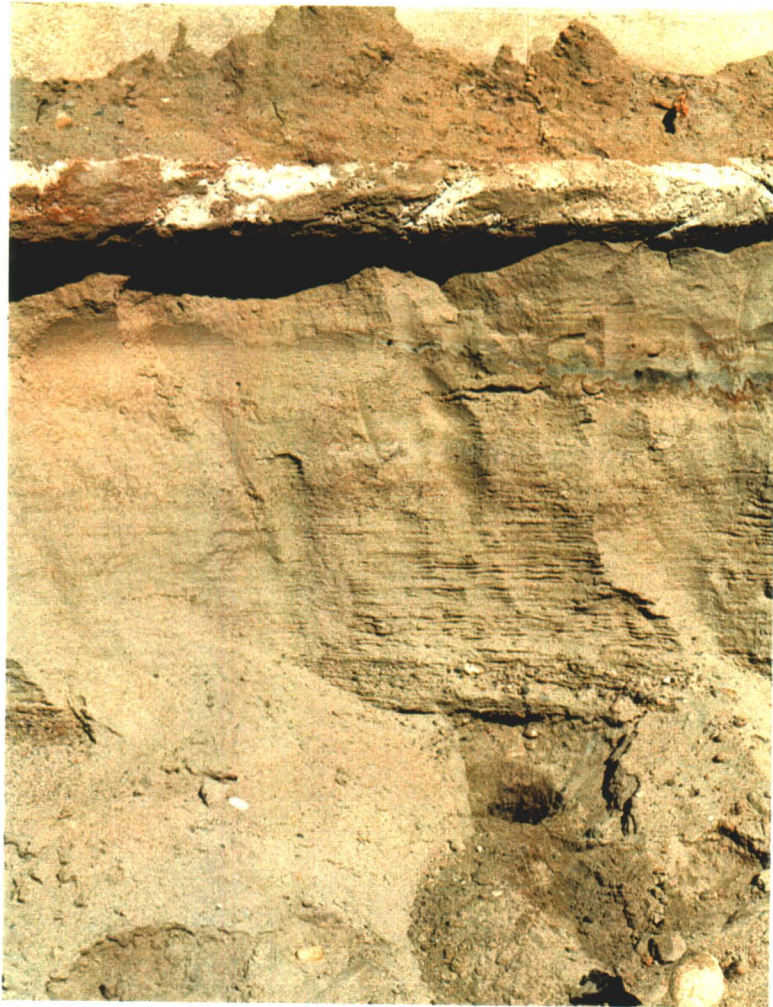
Photograph IV-7: Sample location at the base of the powerhouse diesel tank pit.

The buried diesel fuel tank was removed from the west side of the powerhouse and taken to the landfill. A stain at the bottom of the tank pit was sampled and analyzed for benzene, toluene, ethylbenzene and xylene (BTEX), pesticides and PCBs. Low levels of xylene (p,m-xylene (0.34 ppm) and o-xylene (1.8 ppm)) was detected. None of the other BETX compounds were detected. Pesticide and PCB levels were below the detection limits. These results indicate that the levels and nature of the contamination are not deleterious to the environment. Further, the depth of contamination suggested that back-filling the tank pit with gravel provided a suitable remediation solution (Photograph IV-6 and Photograph IV-7).

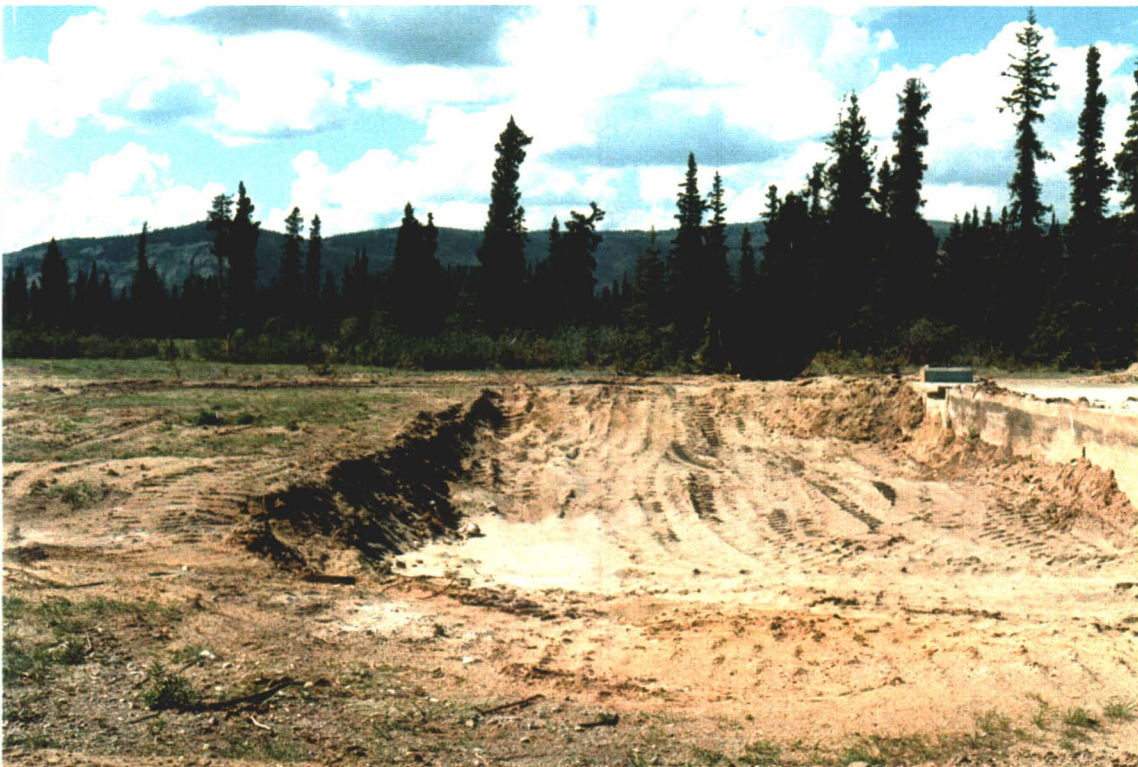
Photograph IV-8: Graded trench after removal of soil from around the powerhouse concrete pad.

A 3 m wide and 0.5 m deep trench of soil was removed from the west and south sides of the building (Photograph IV-8) using a front-end loader and placed in the landfill, in order to ensure that any near surface contamination, which may not have been detected in previous investigations, was removed. All excavated areas around the powerhouse were backfilled with soil and gravel from a local source. Soil was banked around and over the concrete pad to a depth of 0.5 m to ensure encapsulation and isolation of the pad from any environmental influence (Photograph IV-8 and Photograph IV-9).

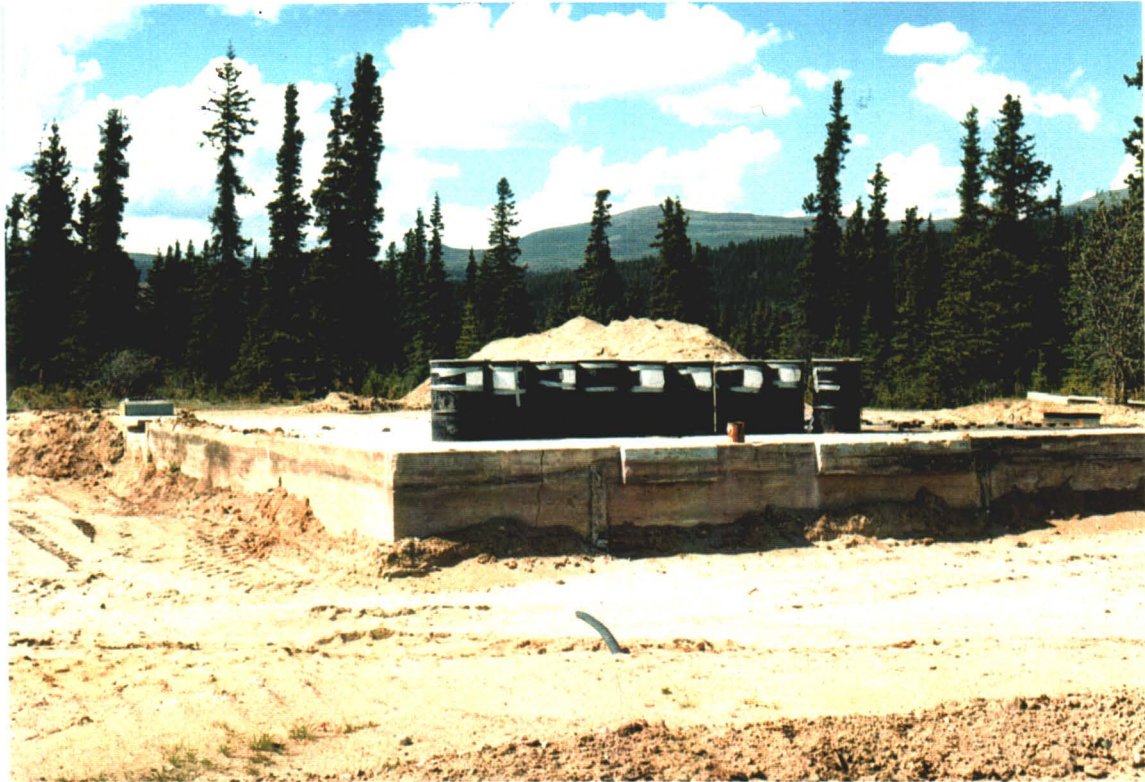
Photograph IV-9: Barrels awaiting shipment off site, temporarily stored on powerhouse concrete pad.
