**PRELIMINARY ENVIRONMENTAL ASSESSMENT
OF FOUR FORMER U.S. MILITARY CAMP SITES
YUKON TERRITORY**

**Indian and Northern Affairs Canada - Yukon
Arctic Environmental Strategy
Action on Waste Program**

UMA Engineering Ltd.
Engineers, Planners & Surveyors
17007 - 107 Avenue
Edmonton, Alberta
T5S 1G3

December 1996
4440-035-00-02

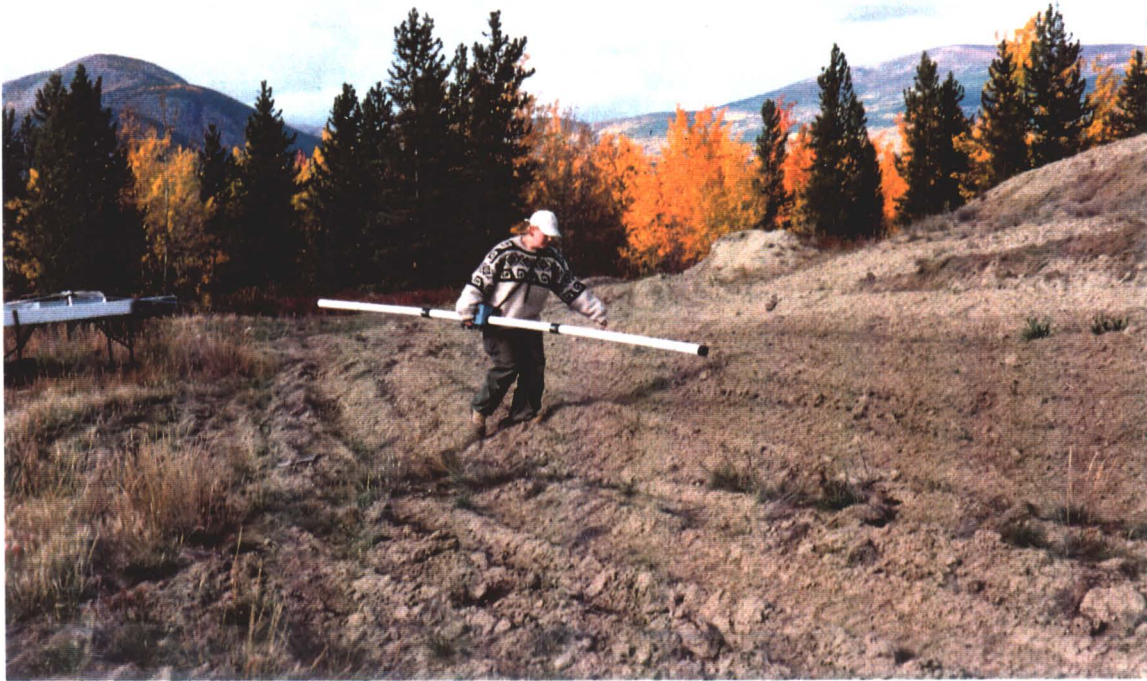
EM31 Geophysical over disturbed area - SITE 15

In the vicinity of the existing building, the area to the north has been regraded, and to the east a shallow mound of material was observed. A reconnaissance EM-31 geophysical survey was conducted in this area, but no significant anomalies were recorded. Low apparent conductivity readings were recorded over the mound indicating possible shallow bedrock.

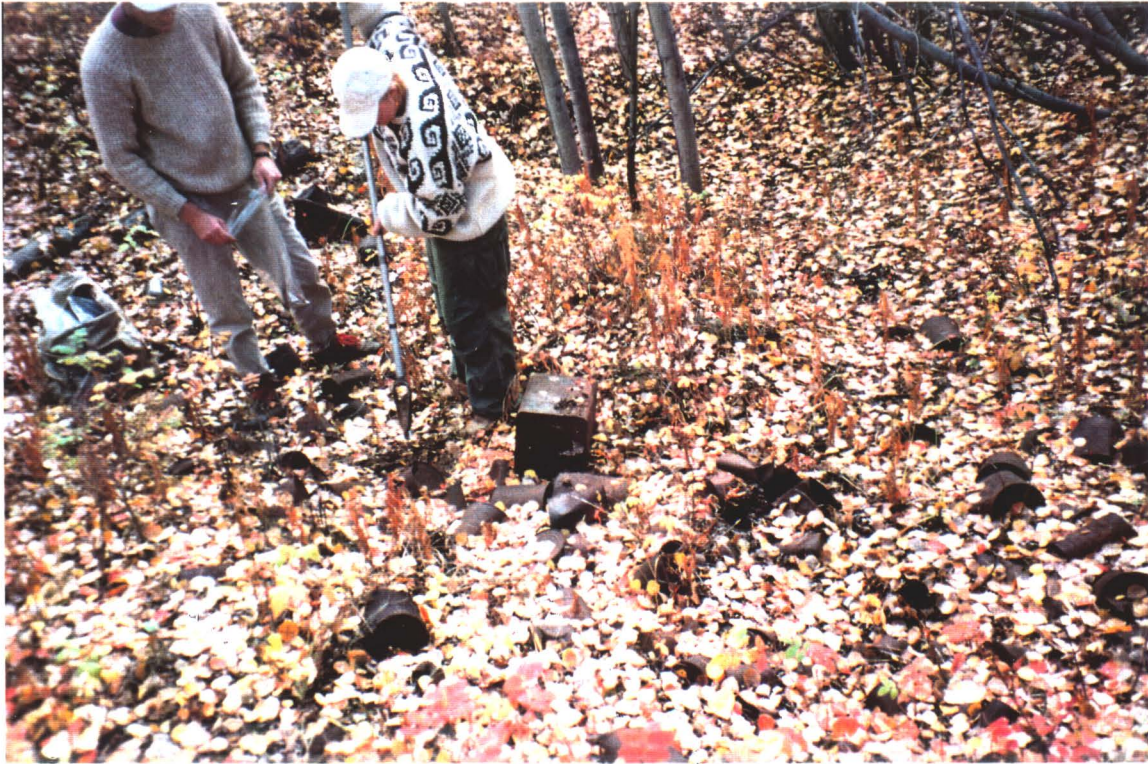
Debris area at SITE 15 dump site, soil sample 15 BH1-0.3

Piles of debris were found at the dump site, and included both recent and older metal cans, wood, scrap metal, paper, plastic, and a recent vehicle chassis.

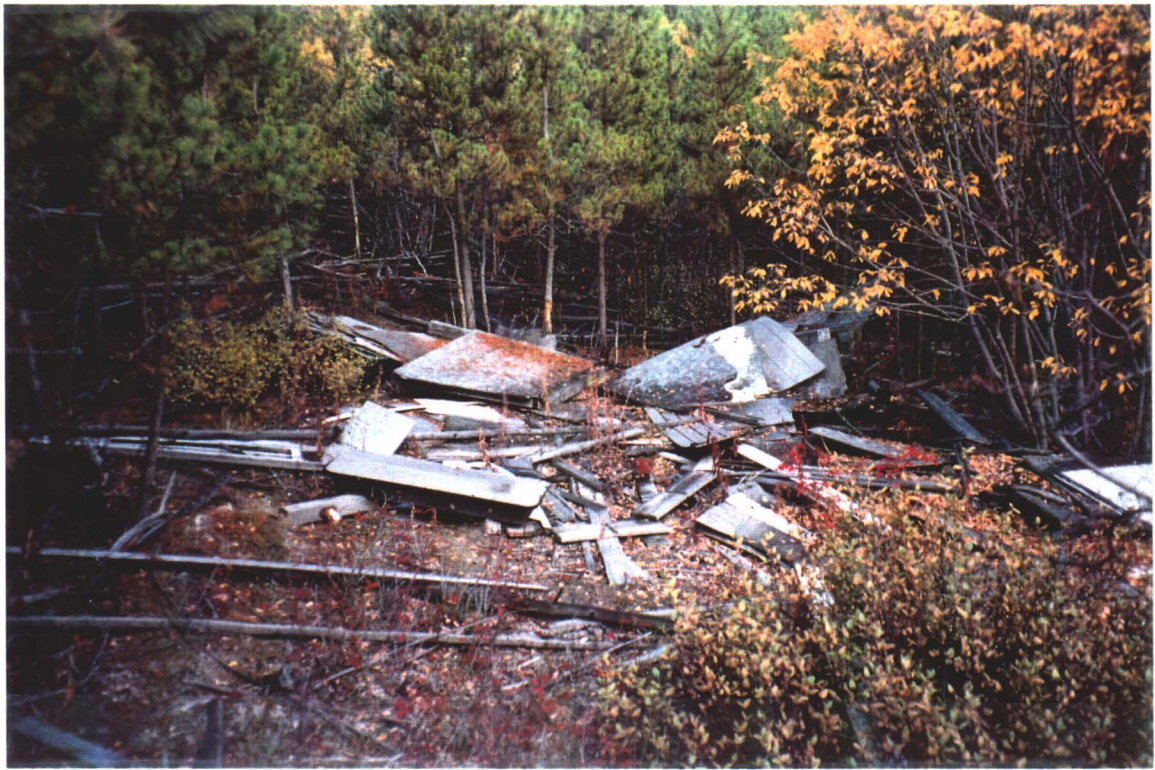
SITE 15 - Overview of dump site

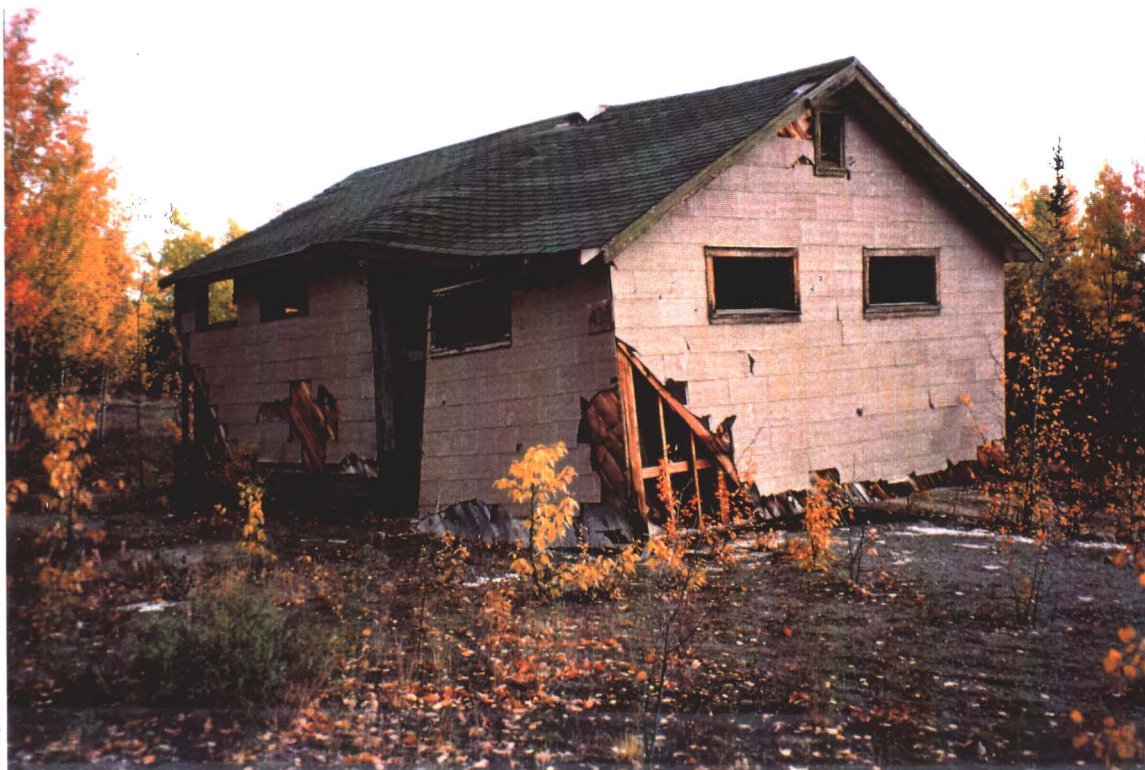
The remaining camp building which was founded on blocks, appeared to be a residence and was in poor condition. The concrete foundations of the other buildings identified in historical records were identifiable. Debris, including metal cans, empty barrels, plastic, wood, and scrap metal, was scattered across the site. A large pile of debris, primarily building materials (wood and metal), was observed on the north side of the site. Partially buried debris was noted on the west side of the camp. Near the south end of the camp, metal debris was observed within the riverbank, at the top of the bank and in the river.

SITE 16 - Damaged building - interior paint sample obtained

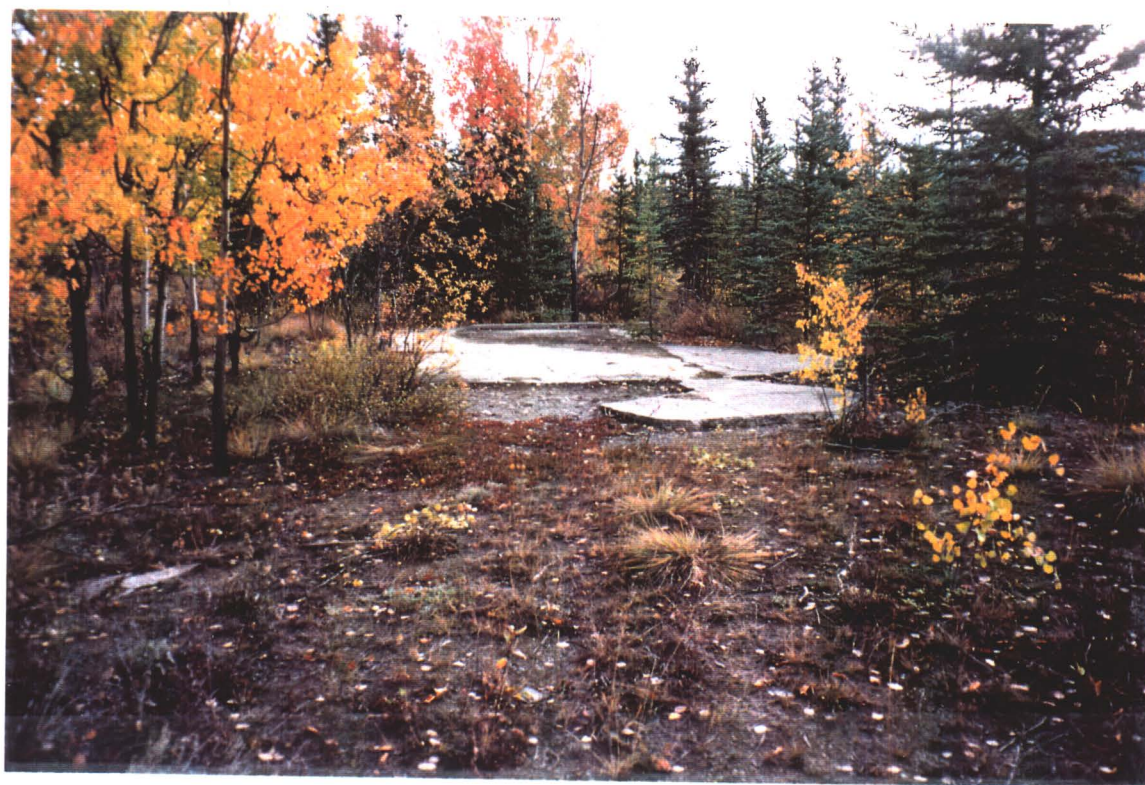
SITE 16 - Concrete foundations

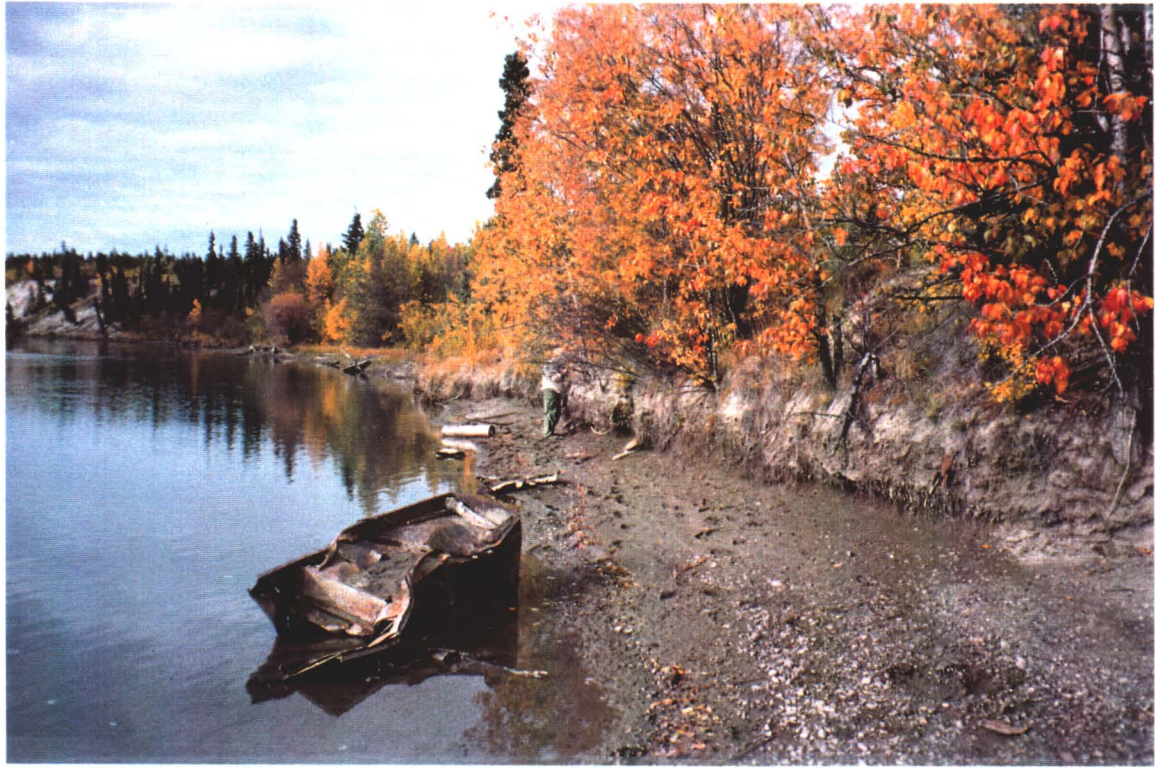
SITE 16 - Debris in Takhini River

Adjacent to the river, where debris was observed, it was noted that the vegetation was less developed than the surrounding area and there appeared to be backfilled trenches leading from the site to the river. A sediment sample, TR16-SS1 was collected from the riverbank to assess potential contamination and was tested for BTEX, TPH, TEH, metals, PCBs, PAH, and pesticide concentrations. The concentrations measured in this sample were below applicable remediation criteria.

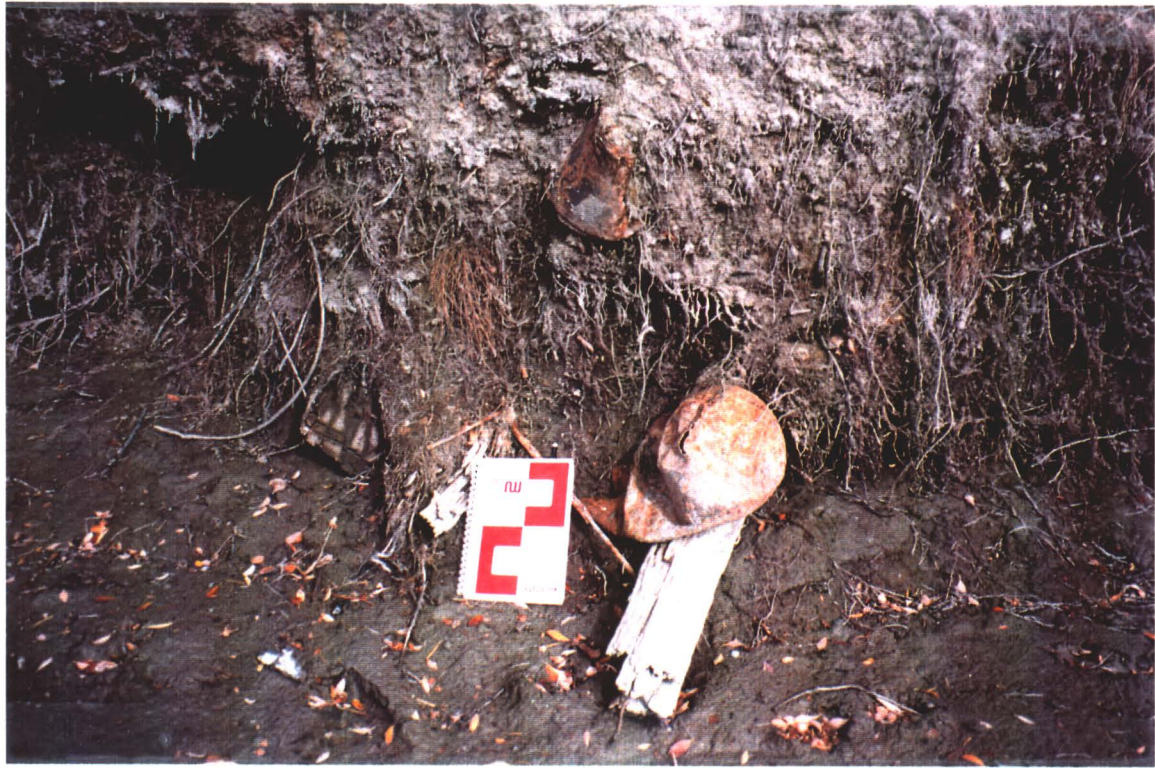
SITE 16 - Close up view of debris embedded in river bank

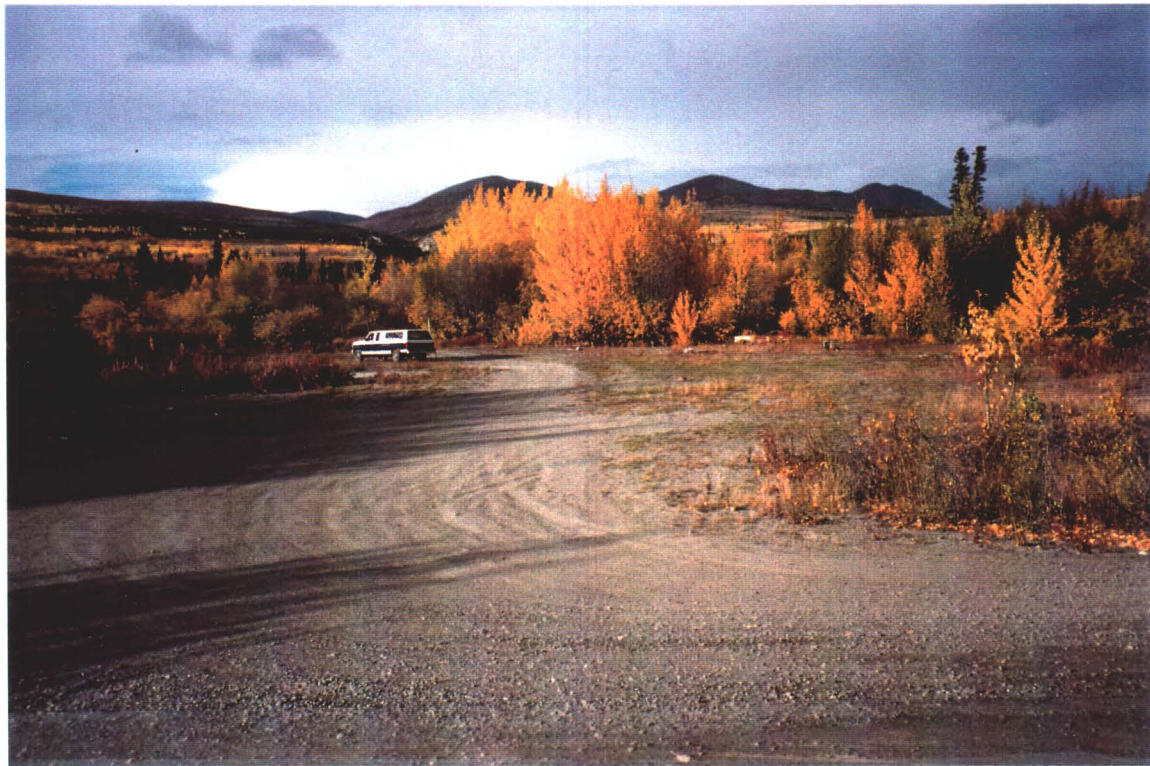
SITE 17M - Overall view of site, view north

No buildings remain at Sites 17M and 17E. Waste consisting primarily of building materials was noted in the vicinity of the concrete foundations. Several small debris areas, consisting primarily of metal cans and scrap metal, were observed across the site. The main dump site, located northeast of Site 17E, contained one vehicle chassis, a large piece of chain, and various wood and metal debris, including empty small oil cans and empty 45 gallon drums, scattered at various locations in the forested area.

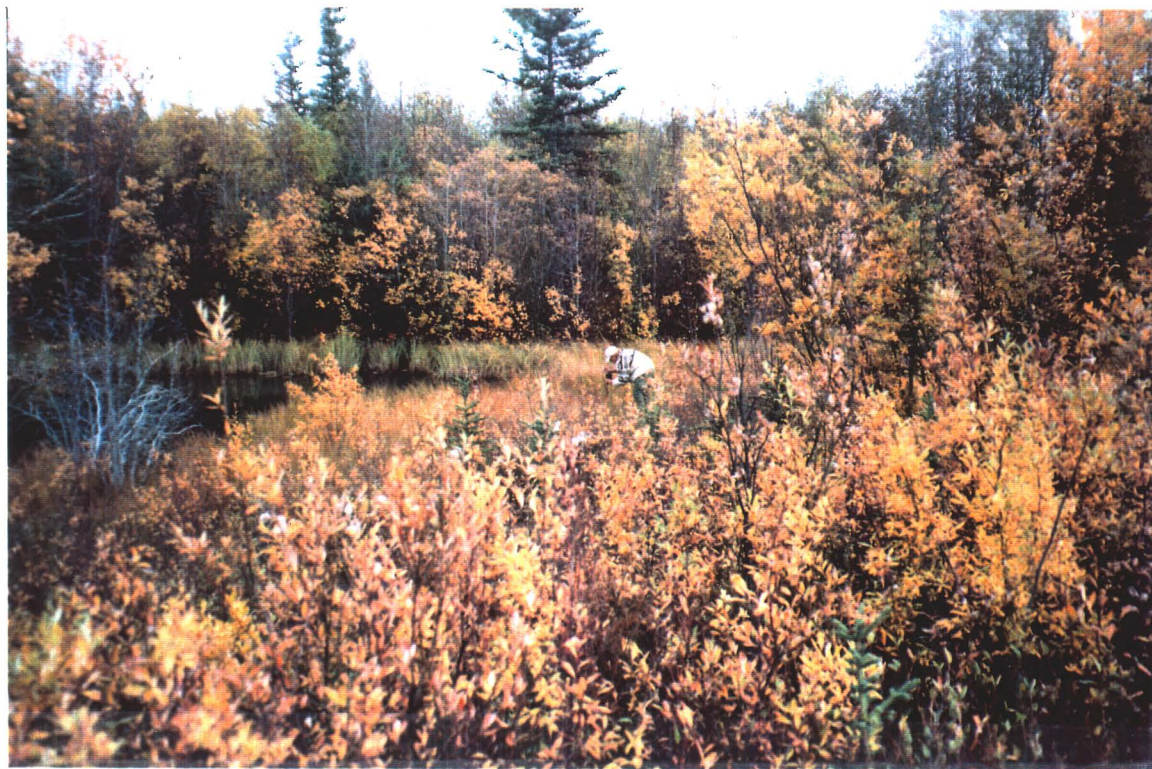
SITE 17M - Water sample location at slough

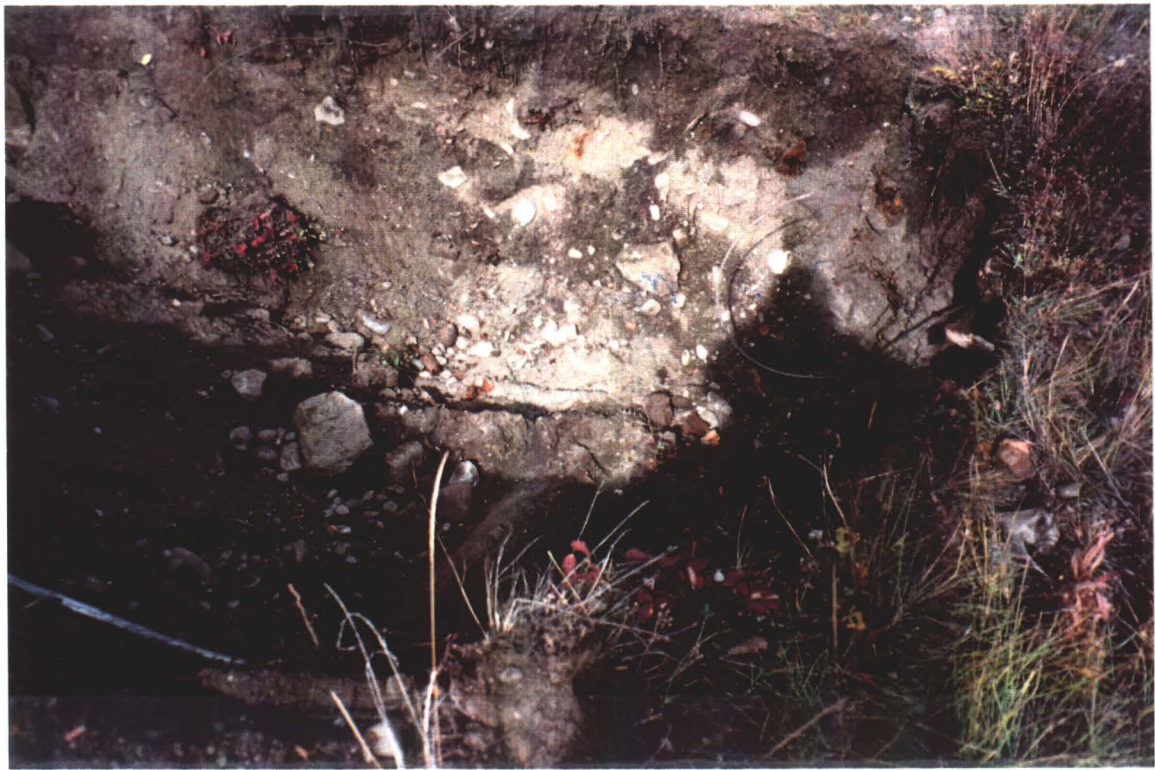
SITE 17M - Debris exposed in TP1

Two detailed EM31 geophysical surveys were carried out at Site 17M. Grid No. 1 encompassed an area of approximately 86 metres by 92 metres, in the main camp site where the majority of foundations and associated building debris were observed. A grid spacing of approximately 7.5 metres was used. Two localized areas, where anomalous EM-31 readings were measured, were targeted for further investigation during the subsequent test pit excavation program. Test pit TP1, excavated on the west side of Grid No. 1, uncovered a small waste disposal pit. Debris included metal, wood, and pipes and what appeared to be remnants of the Canol pipeline. Test pit TP2, excavated approximately 30 metres north of TP1, uncovered a 25 mm and 75 mm diameter steel pipe. Test pit locations are shown on Drawing 3-3.

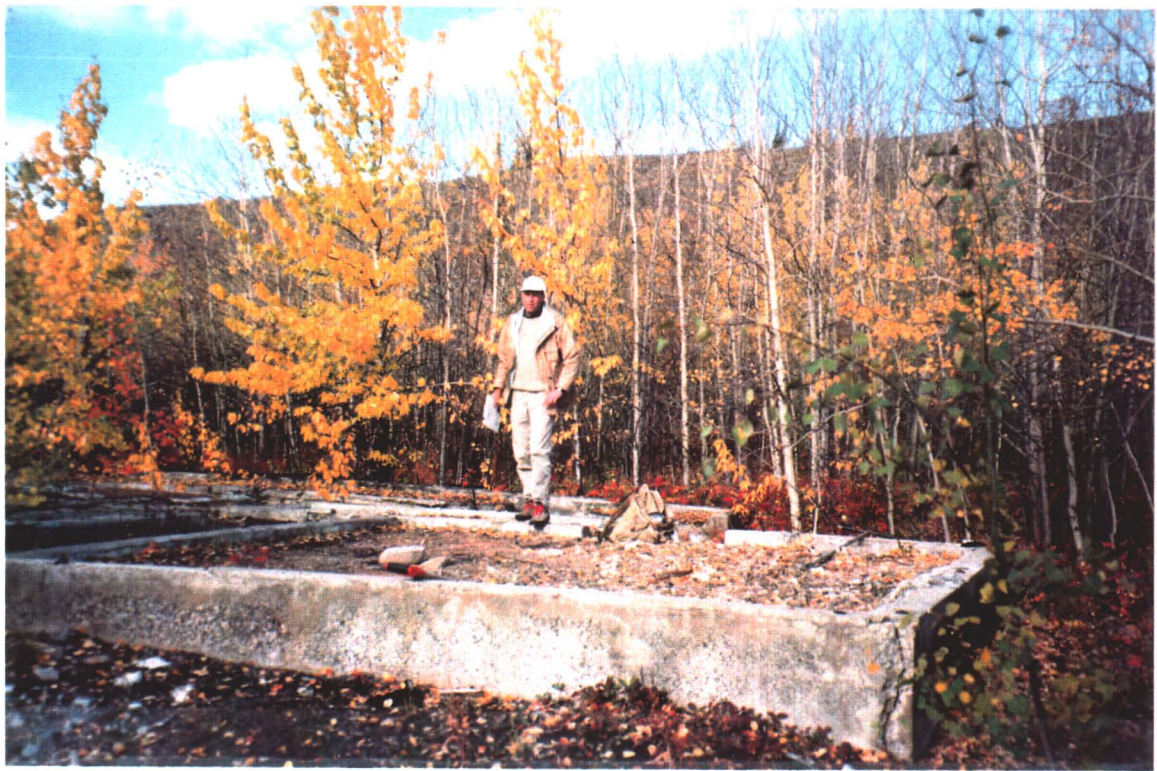
SITE 17C - Canol pump house foundation

At Site 17C, the Canol Pump Station, only the pump house foundation remains. The site is located south of a large ridge, and slopes gently to the south towards the Alaska Highway. Several abandoned borrow areas were noted in the vicinity. Vegetation is dominated by trembling aspen forest cover with some white spruce. The understorey consists of prickly rose shrubs and grasses. The forest growth area has been affected by a forest fire that had gone through the area in the late 1950's.

At Site 17C, the pump house structure has been removed. Metal debris and concrete rubble were observed adjacent to the access road at the entrance to the site. Abandoned borrow areas, west of the site, contained small piles of debris, primarily empty metal cans.

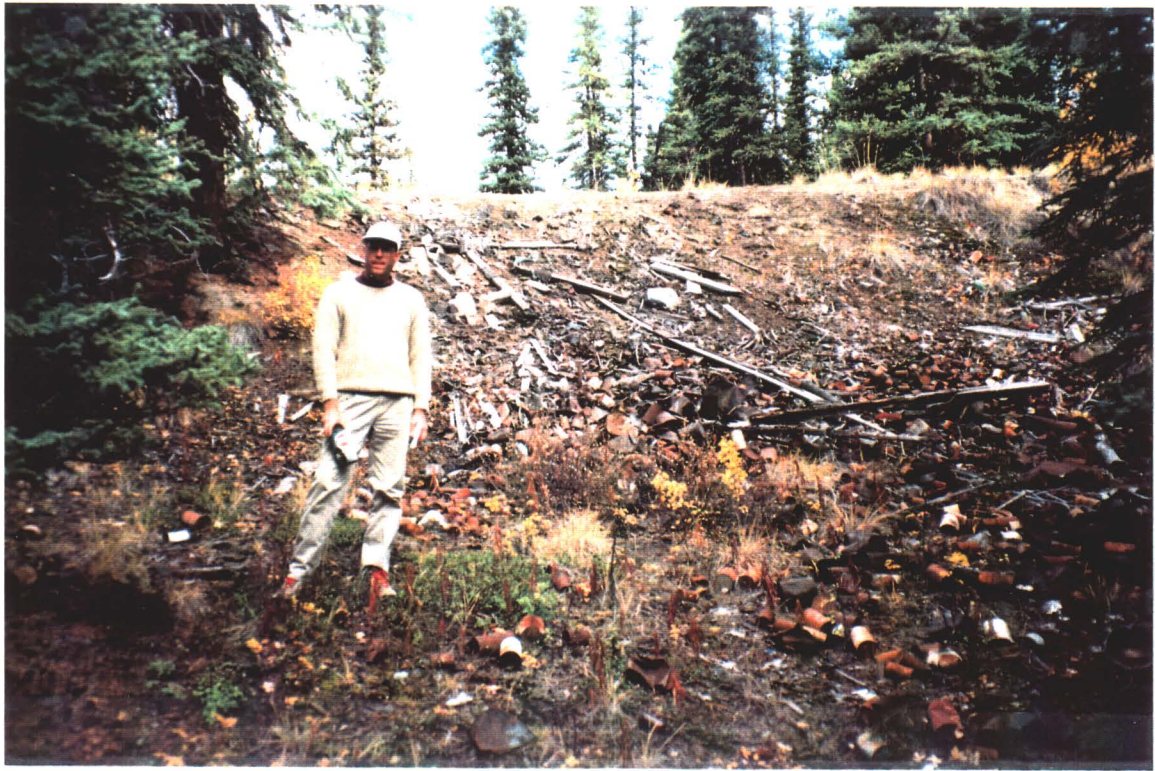
SITE 18 - Debris area at south end of site

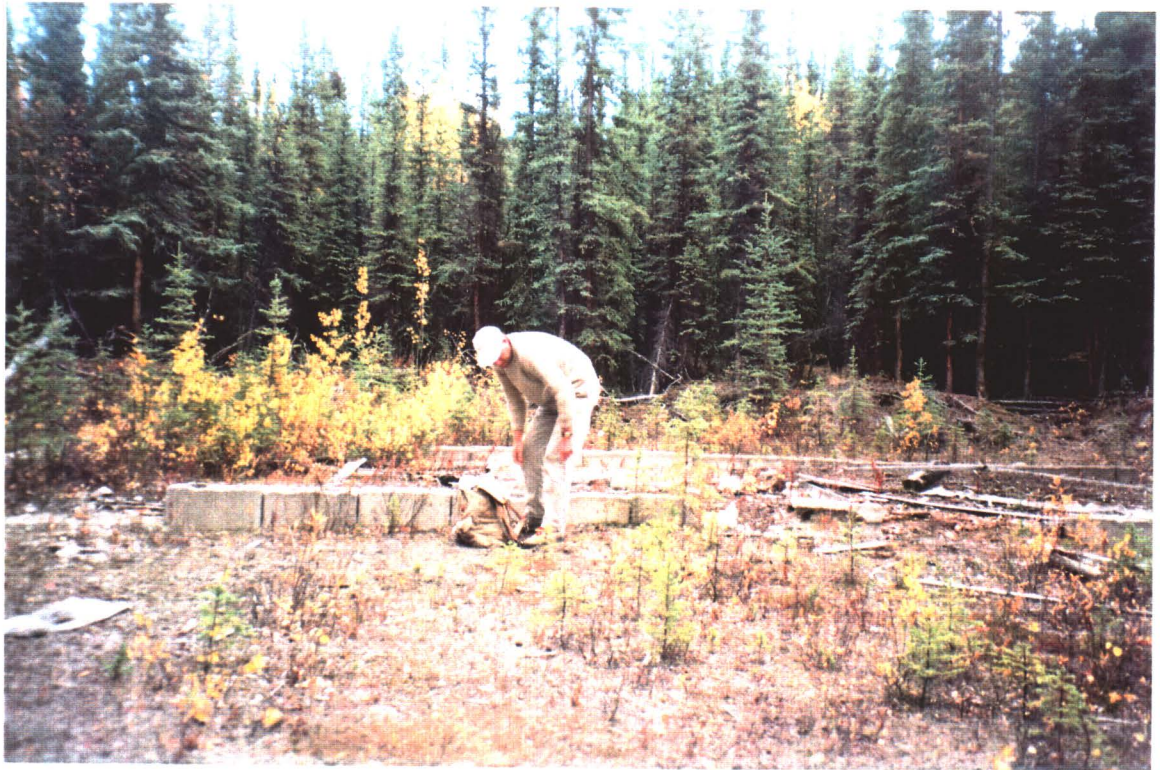
Concrete building foundations were identifiable in the campground area. A cleared area, adjacent to the highway, appeared to be the site of the former retail fuel outlet.

SITE 18 - Typical building foundation

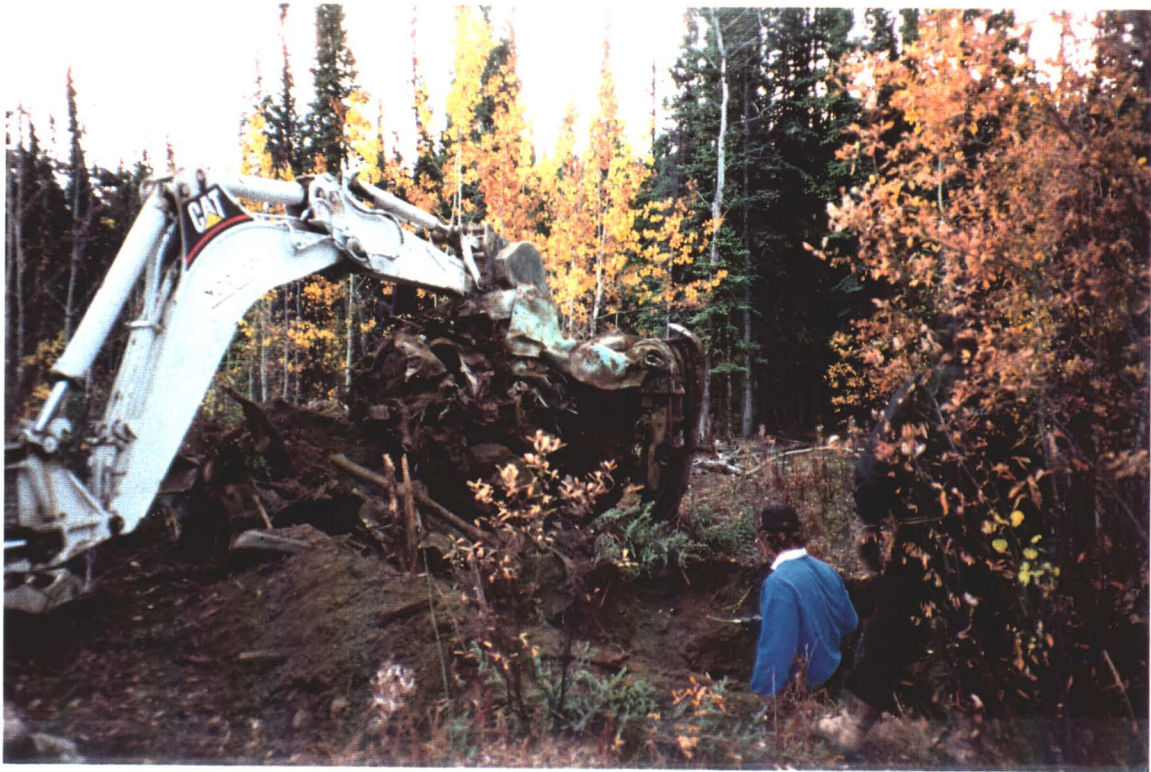
The test pit investigation at the Mendenhall River and Stony Creek sites was carried out. Excavations at Mendenhall uncovered dump sites with assorted debris including metal cans, vehicle bodies, tires, scrap metal, etc. A test pit also exposed the probable location of the former underground storage tank at the service station. High PID readings were noted in soils sampled from this test pit. One other test pit uncovered a culvert which may have been part of the old approach to this site.

SITE 18 - Vehicle excavated at TP5

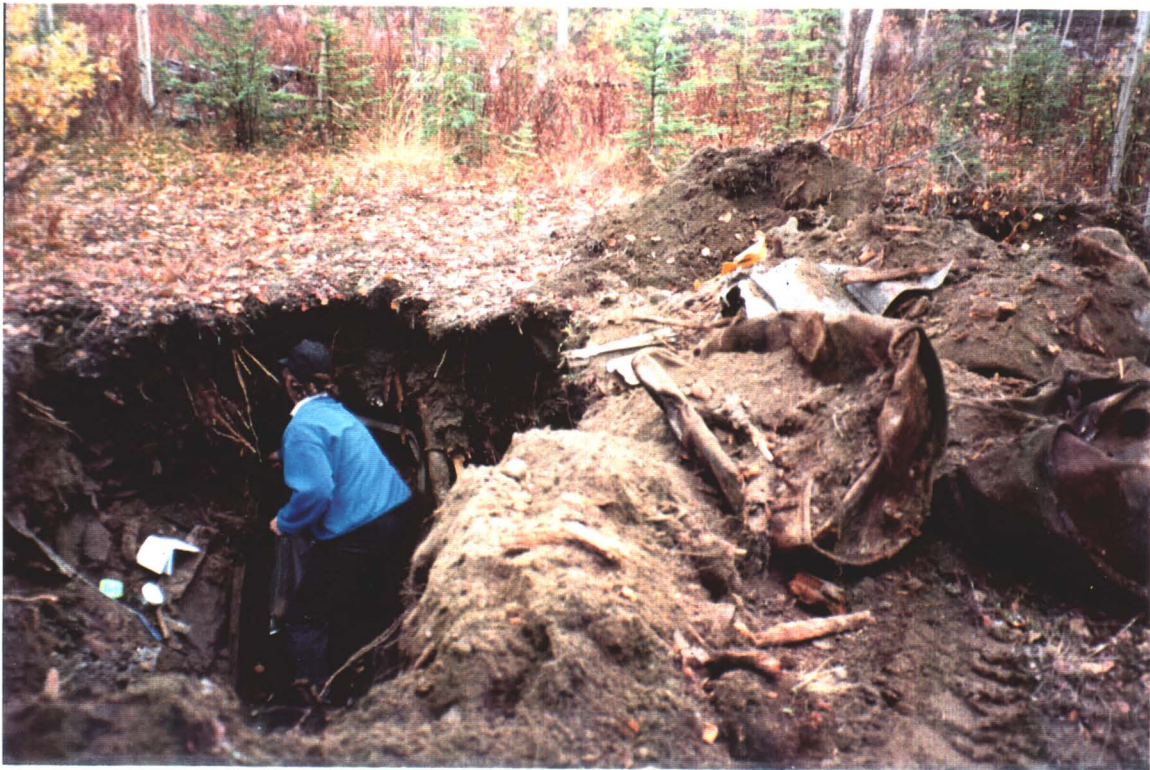
SITE 18 - Debris at test pit, TP6

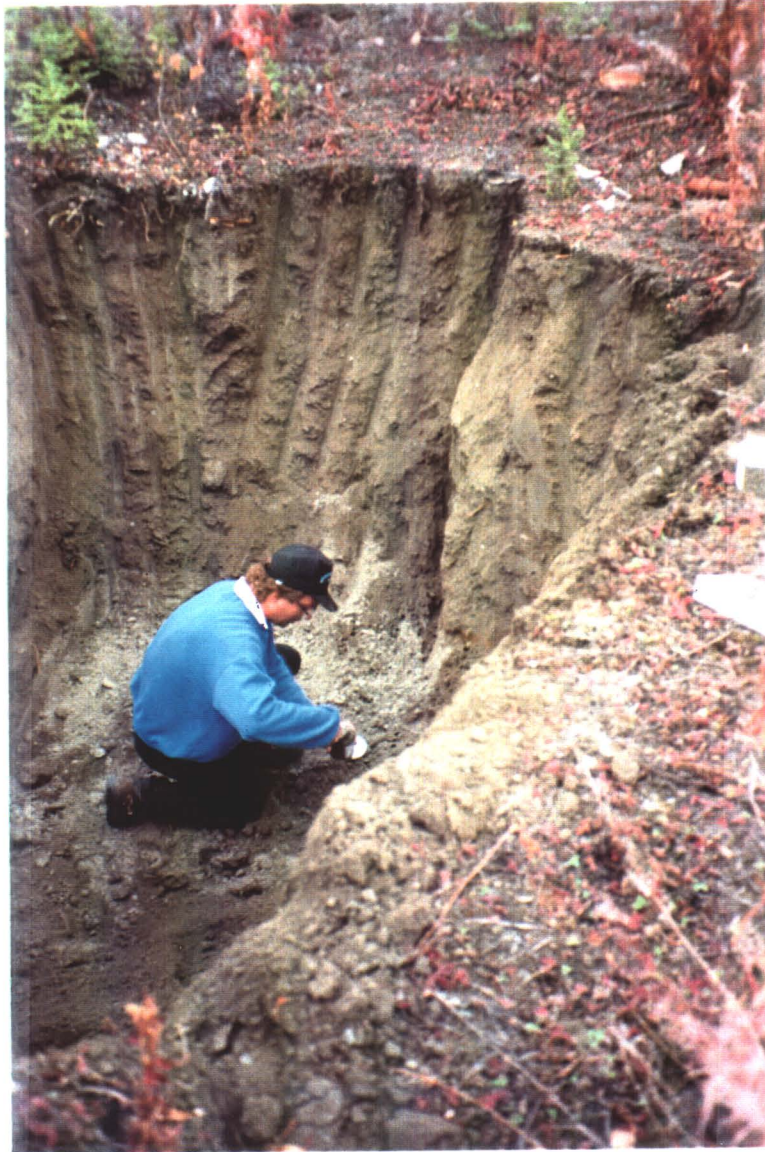
SITE 18 - Test pit, TP4, suspected location of underground storage tank

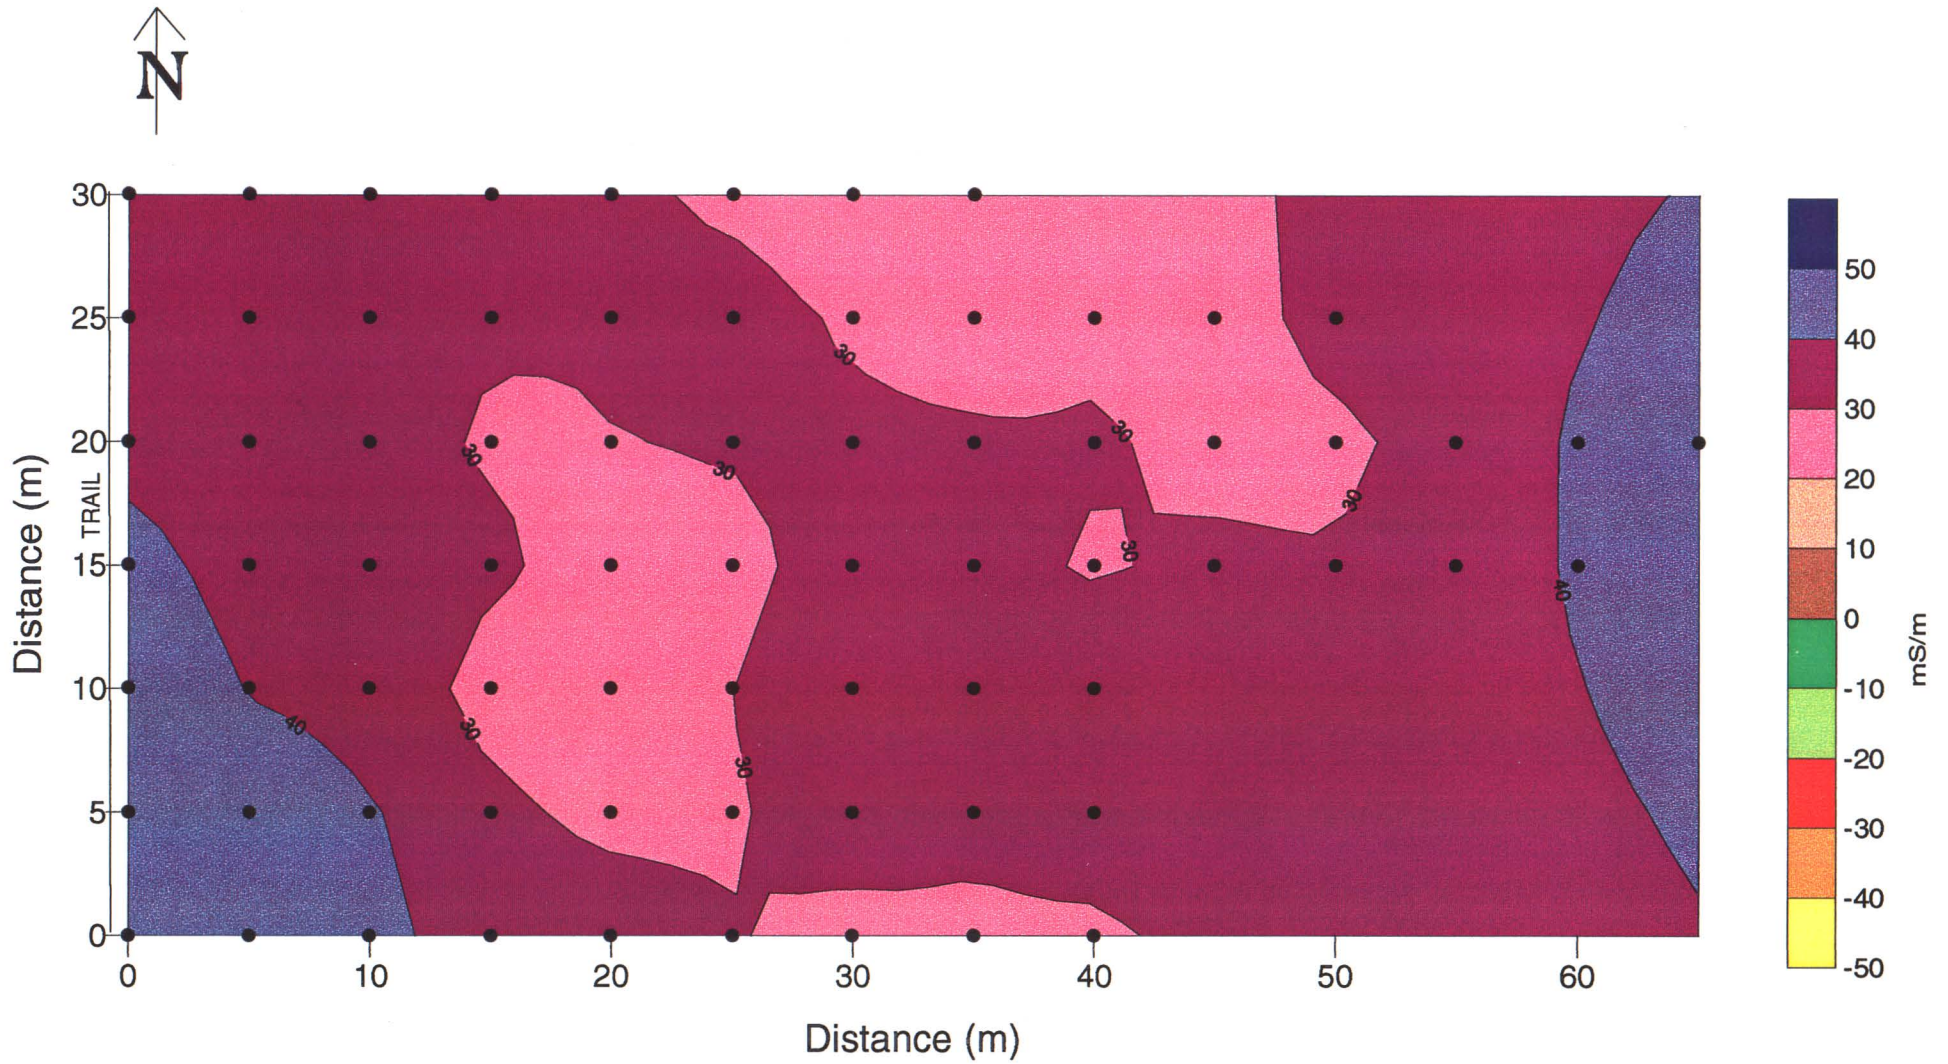
At the dump site to the east of the former camp, it appeared that some burning had taken place, as evidenced by the charred timbers in the area. Minimal surface debris was noted. To assist in the evaluation of the dump site, a detailed EM31 geophysical survey was carried out, encompassing an area of 30 metres by 65 metres, with readings obtained at 5 metre intervals. No anomalies were measured during this survey.

Preliminary Environmental Assessment,
 DIAND Yukon
 Site 16 - Takhini River Dump Site
 EM31 Survey Grid
 Figure A.1

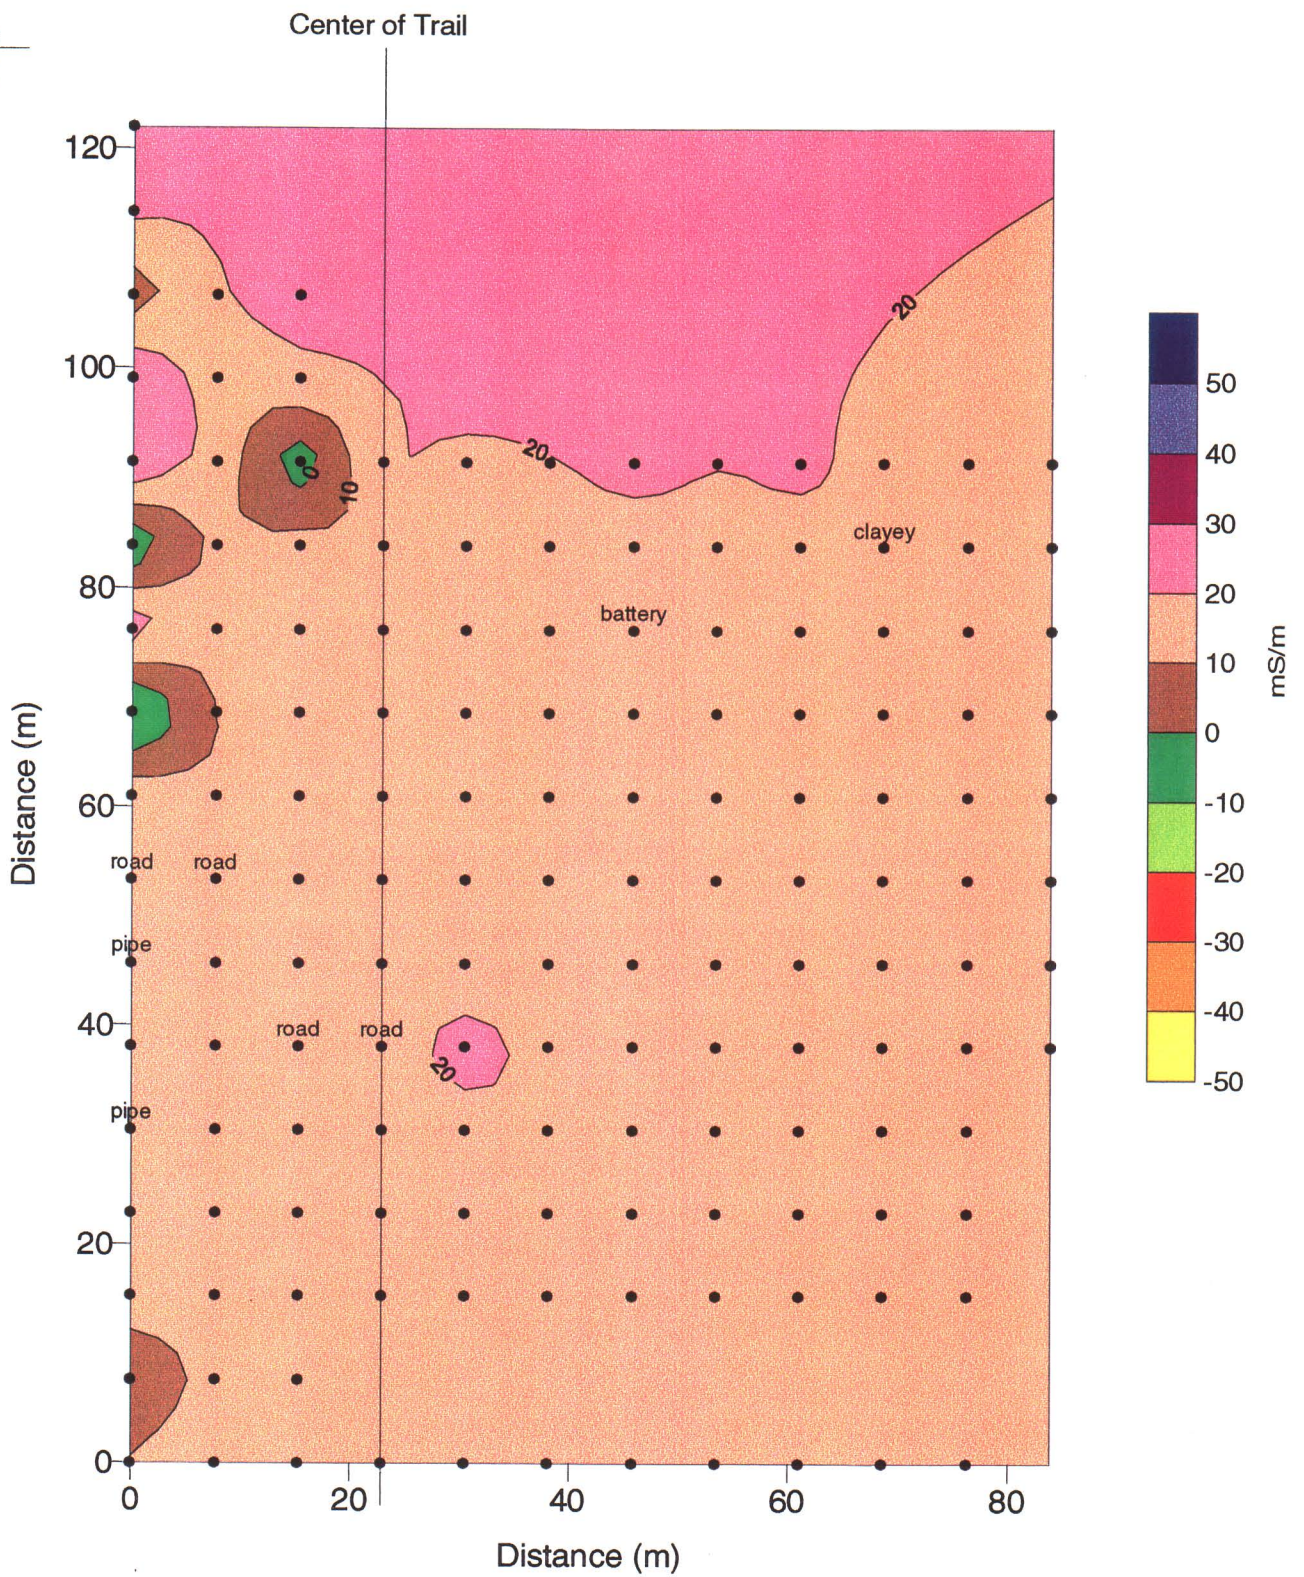
Preliminary Environmental Assessment,
 DIAND Yukon
 Site 17M - Stony Creek - Site Area
 EM31 Survey Grid No. 1
 Figure A.2

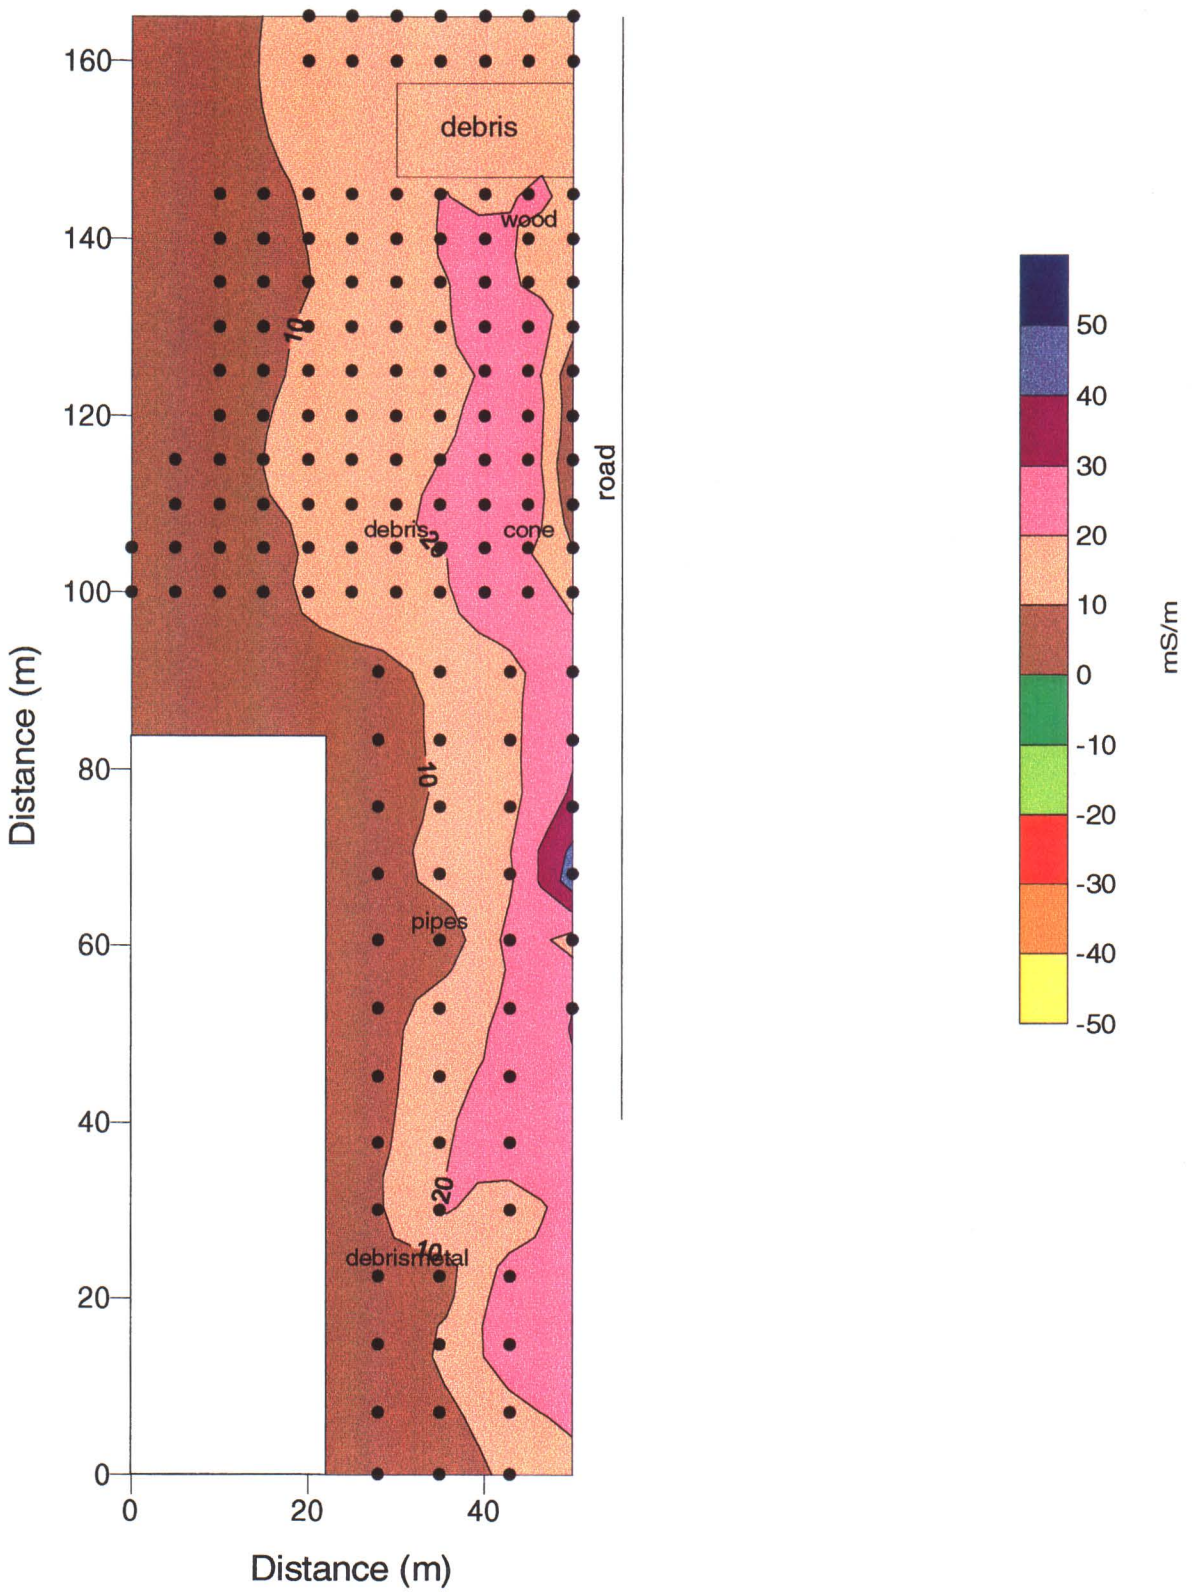
Preliminary Environmental Assessment,
DIAND Yukon
Site 17M - Stony Creek - Top of Ridge
EM31 Survey Grid No. 2
Figure A.3
