**PRELIMINARY ENVIRONMENTAL ASSESSMENT
OF FOUR FORMER U.S. MILITARY CAMP SITES
YUKON TERRITORY**

**Indian and Northern Affairs Canada - Yukon
Arctic Environmental Strategy
Action on Waste Program**

UMA Engineering Ltd.
Engineers, Planners & Surveyors
17007 - 107 Avenue
Edmonton, Alberta
T5S 1G3

December 1996
4440-035-00-02

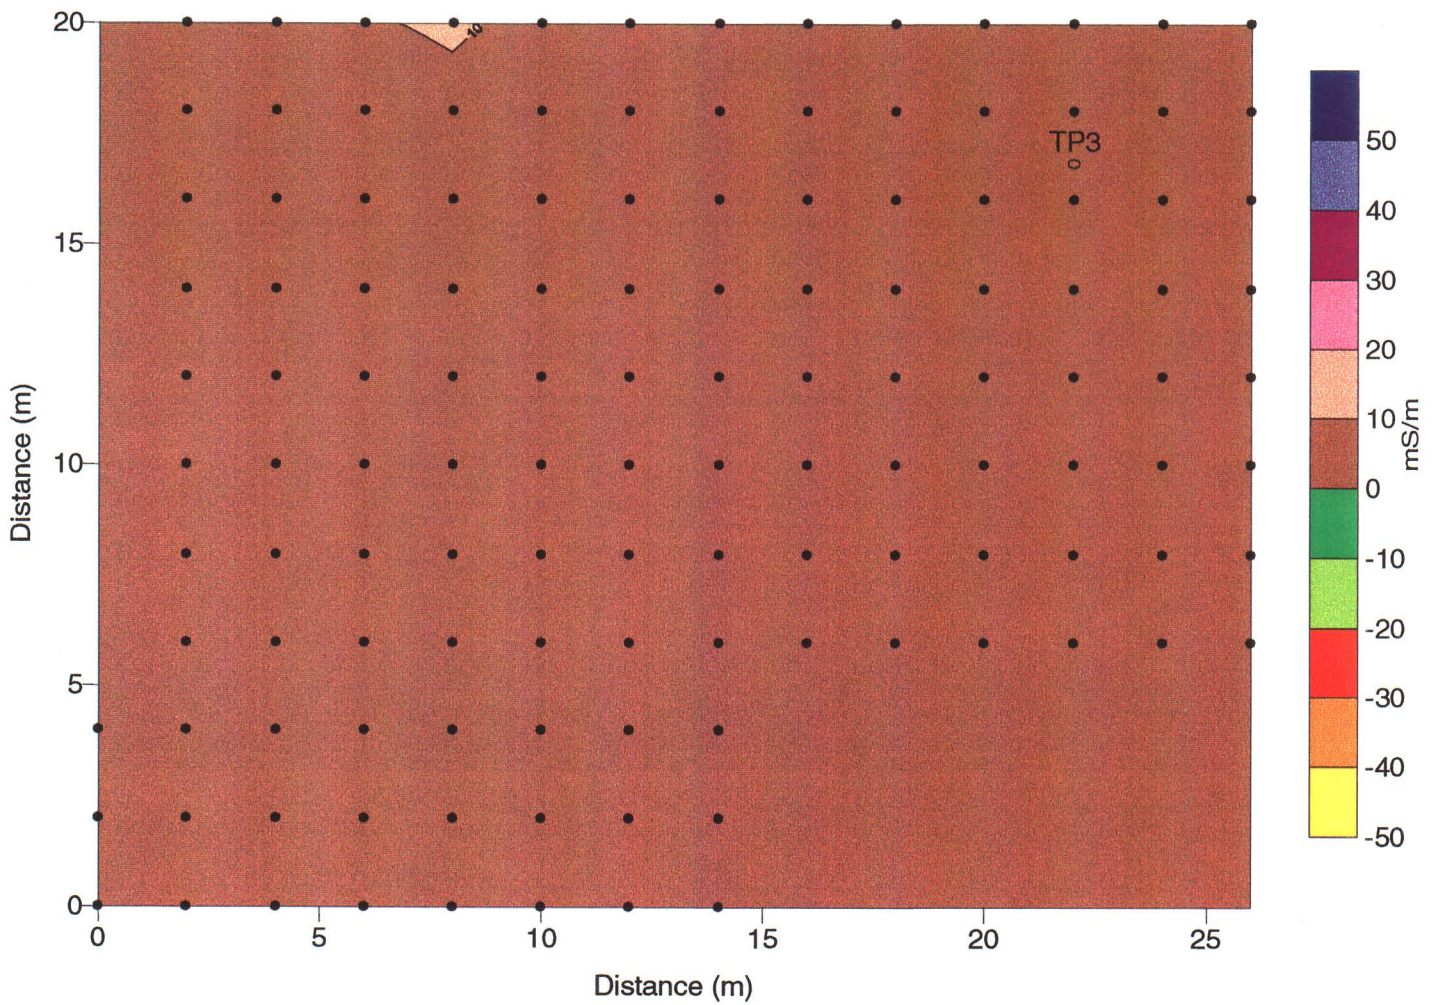
Two detailed EM-31 geophysical surveys were carried at Site 17C. Grid No.1 , covered an area of approximately 50 m x 12 metres, west of the access road to the pump station, and adjacent to the highway. Grid No. 2, located south of the pump house foundation in a gravelled, disturbed area, encompassed an area of approximately 25 metres by 20 metres. A 2 metre grid spacing was used in both surveys. No anomalies were detected in either survey. One test pit, TP3, was excavated in the disturbed area, to complement the data from geophysical survey. The test pit location is shown on Drawing 3-3. No debris or staining were observed in the test pit.

Preliminary Environmental Assessment,
DIAND Yukon
Site 17C - Canol Pump Station
EM31 Survey Grid No.2
Figure A.5
