# FINAL REPORT

## Snag Airstrip Remediation

### Snag, Yukon

Re: Snag Airstrip Remediation Project  
Final Report

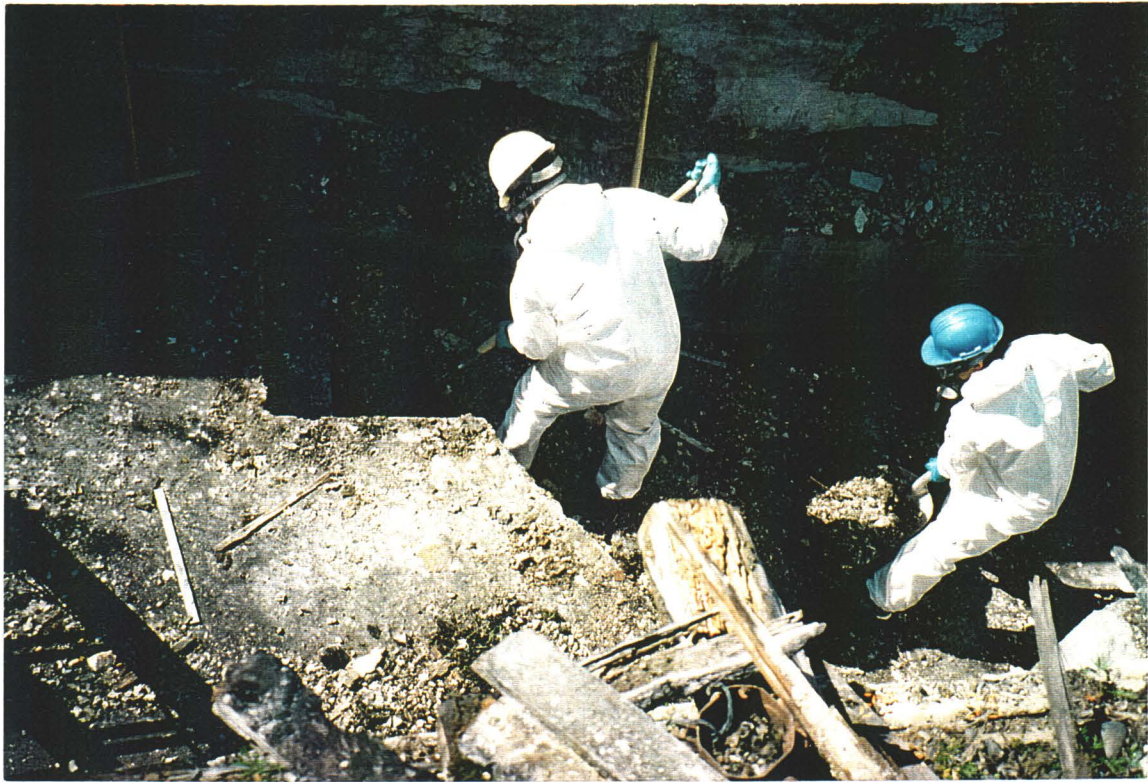
**PHOTO 1:** Barracks Building - Manual removal of moss and debris indicated by ESG (ESG 1995) to contain concentrations of PCBs above CEPA criteria.

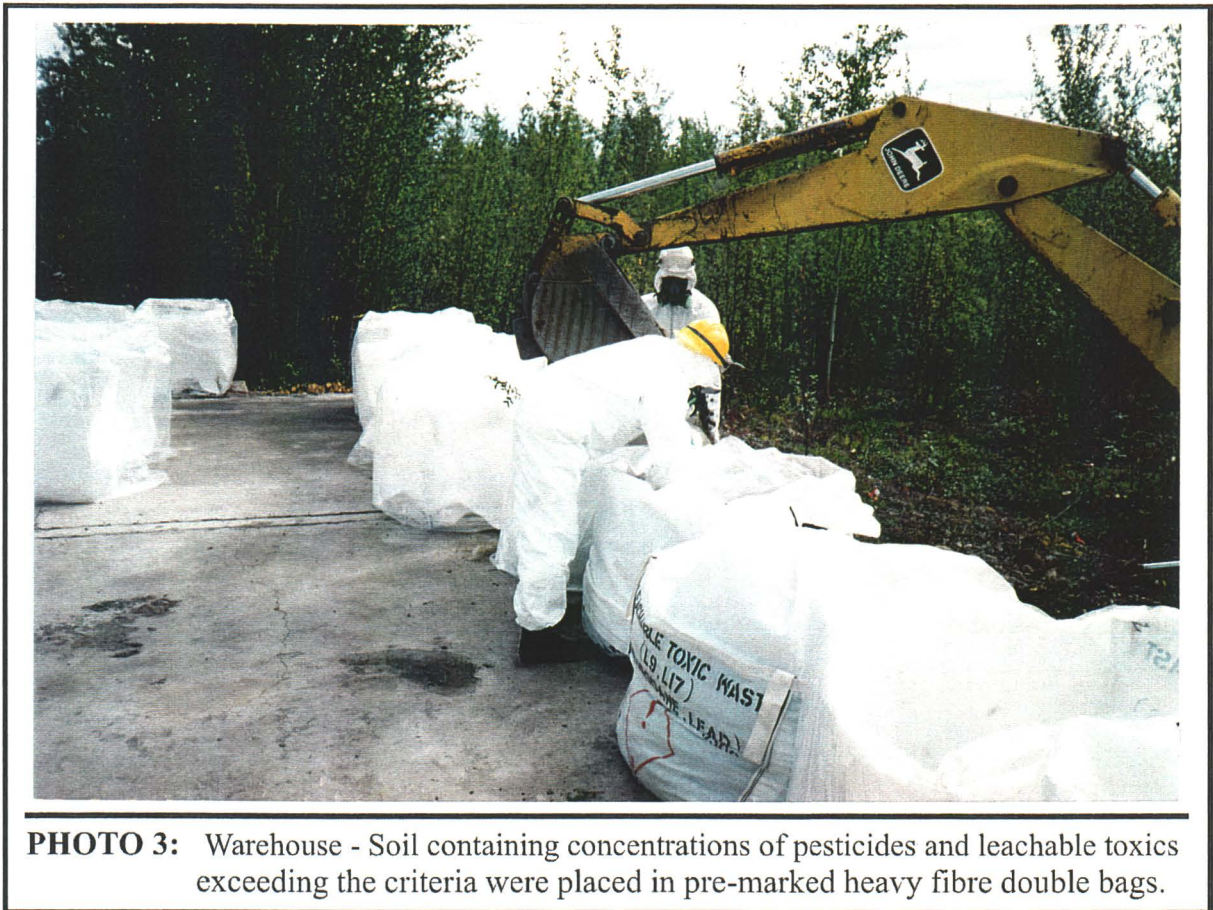
**PHOTO 3:** Warehouse - Soil containing concentrations of pesticides and leachable toxics exceeding the criteria were placed in pre-marked heavy fibre double bags.

Soil determined to contain concentrations of pesticides and leachable toxics above the applicable remediation criteria was excavated and immediately placed in Supersacks or secure barrels. The sacks each contained approximately 1 m<sup>3</sup> of soil; 150 sacks were filled. Twenty seven barrels holding approximately 0.3 m<sup>3</sup> of soil each were also filled. Closure was achieved when the confirmatory samples analysed indicated concentrations of contaminants below the remedial criteria both horizontally and vertically. The excavated areas and the concrete foundation were backfilled and the entire area was graded.

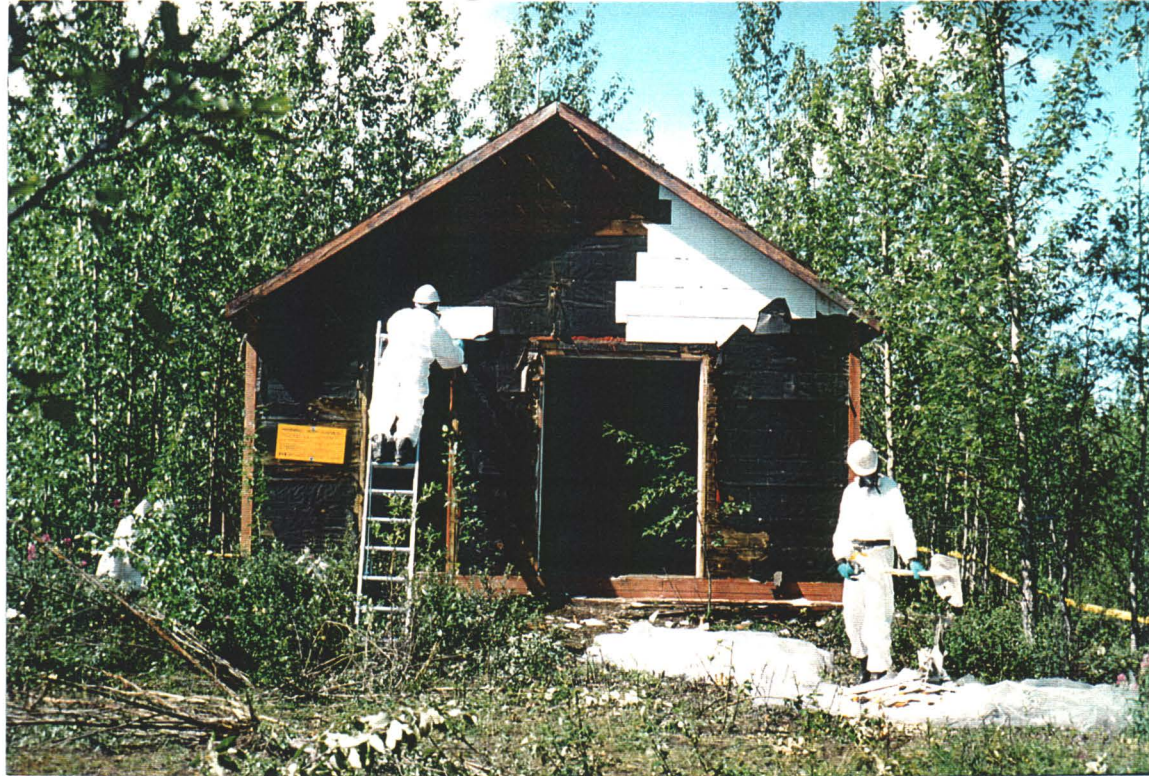
**PHOTO 5:** Firehall -Removal of asbestos containing roof tiles and exterior building shingles. Tiles and shingles were double wrapped in polypropylene.

The roof and exterior wall tiles of the Firehall were treated as asbestos containing material. The tiles were wrapped in a double layer of polypropylene, labelled and placed in the landfill. Their approximate positions in the landfill were documented.

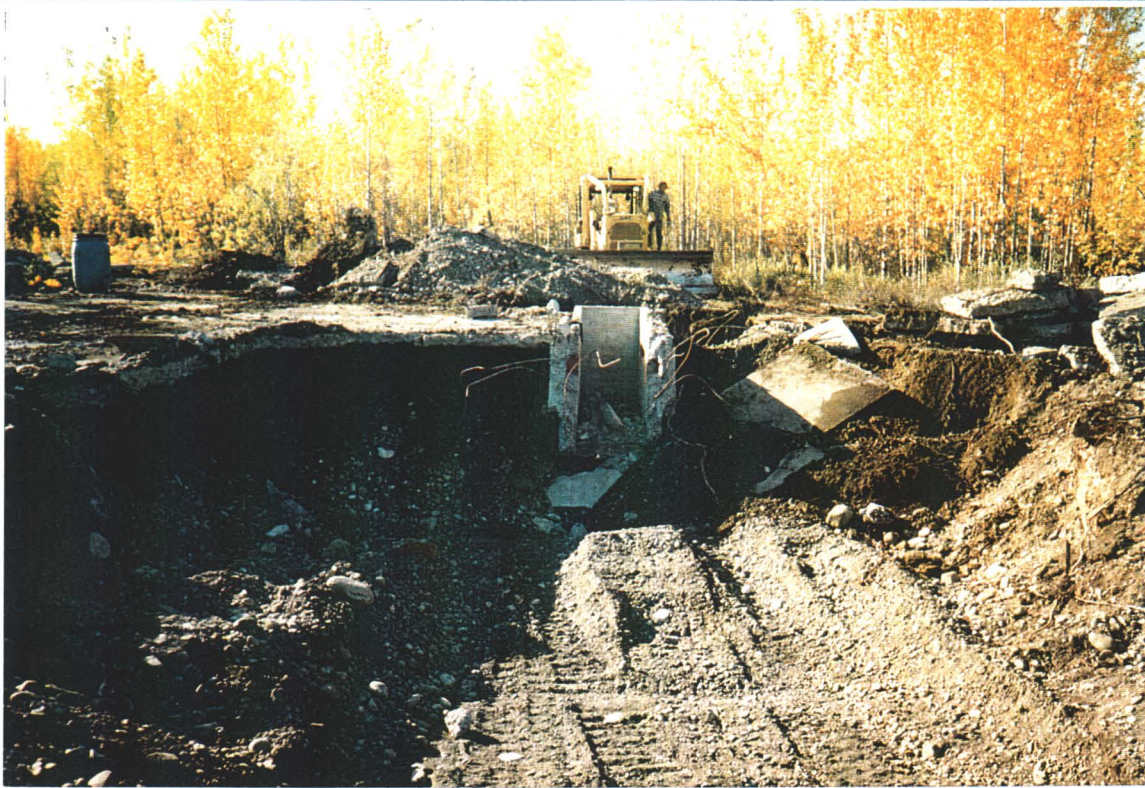
**PHOTO 6:** Garage - Photograph of large concrete garage pit with sump removed

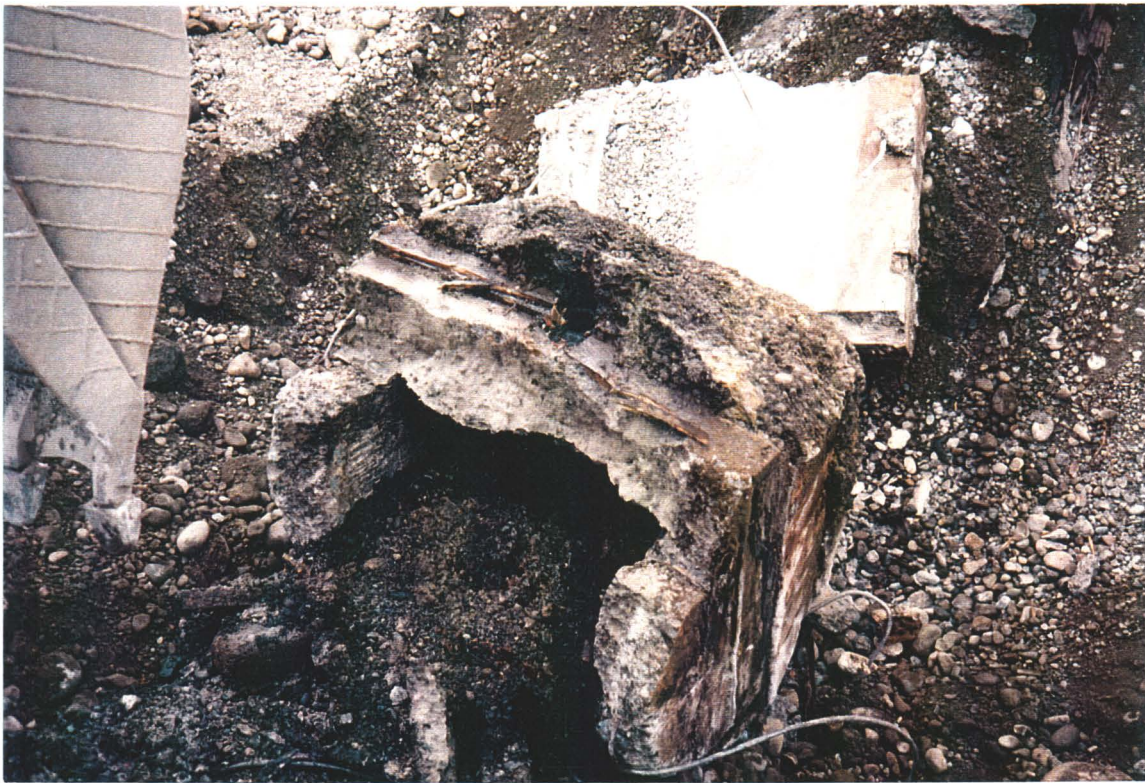
**PHOTO 7:** Garage - Concrete sump from garage pit. Note, black sludge in sump.  
NOTE: This sludge was removed and placed in secure barrels for disposal.

Sediment below the pits was treated as containing concentrations of PCBs above the CEPA criterion. Therefore, it was excavated and placed in barrels. A field immunoassay kit was used to analyse sediment from the barrels. Two of the samples indicated high concentrations of PCBs and these barrels were shipped offsite with the other containers containing waste with concentrations of PCBs in excess of the CEPA criterion and pesticide concentrations in excess of the applicable remedial objective. The analyses of the remaining samples indicated low concentrations of contaminants. Therefore, these barrels were placed in the containment cell.

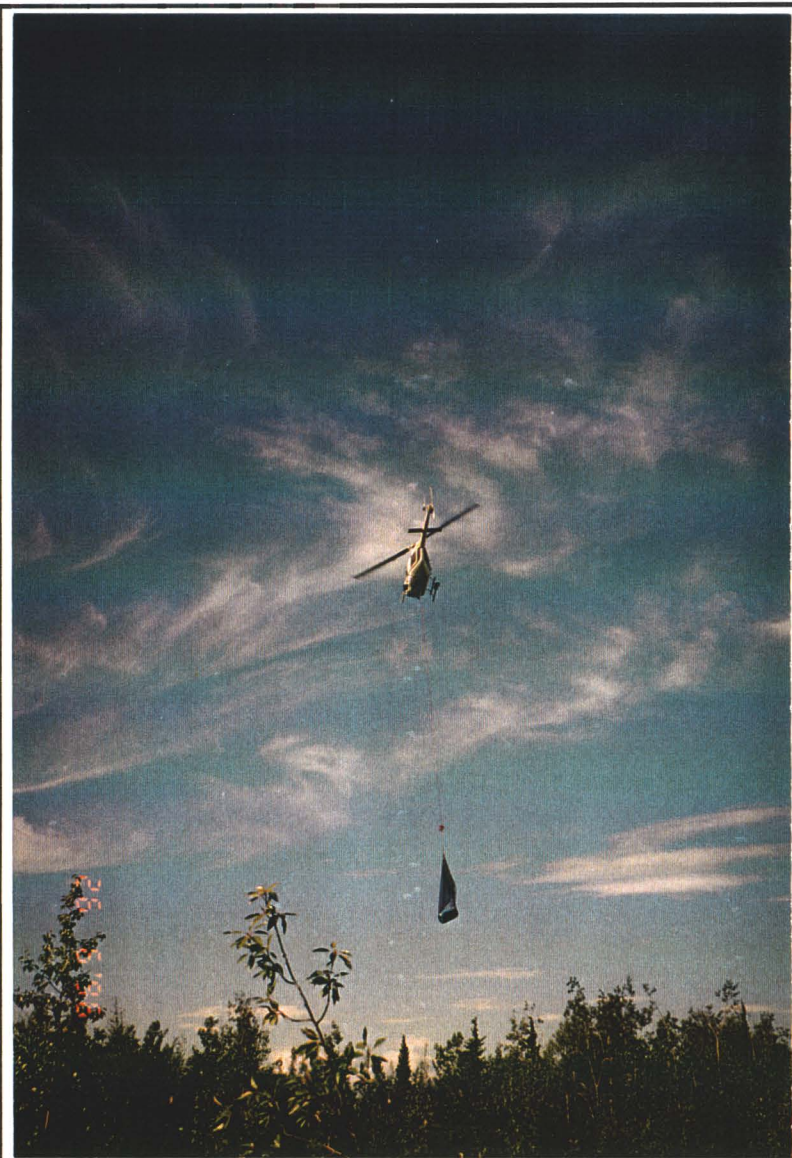
**PHOTO 8:** Beacon Site - Excavated soil, painted wood and metal debris were slung by helicopter to the temporary staging cells, where the the nets were unloaded.

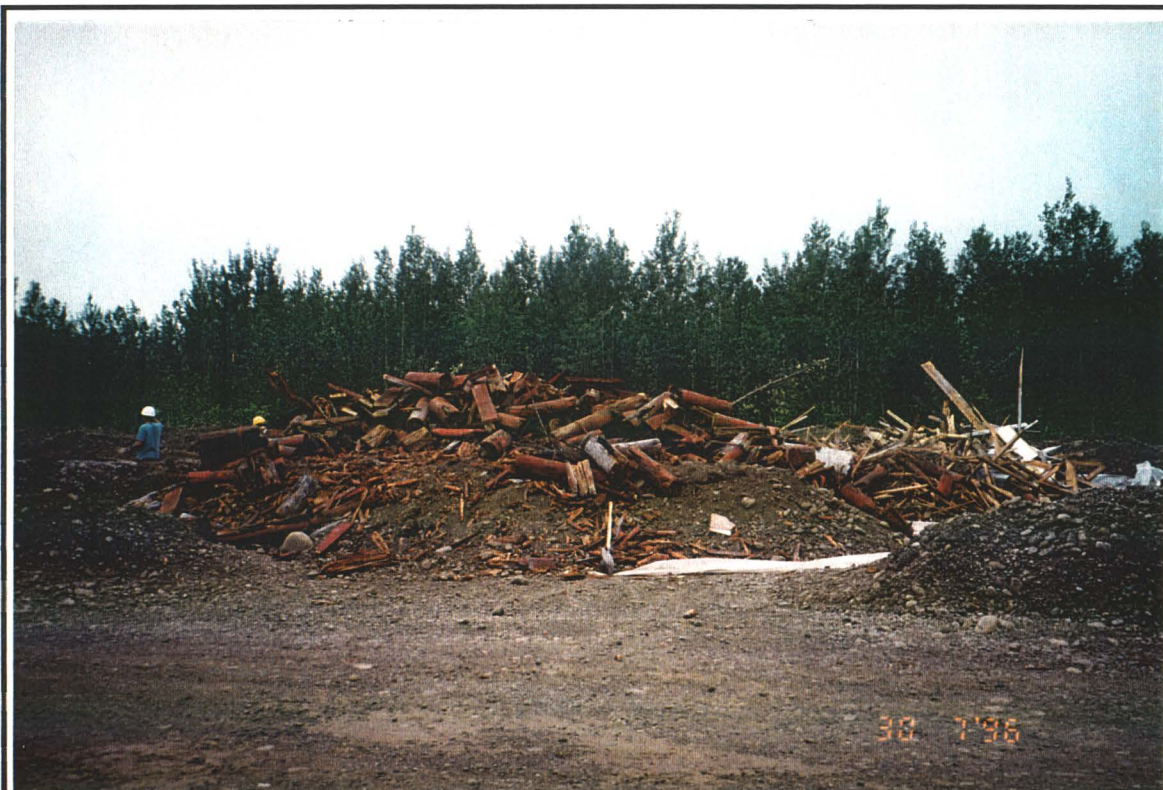
**PHOTO 9:** Beacon Site - Painted wood towers and fence debris, removed from the Beacon Site, in one of the temporary staging cells.

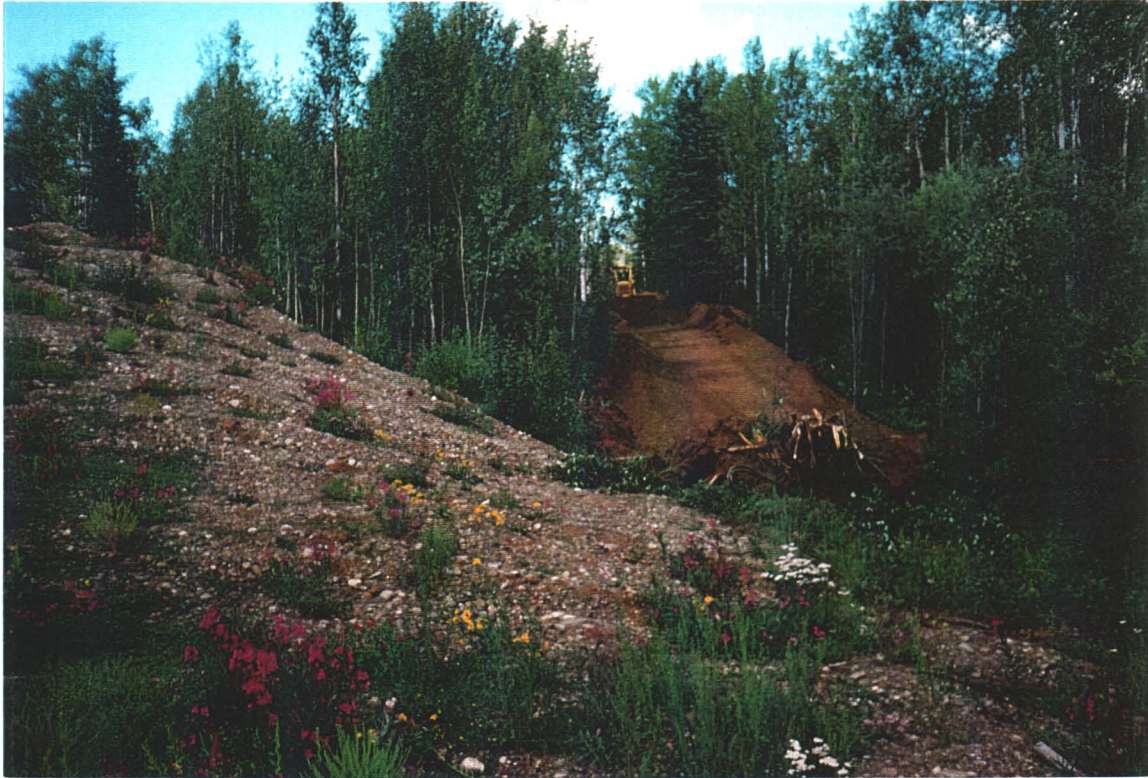
**PHOTO 10:** Landfill - Unpaved road constructed from road leading into landfill to the toe of the landfill. Photograph taken from toe of landfill.

To facilitate access for the drill rig an unpaved road was constructed from the road leading into the landfill to the toe of the landfill (Photo 10). The road included a small turnaround pad at the base. Borrow material was placed on the road to stabilize it. Three groundwater monitoring wells were placed at the bottom of the landfill slope (Figure 9).

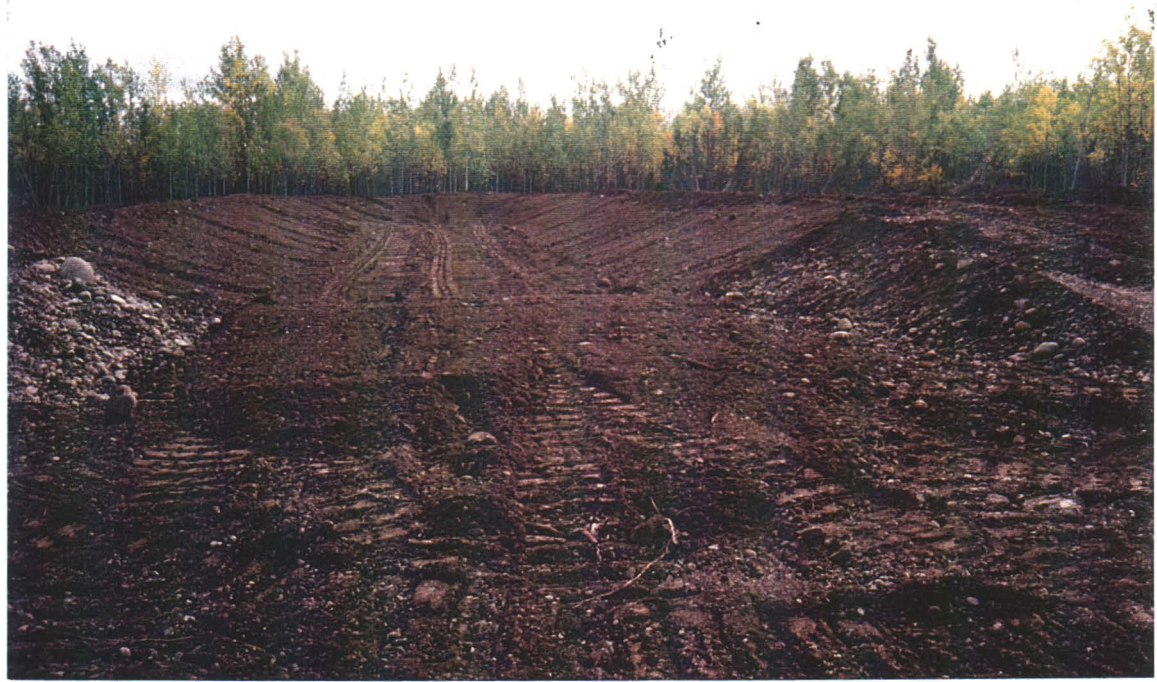
**PHOTO 11:** Containment Cell - Containment cell with compacted berms subsequent to grading. View looking east.

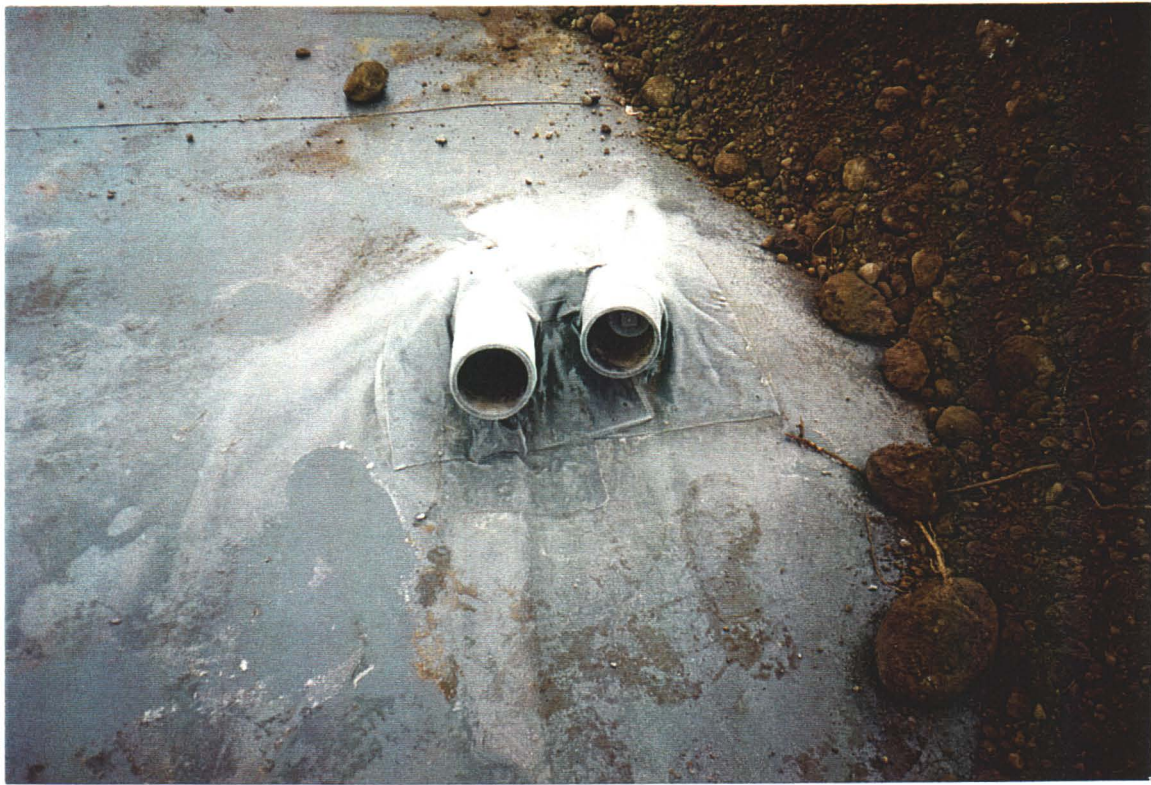
**PHOTO 13:** Containment Cell - Two monitoring wells in containment cell. Note: Liners were sealed around protruding pipes with custom fabricated boots.

It was also the intention to install observation wells in the vicinity of the containment cell, however the conditions were deemed too difficult for the available auger rig. Time constraints did not permit mobilizing a new rig and so it was agreed that monitoring wells would be installed there at a later date. However, the two wells, previously discussed, were installed directly in the containment cell which will allow for sampling.

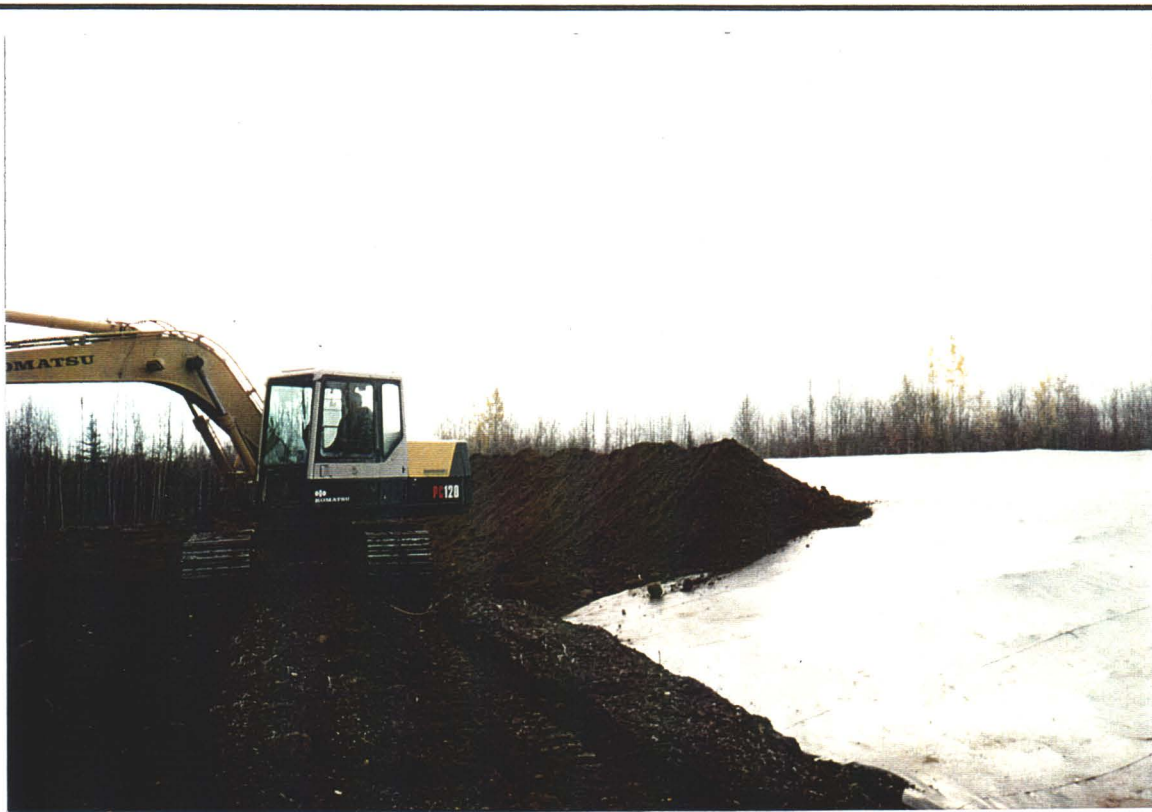
**PHOTO 14:** Containment Cell - Coverage of containment cell with layer of topsoil.
