Delineation of a Contaminated Site: Snag Airstrip, YT

Prepared by

Environmental Sciences Group
Royal Military College
Kingston, Ontario

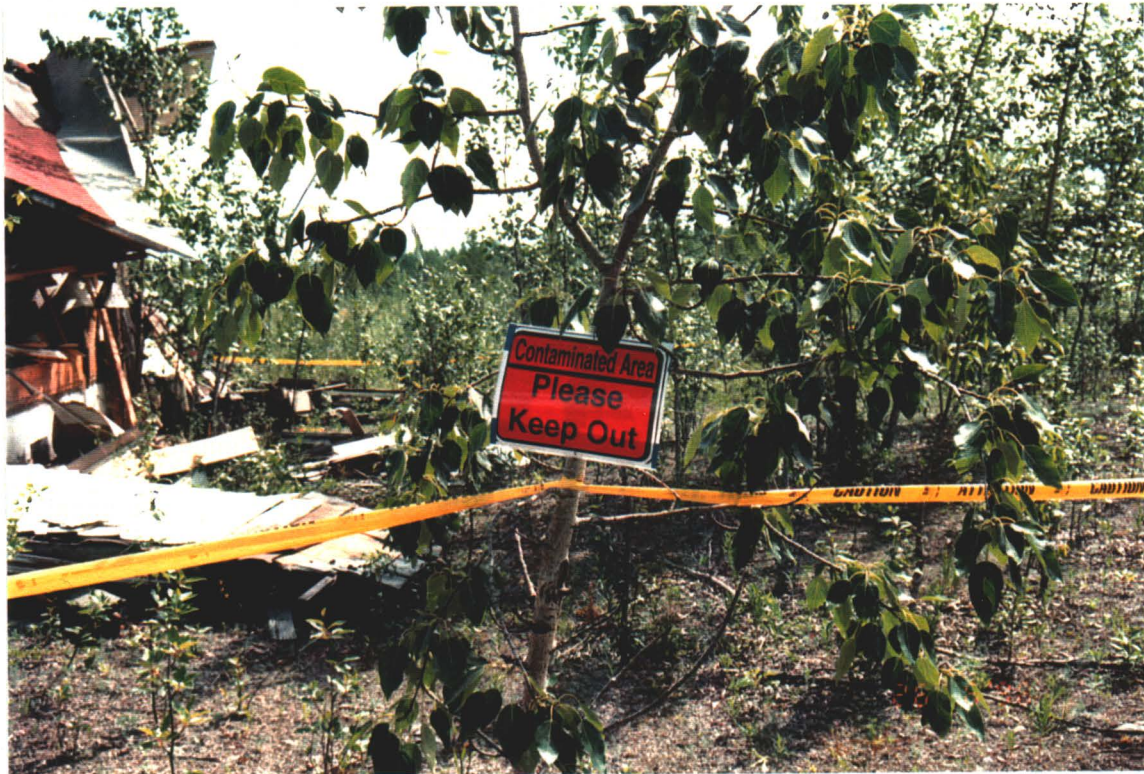
Photograph III-1: Signs and yellow caution tape were used to warn recreational visitors that contamination was present around the buildings at Snag Airstrip.

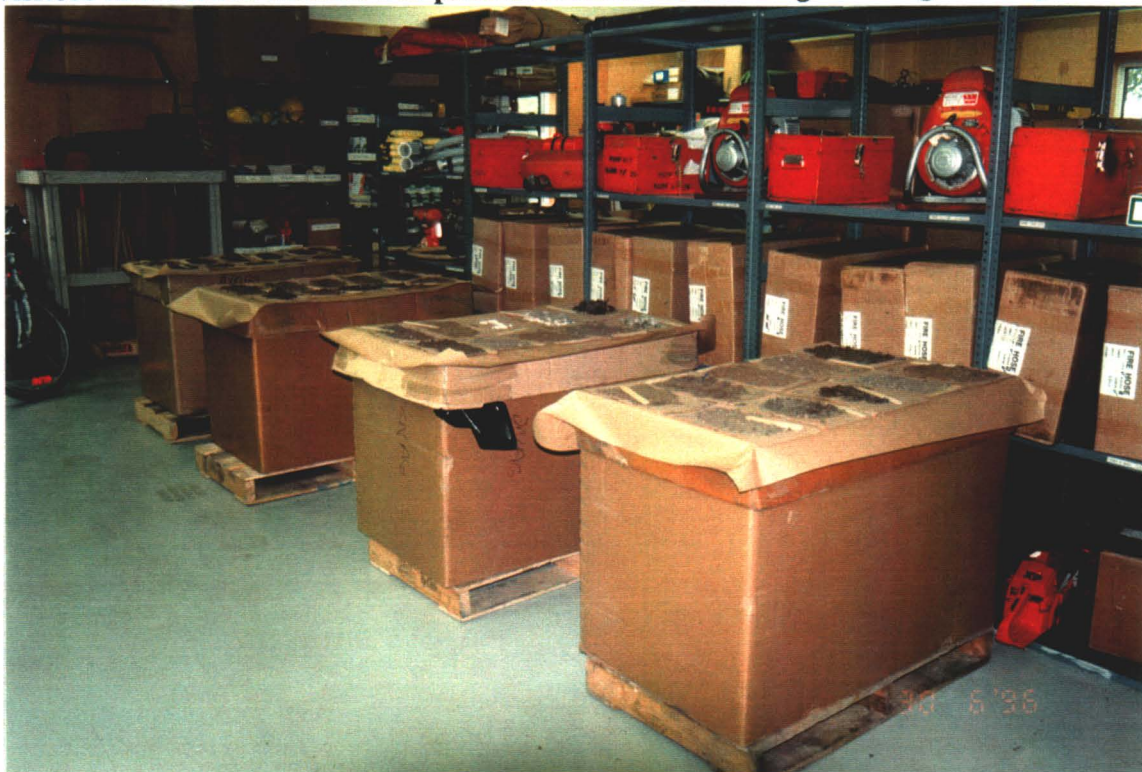
Photograph III-2: Soil samples were homogenized and laid out to dry on laboratory-grade paper towels before they were analyzed.

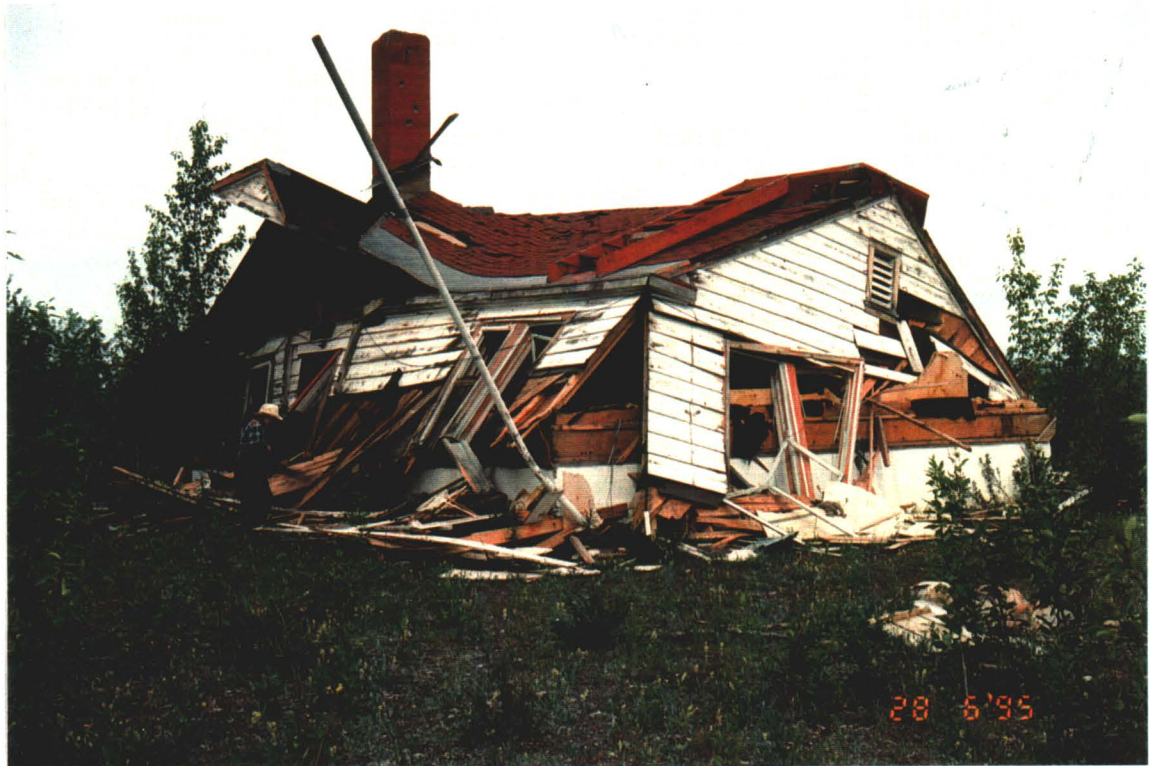
Photograph III-3: The Tower Building as it appeared in July 1995, before the start of remediation activities in June 1996.

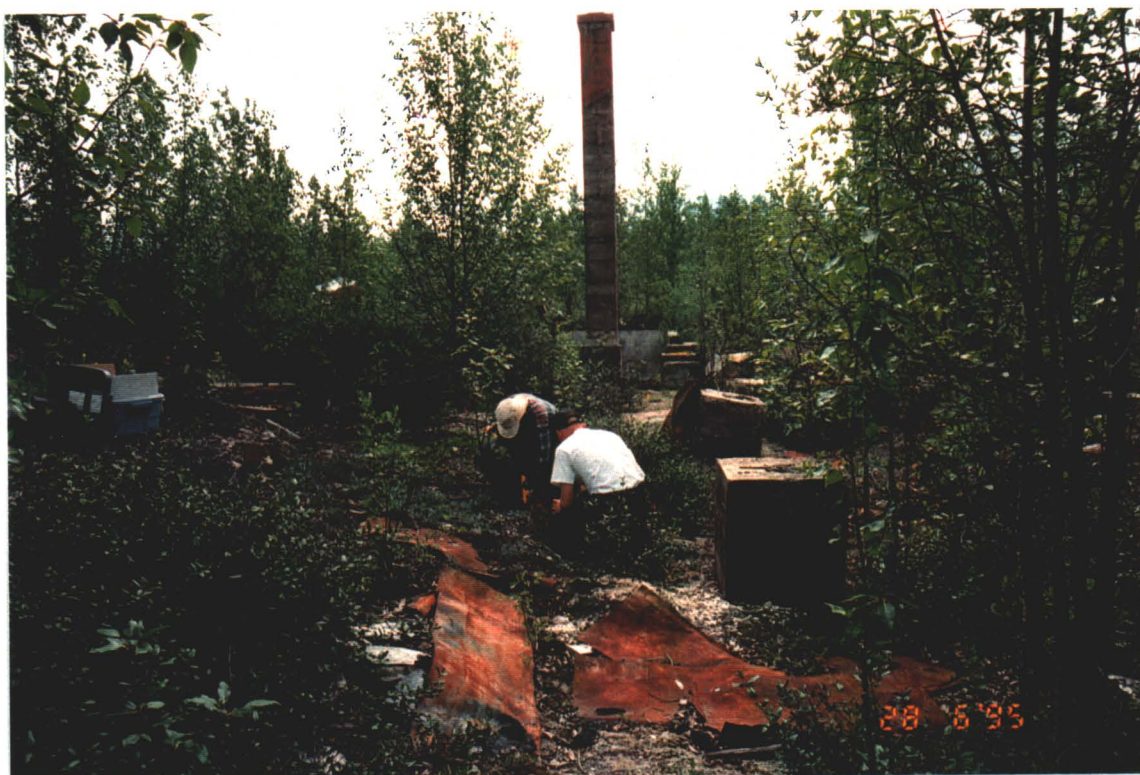
Photograph III-4: The DOT Barracks Building remains as they appeared in 1995.

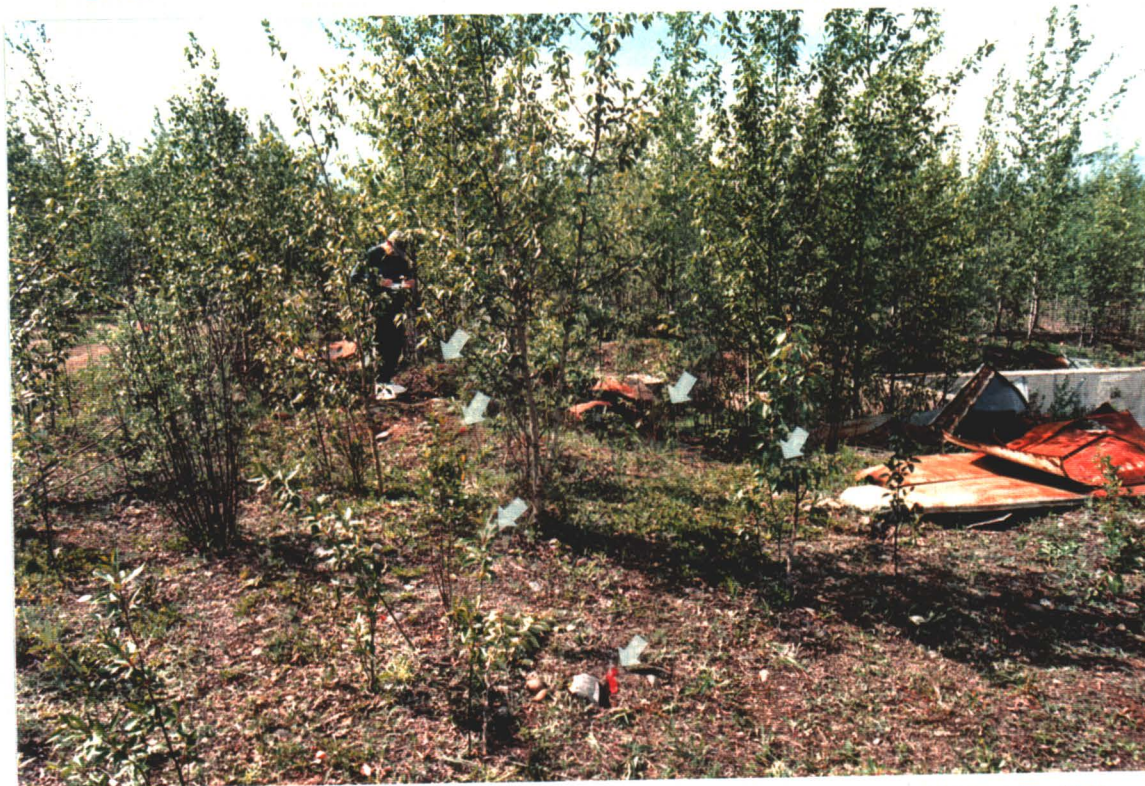
Forty-three delineation soil samples including four field duplicates were collected in the Barracks area in 1996 (Photograph III-5). The thin layer of moss on the basement floor was not delineated but estimated to be uniformly contaminated with PCBs at a concentration exceeding 50 ppm. Of the delineation soil samples collected around the foundation, 40 (93%) were analyzed on site by XRF test kit for lead, copper and zinc, and 13 were found to contain at least one of these contaminants at concentrations exceeding the CCME R/P Criteria. Map III-3 illustrates where delineation soil samples were collected during the 1996 ESG field program, and the extent of contaminated areas as determined by field analyses. Contamination was confined to the immediate area of the building, including a narrow trench that ran between the concrete supports to the northeast. Debris and moss covering an area of approximately 45 m² contained PCBs at concentrations above 50 ppm, and in another area of approximately 75 m² soil contained metals at concentrations above the CCME R/P Remediation Criteria.

Photograph III-5: Delineation of the south side of the DOT Barracks Building - sample locations are indicated by the arrows.

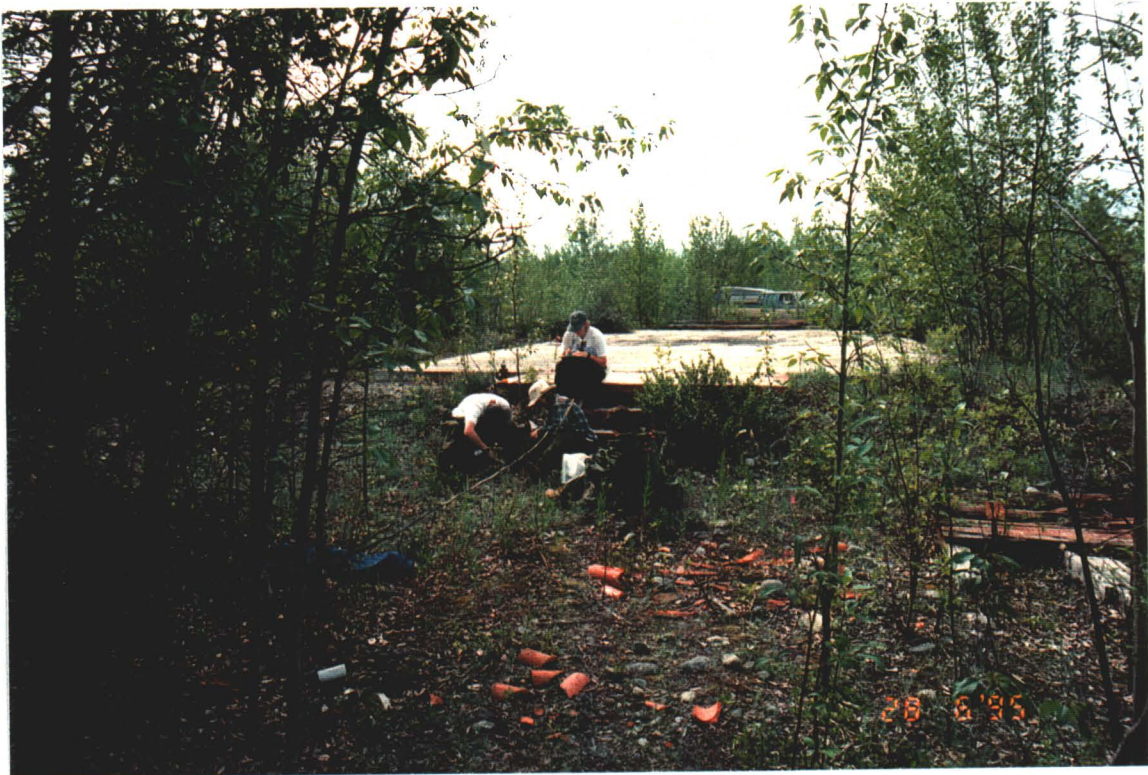
The Warehouse was located between the DOT Barracks Building and the Married Quarters on the east side of the Snag Road (see Map II-1, Photograph III-6). All that remained of the Warehouse was its foundation and a wooden staircase running off its northwest end. A painted wooden pallet/platform, some transformer plates and a transformer case made up the bulk of debris in the immediate area of the warehouse. In addition, some grey powder with a metallic appearance was scattered over the foundation surface.

Photograph III-6: The Warehouse Foundation as it appeared prior to cleanup.

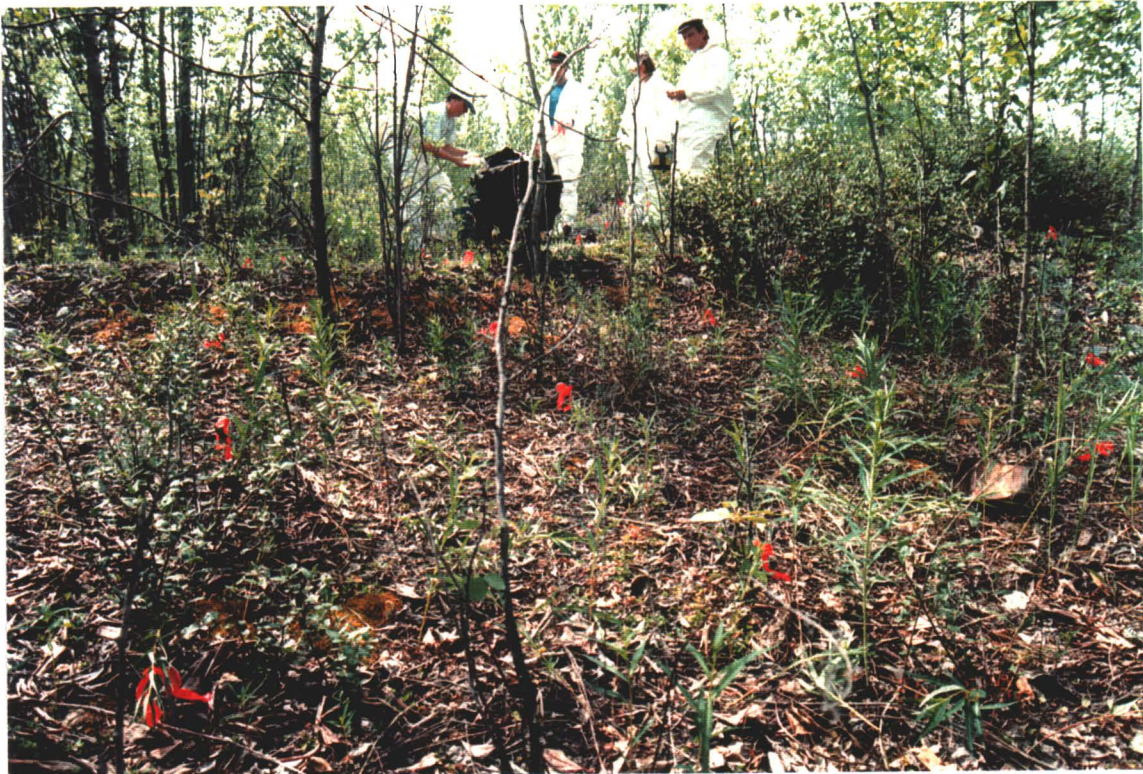
Photograph III-7: Delineation of the perimeter of the Warehouse Foundation.

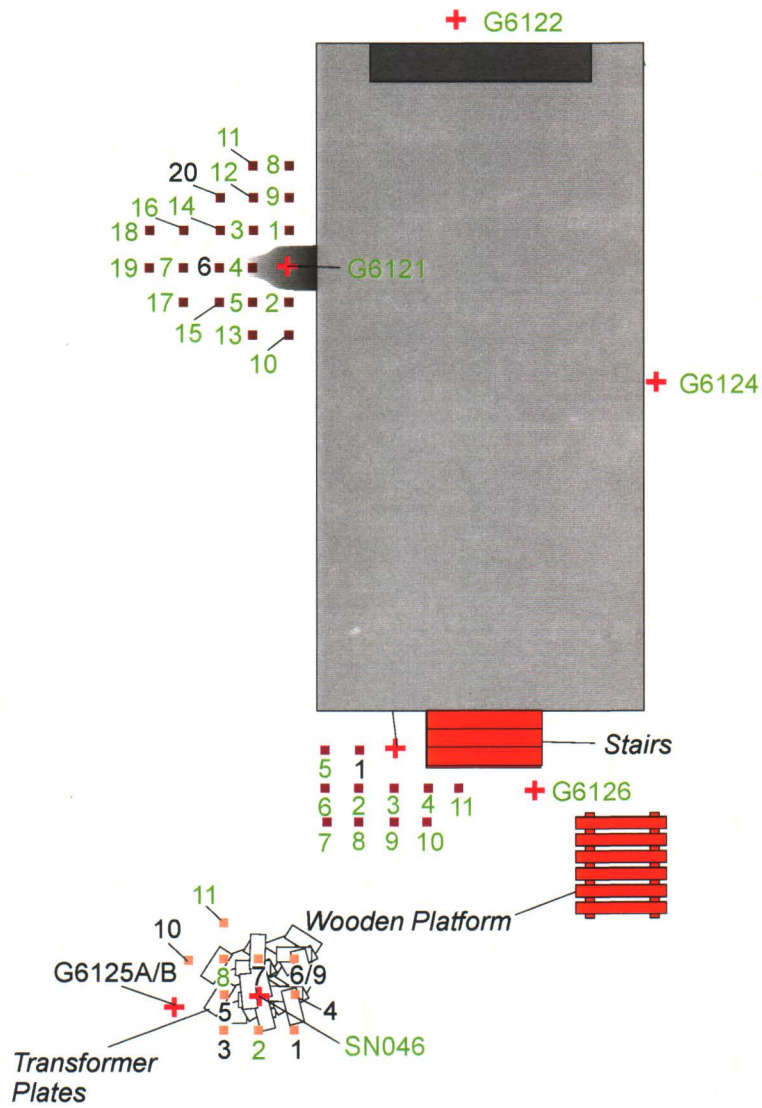
Map III-5: 1995 Sample Locations at the Warehouse

In total, eight assessment soil samples were collected around the Warehouse in 1994 and 1995 (Map III-5). Six of these contained at least one contaminant at concentrations exceeding the applicable criteria. Contaminants exceeding the criteria included lead, zinc, copper, chromium and pesticides - soil from the west side of the foundation (G6121) leached lead at concentrations classified as hazardous according to the British Columbia MOE Leachate Criteria. During the 1995 assessment conducted by ESG, 43 delineation soil samples were collected from three different locations around the warehouse where it had been determined that one or more metals exceeded the CCME R/P Criteria: 21 delineation soil samples were collected in a grid around assessment soil sample G6121, collected off the west side of the Warehouse Foundation and containing elevated concentrations of copper, zinc and particularly, lead; 11 delineation soil samples were collected around assessment soil sample G6123 at the south end of the foundation containing elevated levels of copper and zinc; and finally, copper and lead contamination detected in assessment soil sample SN046 taken in a pile of transformer plates south of the foundation was delineated with 11 soil samples.

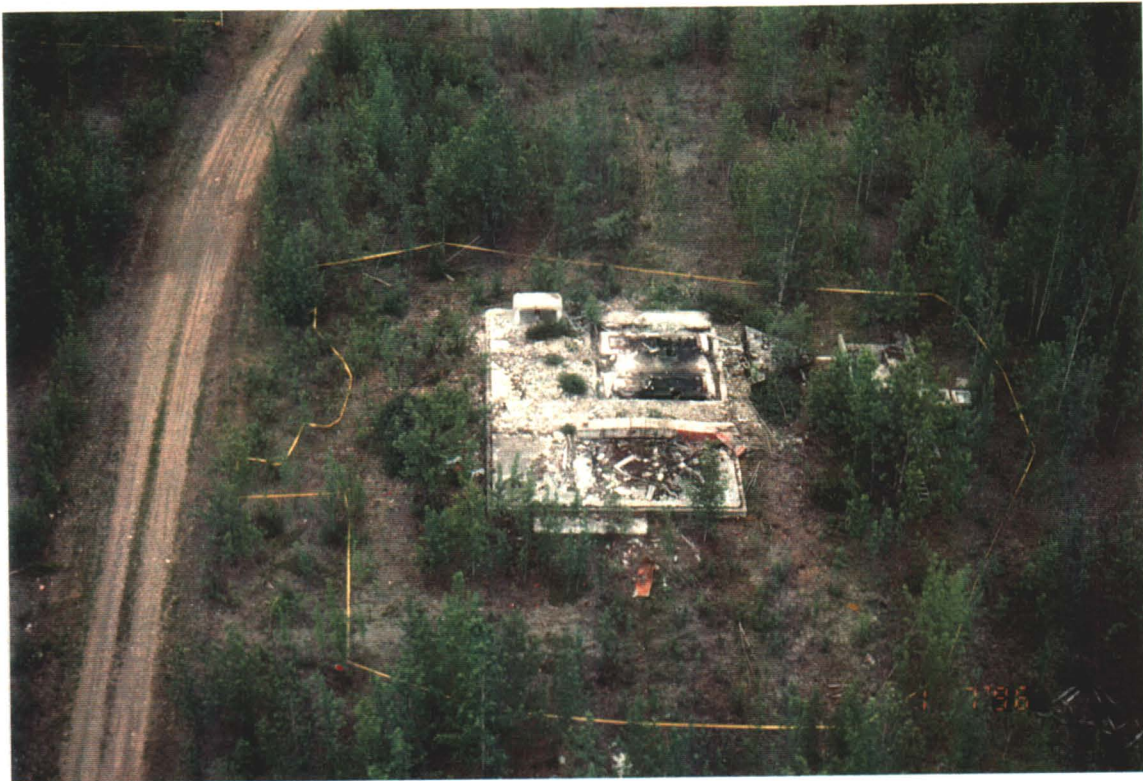
The Powerhouse, and Pump House to the west of it, were located together at the north end of the site on the west side of Snag Road across from the Warehouse (see Map II-1). All that remained of the Powerhouse was the foundation and a large concrete chimney which lay across it. The Powerhouse Foundation was darkly stained by an oily substance, and littered with building materials such as pressboard, insulation, sheet metal and crumbled concrete (Photograph III-8). The Pump House consisted of a basement and a ground-level floor with a cistern attached off its western end (Photograph III-9).

Photograph III-8: The Powerhouse and Pump House Foundations as they appeared in 1996 before their cleanup.

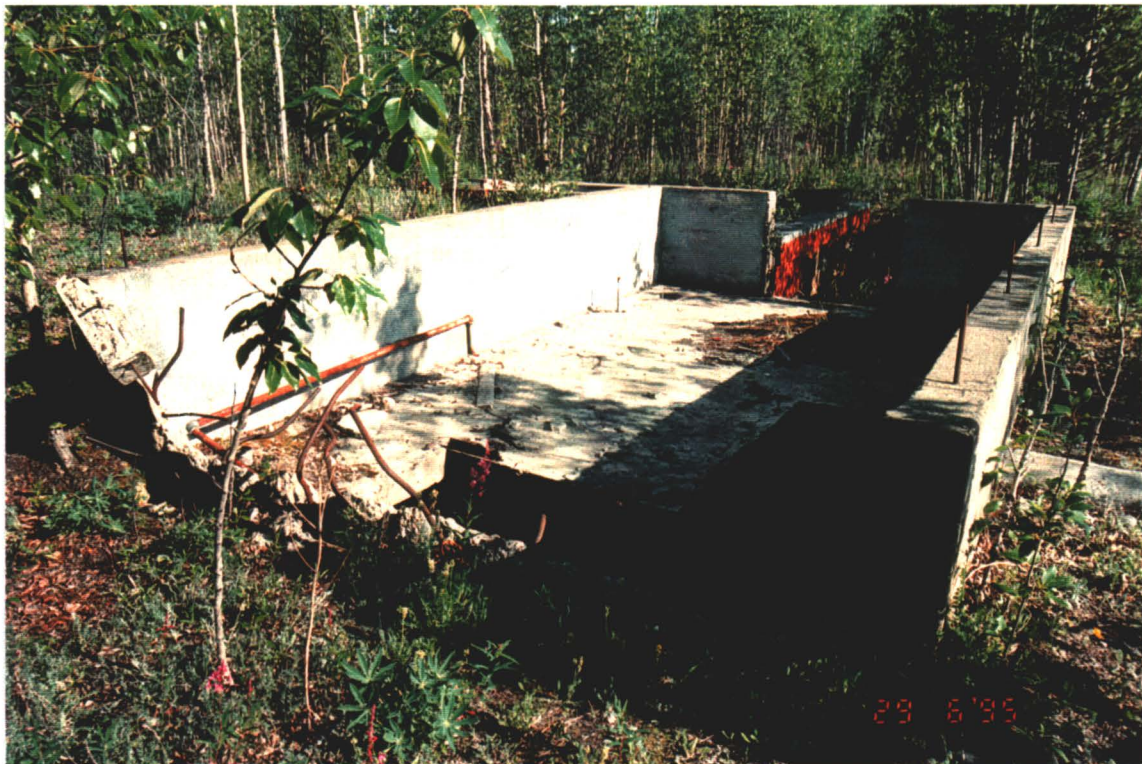
Photograph III-9: A close-up of the Pump House Foundation prior to cleanup.

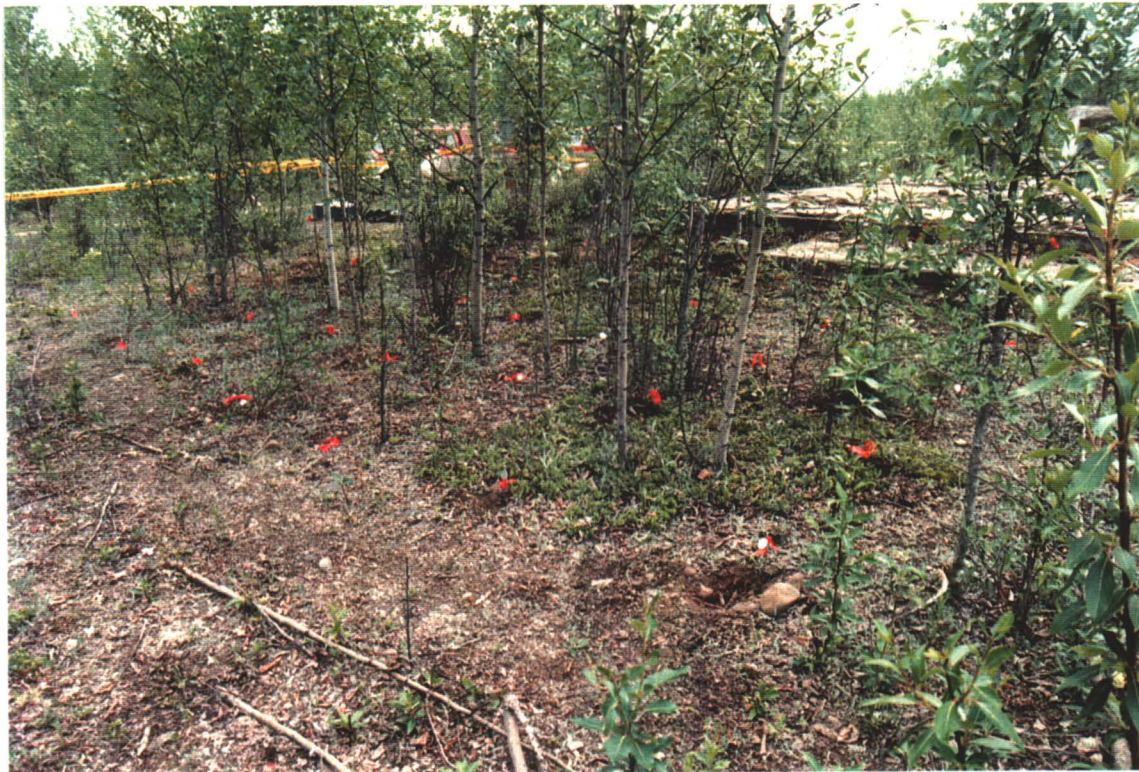
Photograph III-10: Delineation sample markers along the edge of the Powerhouse Foundation where soil was collected to determine the extent of PCB and metal contamination.

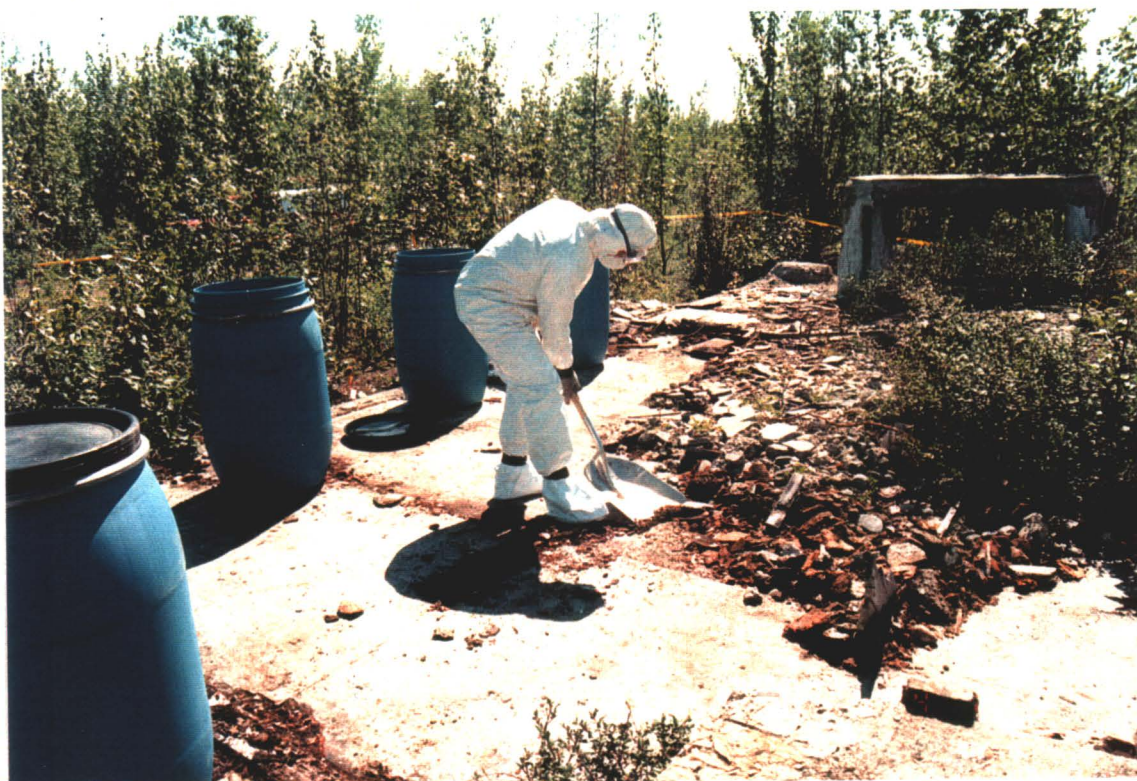
Photograph III-11: Removal of PCB-contaminated surface debris from the Powerhouse Foundation was completed by the ESG field team.

After completing the delineation sampling at the site, the ESG field team began containerizing the debris that was contaminated with PCBs above 50 ppm from the surface of the Powerhouse Foundation (Photograph III-11). Fourteen barrels were filled.

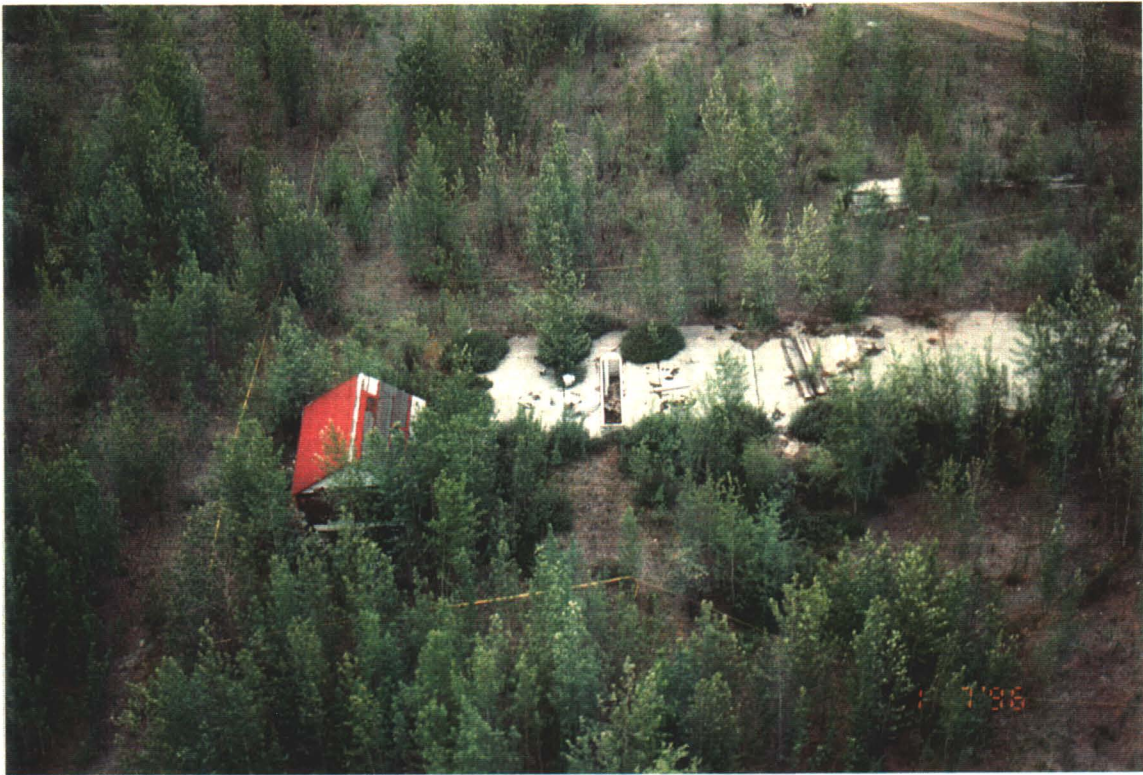
The Fire Hall was one of three buildings still standing at Snag Airstrip during the 1994-5 assessment. It was located on the western side of the site immediately north of the Garage Foundation (Map II-1). The Garage had been next to the Fire Hall, north of the main access road and west of Snag Village Road, but all that remained was its foundation (Photograph III-12).

Photograph III-12: The Garage Foundation and Fire Hall, viewed from the air prior to cleanup in 1996.

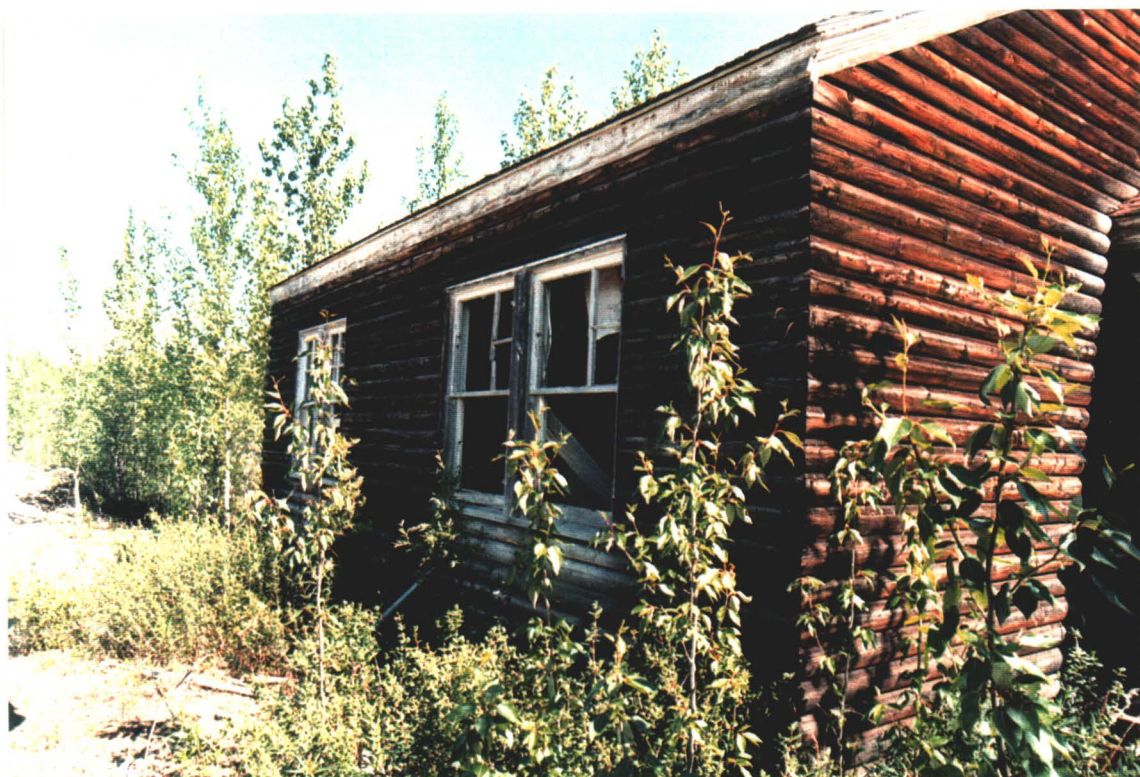
Photograph III-13: The Married Quarters as they appeared prior to cleanup in 1996.

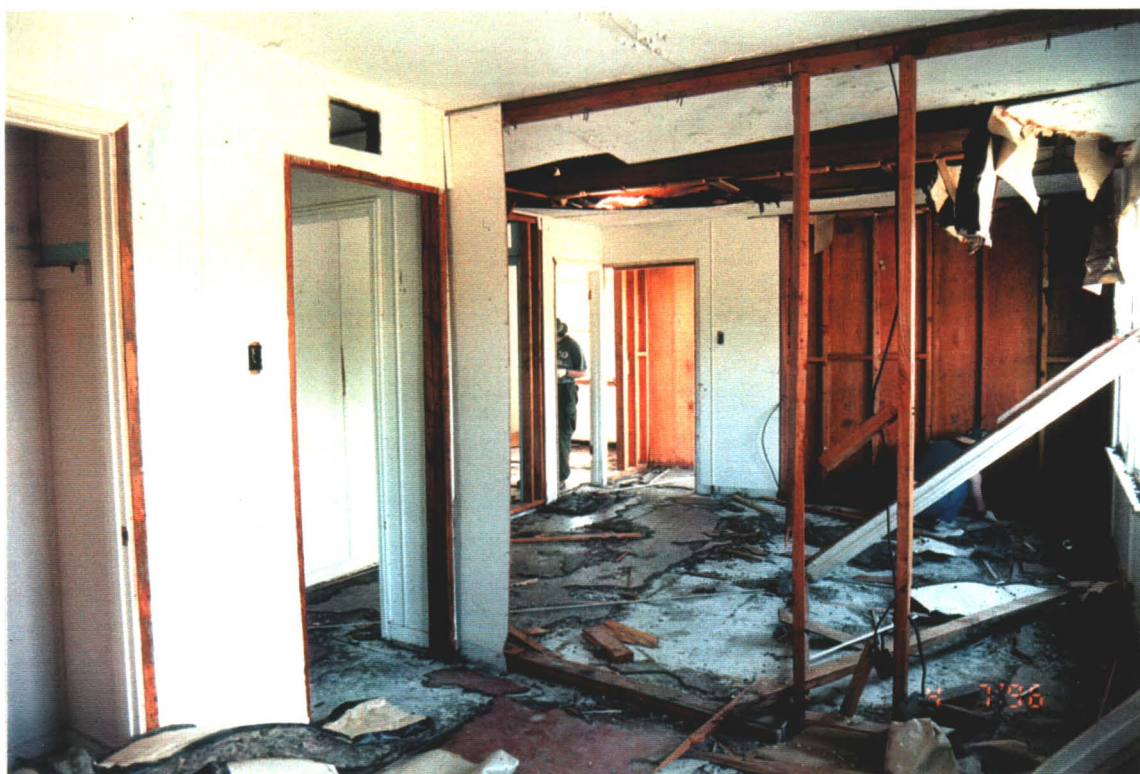
Photograph III-14: The interior of the Married Quarters had been vandalized over the years prior to the cleanup.

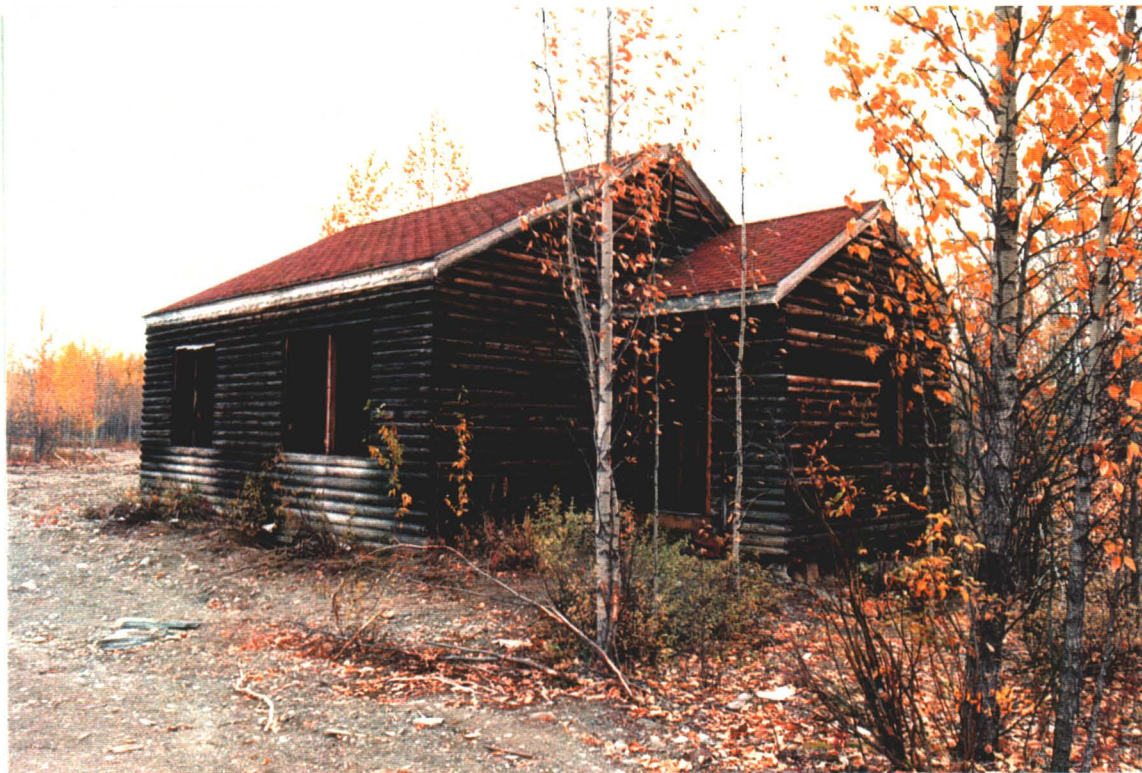
Photograph III-15: The exterior of the Married Quarters after all interior materials with painted surfaces were removed.

Prior to commencement of the Snag Airstrip cleanup, a request had been made by the local White River First Nations Band that ownership of either the Fire Hall or the Married Quarters be transferred to them. Therefore it was necessary during the cleanup to ensure that the Married Quarters was clean from both an environmental and human health perspective. Three samples of paint and two of wood from the interior of the building were therefore collected for inorganic and PCB analysis (Figure III-1, Photograph III-14). Although all the paint chip samples contained elevated concentrations of lead, copper, zinc and PCBs, the results were comparable to those obtained for paint from the Tower Building, and it was determined in the 1995 study that these contaminants did not leach from the paint. The wood samples taken from the interior of the Married Quarters both contained elevated concentrations of lead and zinc. Previously insulation from the building was found not to contain asbestos (<0.5%). Based on the paint chip results the recommendation was made that all painted surfaces and interior walls be removed from the building and placed in the containment cell before transferring ownership (Photograph III-15, Photograph III-16).

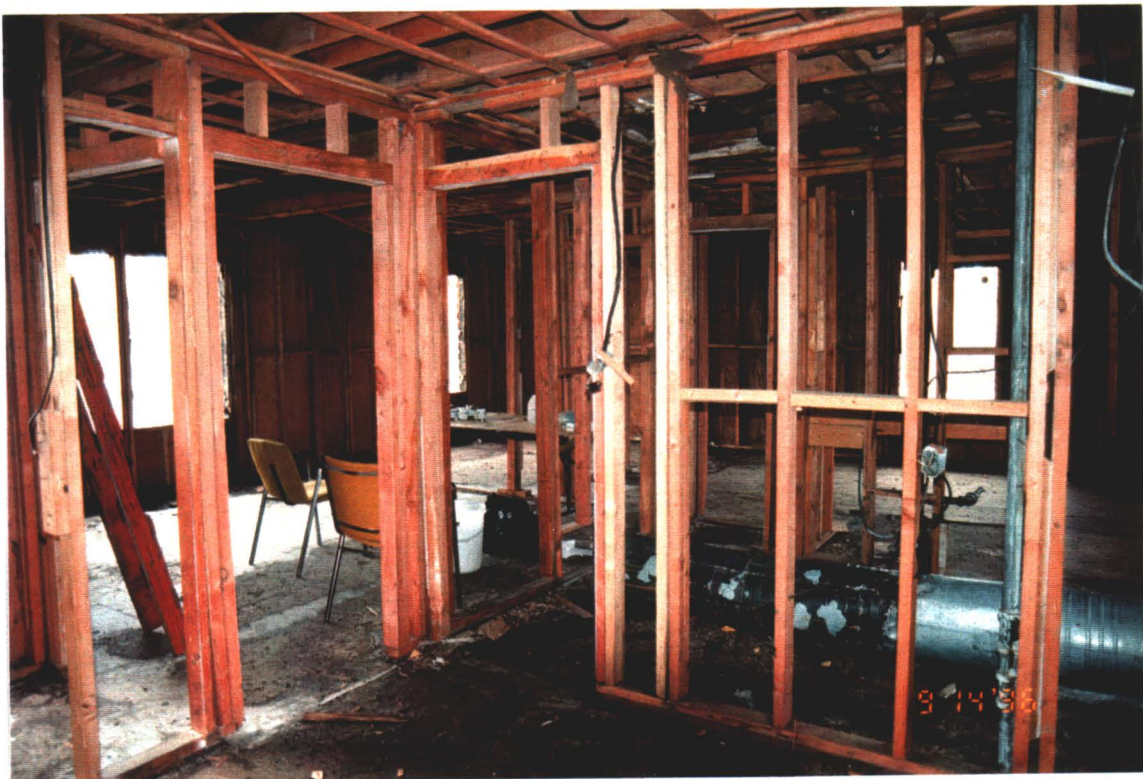
Photograph III-16: The interior of the Married Quarters following the removal of all interior materials with painted surfaces.

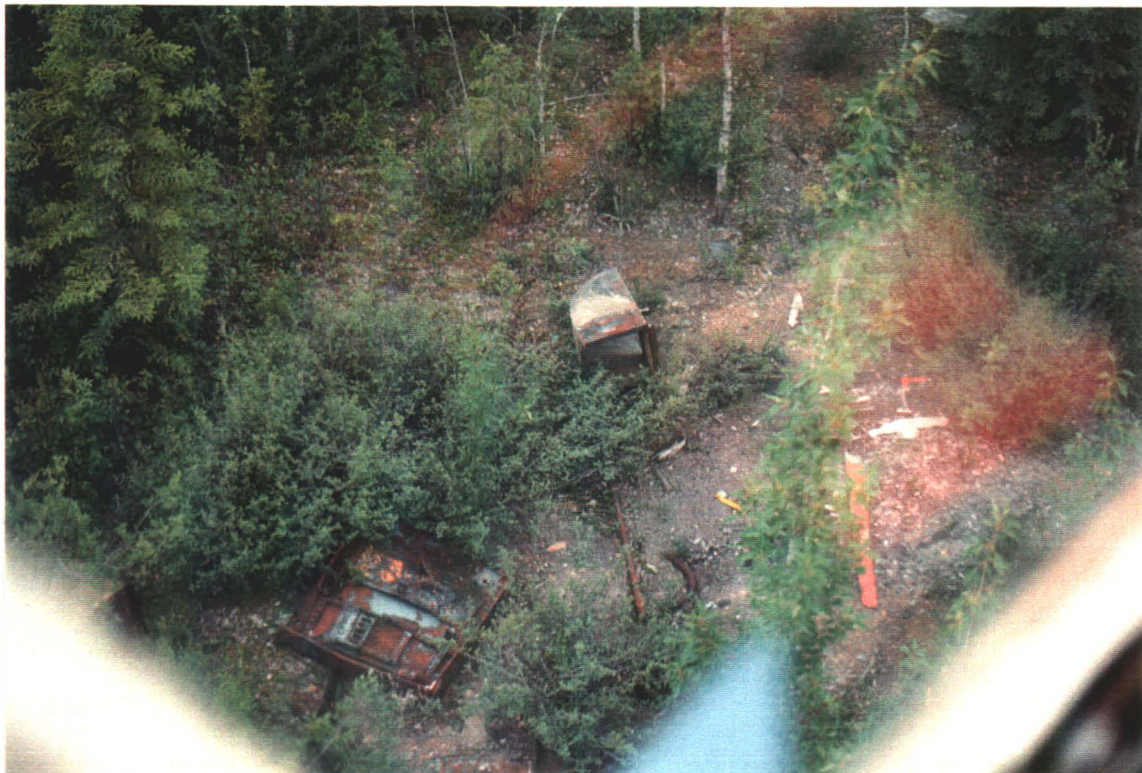
Photograph III-17: The location of the building at the Beacon Site, viewed from the air prior to cleanup in 1996.

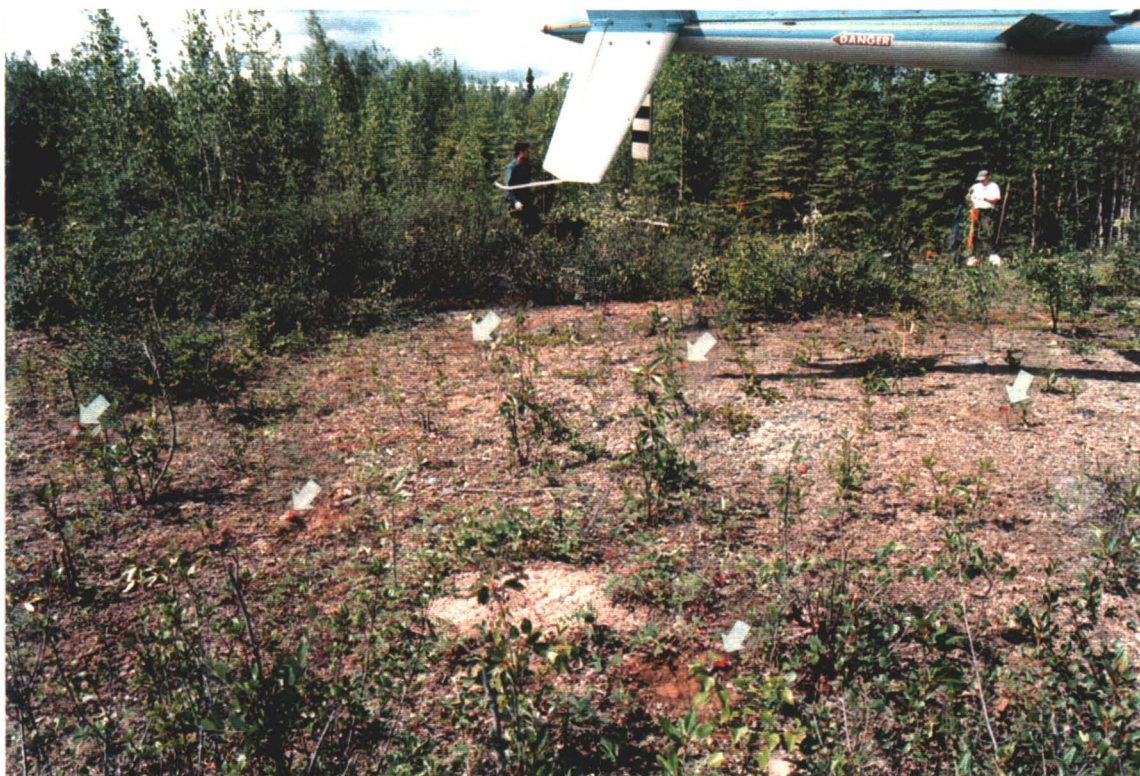
Photograph III-18: Delineation at the Beacon Site.

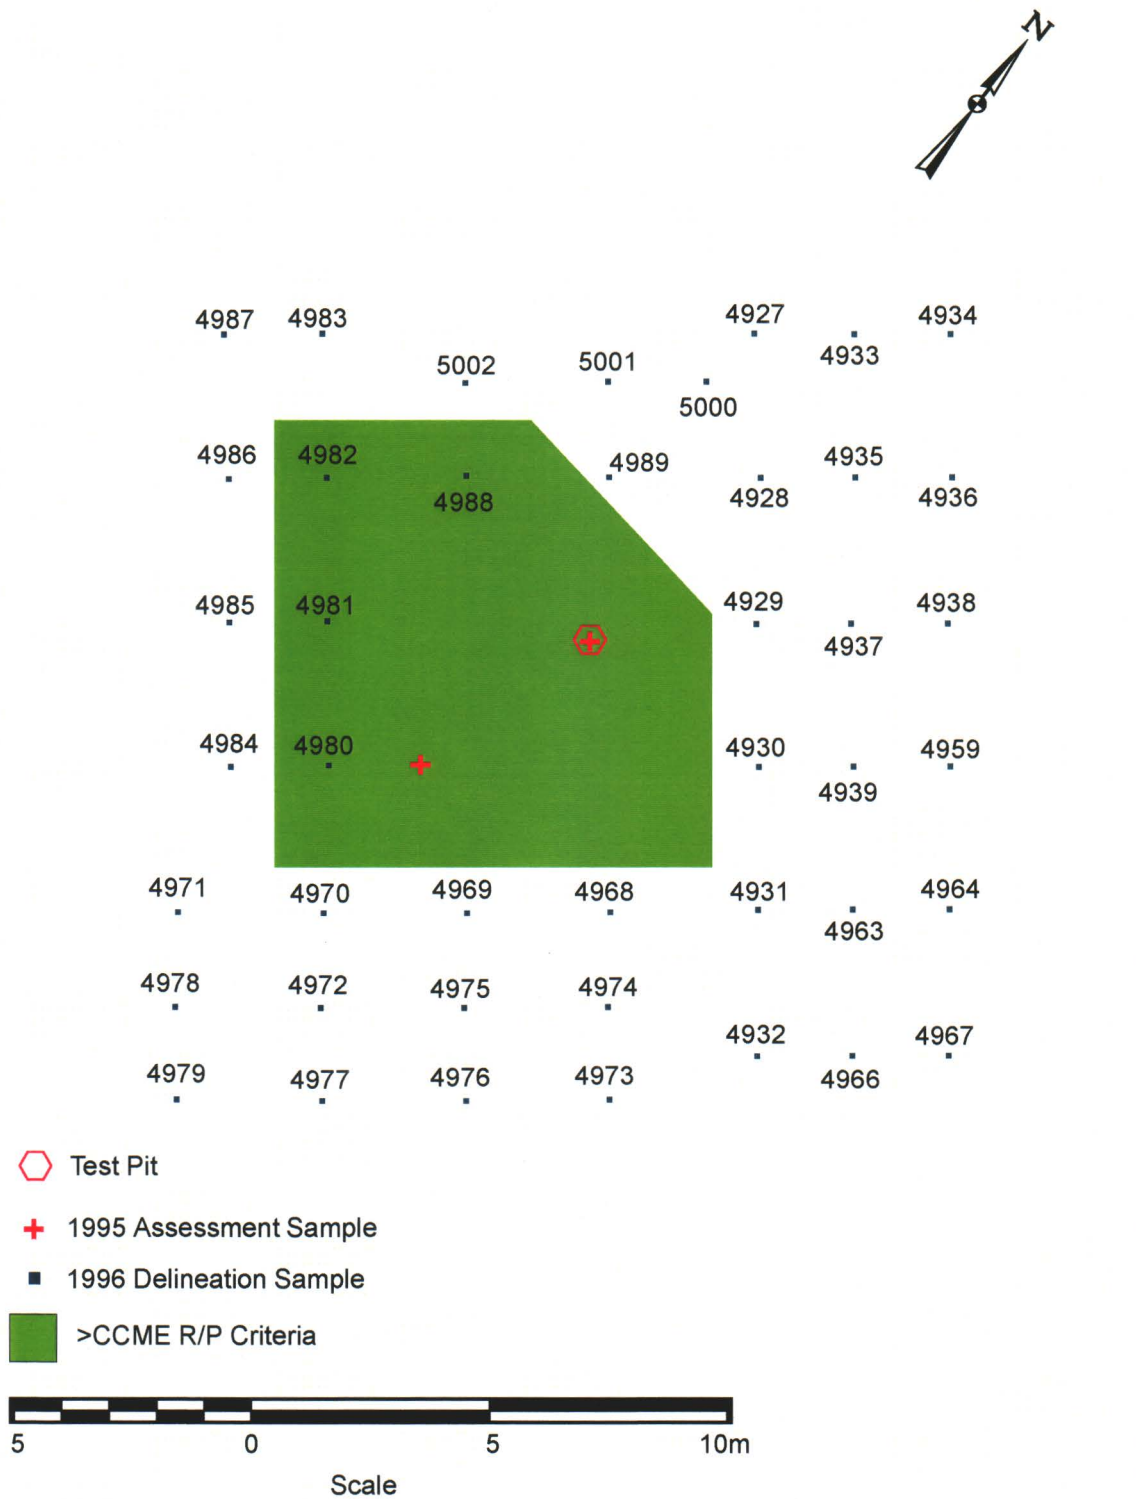
Map III-13: 1996 Delineation Sample Locations at the Beacon Site

As part of the 1996 field program, 55 delineation soil samples including five field duplicates and one test pit sample were collected in the area of G6186 and G6187 (Map III-13, Photograph III-18). A total of 37 (67%) delineation soil samples from the Beacon Site were analyzed for copper, lead and zinc by XRF test kit. Of the delineation soil samples analyzed, only four (11%) contained one of these metals at a concentration exceeding the applicable criteria. As shown in Map III-13, contamination at the Beacon Site was confined to the area of the building remains (total area affected: 70 m²).

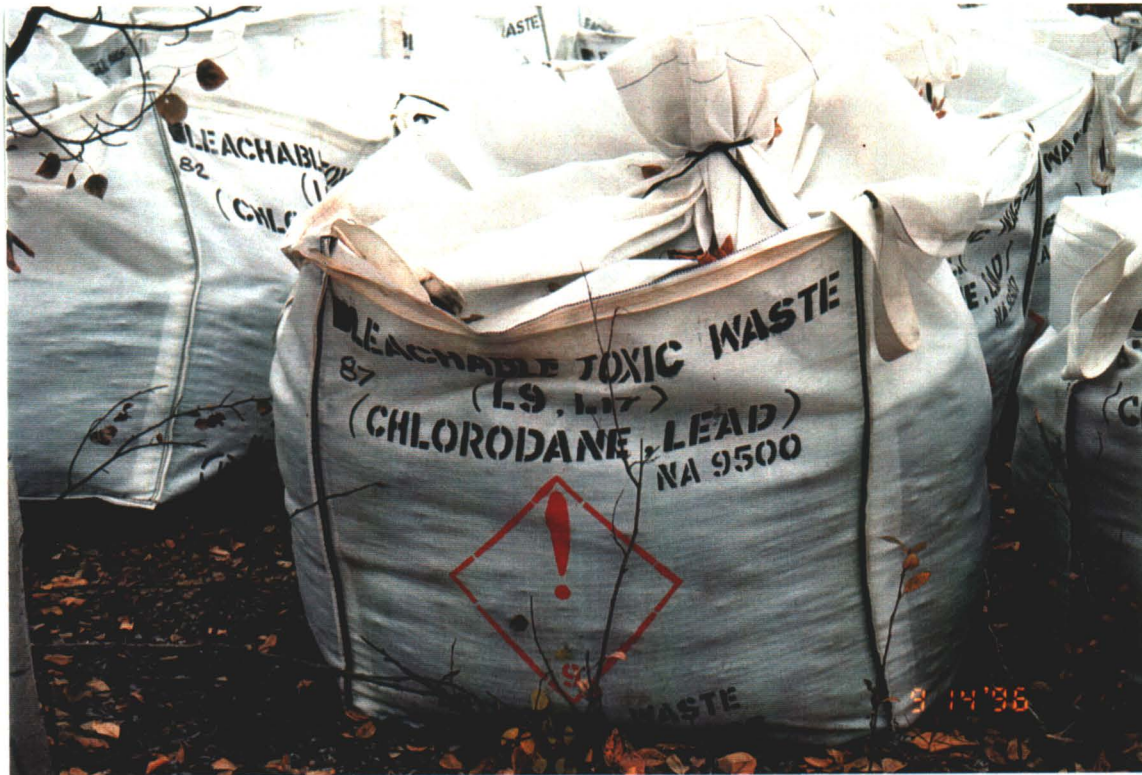
Photograph IV-1: Double-bagged leachate toxic and/or pesticide-contaminated soil at Snag Airstrip awaiting transport to a southern disposal facility.

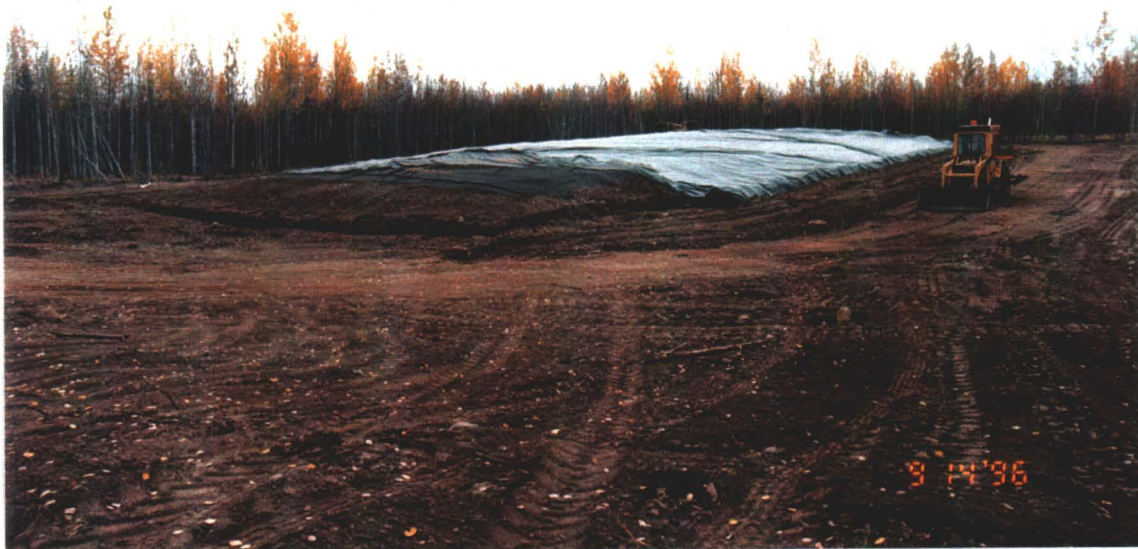
Photograph IV-2: The containment cell for CCME contaminated soil was constructed in a concealed location behind and south of the former location of the Tower Building.
