Delineation of a Contaminated Site: Snag Airstrip, YT

Prepared by

Environmental Sciences Group
Royal Military College
Kingston, Ontario

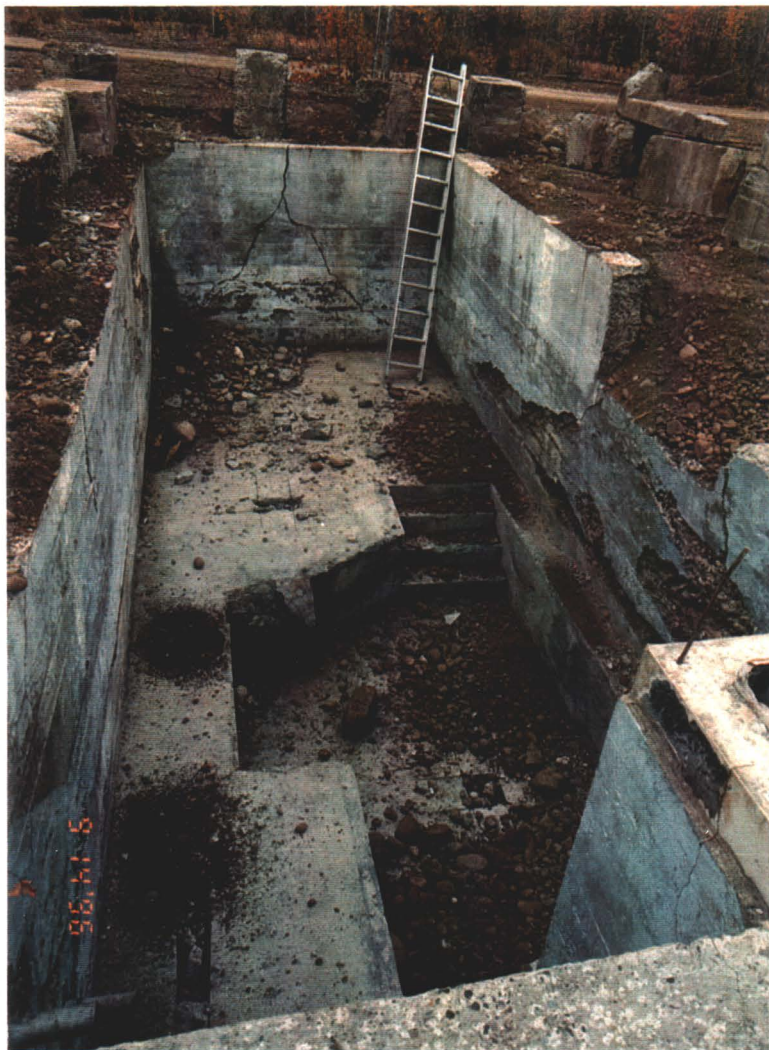
Photograph IV-3: The DOT Barracks Building basement following containerization of debris and moss contaminated with PCBs and dioxins. In addition, a portion of the foundation was later containerized because high levels of PCB contamination were detected in the cement.

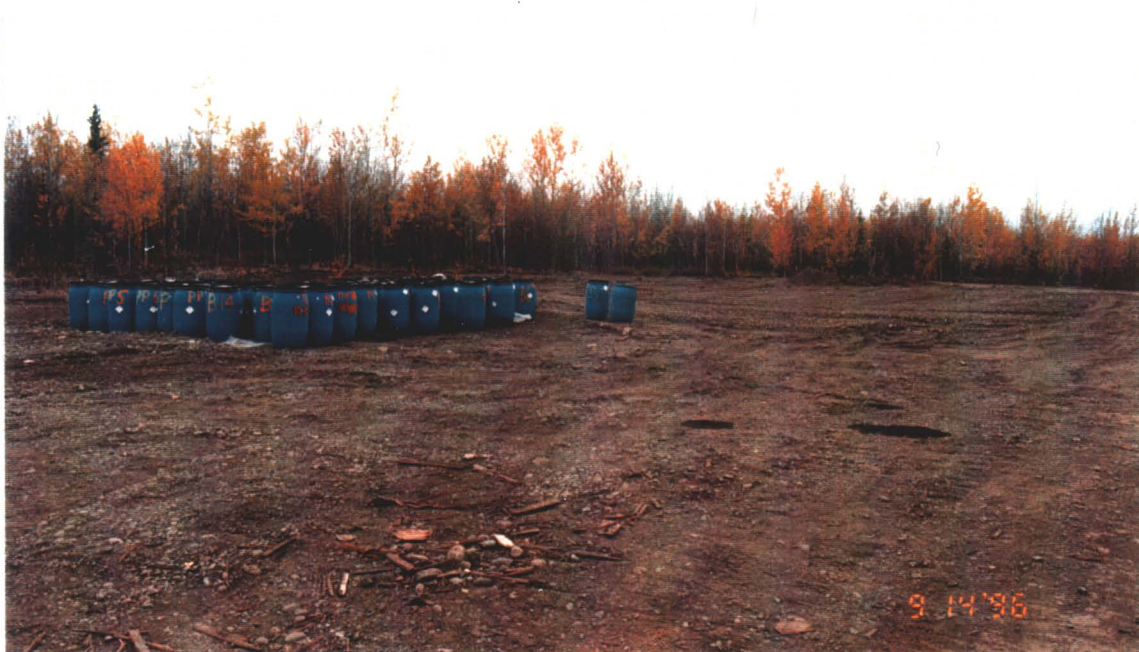
Photograph IV-4: The former location of the Tower Building was used to store barrels containing soil contaminated with CEPA PCBs.

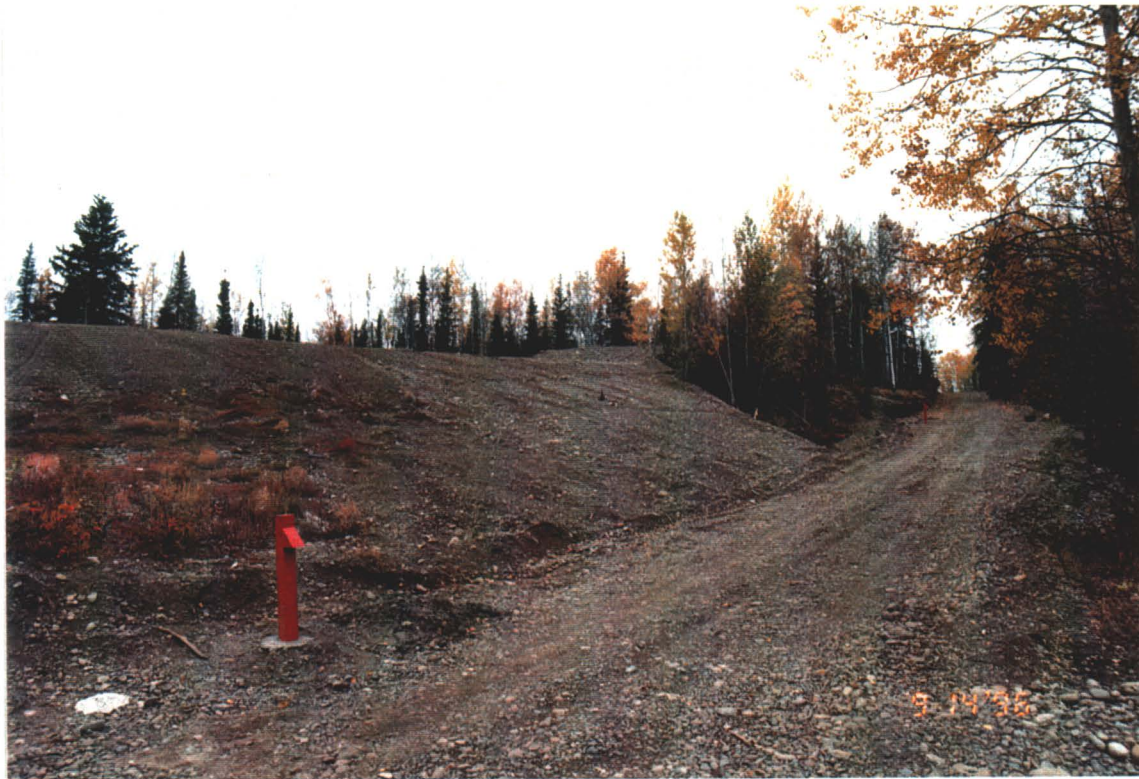
Photograph IV-5: The Snag Airstrip Dump, after the application of additional fill and regrading, and the installation of monitoring wells.

According to recommendations made by ESG, monitoring wells were installed at the base of the Snag Airstrip dump, and the dump was capped with additional fill and regraded to reduce its slope. If water from the dump is monitored regularly, this will provide the information necessary to determine its environmental status.
