PRELIMINARY ENVIRONMENTAL INVESTIGATIONS

DESTRUCTION BAY SITES 24, 25, & 26

Conducted for the
Action on Waste Program,
Arctic Environmental Strategy
Whitehorse, Yukon

TransNorthern Consulting
Whitehorse, Yukon

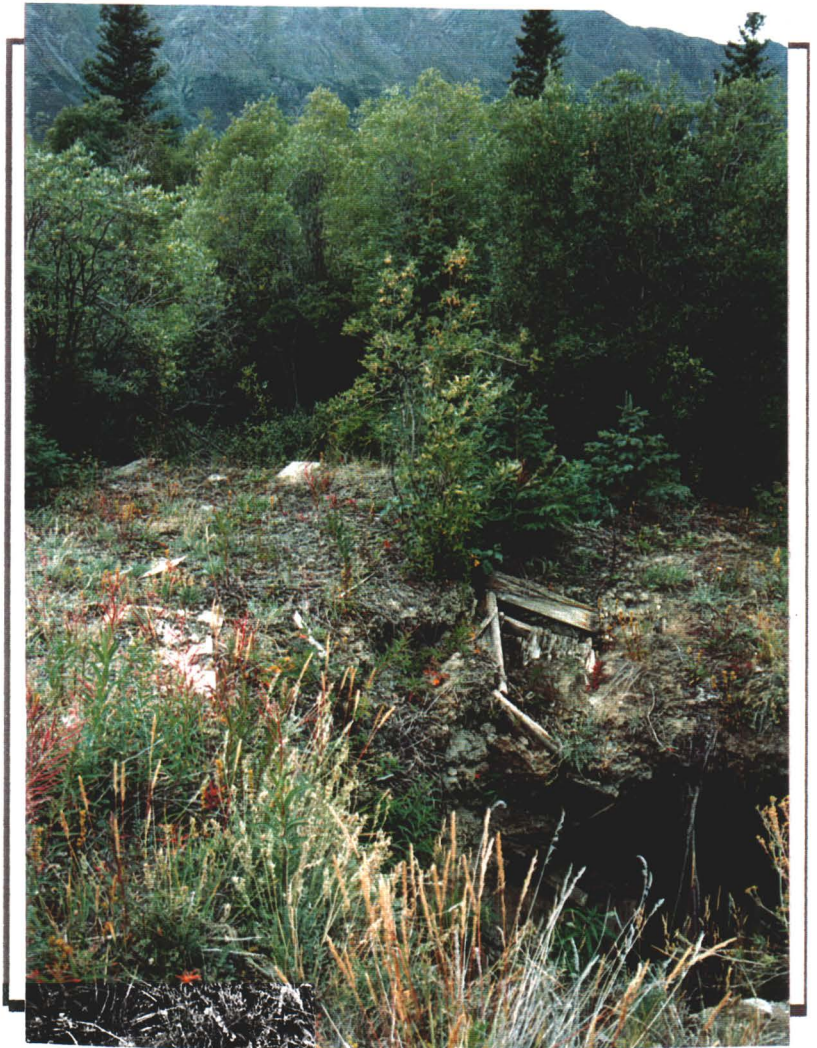
Photo # 1
Site 24A

Pit with wooden cribbing, shown in lower right hand corner of photo, trees in background are along stream bank.

Soil sample locations for Sites 24A & B were based on areas identified during the site reconnaissance (Photo 1 & 2), as having the greatest potential for contamination (discretionary samples). Water samples were taken from adjacent surface waters (Figure 4).

1. pit with wooden cribbing appearing to be a sewage or liquid waste disposal site
2. pit with wooden cribbing adjacent to stand pipe
3. loose piles of sandy gravel intermixed with wood and metallic debris
4. area of visible waste disposal along drainage course

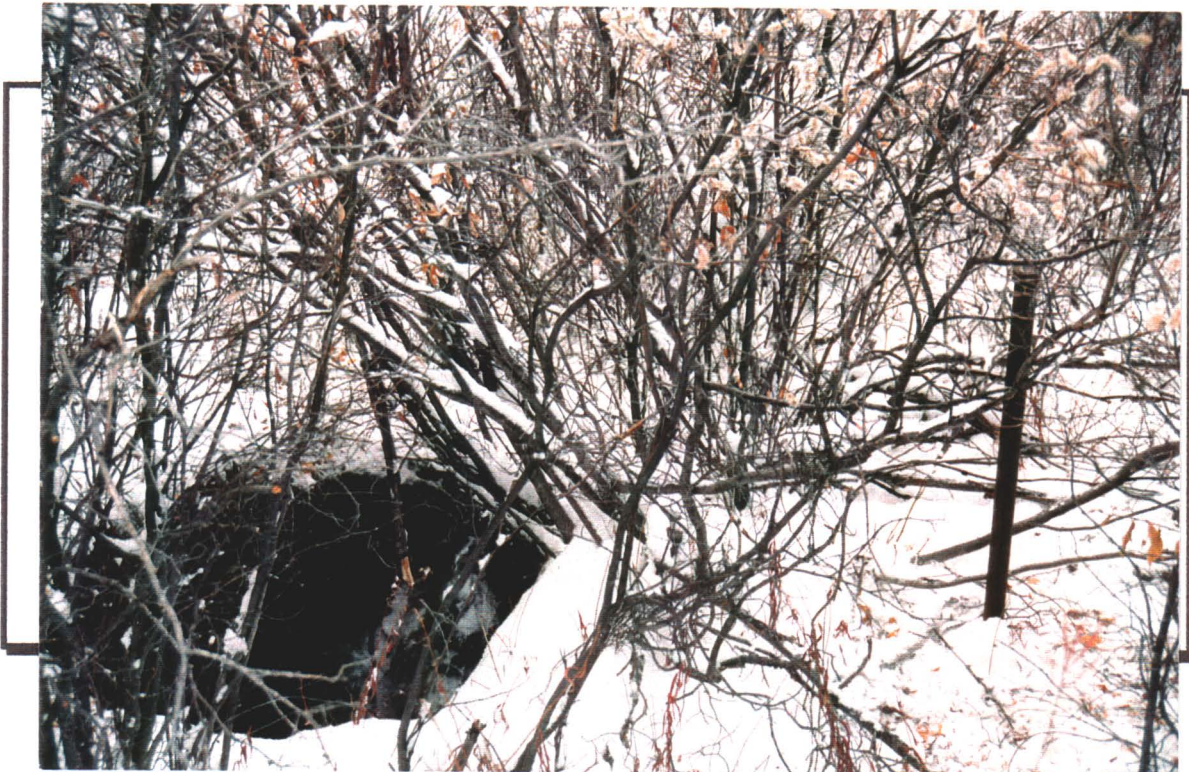
Photo # 2
Site 24A

Pit with wooden cribbing and stand pipe, no liquid found in pipe.

Sites 24a and 24b appear benign and do not warrant further testing. For purposes of public safety, the old septic pit and the pit adjacent to the buried fuel tanks might be filled in. As with many similar sites, these could benefit from cosmetic restoration, but this would not be essential for public purposes.

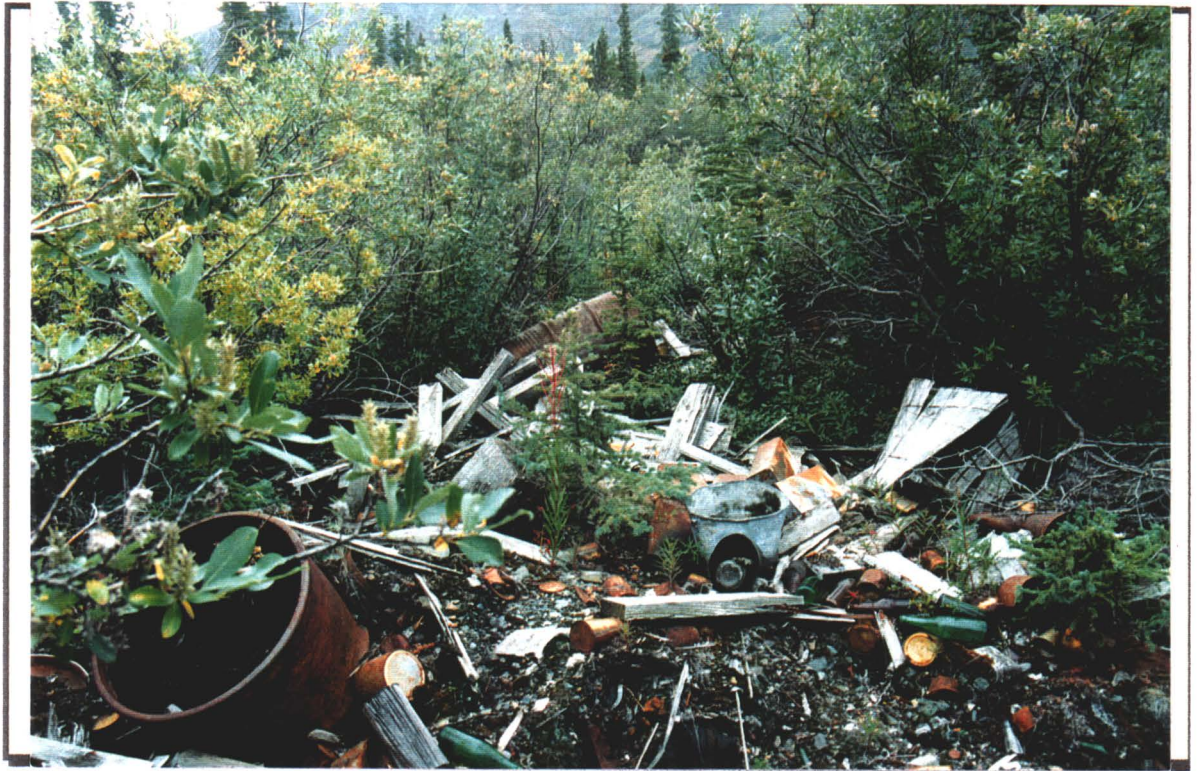
Photo # 4
Site 25 Wood debris, barrels and domestic wastes

Site 25 appears to be benign so far as contaminants are concerned. Although it is hidden from view and well removed from present land-uses, it is an eyesore and could in the future be considered a public hazard because of the quantities of sharp and jagged debris.

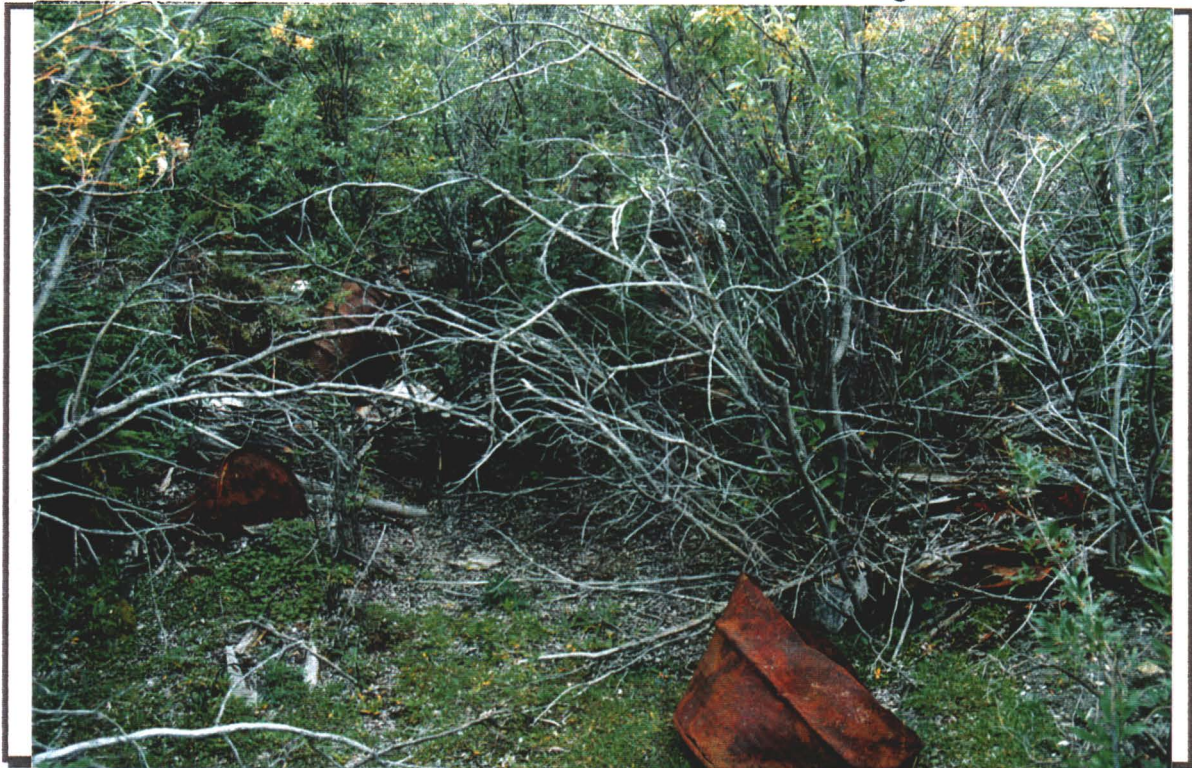
Photo # 5
Site 25 Barrels with ends removed or cut in half scattered along creek bed.

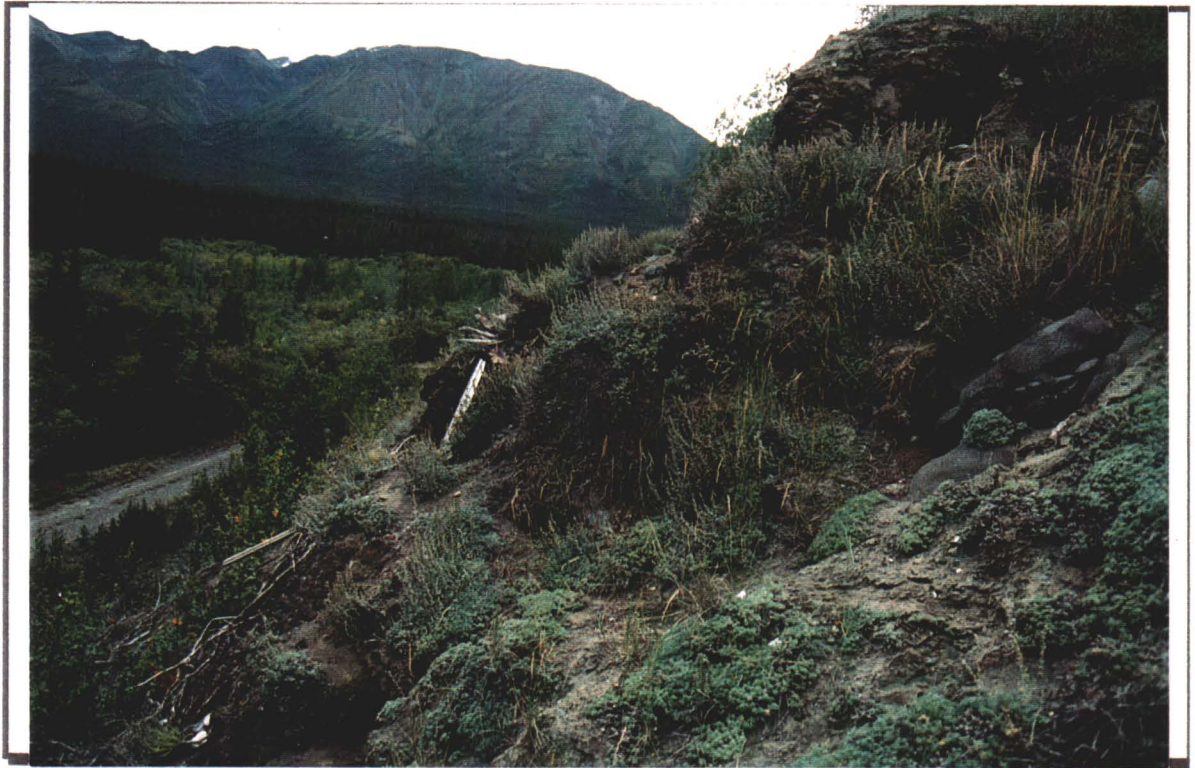
Photo # 6
Site 26A Domestic wastes and burn debris.

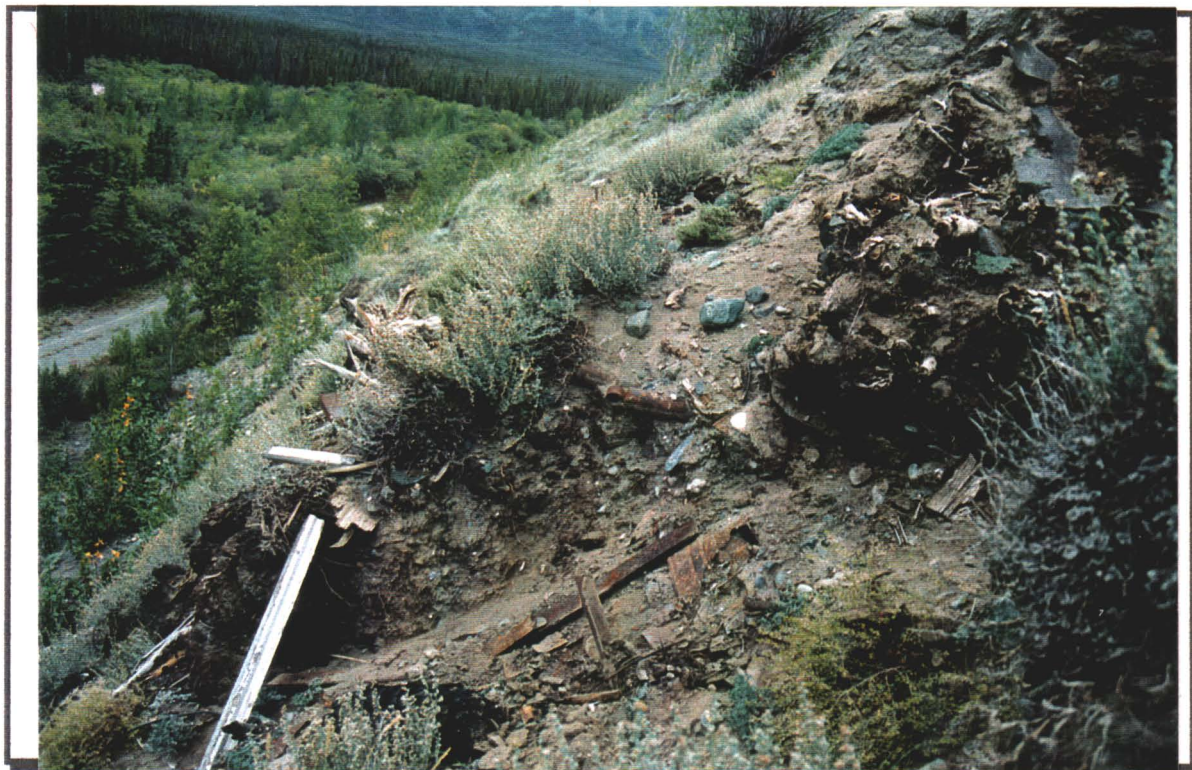
Photo # 7
Site 26A Scrap metal and construction materials partially buried in slope

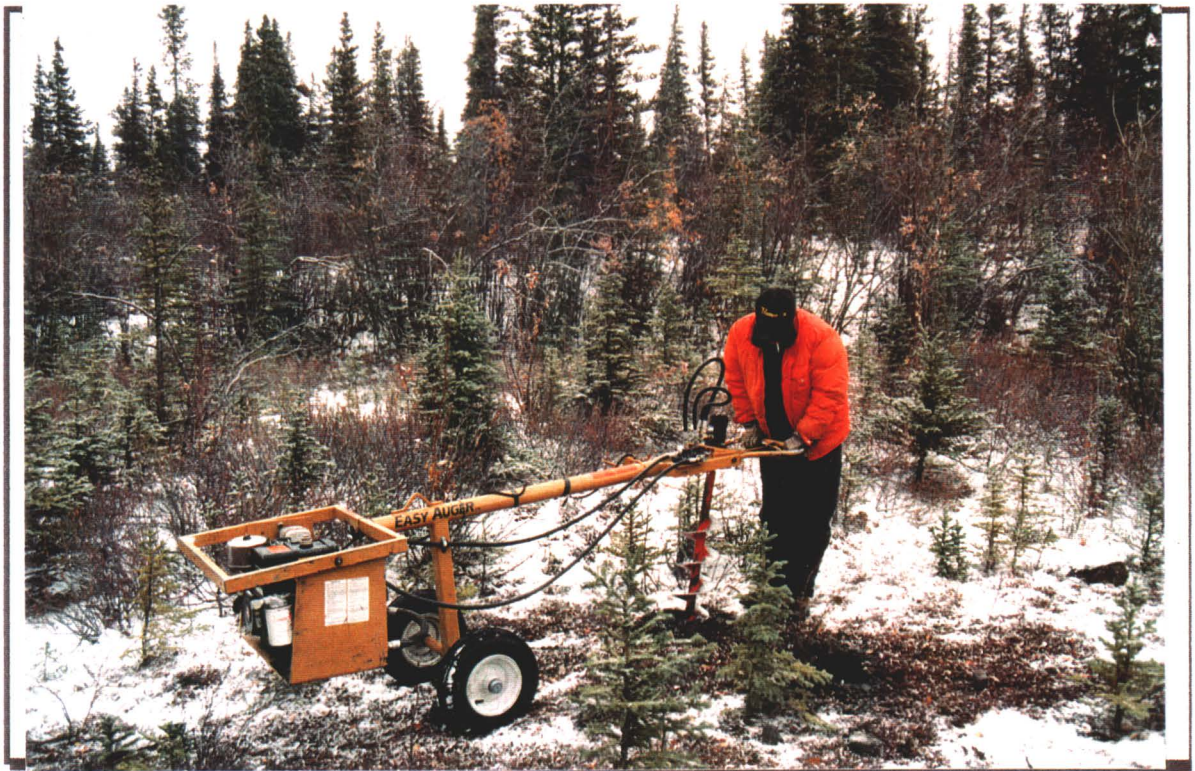
Photo # 8

All soil samples were taken by excavating a preliminary hole to the required depth using a power auger or shovel (Photo 8).

Site 25

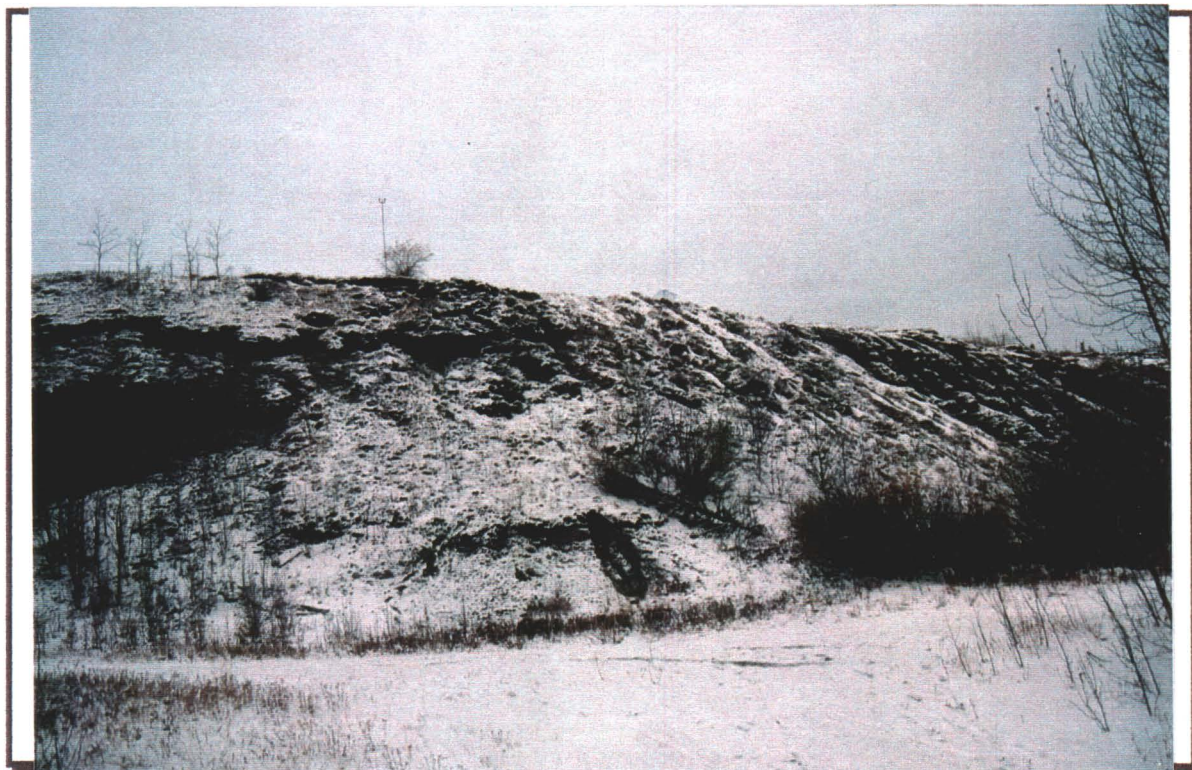
Site 26A

Wastes had been tipped off the edge of the embankment and later partially buried.

Site cross sections and slope profiles were surveyed at Site 24A (Figure 3) and Site 25 (Figure 5). There was no cross section or profile survey of Site 26. A clinometer slope measurement of 40 to 41° was taken of the area with visible debris (Photo 9).
