SITE REMEDIATION OF BORDER PUMP STATION AND RAINY HOLLOW, BRITISH COLUMBIA, CANADA

**INDIAN AND NORTHERN AFFAIRS CANADA
WASTE MANAGEMENT PROGRAM, WHITEHORSE, YUKON**

**ROYAL ROADS UNIVERSITY - APPLIED RESEARCH DIVISION
And
UMA ENGINEERING LTD.**

January 1998

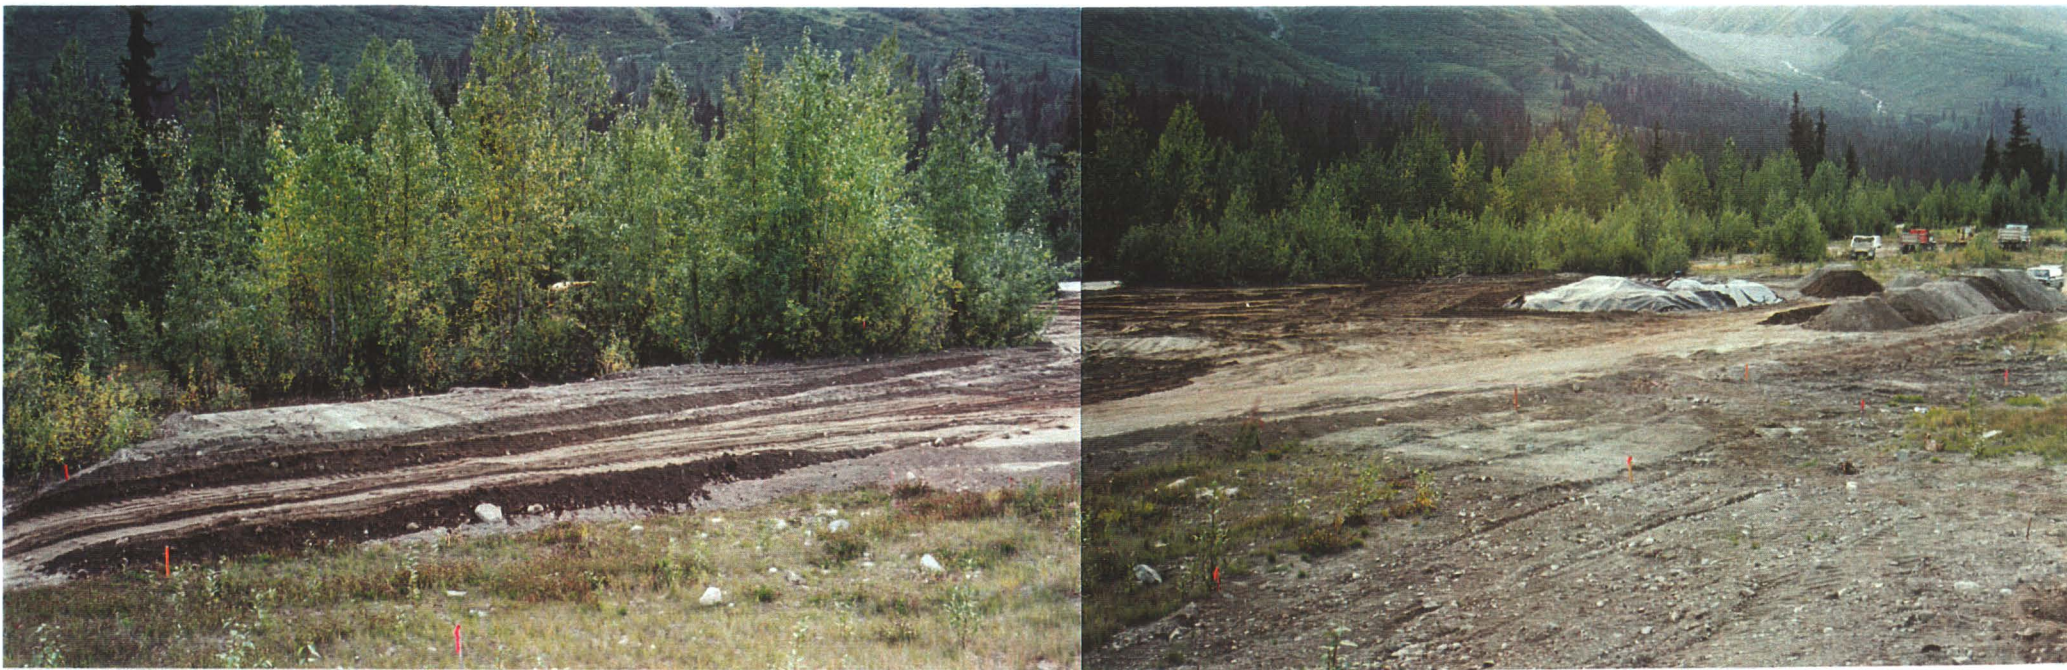
Photograph 1: Border Station showing the partially placed cap at the former location of the Temporary Storage Facility, the stock pile of clean fill required to complete the cap, and tarp covering the temporary stock pile of contaminated soil excavated from DDT contaminated areas.

Excavated soil was hauled to the upper bench (former Temporary Storage Facility) and temporarily stockpiled. The soil was placed on tarps laid out in the area already designated for capping to eliminate the possibility of contaminating a new area at the site. The tarps were taken from the old excavation area on the Rainy Hollow site and turned so that the clean side was facing down. After all of the excavated soil was placed on the tarp, the soil was covered with additional tarps prior to removal off-site (Photograph 1).

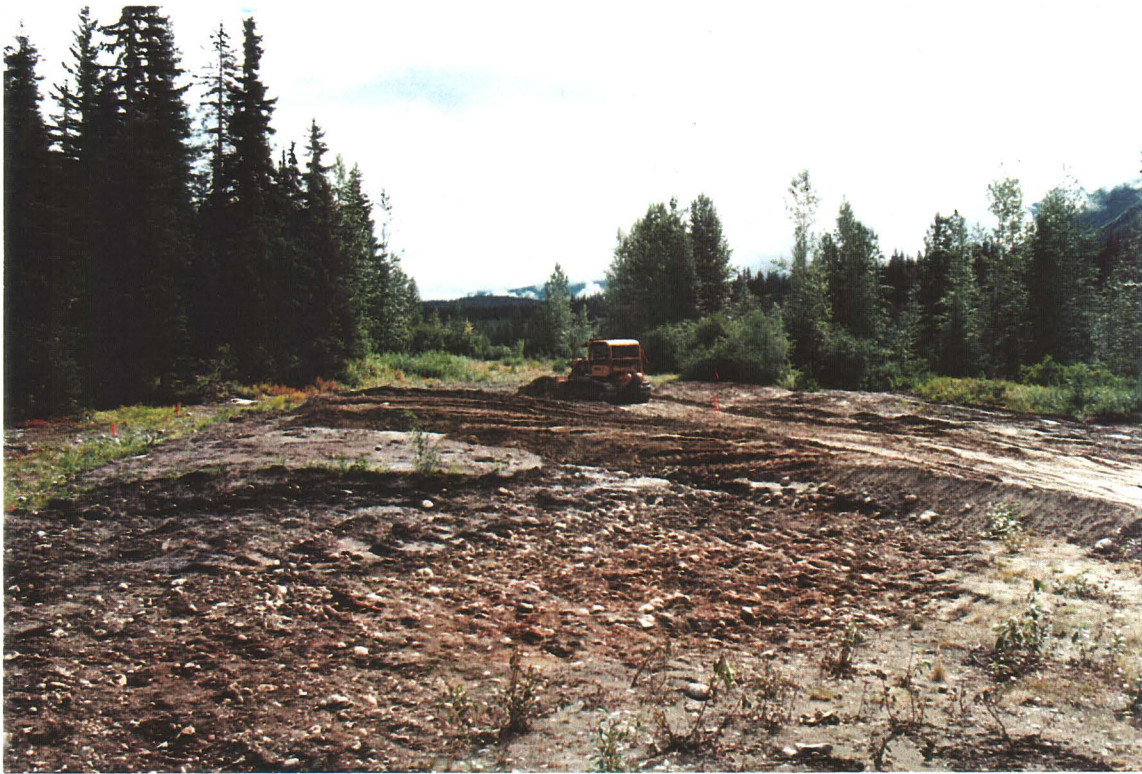
Photograph 2: Excavated area near the Trench at Rainy Hollow looking east

Confirmatory sampling locations and DDT concentrations are given on Map 2-2. The excavated area is shown on Drawing 02 (Appendix B) and Photographs 2 and 2a. The total in place volume of soil excavated from the lower level (Rainy Hollow) for off site disposal was 110.5 m³.

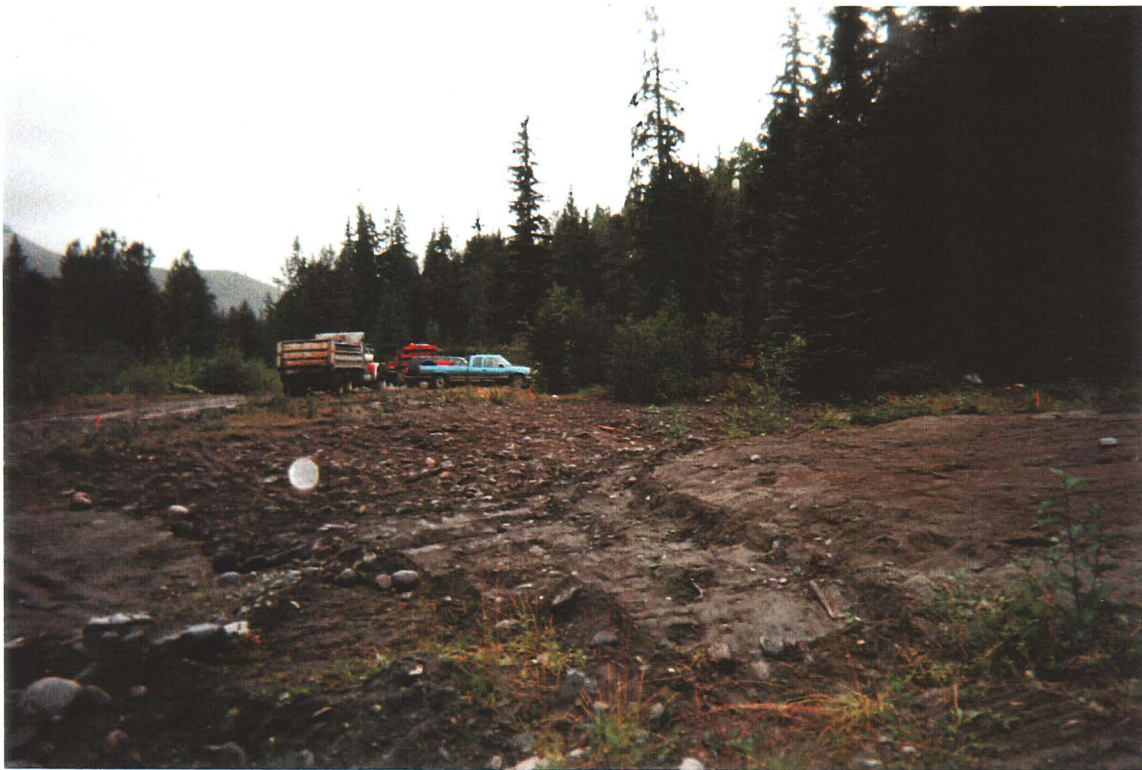
Photograph 2a: Excavated area near the Trench at Rainy Hollow looking north

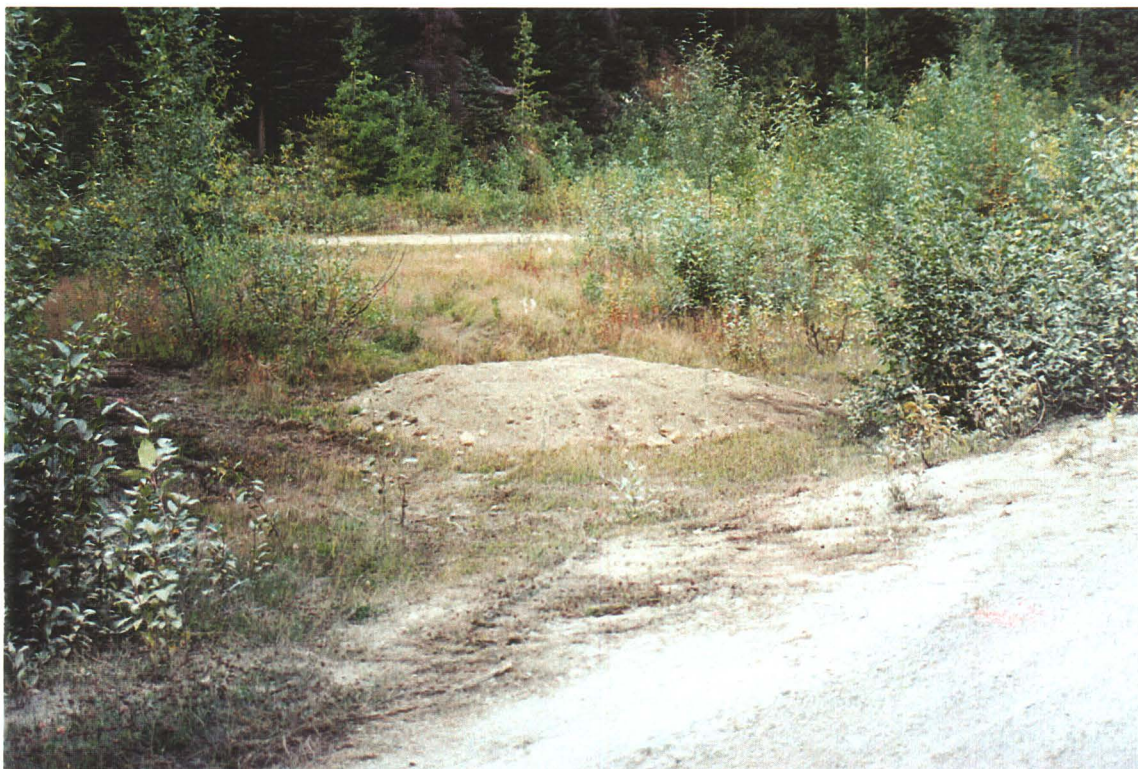
Photograph 3: Depression near the entrance of the road leading to the Temporary Storage Facility (M14) after the excavation of DDT contaminated soil and capping with gravel

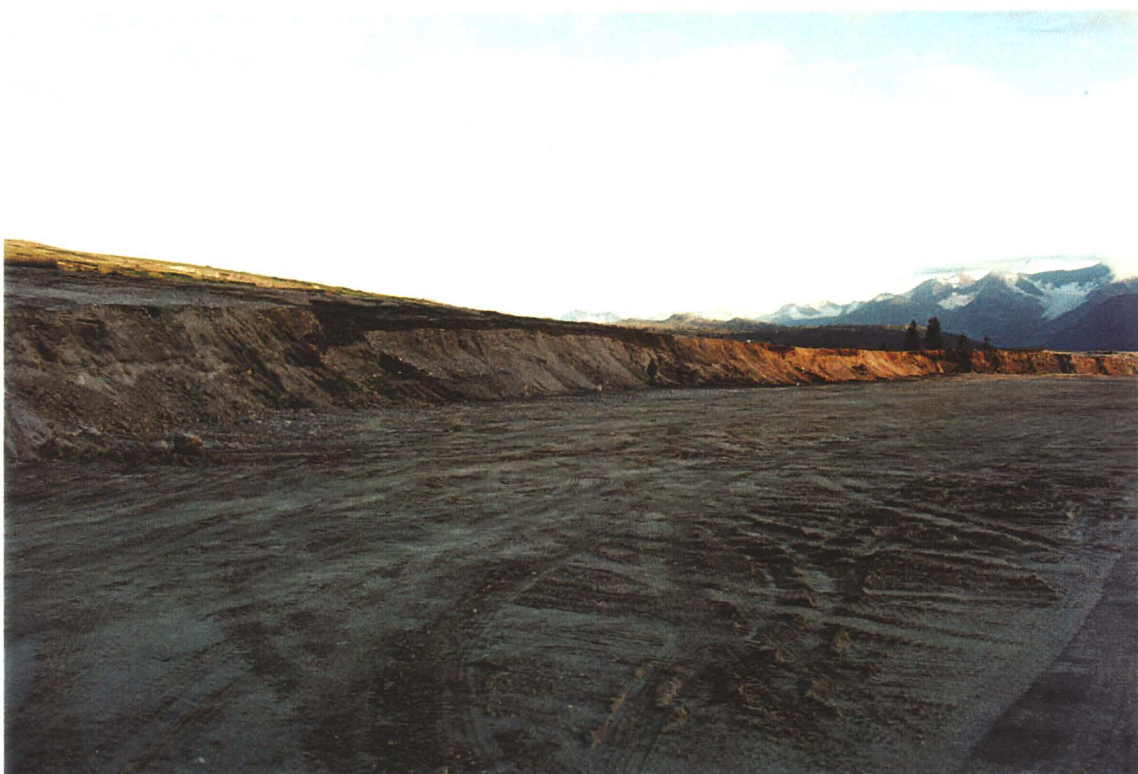
Photograph 4: Gravel borrow area after removal of material and prior to final landscaping

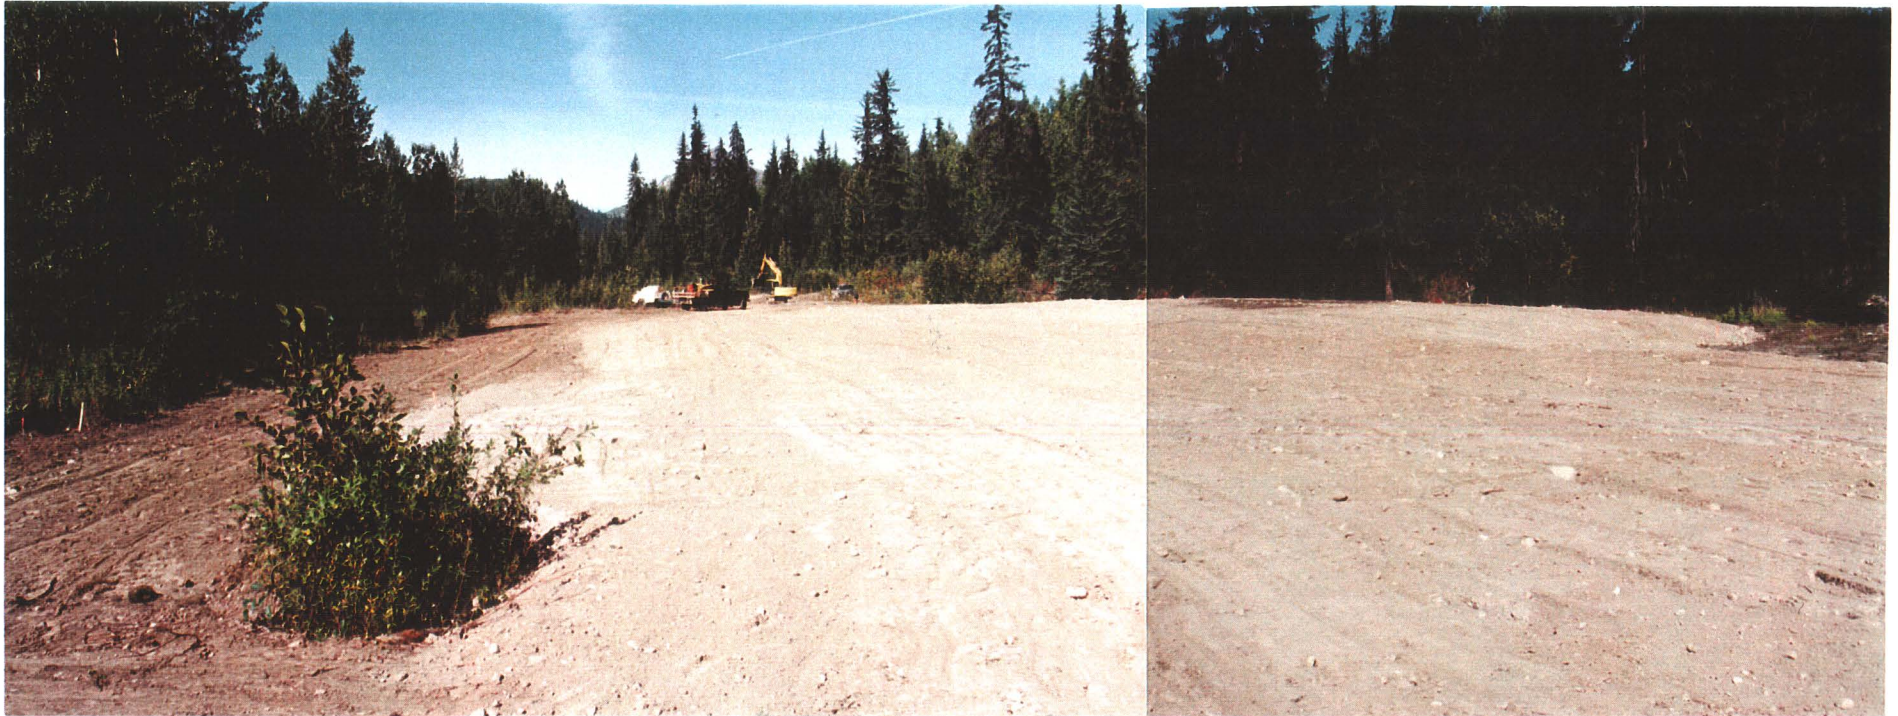
Photograph 5: View from the southern end of capped and graded area at Rainy Hollow

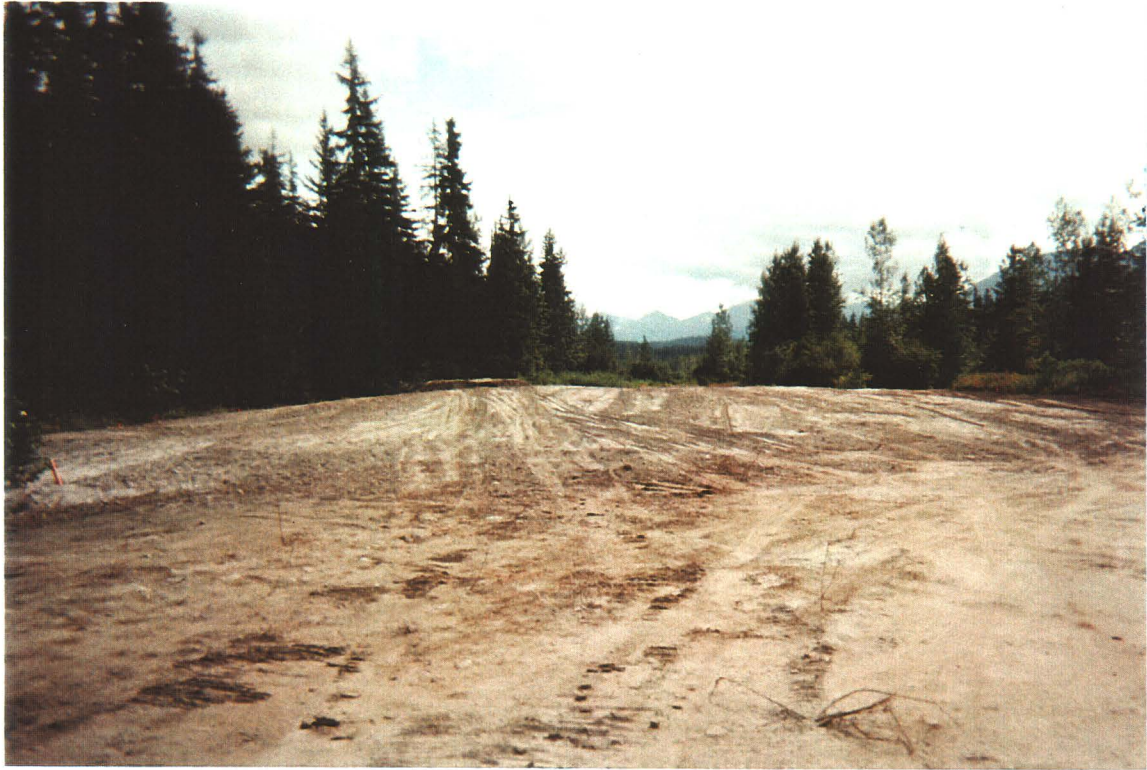
Photograph 5A: View from the northwestern end of Rainy Hollow after capping and grading

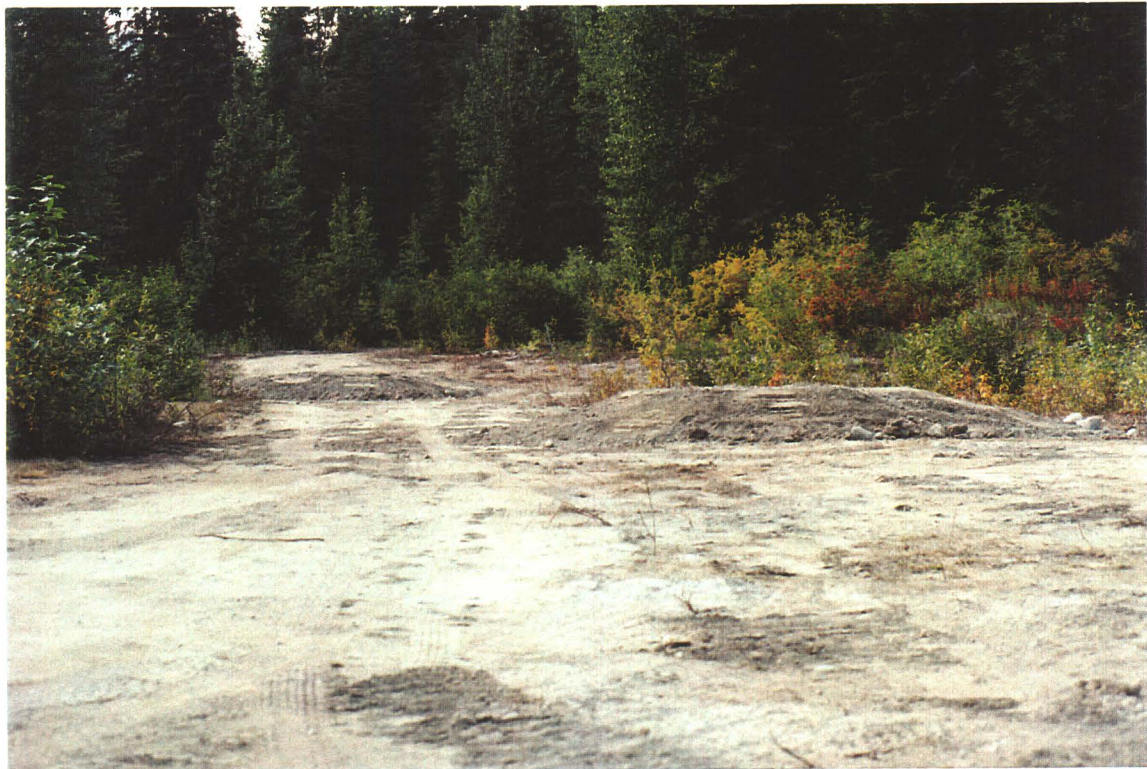
Photograph 6: View of two localized capped and graded areas at Rainy Hollow

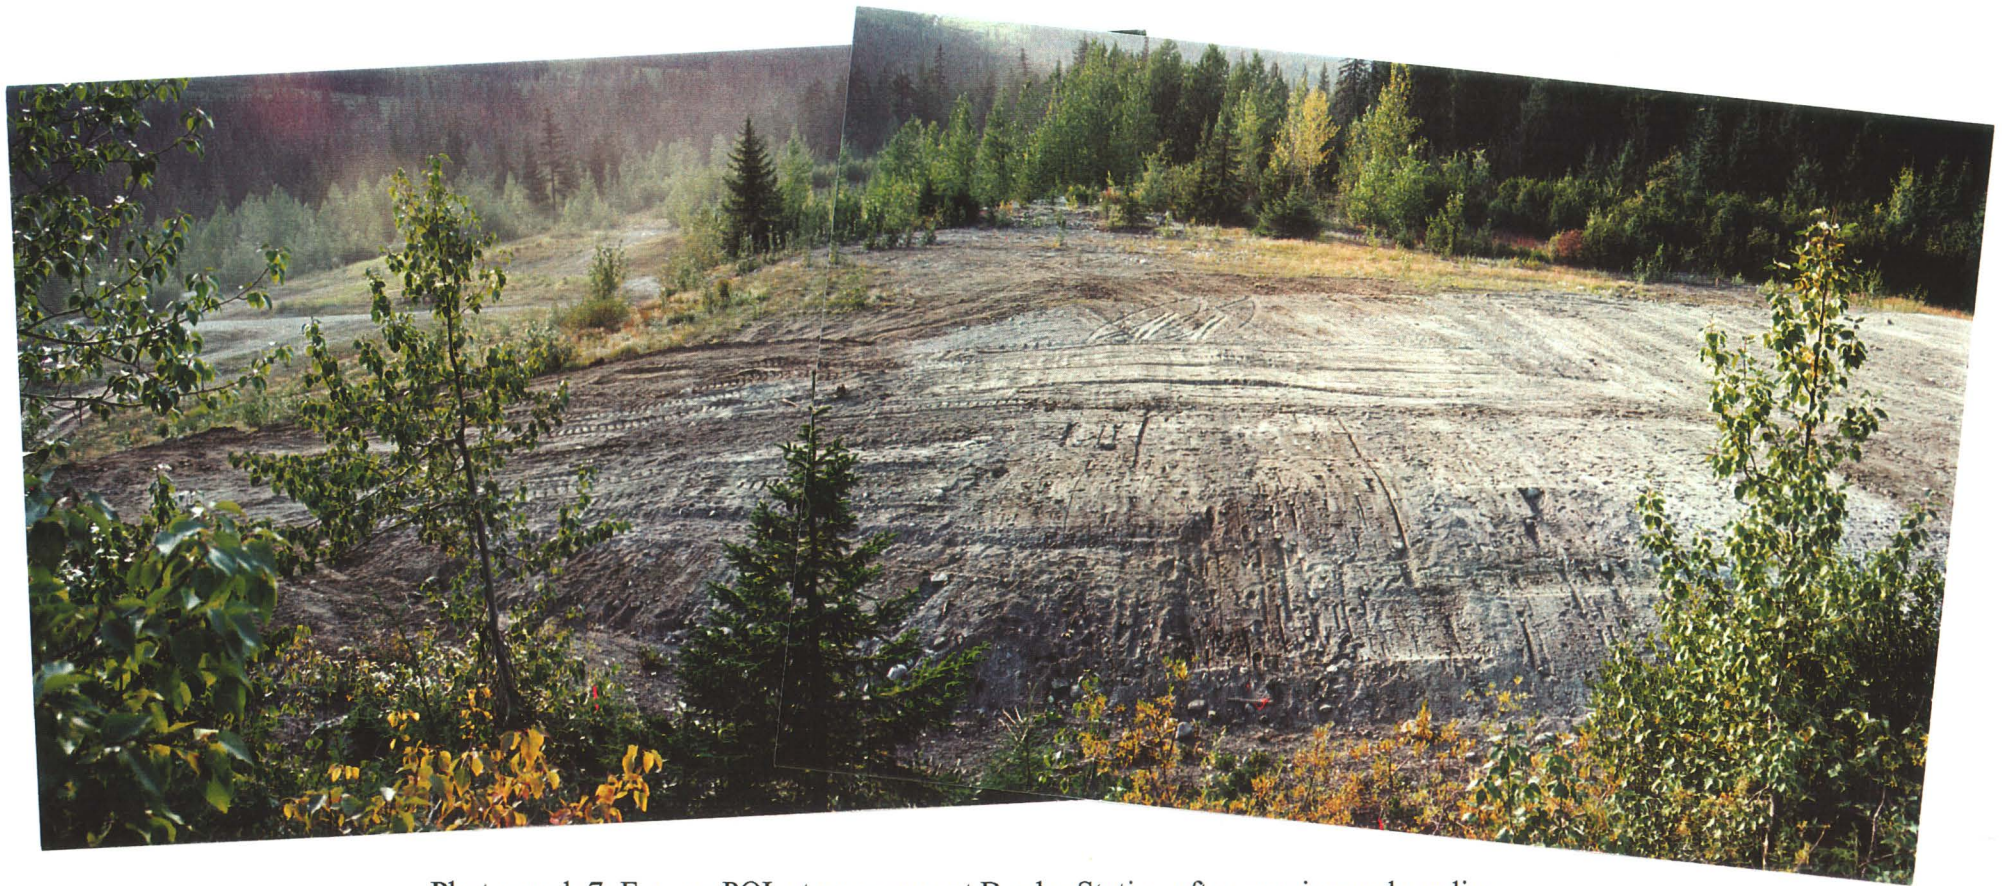
Photograph 7: Former POL storage area at Border Station after capping and grading

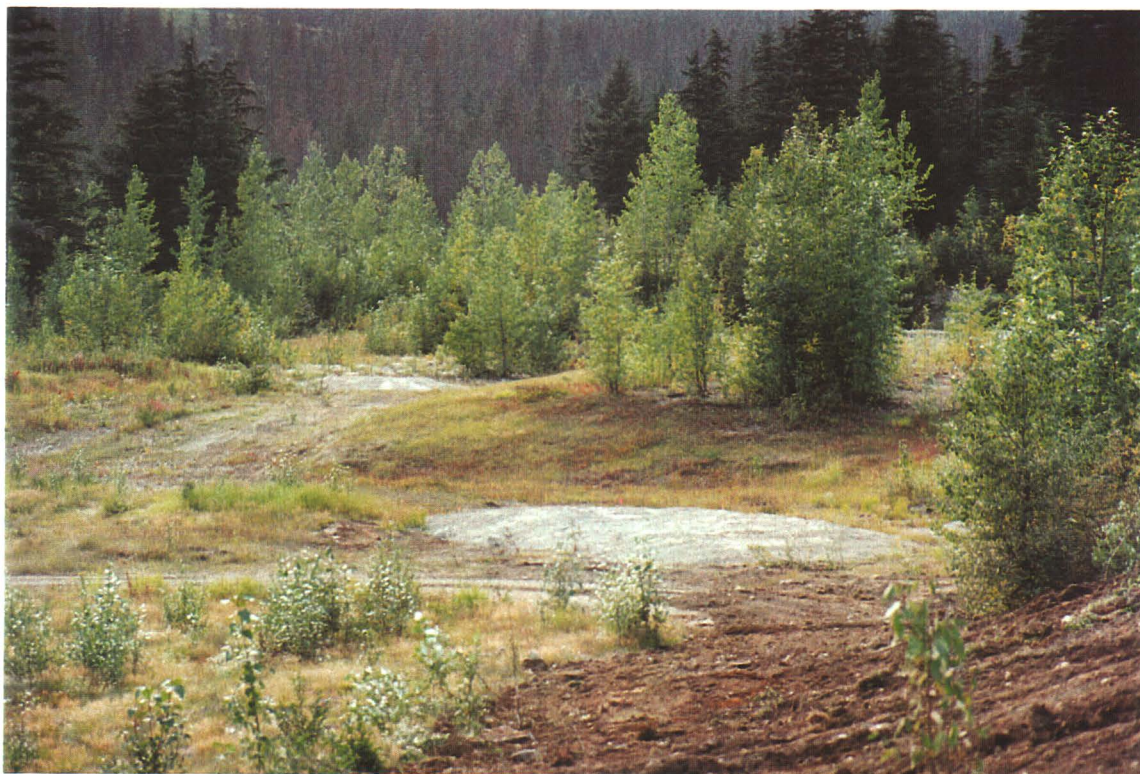
Photograph 8: TP96-14 and TP96-03 (background) after capping and grading

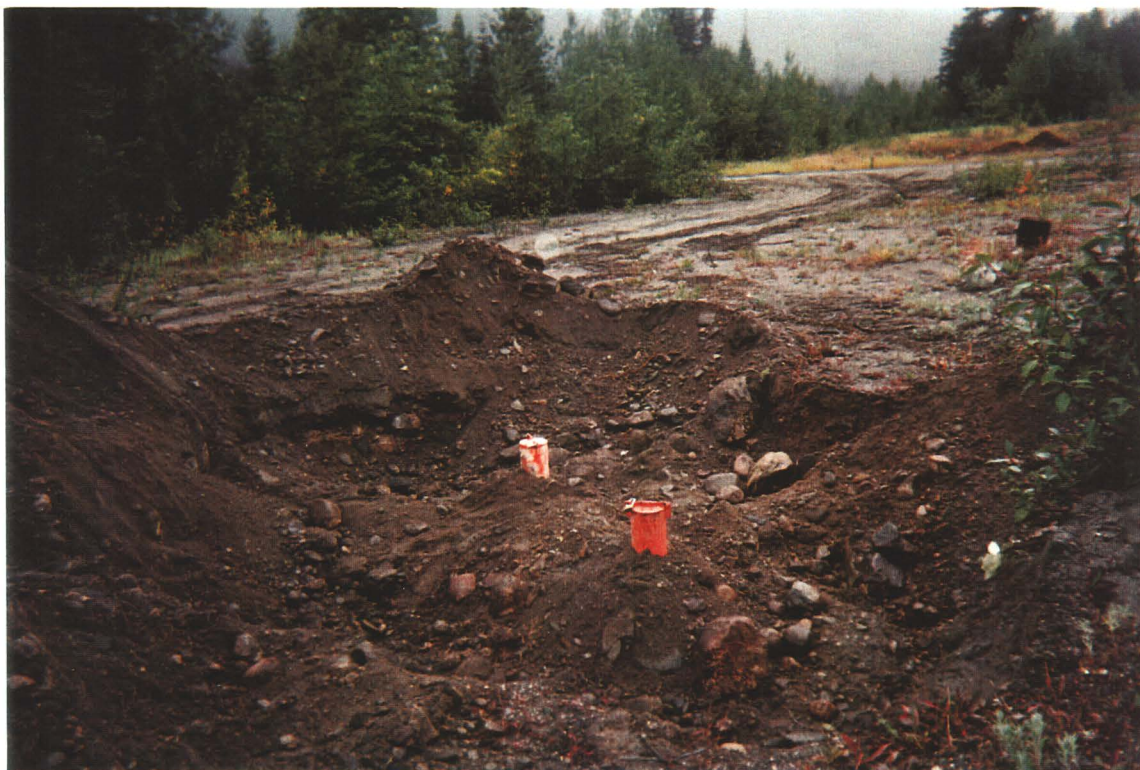
Photograph 9: Monitoring wells after modification for burial
