**PHASE II ENVIRONMENTAL SITE
ASSESSMENTS
Sites HJ035, HJ036 & HJ041
Kluane Lake Area, YT**

0201-97-12447.1

Submitted to:
Indian and Northern Affairs Canada

March, 1998

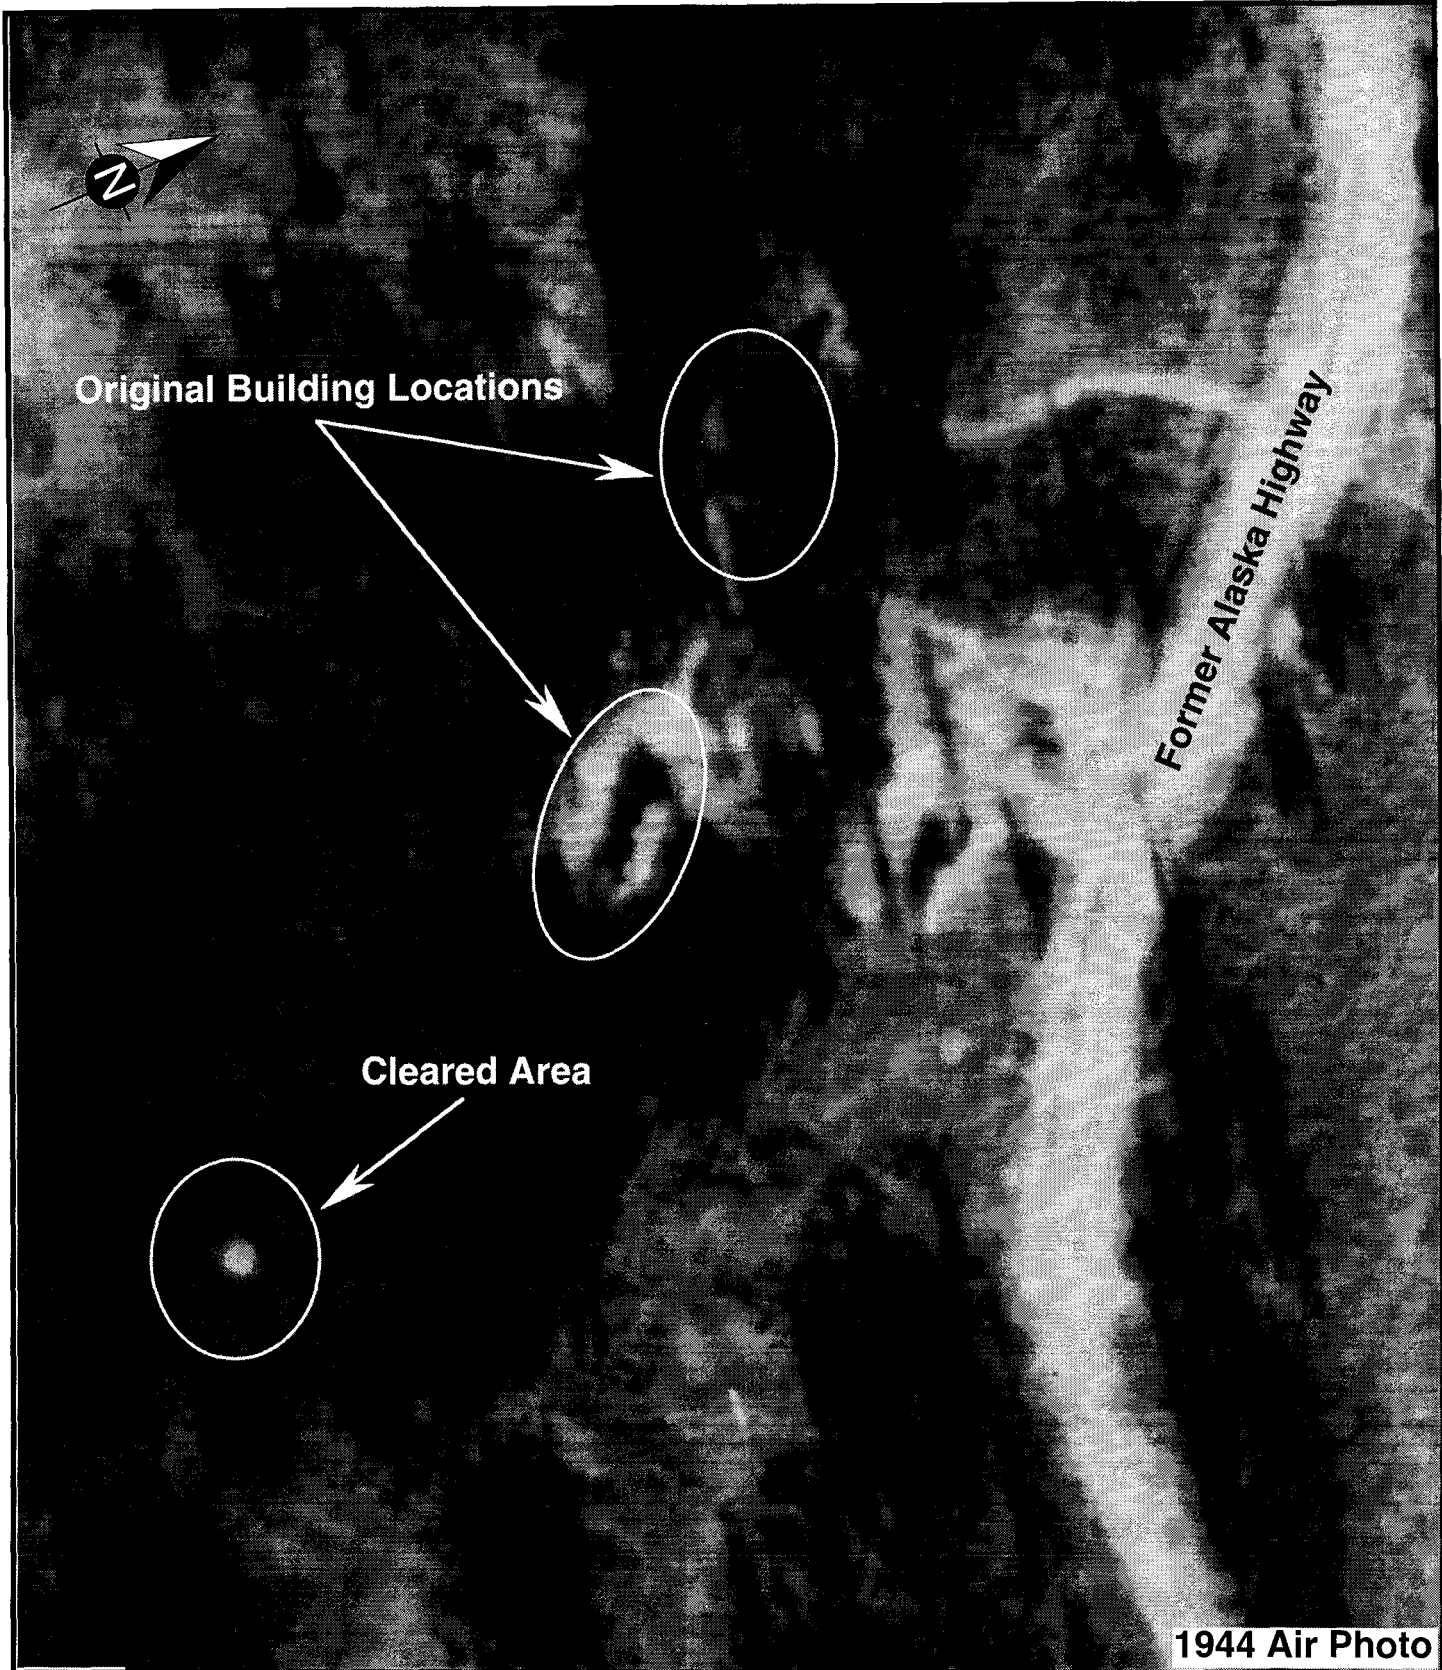
EBA Engineering Consultants Ltd.	PROJECT PHASE II ENVIRONMENTAL SITE ASSESSMENTS KLUANE LAKE AREA, YUKON				
CLIENT	DIAND, RENEWABLE RESOURCES CONTAMINANTS/WASTE PROGRAM	TITLE Figure 3: Site HJ035 Site Layout				
DATE	97 12 21	DWN. DJW	CHKD.	FILE NO. 0201-97-12447.1	DWNG. 12447.1 Figure 3	REVISION 0

The site which was identified as having possible vegetation stress in the Phase I portion of the work was an area where the organic layer had been removed. This area is shown in Figure 3, and is in the process of revegetating. No signs of stress were noted during the site investigation and no anomalies were found using the PID.

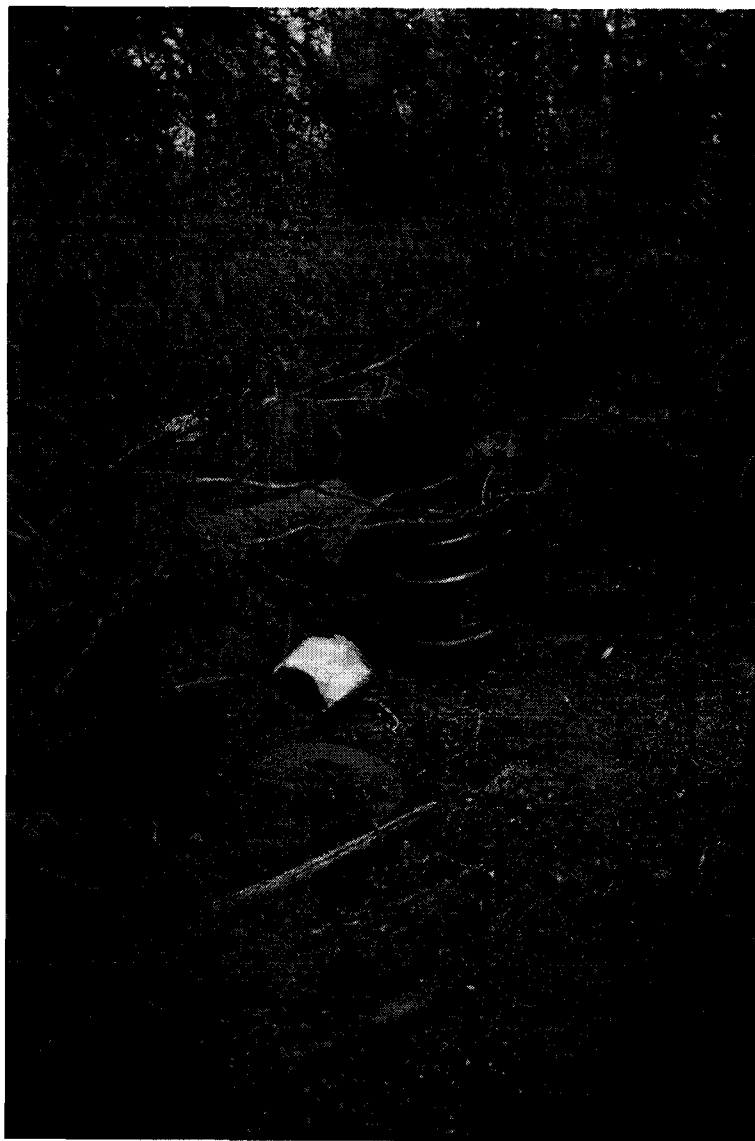
Location 41-2 does not appear to be an area of long term waste disposal. While there are numerous drums, pails and a variety of other containers, it appeared they had been used to manufacture other items such as culverts and wood burning stoves. Most of the containers had been cut apart and partially assembled items were found on the site. Spruce and willows are growing between the material suggesting that surplus materials may simply have been discarded amongst the trees.

Photograph 4: Site HJ041-2 showing drums and waste metal scattered amongst trees.

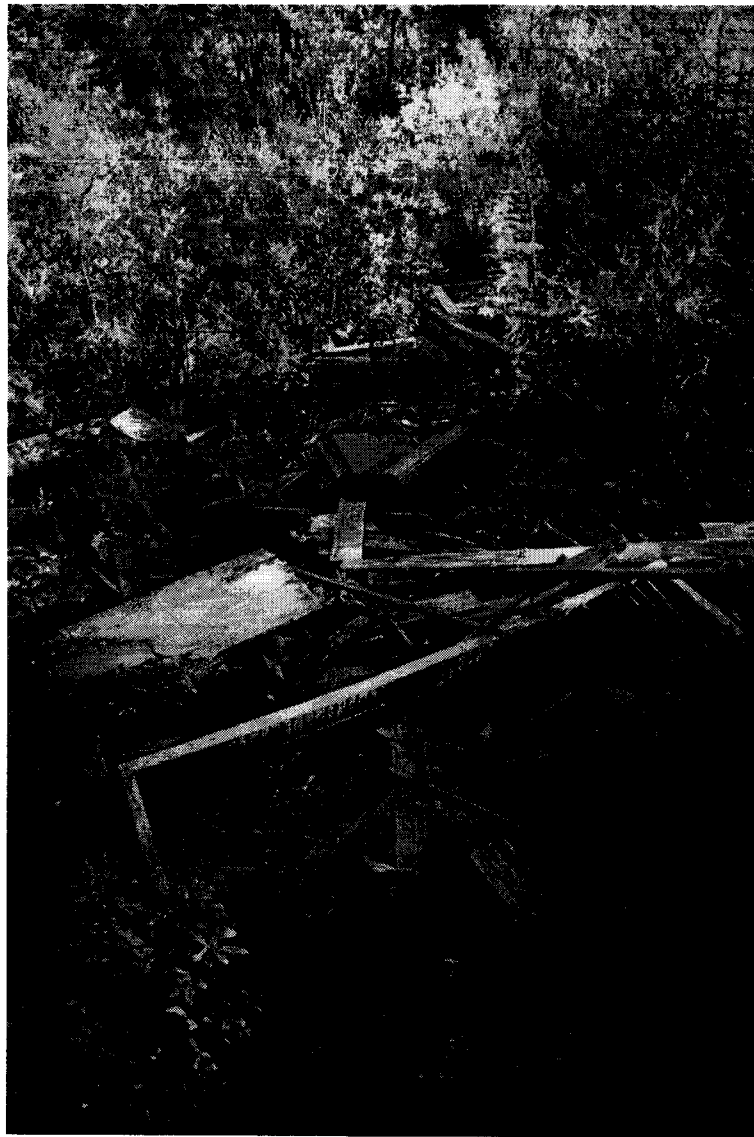
Location 41-3 was an area identified by Edey, 1976. The material present was mainly wood debris (Photographs # 7 & 8) with some small cans and other miscellaneous wastes which are scattered on the surface of the ground. Based on the extent of deterioration of the wood it is suspected that this site was not from the same era as the maintenance camp. Trails accessing the site were impassable by vehicle due to standing water. The area is overgrown with willow and immature spruce. The surrounding area has been used for cutting firewood, this does not appear to have disturbed the actual waste disposal site.

Photograph 7: Site HJ041-3 showing waste disposal site with wood and metal wastes.

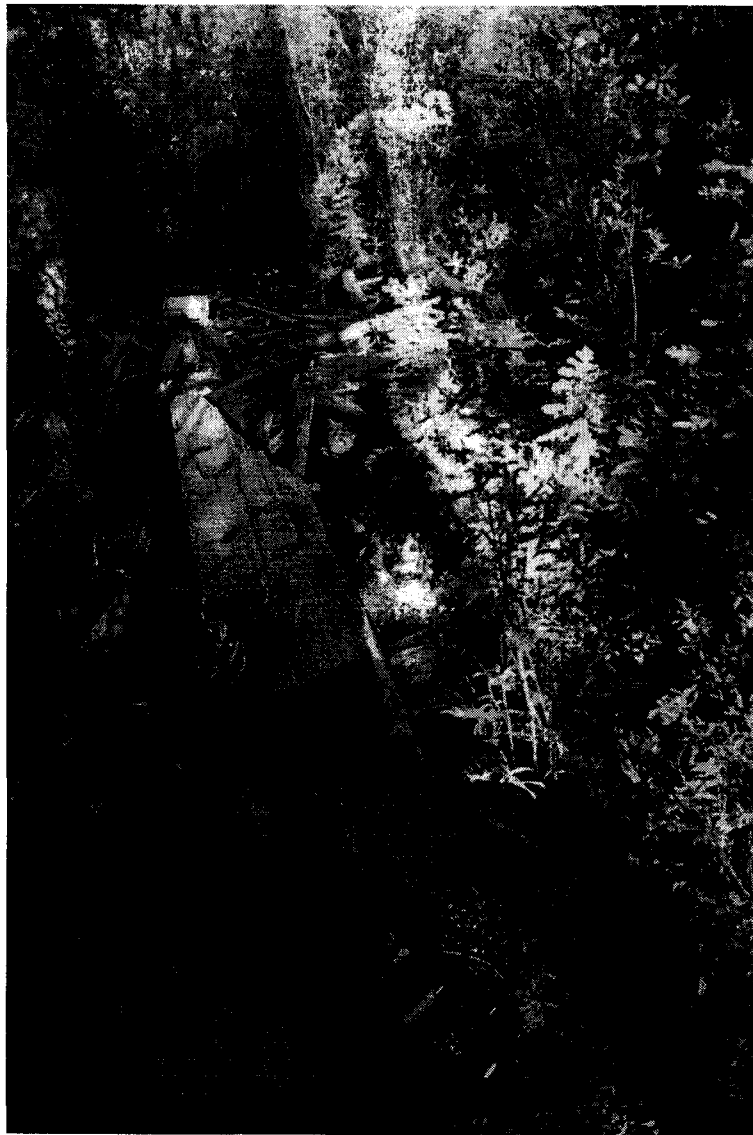
Photograph 8: Site HJ041-3 showing waste disposal site.
