**PHASE II ENVIRONMENTAL SITE
ASSESSMENT
Site HJ045, ~~Kluane~~ Maintenance Camp
Kluane Lake, YT**

0201-97-12447.2

Submitted to:
Indian and Northern Affairs Canada

March, 1998

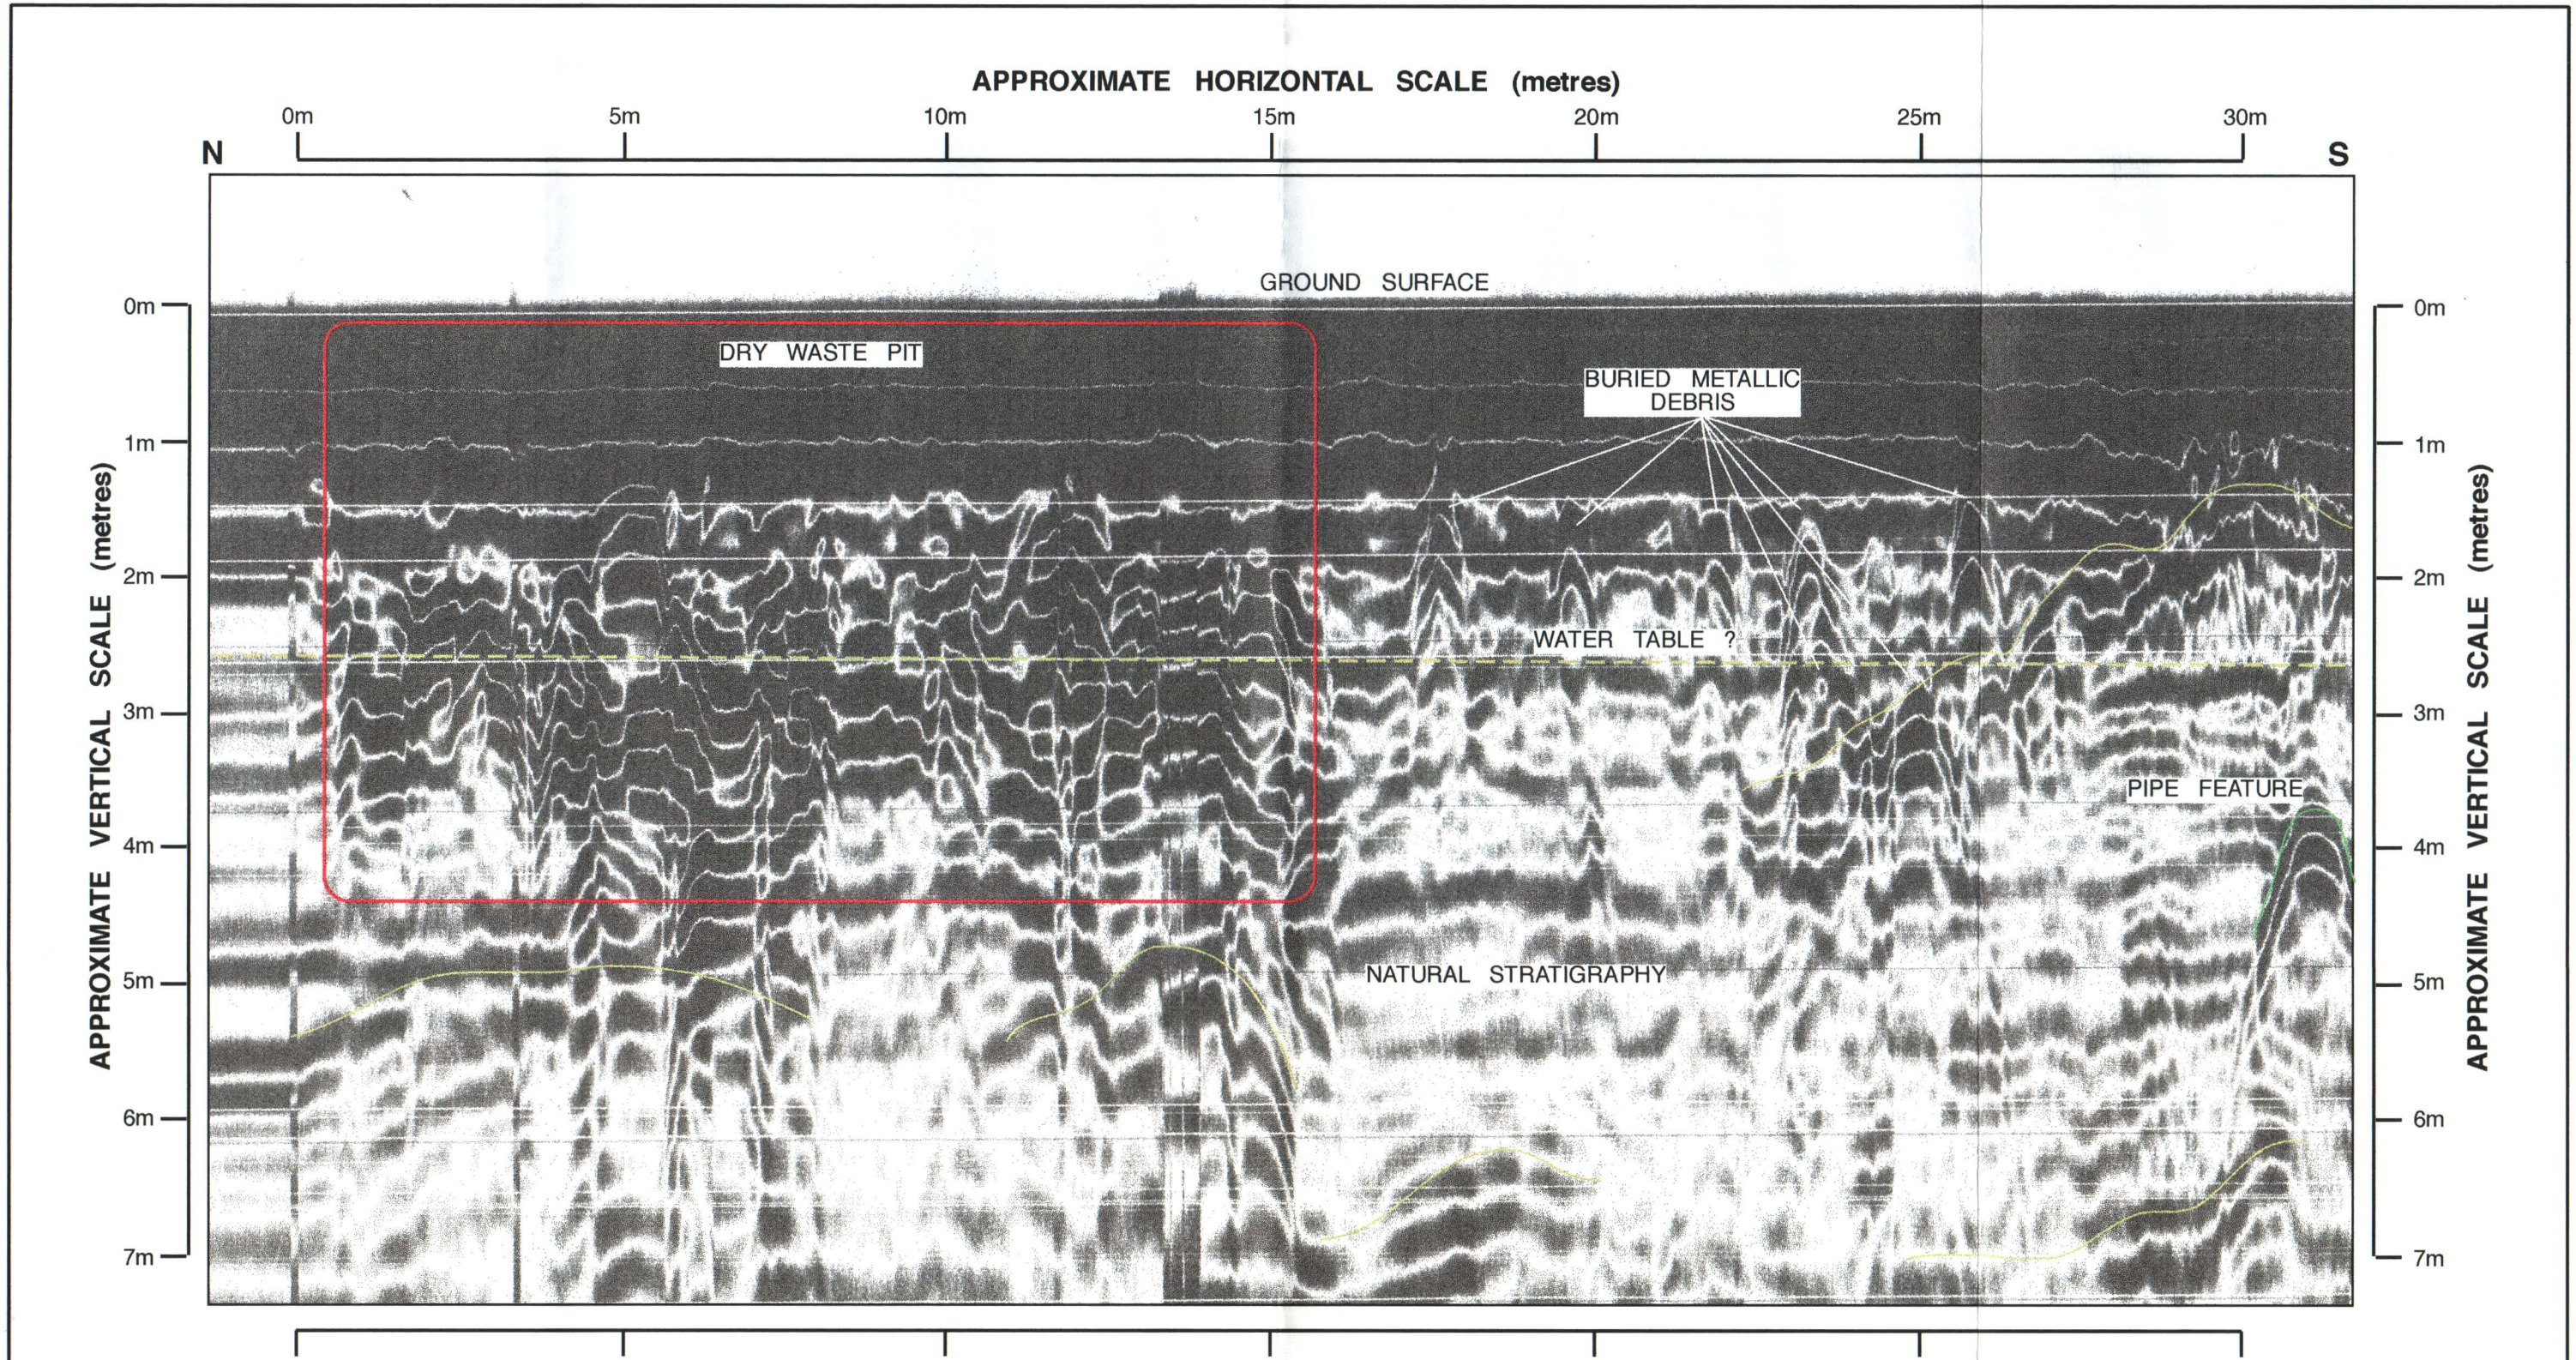
Figure 3 shows a section of line that traverses a solid waste disposal pit (Testpit #1) located on the site surveyed. The change in reflection strength due to the presence of rebar and wooden beams is very obvious. In addition to the solid waste pit there are numerous single point reflectors caused by metallic debris of one kind or another. These objects may range in size from rebar to engine blocks and are scattered throughout the area surveyed. No evidence was seen that would suggest a concentration of these objects in a pit.

On both figures a largely horizontal reflector was seen that appears to correlate with the water table identified during testpitting. All metallic type reflectors seen on the records are between

2.5 m and ground surface, i.e., there does not appear to be foreign objects below the water table.

- The depth scales shown in Figures 3 and 4 are only approximate and should be considered as general guides only. This is a result of the fact that the GPR data is actually directly measuring a two-way travel time rather than depth and an average velocity has been assumed to derive the depth scale shown. The conversion from the time delay measured to depth requires an estimate of the propagation velocity of the GPR signal through the ground, and this will vary across the site as the soil and moisture contents vary.
- The GPR data will detect reflection anomalies that are generally within 1 to 1.5 m of the profile centreline. As profile spacings were either 1.5 or 3.0 m apart, small individual objects between these profile swaths may not be detected.

GPR data quality was good with strong and clear reflections being obtained down to 5 m. A marked increase in attenuation below 2 to 2.5 m was caused by the saturated soil conditions below the water table. Typical traces are included in Figures 3 and 4.

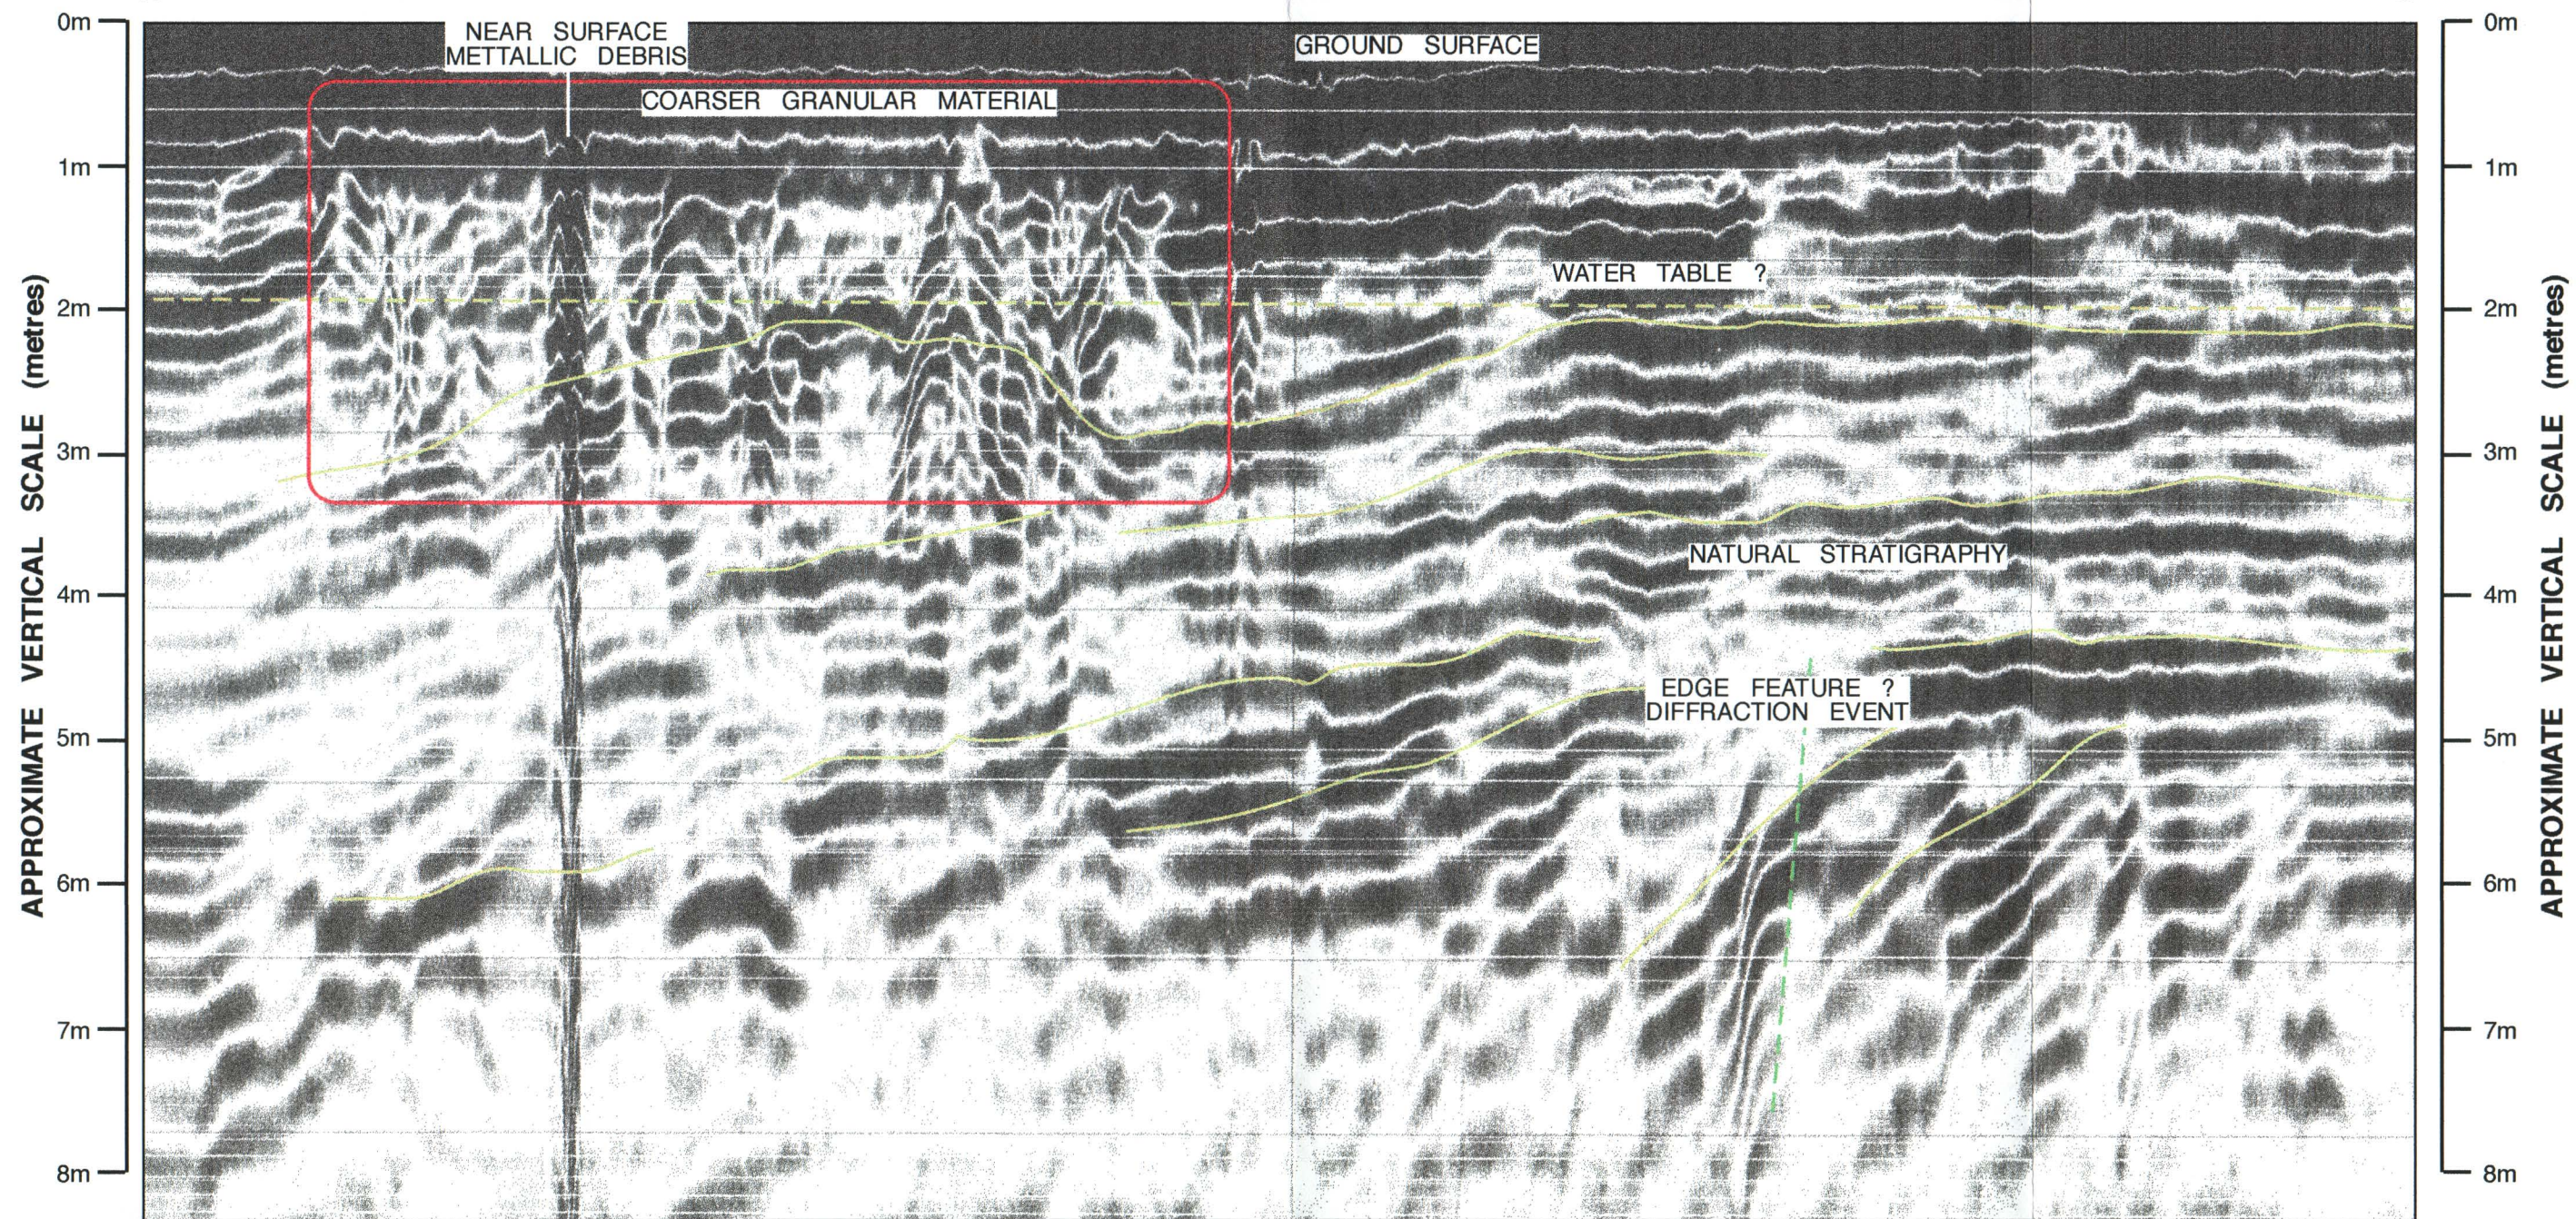
PROJECT	Phase II ESA Site HJ045
CLIENT DEPARTMENT OF INDIAN AND NORTHERN AFFAIRS		TITLE	TYPICAL GPR PROFILE, TEST PIT AREA #2
DATE	97-11-28	DWN.	NSP
CHKD.	NSP	FILE NO.	201-12447NSP01
			FIGURE 4

Figure 4 shows reflections that are very typical of undisturbed pad material. Strong horizontal reflectors are present. These reflectors are likely a result of abrupt changes in moisture content and/or natural depositional layering. A distinct region was tentatively identified as a second possible pit and is shown on Figure 4. Within this area the distinctive horizontal layering seen in other areas is broken and more chaotic reflectors are seen. Upon digging a testpit in this area (Testpit #2) it was determined that a waste disposal pit did not exist at this location. The chaotic reflectors seen are a result of pockets of coarser granular material within the ground. A single metallic reflector is seen in this example and is typical of reflections caused by lengths of steel wire found on the ground surface.

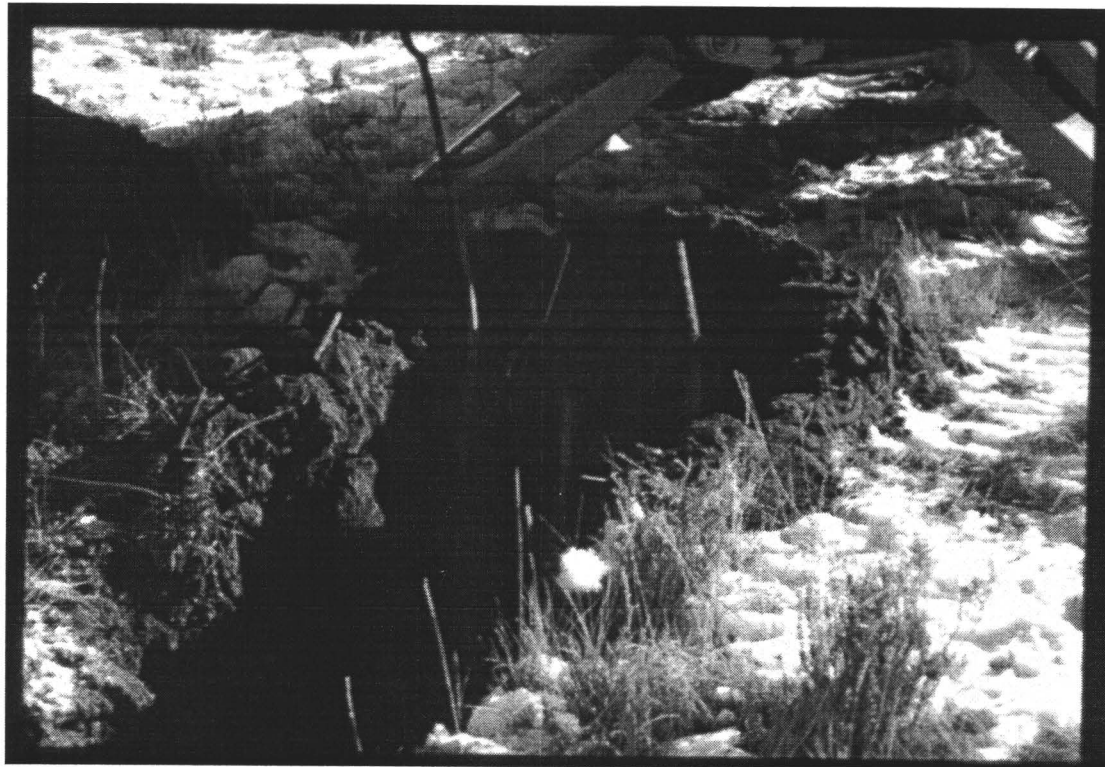
Photograph 10: Metal debris (rebar) in Testpit # 1.

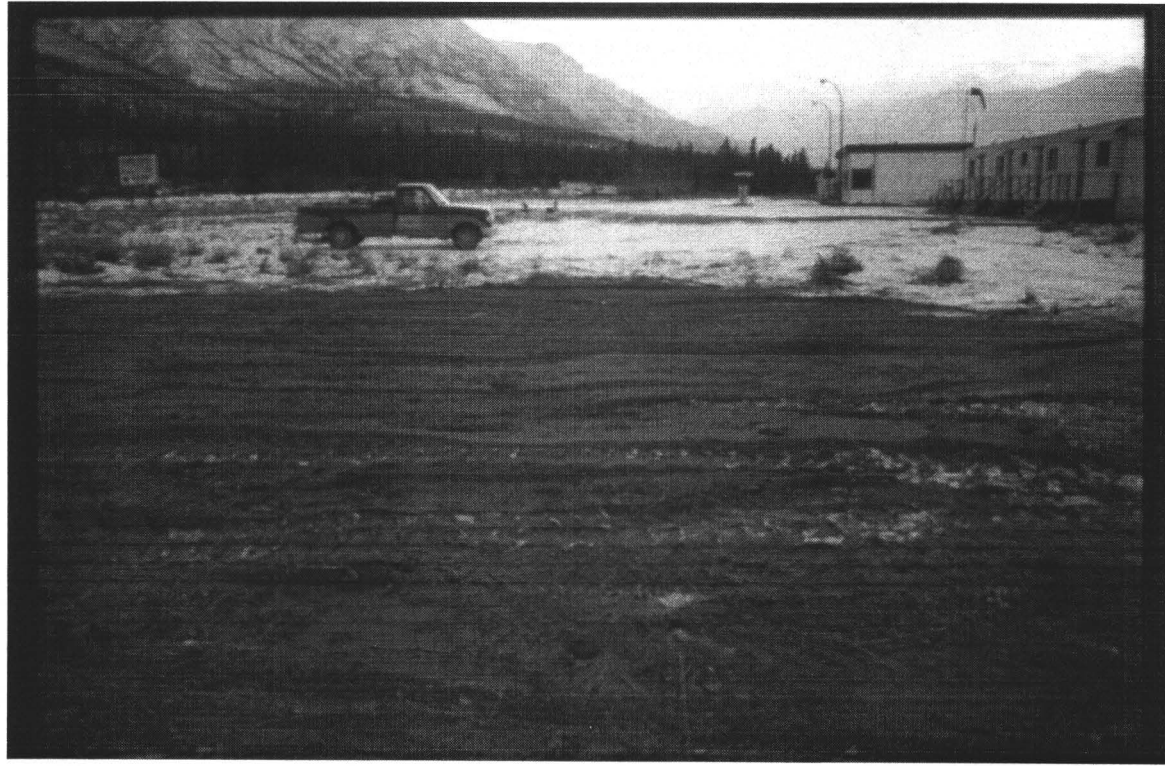
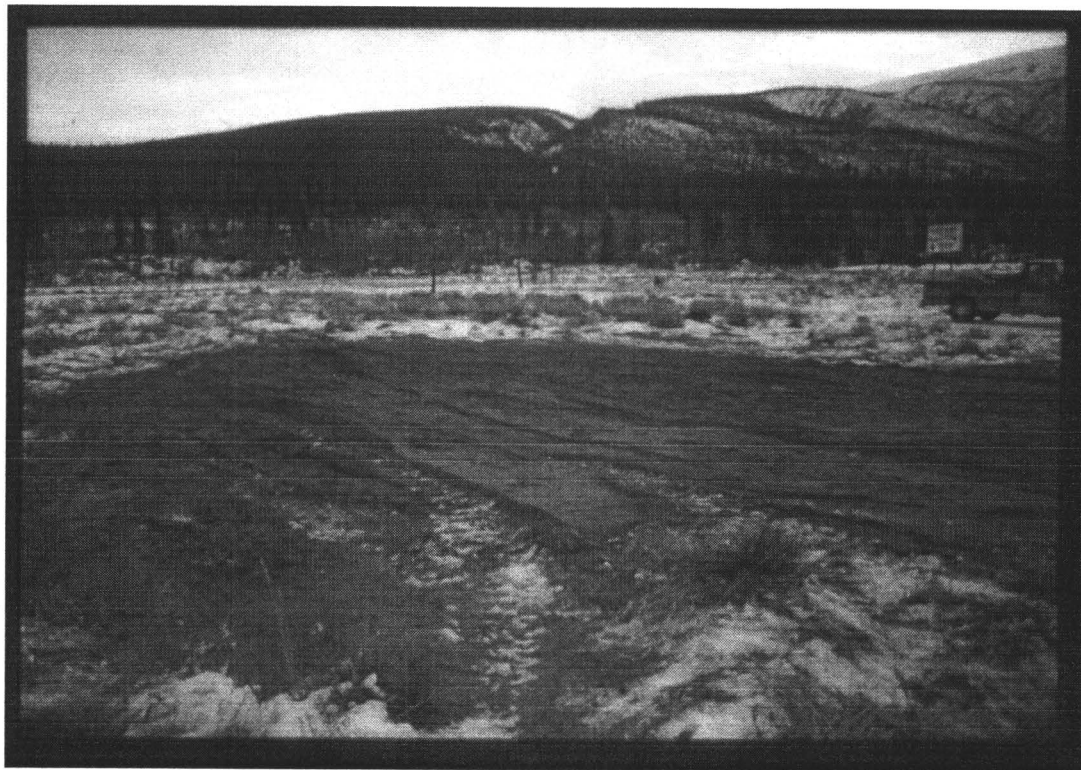
Photograph 14: Testpit #1 following backfilling.

Photograph 15: Testpit #1 following backfilling.

Photograph 16: Testpit #1 following backfilling.

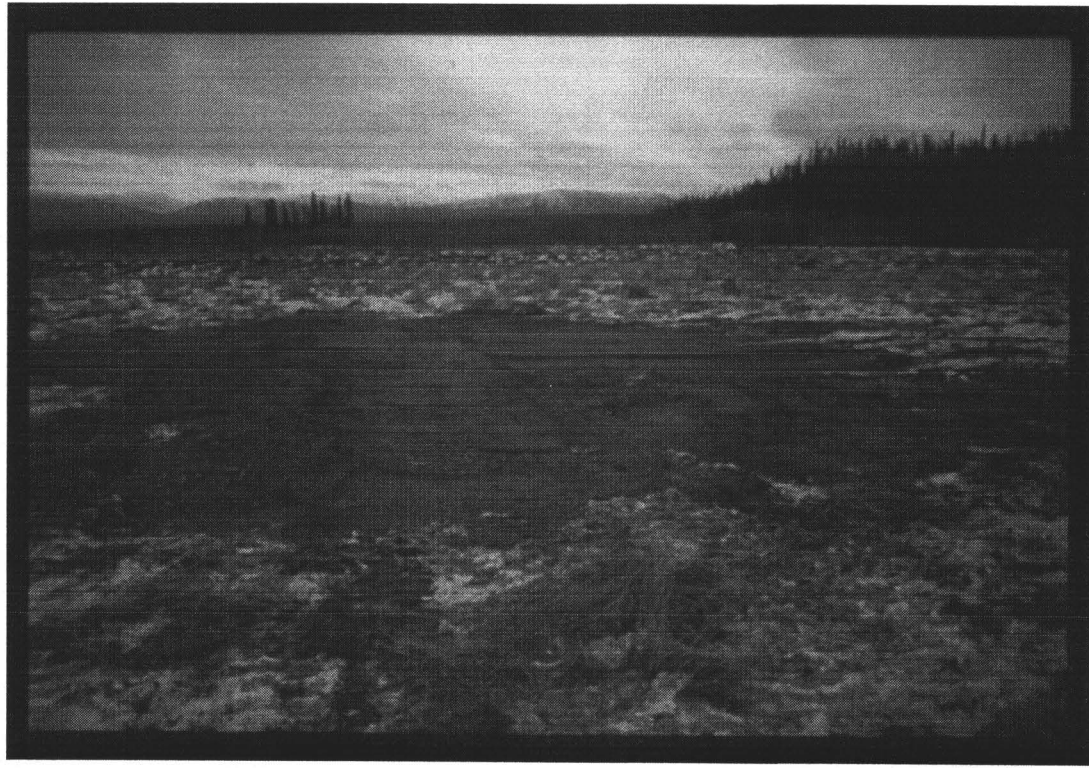
Photograph 18: Testpit #2 following backfilling.

Photograph 19: Testpit #2 following backfilling.
