# **AN ENVIRONMENTAL REVIEW OF THE CLINTON CREEK ABANDONED ASBESTOS MINE, YUKON, CANADA**

**Prepared for:**  
**Indian and Northern Affairs Canada**  
**Waste Management Program, Whitehorse, Yukon**

**By:**  
**Royal Roads University - Applied Research Division**

**March 1999**

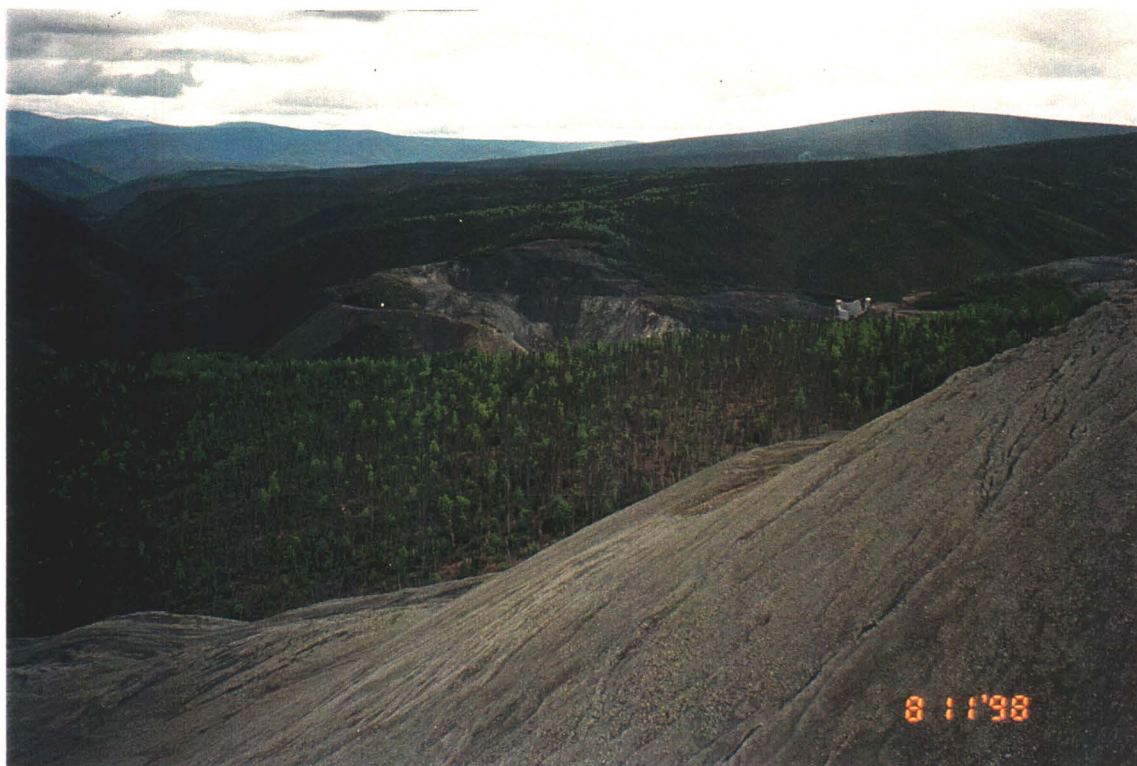
Photograph 2-1: View of the mine site from the south lobe of tailings pile. Note tailings in the foreground and characteristic terrain in the background

The Clinton Creek Abandoned Asbestos Mine is within the unglaciated Yukon – Tanana Upland with terrain consisting of a series of ridges (Photograph 2-1). The valley bottoms of the ridges are at an elevation of 400 m with the highest levels reaching 610 m above sea level. The site has been described to be in a region of widespread discontinuous permafrost (Stepanek and McAlpine, 1992).

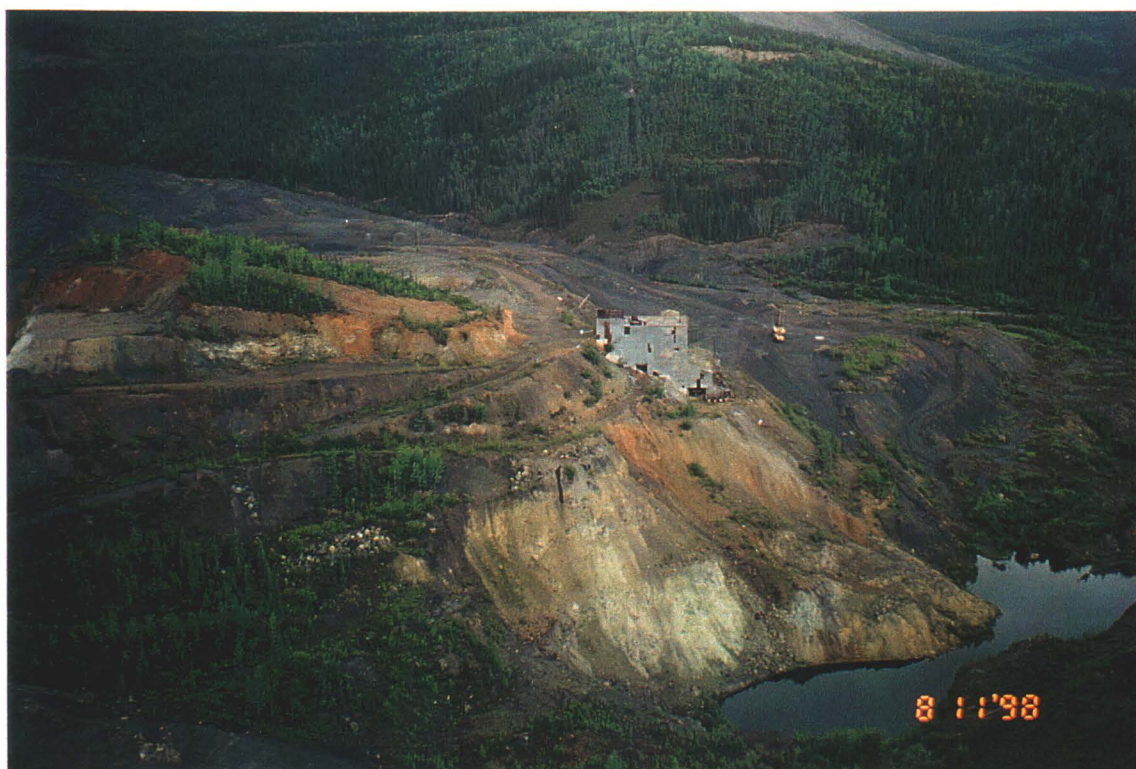
Photograph 2-2: Creek Crusher overlooking Porcupine Creek Open Pit

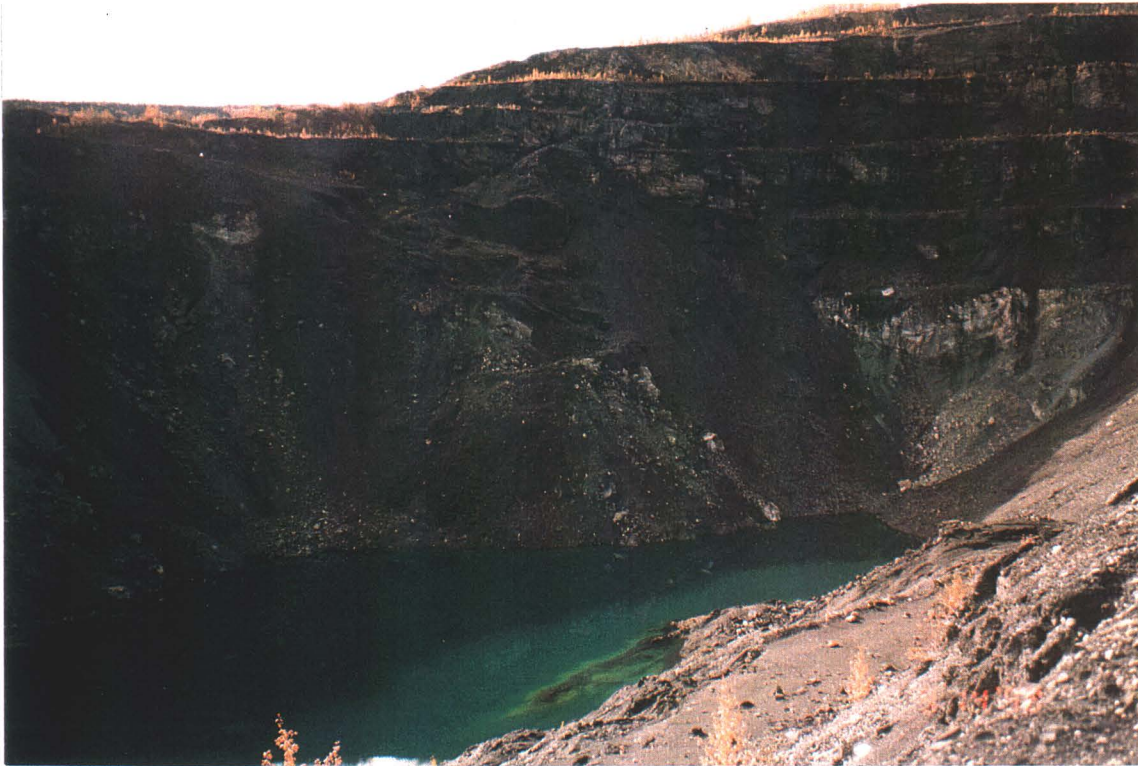
Photograph 2-3: Porcupine Open Pit, view of the southern end

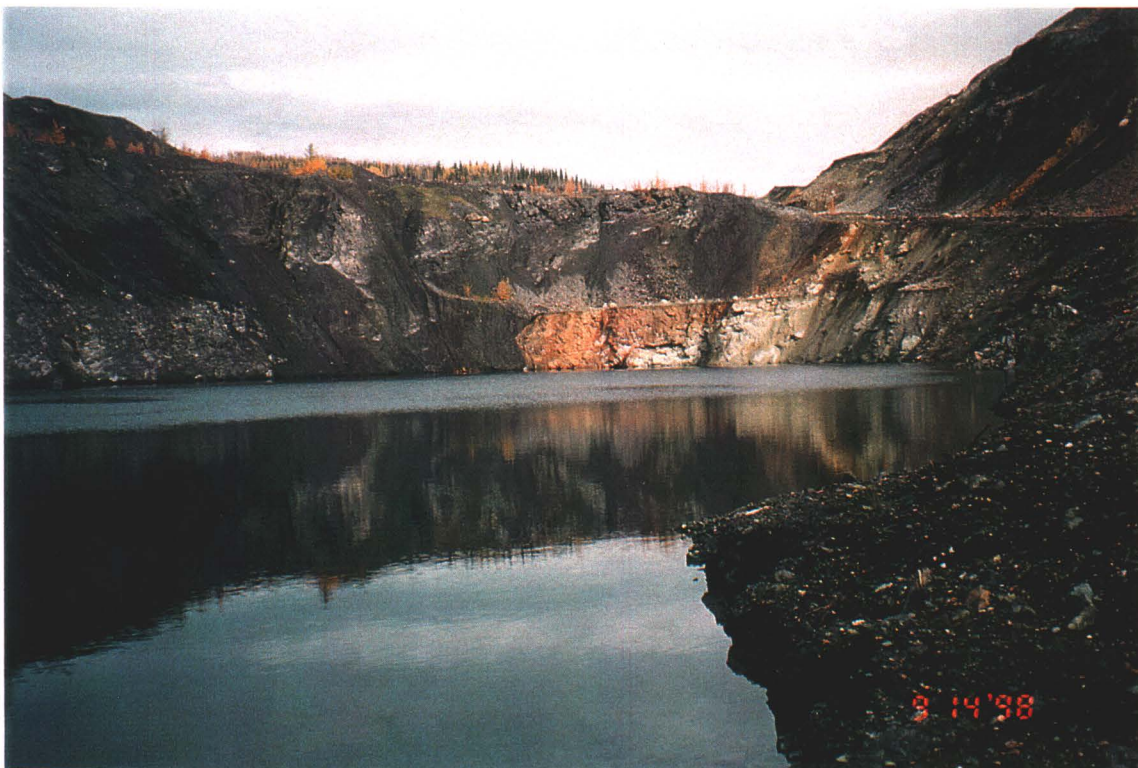
Photograph 2-4: Porcupine Open Pit, view of the northern end.

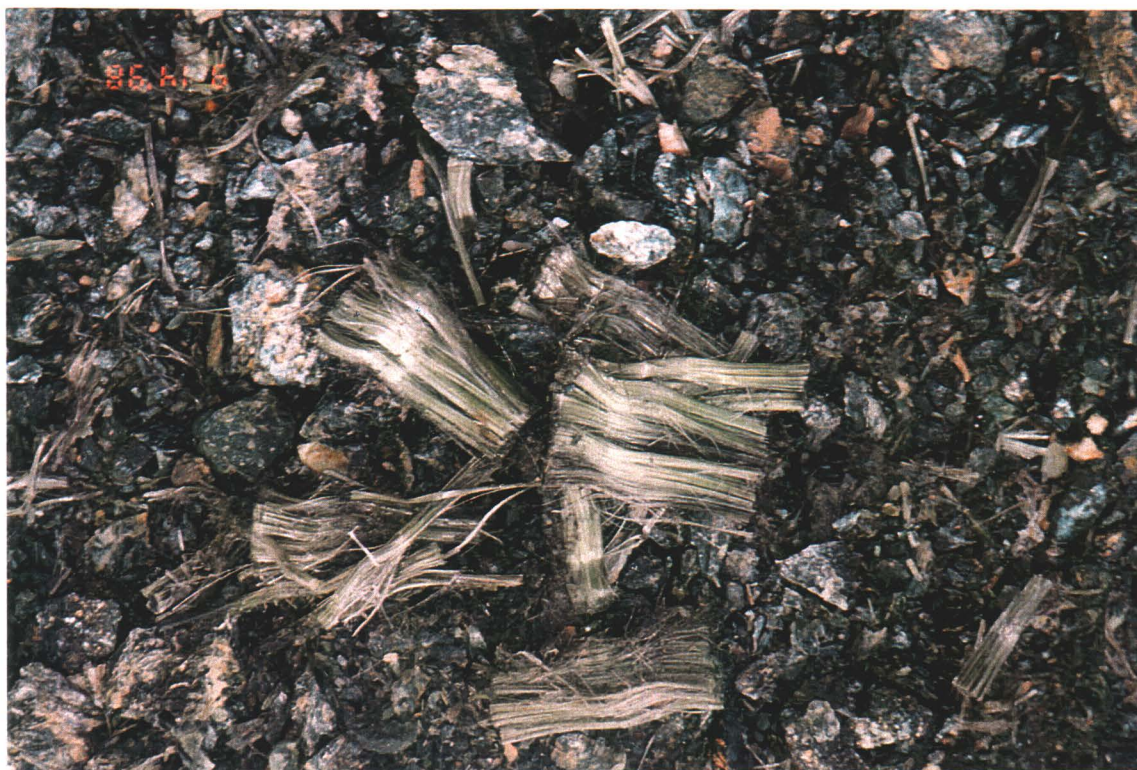
Photograph 2-5: Asbestos fibres amongst waste rocks at the Clinton Waste Rock Dump

Waste rock from the three open pits was deposited on the valley slopes adjacent to the pits. This practice created three waste rocks dumps (Clinton, Porcupine, and Snowshoe). The last of the waste rock materials was consigned to the dump sites in the summer of 1977. The waste rock predominantly consists of argillite. The volume of the waste rock piles has been estimated at 60 million tonnes (Roach, 1998). The waste rock consist mainly of argillite, phyllite, platy limestone and micaceous quartzite (Stepanek and McAlpine, 1992). Asbestos fibres are occasionally found amongst the waste rock (Photograph 2-5).

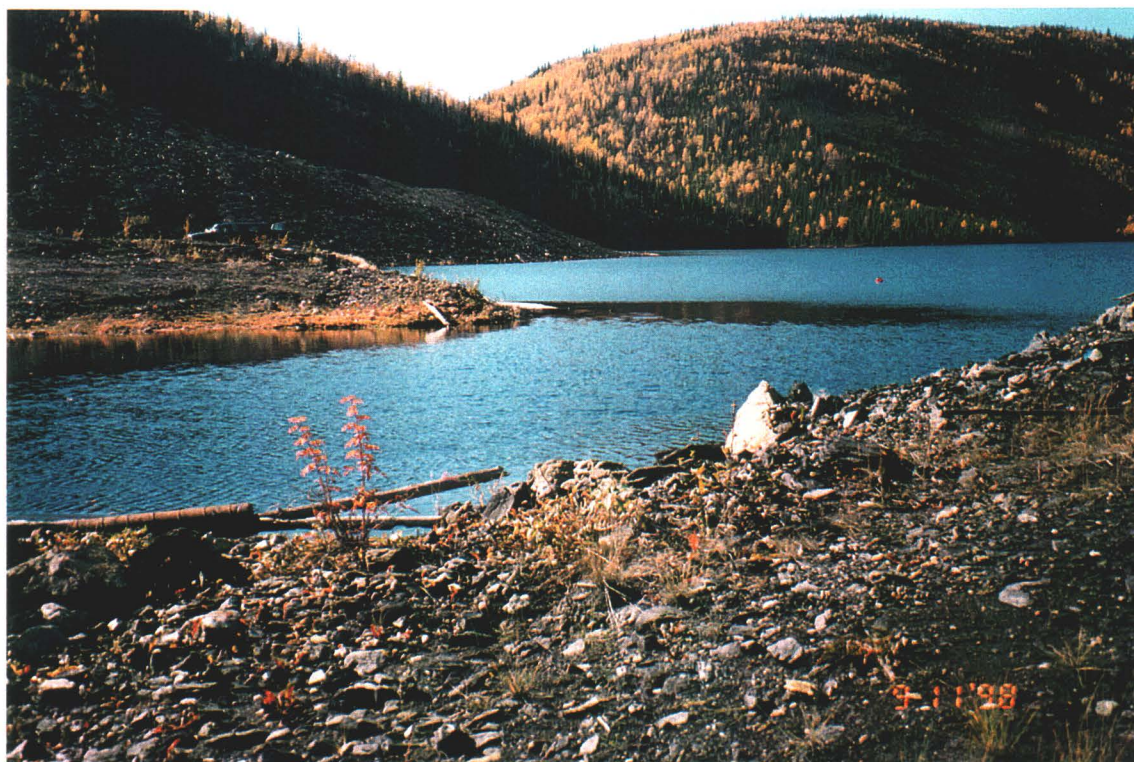
Photograph 2-6: Hudgeon Lake looking west from the northeastern shore, near the outlet into Clinton Creek

The largest dump, Clinton dump, was created by dumping overburden from the Porcupine pit near the crest of the south slope of Clinton Creek. Shortly after dumping commenced the face of the dump failed and the toe of the waste rock pile spread northward onto the Clinton Creek valley bottom. As the toe of the dump reached the valley floor it began to spread on the permafrost alluvial soil of the valley floor. Subsequent downslope movement of waste rock resulted in the blockage of Clinton Creek and the creation of Hudgeon Lake in 1974 (Photograph 2-6).

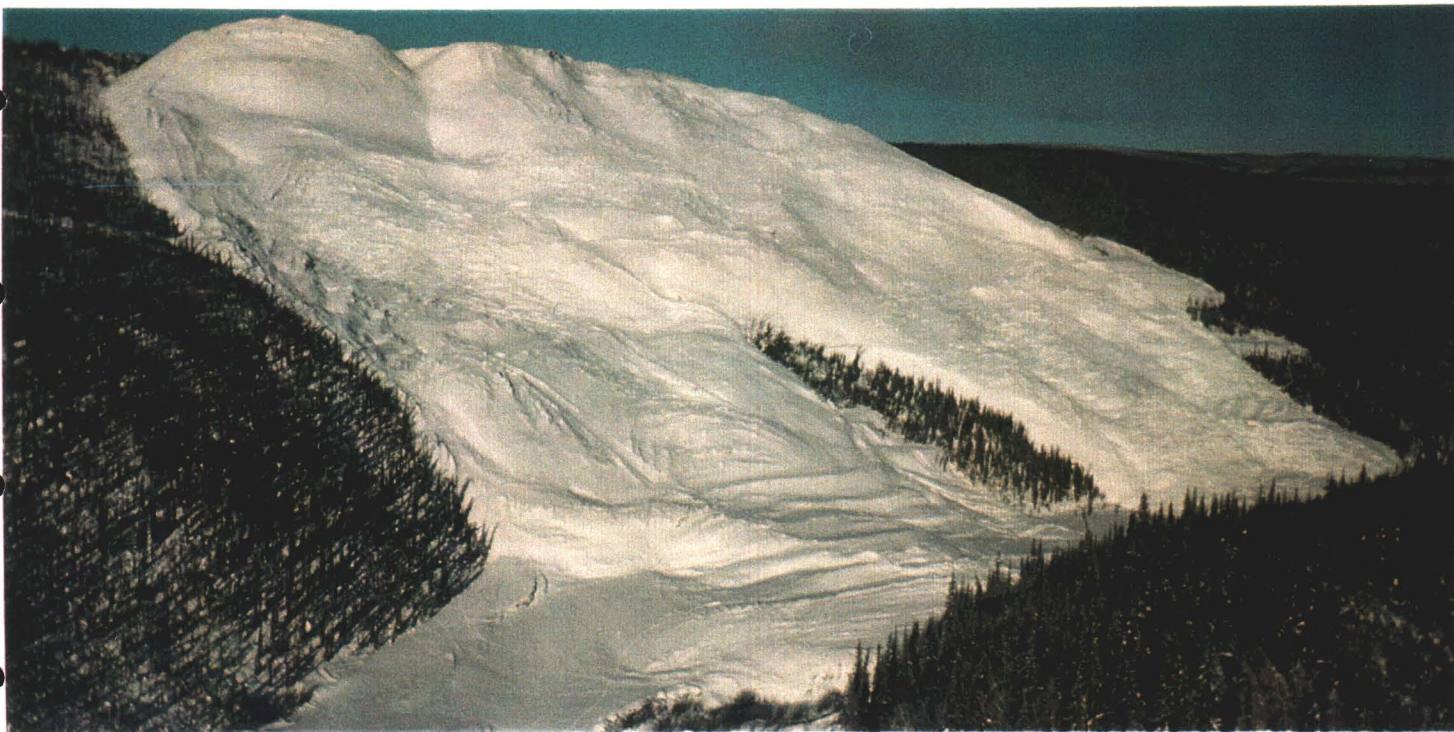
Photograph 2-7: South and North lobes of tailings in Winter 1999 (Photograph courtesy of P. Roach, DIAND)

The mill produced approximately one million tonnes of long fiber chrysotile asbestos and almost 12 million tonnes of tailings (Stepanek and McAlpine, 1992). The mill tailings are predominantly composed of serpentine and asbestos fibers. The mill tailings were deposited with a conveyor stacker near the mill on the open west slope of Wolverine Creek valley. The original tailings deposit is known as the south lobe. The south lobe failed in 1974 and a second tailings deposit, the north lobe, was used until the mill was decommissioned in 1976 (Photograph 2-7).

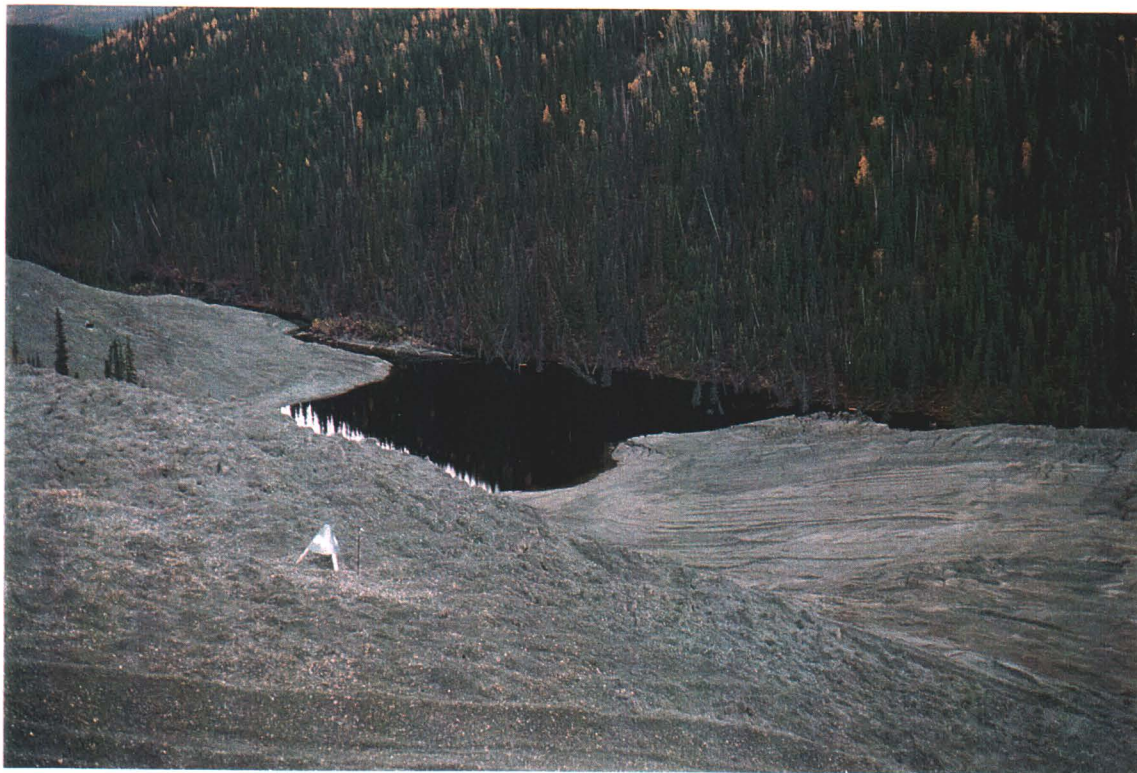
Photograph 2-8: Toe of the tailings piles showing the blockage of Wolverine Creek resulting in the formation of two ponds

When the south lobe of the mill tailing pile failed it ran down the slope of Wolverine Creek valley and caused the blockage of Wolverine Creek. This blockage resulted in the creation of an unnamed lake. The initial valley blockage was breached almost immediately, and tailings were dispersed approximately 2 km downstream (Stepanek and McAlpine, 1992). Cassiar constructed a rock-lined outfall channel and weirs in 1978 to mitigate impacts and convey Wolverine Creek over the south lobe. At the time of mill closure Wolverine creek was eroding the south lobe tailings pile and resulting in downstream sedimentation of Wolverine and Clinton Creeks (Golder, 1978). The north lobe was moving downslope at a rate of approximately 23 m/yr (Golder, 1978).

Progressive failure of the north lobe began in 1978 and in 1985 the north lobe mass reached Wolverine Creek (Photograph 2-8). Both lobes were terraced in 1978 in expectation that stabilization would be achieved by 1987. Movements in both lobes have

been monitored since 1978. Mass movement of the tailings piles continues at rates as high as 19 m/yr (Roach, 1998). Wolverine creek continues to erode both the tailings piles and the east side of Wolverine Creek valley.

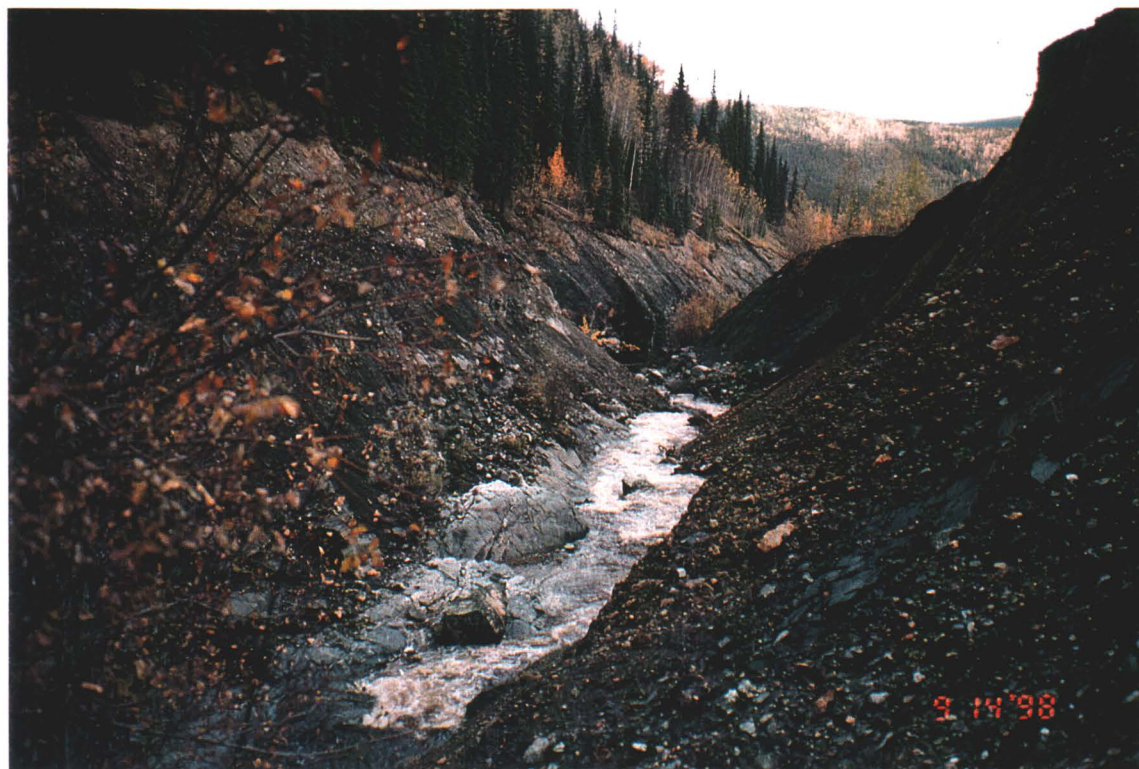
Photograph 4.1: Canyon area of Zone 1 in Clinton Creek below Hudgeon Lake showing steep scree slopes, exposed bedrock and swift currents downstream

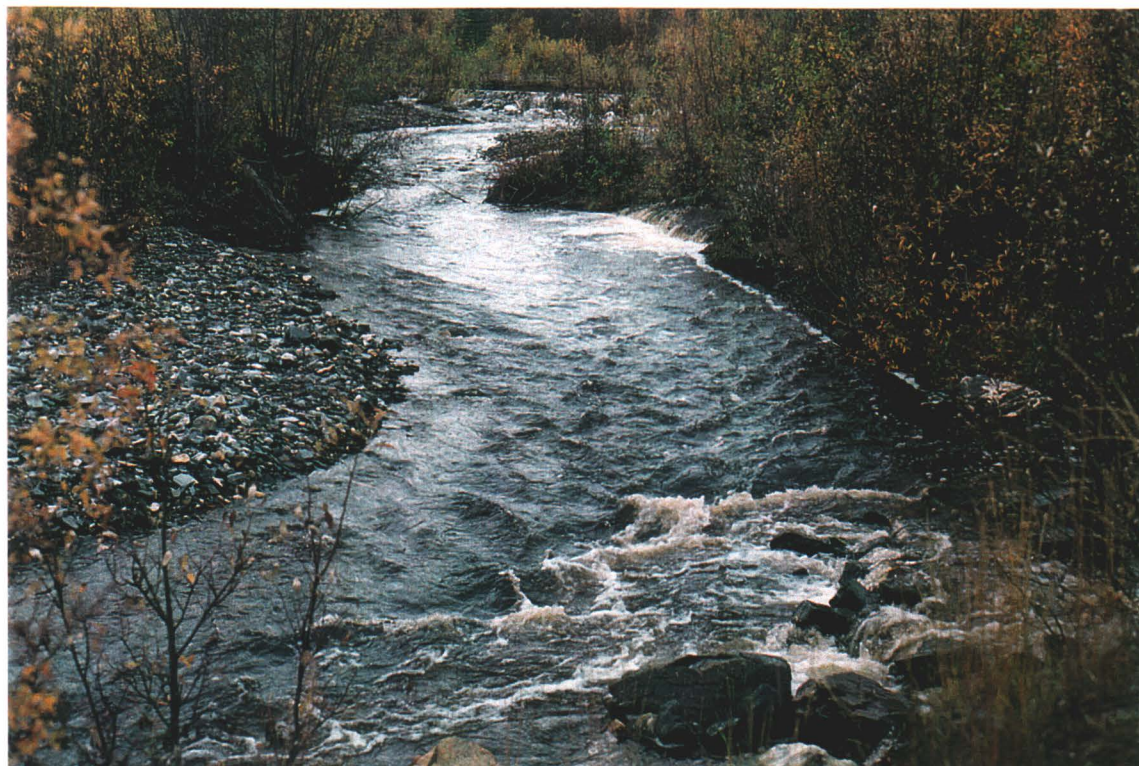
Photograph 4.2: Zone 2 of Clinton Creek looking upstream towards beaver dam in background, side flooding channel on the right and Wolverine Creek confluence in lower right corner.

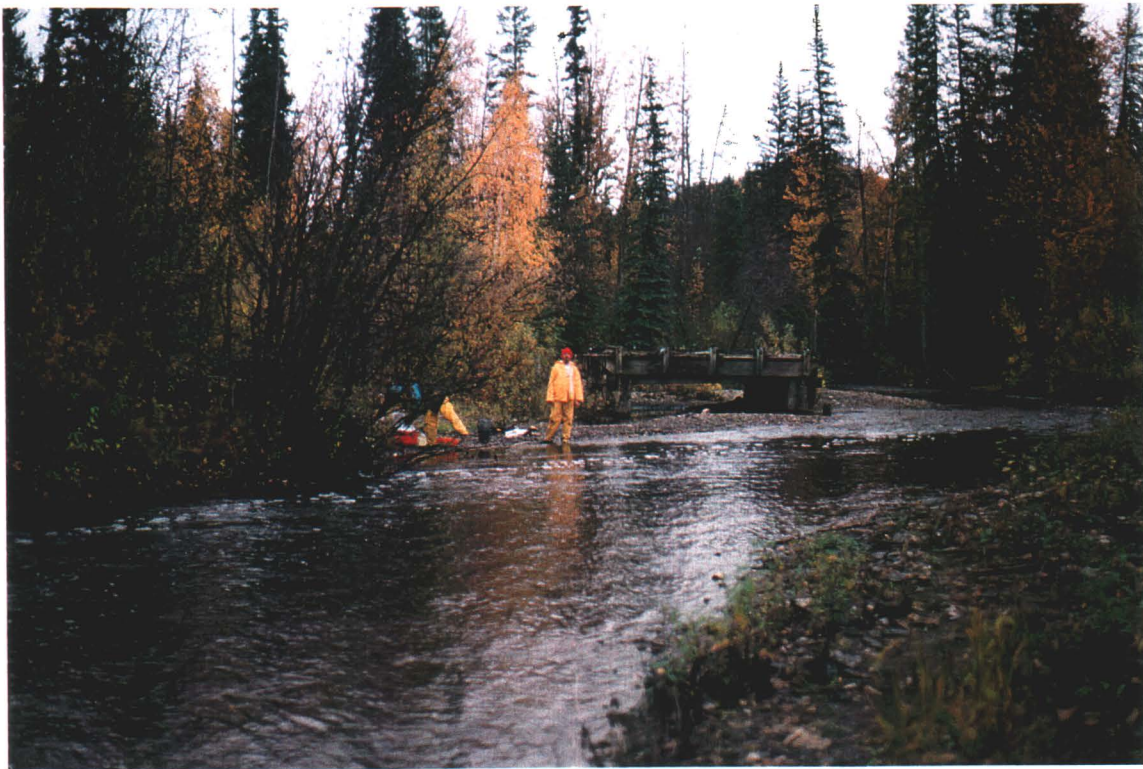
Photograph 4.3: Zone 6 looking downstream towards remnants of bridge and ford crossing to town site.

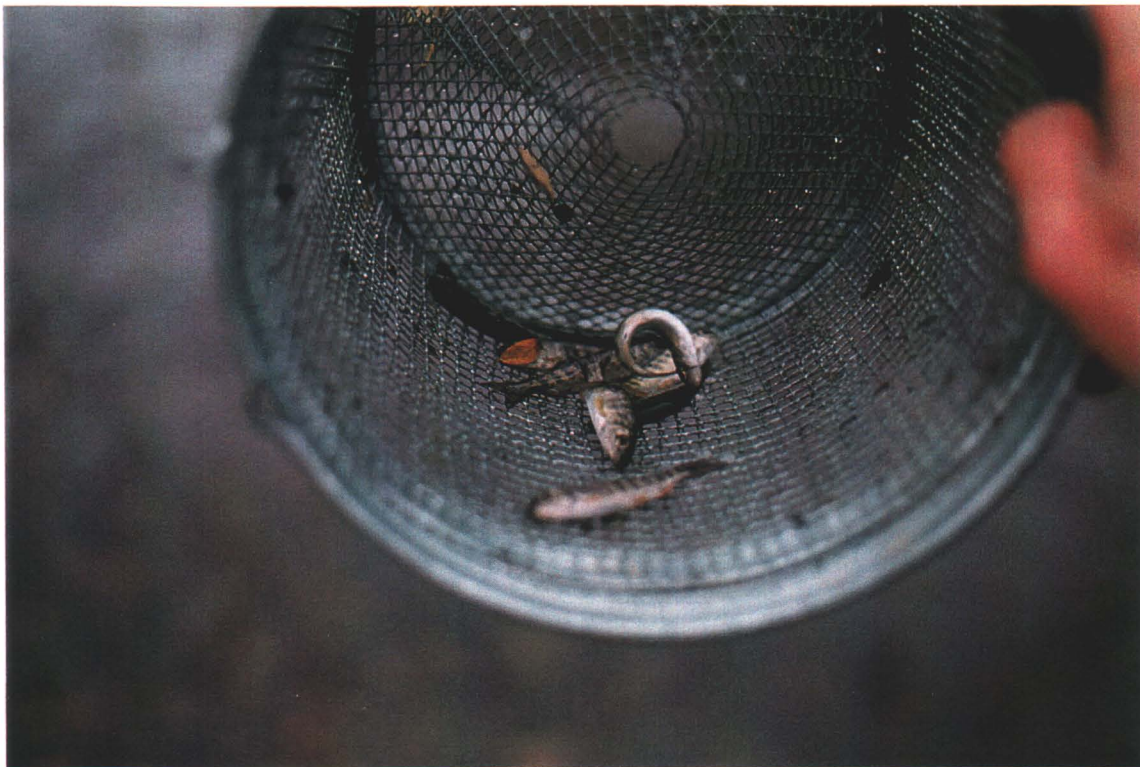
Photograph 4.4: Chinook salmon fry (0+ year class) captured in minnow trap from Zone 6.

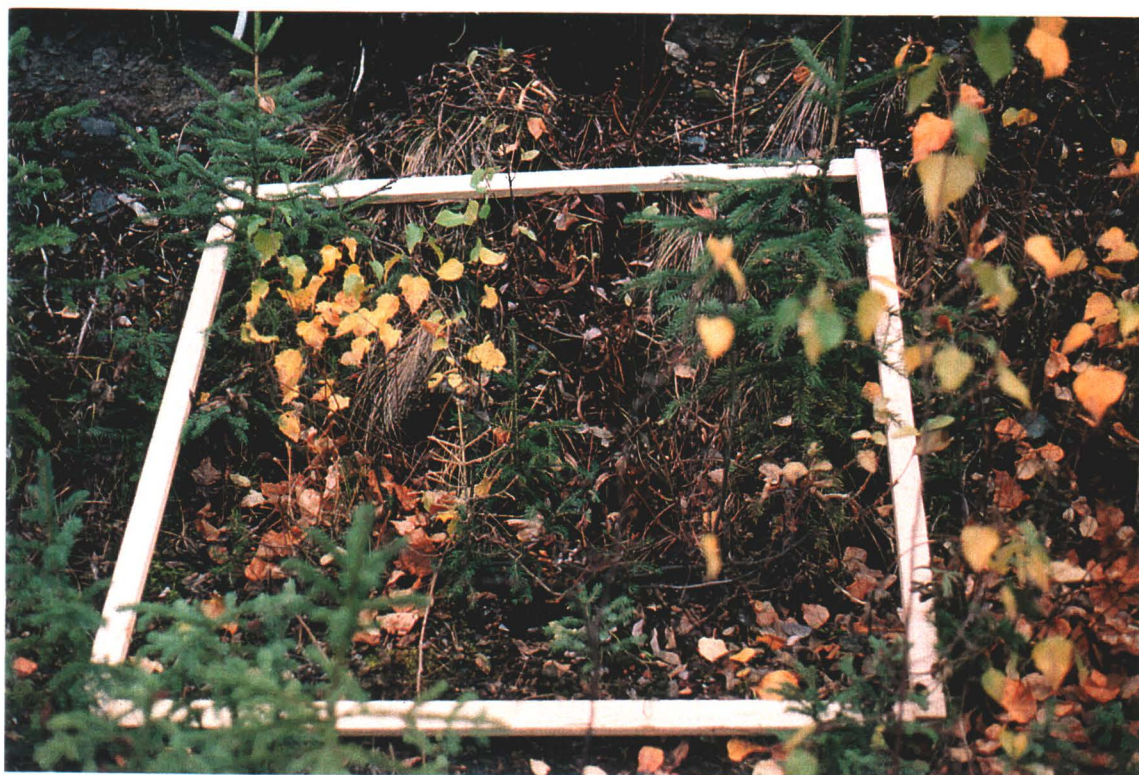
Photograph 4.5: Survey quadrat at a reference location, CLMS-13, showing naturally occurring groundcover in surrounding spruce forests.

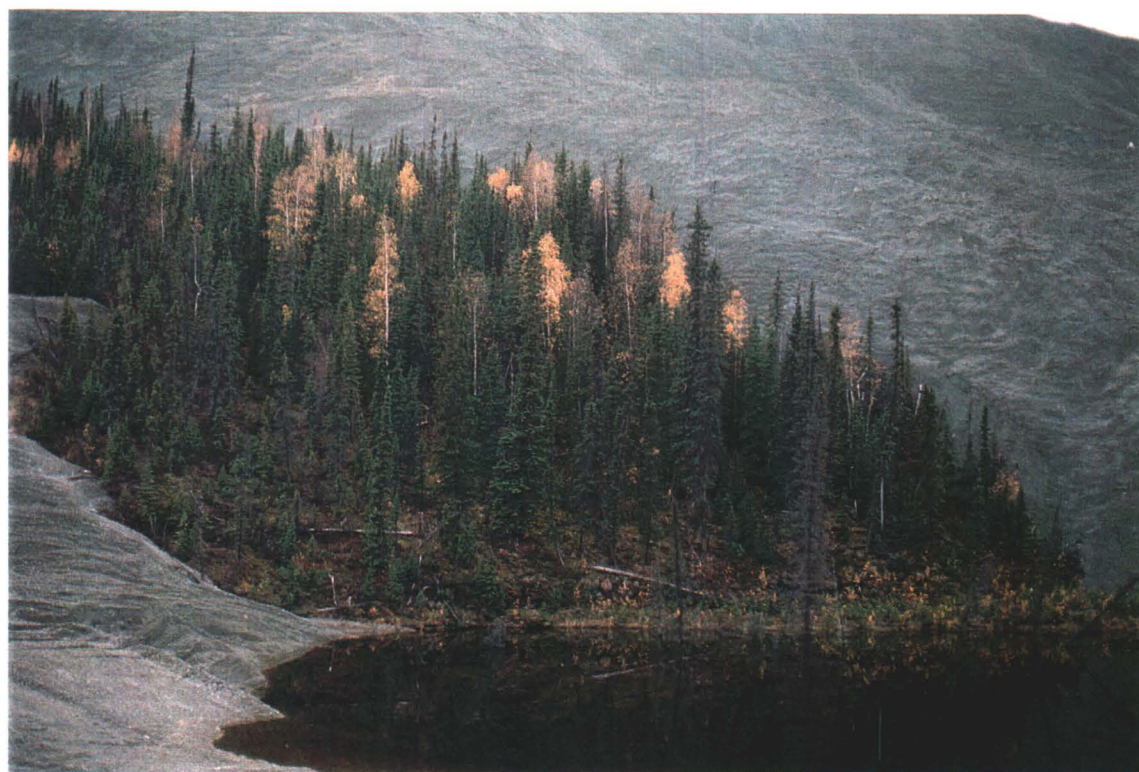
Photograph 4.6: Relic forest patch along east slope of tailings pile by Wolverine Creek.

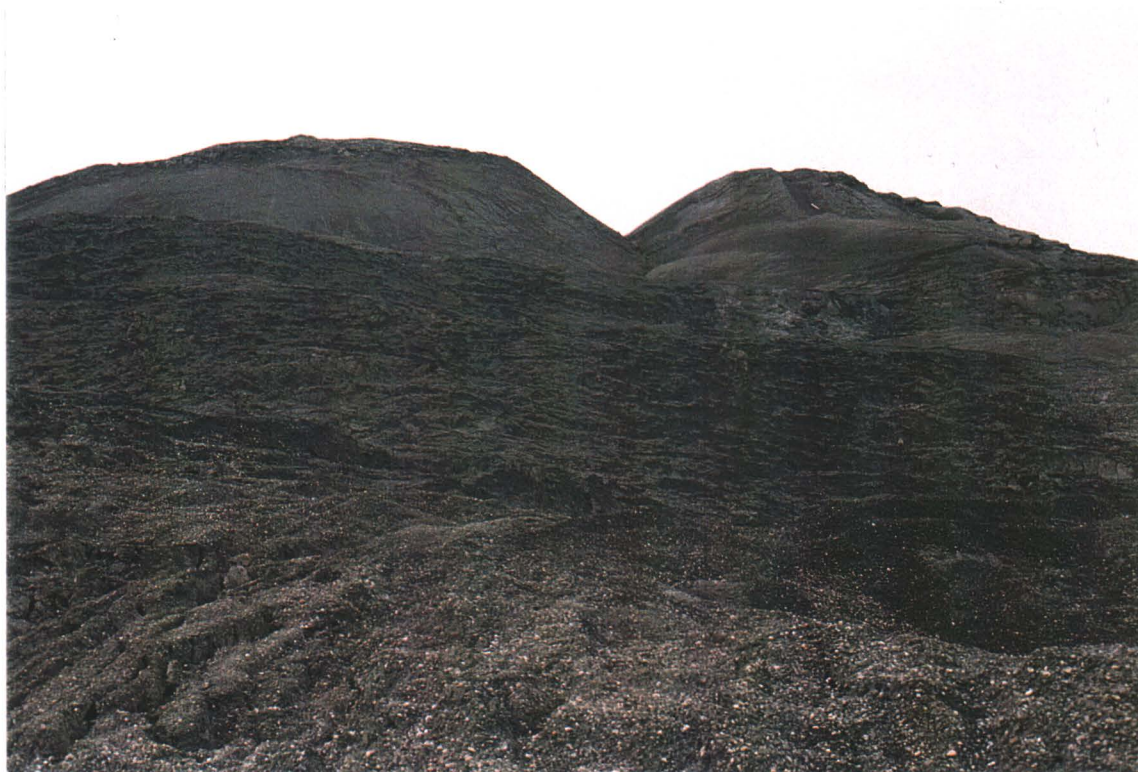
Photograph 4.7: Southeast slope of tailings pile from Wolverine Creek showing barren surfaces absent of any groundcover.

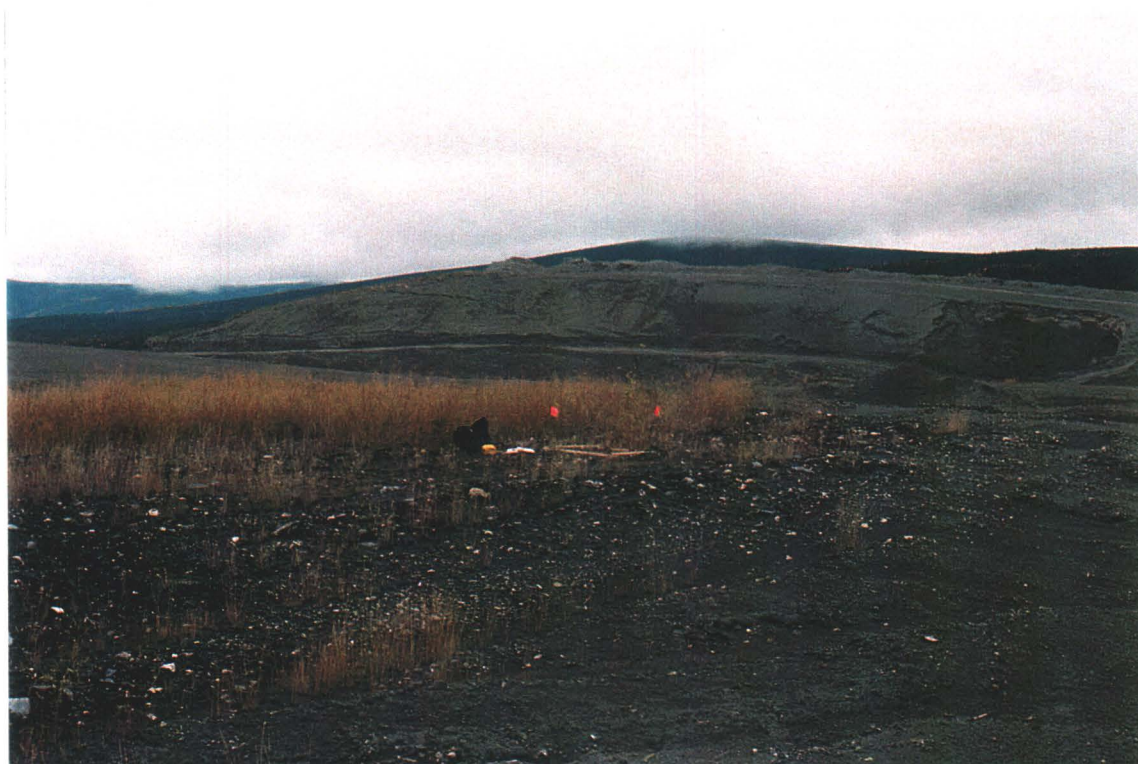
Photograph 4.8: Isolated patch of scrub vegetation at top of tailings pile between north and south peaks; the latter can be seen in the background.

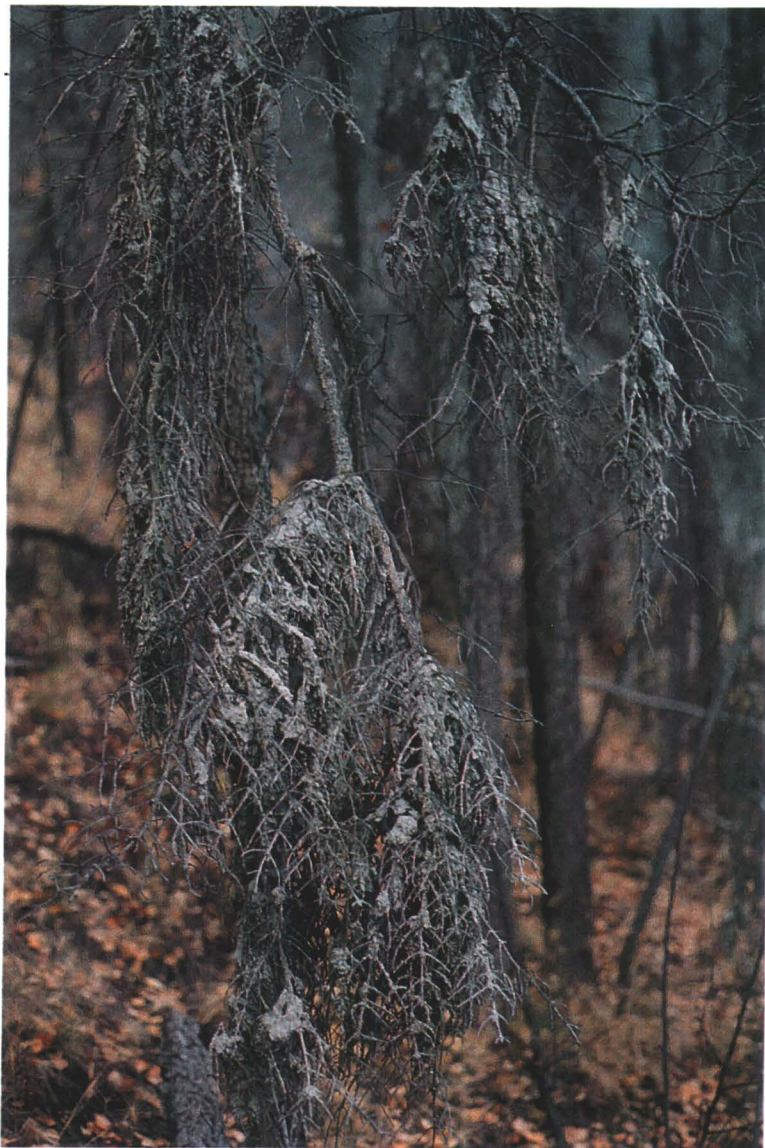
Photograph 4.9: Indirect smothering of tree leaf surfaces from wind and snow blown tailing materials along forest edge to the south of the site.

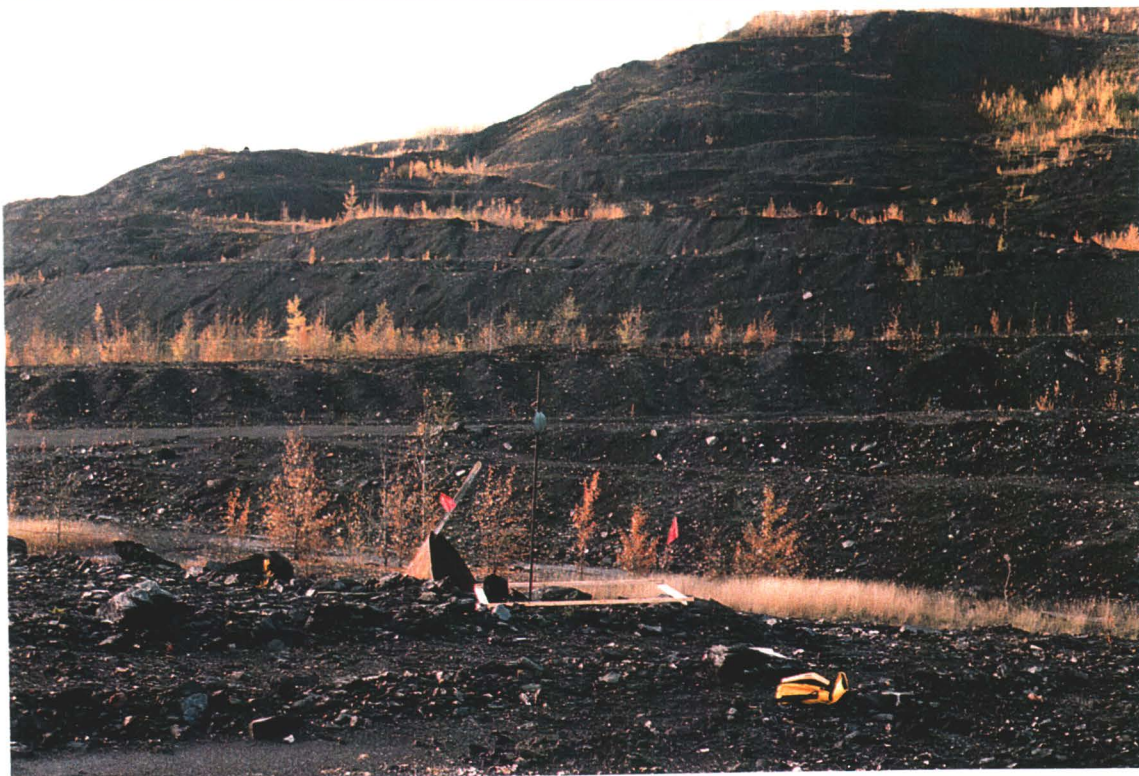
Photograph 4.10: Establishment of trees (primarily willow, birch and balsam poplar) between roadways on the Clinton Waste Rock Dump.

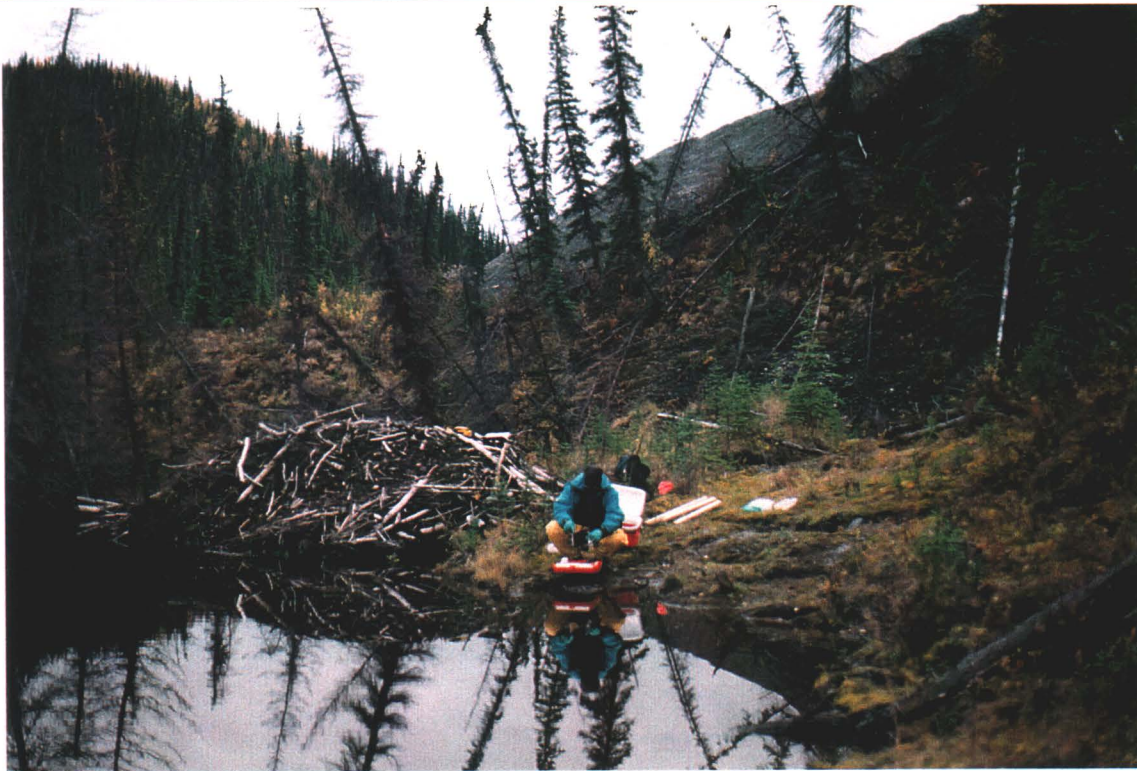
Photograph 4.11: Active beaver lodge along shoreline in widening area of Wolverine Creek; the north lobe of the tailings pile can be seen in the background to the south.

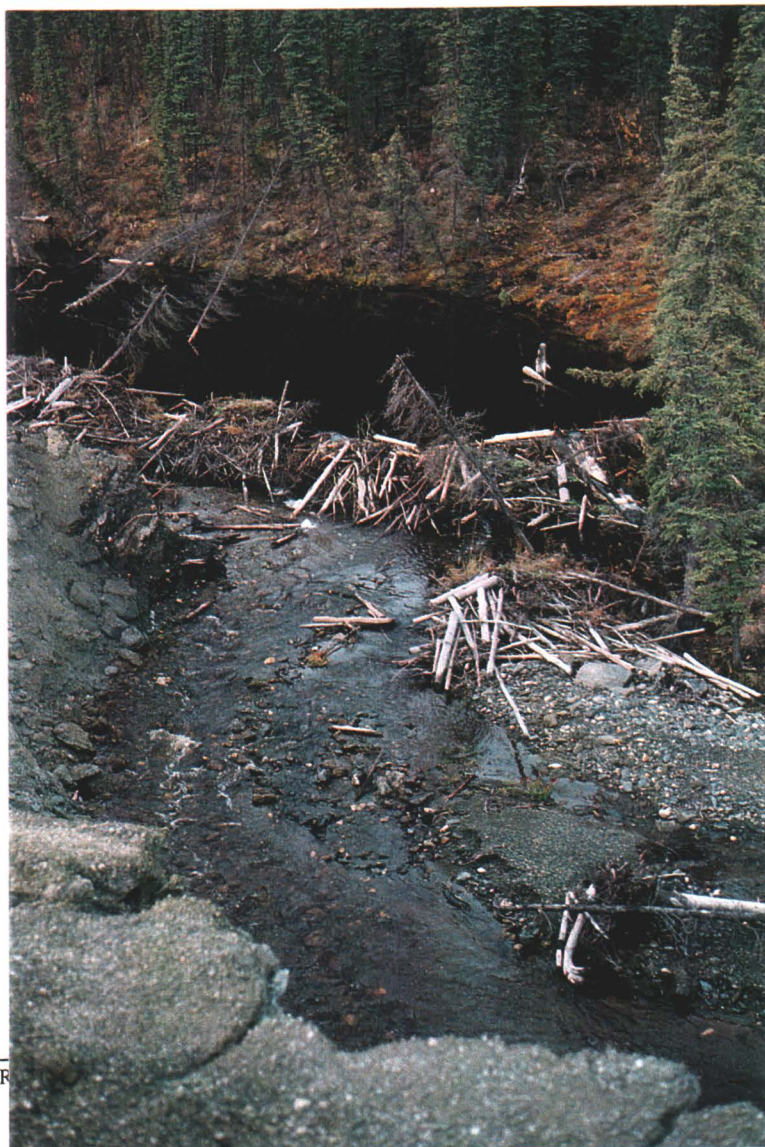
Photograph 4.12: Beaver dam in contact with edge of tailings pile at the south outlet of Wolverine Creek near WC-2/3.

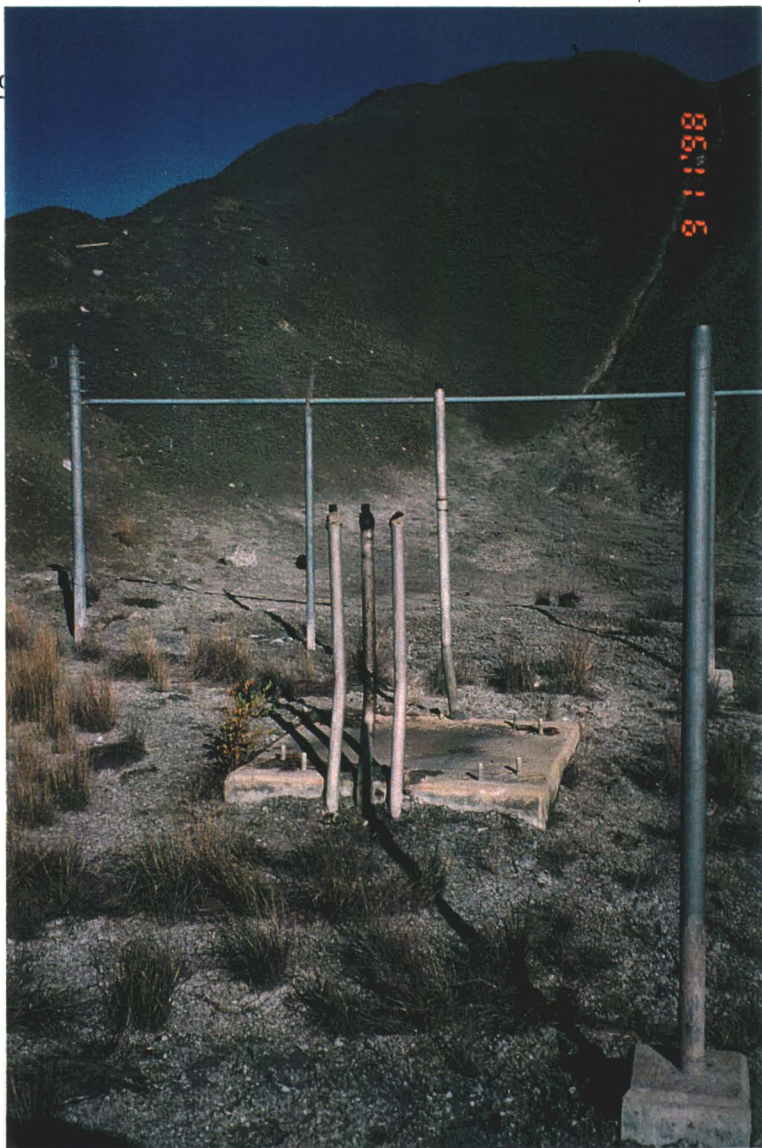
Photograph 4-13:  
Concrete foundations and  
remnants of fence with on  
the southern edge of Mill  
site. Note tailings and  
crushed rocks in the  
vicinity

One sample (CLMS-14) collected from the south side of concrete foundation on the southern edge of Mill site near three standpipes (Photograph 4-13) was analyzed for PCBs as Aroclors. The foundation was thought to originally house large electrical transformers. The sample was obtained from the base of the middle standpipe that contained an oily residue to ascertain if any PCB containing fluids had been spilled in the area. The concentration of PCBs in this sample was below detection ( $<0.5$  mg/kg).

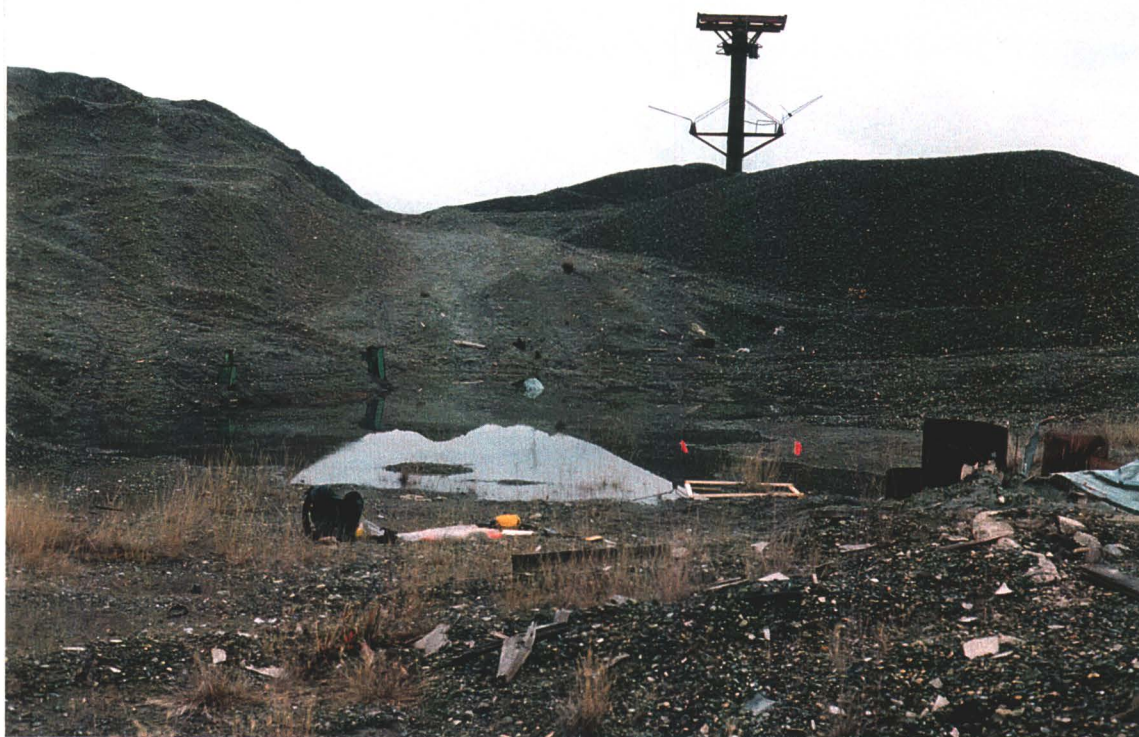
Photograph 4.14: Pool in  
a low-lying area at the  
Mill Site. Note crushed  
rocks and debris in the  
area.
