Indian and Northern Affairs  
Canada

ABANDONED CLINTON  
CREEK  
ASBESTOS MINE

CONCEPTUAL DESIGN  
REPORT  
NOVEMBER, 2000

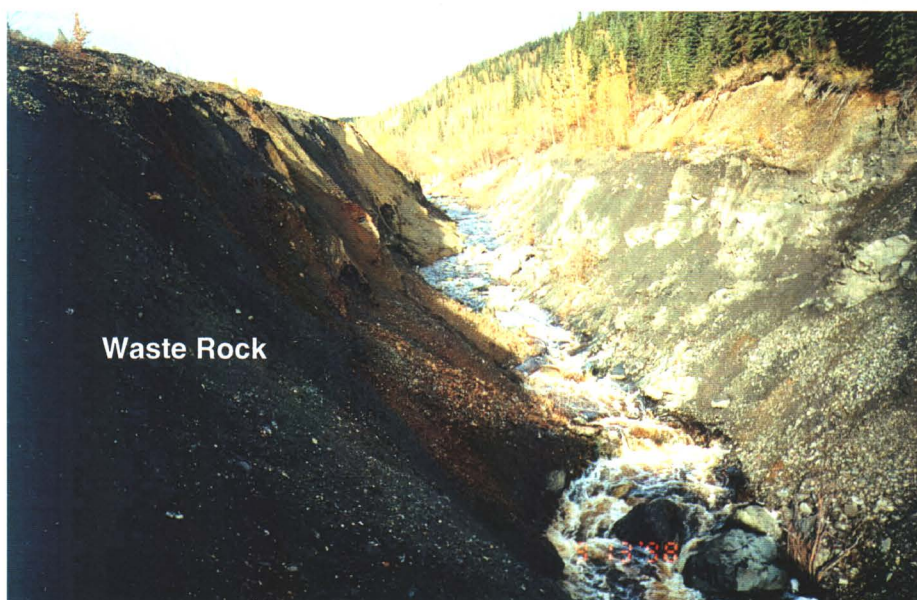
***Clinton Creek Channel Over Waste Rock Dump (view upstream)***

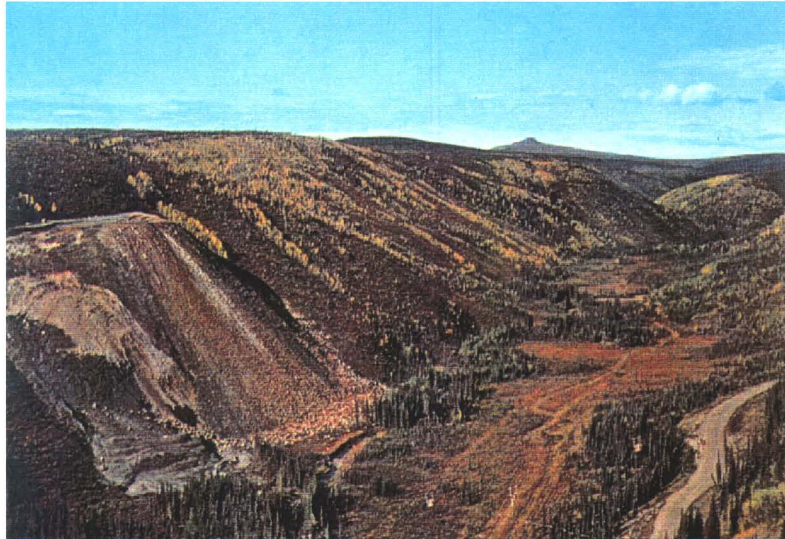
***Waste Rock Dump in About 1970 (View Upstream)***

Evidence of slumping at the toe of the waste rock dump seen in the 1970 aerial photograph (page 3) was likely the first sign of the impending problem. At this time (1970) there was no water impounded i.e. the time before the formation of Hudgeon Lake. Assuming permafrost existed at shallow depths there may have been zones of varying strength within the waste rock and foundation soils at the time of the failure as follows:

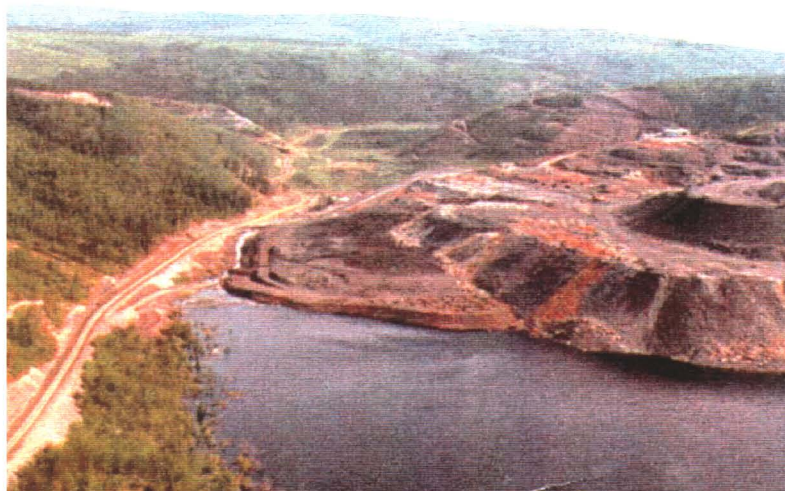
***Waste Rock Dump in 1974 (View Downstream)***

A significant slope failure of the waste rock dump into the Clinton Creek valley occurred in 1974 and the resulting landslide dam blocked natural drainage through the valley creating a 74 ha lake (Hudgeon Lake). A new creek channel was subsequently formed along the interface between the landslide material and north valley slope, some 25 metres above the original valley bottom at the Hudgeon Lake outlet. Within the area now occupied by the waste rock dump, the creek channel is approximately 700 m long with a gradient ranging from 3 to 5.5 percent compared to its natural gradient of approximately 0.075 percent.

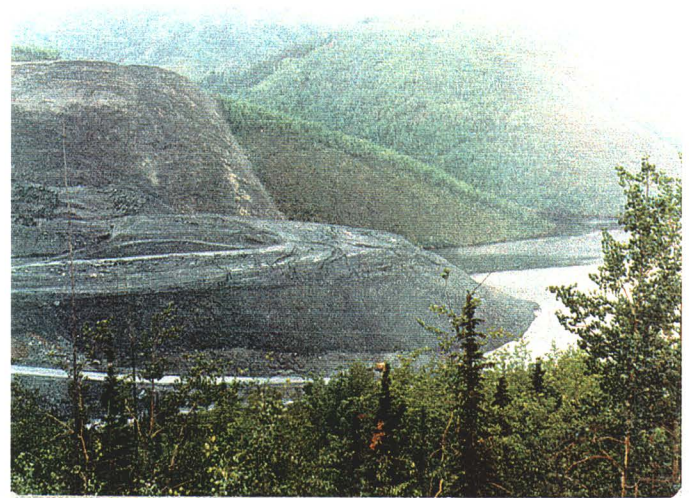
**Waste Rock Dump in 1976**

*Note North South Orientation of Cracks (above left)*

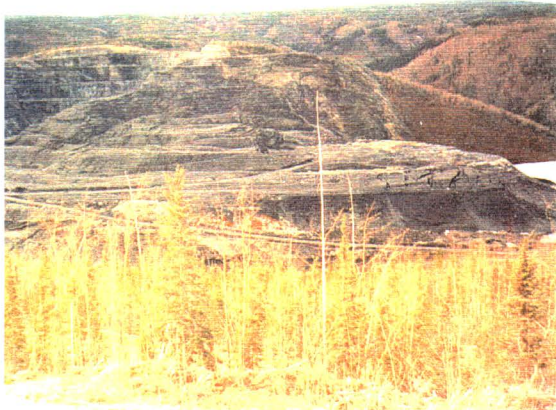
**Waste Rock Dump (1977).**  
**Note Cracks in Upper and Lower Portions**

- “We understand that as creep was taking place, there was no sudden or deep seated movements of material”. “Cracks up to 3 feet and 10 feet deep were observed in the upper portion of the dump. The cracks were oriented east west i.e. parallel to the dump surface and original ground surface contours. In the lower part of the dump, the cracks were oriented north south indicating grabben development. In some areas near the crest of local slopes in the lower part of the dump, cracks have developed parallel to the crests of these slopes” (Golder 1977, V76083, pg1).

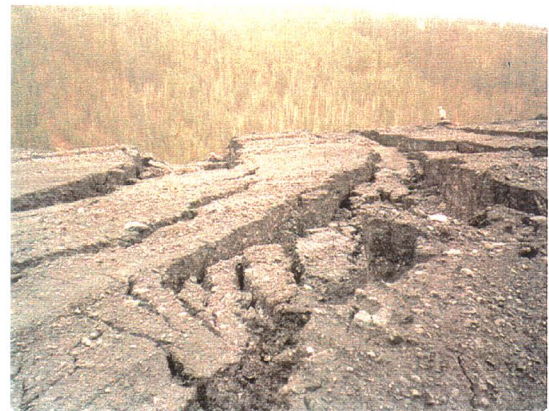
**Cracks Near Crest (Mon #7 on Right)**

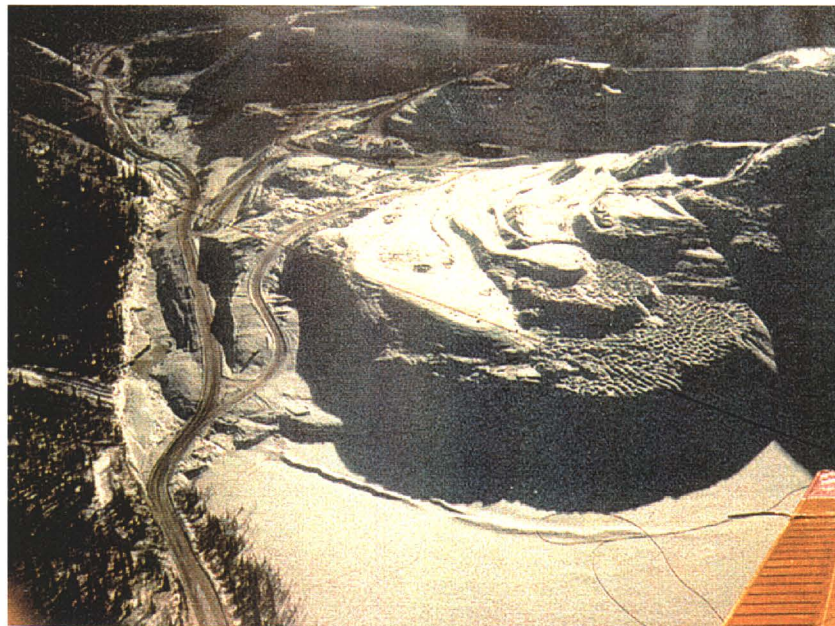
***Pressure Ridge on Hudgeon Lake Ice Surface (March, 1978)***

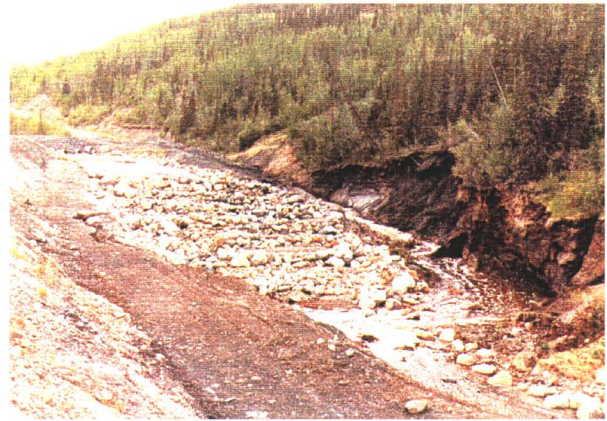
**Channel bypassing weirs (1982)**

- Remedial work to repair the channel where it had escaped the rock weirs was recommended in 1983 (Klohn 1984, pg2). The work, consisting of a rip rap plug with a geotextile lining at the upstream end of the erosion channel was initiated in November 1983 and completed in 1984. It was further recommended that the channel be widened at the upstream plug to allow for squeezing by future dump movements.

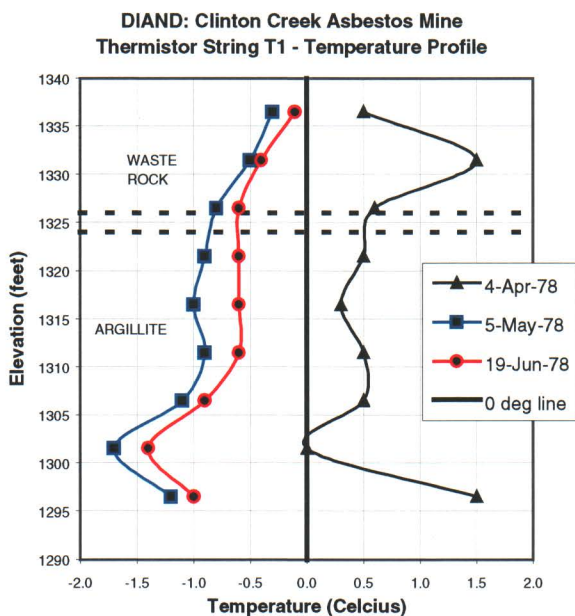
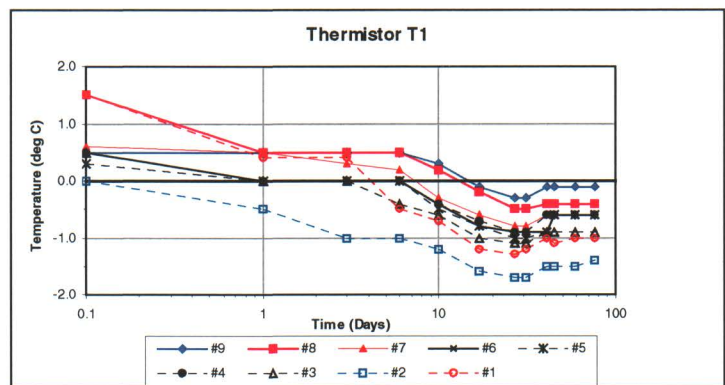
**Figures 3-1 and 3-2  
 Thermistor String T1**

Thermistors T1 & T2 are located on the southern edge of the dump (well away from the creek channel) as shown on Drawing 01. Points installed within the waste rock and foundation were below 0 degrees C indicating permafrost had advanced into the waste rock. Temperatures range from close to 0 degrees at the top of the string (within the waste rock) to  $-1$  to  $-1.5$  degrees in the foundation (argillite). Ice chips were noted on the test hole logs within the argillite for Thermistor T1 (BH1) and T2 (BH2).

- The waste rock serves as an insulator, which isolates the foundation from ambient temperatures. More importantly, groundwater seepage from Hudgeon Lake provides a continuous source of heat. As a result, the permafrost beneath the dump is melting. *This contradicts the monitoring results from Thermistors T1 and T2.*

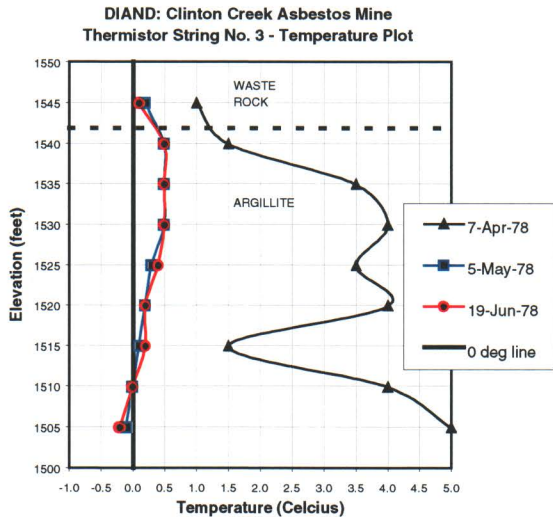
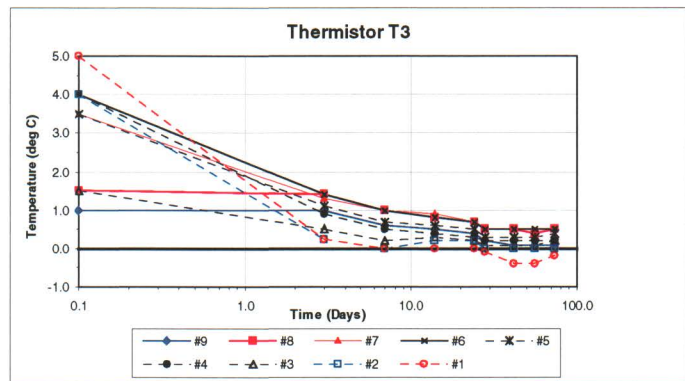
**Figures 3-5 and 3-6**  
**Thermistor String T3**

Thermistor T3 is located farther to the west but still some distance from the creek. The results indicate the ground temperatures are above 0 degrees (about +0.5 degrees) for a depth of 30 feet below the original ground surface. At the location of T3, the ground surface formed part of a north aspect and quite likely was underlain extensively by permafrost. It appears therefore that the permafrost may have degraded to a depth of 30 feet in this area of the waste rock dump. No ice chips were observed during installation of the Thermistor T3 (BH4).

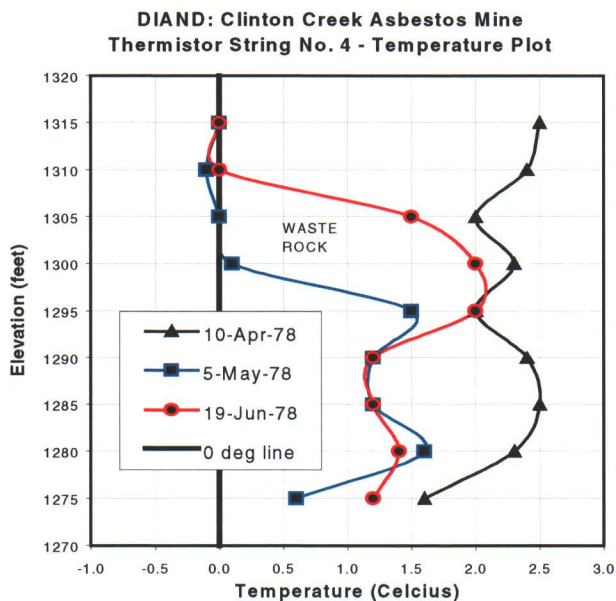
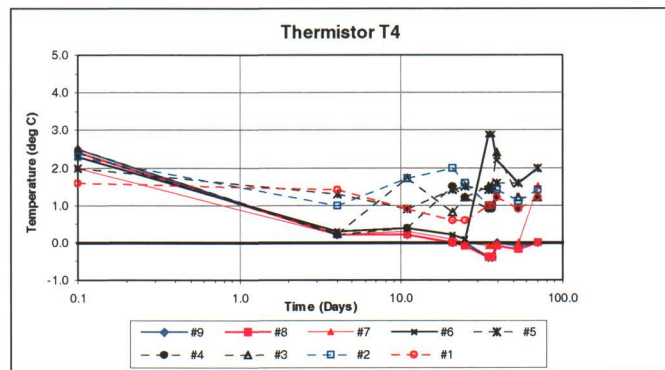
**Figures 3-7 and 3-8**  
**Thermistor String T4**

Thermistor T4 is located near the northern edge of the waste rock dump along the access road adjacent to Clinton Creek, approximately coincident with the original toe of the north valley slope. Unfortunately, the base of the waste rock dump was not reached with the borehole and sloughing prevented the installation of the string to the base of the hole. Golder Associates concluded that the measurements reflected the temperature of seepage water within the base region of the dump. Based on the temperature profile, it was speculated that the phreatic surface was at approximately elevation 396m (1300 ft).

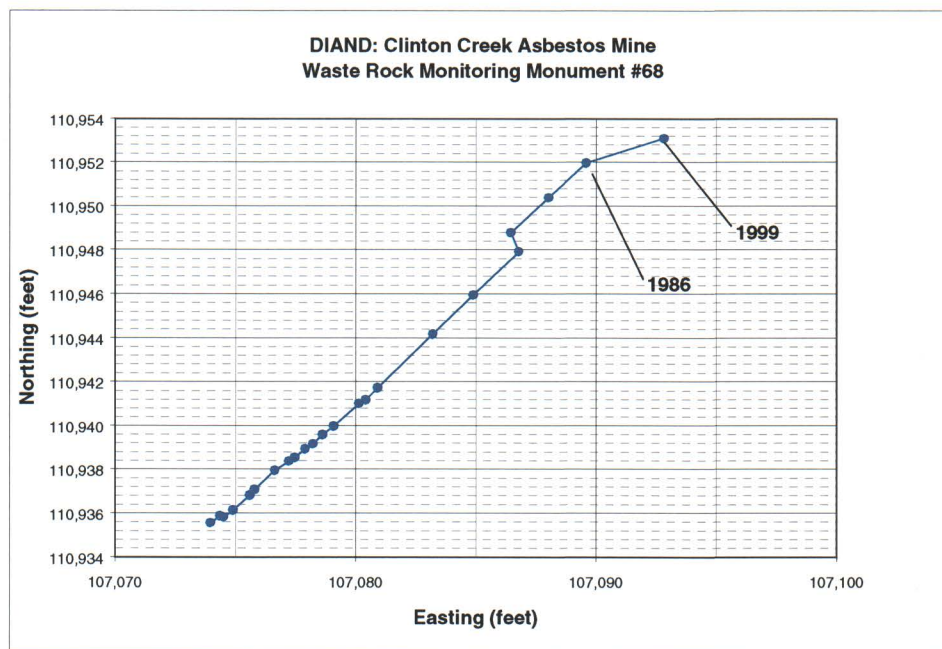
**Figure 4-1**  
**Target Coordinates**

Plots of movement data are illustrated in Figures 4-1 to 4-3 using Movement Monitor #68 as an example. Movement vectors are generally consistent throughout the observation period i.e. the direction of movement is consistent (Figure 4-1). Current (1999) horizontal movement rates appear to have reduced significantly from those observed prior to 1986 (Figure 4-2). Over the same period, however, settlement rates have remained about the same, currently at a magnitude about double that of the horizontal movement (Figure 4-3). It therefore appears that while the horizontal movement has slowed down considerably or may have ceased, settlement of the waste rock is continuing at a more or less constant rate.

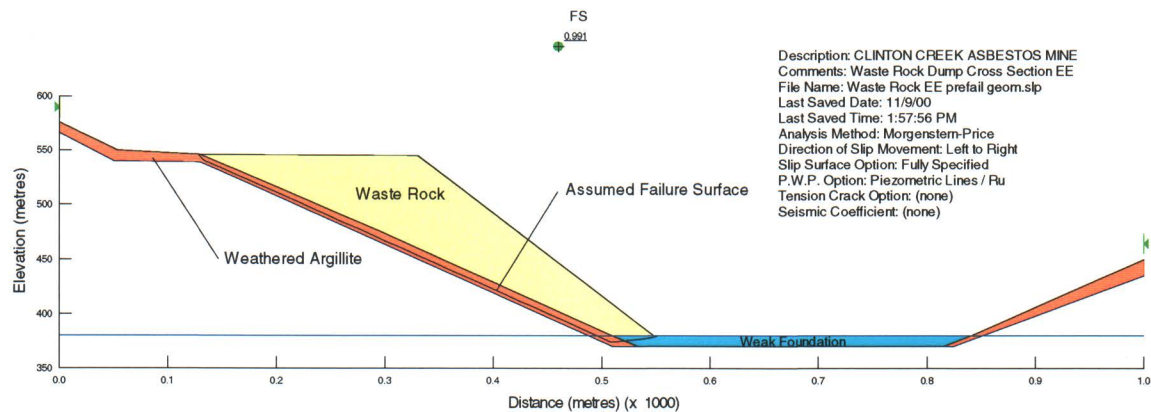
**Figure 5-1**  
**SECTION E – Initial Failure**

The failure surface was assumed to be within a weak layer of the weathered argillite at a shallow depth in the foundation soil across the valley floor. The resisting forces in the rock fill were excluded in the analysis by forcing the failure through the weathered argillite. The piezometric level within the weak foundation soil is assumed to be coincident with the top of the original creek bank (valley floor). Sensitivity analyses were then carried out to determine the influence of pore water pressures and friction angles for the argillite. A friction angle in the weathered argillite of 33.5 degrees (close to the

direct shear testing results) was then selected to determine the porewater pressures necessary to achieve a FS of 1.0, as illustrated in Figures 5-1 and 5-2.

The resistance to sliding within the frozen foundation soil at the toe of the dump and along the valley slope would be expected to decrease if the drainage of water from the thawing permafrost affected soil is restricted. To investigate the parameters necessary to cause an initial foundation failure of the waste rock, the pre-failure dump geometry was generated from historical surveys and photographs. Two representative cross sections (E and K) were chosen for the slope stability back analysis which assumes the factor of safety (FS) at the time of failure was unity (Drawing 02).

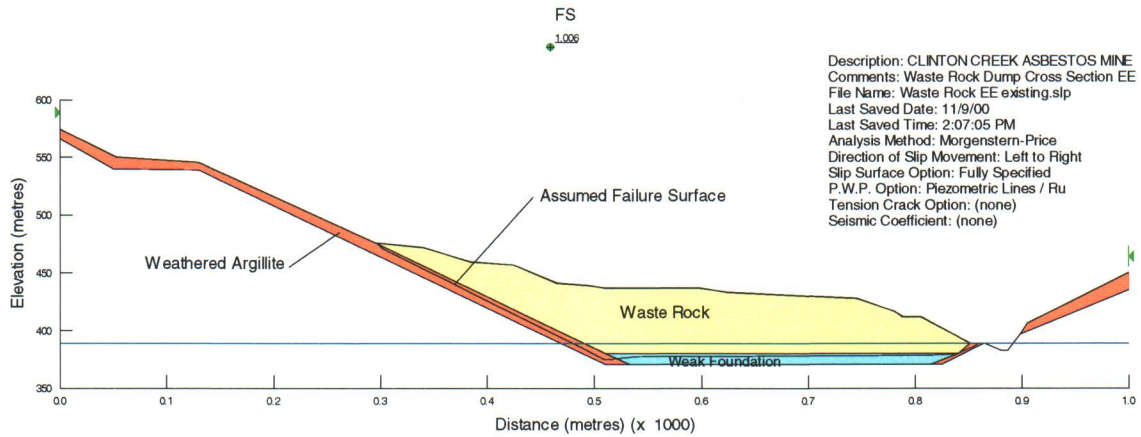
**Figure 5-3**  
**SECTION E – Existing Geometry**

A slope stability back analysis was carried out to determine approximate operating soil strengths and piezometric levels necessary to satisfy a FS of 1.0. The analysis assumes a residual friction angle for the waste rock of 23 degrees based on direct shear testing results. Combinations of strengths for the foundation and argillite were used under varying piezometric levels to determine combinations of parameters necessary to satisfy a FS of unity as illustrated in Figures 5-3 and 5-4.

The analysis indicated that a combination of very low shear strengths and high pore-water pressures in the foundation material are required to achieve a FS of unity. It can therefore be concluded that unique geological conditions, in particular a very weak foundation layer, are responsible for continued movement of the waste rock pile. Almost certainly, disturbance of the thermal regime, in particular thawing of the permafrost resulting from filling of the upstream reservoir (Hudgeon Lake) has been a contributing factor. Penetration of the thaw front will likely be downward below the lake and laterally (downstream) into the waste rock and foundation soil. Detailed knowledge of the thermal changes which occurred during mining and after mine closure, however, are not known and these changes may be continuing i.e. equilibrium may not have been reached. Given the limited site specific geological information, there is considerable uncertainty in the absolute values or combinations of values calculated from the back analysis. The model generated however, is considered sufficient to comment on and assess the relative improvement available through remedial options for the purposes of conceptual design.

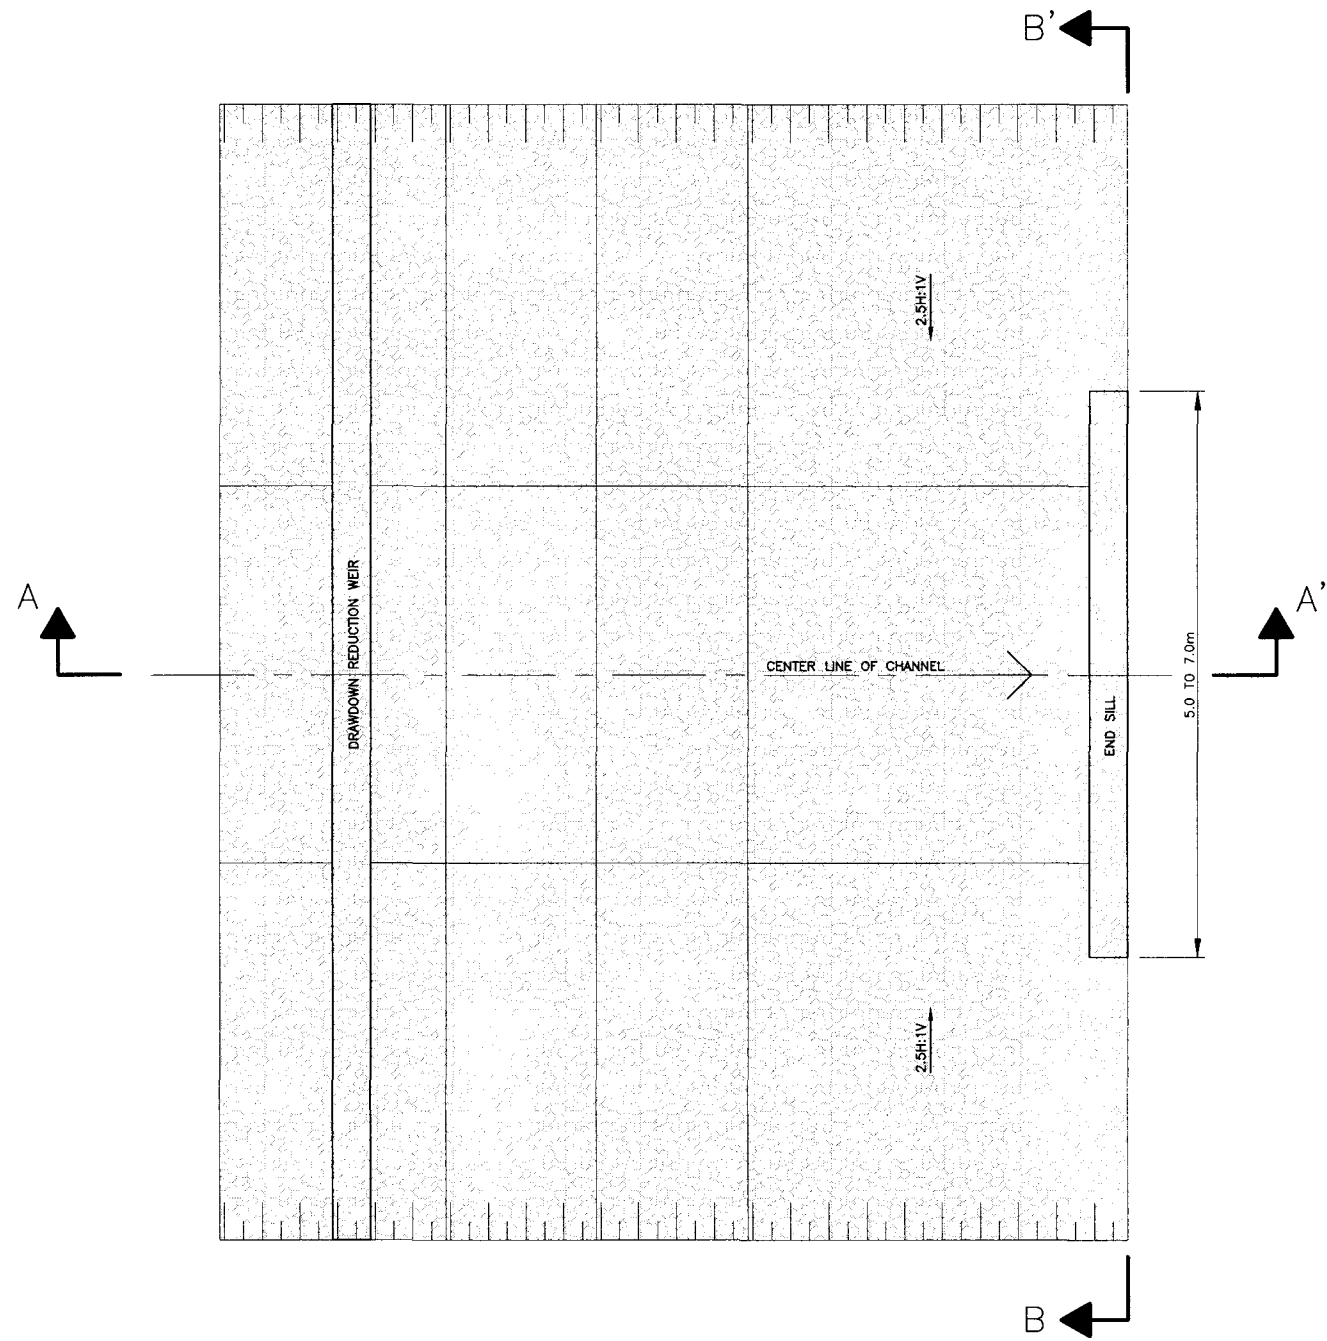
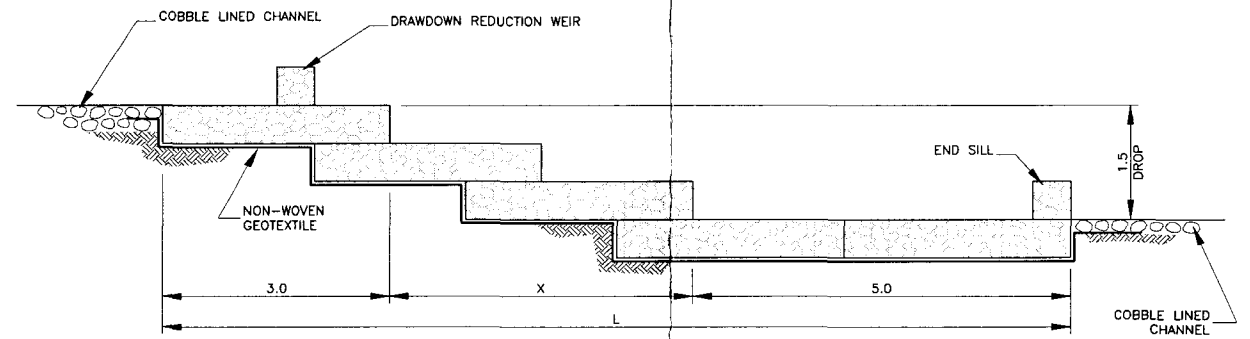
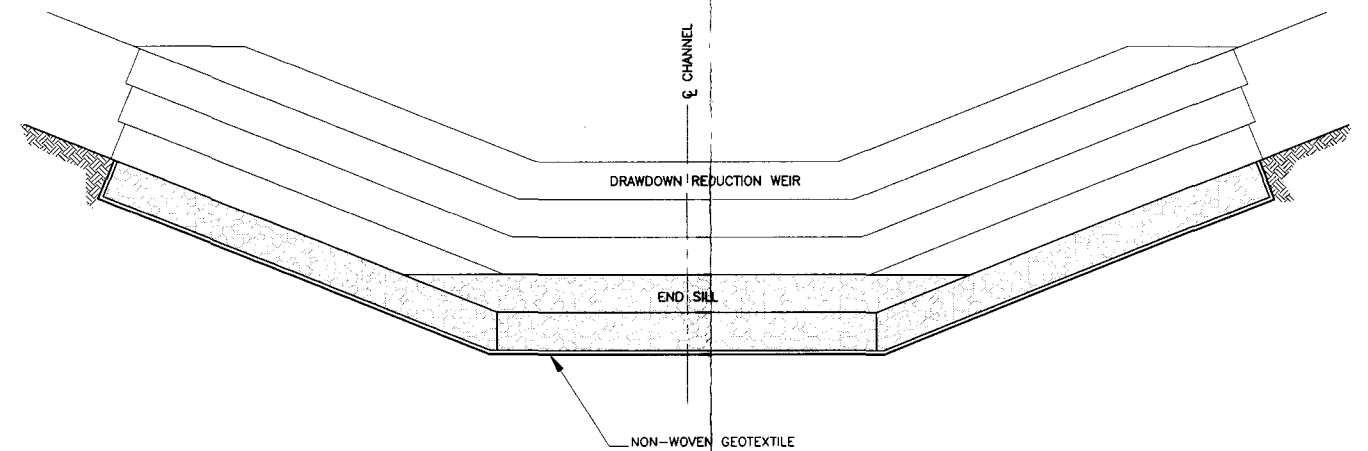
**INDIAN AND NORTHERN AFFAIRS CANADA**  
**ABANDONED CLINTON CREEK ASBESTOS MINE**  
**CONCEPTUAL STABILIZATION MEASURES**  
 PROPOSED GABION DROP STRUCTURE  
 04 -  
 DWG. No. REV.

NOTE:  $X = (\text{NUMBER OF } 0.5\text{m STEPS} - 1) \times 2\text{m}$   
 ie. FOR 3 STEPS (1.5m DROP)  $X = (3 - 1) \times 2 = 4\text{m}$   
 FOR 8 STEPS (4m DROP)  $X = (8 - 1) \times 2 = 14\text{m}$   
 $L = 12\text{m FOR } 1.5\text{m DROP}$   
 $L = 22\text{m FOR } 4.0\text{m DROP}$

As the weir and end sill are made of gabions, a part of the channel flow will pass through the gabions rather than over them. As a result, neither the weir nor the end sill will cause any significant ponding of water. In fact, during low flows, the water surface may be below the top of the gabions i.e. between the cobbles. Because there will be a small flow of water through the gabions most of the time, it is important that the gabions sit on a geotextile and gravel bedding layer to prevent the loss of fine grained material below the baskets. Some sand and gravel will be washed through the channel, in particular during spring runoff. The finer material will become trapped between the cobbles in the gabion baskets further stabilizing the structure.
