# PHASE I ENVIRONMENTAL SITE ASSESSMENT AND FIELD SAMPLING INVESTIGATION

## MILLION DOLLAR FALLS

PREPARED FOR:  
INDIAN AND NORTHERN AFFAIRS CANADA

APRIL 2000  
14048 (2 - 2ND ISSUE)

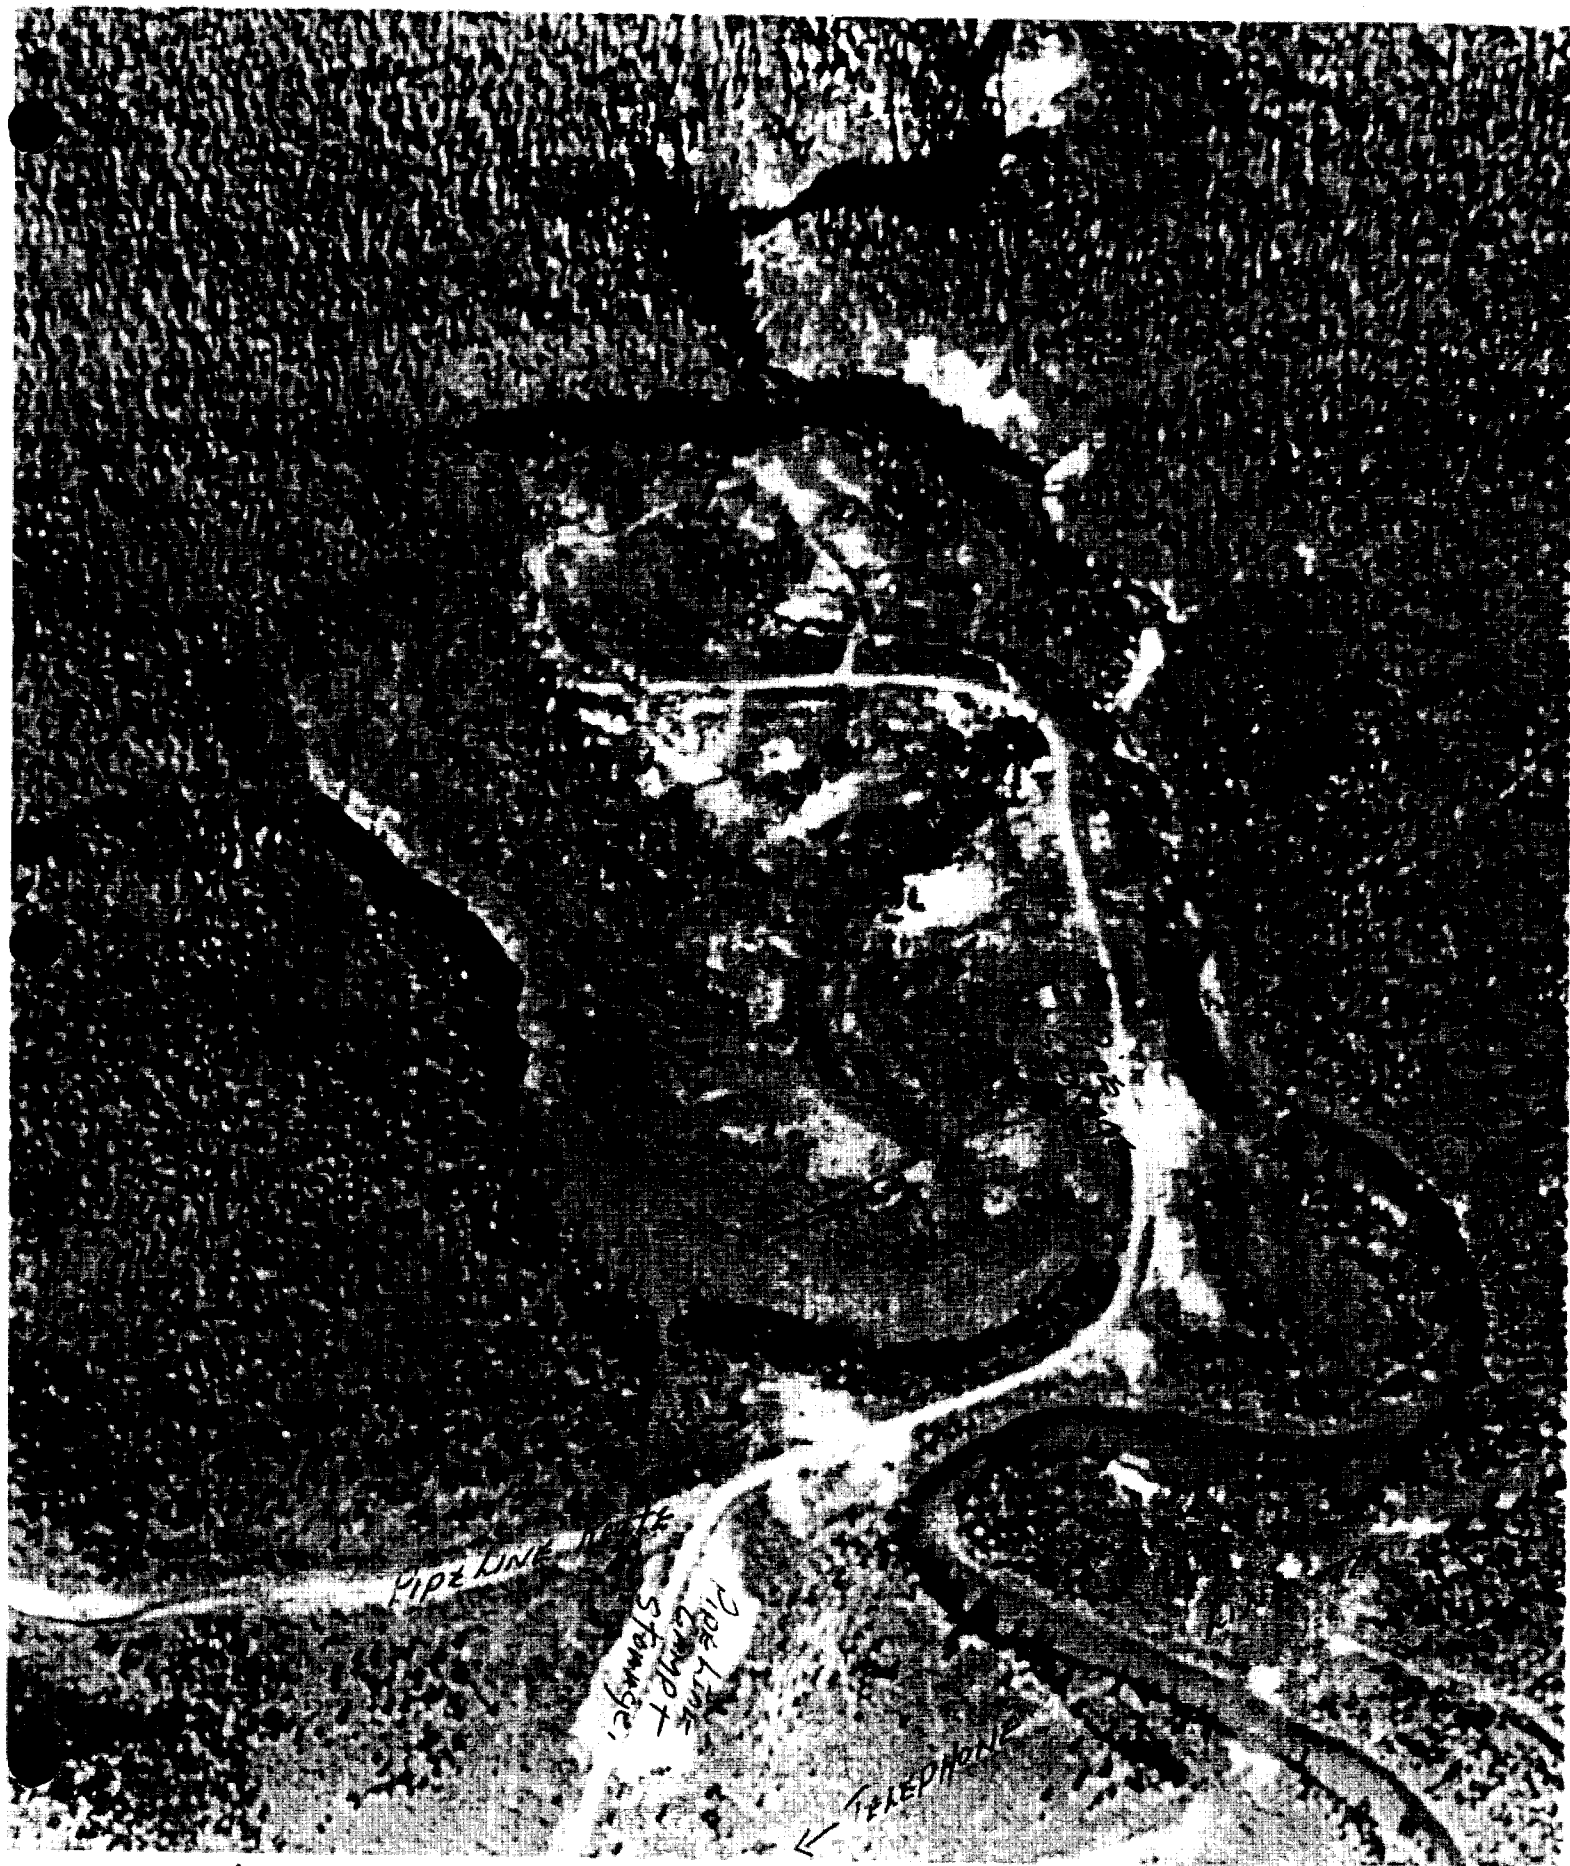
JULY 17, 1964

Annotations by Mr Chuck Hume, CAFN Band counsellor  
February 2000.

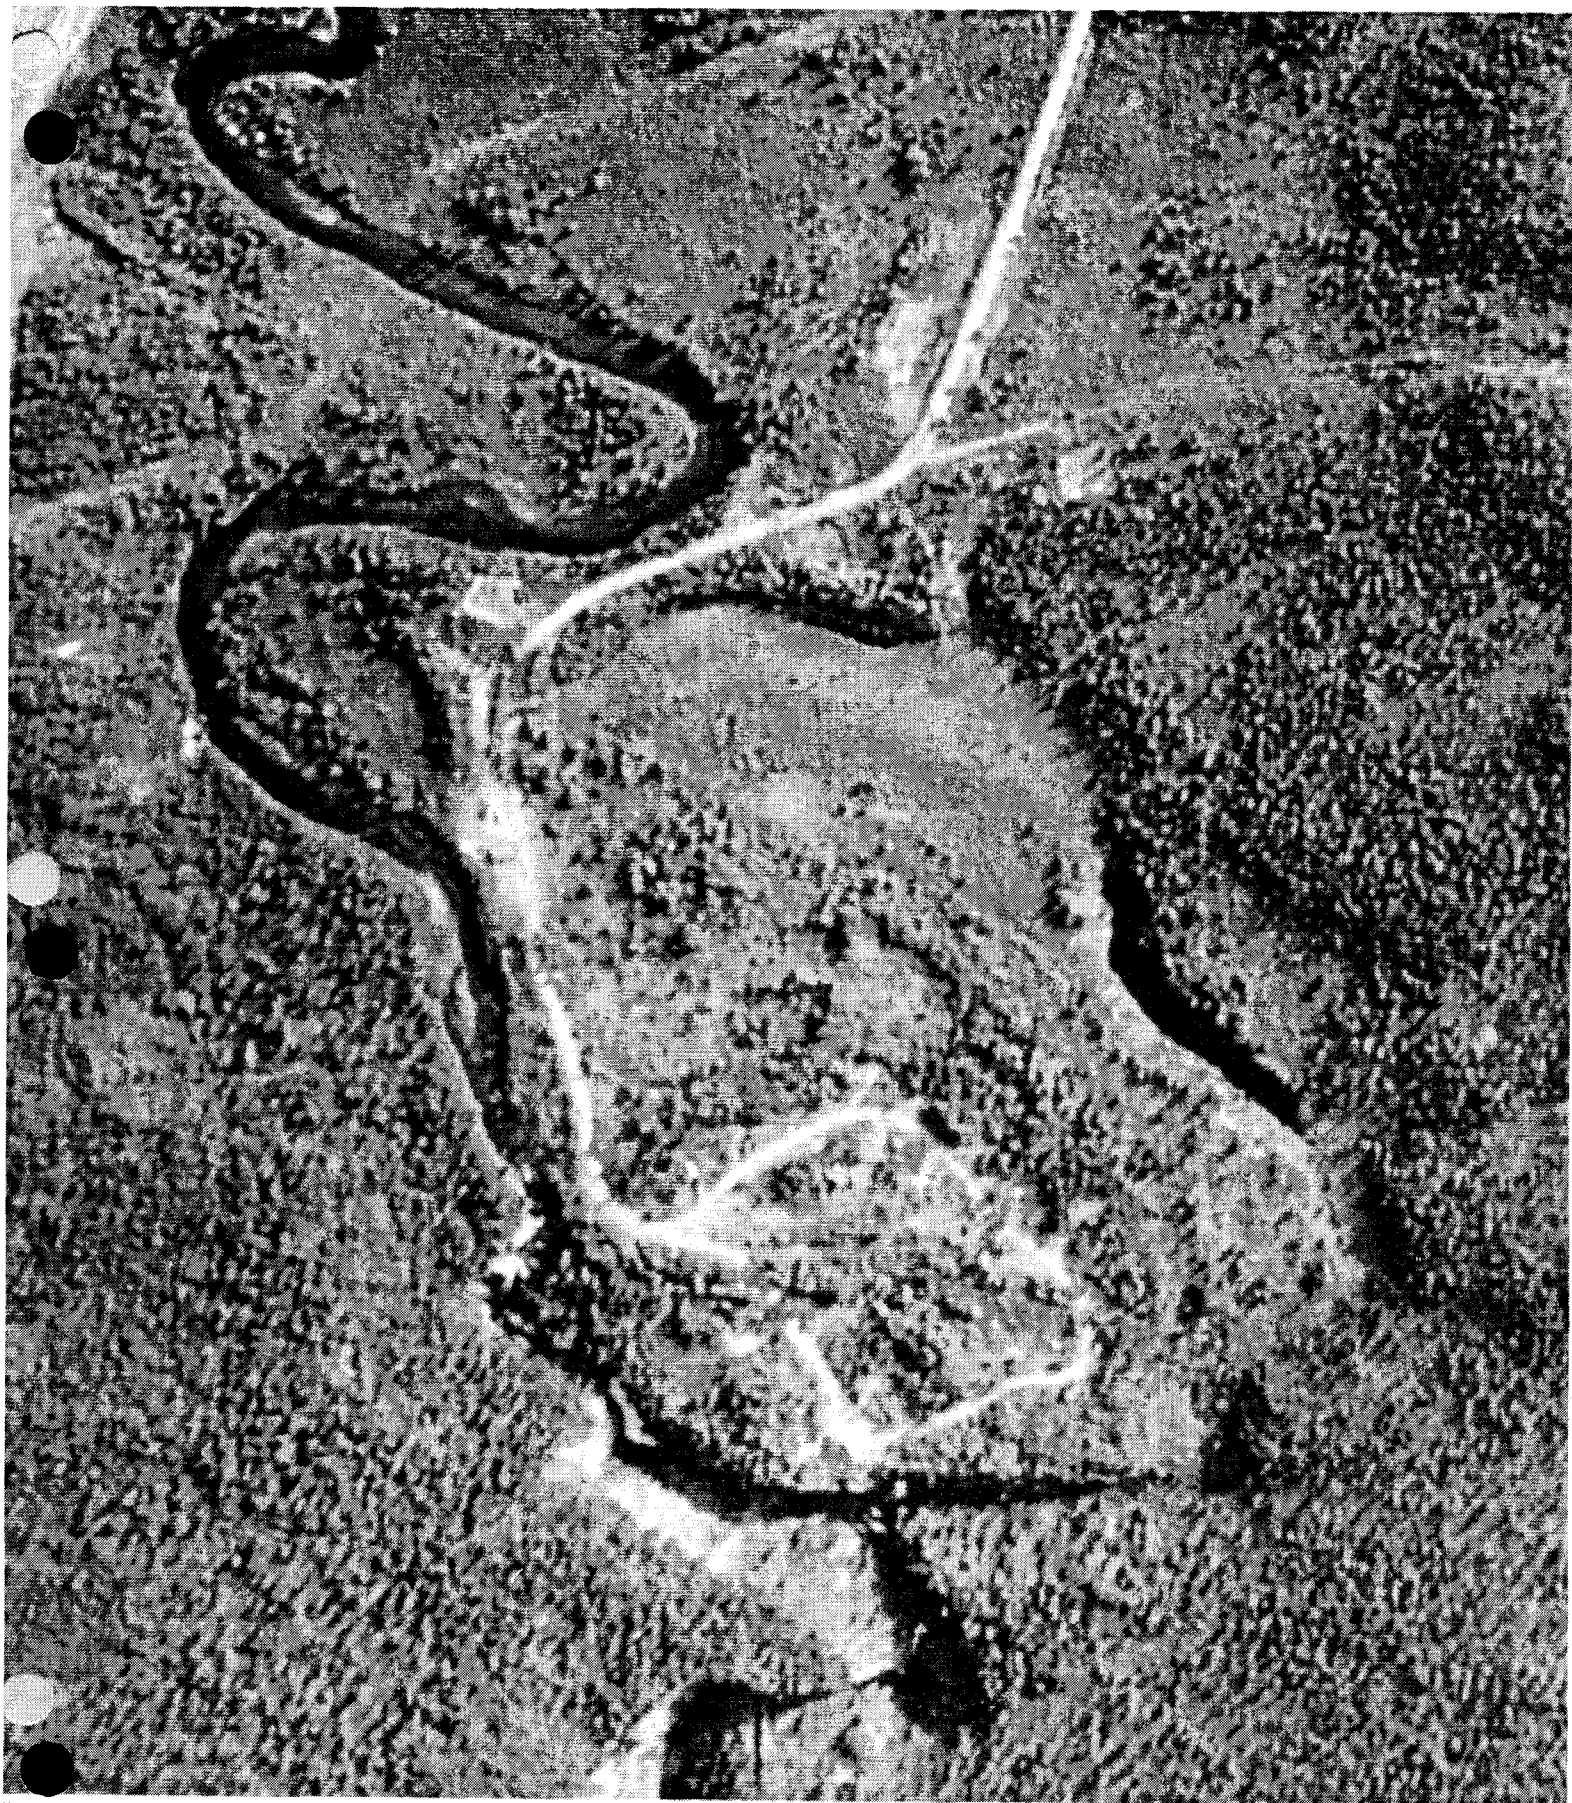
AUGUST 30, 1992

The small scale of this aerial photograph precludes the ability to distinguish individual features. However, the road network at the Site has been altered from that previously noted in 1964 and 1972. In this photo, the Site has been redeveloped as a recreational campground, and the campground loop road and campsites are evident.

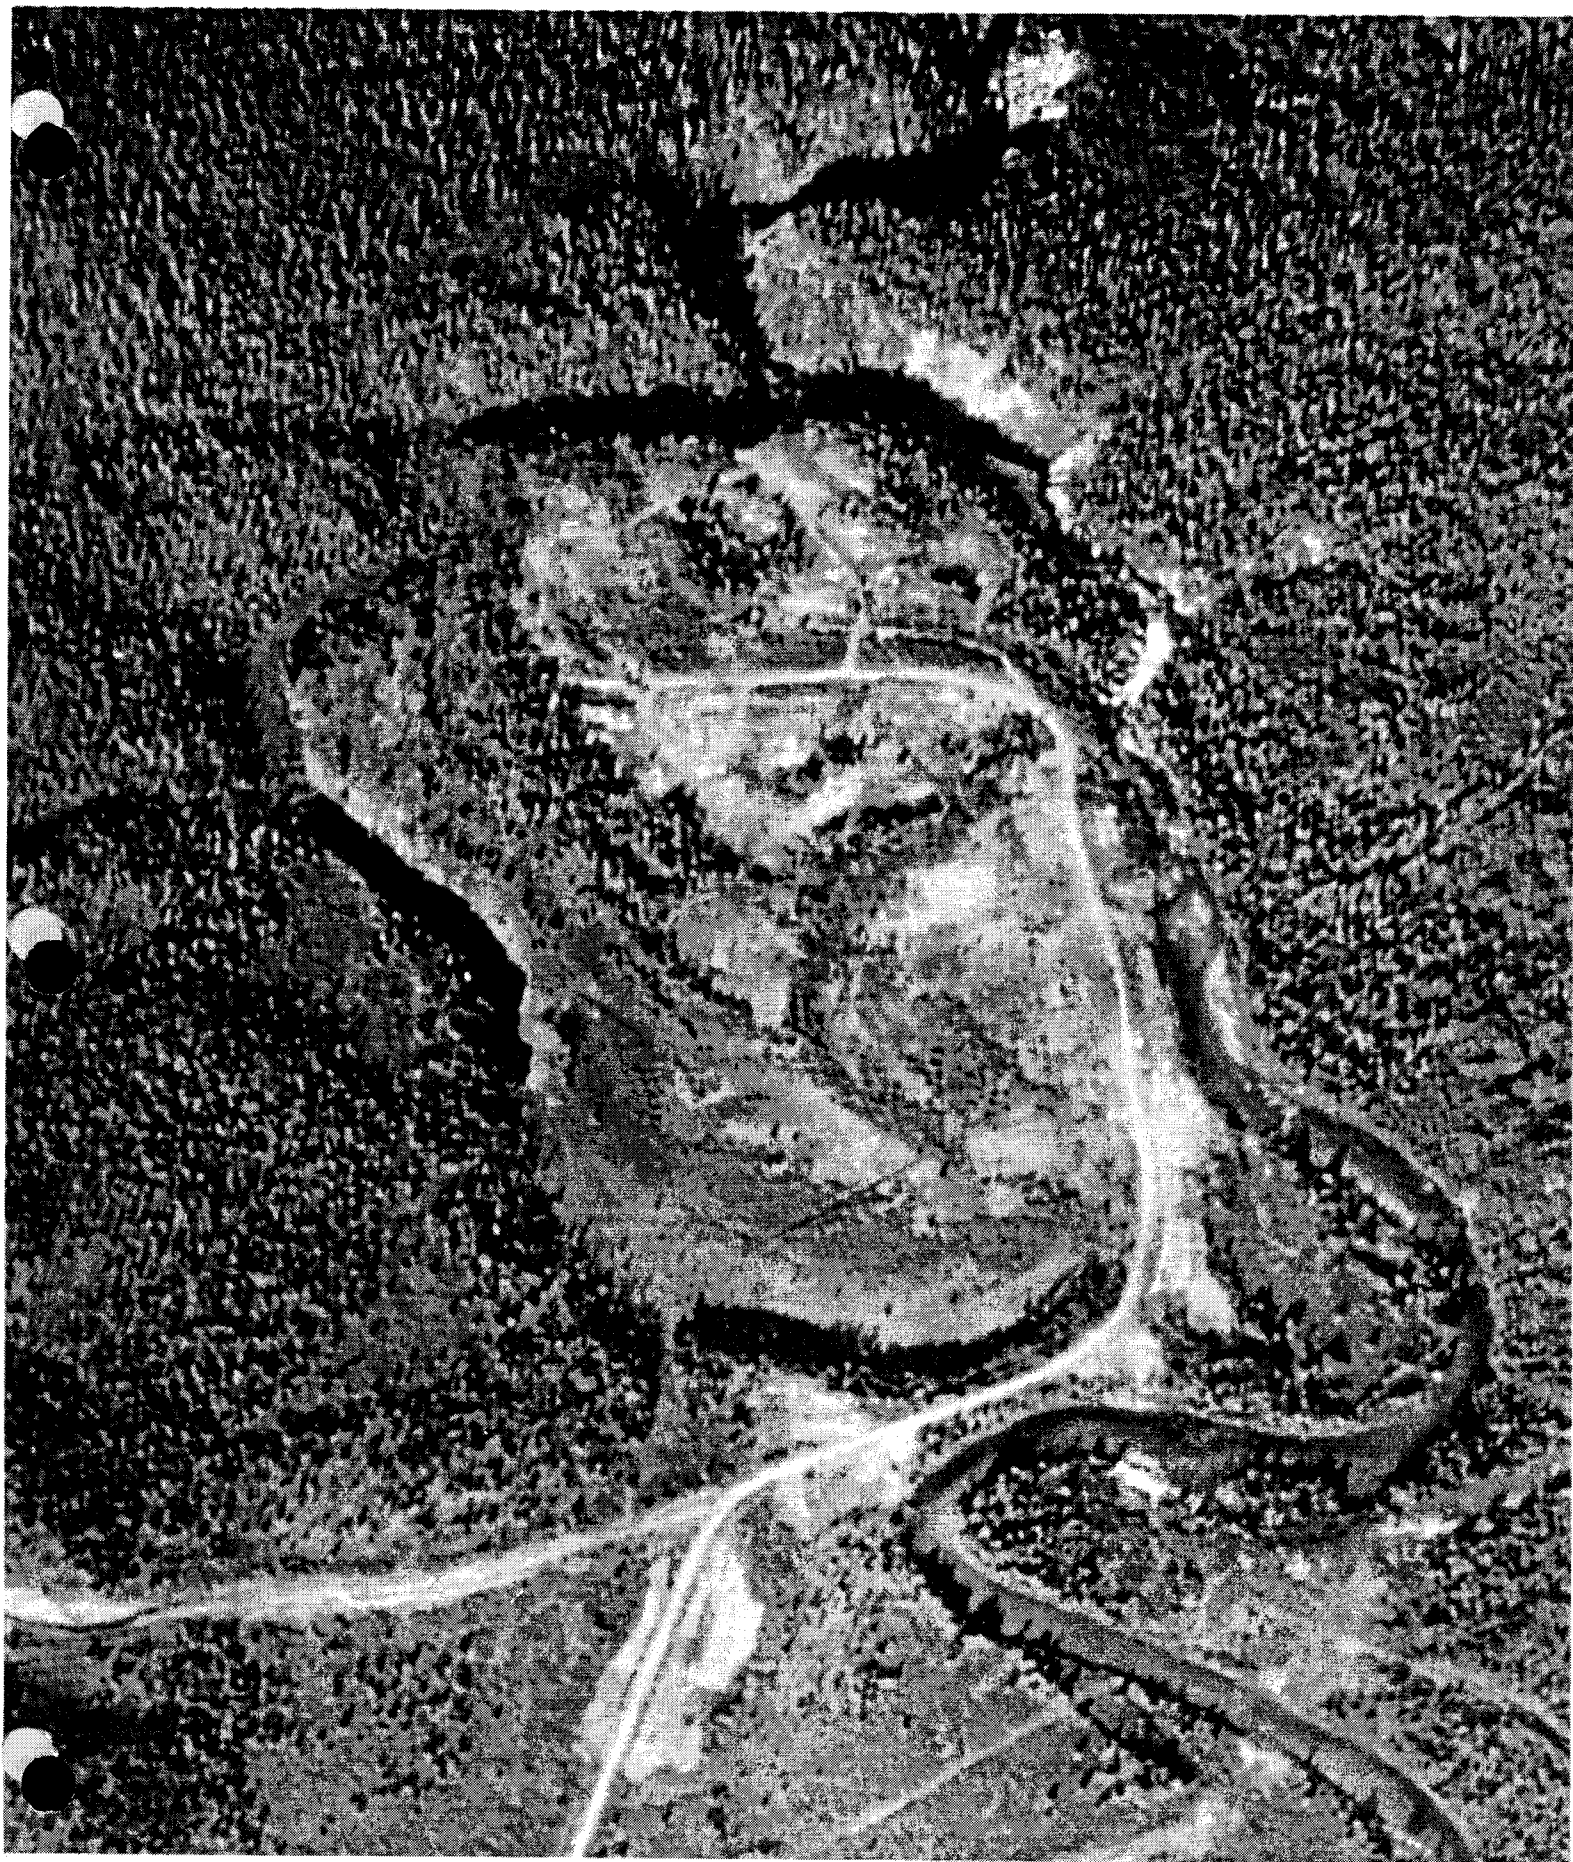
JULY 17, 1964

This sequence of aerial photographs indicate that buildings at the Site that were originally constructed for the camp in the 1940s were almost all removed by 1964 and are no longer present except for the concrete pads. The locations of former building pads were noted to fall within the alignments of reconstructed campground roadways in 1986.

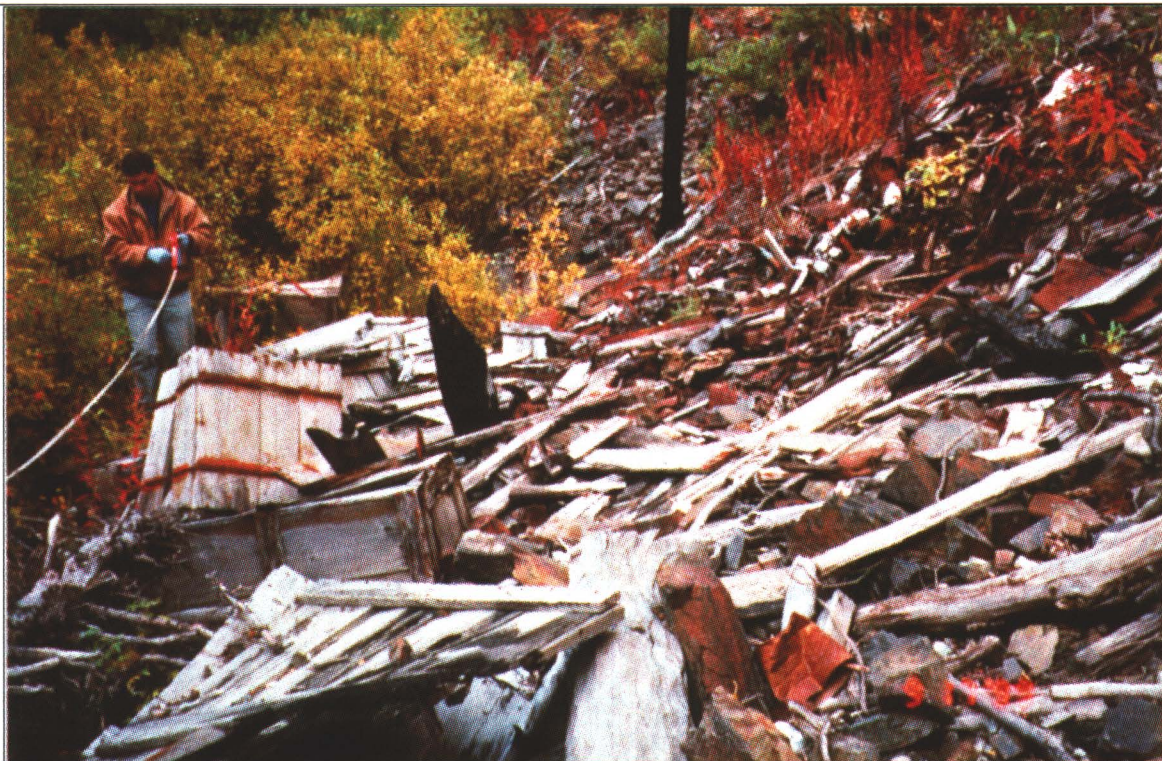
The debris was thoroughly interbedded with native rock, thought to have been knocked into the area during the disposal of materials from initial decommissioning activities at the Site. Although two separate areas of debris were noted, they were in close proximity and conditions at both were similar. The total volume of the debris is estimated to be approximately 250 m<sup>3</sup>. Additional debris was strewn along the streamside, adjacent to and between the main debris areas.

Materials typically encountered included: scrap lumber and wood; metal cans (food and beverage, paint, other); steel banding; crates; drums; steel cables; duct insulation; wiring; scrap metals; piping; wiring; (dry cell) battery; and native rock materials. Metal drums were present in the vicinity of the debris areas and in the stream. Several partially buried drums were also noted.

PHOTO No. 1: CRA conducting inspection of primary debris area

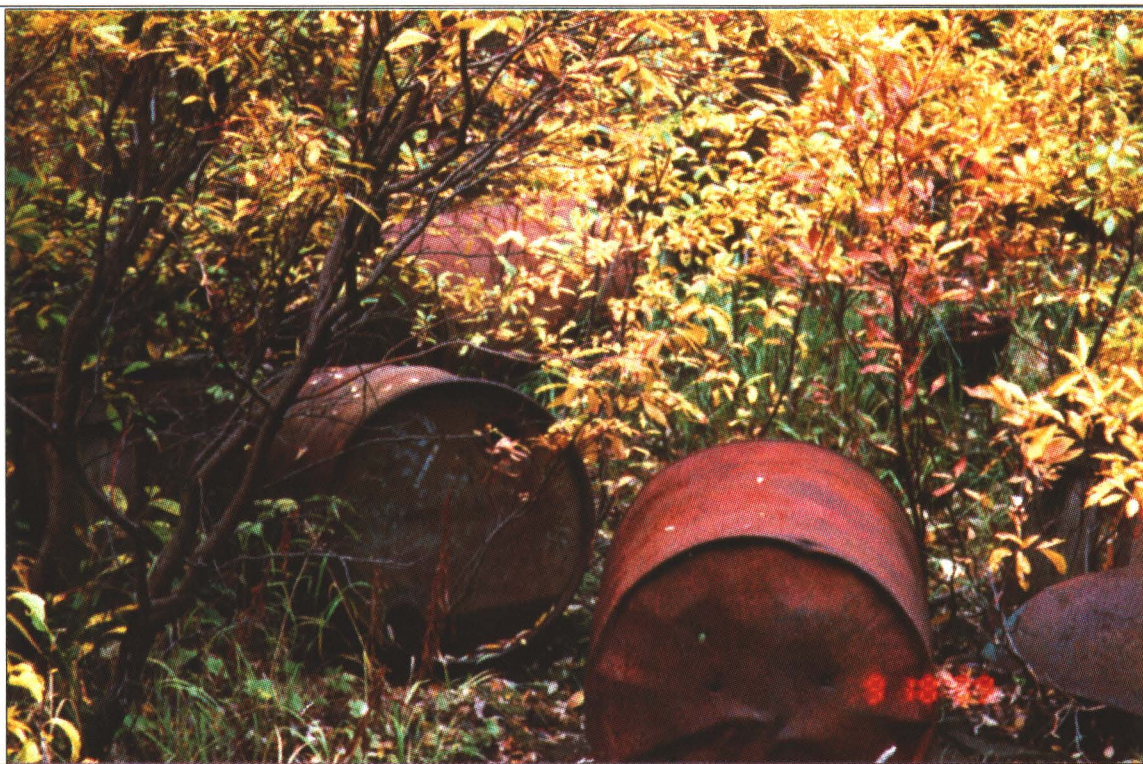
Though numerous metal containers were encountered, they were thoroughly rusted. Many were perforated by rust or by the native rock materials. Some of the drums were mostly intact, holding water but appeared to have been well flushed. No containers labeled for DDT or organic pesticides were found.

PHOTO No. 2: Drums typical of those found in debris area(s)

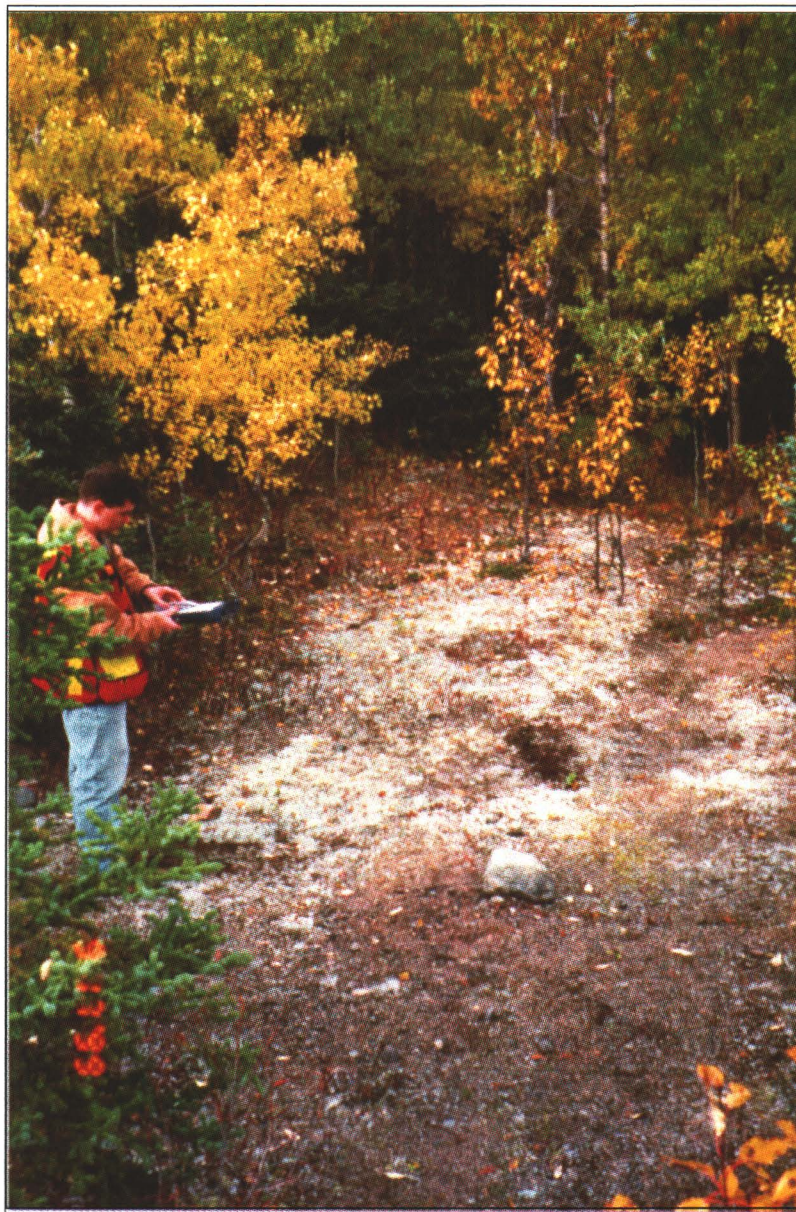
CRA staff conducted an overall ground reconnaissance of the Site on September 17 and 22, 1999 as part of the field investigation. During these two days the debris areas were located and the Site was investigated for other potential areas of environmental concern. However, other than building foundations and other building remains from the

decommissioned camps, no other signs of contamination or buried wastes were found. Representative photos of the Site are shown in Appendix E.

PHOTO No. 3: CRA conducting visual inspection during site reconnaissance

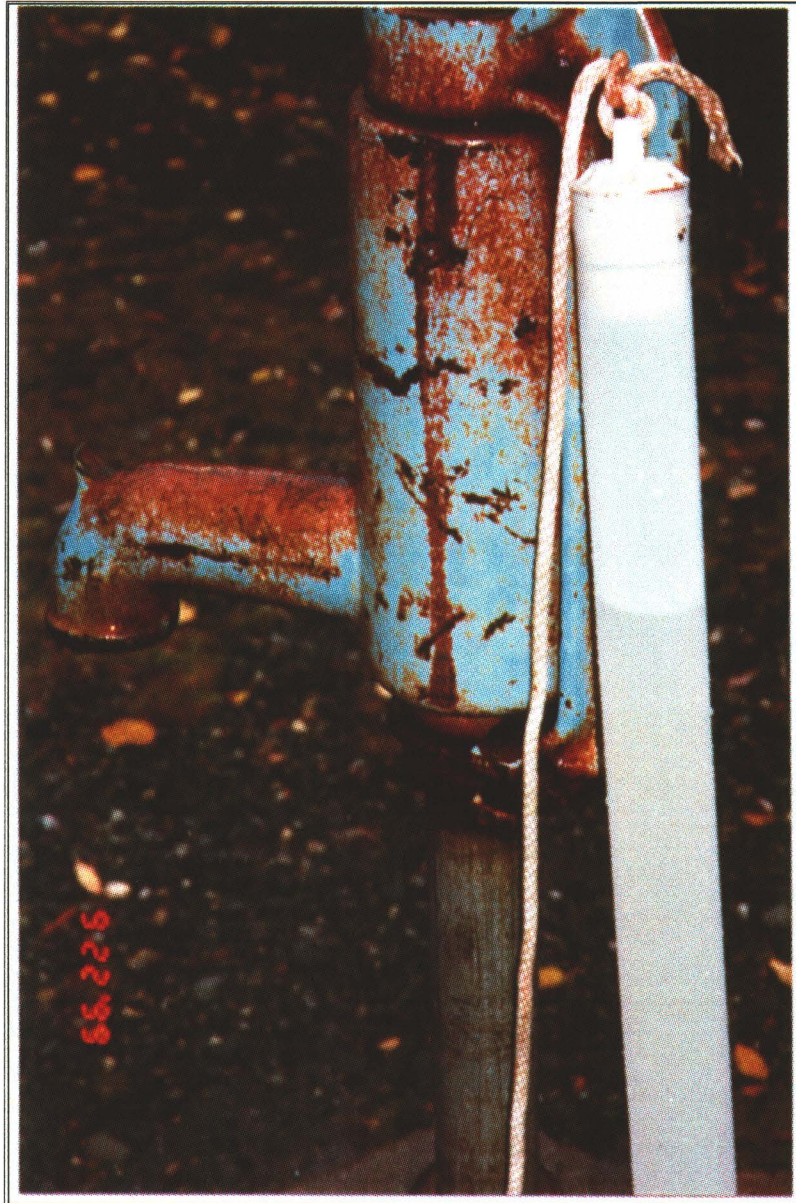
PHOTO No. 5: Teflon bailer showing sample from campground supply well
