**DETAILED SITE INVESTIGATIONS AND SITE  
RESTORATION OF BLANCHARD RIVER STATION,  
YUKON, CANADA**

*Prepared for:*

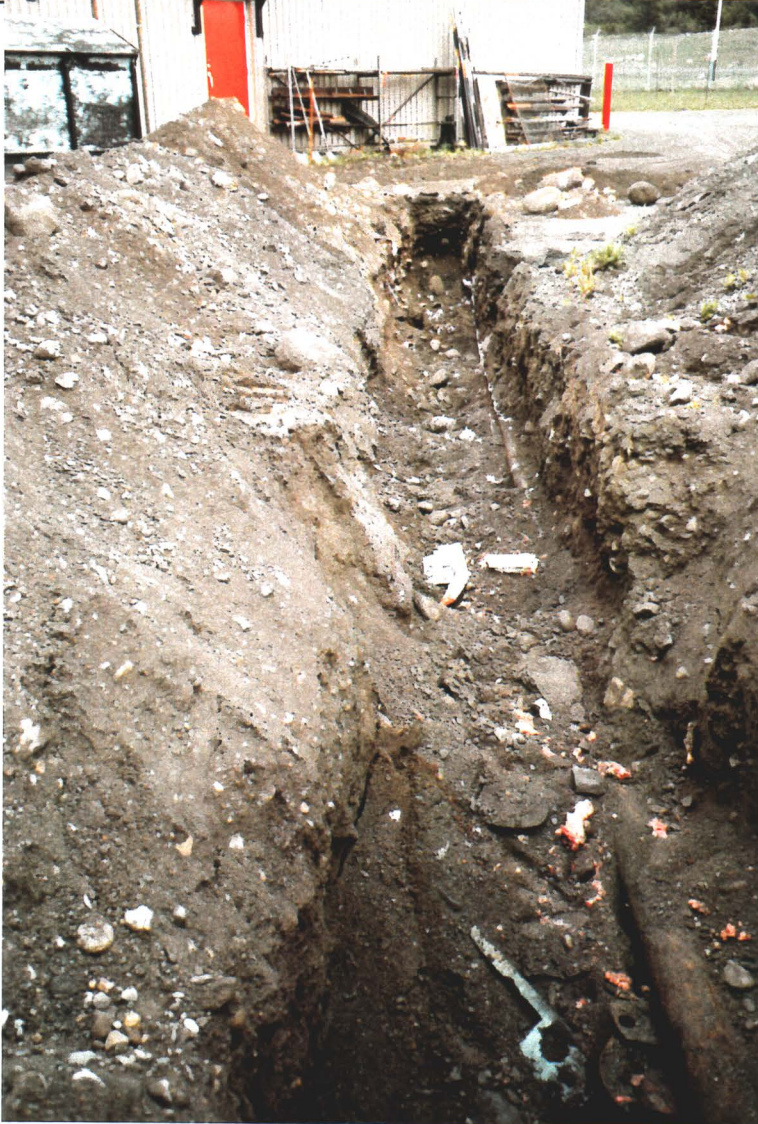
Photograph 3.1: Trench excavated on the southern end of maintenance building showing feed line to the soak away pit

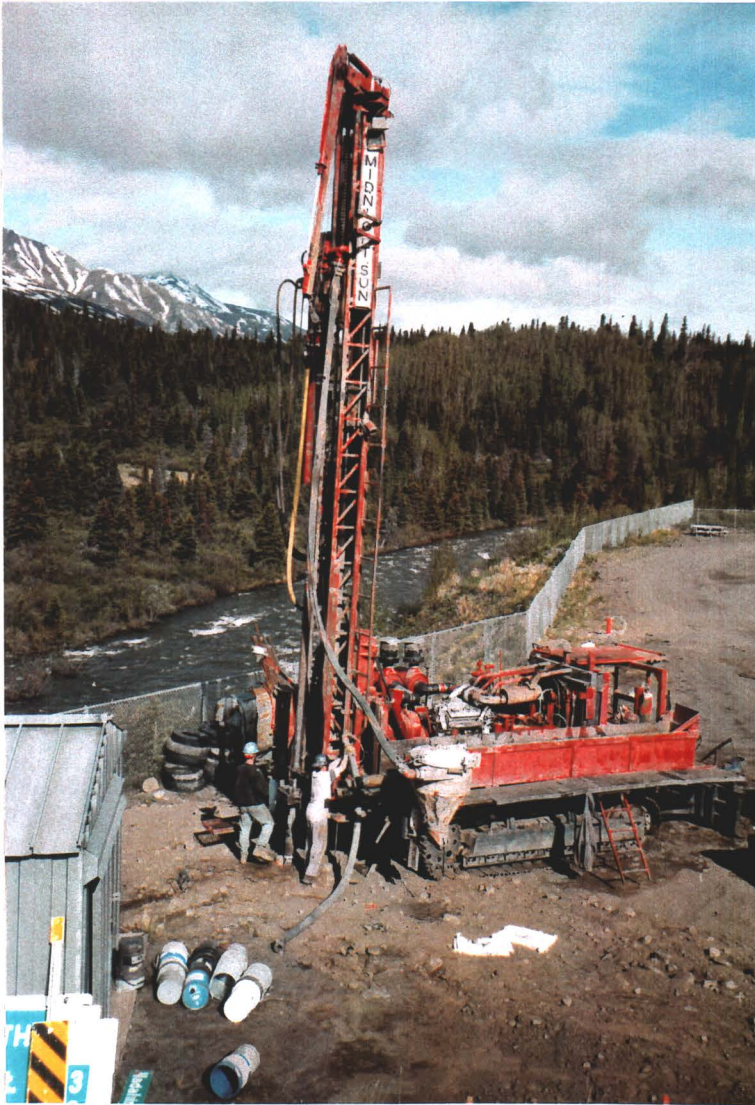
Photograph 3.7: Air rotary drilling at the upper terrace southeast of the maintenance building south and near the storage shed (TH99-14) with Blanchard River below the lower terrace

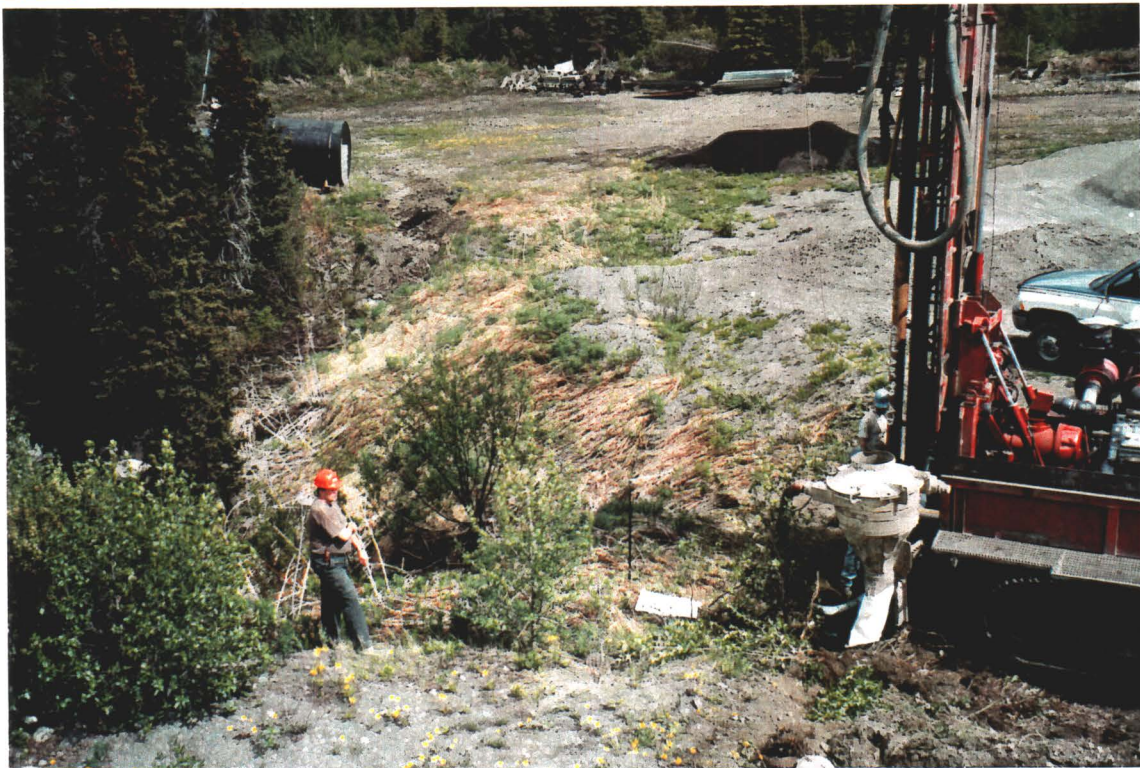
### 3.3.4 Surface Investigations at Rust Coloured Drainage Ditch

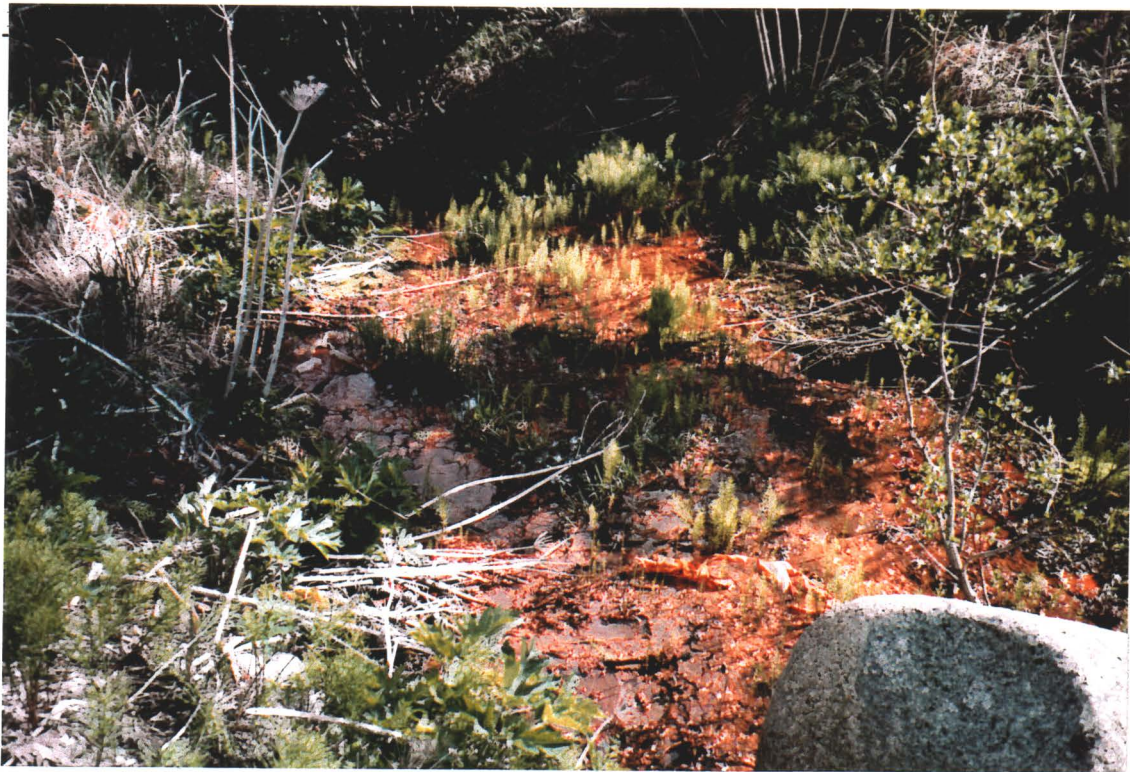
Photograph 3.9: Rust-coloured stained soil and water with hydrocarbon sheen in drainage ditch north of the site.

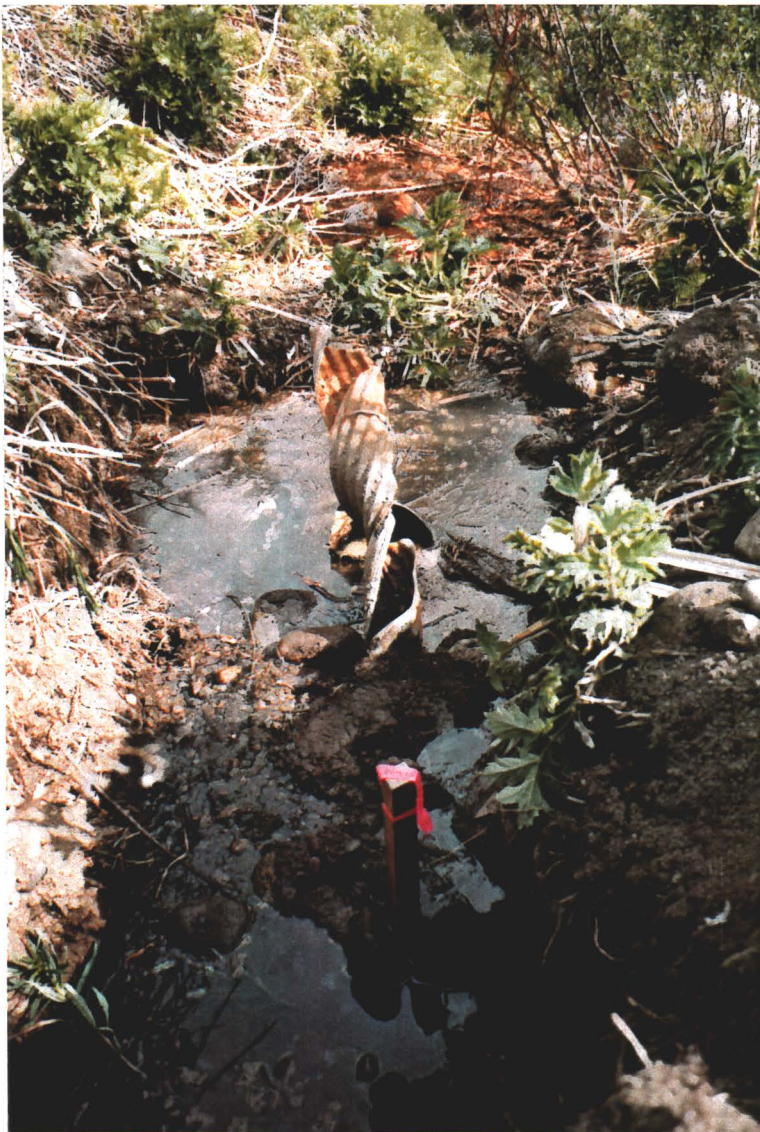
Photograph 3.10: Galvanized zinc culvert unearthed at the source of rust-coloured leachate.

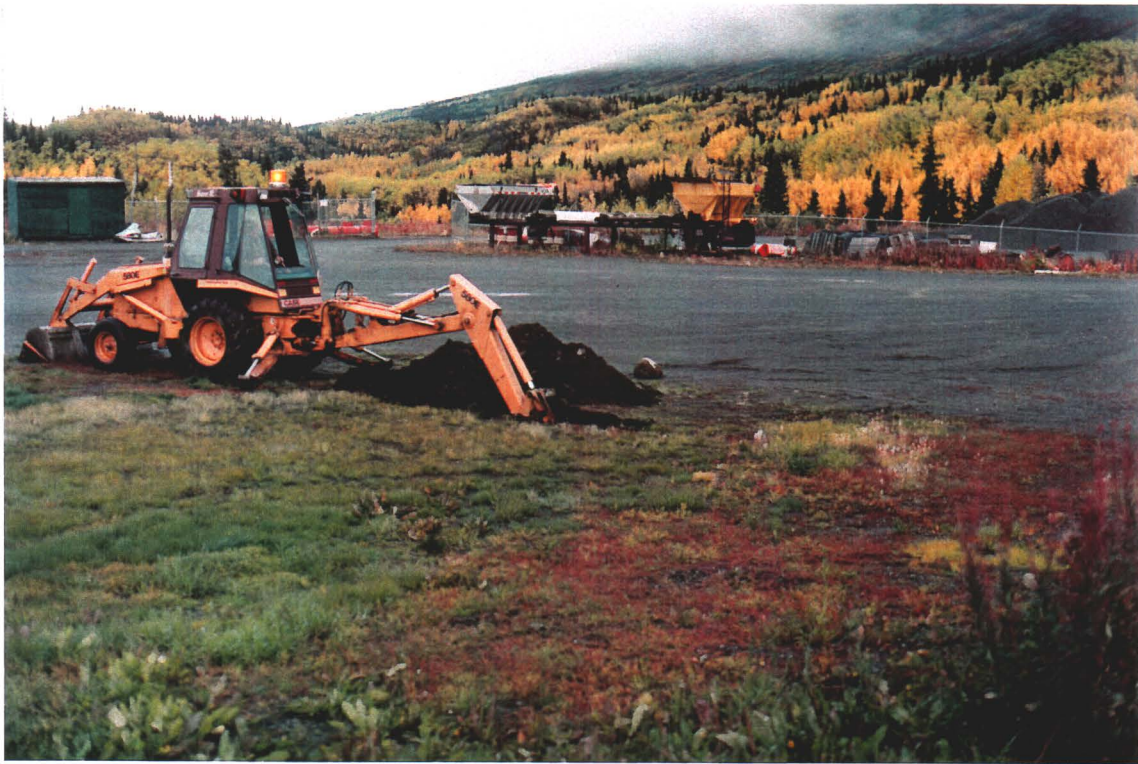
Photograph 3.11: Excavating a test pit (TP99-45) at the southernmost end of the EM anomaly, northeast of the residence.

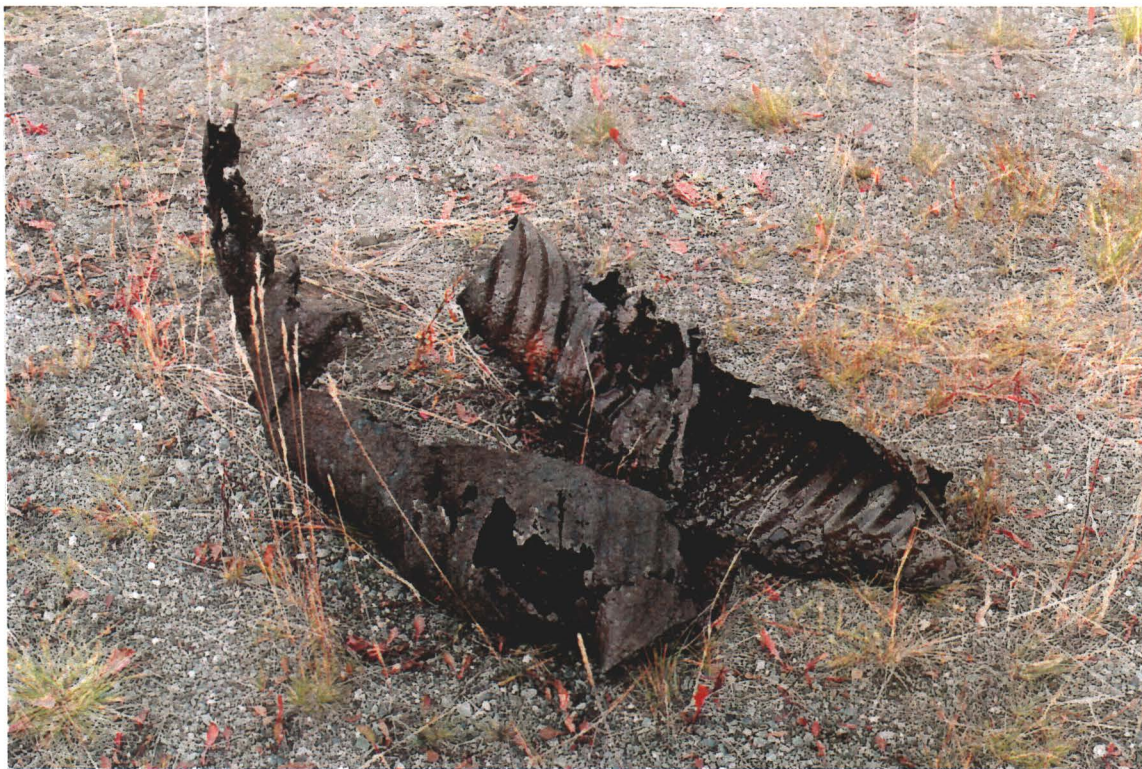
Photograph 3.13: Sections of galvanized culvert removed from trench dug along the EM anomaly leading to the rust-coloured graining ditch.

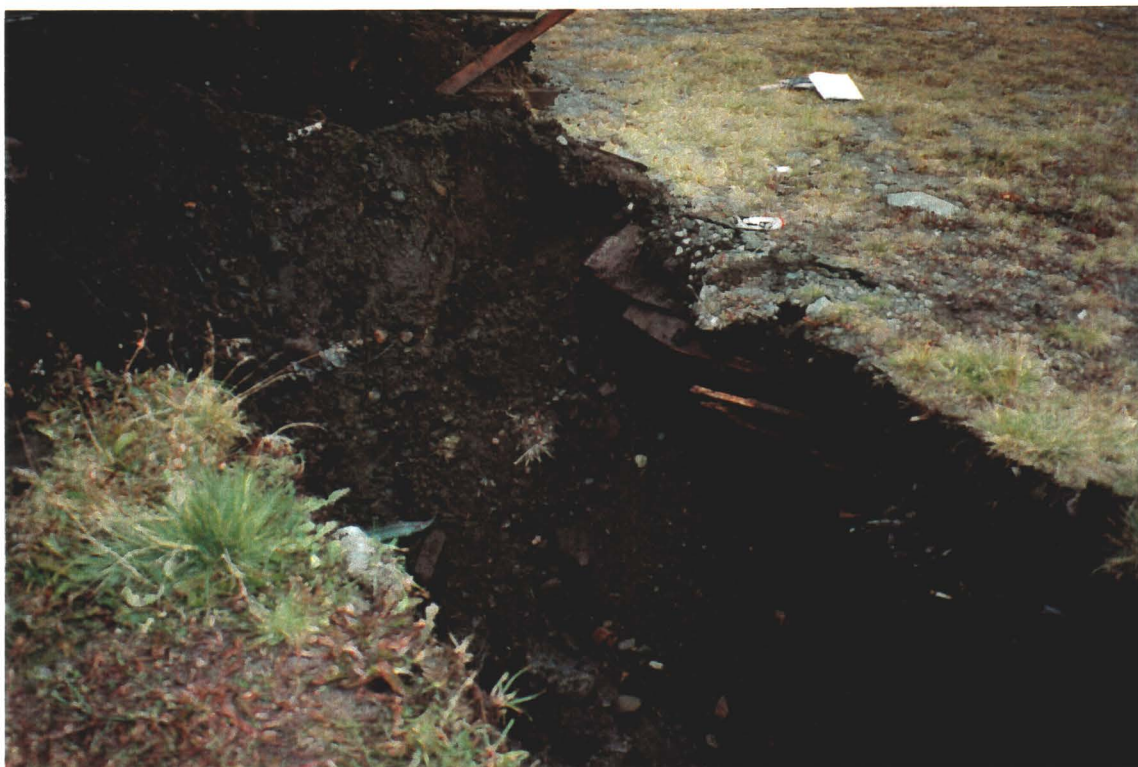
Photograph 3.14: Test pit excavation at the rafters camp (TP99-58) showing debris including wood and plastic materials.

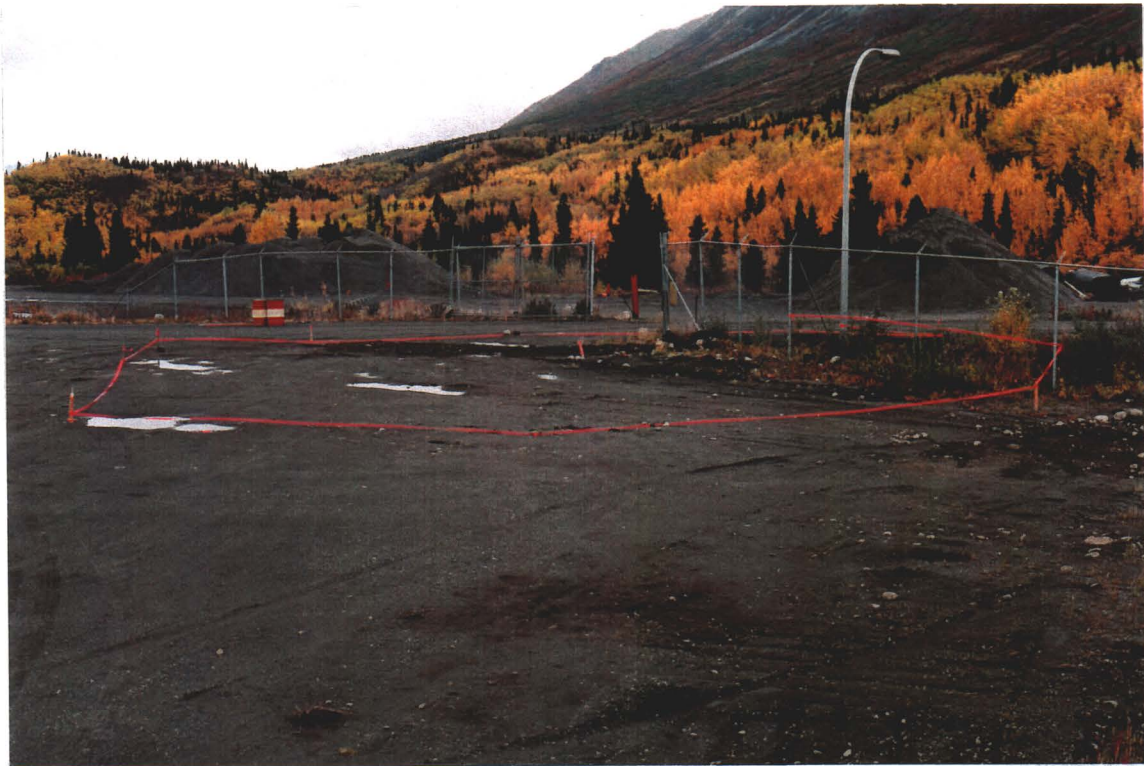
Photograph 6.1: Demarcated of the Burn Pit prior to excavation

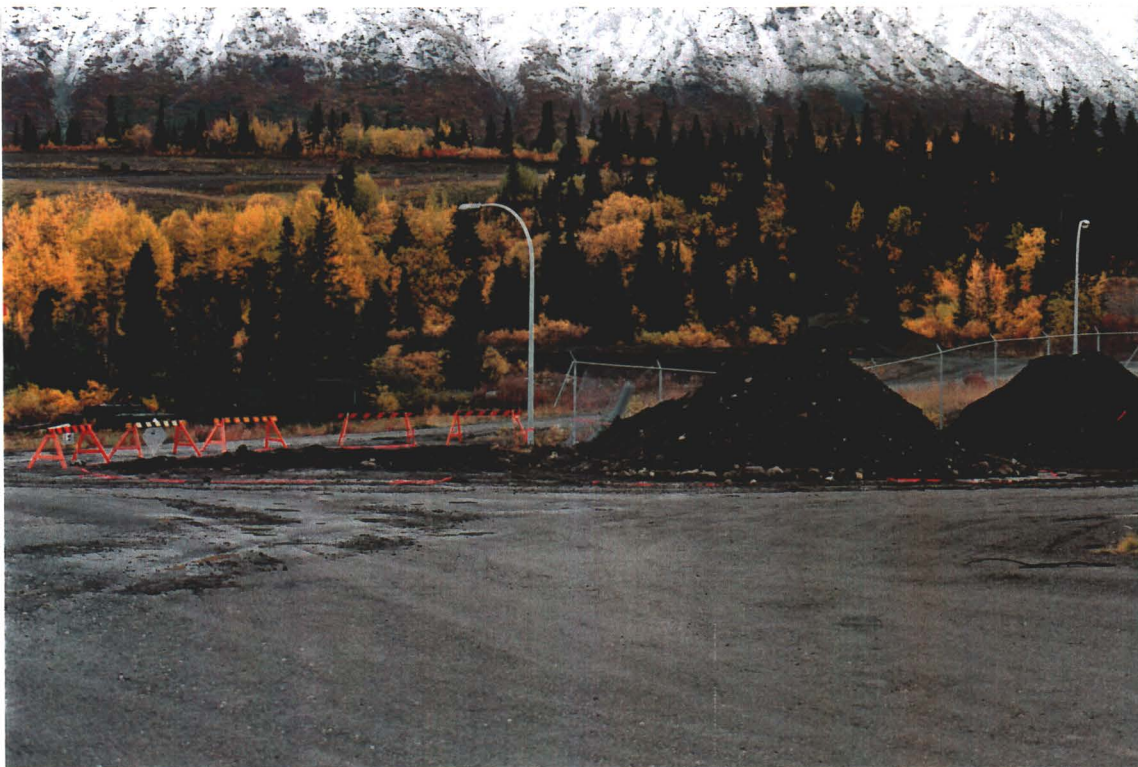
Photograph 6.2: Uncontaminated overburden removed from burn pit stockpiled to the side of the excavation for future backfilling use

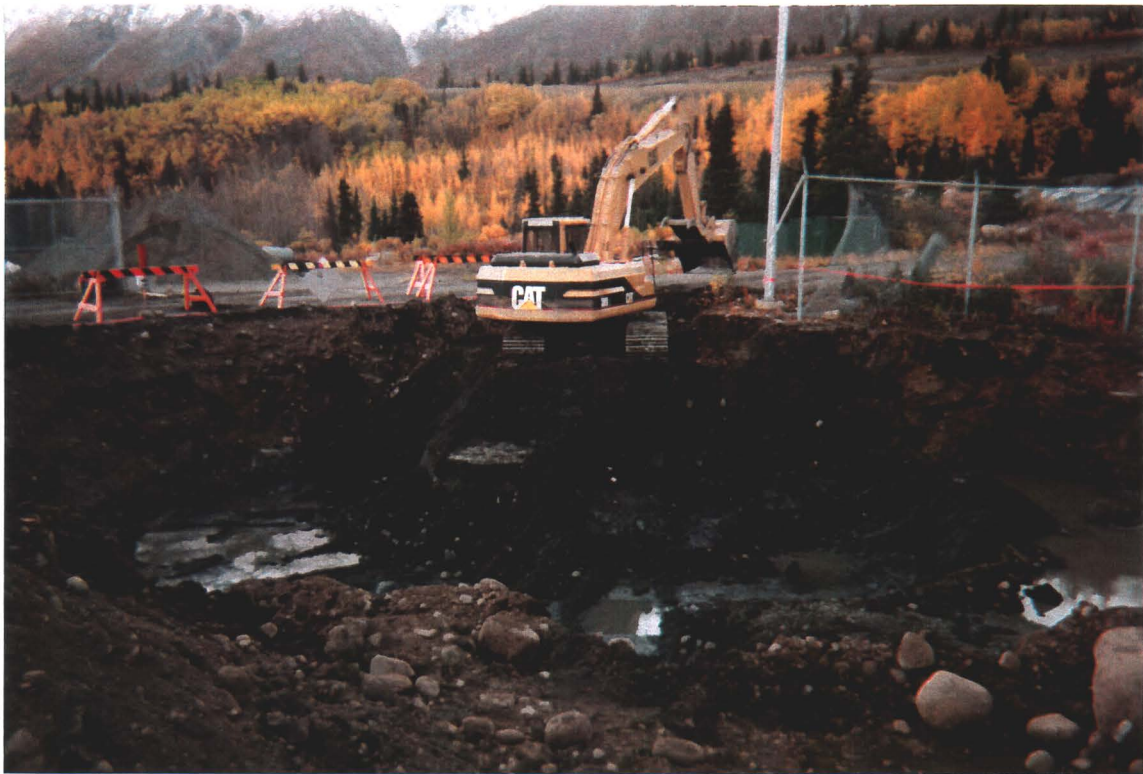
Photograph 6.3: Excavation of the burn pit and surrounding area. Note the heavily stained soils in the immediate vicinity of the former burn pit location (center of the photograph).

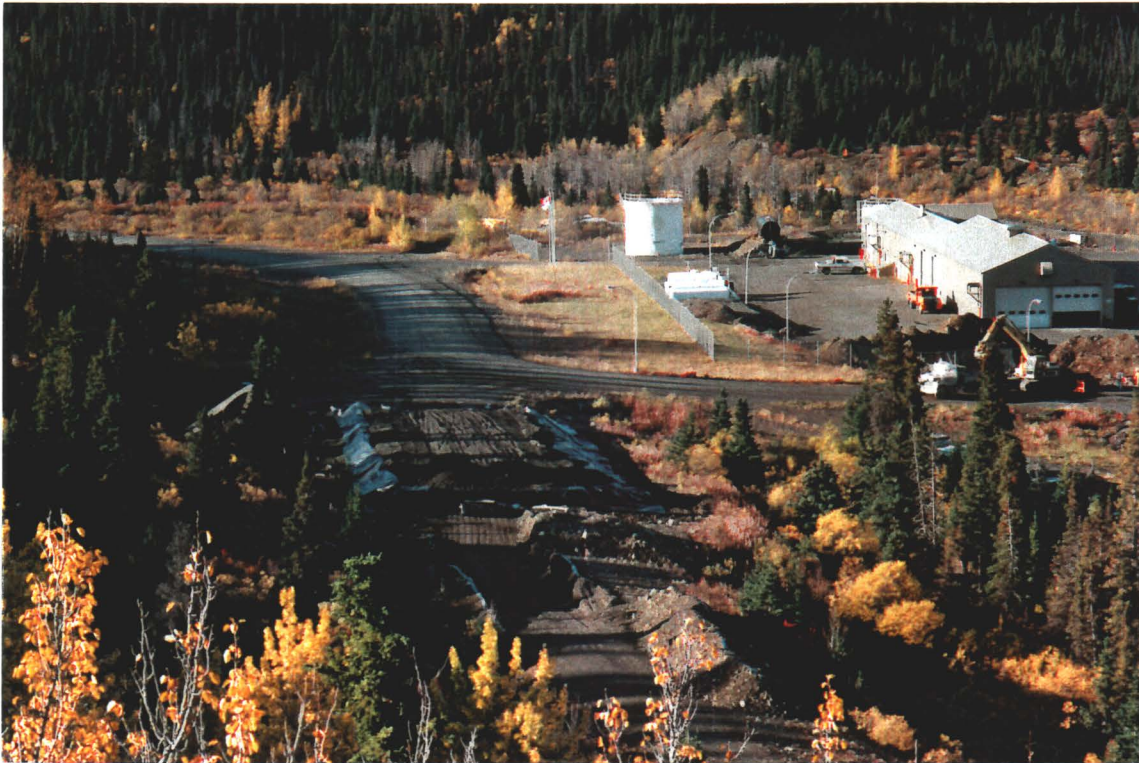
Photograph 6.6: View of the Temporary Containment Cell from Haines Highway prior to covering it with a polyethylene liner.

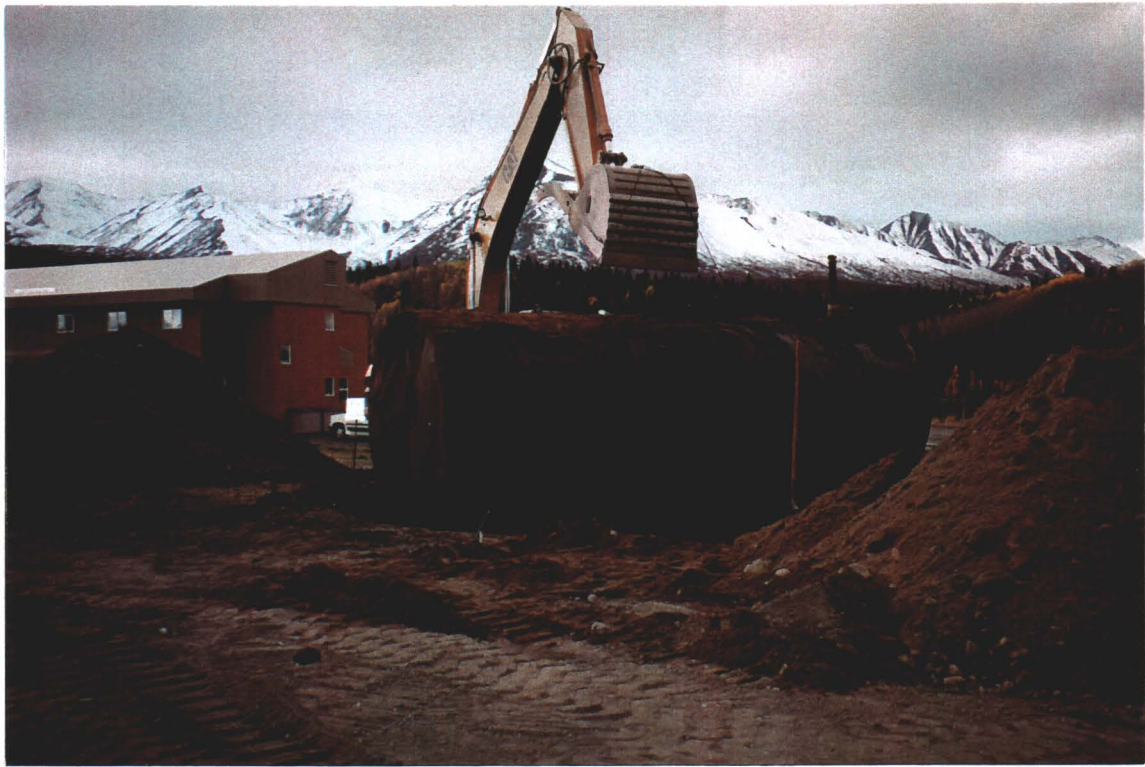
Photograph 6.9: Excavation of Underground Storage Tank northwest of the Maintenance Building
