**Re: Completion Report for Ex-Situ Soil Remediation of the Peel-Caribou Staging Area.**

**EX-SITU SOIL REMEDIATION OF THE  
PEEL-CARIBOU STAGING AREA, YUKON TERRITORY:  
COMPLETION REPORT**

Royal Roads University - Applied Research Division

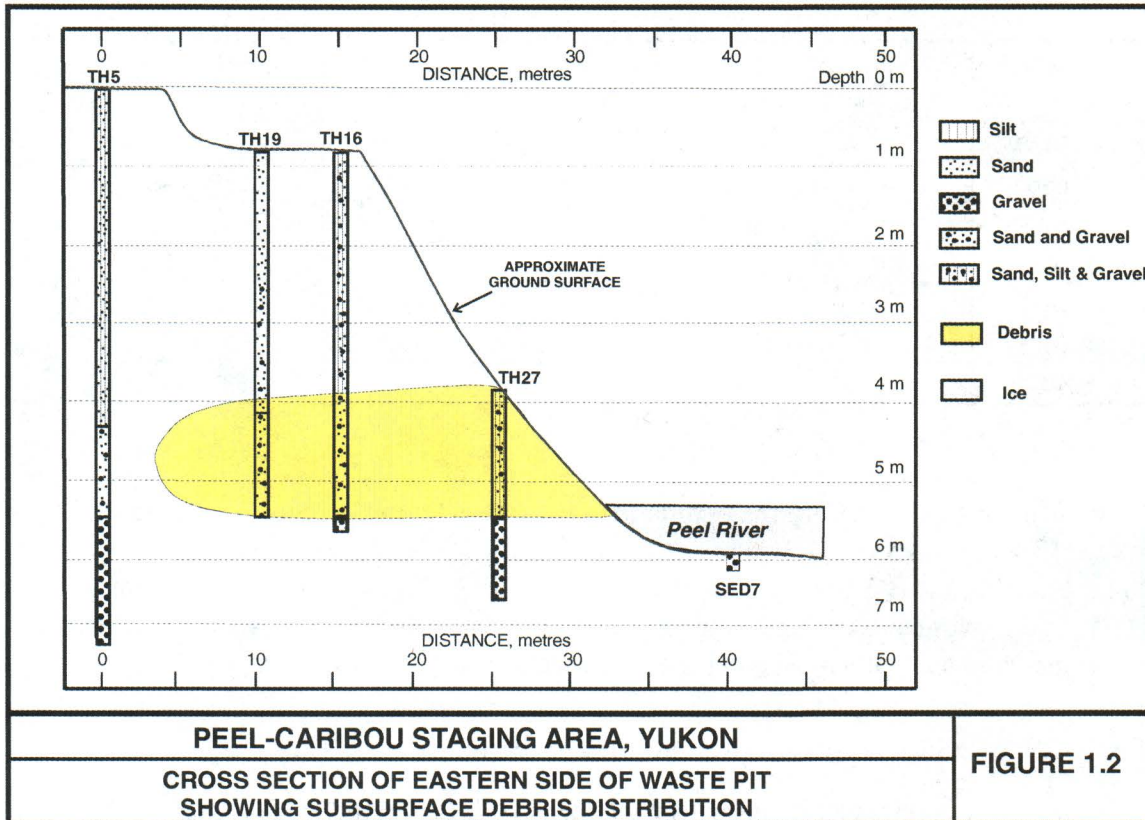
Debris including wood, bentonite, metals, cement and an unidentifiable brown fibrous material (coconut husk) was generally located at a depth of 3 to 4 m below ground surface

on the upper bench and extended to a maximum depth of 2 m. This debris was exposed along the cut bench of the river (Figure 1.2). Snow cover during the site investigations precluded observation of the extent of exposed debris along the riverbank. The volume of this debris was estimated to be 2000 cubic metres. Allowing for a contingency factor of 50%, the total volume of debris was approximately 3000 cubic metres.

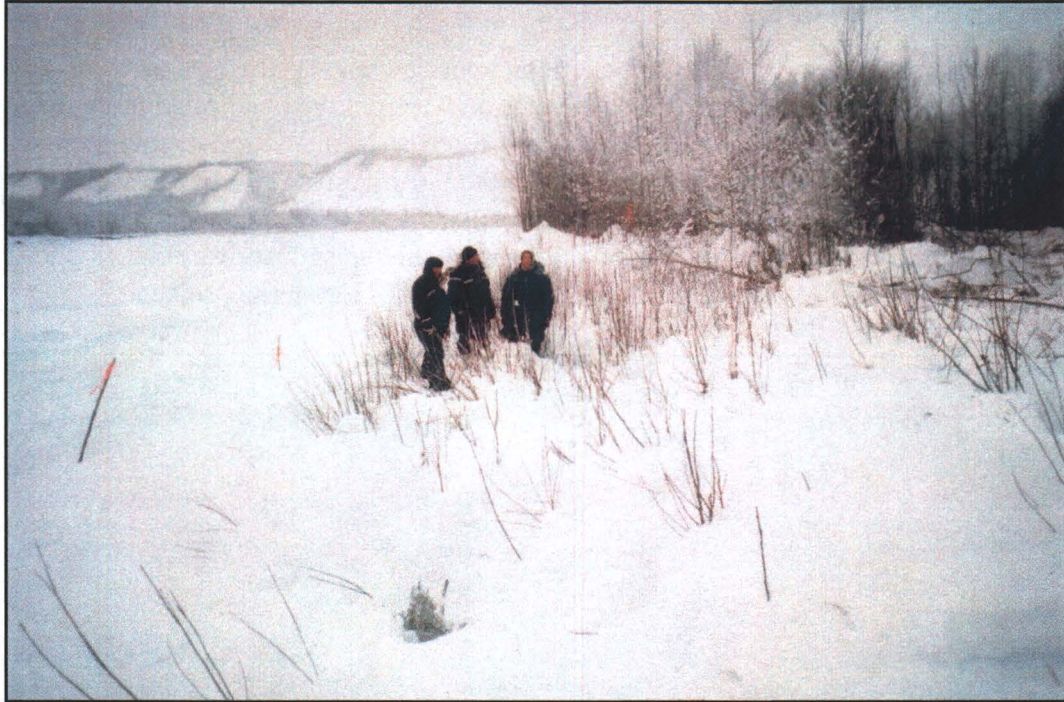
**Photograph 2.3: View of the upper bench of the waste site showing snow cover**

A site meeting was conducted on February 13, 2002 to initiate site excavation activities. The site was covered with up to 0.5 m of snow (Photographs 2.3 and 2.4).

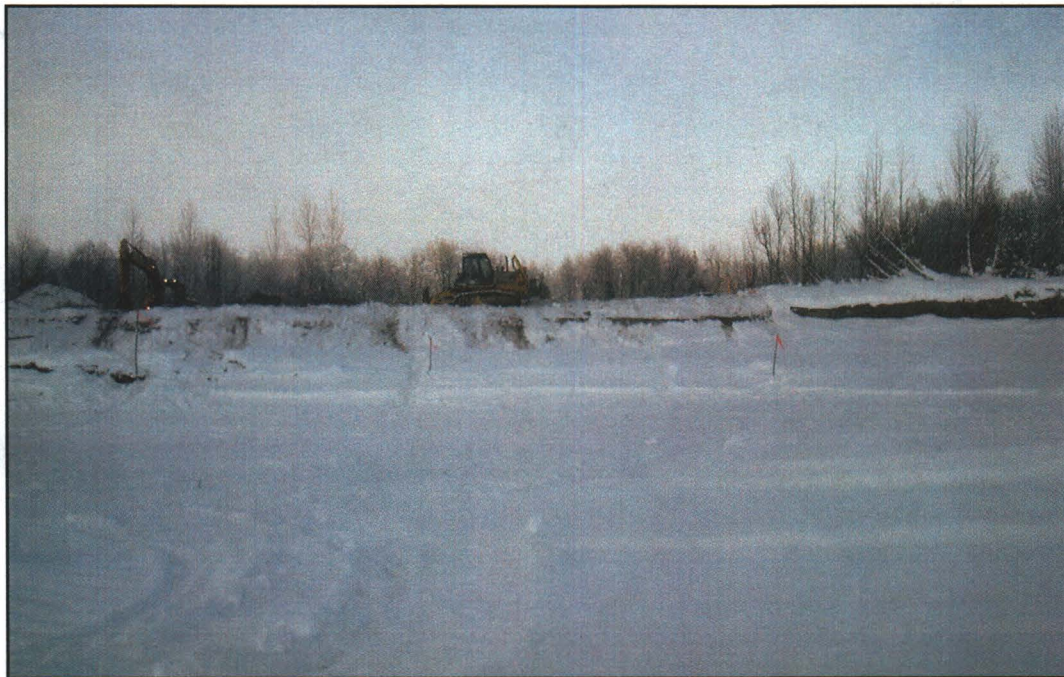
**Photograph 2.4: Removing snow cover from the waste site as viewed from the frozen river**

This snow cover was removed using the front blade of a D6 caterpillar. The approximate limits of the waste pit were demarcated based on the results from the detailed site investigation (see Figure 1.3). A survey was then conducted to establish the base line prior to excavation. A plot of the baseline is given in Drawing 1, which is reproduced as an attachment to this report.

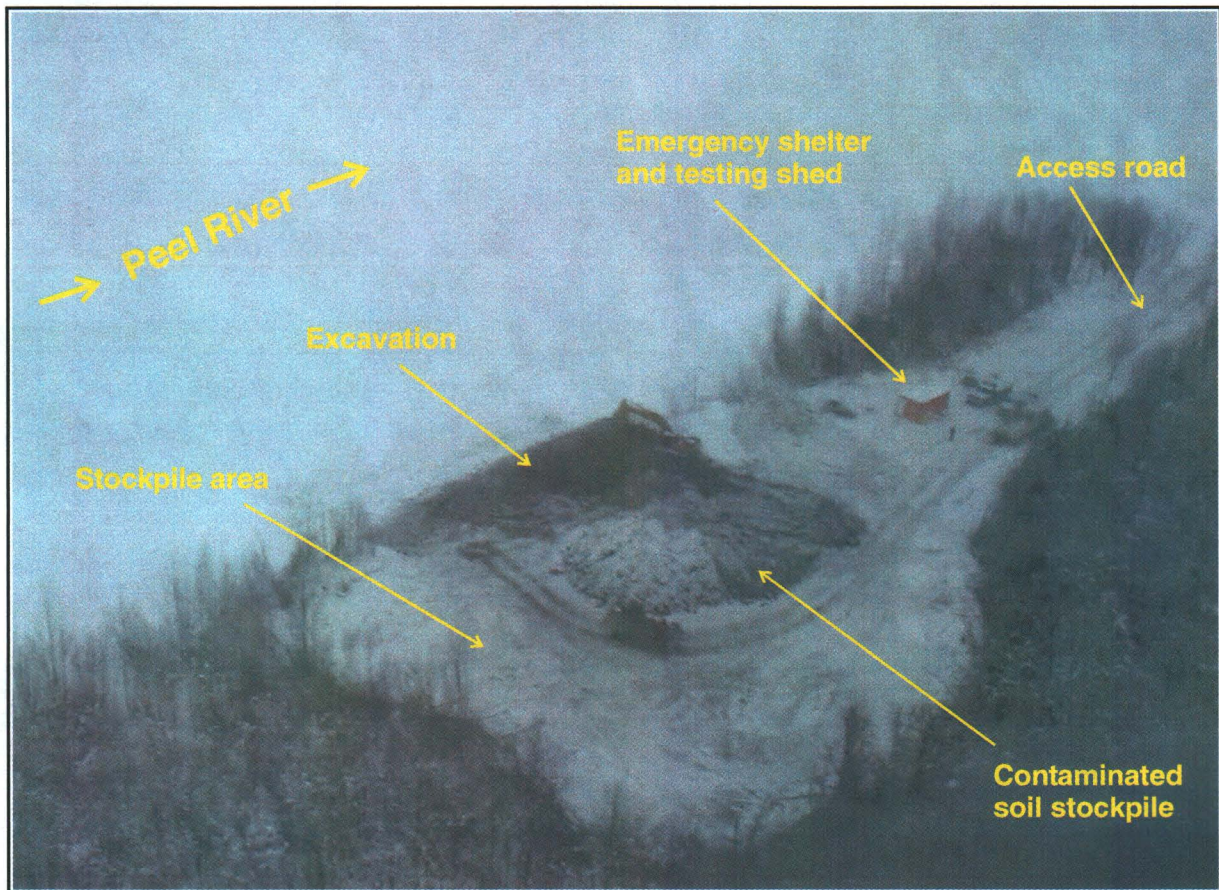
**Photograph 2.5: Aerial view of the Peel-Caribou showing site layout halfway during the project**

An area of approximately 100 m x 100 m on the upper bench was then prepared to serve as a stockpile and loading area. All surface vegetation was removed and piled at the edges of the clearing for re-use after completion of the project. A small trailer equipped with a portable generator and heater was also set up at the northwestern end of the stockpile area to serve as an emergency shelter and on site testing facility. A general layout of the site showing the excavation, stockpile area, emergency shelter and access road is shown in Photograph 2.5 below. The photograph was taken halfway during the project.

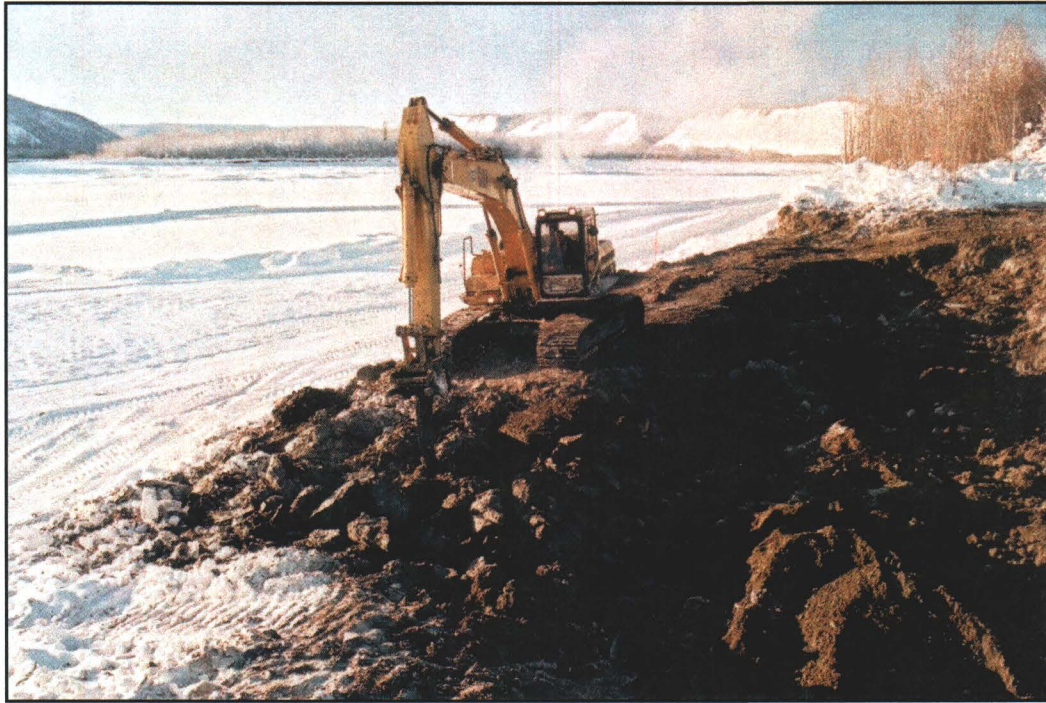
**Photograph 2.6: Ripping the surface frost layer using a pick which was attached to the Cat 322 excavator**

As summarized in Section 1.5, debris and contaminated soils were generally located at a depth of 3 to 4 m below ground surface on the upper bench and were exposed along the cut bench of the river (Figure 1.2). This necessitated removal of the non-contaminated overburden, which consisted mostly of sand, silt and gravel. The surface frost layer was broken using a pick attached to the front end of a Cat 322 excavator (Photograph 2.6).

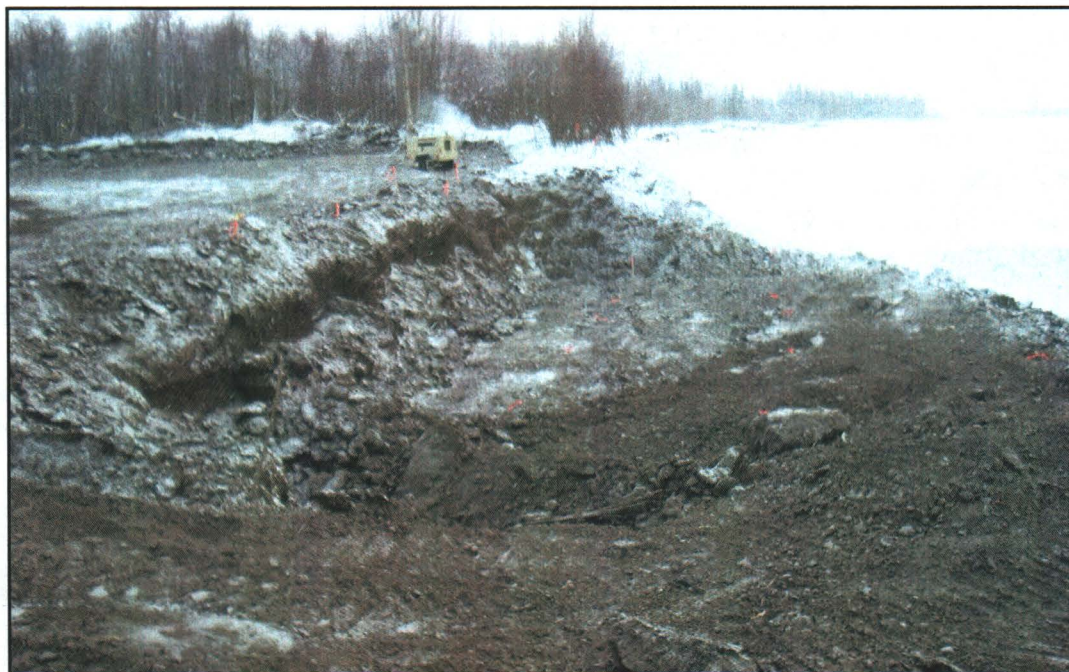
**Photograph 2.7: Waste pit after removal of overburden from the contaminated zone**

Following the initial excavation of all the non-contaminated overburden (Photograph 2.7), the area was surveyed to establish the base line for the contaminated area. This was to allow for an estimation of the in-situ volume of contaminated materials to be removed (Drawing 2).

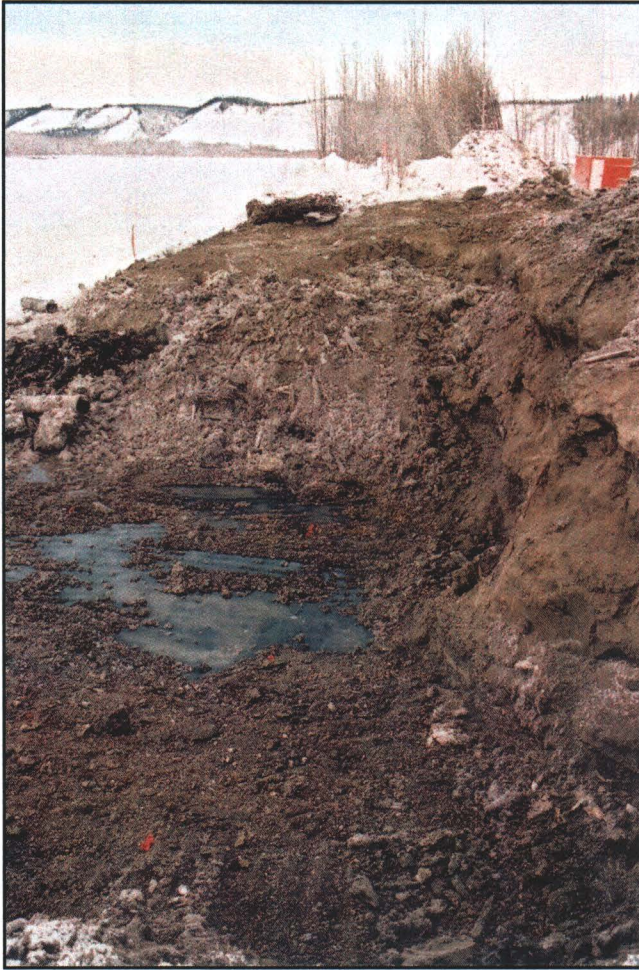
**Photograph 2.8: Waste pit after excavation of contaminated soils**

Removal of materials from the contaminated zone was initiated on February 20, 2002 and completed on February 25, 2002. Excavation was achieved with a CAT 322 excavator operated by the prime contractor. Contaminated soil and all debris were removed from the contaminated zone until native gravel was encountered (Photograph 2.8). The excavated materials were either placed directly on a synthetic liner at the stockpile area or in the case of materials at the lower bench, loaded onto a truck and transported to the stockpile area.

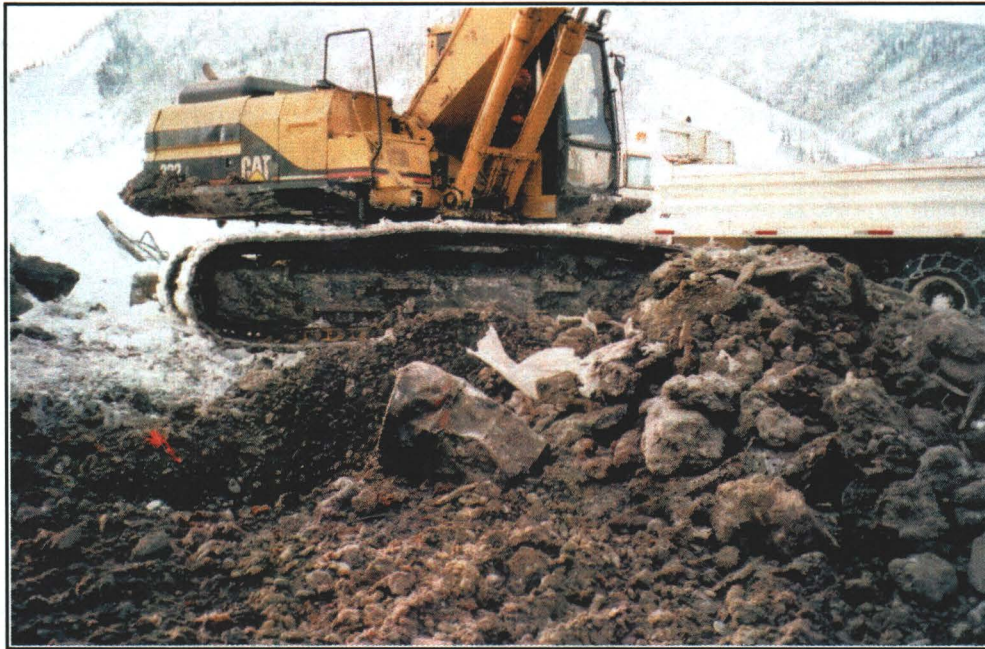
**Photograph 2.9: Barrel and other debris excavated from the contaminated zone**

The contaminated soils and debris were placed on a geomembrane liner at the stockpile area. The drill casings and other debris in excess of 0.5 m in any dimension (excluding barrels) were segregated from the contaminated pile. These were treated as per the non-contaminated debris (see section 2.8).

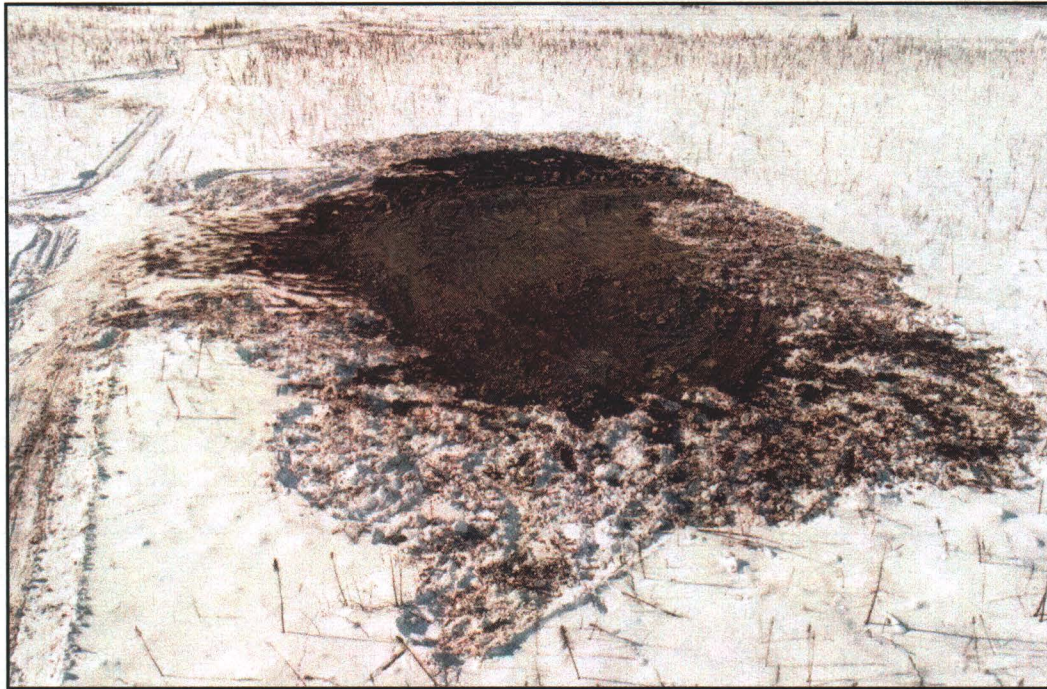
**Photograph 2.16: Aerial view of the new landfill after burial of non-contaminated debris and site re-contouring.**

The excavated soils and debris from the un-contaminated areas were loaded directly into dump trucks and transported to a landfill which was created outside the Peel River Game Preserve, approximately 20 km from the waste pit. The materials were placed into the landfill and covered with excavated overburden. The entire landfill area was then graded (Photograph 2.16).

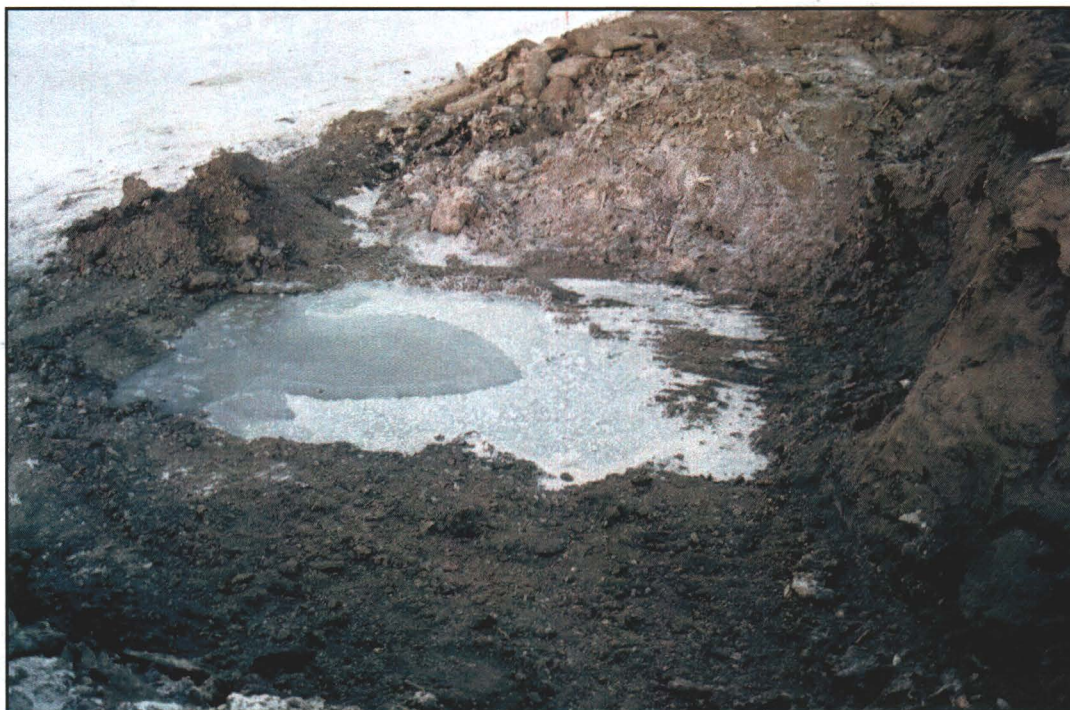
**Photograph 2.17: Small pool generated after excavation at the contaminated zone**

along with the ice barrier prevented the release of this water into the river (Photograph 2.17). A sample of the water was collected for laboratory analysis for DDT. The results are discussed in Chapter 3. The water froze overnight. Since the results of the field-testing indicated substrate in the area contained DDT in excess of 1 ppm, additional excavation was conducted. Sediments, along with water in the area were removed to the stockpile area and subsequently shipped off site for disposal.

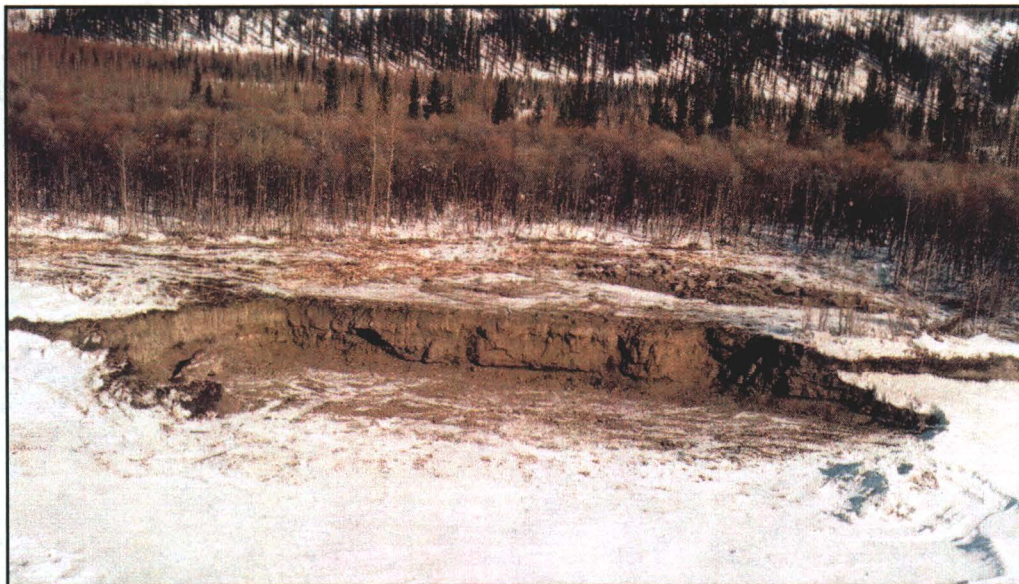
**Photograph 2.18: Waste Pit after removal of all debris and contaminated soil**

The original intention was to replace the excavated overburden back into the pit and re-contour the slope after completion of the excavation. However it was felt that the erosion forces of the Peel River would remove this overburden and deposit it into the river. Following consultation with stakeholders and regulators an application was submitted to the Yukon Water Board to allow for a deviation to the original plan for re-contouring and leaving the excavation as is. The excavation was therefore left as is following the removal of all contaminated soils and debris (Photograph 2.18): no overburden was re-placed into the pit. A copy of the approved amendment is attached to Appendix A.

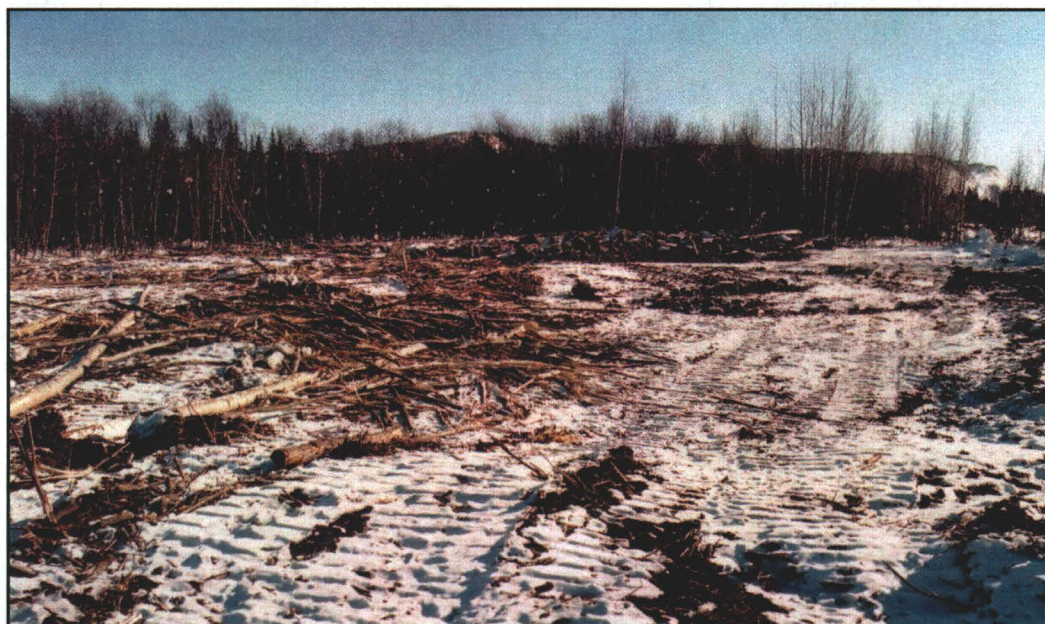
**Photograph 2.19: Stockpile area after project completion**

The removal and off site transport of contaminated soils and debris from the stockpile area was completed in March 2002. The emergency shelter was removed and transported off site. The ground was then re-graded in a manner which was consistent with the topography of the site and which prevented erosion and surface runoff from carrying sediments into the river. Vegetation removed from the site during site preparation was then spread over the site. Photograph 2.19 shows the status of the stockpile area after completion of the project.

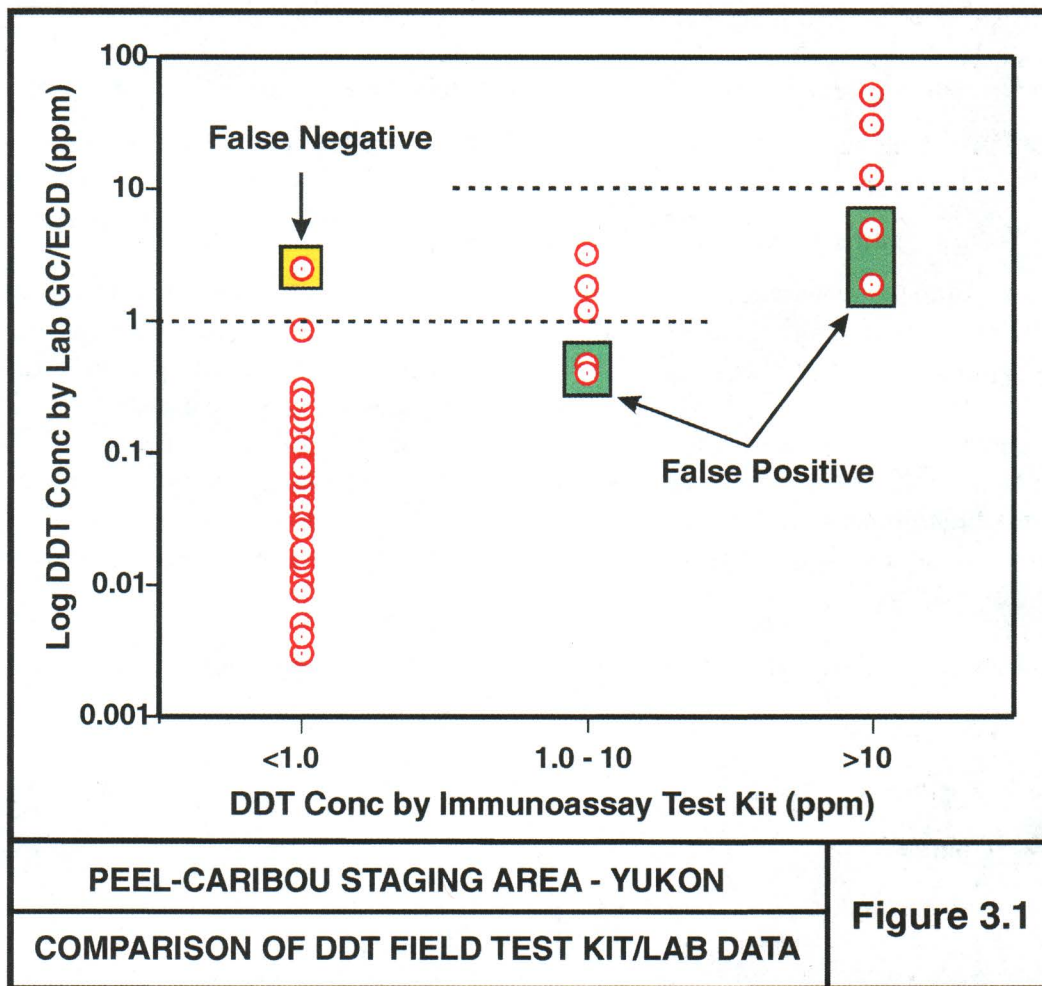
A total of 50 soil samples were analyzed for DDT using field test kits and laboratory gas chromatography with electron capture detection (GC/ECD). The field test kits accurately estimated the ‘true’ concentration as determined by GC/ECD for a majority of the samples. However, there was one false negative and 4 false positives (Figure 3.1).

The false negative result (i.e., the field test kit indicated the concentration was less than what was found in the laboratory) was for a sediment sample. High moisture content in this sample may have accounted for the discrepancy. Sediment samples were not target for remediation. While four soil samples indicated false positives (i.e., over-estimate the total DDT concentration based on laboratory analysis), in no case did a soil sample determined to contain less than 1 ppm DDT using the field test kits have a real total DDT concentration greater than 1 ppm. It was concluded that the DDT field test kit data would provide a good indication of soil samples at the sites with DDT concentrations above or below 1 ppm. To determine the exact concentration a subset of the samples would be analyzed in the laboratory using gas chromatography with electron capture detection.

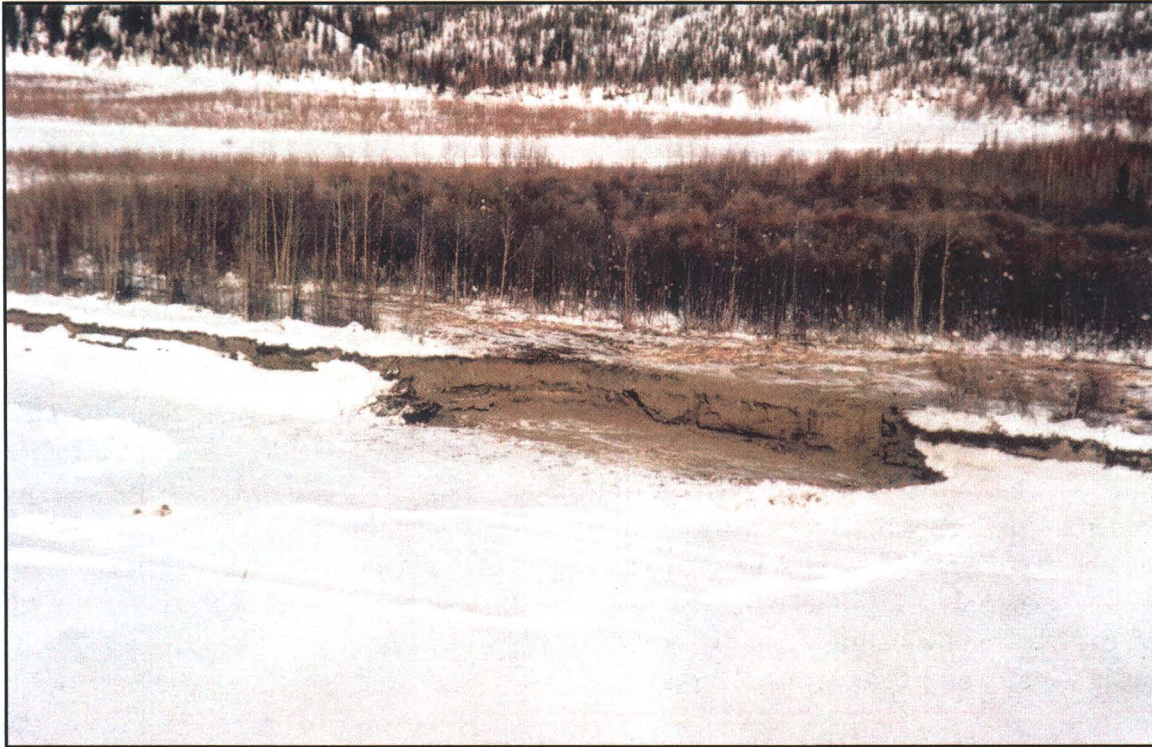
**Photograph 4.1: Area view of the Peel-Caribou Staging Area looking north, after project completion in March 2002**

The waste pit excavation was left as is, without the replacement of overburden. It was anticipated that erosion forces of the Peel River would remove any overburden placed in the pit and deposit it into the river thereby increasing the sediments loading. A view of the site upon completion of the project is shown in Photograph 4.1.
