ASSESSMENT REPORT

106D-02-1

CLARK

DIAND TECHNICAL SERVICES

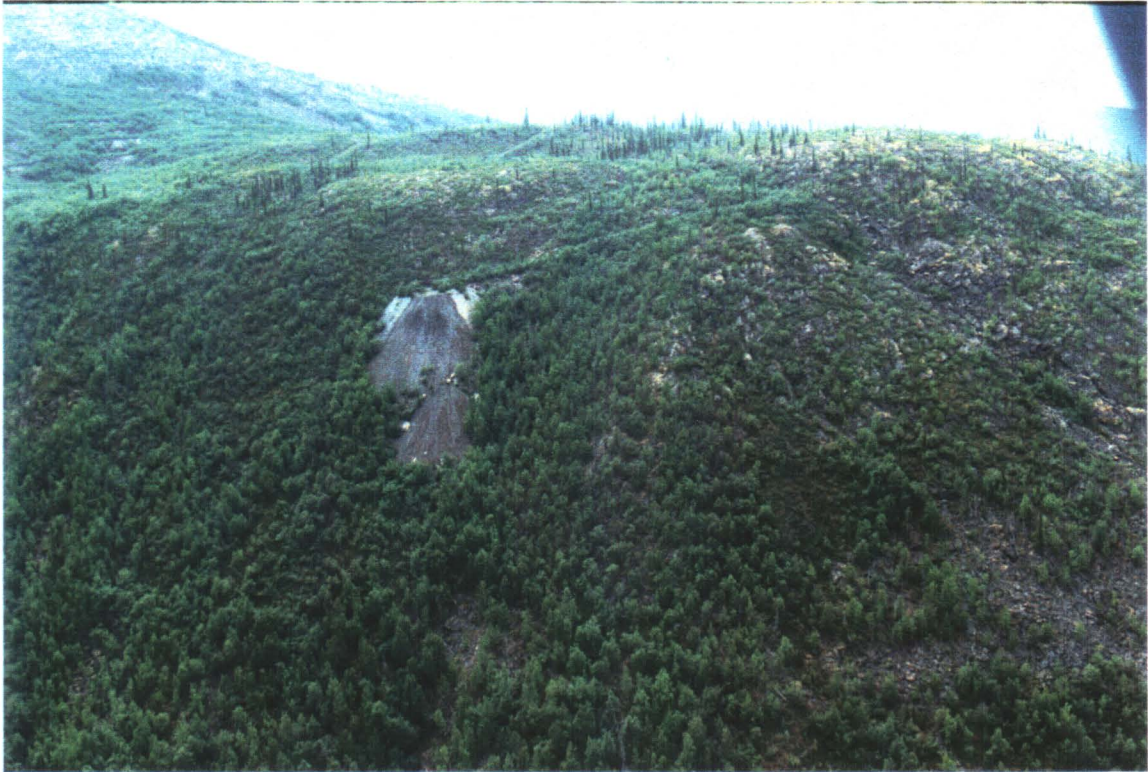
The predominant feature at this site is the adit mid-point on the slope, with the waste rock dumped below the entrance. Above the adit is the remains of the tent camp and core. The trails between the adit and camp as well as the trenched areas are overgrown with vegetation.

OVERVIEW OF SITE

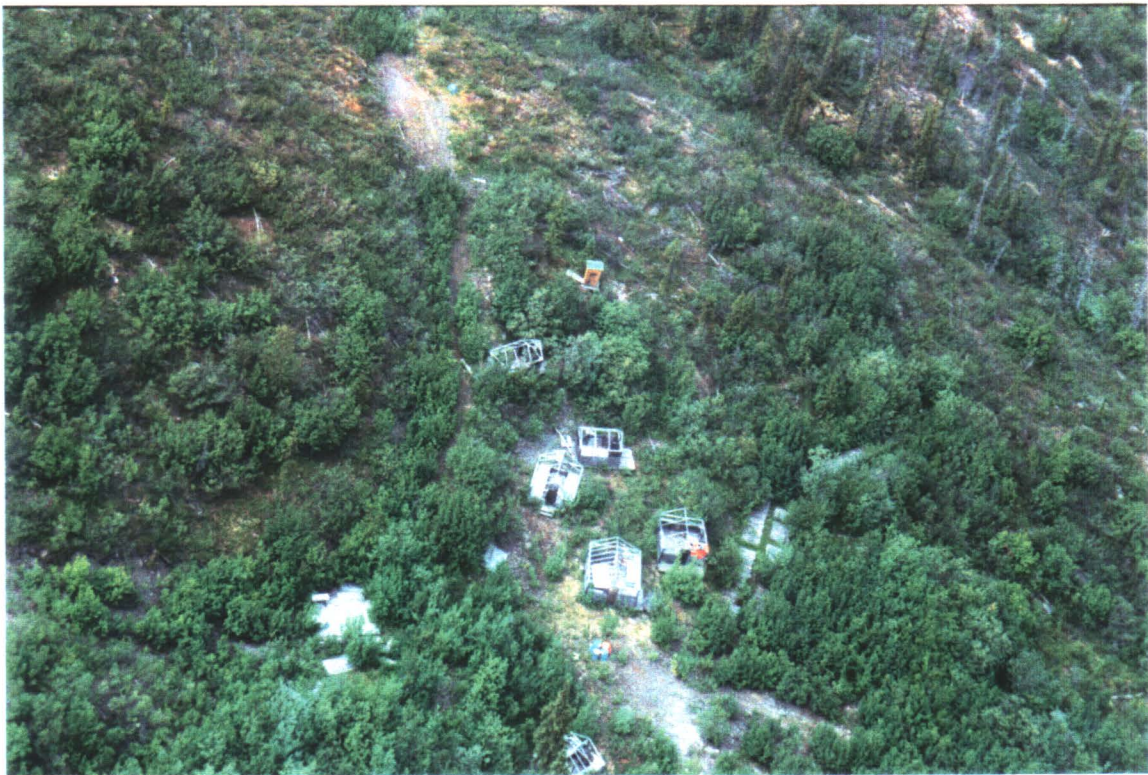
The core located at the camp site is getting scattered, is weathered and does not appear to be of much value. A qualified geologist would need to be retained to determine the residual value of the core.

TENT CAMP

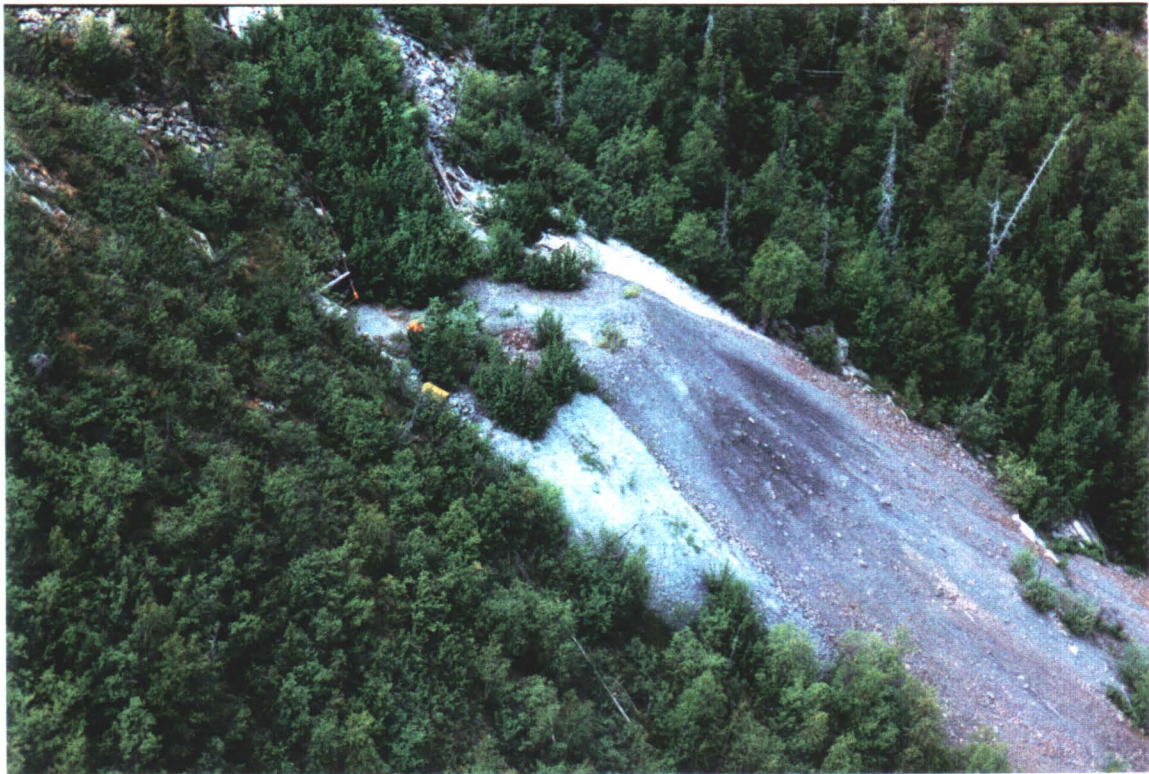
The most impact at this site has been caused by the development of the adit and the resulting waste rock dump. The adit is open and could be accessed by the public and should be considered a safety hazard. However it should be noted that the adit is in a very remote location and very difficult to reach. For this reason closing the adit to prevent access to unauthorized people is considered a **LOW** priority because this site is so remote.

The most significant environmental damage at this site was from the development of the adit and the resulting rock waste dump. The impact on the environment from this activity is considered **LOW** at this site as there does not appear to be any ongoing damage to the environment. Revegetating the roads, drill sites, and trenching sites has occurred naturally and is not needed.

ADIT AND ROCK WASTE DUMP

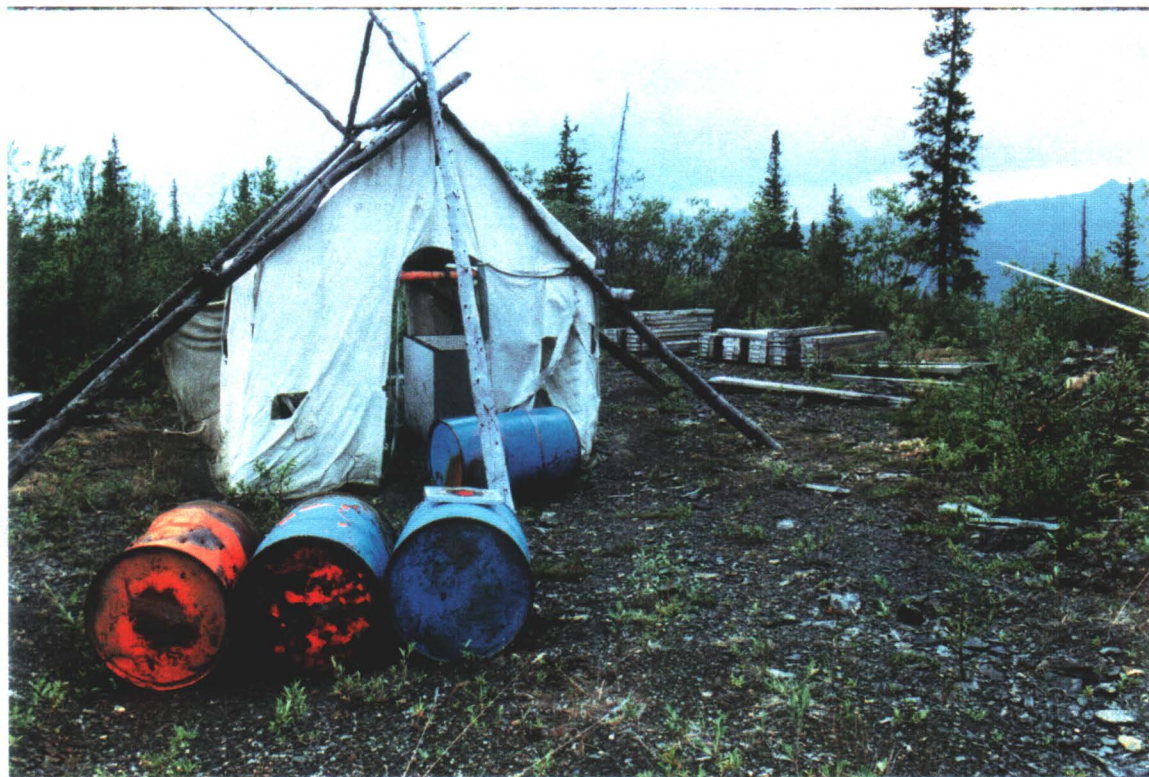
The fuel is located in barrels near the tent frames.

TENT FRAME, FUEL BARRELS, AND ROCK CORE BOXES

Over four barrels of diesel are still located around the tent frames. This fuel should be removed from the site to eliminate the potential for small hydrocarbon spills in the area.

The waste that has been left around the site does not appear toxic in any way and is also considered to be having a **LOW** impact on the area. The only potential damage could be from a small fuel spill and it is recommended that the remaining barrels of diesel be removed.

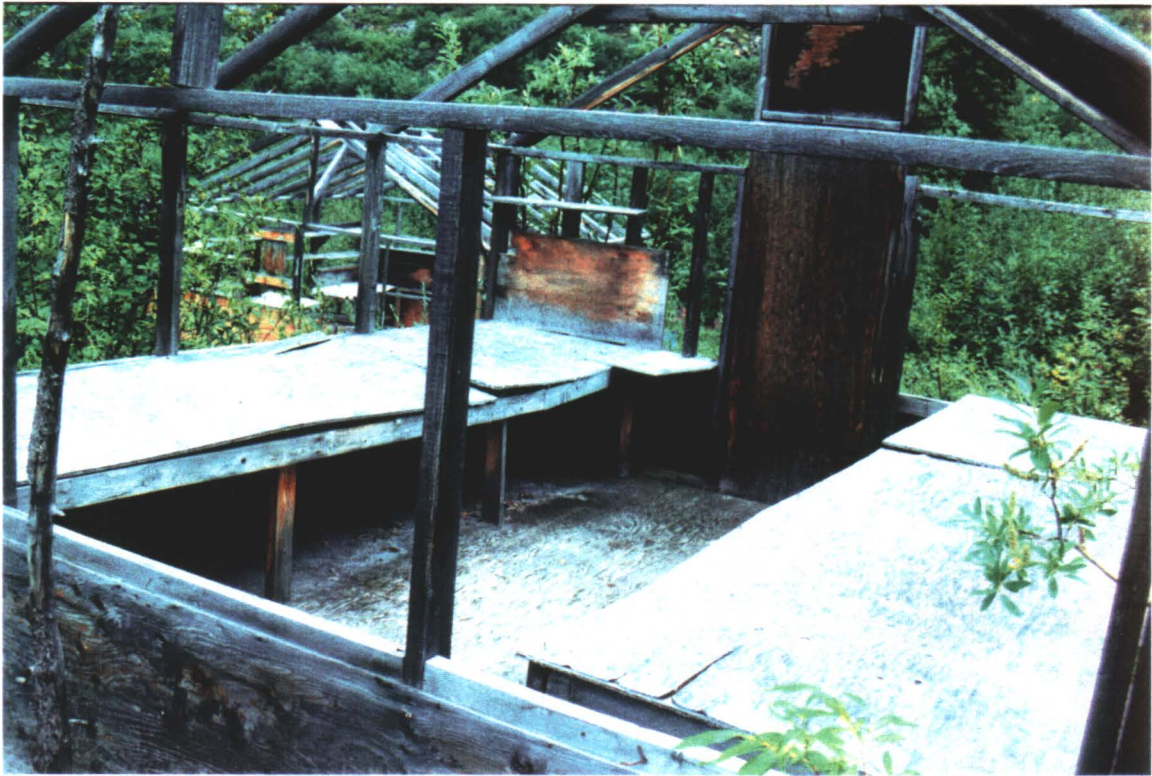
TENT FRAMES

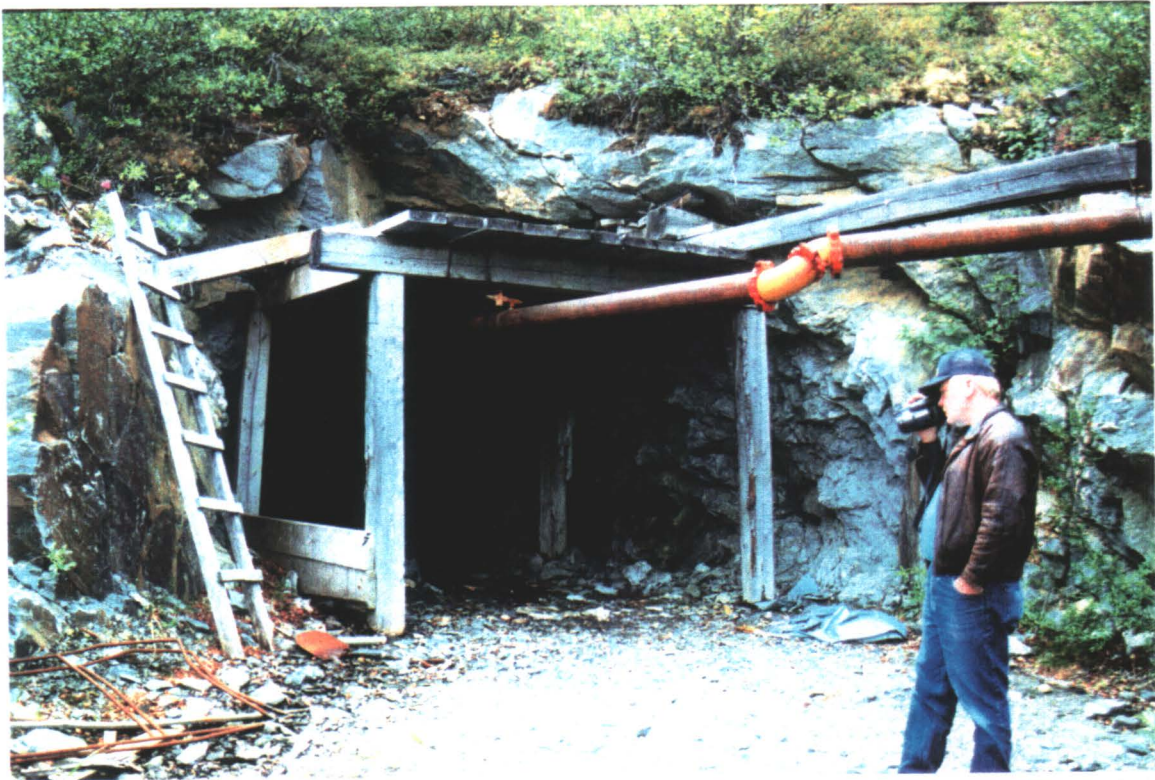
ADIT
