ASSESSMENT REPORT

105B-01-1

DALE

DIAND TECHNICAL SERVICES

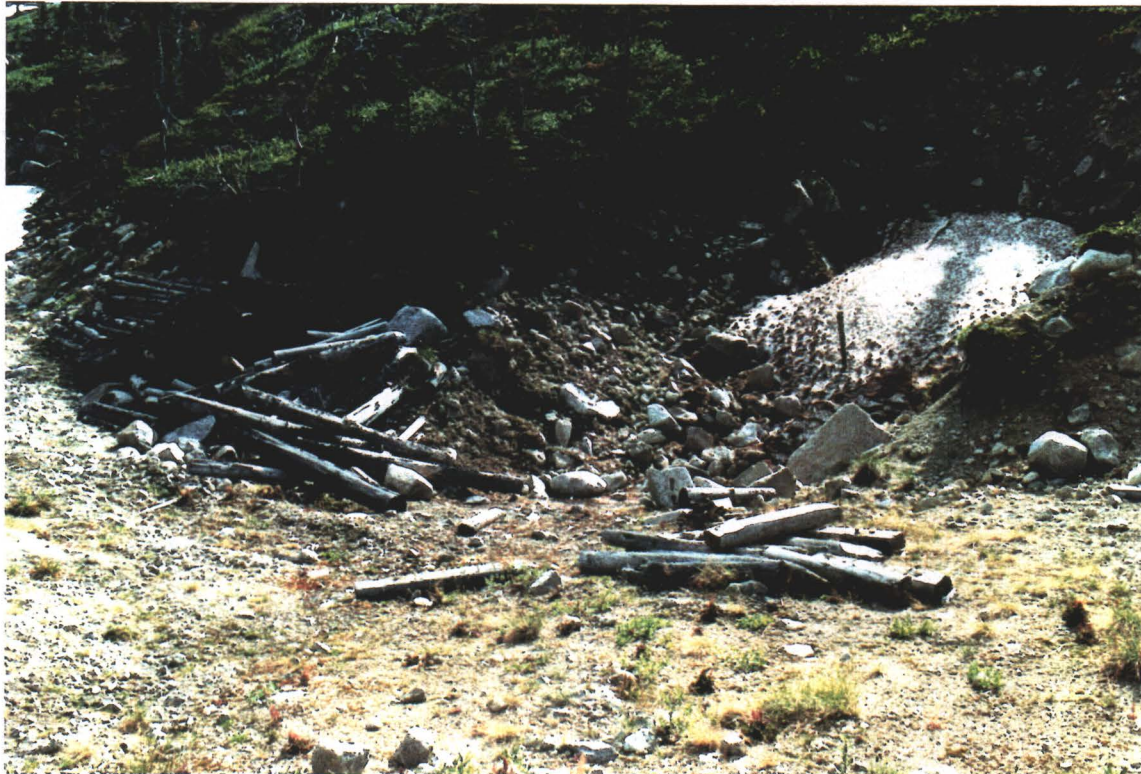
1. ADIT LOCATION

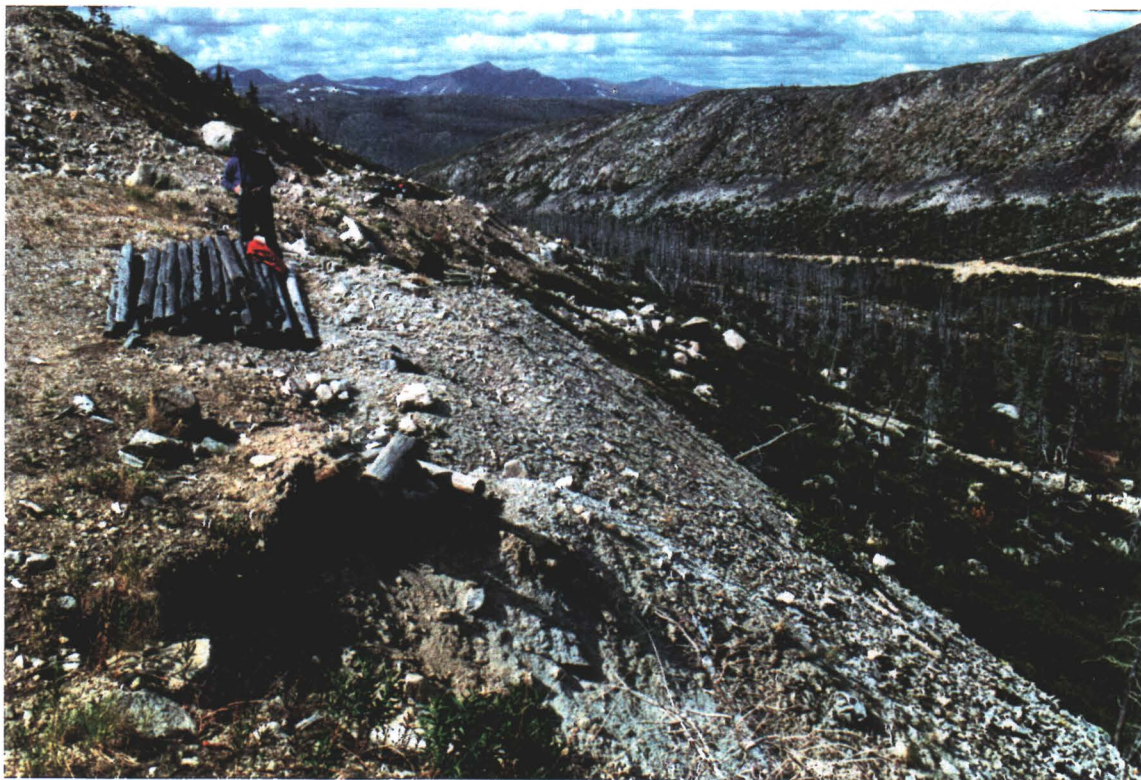
2. WASTE MATERIAL AND LAGGING FROM ADIT

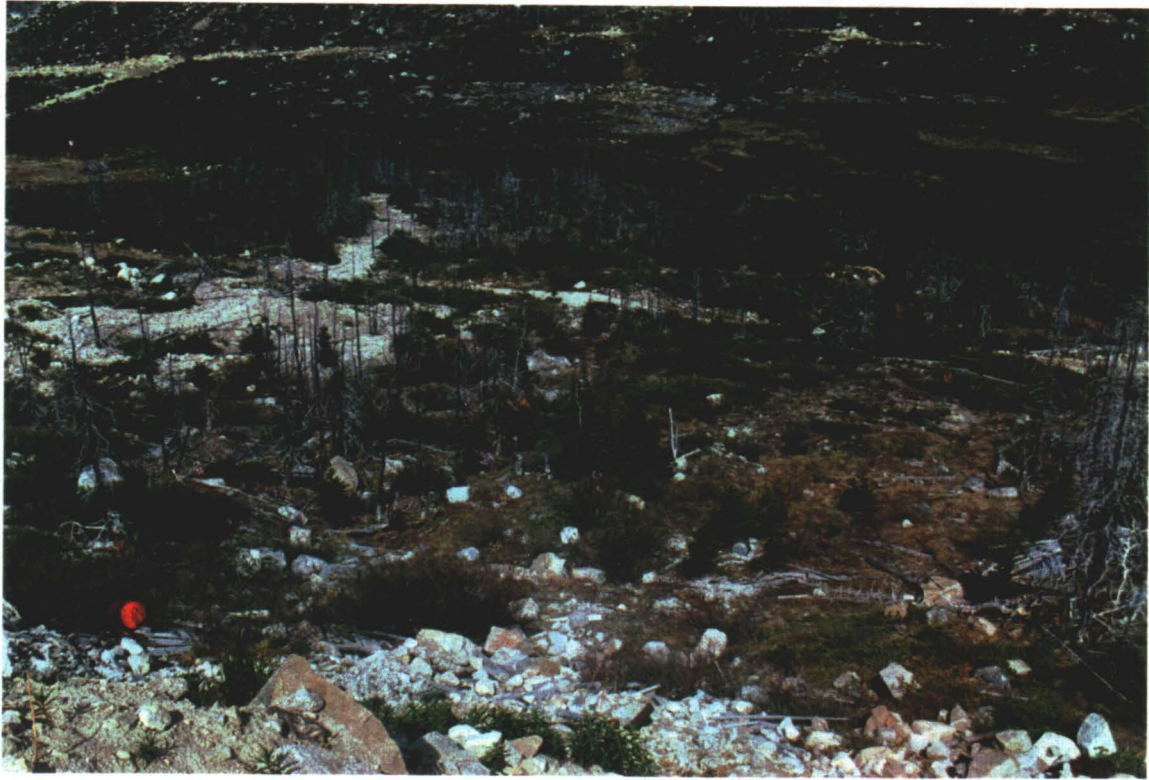
3. WASTE MATERIAL DOWNSLOPE OF ADIT

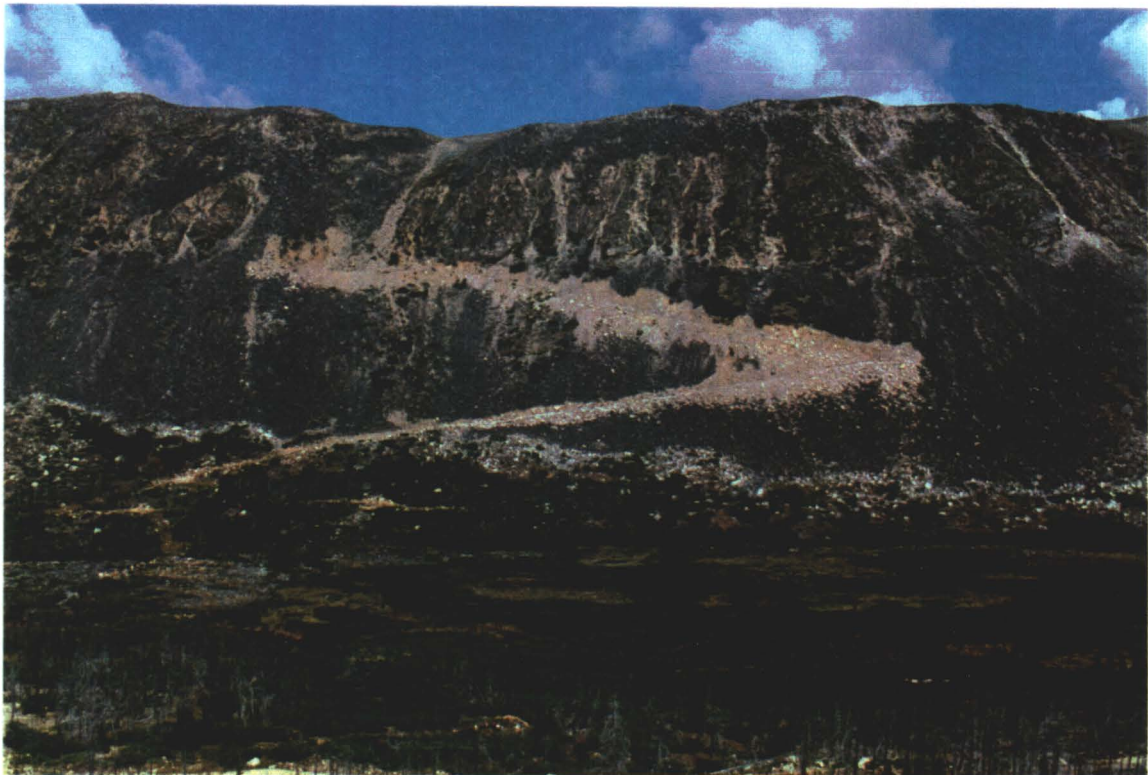
Extensive trenching and stripping across this area has resulted in significant damage to the surface soils and vegetation. The damage to the surface is significant from the exploration activity. Some erosion and slope failures were observed in gullies along the very steep access roads particularly in the area of the adit.

4. EXPLORATION ROAD

Attempting to revegetate the roads and exploration areas would be very difficult. The disturbed areas will eventually revegetate themselves from the local vegetation encroaching into the disturbed areas. This revegetation process is likely the only practical solution in an area that is extremely remote with a harsh climate.

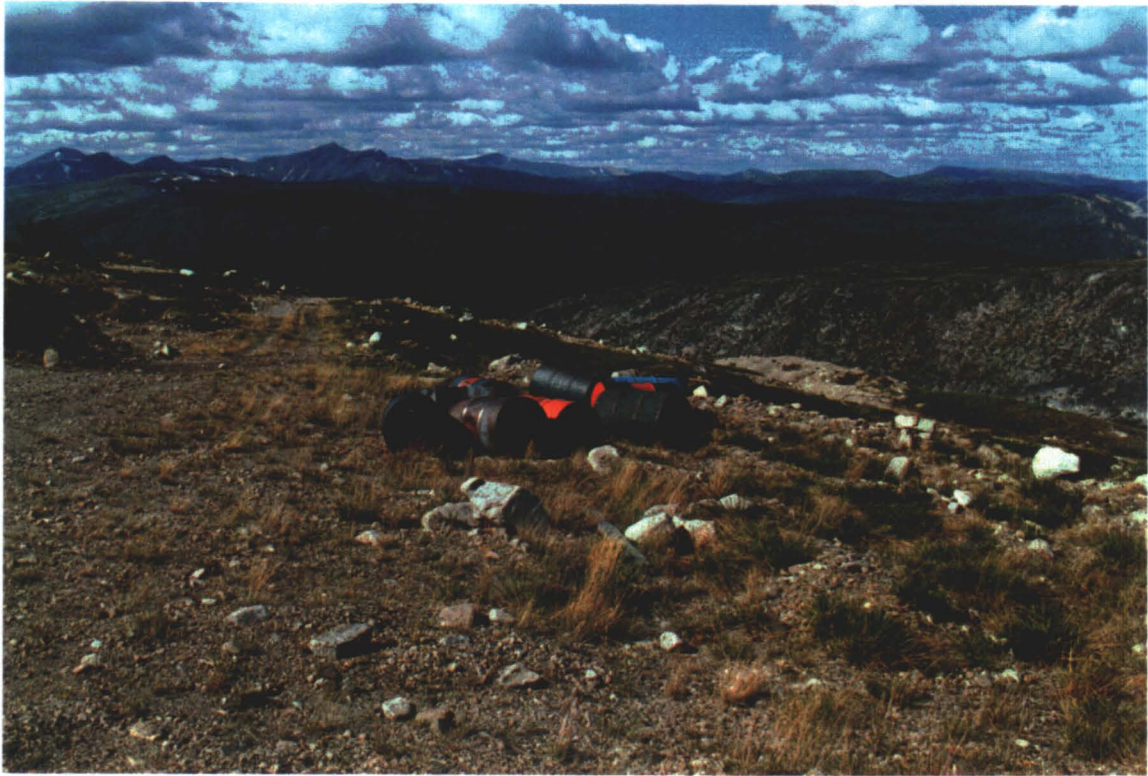
5. EMPTY BARRELS AT EXPLORATION SITE

Recovery of the 7 or 8 metal barrels scattered over the site should be completed if a clean-up program is undertaken in the area. These barrels are empty and no sign of leaking hydrocarbons was observed. These could only be flown off the site as road access to the exploration area is impassable.

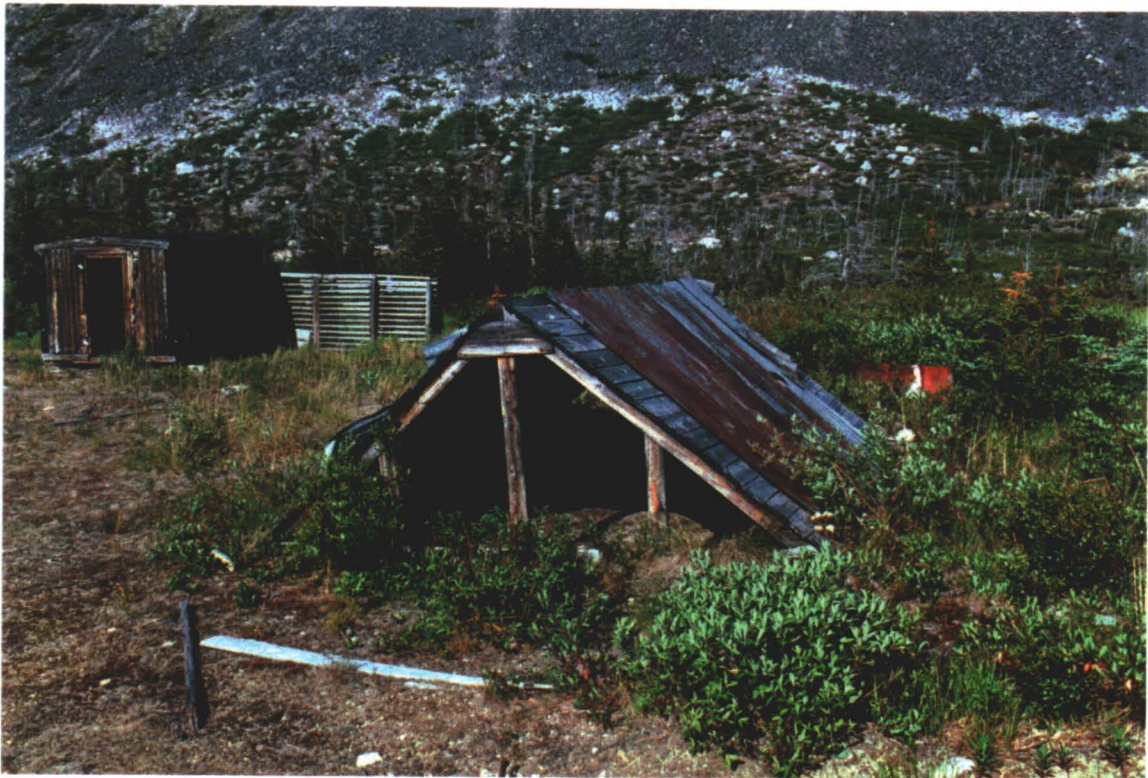
Little remains at the camp site from the original exploration, with a small 4x5m core shed, a core rack, a small wooden A-frame shed, a wooden platform, some scattered core and core boxes, and 8 empty barrels being the only items left. No hydrocarbon products or any equipment remains on-site and no ground or adjacent stream contamination was evident. Although the site is adjacent to a tributary to Freer Creek, the remains of the camp site area is well away from the bank of this stream and does not appear to be having an impact on the stream.

6. A-FRAME, CORE RACK, AND STORAGE BUILDING AT CAMP LOCATION

- removing the barrels from the site,
- removing and storing any recoverable core from the site, and
- burning any wooden structures in a suitable area.

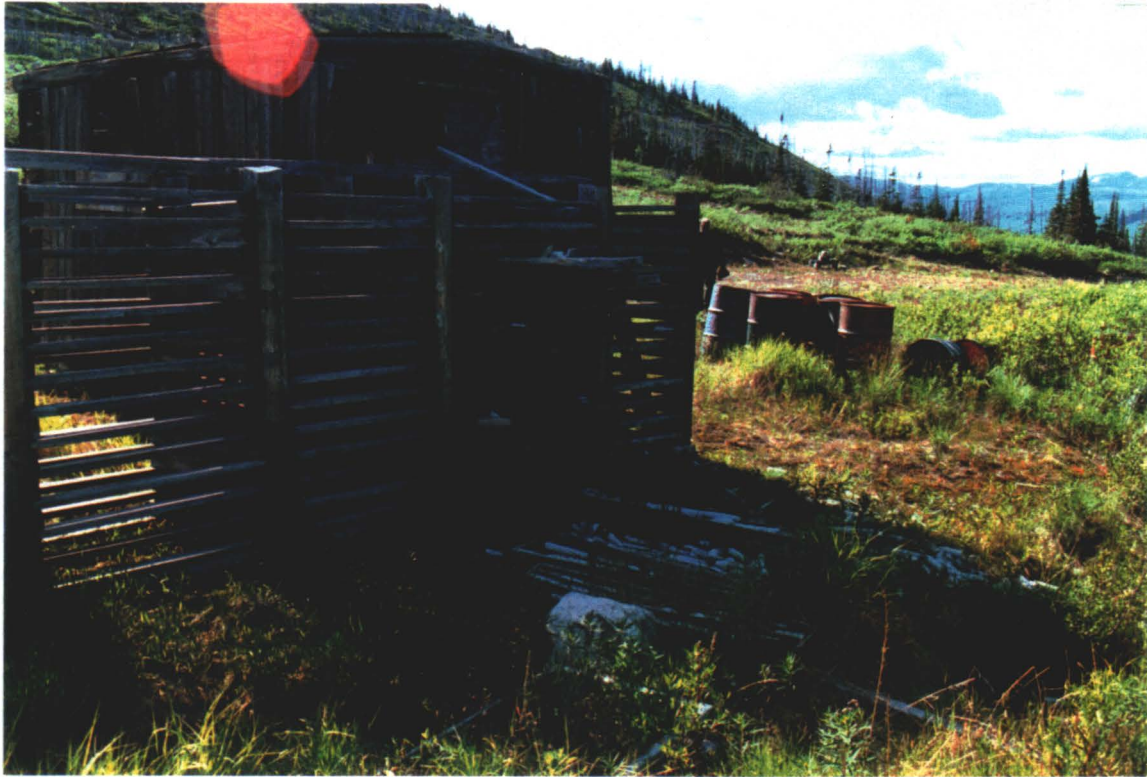
7. CORE RACK, SPILLED CORE, AND BARRELS AT CAMP LOCATION

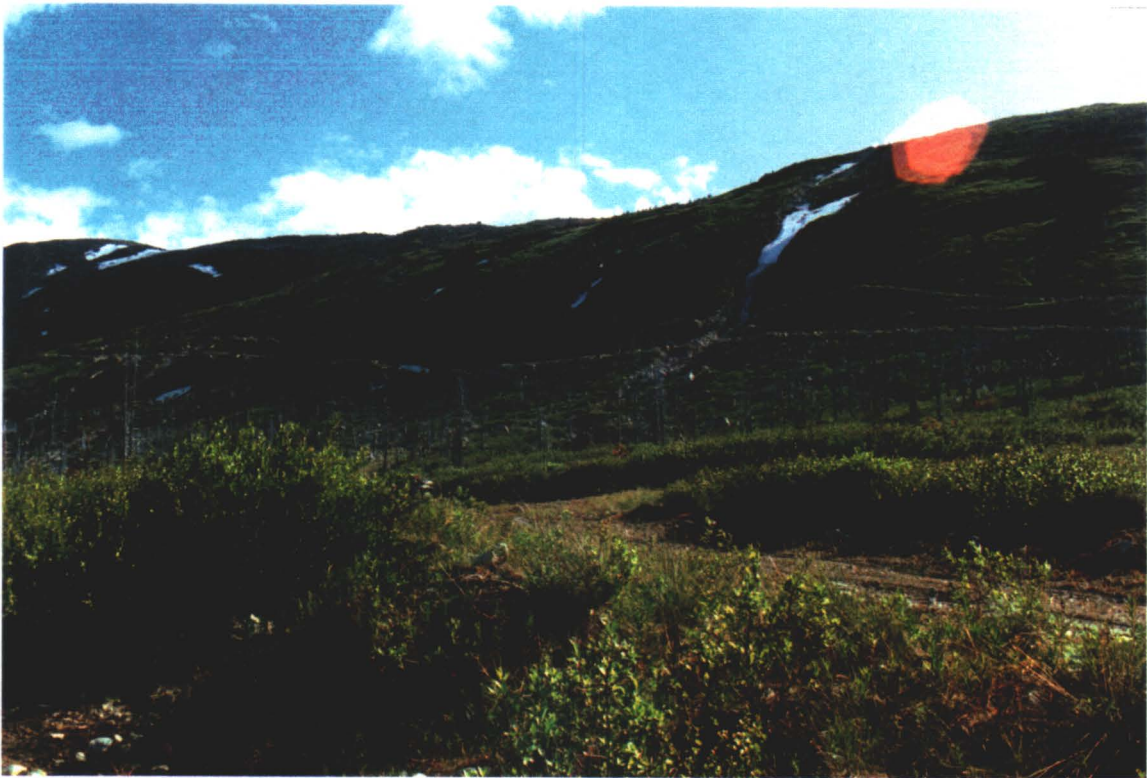
The slope failures and erosion are occurring naturally in the area as part of the local geologic process, as the slopes are naturally oversteepened. Whether or not the original construction of the roads triggered any of the slope failures is speculative, however there is no evidence that leaving the roads in place would cause further failures. As these roads have been in place for a long time, any stability problems caused by the original construction would have likely occurred by now. Site remediation of the roads is considered very difficult and costly in this very remote location. Any site remediation would also cause additional damage to the vegetation. No benefits to attempting any slope stabilization is apparent at this site.

8. EXPLORATION ACCESS ROAD AND SLOPE FAILURES
