ASSESSMENT REPORT

105B-07-1

HART

DIAND TECHNICAL SERVICES

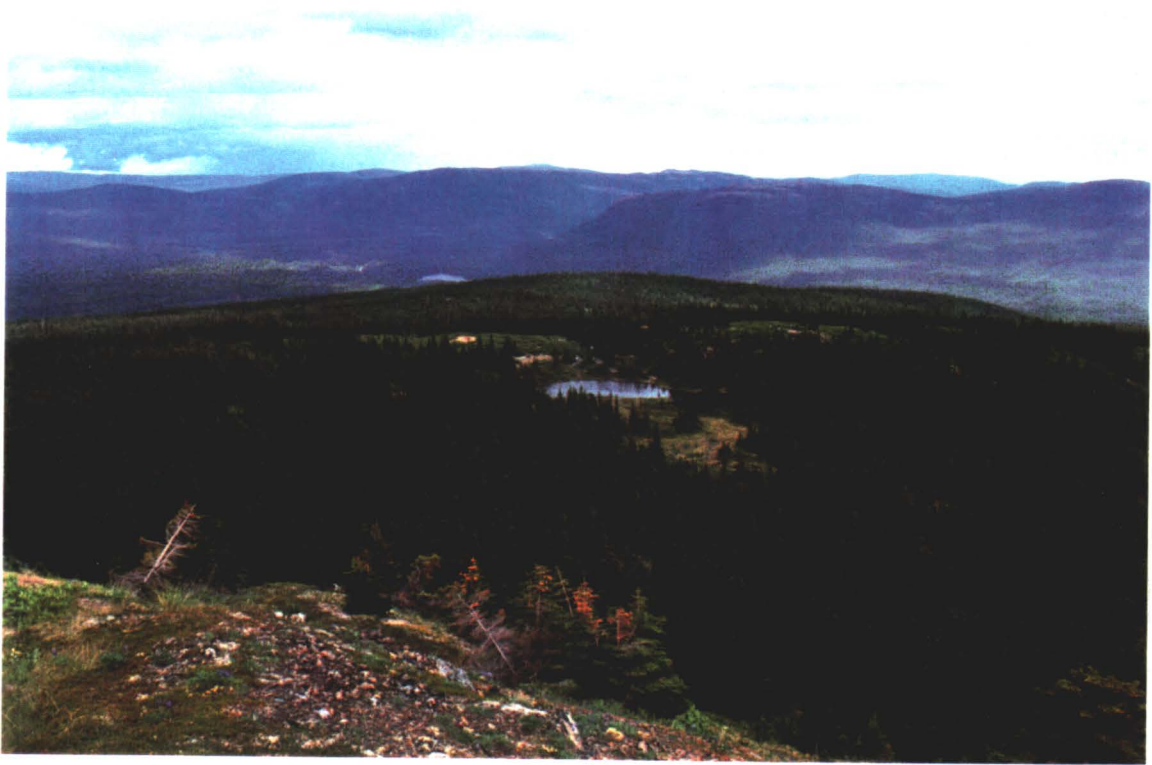
The Hart exploration site is located in the Cassiar Mountains. This exploration site is below an eroded peak on a moraine deposit overlying bedrock adjacent to a small lake. The Hart site is adjacent to and below the Silverhart site.

Exploration at this site was limited to dozer trenching and eight drill holes. This has left a small disturbed area covering an area estimated to be 200 x 100m in size. The majority of the physical exploration took place in 1971 and the site vegetation has re-established itself over the disturbed areas. It is difficult to find the old camp and exploration hole locations because of the revegetation that has taken place.

1. VIEW OF HART EXPLORATION SITE (ADJACENT TO LAKE)

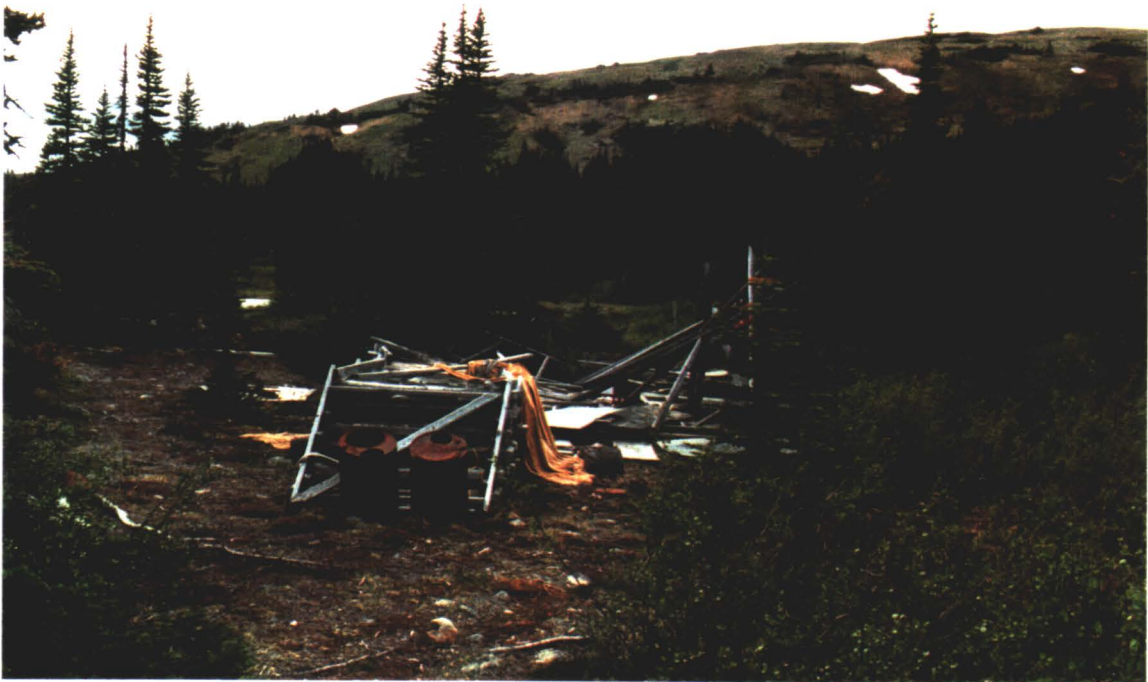
Remains of the camp site were found with two collapsed tent frames, a small inventory of scattered and unprotected core (50-60 core boxes), one barrel (204 litres) of jet B fuel date stamped 1988, eight empty fuel barrels, and minor amounts of other garbage (rusting camp stoves, tarp, etc.).

The core at this site was not stored properly and it will be difficult to properly catalogue any of the remaining core.

2. CORE BOXES, COLLAPSED TENT FRAMES, RUSTED WOOD HEATERS, AND TARP

- removing or incinerating the one barrel of jet B fuel from the site,
- removing the remaining empty barrels and other small pieces of metal waste, and
- piling and burning all wood tent frames and wood waste. This activity could be hazardous as the vegetation has regrown and there are few clear areas to safely burn in the summer season. This activity is considered a **VERY LOW** priority.

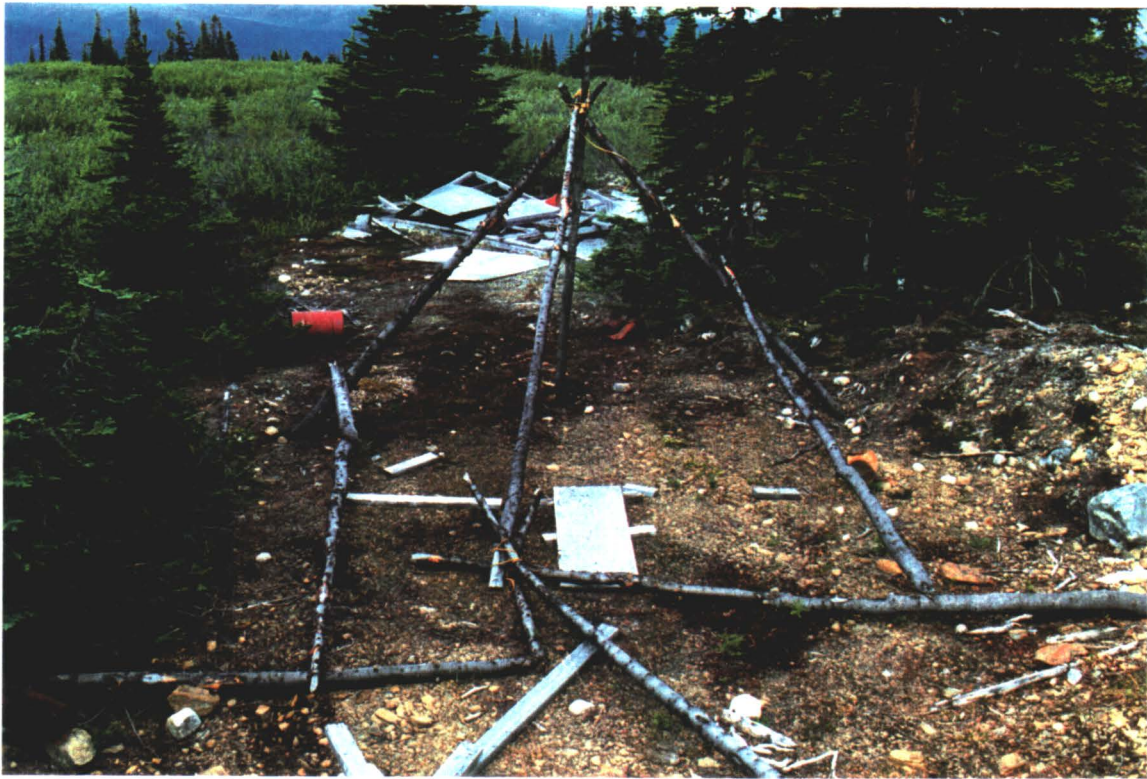
3. DEBRIS AT CAMP SITE

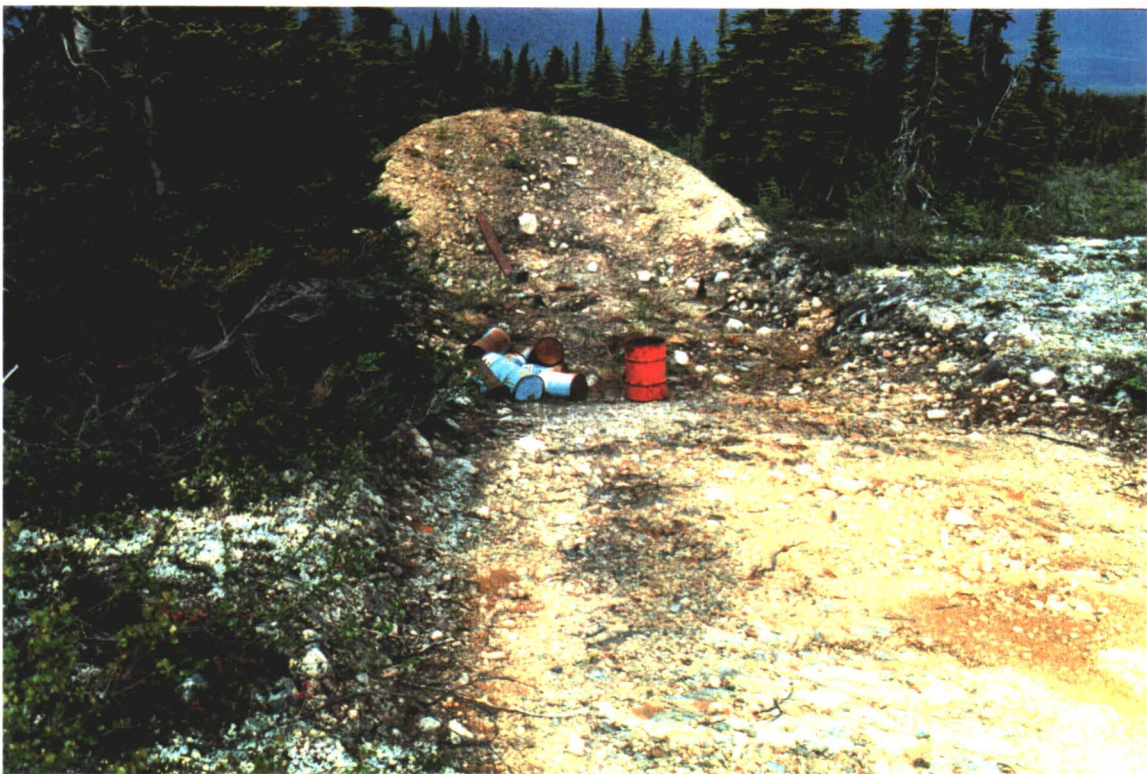
4. EMPTY FUEL BARRELS
