**ASSESSMENT REPORT**

**105B-04-1**

**LOGTUNG**

**DIAND TECHNICAL SERVICES**

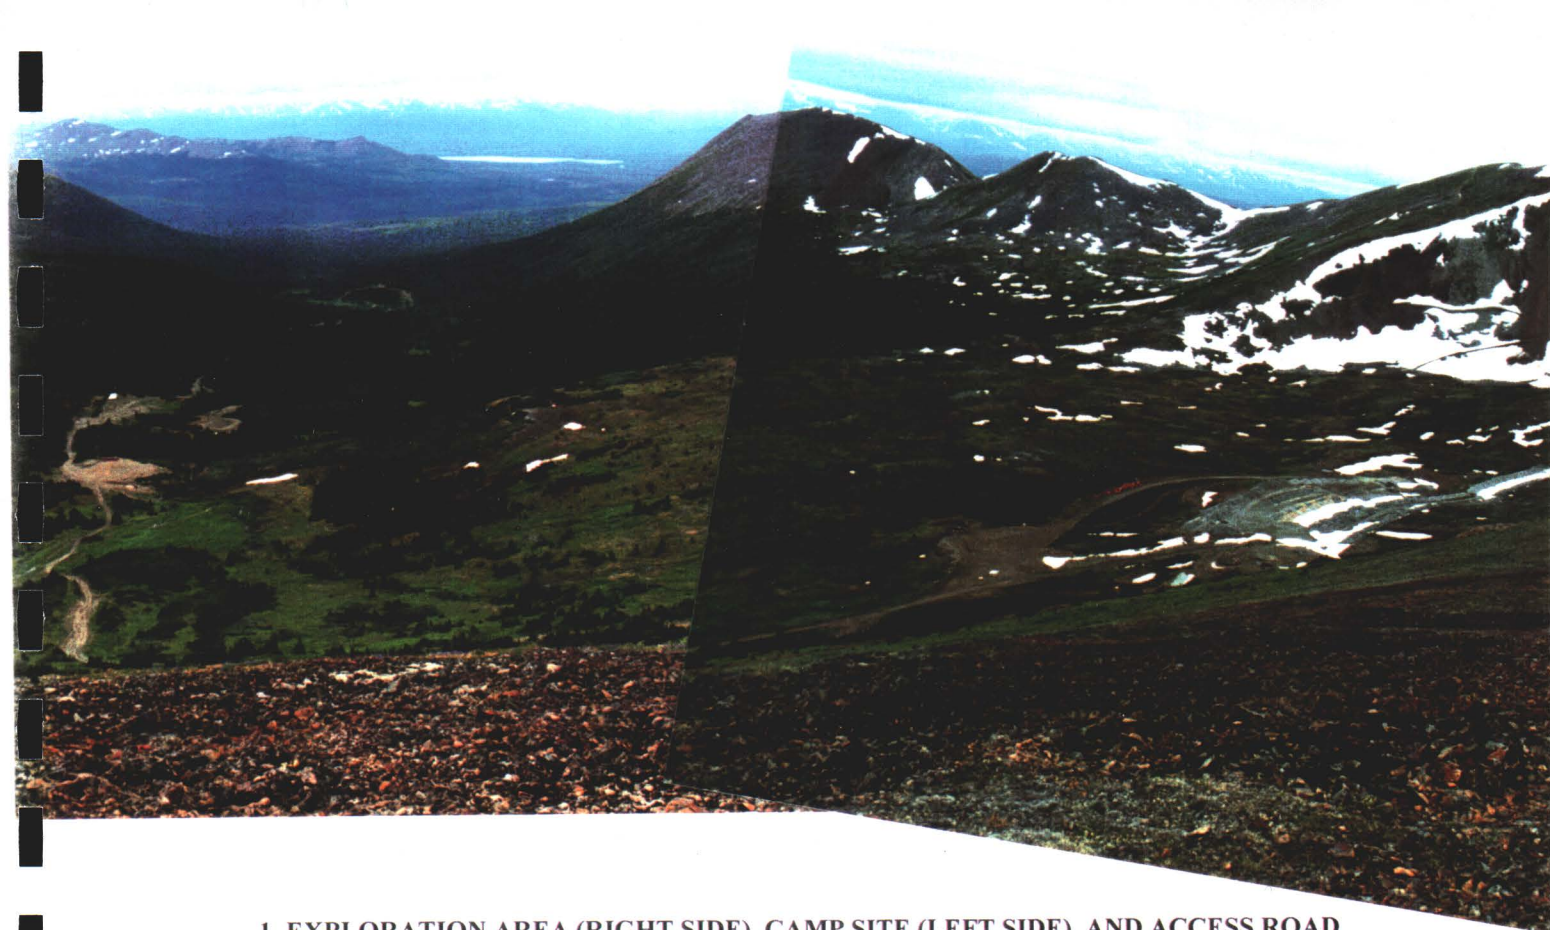
1. EXPLORATION AREA (RIGHT SIDE), CAMP SITE (LEFT SIDE), AND ACCESS ROAD

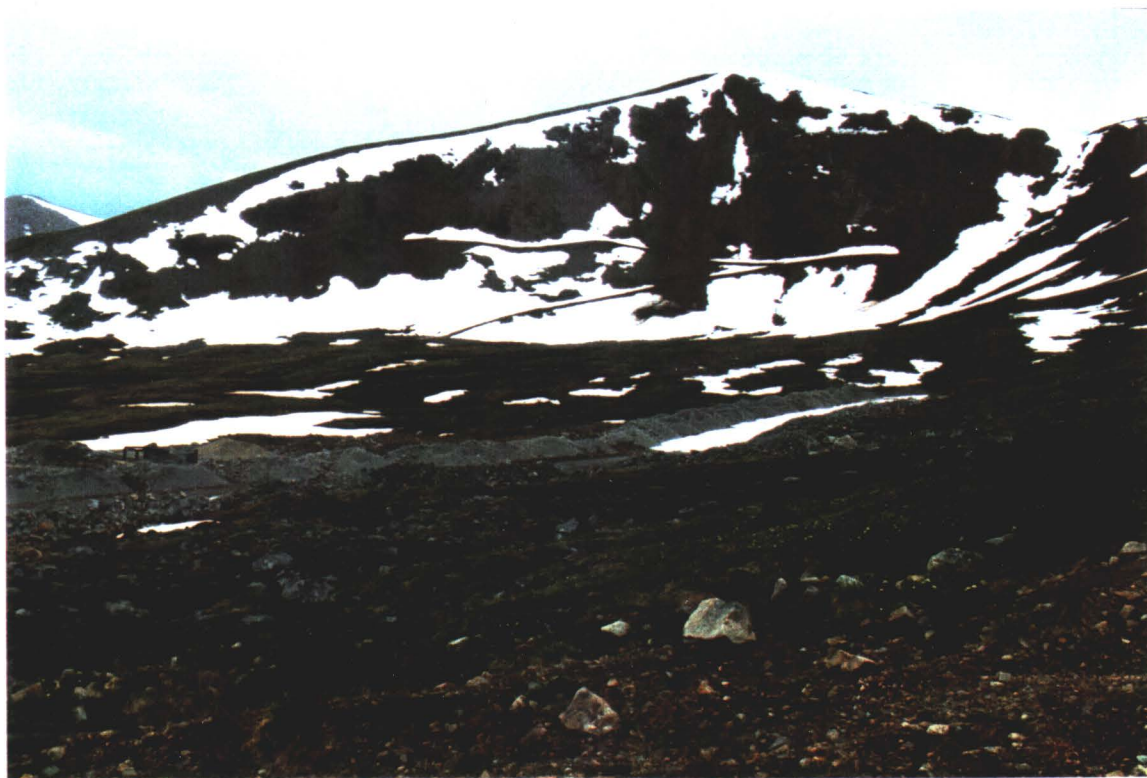
The drill sites are generally situated on the steep slopes above the adit location and had been constructed by means of a "cut and fill" operation. This type of construction requires material to be removed from the slope and mass wasted downslope to provide a level driving surface wide enough for equipment to use. This results in obvious scarring of the

surrounding mountain slopes and depending on the soil and water (surface and groundwater) conditions, can lead to slope instability and erosion problems. Because of the steep terrain in the area the exploration trails are seen from some distance away.

2. EXPLORATION ROADS AND SAMPLE PILES

Drill Sites and Roads - As noted the roads to the drill sites have been constructed on very steep, rocky talus slopes. These slopes are dry with very little vegetation cover. No sign of any slope instability or surface erosion was observed where the roads crossed the slope, and none would be expected to occur in future. The impact from these "road cuts" is visual, however it would not seem practical to restore the road cuts to the original surface profile in this very remote area. Doing so would be very costly, as well as additional disturbance to existing vegetation would cause additional damage.

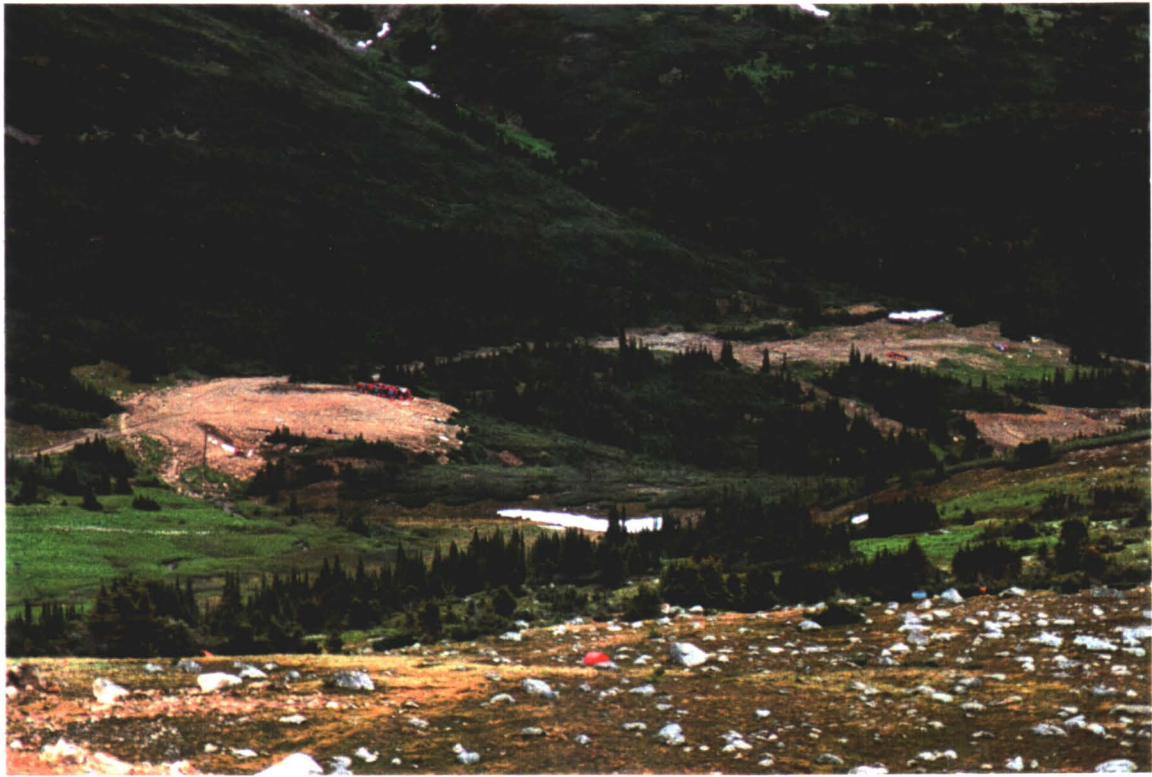
- 5 collapsing core sheds measuring 2.4x6.1m. Four core sheds are full and each contains 640 trays of core. One core shed is empty.
- 270 barrels of crushed ore stored on wooden pallets at two separate locations (240 barrels at one location and 30 barrels at another location).
- 21 empty barrels.
- one partially full barrel of oil. The remainder of the oil has leaked into the ground after the barrel was punctured from what appears to be a gunshot.
- a sewage lagoon constructed of the local silt and gravel. If fluids had been pumped into this lagoon, they have since leaked out.
- an excavated garbage pit adjacent to the sewage lagoon. The garbage pit contains small volumes of metal and wood waste.

3. CAMP LOCATION AND ORE STORAGE SITE

Ore Barrels - The 270 barrels of ore if left on-site are not expected to cause any additional site problems. Eventual deterioration will occur with rotting of the wooden pallets the barrels are stacked on, rusting of the barrels, and spillage of the ore product if the stored barrels upset. One option for clean-up of these barrels would involve;

- unstacking all barrels,
- hauling the barrels to the area where the bulk samples are stored,
- emptying all the barrels,
- crushing the barrels when the other empty barrels are crushed,
- loading all crushed barrels on trucks, and
- hauling all metal waste off-site.

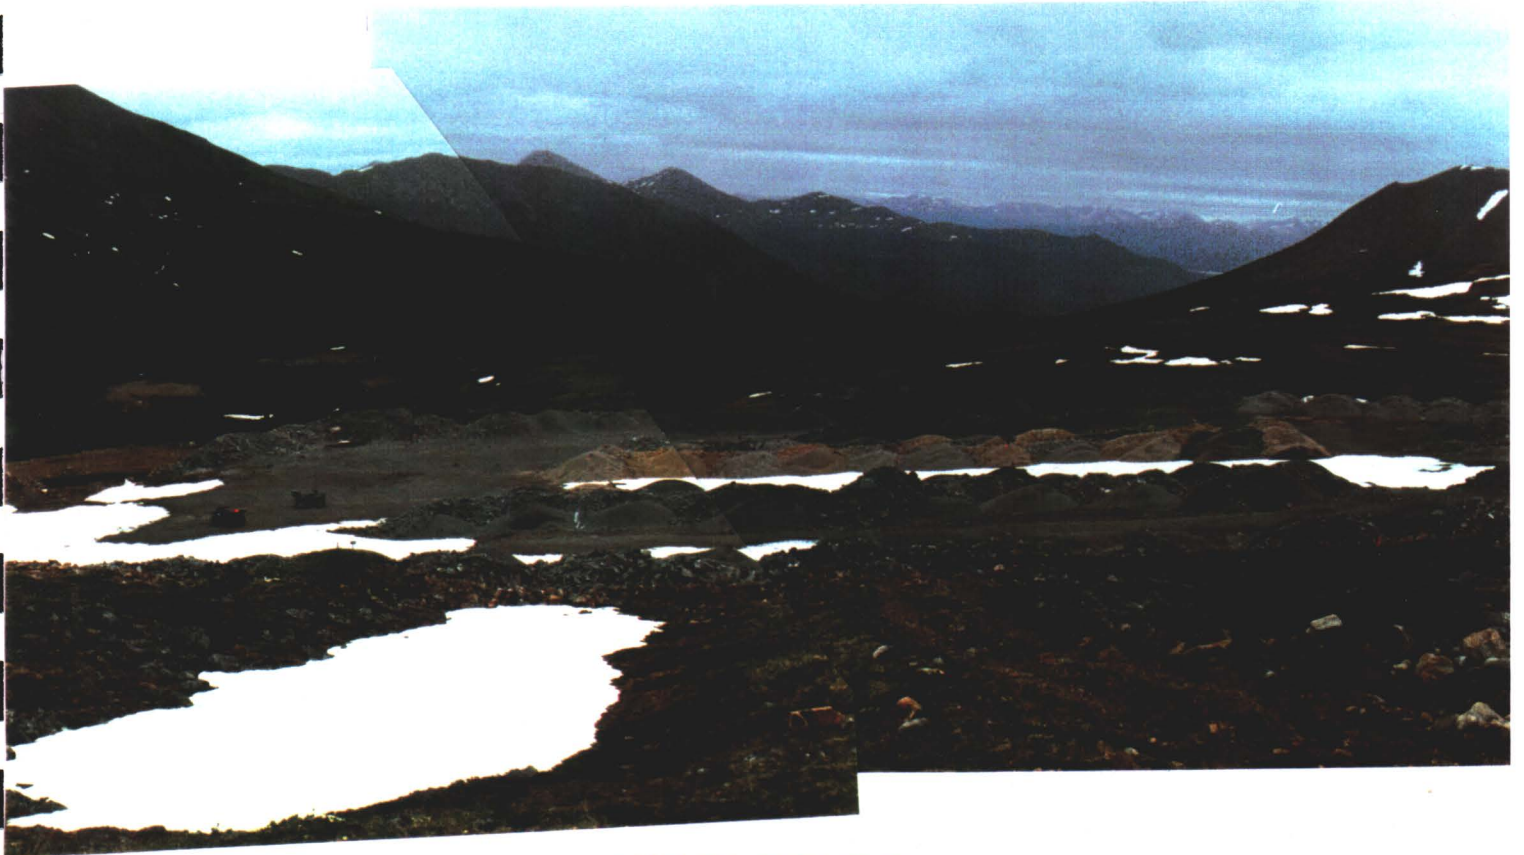
4. BULK SAMPLE PILES

Sample Storage and Barrel Loading Area - The bulk sample storage area appears as a continuation of the adjoining waste rock pile with samples piled in four rows covering an area measuring approximately 40x60m in size. Adjoining this site is a loading platform with built-in rollers for handling barrels. The only potential salvage at this site is dismantling and removing the loading platform. This is a very **LOW** priority and should only be considered if a comprehensive clean-up program is undertaken. It is recommended that this site not be disturbed as the only impact on the environment appears to be visual.

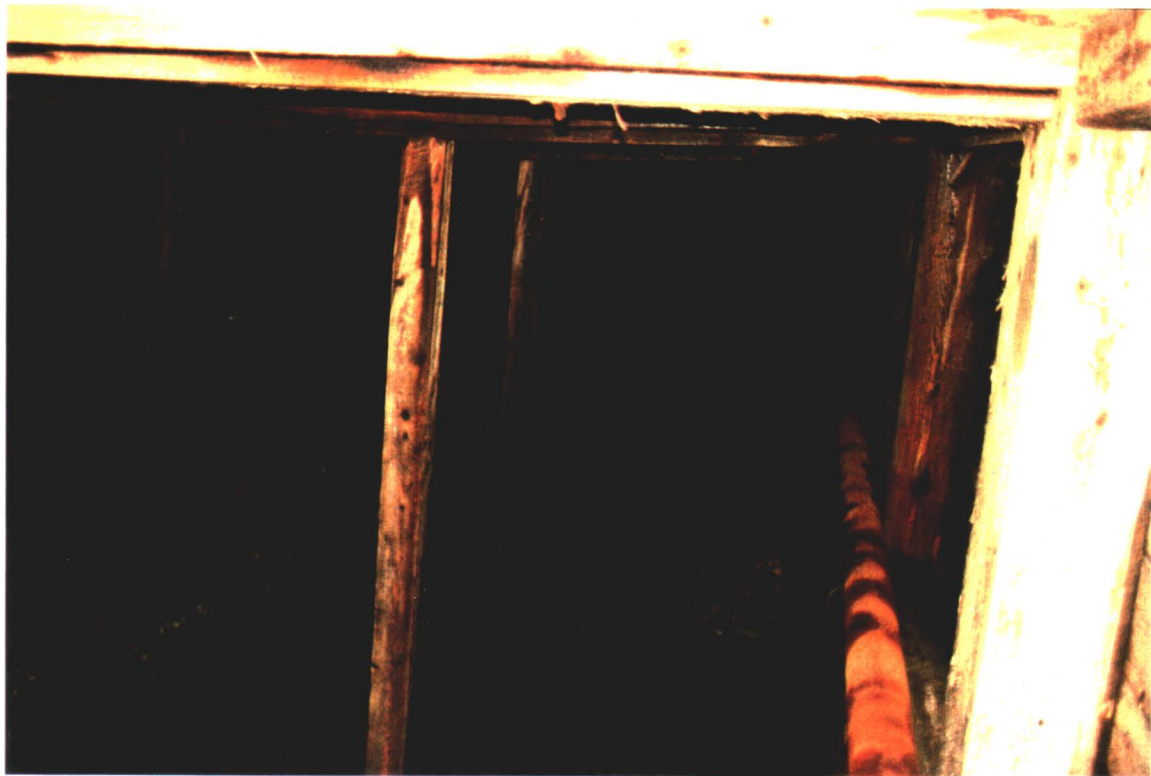
An exploration adit is situated near the base of the steep mountain slope. The entrance of the adit has been covered with a wire screen and a pile of rock has been dumped at the adit entrance to block any access. The wire screen is loosening from the weight of the seasonal snow pack and one corner of the adit is now accessible. Waste rock has been placed around the entrance to the adit and used as a working platform during the exploration phase. This waste rock covers an area approximately 50x100m. In excess of 100 bulk samples are also placed in four rows. Each row is two samples wide and measures approximately 10m wide and 60m long.

5. INTERIOR OF ADIT ENTRANCE

Adit - When the exploration site was closed the adit was properly sealed with a heavy wire mesh screen placed across the adit as well as waste rock being piled in front of the adit entrance. It was observed that the wire mesh was starting to be pulled down from the weight of the annual snow pack. Repairs should be made to this screen to ensure access to the adit cannot be gained easily.

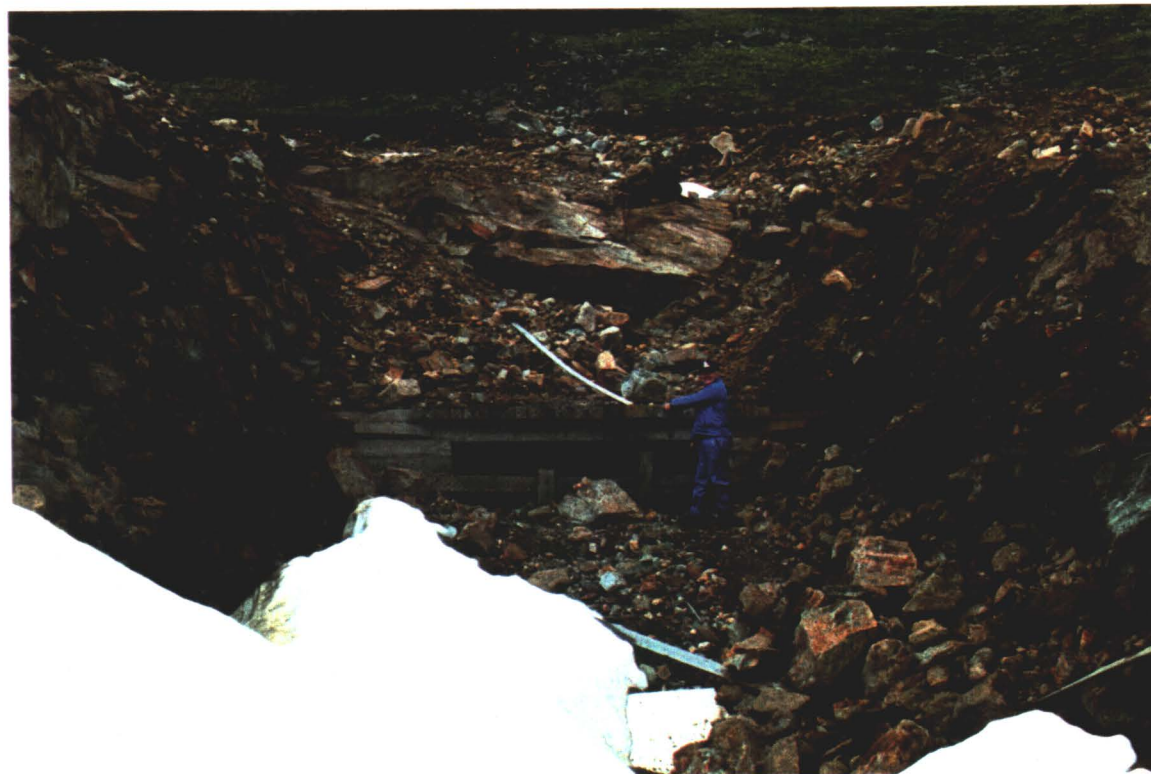
6. ADIT ENTRANCE

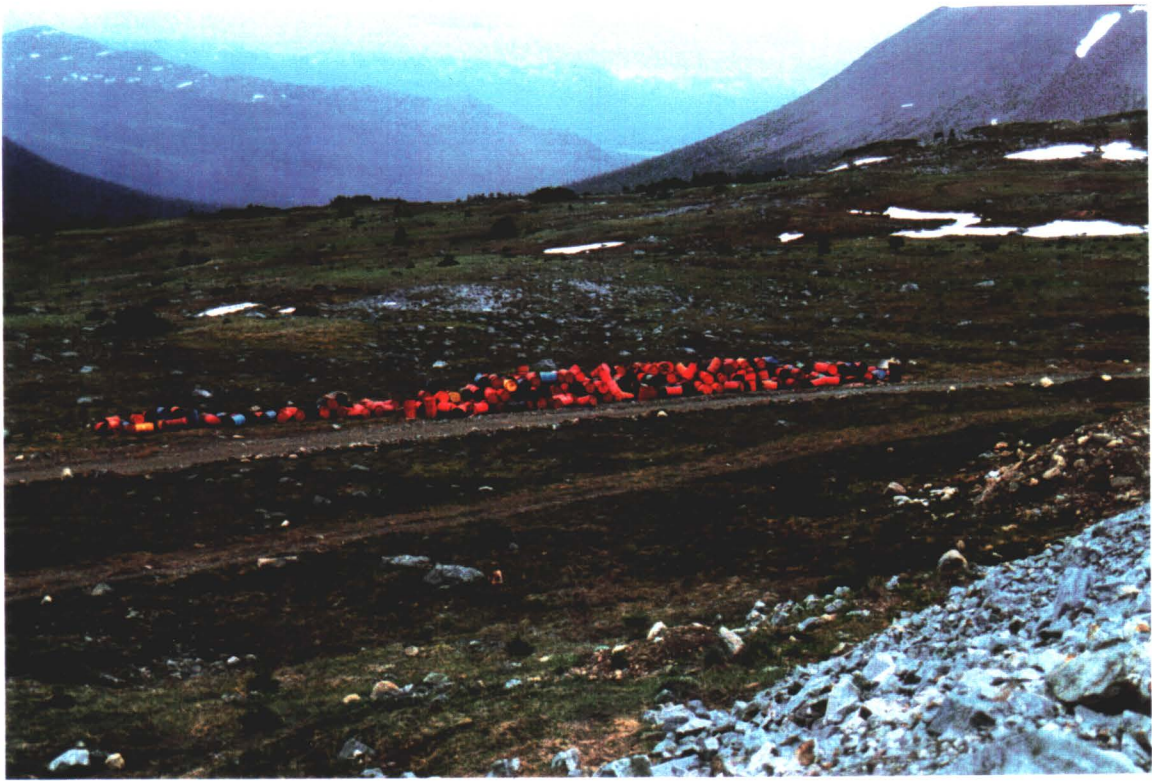
Below the adit between 200-300 empty barrels are randomly stockpiled in one large pile.

7. BARREL SITE

Barrel Storage Site - Between 200-300 empty barrels are piled below the adit and waste rock site and could be crushed and removed quite easily. If a metal waste recovery

program is in place, the removal of these barrels should be included in this program. Removal of these empty barrels is still considered a **LOW** priority because of the relative inertness of the metal.

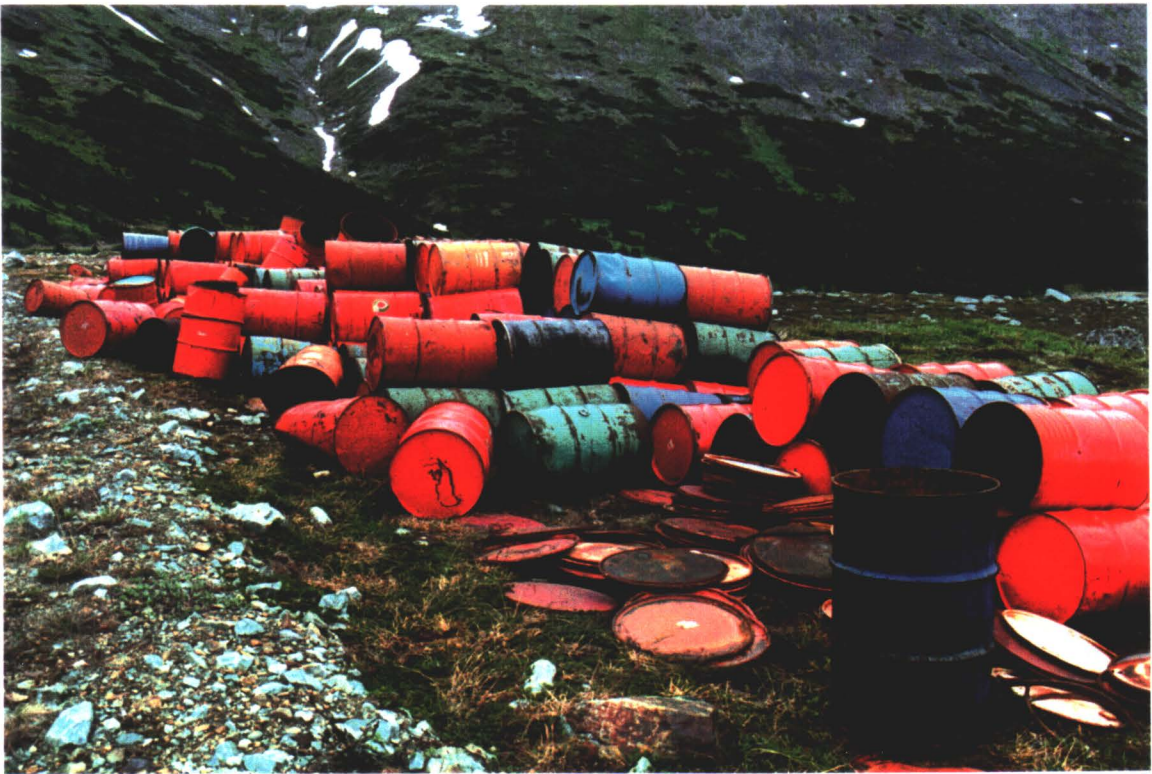
8. CLOSE-UP OF BARREL SITE

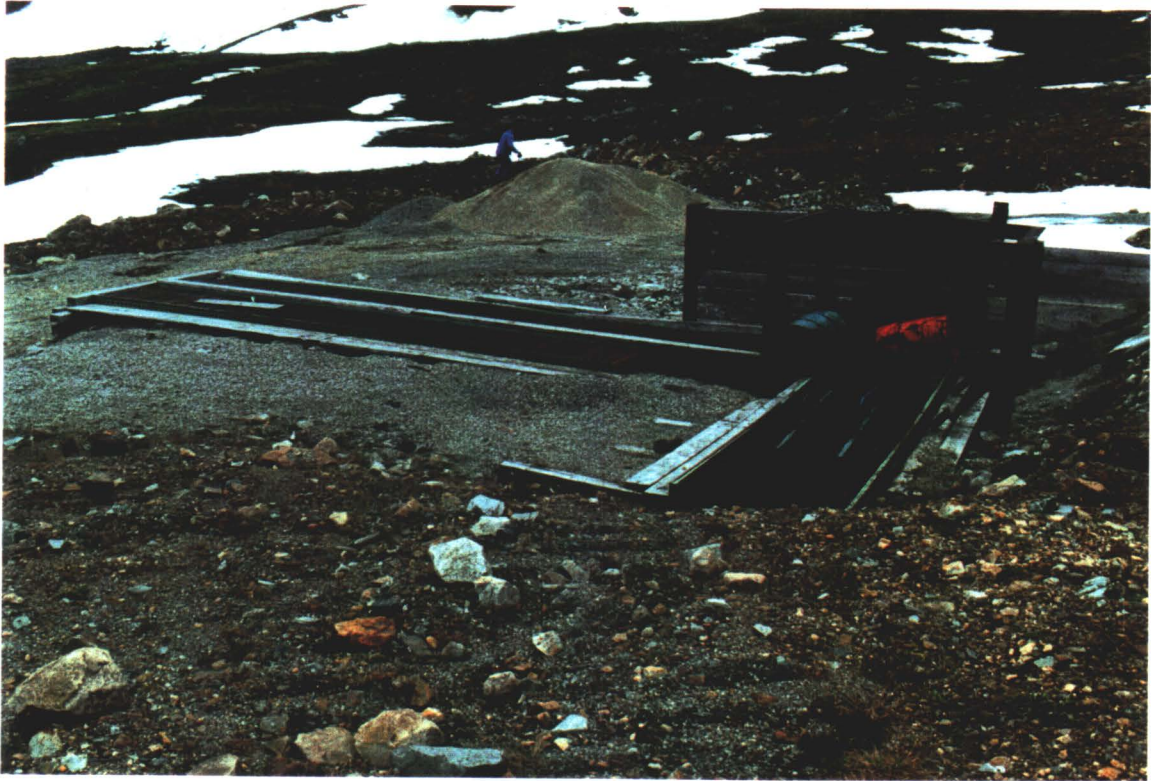
Adjacent to the bulk sample storage area is a loading platform with built-in rollers for handling barrels. This loading platform was used to load crushed ore samples into 204 litre barrels. The barrels were then loaded onto transport trucks and hauled from the site for additional refining and analyzing.

9. LOADING PLATFORM

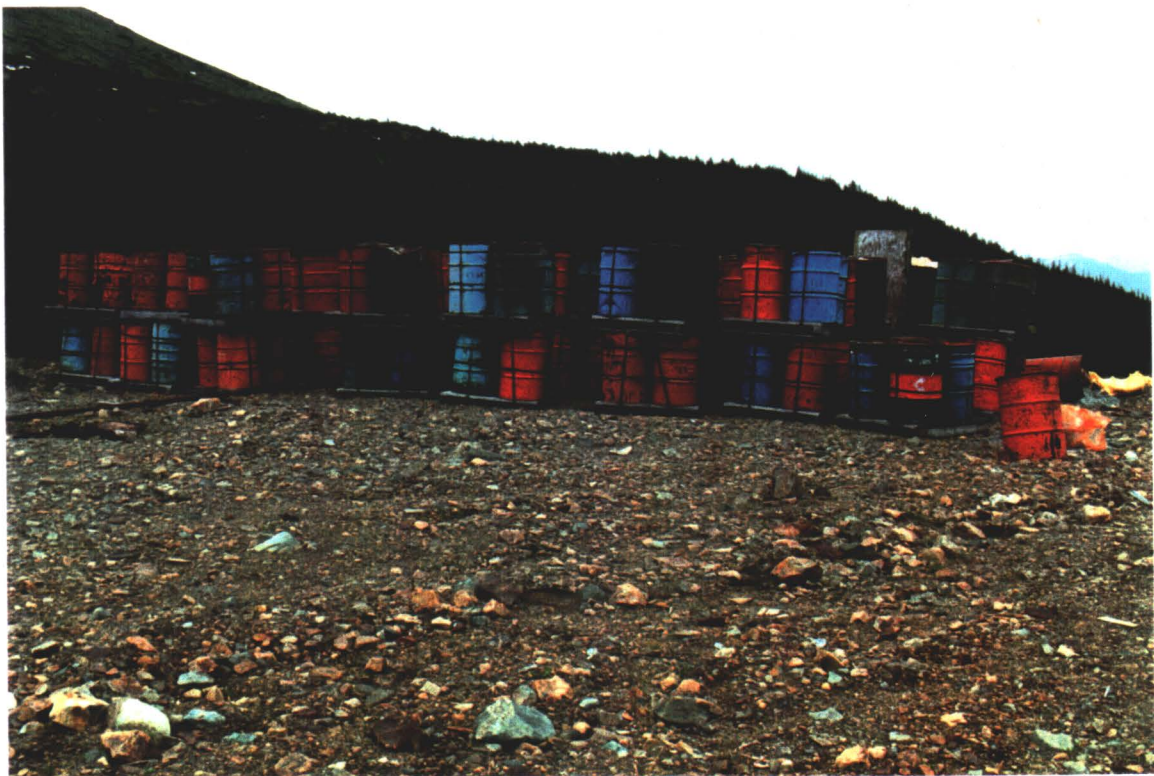
10. LOADED SAMPLE BARRELS

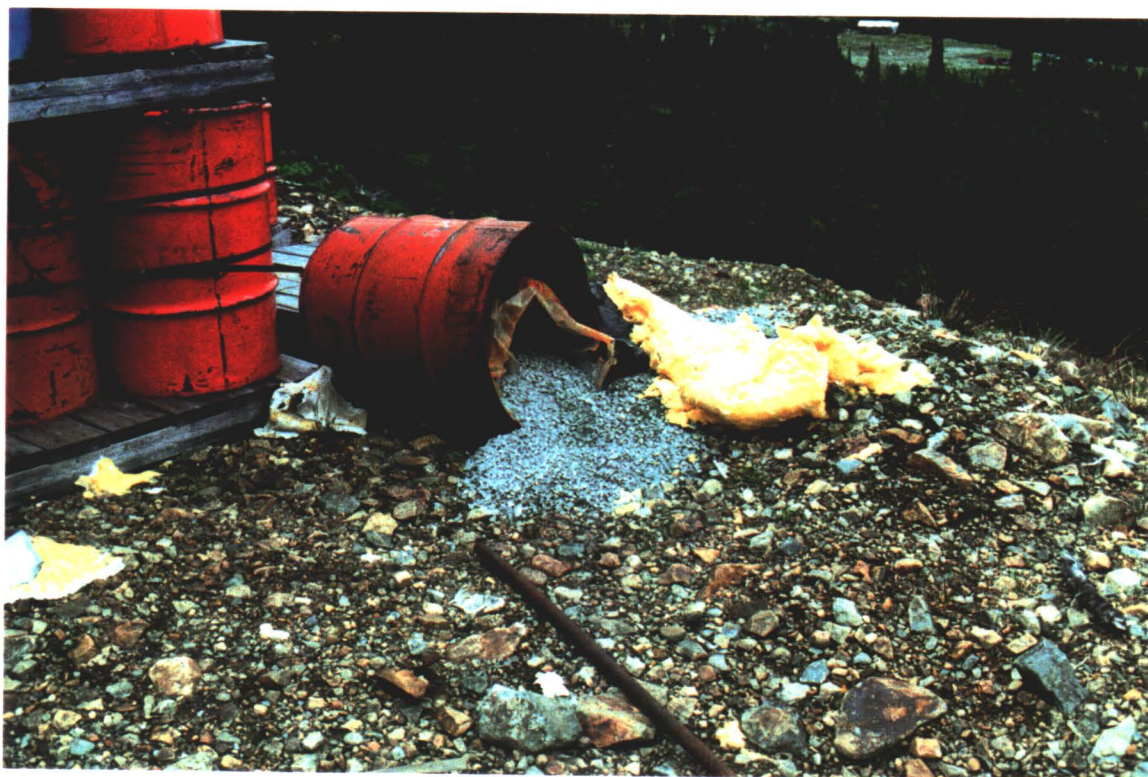
11. SPILLED SAMPLE

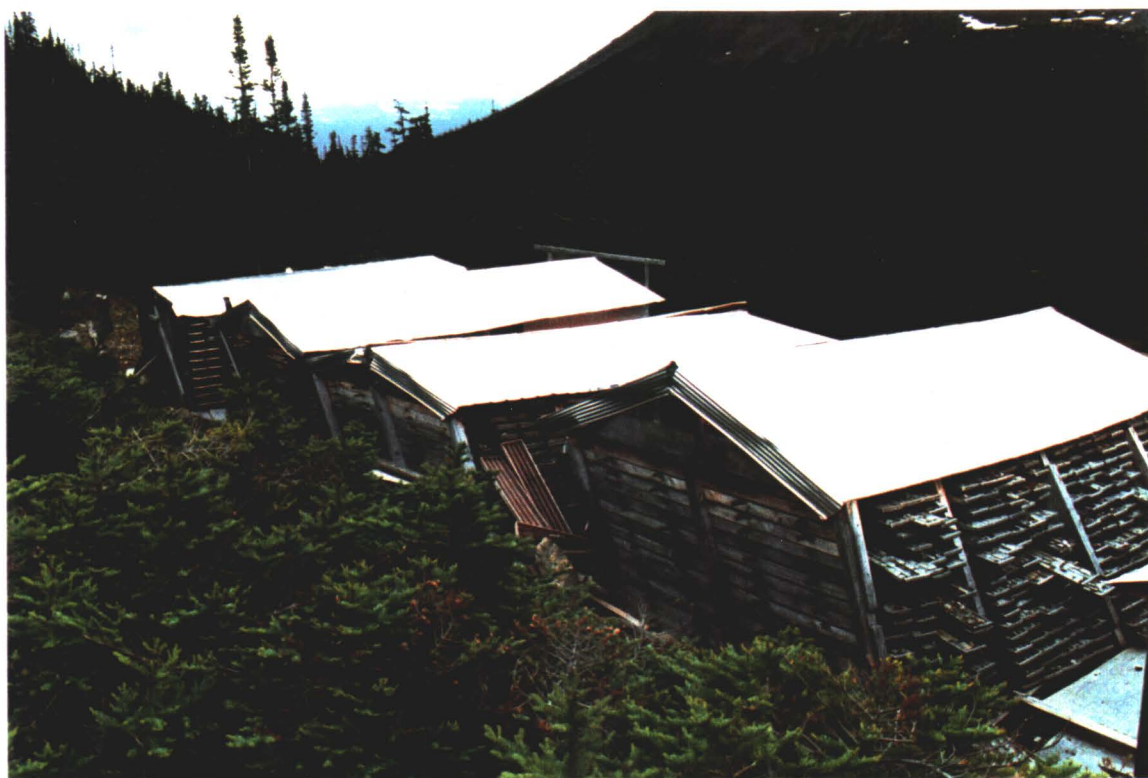
12. CORE STORAGE SHEDS

Core Sheds - An extensive inventory of core is stored in the collapsing core sheds. Proper clean-up of the core storage area would involve loading all core on trucks and hauling the core off site to a central storage facility. The collapsing sheds could then be piled and burned if all the metal core rack supports and metal roofs were removed. All metal could be removed at the same time other metal waste is being hauled from the site.

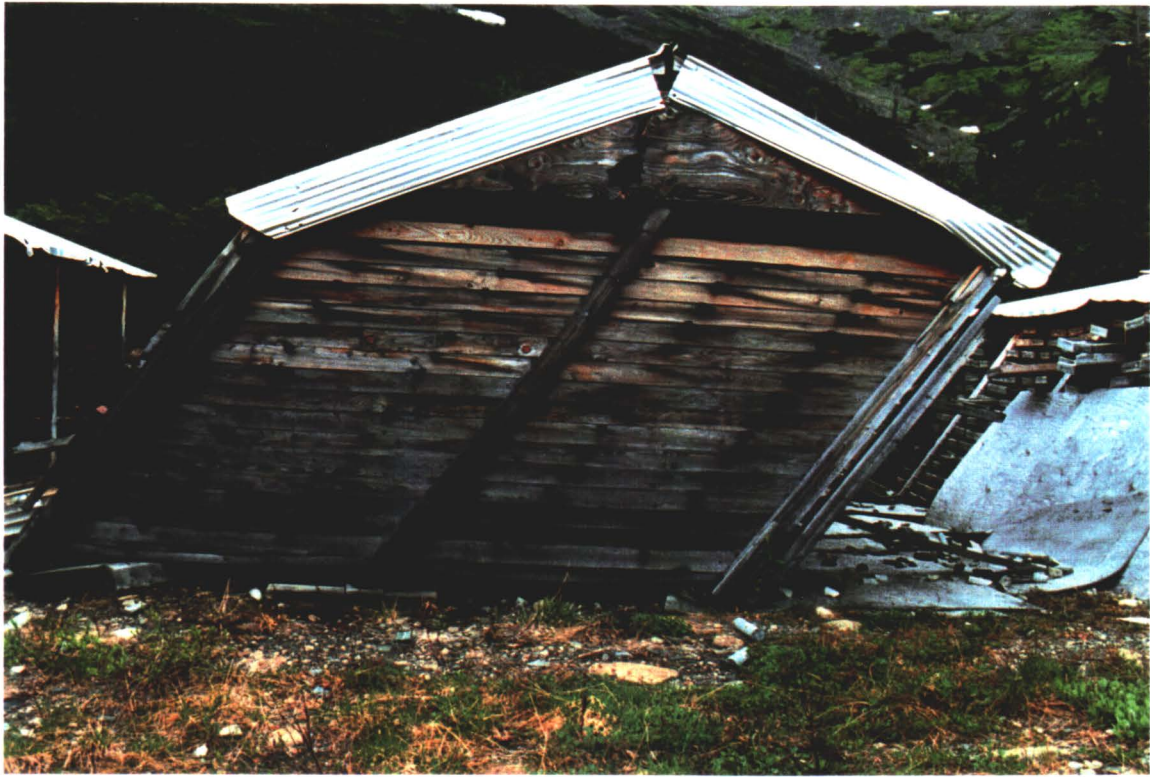
13. COLLAPSING CORE STORAGE SHED
