**ASSESSMENT REPORT**

**105D-06-3**

**UNION**

**DIAND TECHNICAL SERVICES**

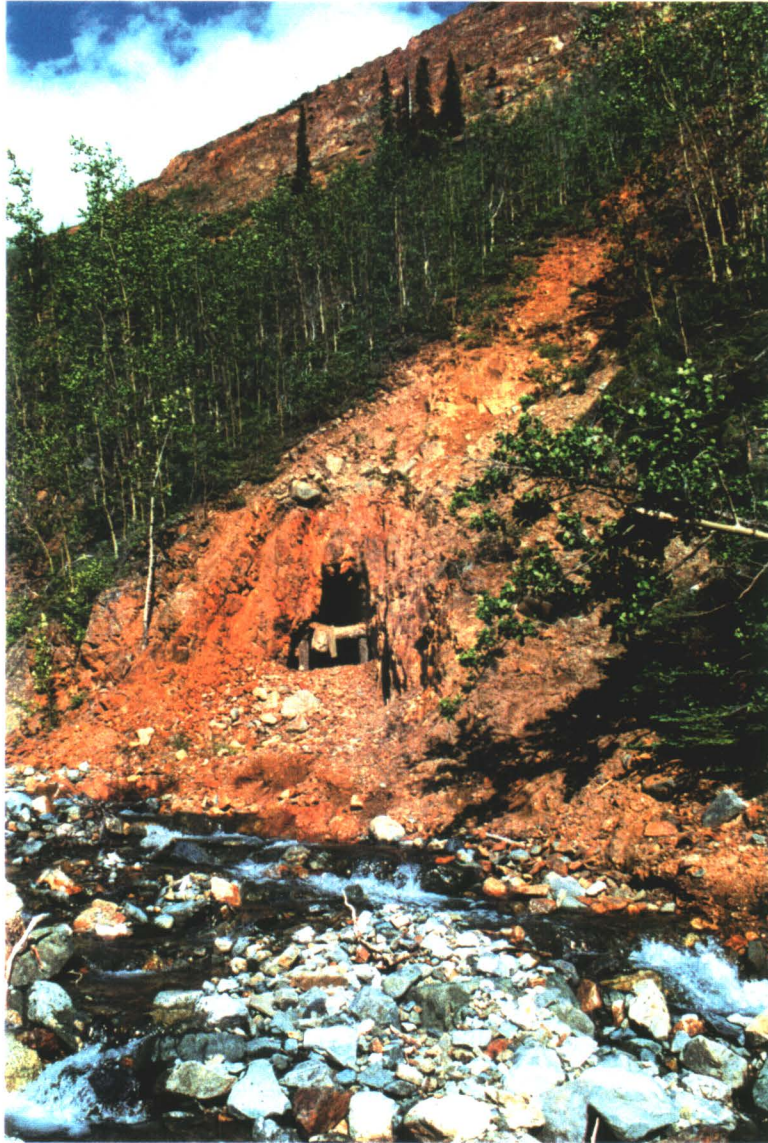
Only one of the three adits found extends beneath the surface (41m, according to historical records). The other adits were shallow and did not extend into the hillside. The one remaining adit is open and appears frozen over between 10-15m back from the surface. The largest pile of hand dumped waste rock is at the entrance to the uppermost

adit and consists of between 20-30 cubic metres of material. The waste rock from the middle adit, the deepest one, appears to have been removed.

MIDDLE ADIT

The open adit that was inspected poses a safety hazard for anyone that finds this excavation. For public safety concerns it is recommended that this excavation be closed. This could be accomplished by taking a rubber tired backhoe to the site and filling in the entrance.

The open adit, although in a relatively remote location, should be covered to prevent access to the general public. This should be considered a **HIGH** priority.

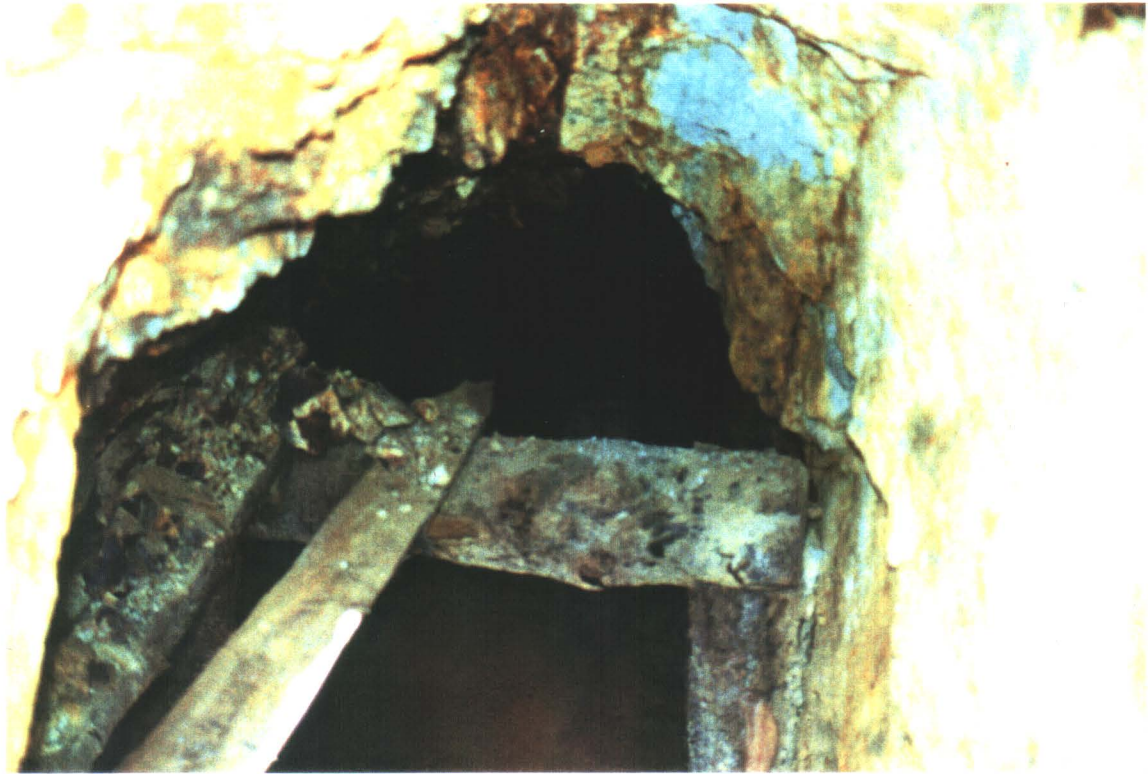
INTERIOR OF MIDDLE ADIT

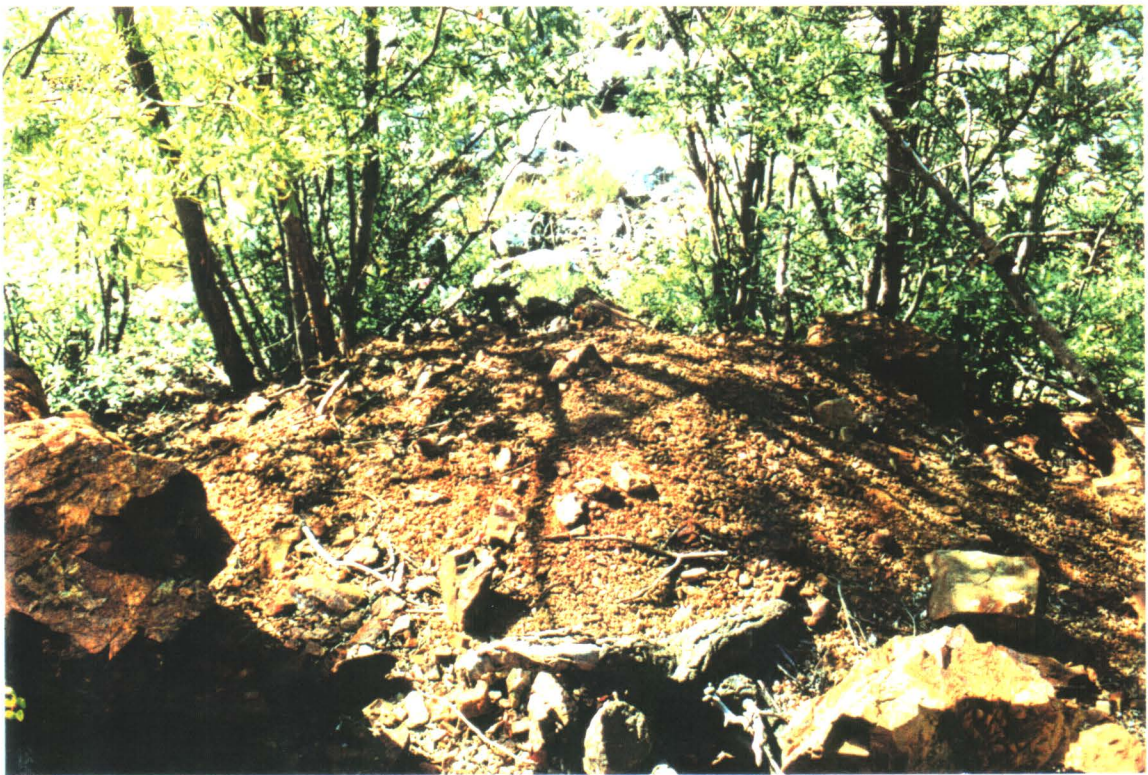
UPPER ADIT WASTE PILE

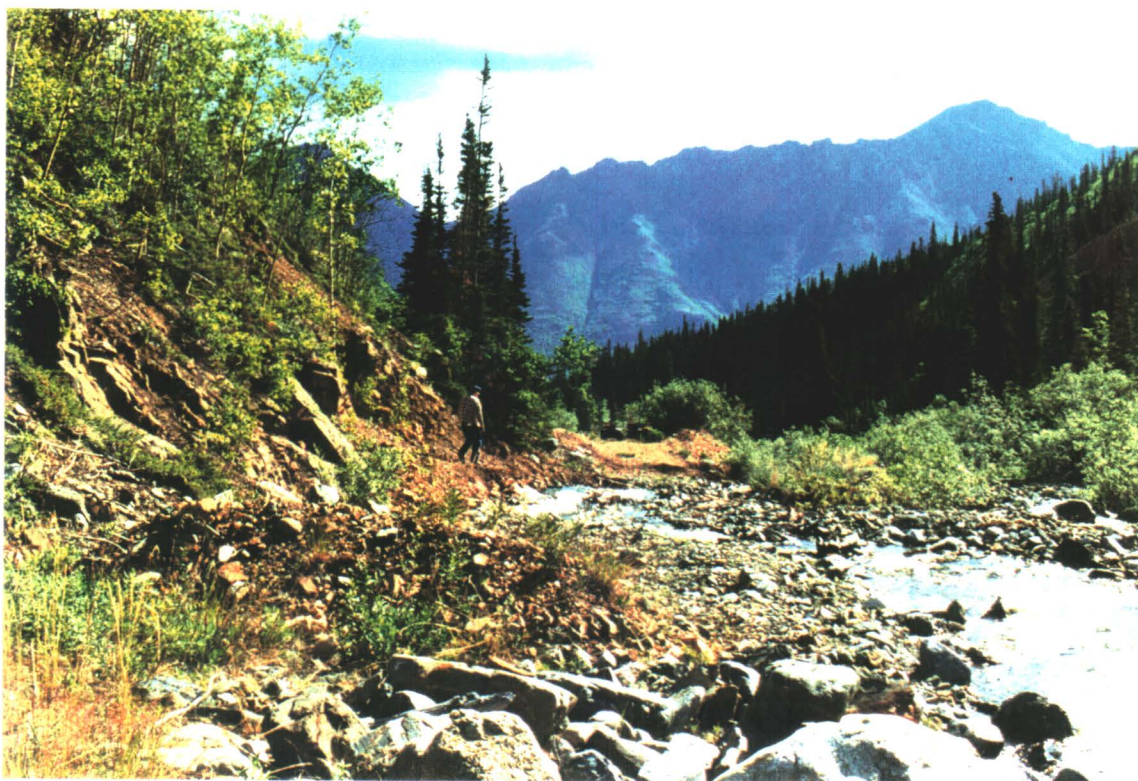
The predominant features from the past development are the trails to the adits and the trenching sites. The first 2km of the trail from the intersection of the Wheaton River valley road is generally overgrown with local vegetation. The last half kilometer of this trail is steep and usually encroached or was in the streambed and has long since been washed away in many places.

The most impact at this site is from road development in the area. The lower two kilometres of the road to the adits is overgrown from encroaching vegetation and much of the last half kilometre of the road has been washed away by Schnabel Creek. In general, the environment has reclaimed this road and it is recommended to leave the road as is. The roads to the trenching sites were constructed using typical "cut and fill" methods and are quite noticeable on the hillside. However there is no evidence that any significant slope instability or erosion has been created from this road construction. It is not recommended that any site remediation be considered for the roads or trenched areas. Site remediation of these roads and excavations would require reestablishing the original ground profile and revegetating the disturbed areas. This is considered a very costly exercise and will set back any natural revegetation that has already started.

LOOKING DOWNSTREAM SCHNABEL CREEK (NOTE ROAD WASHOUT)
