**ASSESSMENT REPORT**

**106F-07-1**

**CREST**

**DIAND TECHNICAL SERVICES**

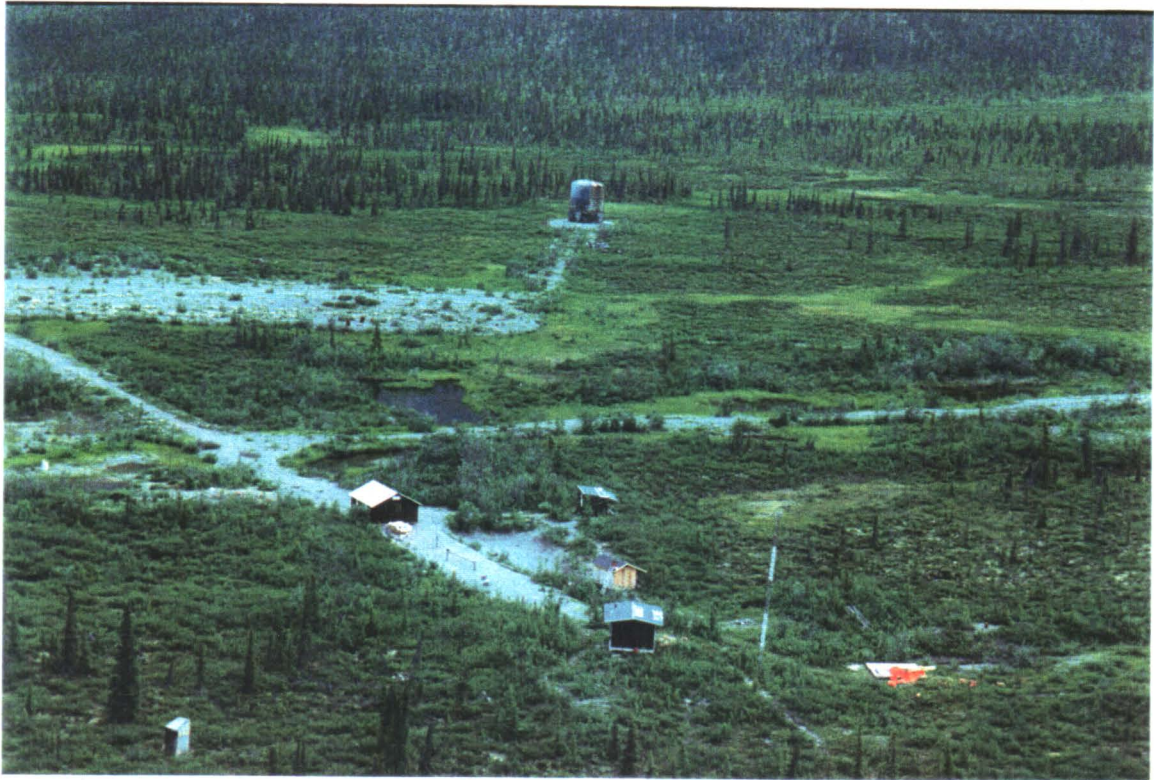
TANK, END OF AIRSTRIP, AND OUTFITTER'S CAMP

The remaining buildings appear to have been put to use and are currently being used by an outfitter in the area. It is recommended that these buildings be excluded from any clean-up program initiated for the area.

The camp site is obviously being used and should not be touched at this time. If any effort is made to clean-up this area, the user of the remaining facilities should be first consulted.

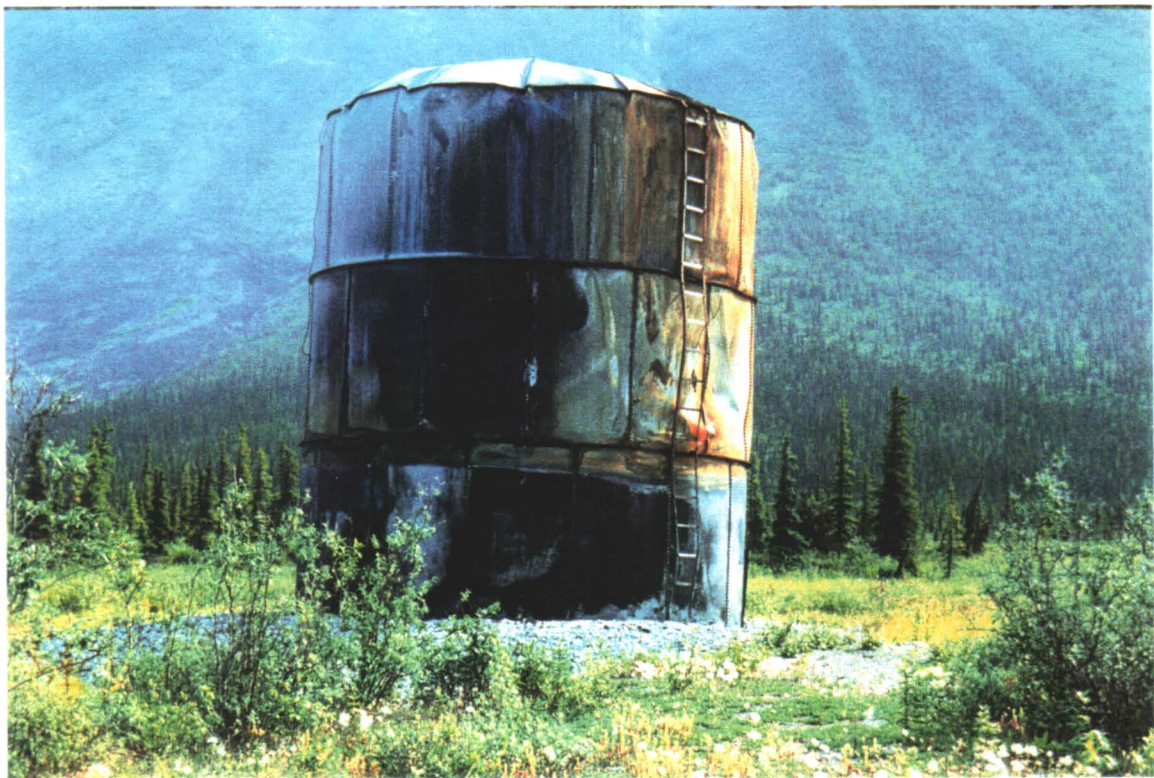
- 4.9m diameter and 7.3m high vertical fuel storage tank. The tank is empty,
- approximately 60 - 204 litre barrels. Over 25 barrels are full of very old aviation gasoline,
- 6 - 204 litre barrels of oil,
- 4 - 23 litre pails of oil,
- 6 - 45 litre barrels (empty).

EMPTY FUEL STORAGE TANK

The only remaining material found from the exploration activity centred around the airstrip. At the airstrip a large damaged fuel storage tank has been left from the exploration in the early 1960's. The main environmental concern observed was the 25 barrels of aviation gasoline, 6 barrels of oil, and 4 pails of oil left on-site. These hydrocarbon products have been left at this site for many years and the product does not appear useable. However, these hydrocarbon products still could be spilled and cause environmental damage to the area. Although this site is extremely remote, people are entering the area and a spill could be caused. It is recommended that the hydrocarbon products be either removed from the site or properly incinerated.

The hydrocarbon products left on-site pose the highest potential damage to the environment. Although no spill appears to have resulted over the many years the fuel has been left on-site, the potential for a spill still exists. It is recommended that this fuel be removed from the site or incinerated. It is also recommended that all metal barrels and storage tanks also be removed if a general clean-up program is initiated in the area.

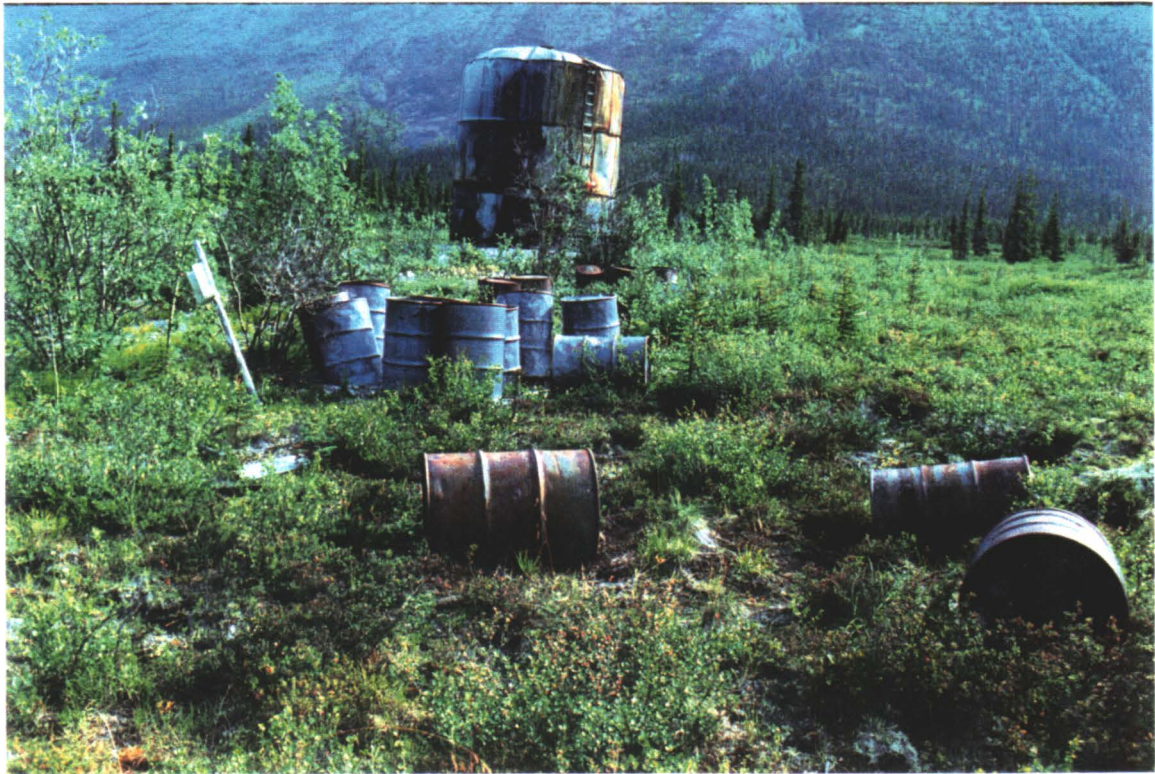
BARRELS LEFT ON-SITE

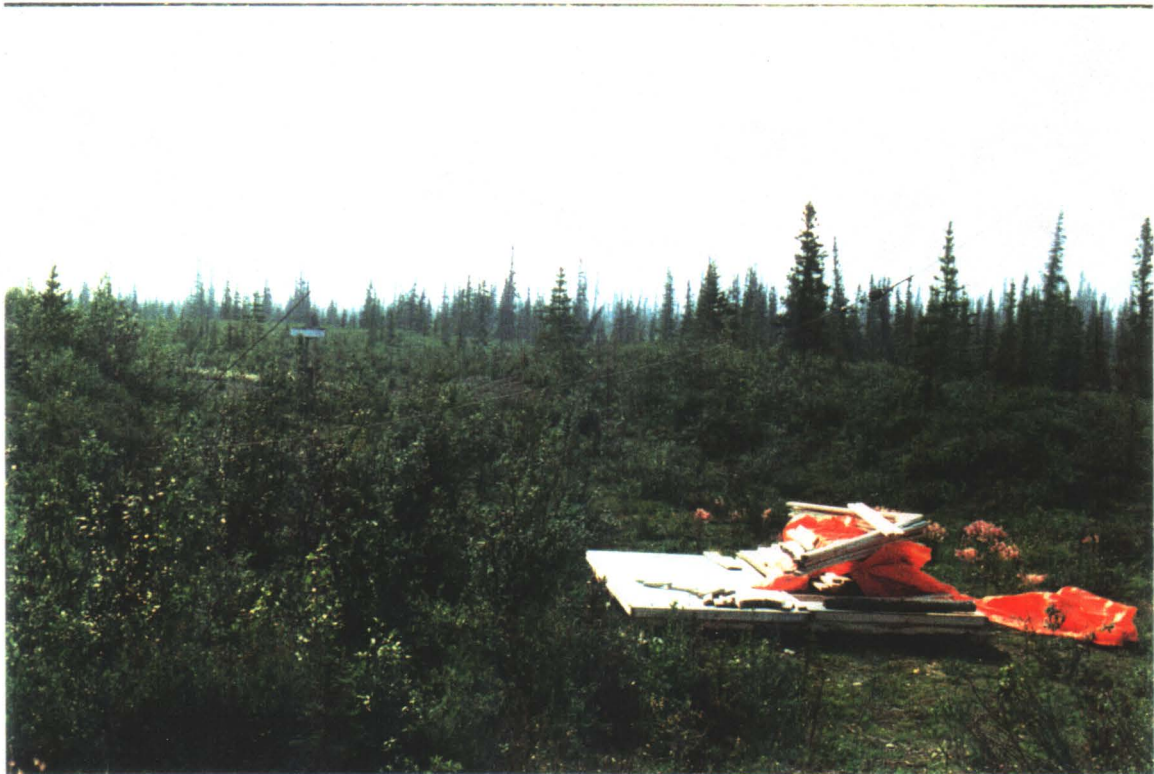
Across the airstrip remains of a camp and radio transmission tower have been left in place. This camp is currently in use by an outfitter with most of the buildings being maintained and stocked. A list of these buildings includes;

- 3.7x4.9m wood frame plywood clad sleeping cabin,
- 4.9x4.9m wood tent frame (folded),
- 2.4x3.7m wood frame wood clad smoke house,
- 4.9x6.1m wood frame wood clad cookhouse, and
- 2.4x3.7m wood frame wood clad maintenance shed.

STEEL TOWER AND DISMANTLED TENT FRAME
