ASSESSMENT REPORT

105M-14-6

DUNCAN

DIAND TECHNICAL SERVICES

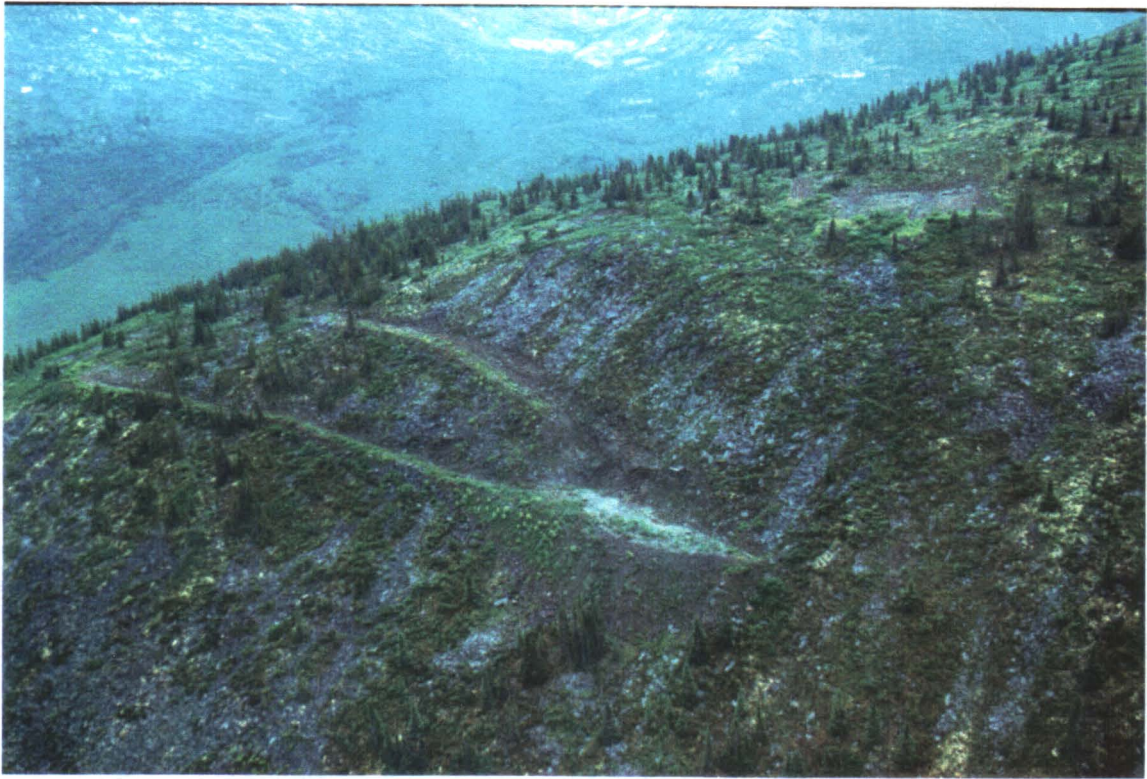
SITE LOCATION - MINE SHAFT NEAR SWITCHBACK OF ACCESS ROAD

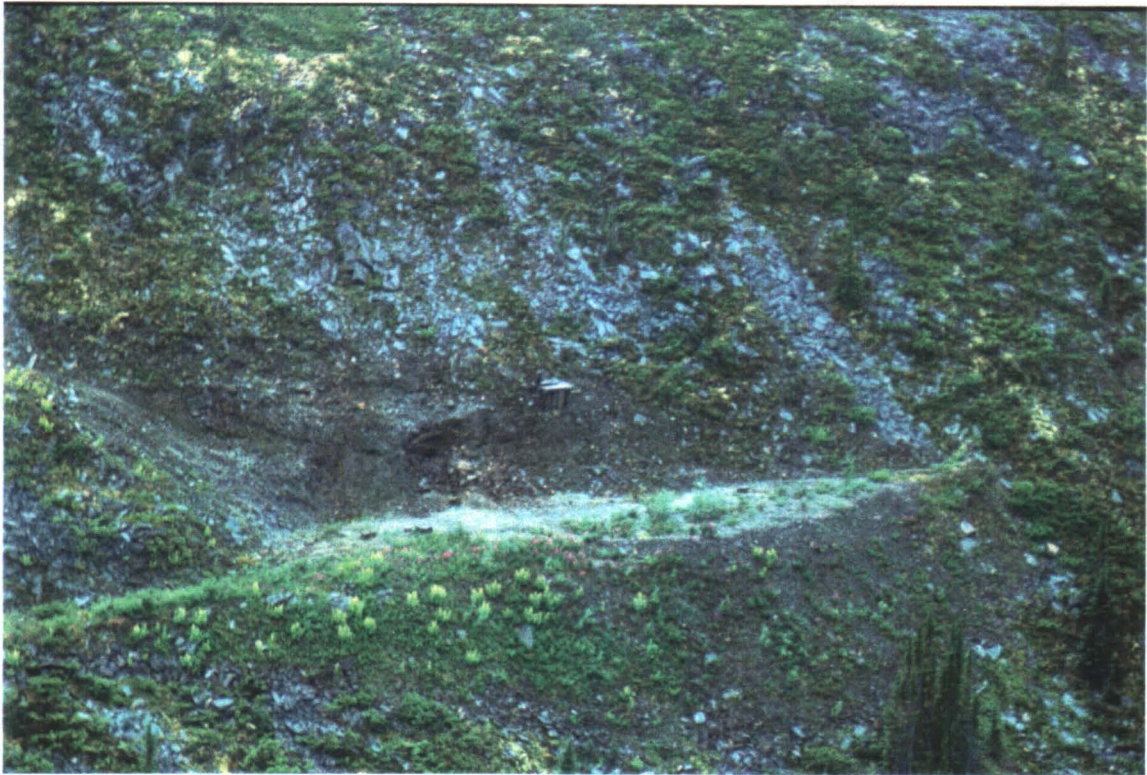
A wood cribbing made out of vertical posts supported the top of the shaft. An old wooden ladder extended into the shaft. The burned out remains of a wooden frame likely used to support a windlass above the shaft was observed. A metal pail used to lift ore from the shaft was also found near the shaft.

MINE SHAFT

The open shaft should be considered a safety hazard and should be posted and preferably sealed to either identify or eliminate the hazard.

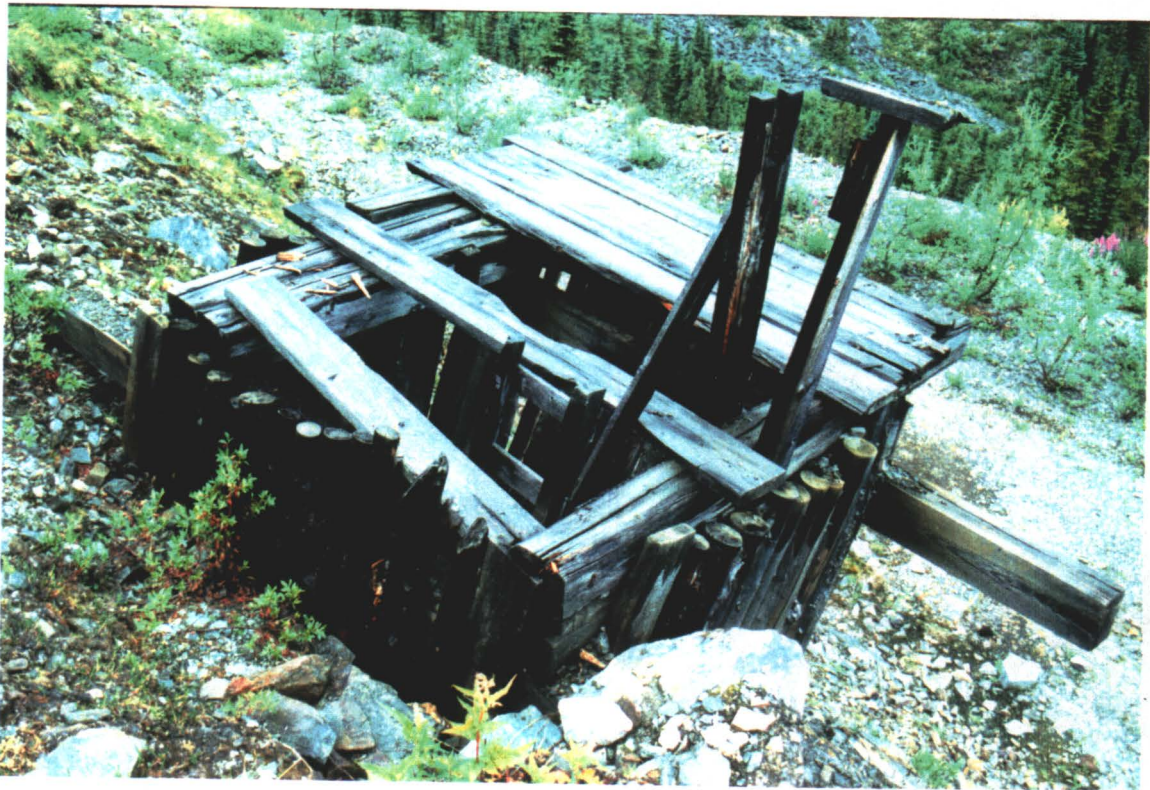
According to the work history most of the work conducted at this site took place over 70 years ago. The main development at that time was the installation of a vertical shaft, which is still in place. The top of the shaft is open and it is possible someone could fall into it, however this is very unlikely because of the remoteness of the site. If the shaft is not sealed or permanently filled in, it is recommended, as a minimum, that the shaft be posted to warn anyone entering the area of the potential danger.

TOP OF MINE SHAFT

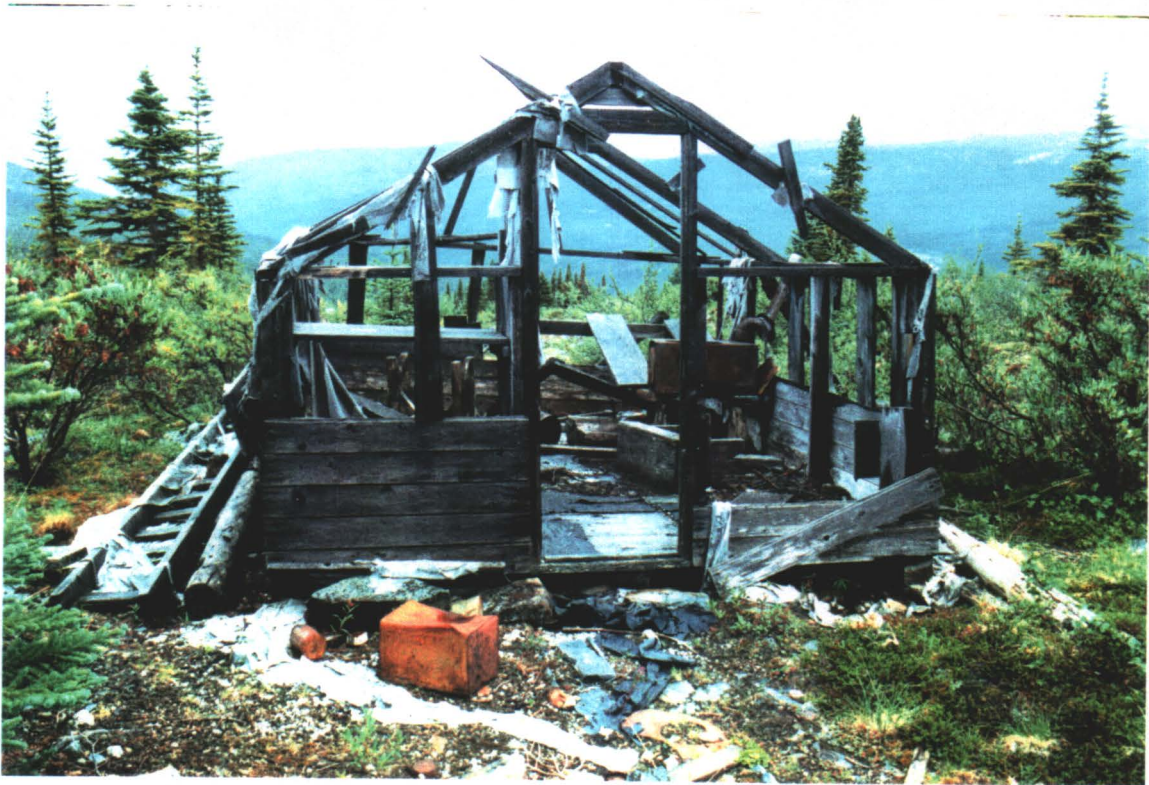
Remains of a wood building, probably from the time the shaft was excavated, was the only other infrastructure found on-site. Some garbage, mostly old metal cans and glass bottles and jars, was the only other material found near the building. This building has deteriorated with only the frame and a portion of the walls and floor remaining

REMAINS OF OLD BUILDING

The small amount of garbage at this site should be picked up if a clean-up program is initiated in the area. At the same time the remains of the building should be piled and burned. This clean-up is considered a **LOW** priority.
