**ASSESSMENT REPORT**

**115J-09-1**

**HAYES**

**DIAND TECHNICAL SERVICES**

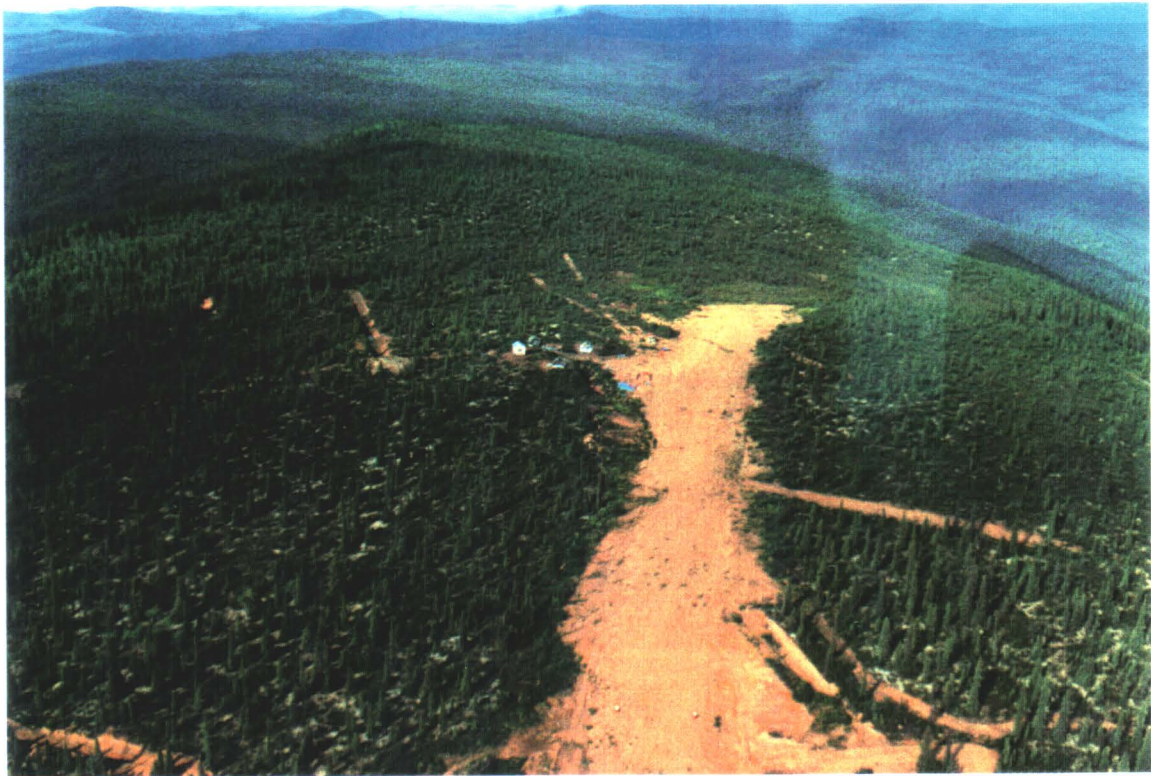
The exploration site covers an unnamed ridge between Senora Gulch and Klines Gulch south of Hayes Creek on the edge of the Dawson Range. This site is on an eroded peak that appears as weathered material made up of granular and silt sized particles.

The site has been developed with a number of trails and trenches over the exploration area. Most of these trails have been developed for drill access and trenching sites. The vegetation has been removed wherever the road or trenching operations took place. No exploration adit was found at this site, although records show one adit was started approximately 90 years ago. Any adit that old has likely collapsed and is no longer visible.

OVERALL VIEW OF AIRSTRIP AND EXPLORATION AREA

Airstrip, trenching, and trail construction has resulted in removal or burial of the vegetation in the disturbed areas. There is no evidence that additional problems such as erosion, slope failures, contamination of water courses, etc. have been caused from the original activity. Site remediation, if it was undertaken, would consist of reshaping cut slopes to blend with the natural slopes and revegetating the site. This method of remediation would be costly and also result in additional disturbance to the site setting back any revegetation that may have started. Instead, it is recommended that leaving the site to recover naturally is the most suitable solution for this site. However, it must be understood that recovery of the site will be slow in this area that is extremely remote, dry, and sensitive to disturbance. Revegetation of the site is likely best left to natural reseeding due to its remoteness, and the difficulty of promoting growth in an extremely dry environment with very poor soil.

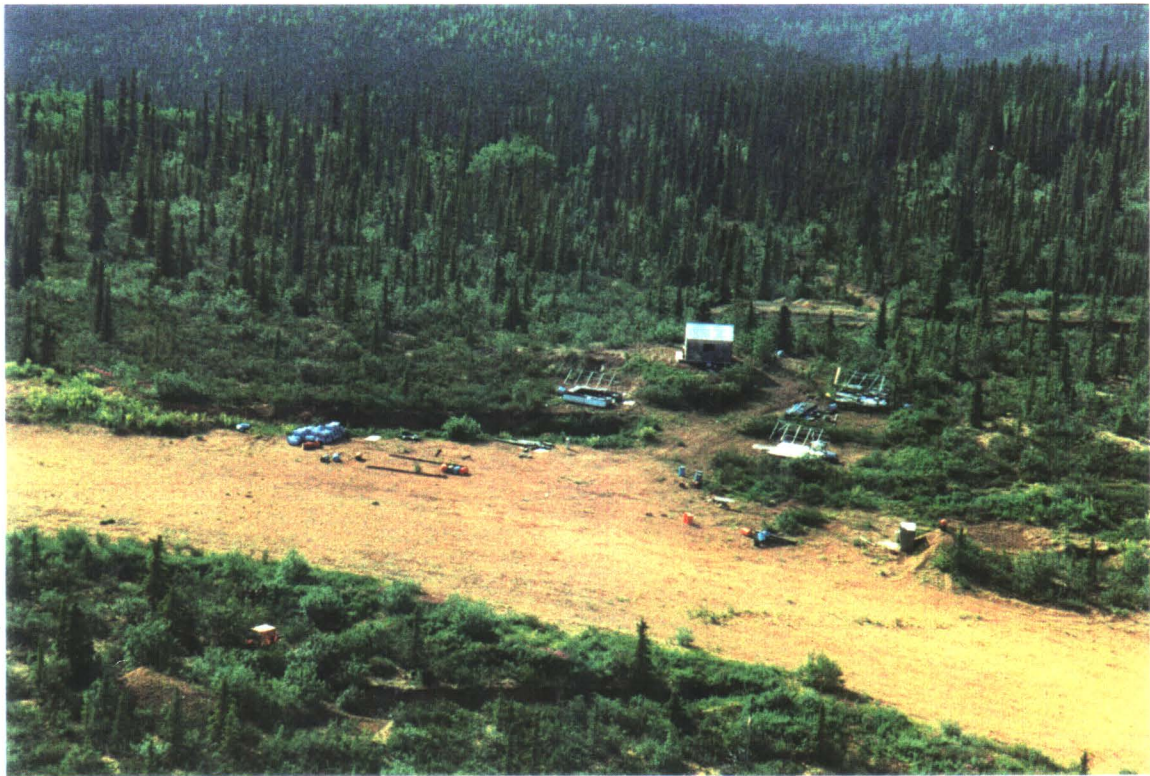
Some infrastructure and material has been left at the old camp site as recorded from the inspection on 1993/07/01. A list of this material includes;

- 65-204 litre barrels. **6 of these barrels are full (2 Jet B, 4 diesel),**
- 5-45 kg propane bottles,
- 3.7x4.9m wood frame plywood clad cookhouse complete with fridge, stove, cooking utensils, propane heater, etc.
- 4.3x4.9m aluminum tent frame,
- 4.3x4.9m wooden tent frame,
- 2 dozer tracks,
- **bag of CIL AMEX II MRN 6H2 Type B explosives,**
- **blasting caps and fuses scattered inside the cook shack,**
- core boxes full of core, and
- a significant amount of metal junk scattered around the camp site.

CAMP AREA

The buildings, dozer tracks, barrels, and other junk left at the site do not pose any particular environmental hazard, however the buildings and material are unsightly and should be removed if a general clean-up program is initiated in the area. Clean-up of this material will be expensive as everything will have to be flown from the site.

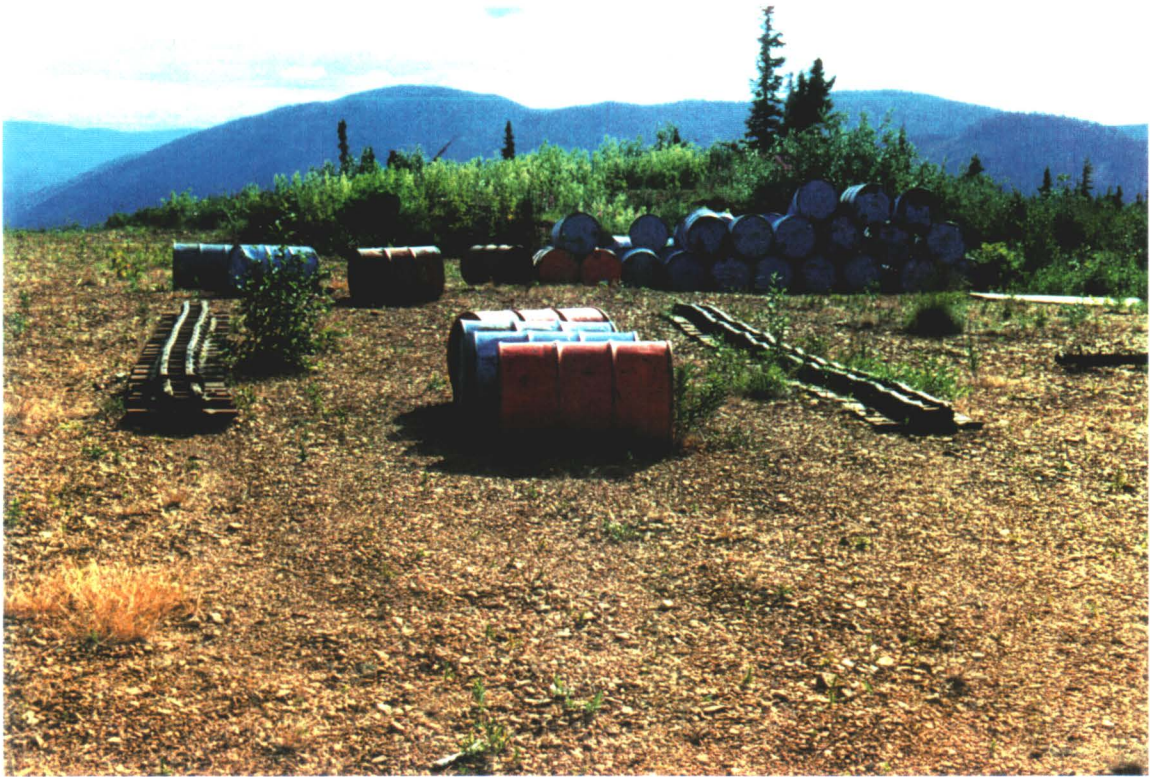
FUEL TANKS AND DOZER TRACKS

The hydrocarbon products left at the site should also be removed or properly incinerated to eliminate the possibility of a spill in future. This should be considered a **HIGH** priority. Removal of the propane tanks from the site should be included as part of the removal of the hydrocarbon products.

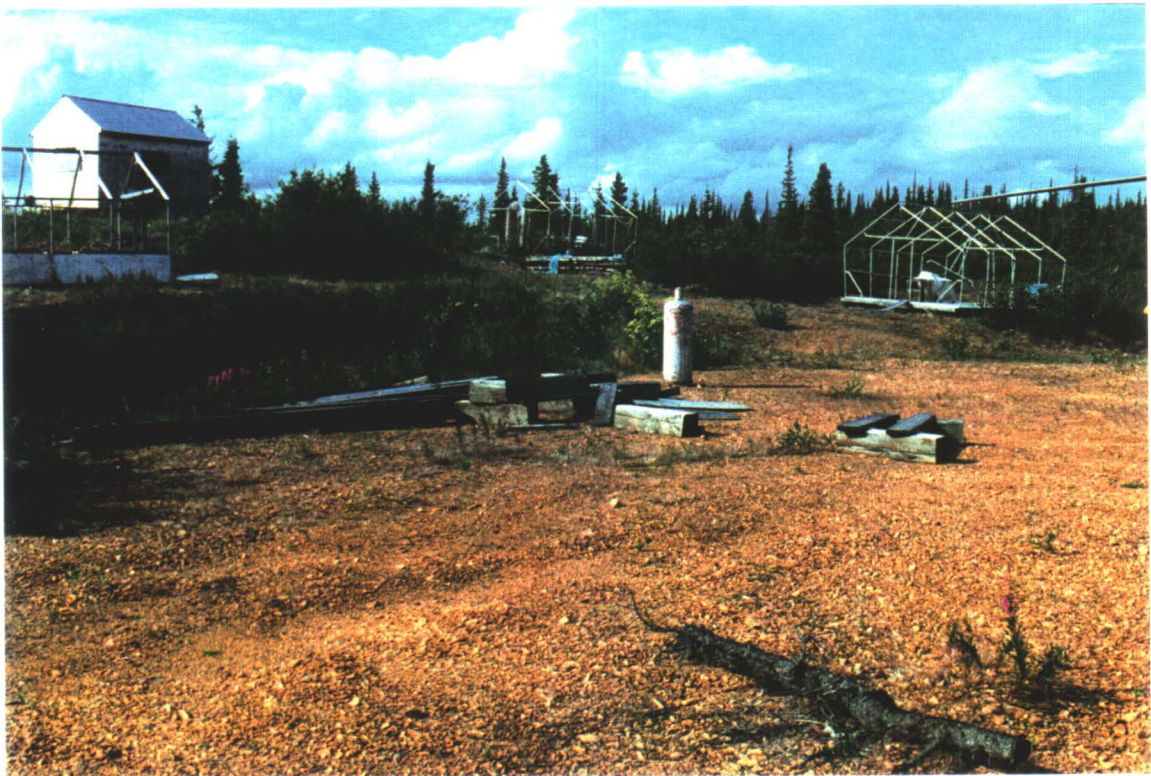
BUILDINGS AND TENT FRAMES

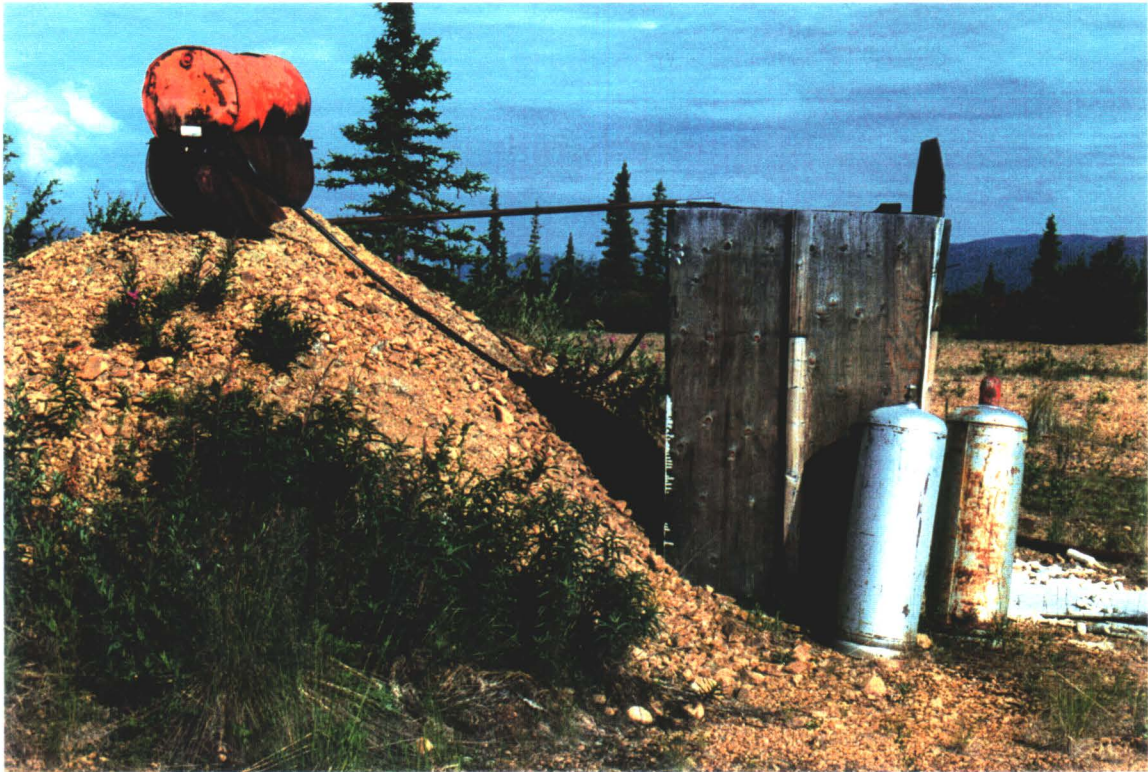
FUELING SITE AND PROPANE TANKS

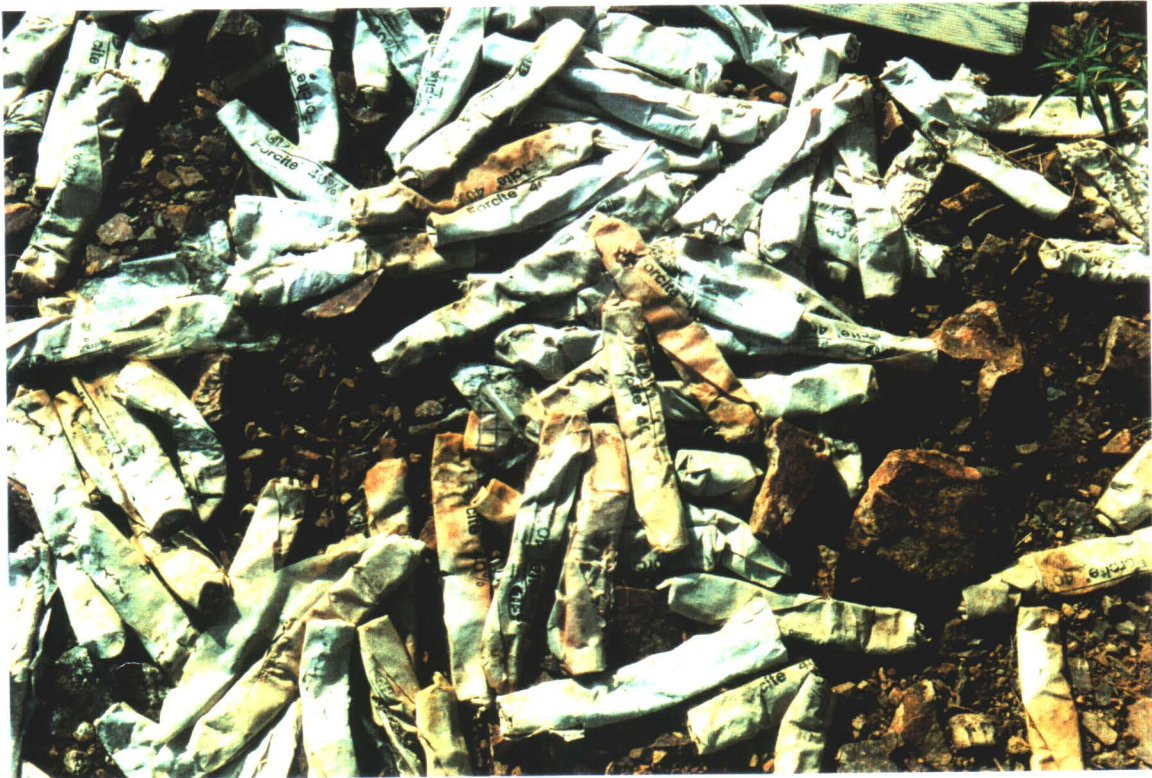
EXPLOSIVES

The most significant concern remaining at the camp are the hazardous materials left behind. This includes the **blasting caps and bag of explosives**. Less dangerous but potentially hazardous to the environment is the fuel left on-site. It is recommended that the blasting caps and explosives be inspected by a qualified inspector and then disposed of in an appropriate manner. Although this site is very remote, this should be considered a **HIGH** priority.

An assessment of the explosives material left on-site should be completed as soon as possible even though it is in a remote location. These explosives appear potentially hazardous and this needs to be confirmed.

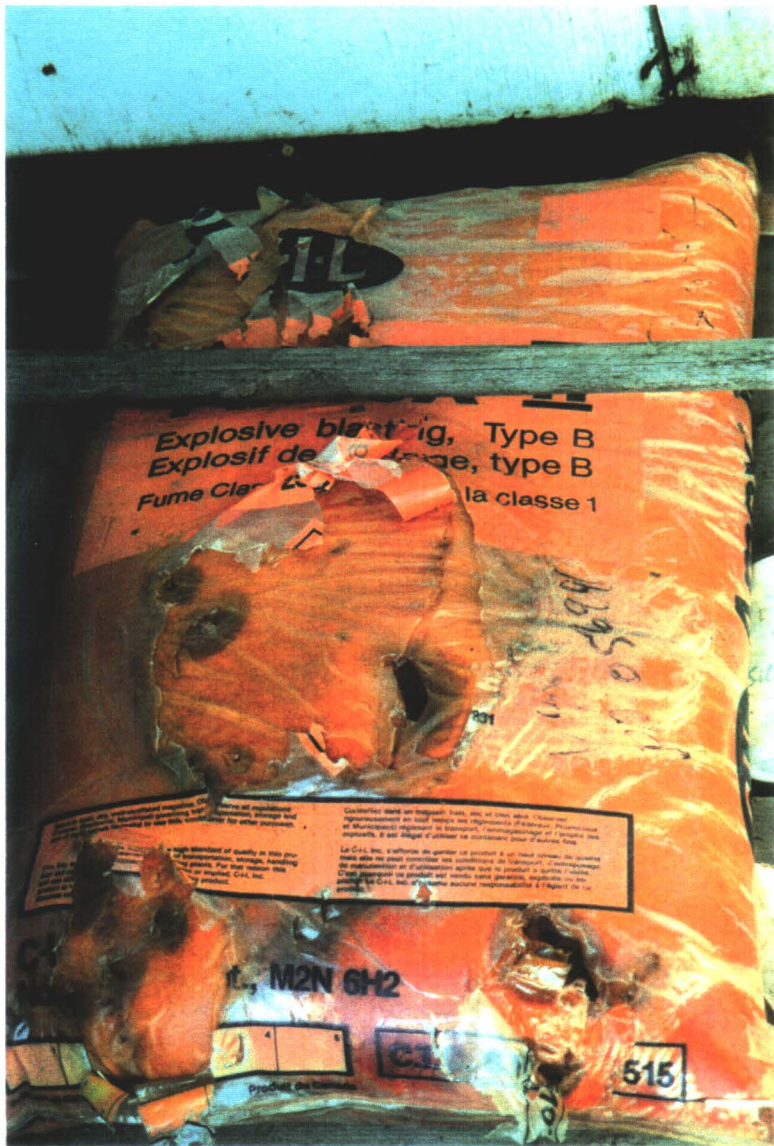
BAG OF EXPLOSIVES
