**ASSESSMENT REPORT**

**105M-14-8**

**GAMBLER**

**DIAND TECHNICAL SERVICES**

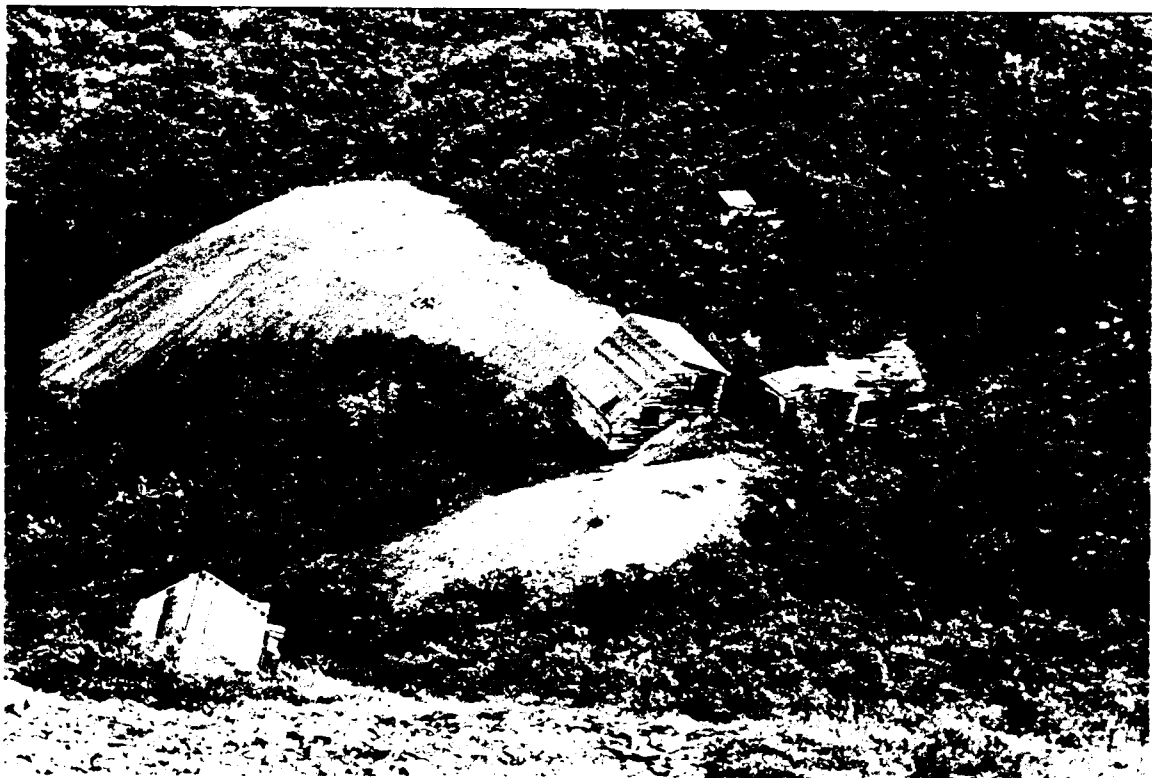
- a 6x9m wood frame, wood clad building used as a cookhouse. Metal bedframes were still in the building,
- a 7x7m empty one and one half story wood frame, wood clad building,
- a 6x10m empty wood frame, wood clad building
- remnants of a collapsed hand excavated adit, and

- a rock waste dump approximately 50m long and 40-50m wide was spilled downslope of the adit.

ADIT AND WASTE ROCK DUMP

Any environmental impact occurred at this site many years ago when the exploration work was ongoing. Since that time the site appears to have been recovering with vegetation growing over the site, with the exception of the waste rock piles which are still barren. Any buildings left on-site are also deteriorating and are beginning to collapse. The adit has collapsed at the entrance, and was difficult to find. This adit does not pose any safety hazard.

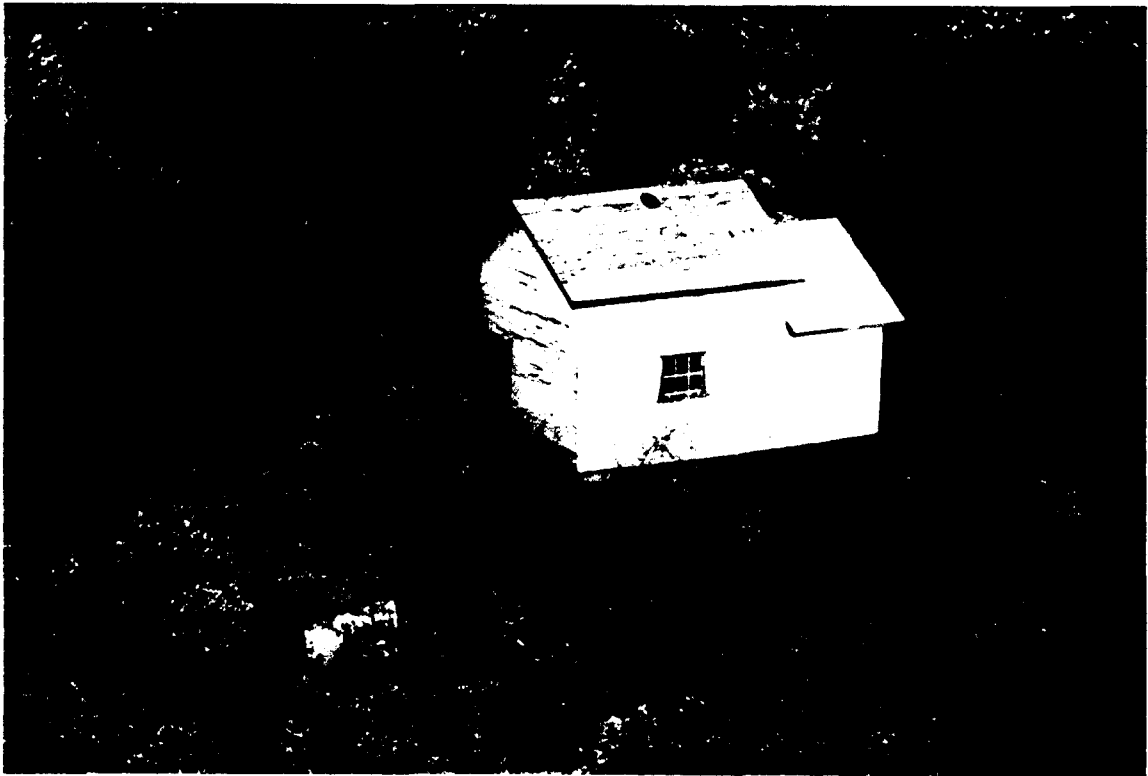
The lower site had a waste rock dump also similar in size to the waste dump at the upper site. Two buildings were spotted at the lower site. Both appeared to be somewhat protected from the weather either with paint or some type of metal cladding.

BUILDING AT LOWER SITE

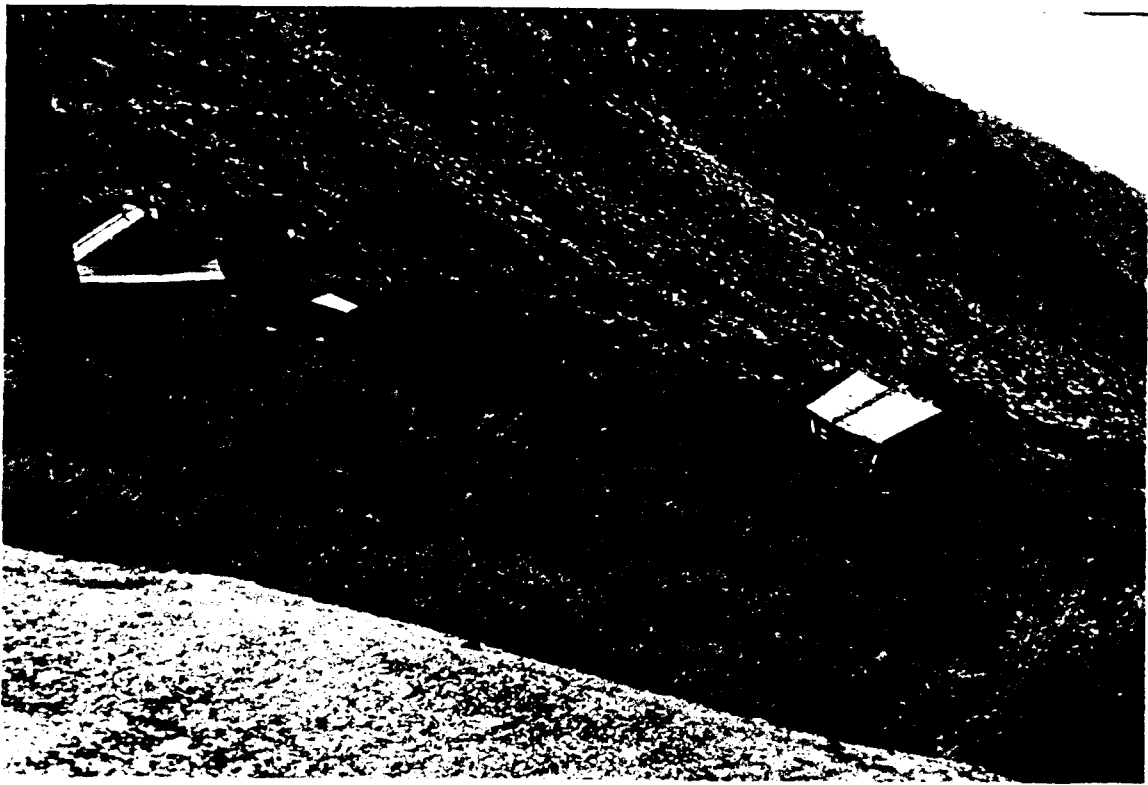
The buildings at this site are very old, deteriorating, and will likely start collapsing within the next few years.

BUNKHOUSE AND COOKHOUSE

The remaining buildings appear to be the only potential safety hazard. There is a very small risk that if someone was to enter these buildings when they are about to collapse that someone could be injured. These buildings are in a very remote location and this risk is **VERY LOW**, however to eliminate any risk, the buildings should be demolished or burned or **posted to warn anyone of the potential hazard**. If these buildings were to be burned care needs to be taken not to start the nearby vegetation on fire.

The only potential hazard appears to be from the possibility of a building collapsing when someone was inside the building. It is recommended that these buildings be posted to warn anyone of the potential hazard before they enter them. Alternatively, these buildings could be removed by either demolition or burning.
