ASSESSMENT REPORT

105M-14-8

DIAND TECHNICAL SERVICES

FEBRUARY, 1994

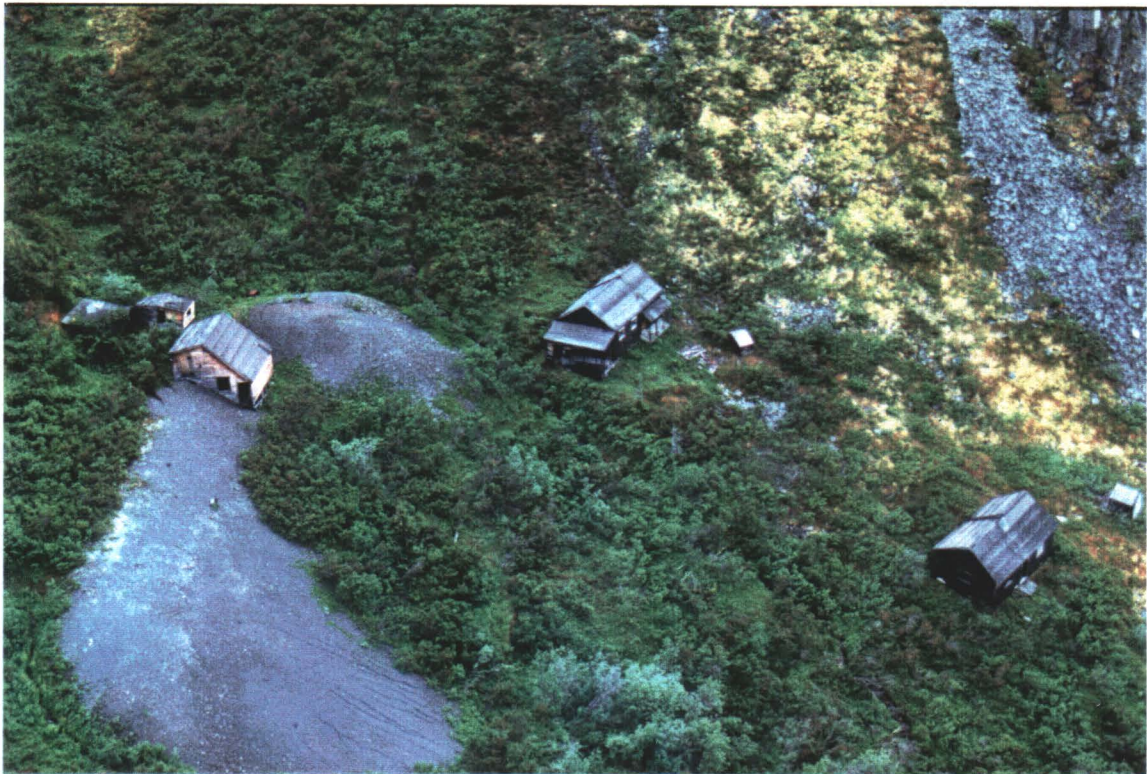
GAMBLER EXPLORATION SITE (ADIT SITE TO LEFT OF PHOTO)

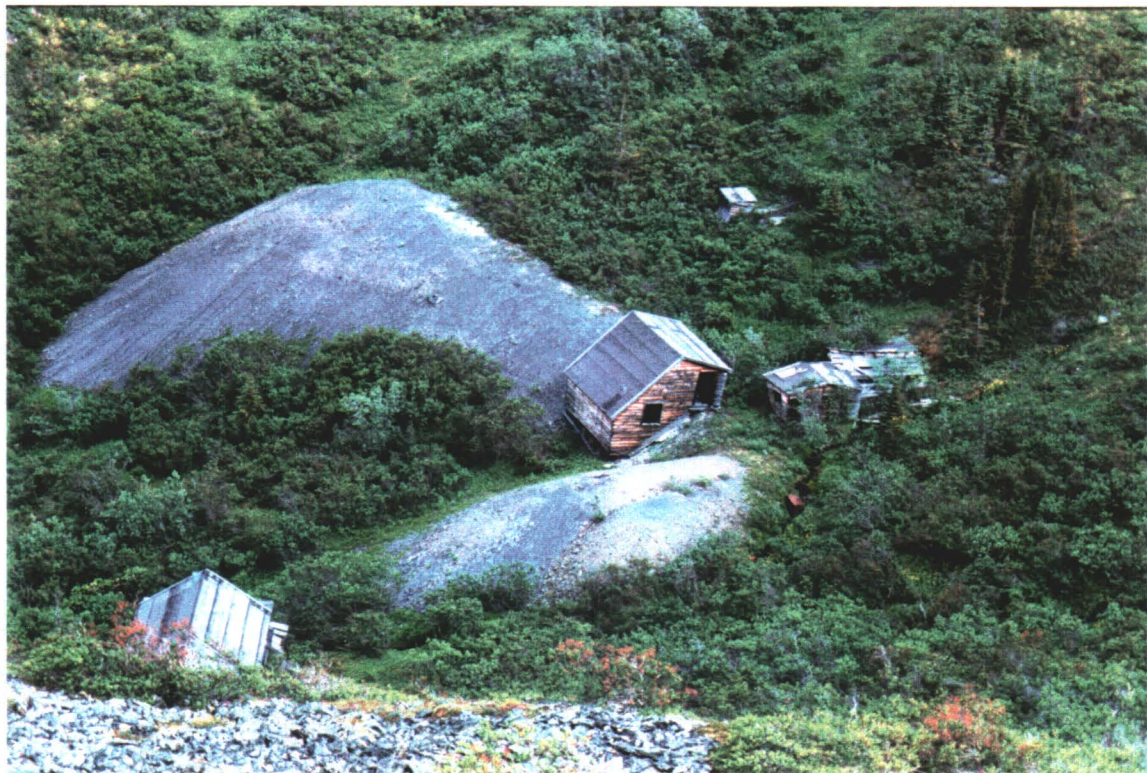
- a rock waste dump approximately 50m long and 40-50m wide was spilled downslope of the adit.

Any environmental impact occurred at this site many years ago when the exploration work was ongoing. Since that time the site appears to have been recovering with vegetation growing over the site, with the exception of the waste rock piles which are still barren. Any buildings left on-site are also deteriorating and are beginning to collapse. The adit has collapsed at the entrance, and was difficult to find. This adit does not pose any safety hazard.

ADIT AND WASTE ROCK DUMP

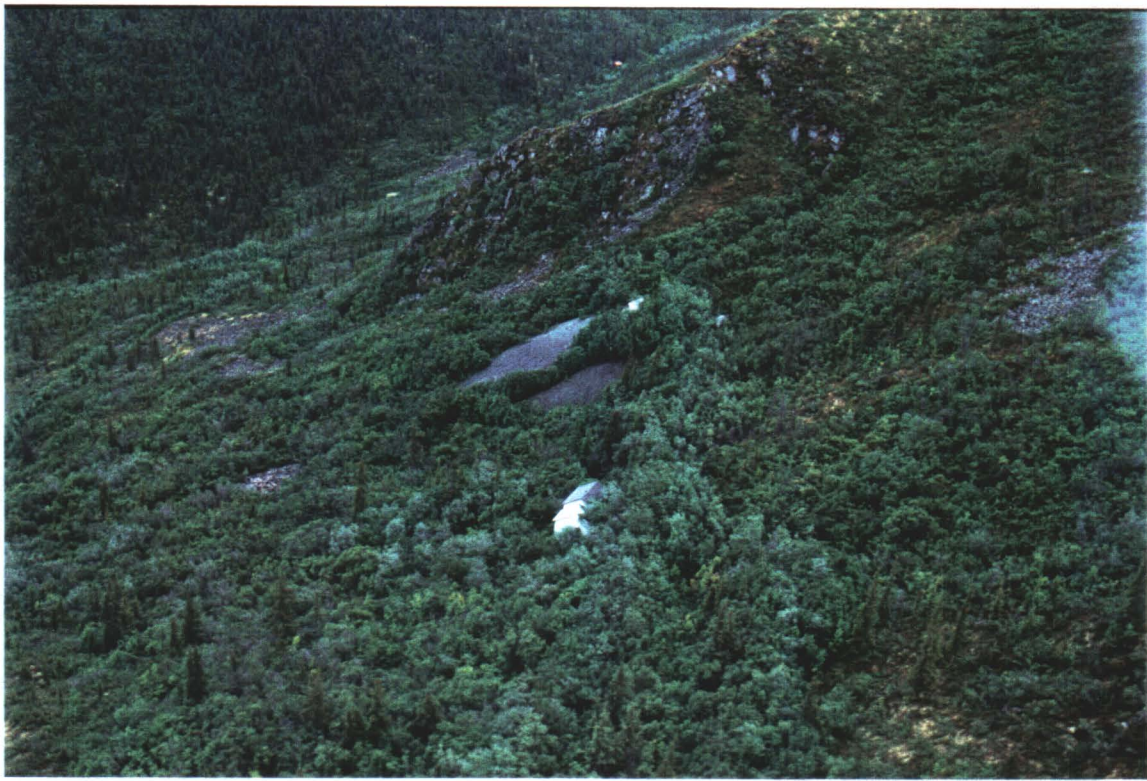
The lower site had a waste rock dump also similar in size to the waste dump at the upper site. Two buildings were spotted at the lower site. Both appeared to be somewhat protected from the weather either with paint or some type of metal cladding.

As noted above, trails directly to these sites could not be found. It is likely that trails did exist at one time connecting to the other larger trail systems, however these have grown over with vegetation and are no longer visible.

LOWER SITE (NOTE OVERGROWN TRAIL PAST BUILDING TO WASTE ROCK DUMP)

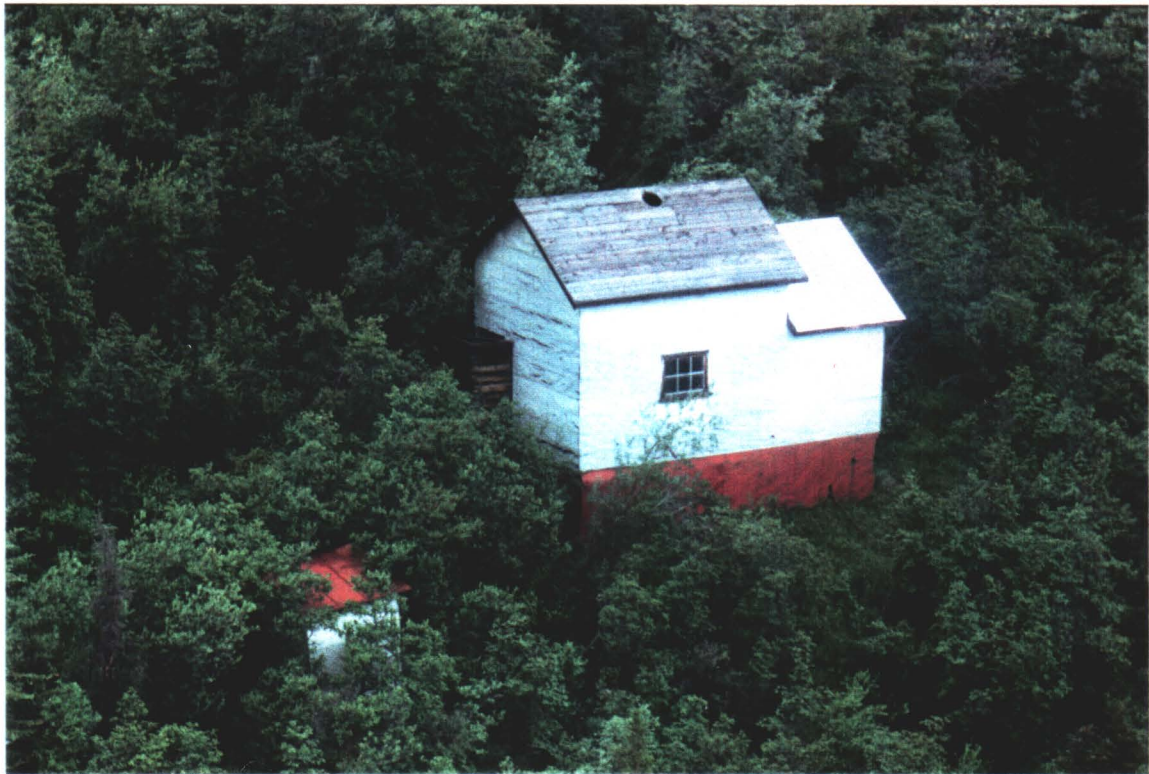
BUILDING AT LOWER SITE

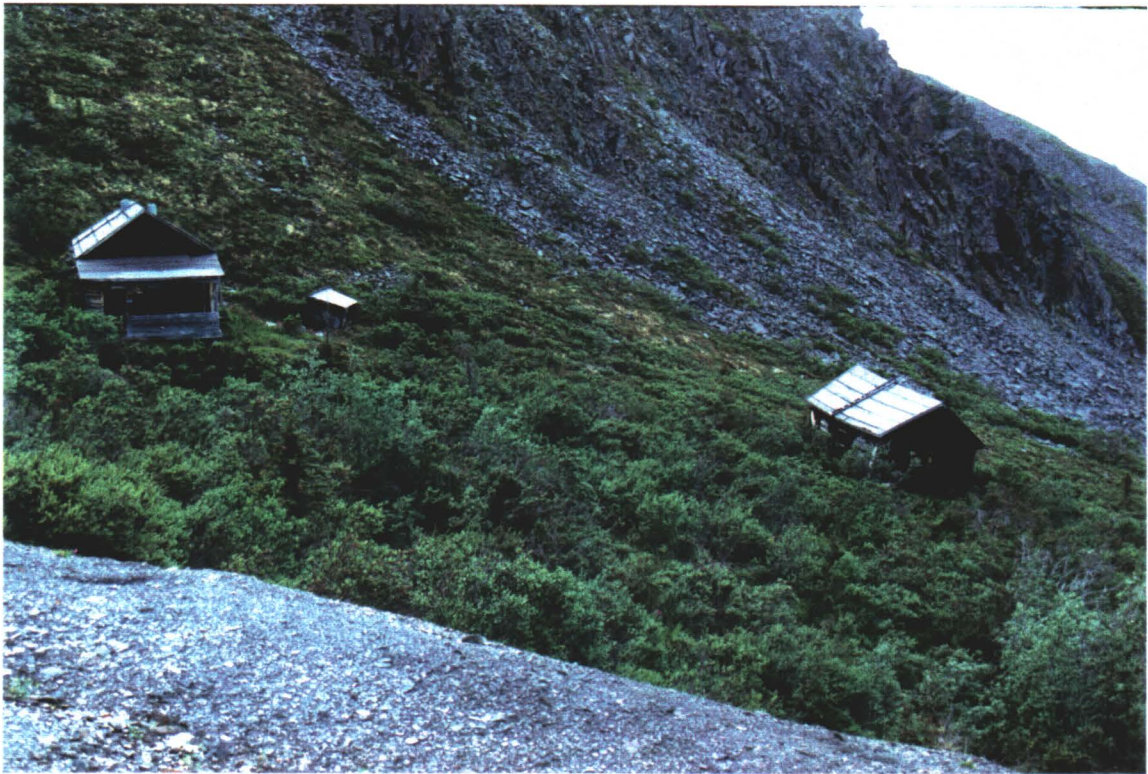
- a 6x9m wood frame, wood clad building used as a cookhouse. Metal bedframes were still in the building,
- a 7x7m empty one and one half story wood frame, wood clad building,
- a 6x10m empty wood frame, wood clad building
- remnants of a collapsed hand excavated adit, and

The buildings at this site are very old, deteriorating, and will likely start collapsing within the next few years.

BUNKHOUSE AND COOKHOUSE

The remaining buildings appear to be the only potential safety hazard. There is a very small risk that if someone was to enter these buildings when they are about to collapse that someone could be injured. These buildings are in a very remote location and this risk is **VERY LOW**, however to eliminate any risk, the buildings should be demolished or burned or **posted to warn anyone of the potential hazard**. If these buildings were to be burned care needs to be taken not to start the nearby vegetation on fire.

The only potential hazard appears to be from the possibility of a building collapsing when someone was inside the building. It is recommended that these buildings be posted to warn anyone of the potential hazard before they enter them. Alternatively, these buildings could be removed by either demolition or burning.

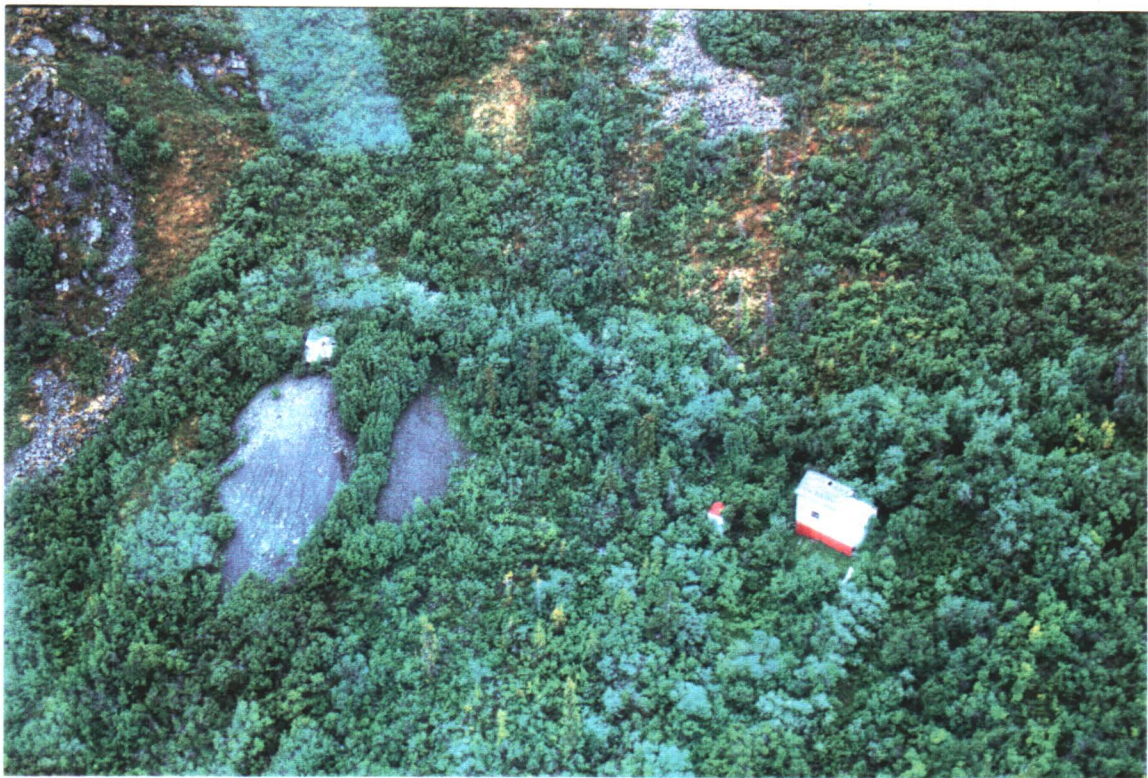
SITE WITH WASTE ROCK DUMP BELOW UPPER SITE
