**ASSESSMENT REPORT**

**106D-08-1**

**KATHLEEN LAKE NORTH**

**DIAND TECHNICAL SERVICES**

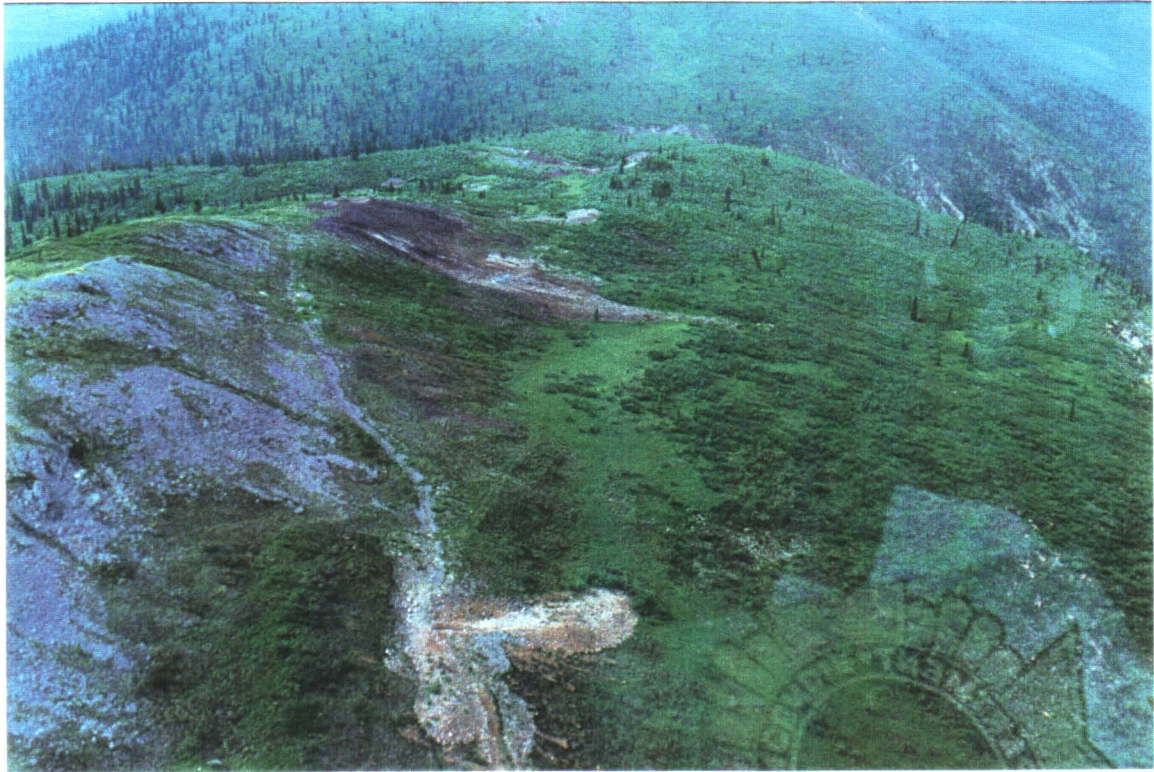
Exploration at this site has been limited to surface drilling and trenching. Extensive areas have been exposed from construction of exploration trails and trenching. No adits were constructed at this location.

OVERALL VIEW OF SITE SHOWING TRENCHING

The exploration trails to the site are steep and narrow and constructed on coarse granular material. The area is dry with only some surface raveling taking place. Revegetation on the road surface and "cut slopes" has started and will advance slowly. Leaving the area to recover naturally appears to be the only practical solution. Reshaping the drill roads to completely blend in to the natural landscape would be very costly and disturb any natural recovery that has occurred in the area, and is not recommended.

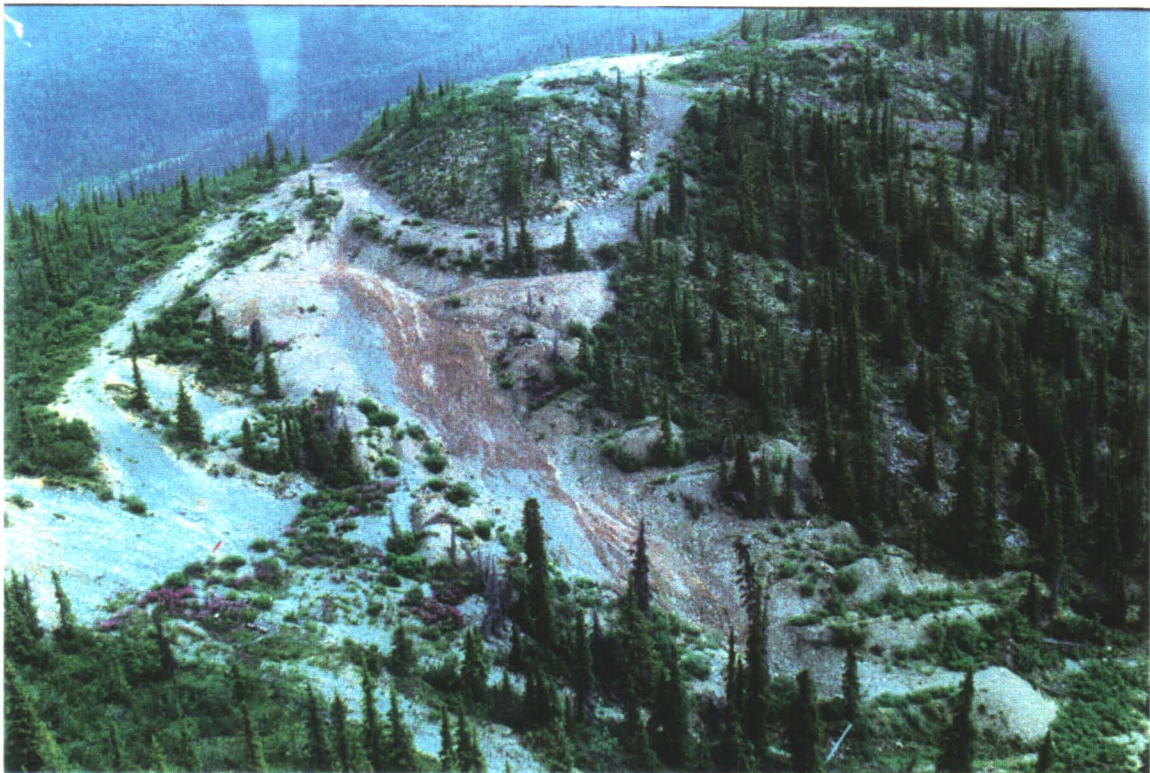
Because the site is so high and dry the exploration trails and trenched areas have not revegetated naturally.

TRENCHING AND EXPLORATION ROADS

Revegetating roads and drill sites is considered a **VERY LOW** priority for this area.

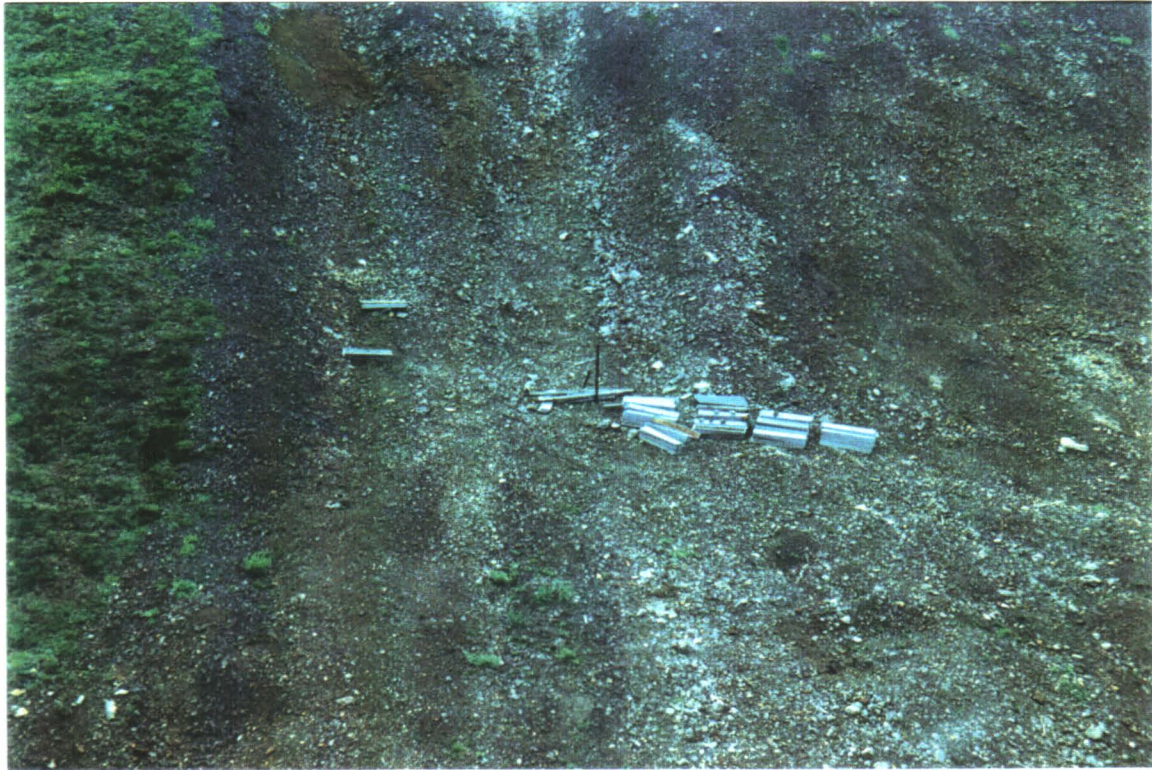
- 3 empty 204 litre fuel barrels,
- 30-40 core boxes.

CORE BOXES LEFT ON-SITE

If a waste clean-up program is ongoing in the area, it is recommended that the 3 barrels and core boxes be removed from the site. Recovery of these barrels and boxes will have to be completed using a helicopter as the site is not practically reached by road. This work should be considered a **LOW** priority at this location.

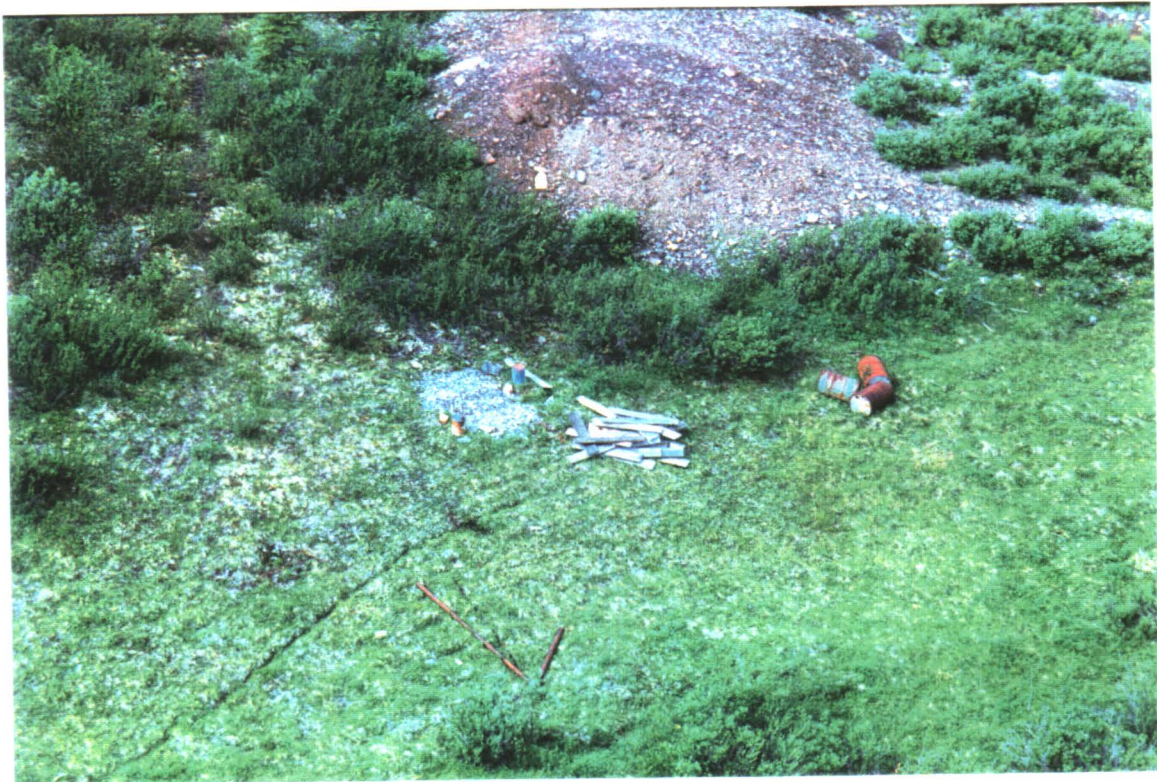
BARRELS, CORE BOXES, AND PIPE
