ASSESSMENT REPORT

105M-07-1

KALZAS TWINS

DIAND TECHNICAL SERVICES

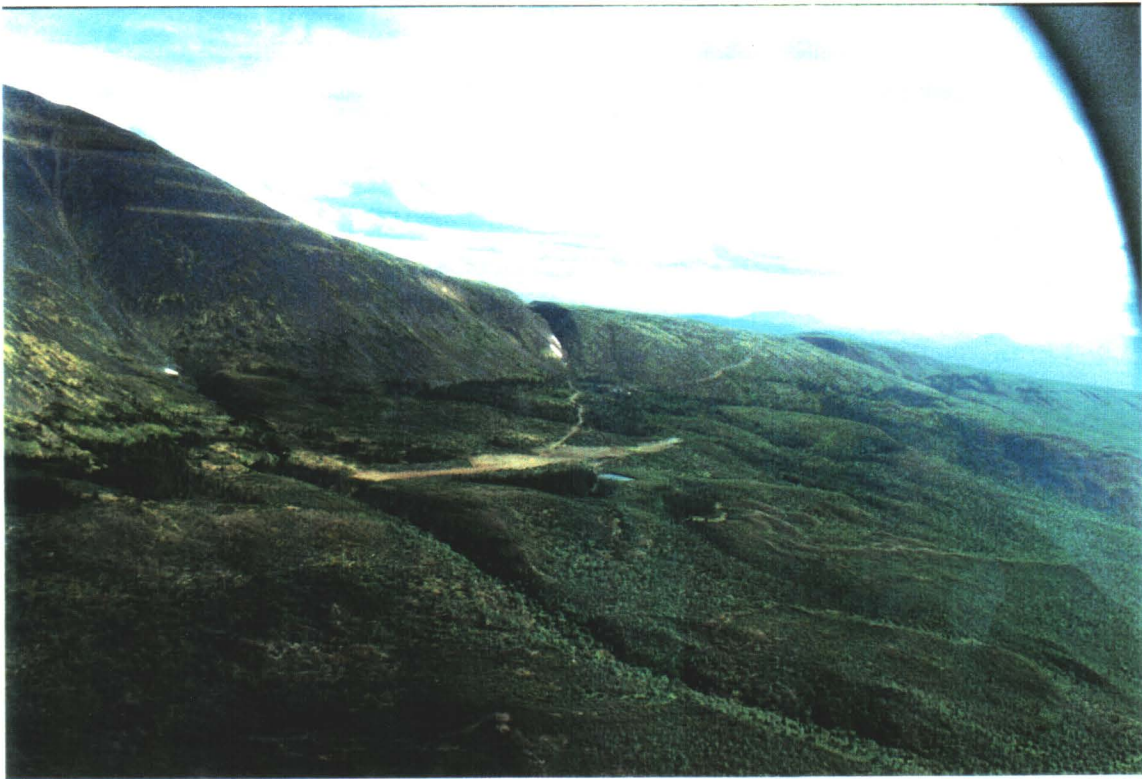
AIRSTRIP, CAMPSITE, AND EXPLORATION AREA

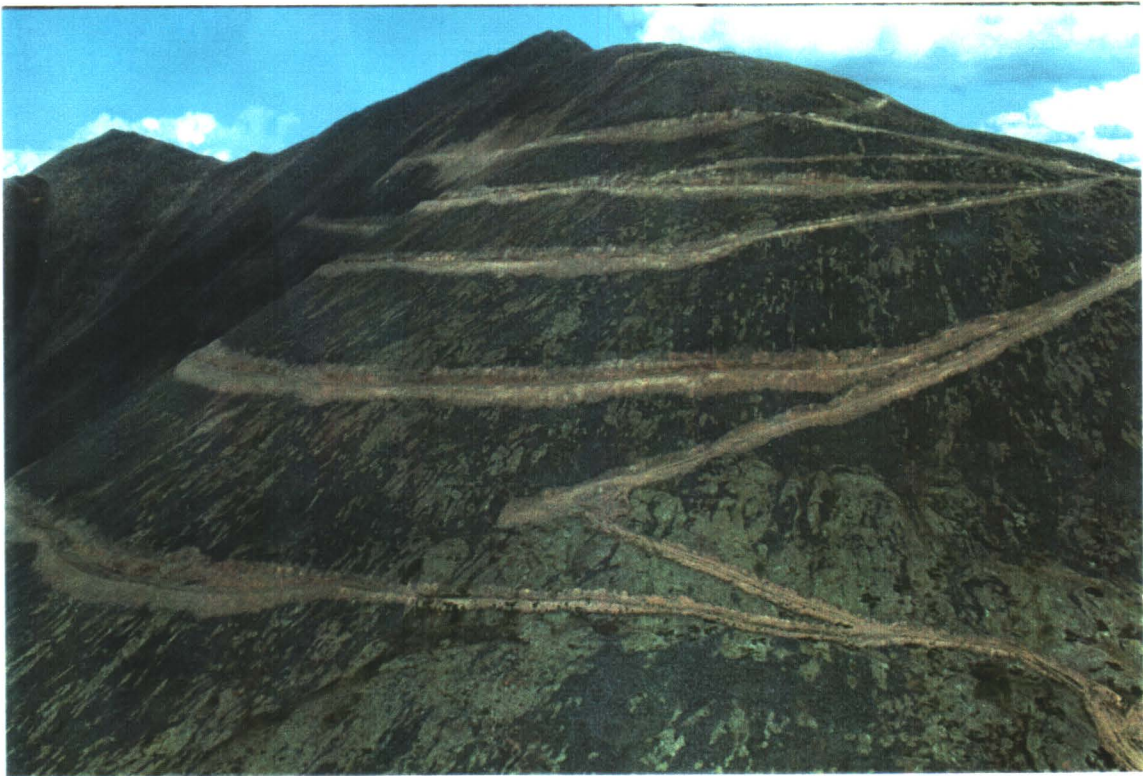
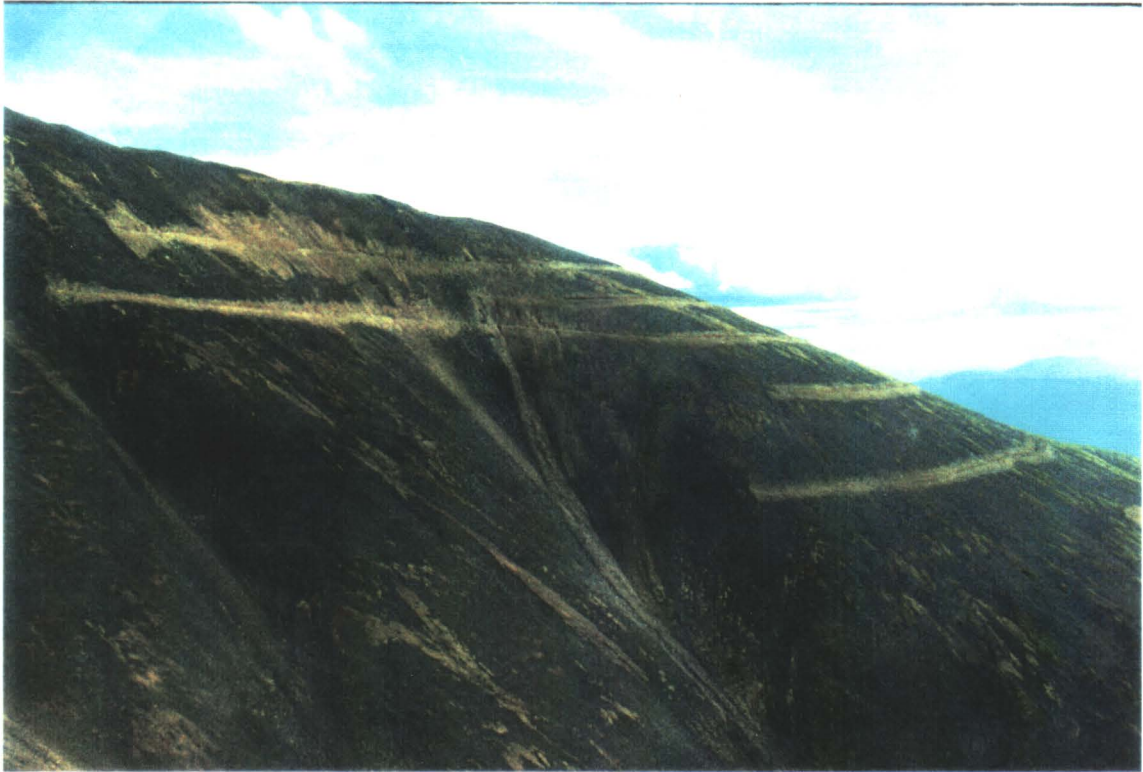
Disturbance from exploration covers quite a large area measuring approximately 1.0x1.0 km over the west side of Kalzas Twins. The site has been explored extensively with a gridwork of trails over the exploration area. Most of these trails appear to have been developed for drill access and trenching above the camp location. These trails are on the steep hillside of Kalzas Twins and have been constructed by cutting into the slope and pushing the "cut" material down the slope. Most of this trail construction was done on steep slopes with little or no vegetative cover and is quite visible. All exploration was conducted from the surface and no exploration adits have been recorded at this site.

Trenching and trail construction at this site has resulted in extensive surficial disturbance. This trail construction has taken place on steep, dry, rock talus slopes with little or no vegetative cover. These trails were constructed on steep slopes by "cutting" into the side slope and "filling" or "wasting" material down the slope to provide a flat road surface. The result has been that placing this material downslope has left this very visible feature on the landscape. However, because the material is rock and well drained, the slopes are stable and this activity should not cause slope failures in the future. The environmental damage caused by the exploration at this site is only visual. Site remediation to rectify the visual impact would involve extensive reshaping of the trails to the original topography. This is not considered a practical solution as it would be very costly and cause additional disturbance to an exposed site. It is recommended that this **LOW** priority remote site be left in its present condition.

EXPLORATION TRAILS

Extensive surface exploration resulted in significant ground disturbance at this site. This disturbance has left a highly visible site in a remote location. However the work that has taken place should not cause additional damage in future. It is recommended that the exploration site be left alone to avoid further damage and allow any naturally occurring remediation to take place.

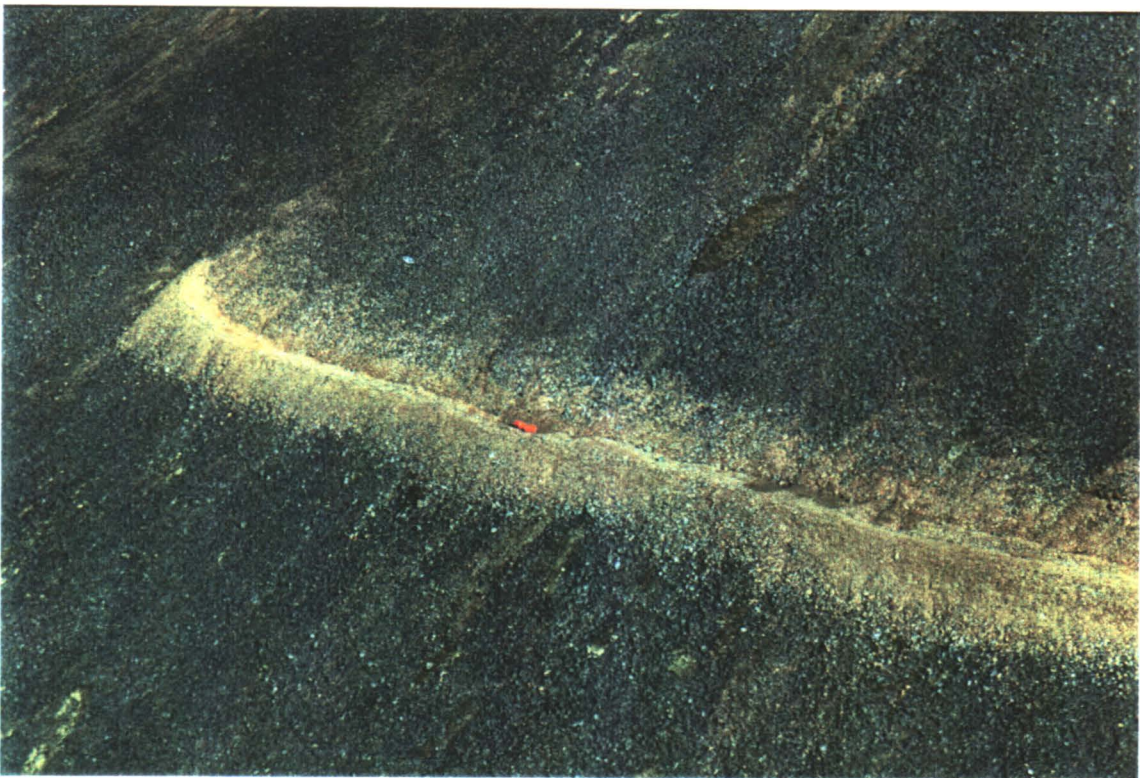
Remaining infrastructure is located primarily at the exploration camp. Fuel barrels are also located at the airstrip and on the mountain side.

FUEL BARRELS ON EXPLORATION TRAIL

The hydrocarbon products on-site are well contained, volumes are relatively small, but they could potentially spill or leak into the surrounding environment. The need to remove and properly dispose of these remaining hydrocarbon products should be considered a **HIGH** priority.

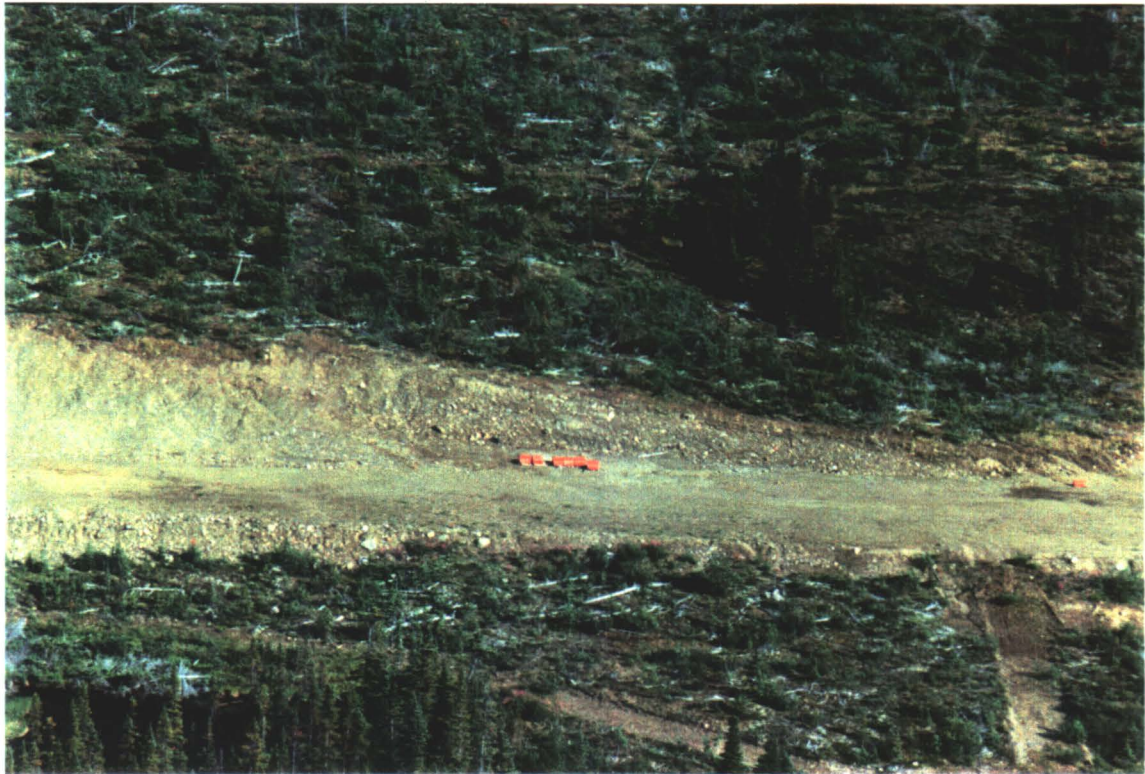
FUEL BARRELS ON AIRSTRIP

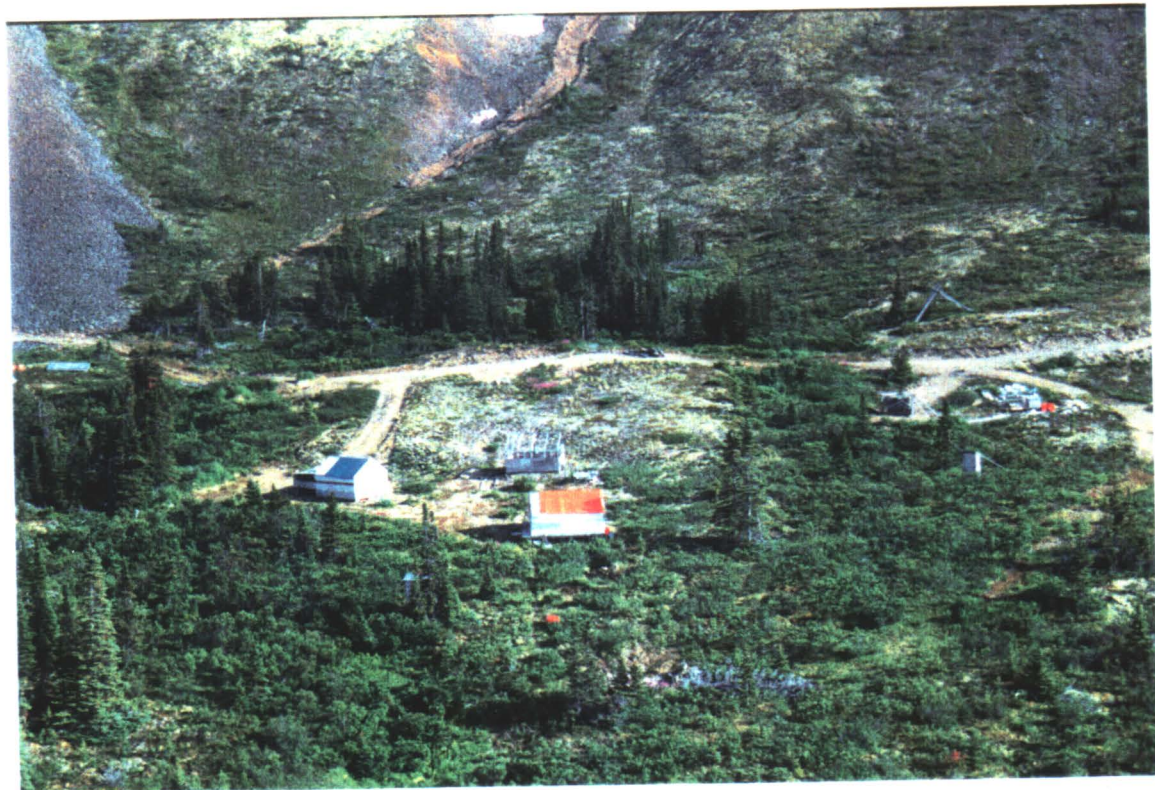
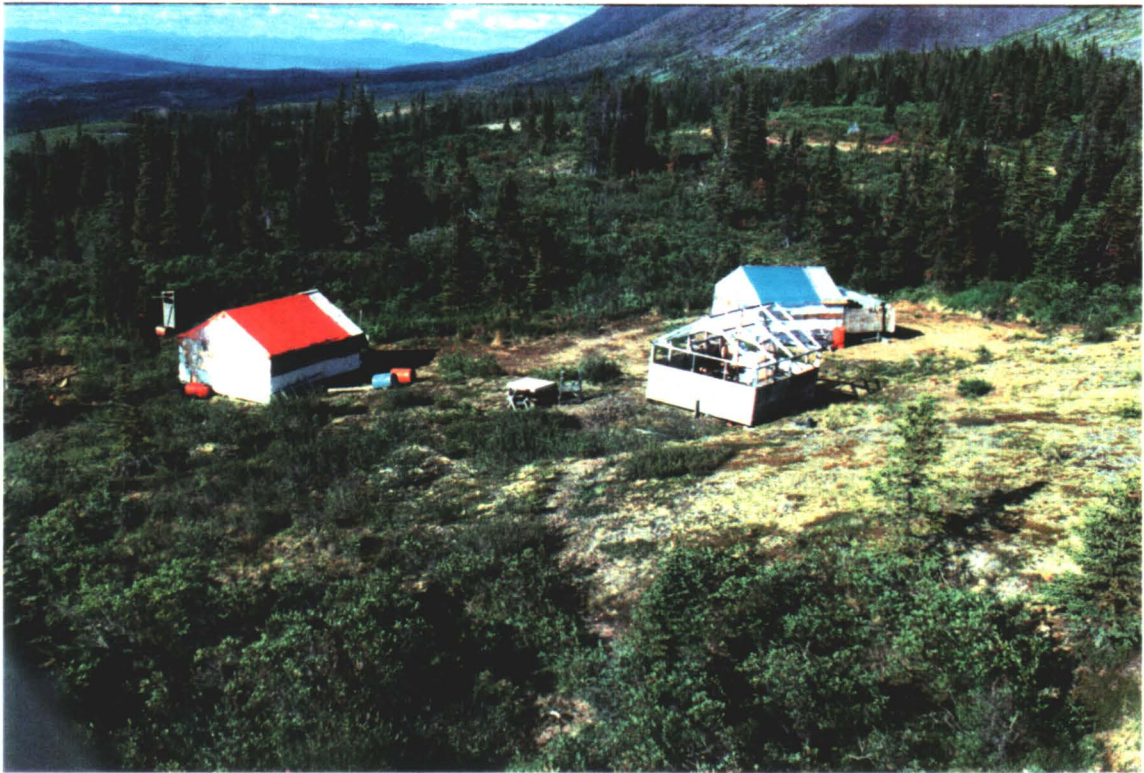
At the exploration camp significant effort has been made to clean up the area. All remaining equipment and supplies were neatly piled, and the tent camp was well secured. The highest risk at the camp and airstrip is the possibility of the remaining fuel on site could be spilled as long as it remains unprotected. This should be considered an environmental hazard at this site and should be cleaned up as soon as is practicable. The most practical way to dispose of this fuel from this remote location would be to fly a portable incinerator to the site and incinerate all remaining fuel or remove the fuel from the site to Mayo. Once the fuel is disposed from the site, clean up of the remainder of the site would be considered a **LOW** priority.

CAMP SITE

If a program to clean up low priority sites is initiated the camp could be dismantled and cleaned up. This should include cataloguing all core, removing any metal waste, demolishing the wood frame structures, and burning all wood waste on-site.

The need to clean up of remaining buildings is considered a **LOW** priority at this time.

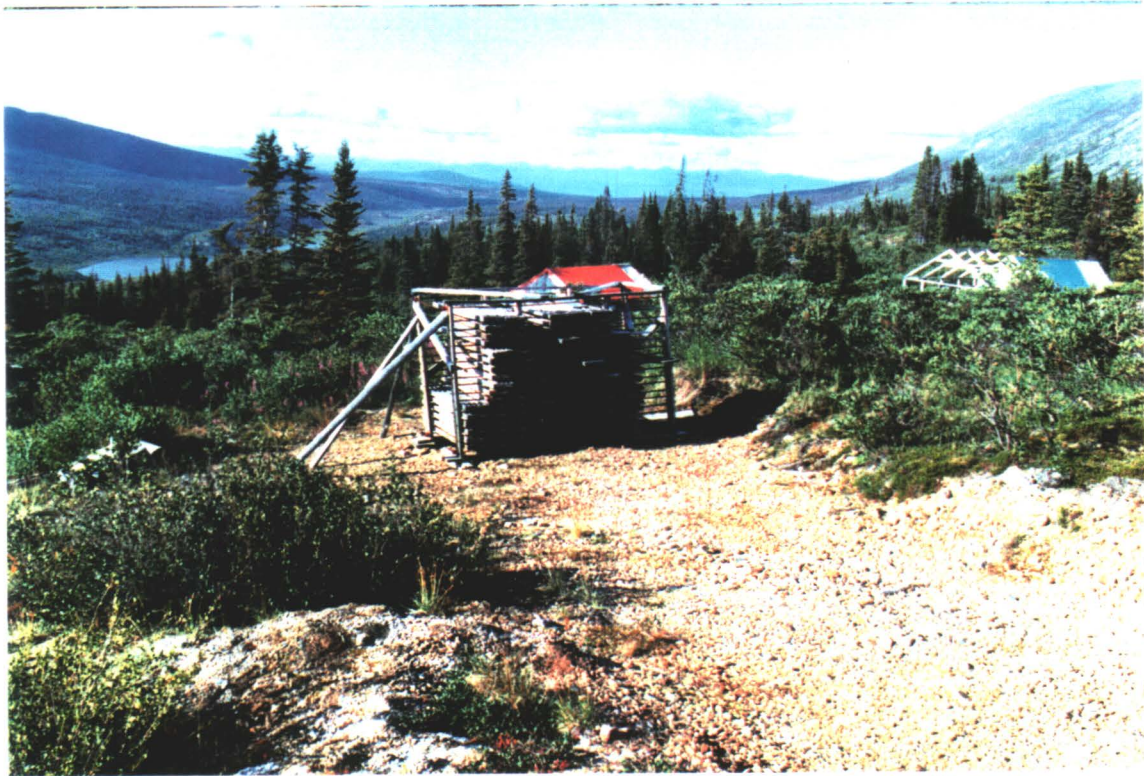
CORE AT CAMP SITE
