ASSESSMENT REPORT

106D-04-1

PESO

DIAND TECHNICAL SERVICES

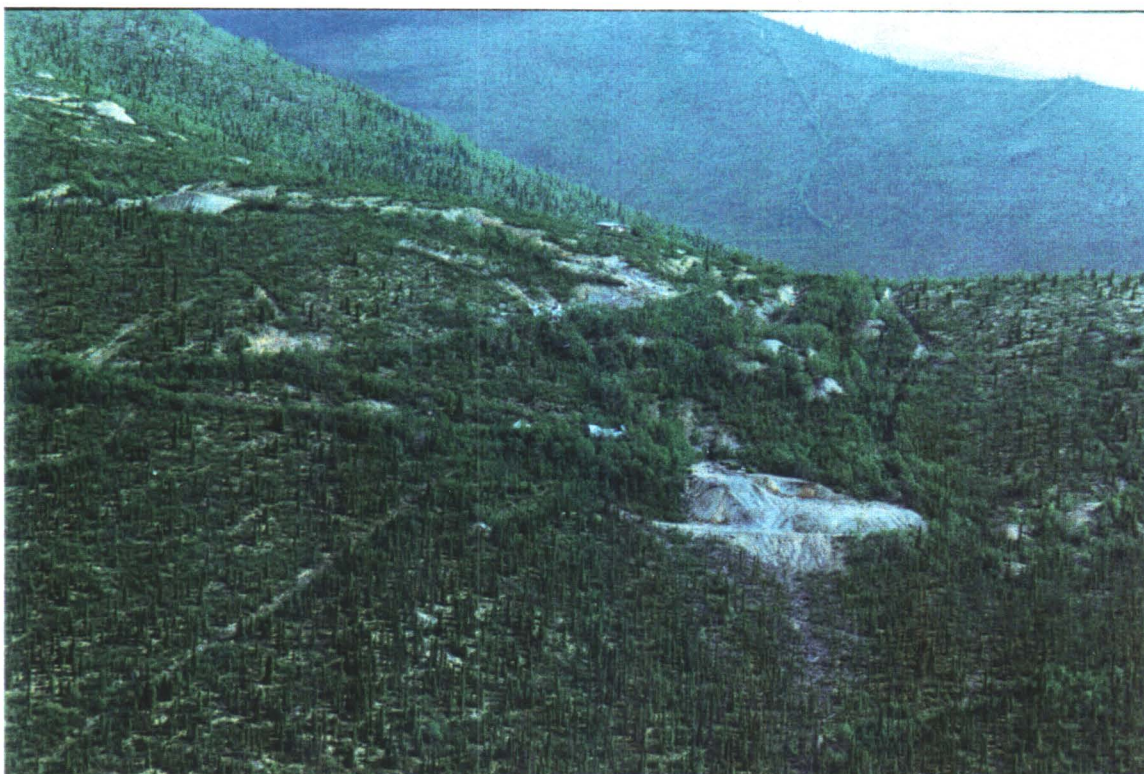
An open adit is located at this site with the resulting waste rock dumped below this adit. The waste rock pile measures about 50m wide and is approximately 100m long. A strong smell of sulphur was noticed. A line of vegetation below the waste rock pile was dying or at least appeared stressed. This vegetation stress appeared for several hundred metres downslope.

The adit is still open and can be accessed by anyone coming into the area. The waste rock has been dumped down the slope outside the adit and covers an area approximately 50x100m. The waste rock is giving off a strong odour of sulphur. The vegetation downslope of the waste rock pile appears to be a lighter colour than vegetation away from the waste rock.

VIEW OF SITE. NOTE VEGETATION STRESS BELOW WASTE ROCK.

The most significant environmental impact appears to be from the waste rock pile below the adit. Some vegetation stress appeared to be occurring downslope of the waste rock pile in this very remote location. If there is concern from any potential contamination of the vegetation below this site then it is recommended that the vegetation be sampled and tested for any contamination. It is recommended that sampling be completed progressively downslope to verify the extent of any contamination that could be occurring.

The vegetation stress that appears downslope of the waste rock pile should be assessed in more detail if there is concern with contamination of the vegetation and any water course downslope of the site. The site is very remote and potential remediation options should be considered before any further testing is considered.

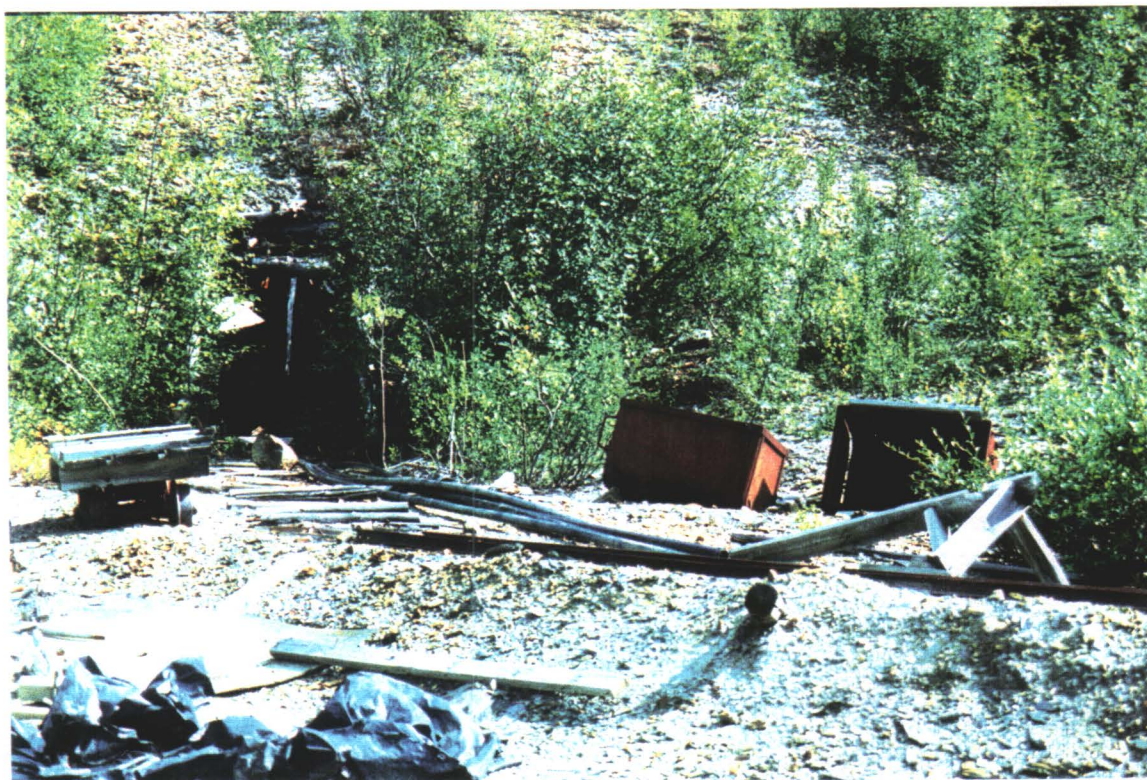
OPEN ADIT

The open adit is considered a safety hazard and it is recommended that it be sealed off to prevent anyone from entering it. Even though this site is in a remote location this should be considered a **HIGH** priority.

The main concern at this site is considered to be the open adit accessible to the public. For safety reasons this adit should be sealed from the public to eliminate any risk of an accident occurring by anyone that could enter it.

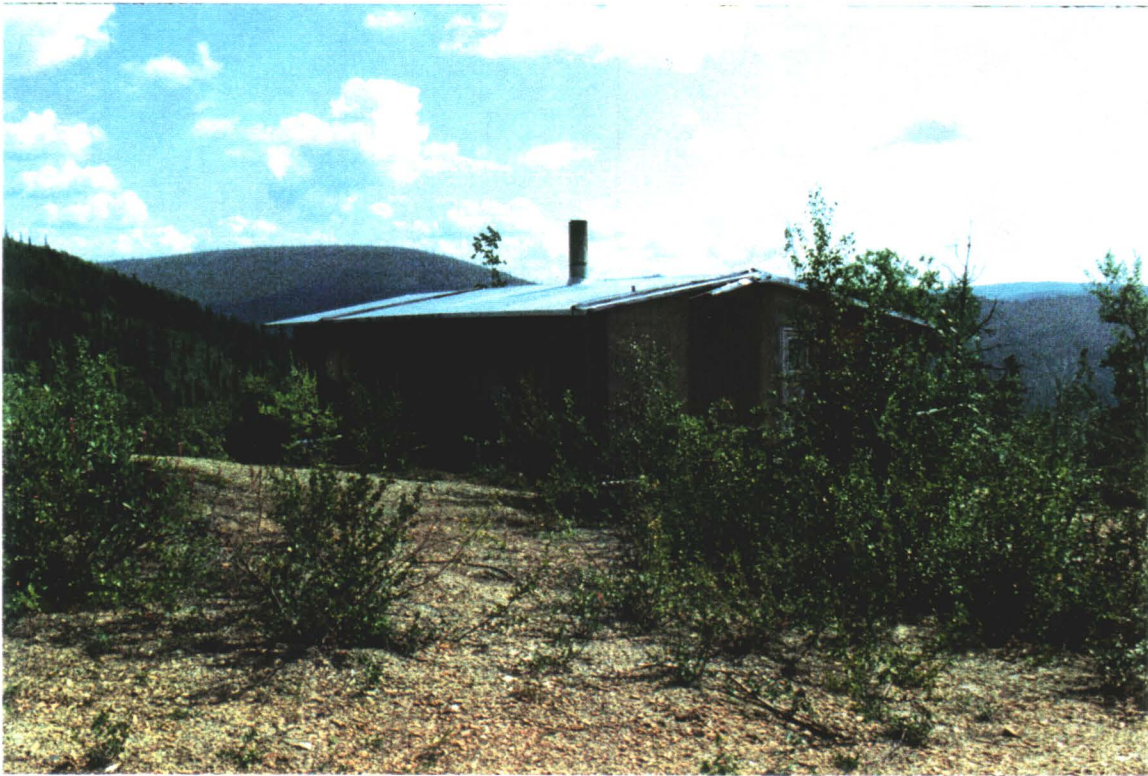
The old buildings at this site have either collapsed or are collapsing. Vegetation has already grown in close to the buildings and the site around the buildings is recovering from any past activity.

OLD RESIDENCE

The buildings, barrels, and metal waste do not appear to be causing any significant long term environmental hazard and clean-up of these materials is considered a **LOW** priority. However, if a general clean-up program is initiated in the area, it is recommended that the barrels and other metal waste (including the metal quonset shed) be gathered and removed from the site. The wooden buildings could be demolished, piled and burned in a safe location.

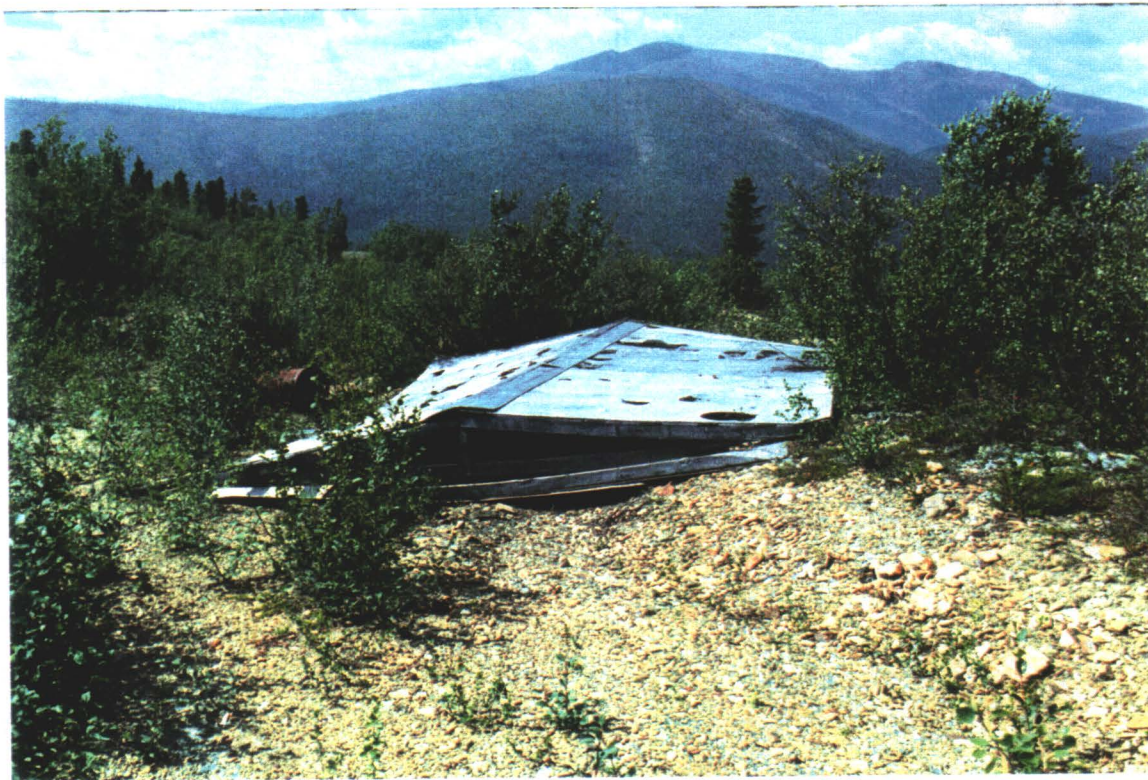
COLLAPSED BUILDING

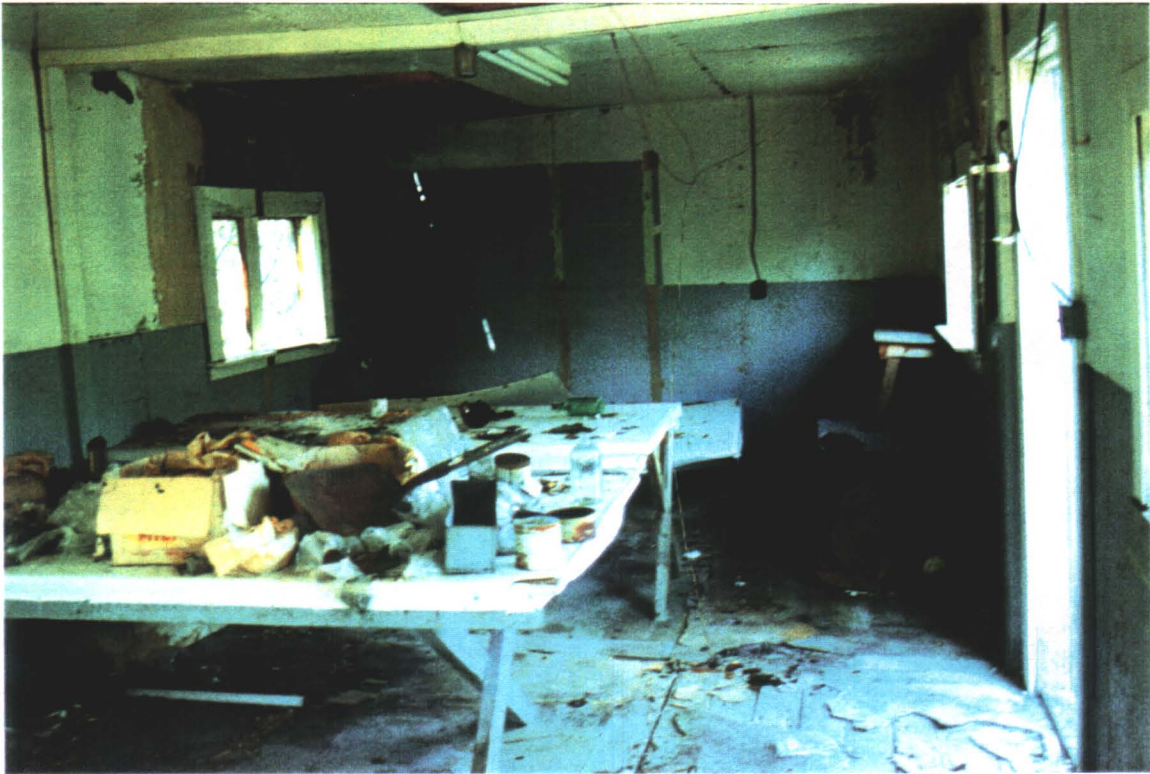
Material left in the buildings has been left scattered throughout the buildings. This consists of old chemical bottles with some chemicals and old books in the old office building, and core along with metal waste in the quonset shed.

INTERIOR OF OFFICE BUILDING

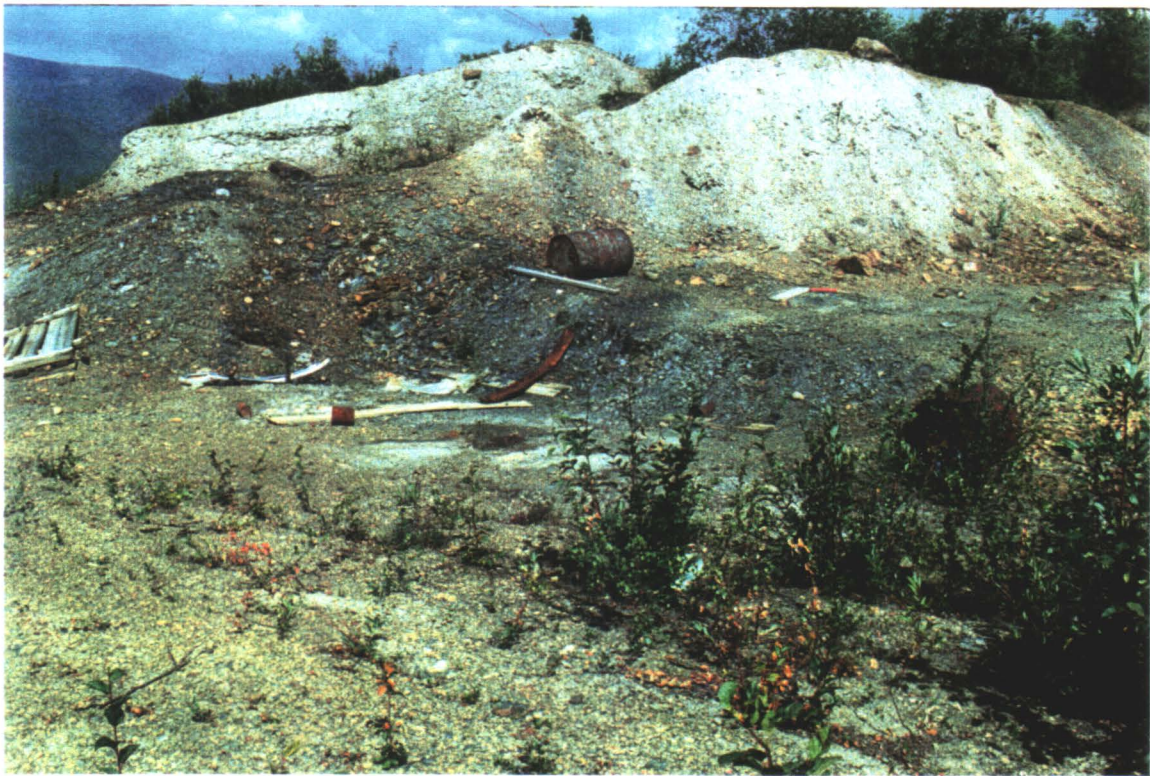
Trails from some old trenching are still visible, but work from this activity does not appear to have caused any instability problems in the area. Vegetation is slowly encroaching over the cleared and stripped areas.

TRENCHING AREA

It is recommended that the areas of trenching not be disturbed as vegetation has established itself over most of the once disturbed areas.

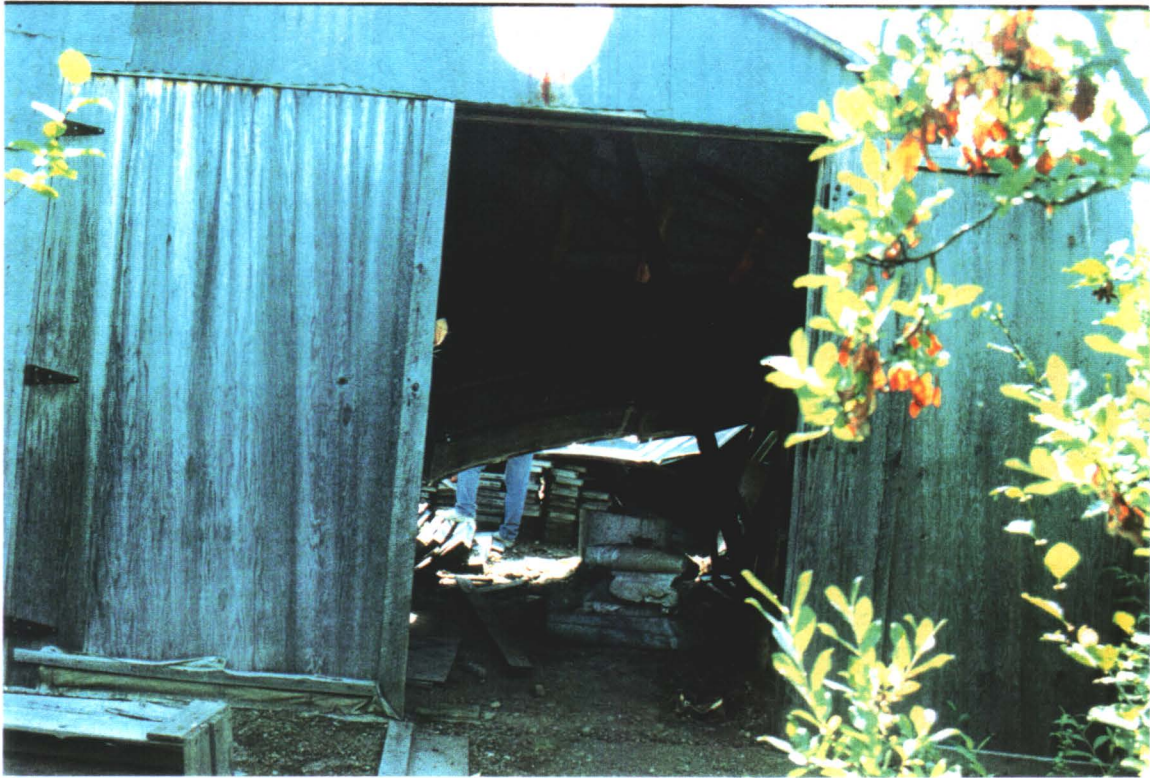
The rock core is scattered around the quonset and does not appear to have any value.

METAL CLAD QUONSET. NOTE ROCK CORE.

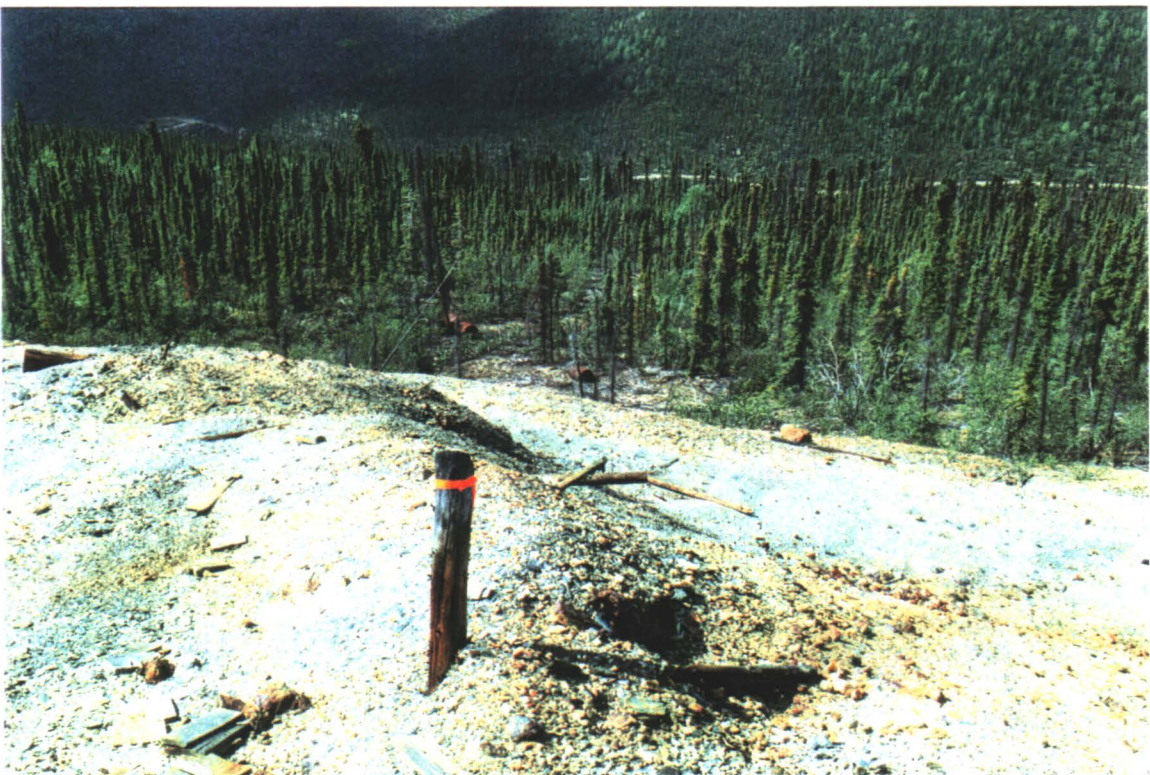
DOWNSLOPE OF WASTE ROCK DUMP SHOWING VEGETATION STRESS
