**ASSESSMENT REPORT**

**116B-05-1**

**SILVER CITY**

**DIAND TECHNICAL SERVICES**

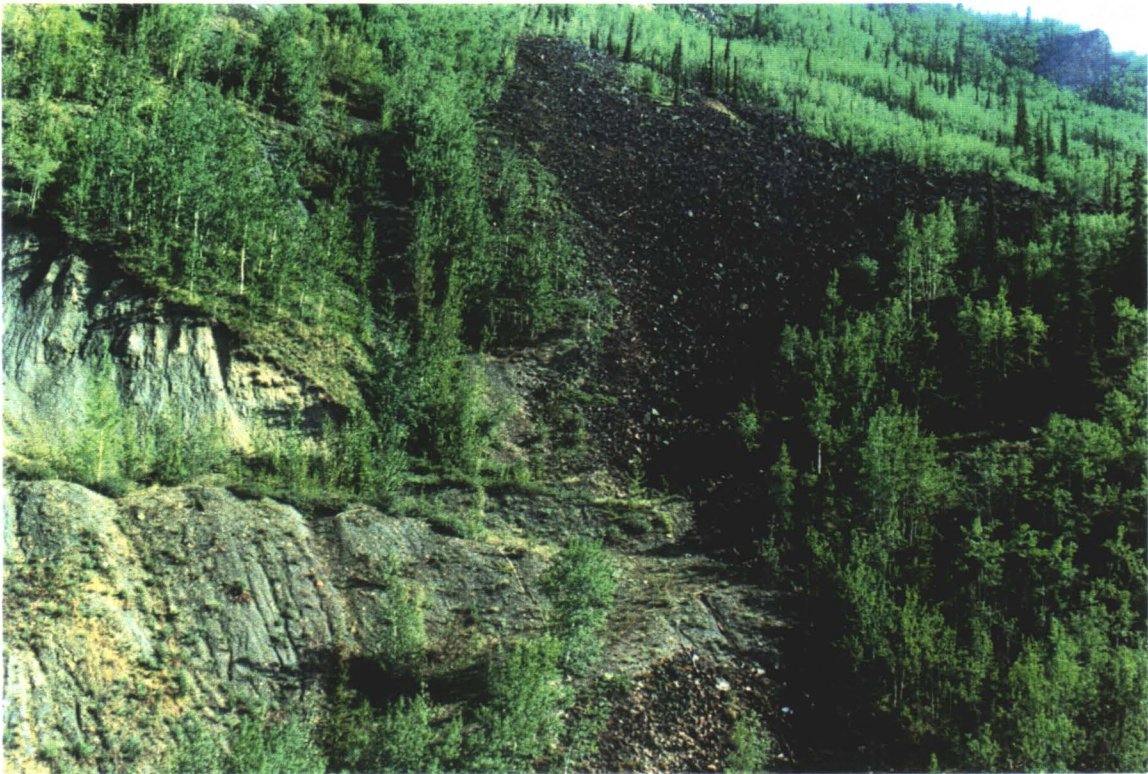
The only evidence of past activity was a water pipe extending from the river to the top of the slope. Evidence of the old adits could not be seen from the site inspection from the air. It is possible that open adits may still be left at this site.

OVERVIEW OF SITE SHOWING PIPE (LOWER PART OF PHOTO)

The only evidence of past activity is the pipe extending up the slope. Removing this pipe is the only clean-up that could be undertaken at this site and this is considered to be a **LOW** priority.

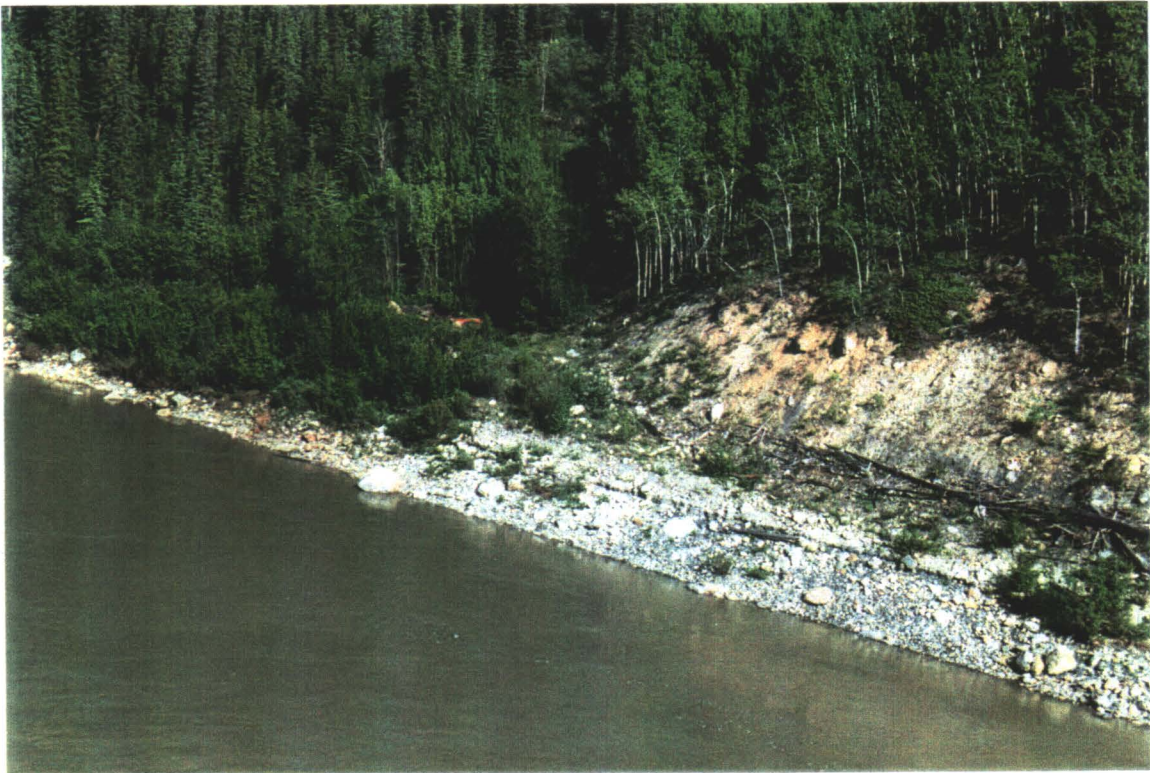
The site is overlain by weathered and fractured bedrock sliding down to the Yukon River.

RIVERBANK AT SITE
