**ASSESSMENT REPORT**

**105B-07-2**

**SILVERHART**

**DIAND TECHNICAL SERVICES**

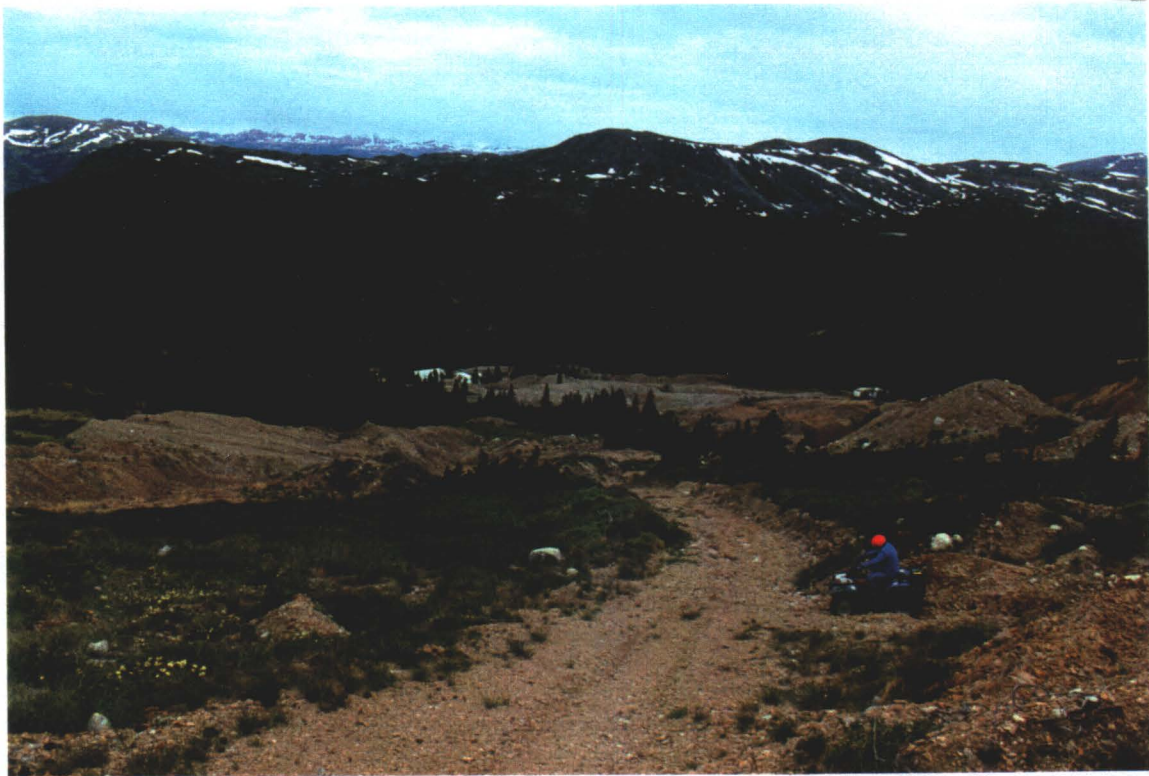
Disturbance from exploration at this site covers an area approximately 1.5x1.5km on the top of an unnamed peak. The site has been extensively developed with roads crossing the exploration area and a gridwork of exploration trenching to a depth of 6m, all above the camp location. The vegetation has been removed wherever the road or trenching operations took place. The exploration adit is located below the camp site with waste material piled below the adit entrance.

Extensive trenching and stripping across this area has resulted in significant damage to the vegetation. The damage to the surface is significant from the activity during the exploration activity. However, there is no evidence that additional problems such as erosion, slope failures, contamination of water courses, etc. have been caused from the original activity. Site remediation, if it was undertaken, would consist of reshaping cut slopes to blend with the natural slopes and revegetating the site. This method of remediation would be very costly and also result in additional disturbance to the site. Instead, it is recommended that leaving the site to recover naturally is the most suitable solution for this site. Recovery of the site will be slow in an area that is extremely remote and sensitive to disturbance. Revegetation of the site is likely best left to natural reseeding due to the remoteness of the site and the inability to promote growth.

1. TRENCHING AND CAMP SITE IN DISTANCE

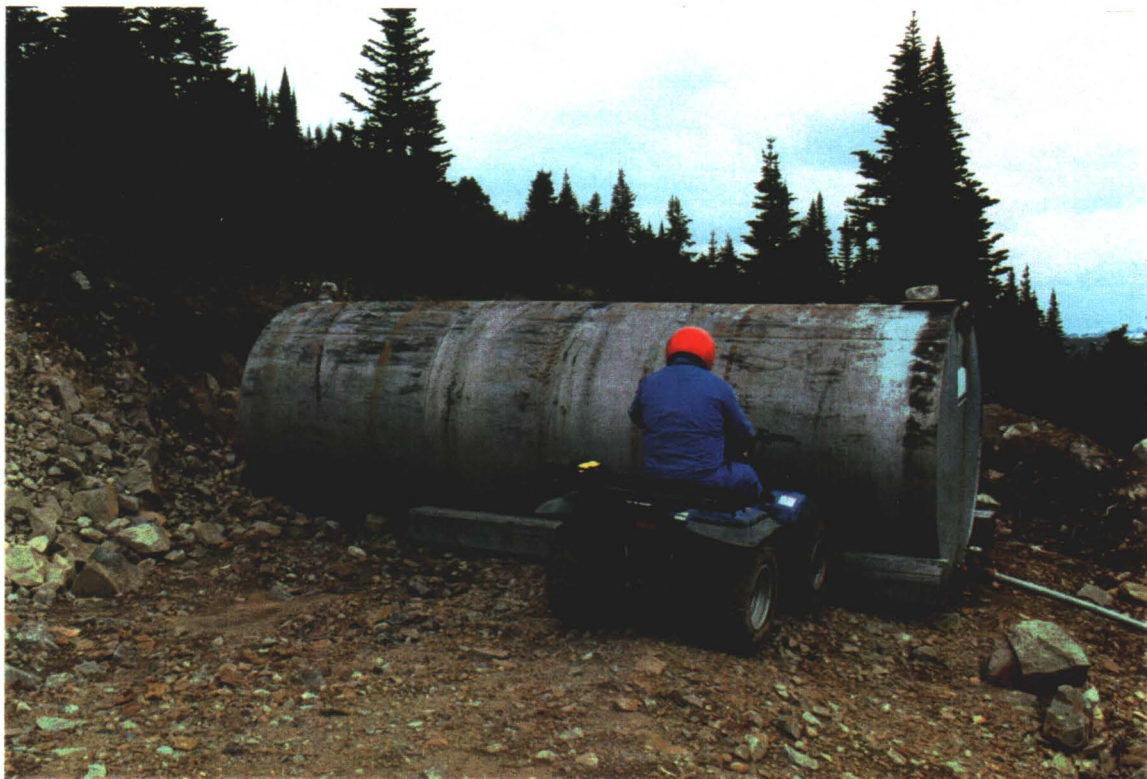
- \* 1 - 1.83m diameter and 5.49m long horizontal tank with 0.3 - 0.6m diesel fuel in the bottom of the tank.

**Note: Valve is leaking and remainder of fuel is leaking and seeping into ground. Tank is located 0.5 km above exploration tent camp area.**

2. LEAKING FUEL STORAGE TANK

One item of site remediation of this area should include the removal of the 1.83x5.49m leaking tank from the area. All spilled fuel cannot be recovered, however the extent of the damage appears to be reasonably small. Confirmation of the extent of soil contamination, if necessary, will require a soils investigation to collect samples, define the extent of contamination, and analyze the samples for type and levels of contamination.

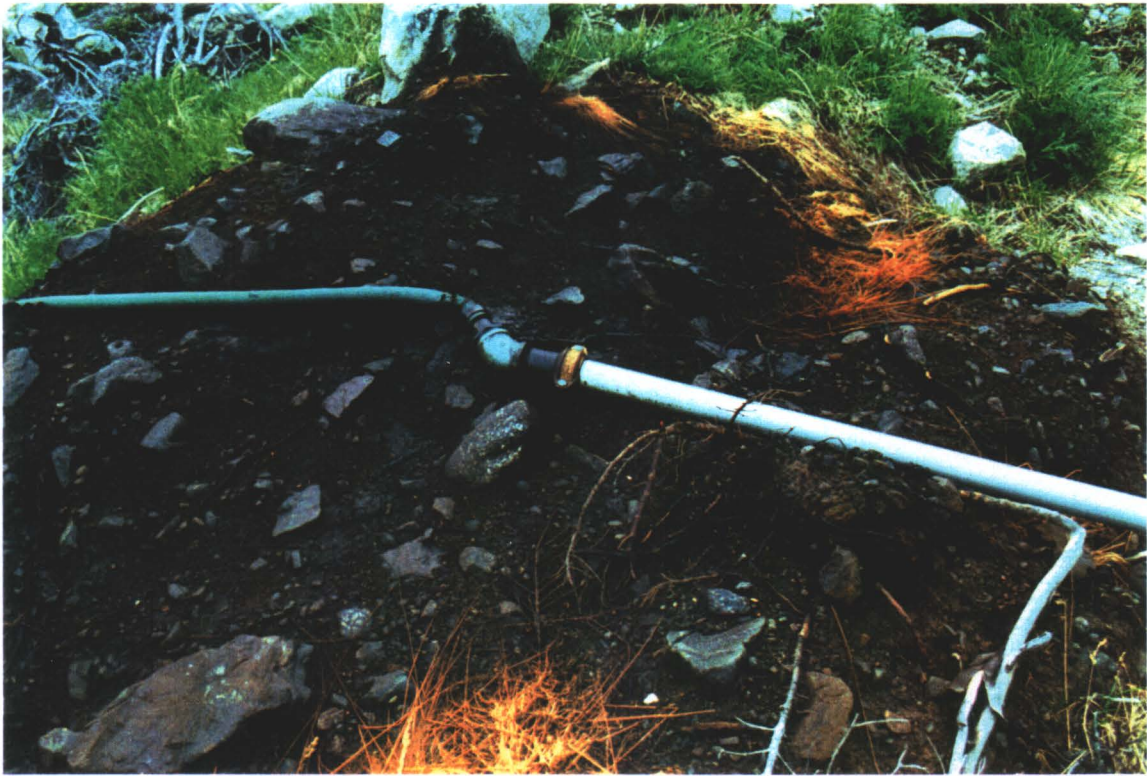
3. DIESEL FUEL SPILL

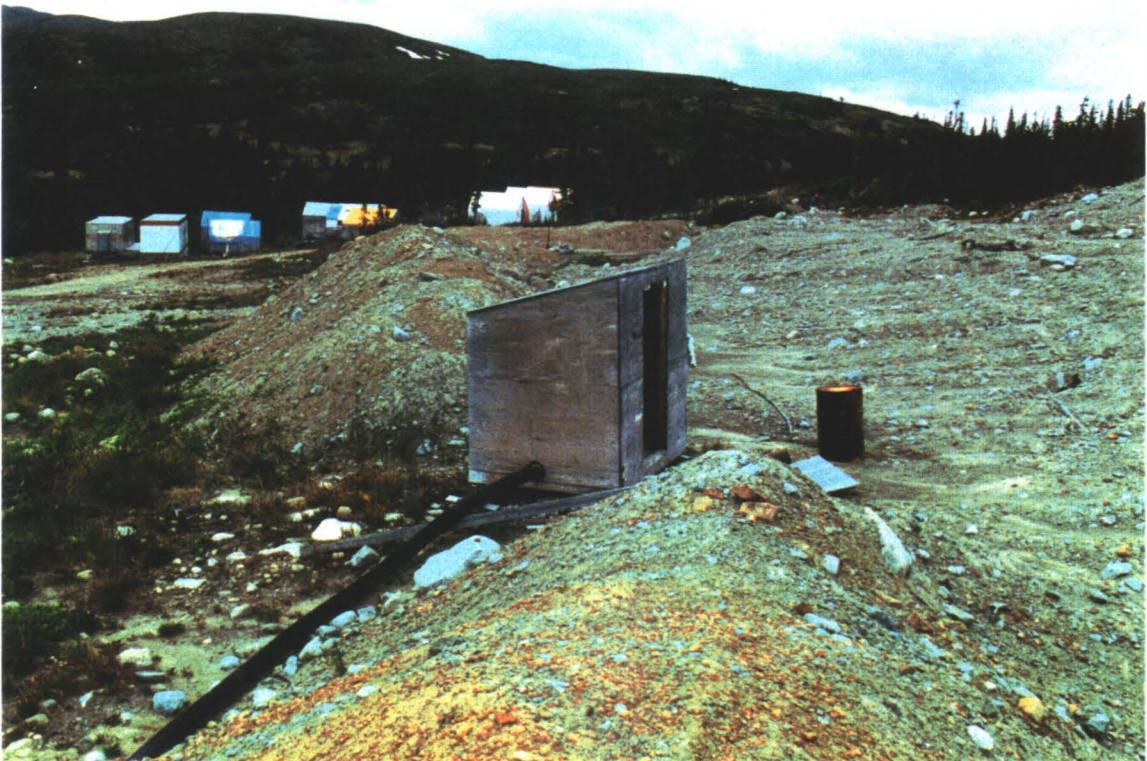
One 150mm diameter drilled and cased well is situated upslope between the exploration tent camp area and the trailer camp site. The depth of the well is not known. A 2.4x2.4m plywood well house covers the well area.

4. WELL AND TENT FRAME CAMP IN DISTANCE

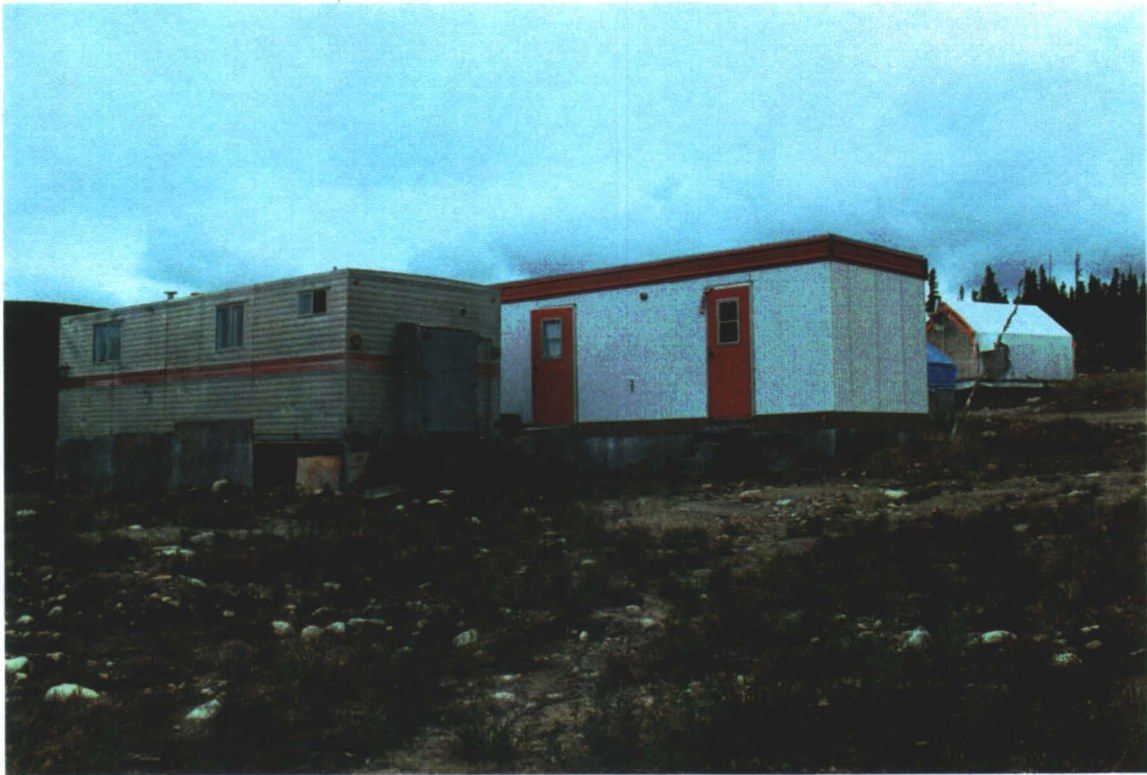
5. TRAILERS AT TENT FRAME CAMP

- Repair the road adequately to drive trucks into site.
- Unhook all connections to the 6 trailers, load, and haul trailers off the site for disposal.
- Empty all fuel storage tanks and either incinerate or remove all hydrocarbon products from the site using acceptable methods.

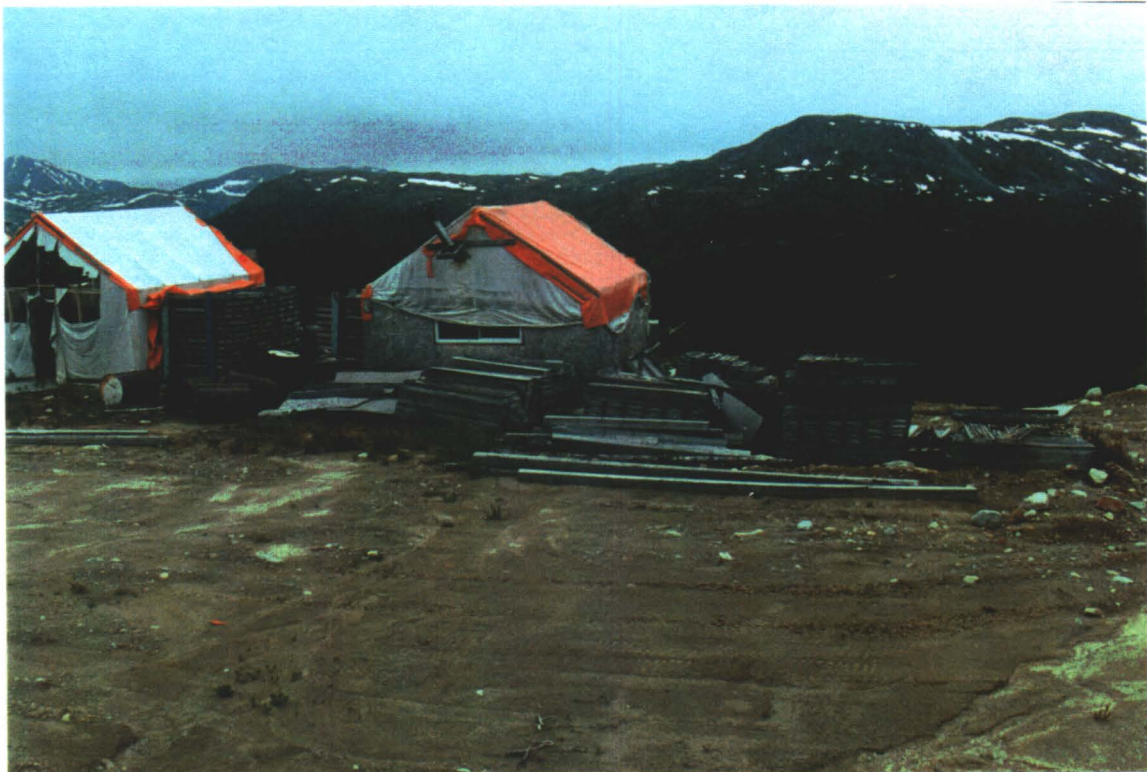
Core is stored adjacent to the tent frames. The volume of core in core boxes measures approximately 9.14x1.52x6.10m. Core is stacked outside and exposed in the tent camp area.

6. CORE STORAGE AND BARRELS OF DIESEL FUEL

- Catalogue, remove, and store rock core in an approved location.
- Sample and analyze any water seepage from the exploration adit for any contamination potential.

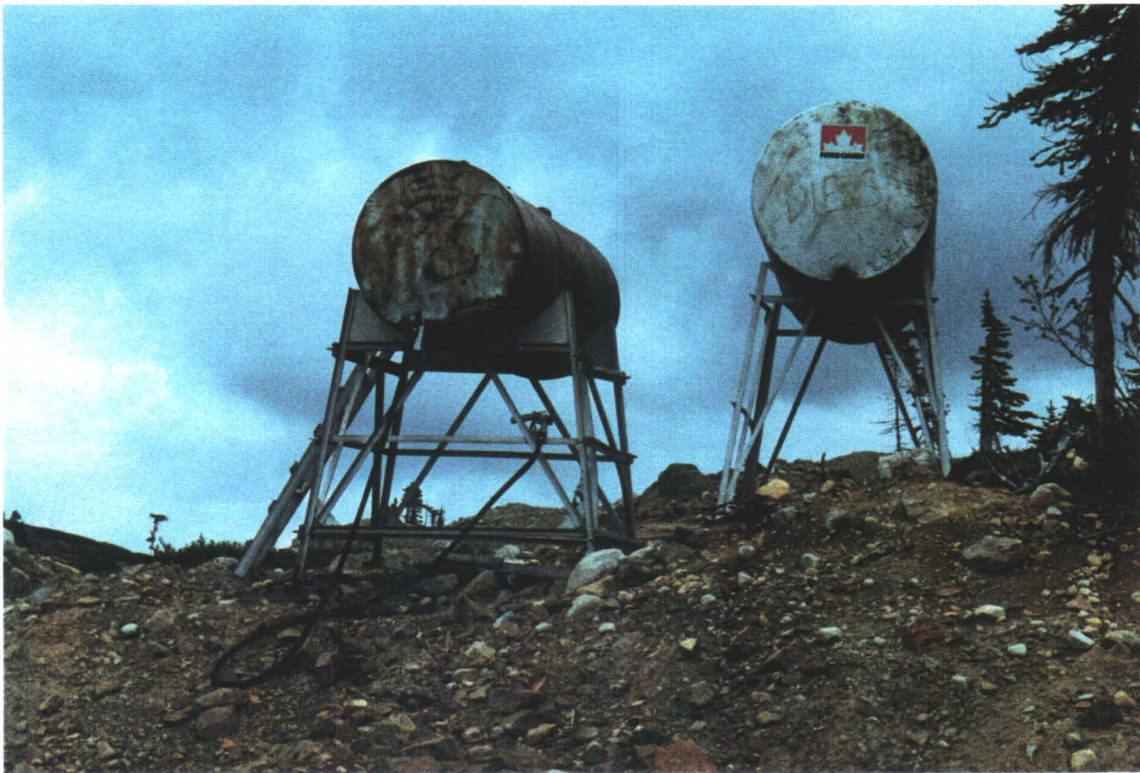
7. 2-4540 LITRE FUEL STORAGE TANKS AT TRAILER CAMP

- Dismantle and remove all tanks and barrels from the site.
- Load and remove any additional metal waste from the site such as pipe, rail, stoves, equipment, etc.

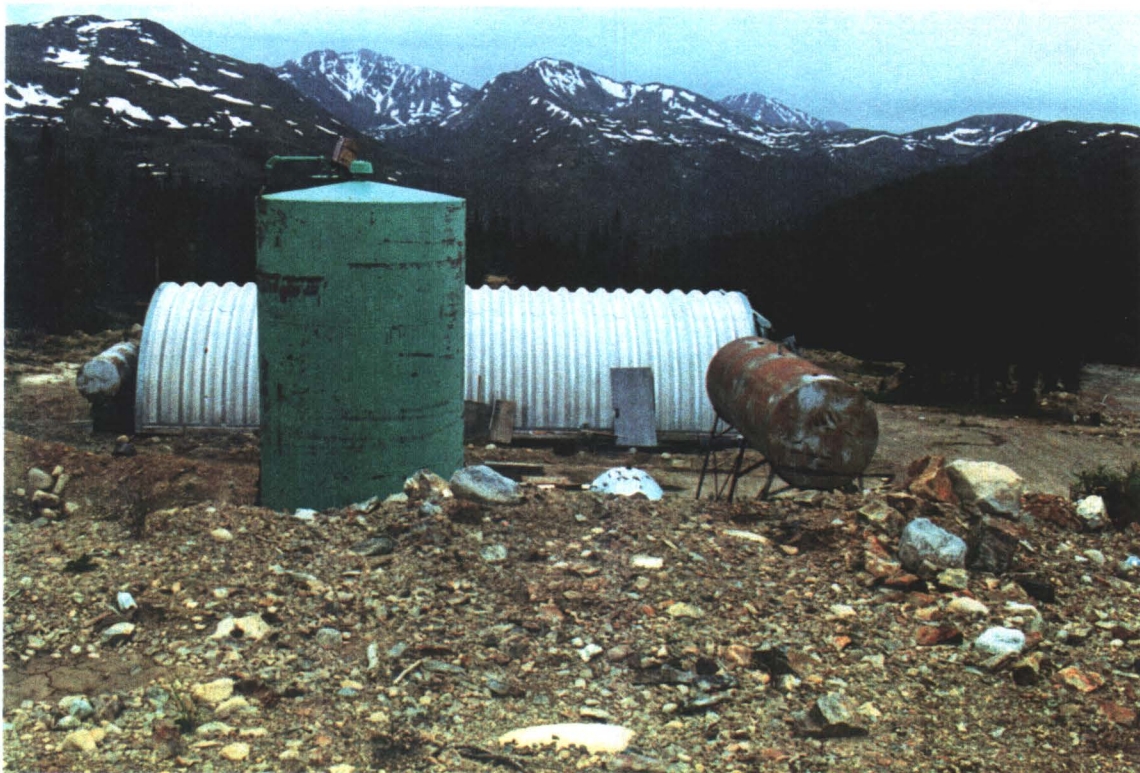
8. 4540 & 22700 LITRE FUEL STORAGE TANKS AND  
QUONSET SHED AT MAINTENANCE AREA

- Dismantle metal quonset building, pile and load all pieces and remove from site.
- Dismantle all wooden tent frames, wood blocking, wood buildings, etc., and burn materials in a suitable area.

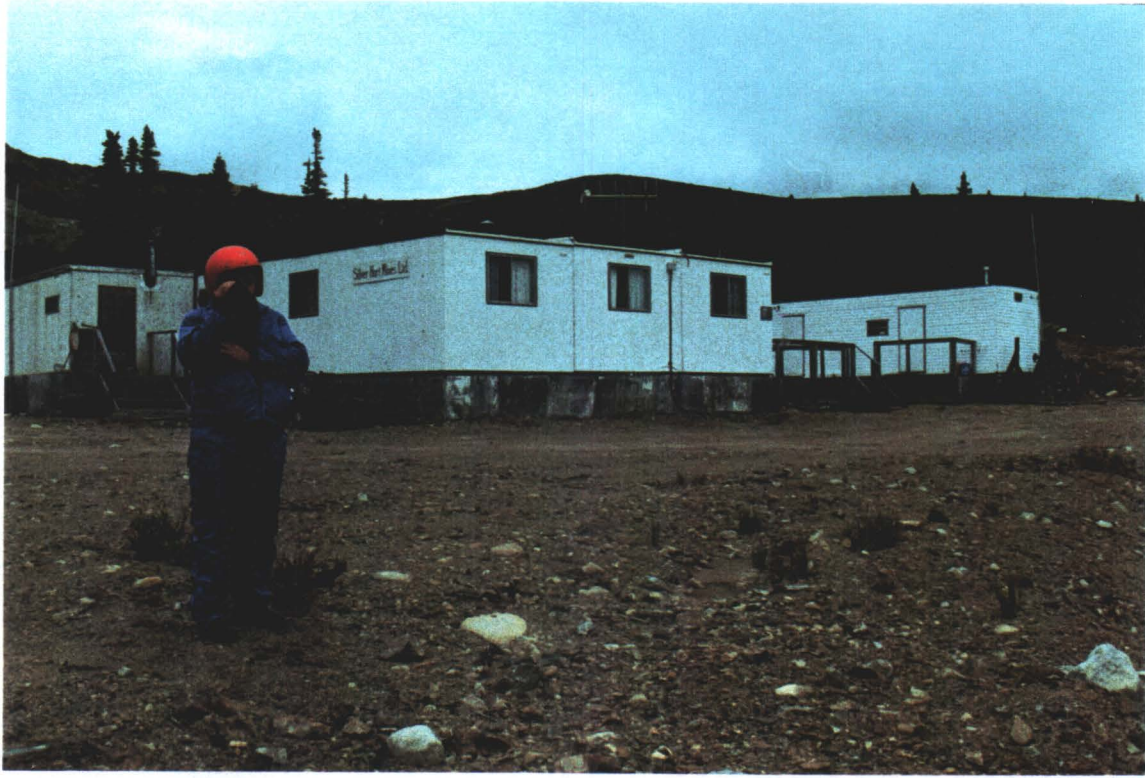
9. TRAILER CAMP

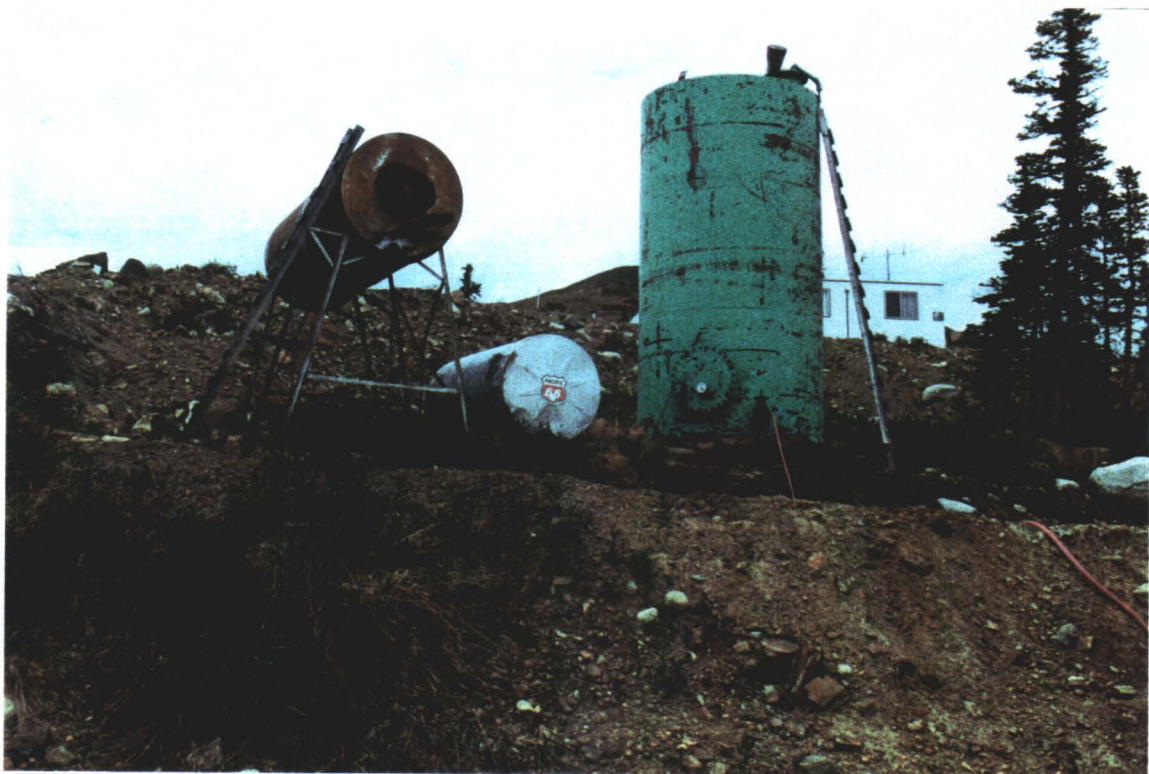
- \* 8 - 204 litre barrels ( 7 are full of diesel, 1 is empty) at the exploration tent camp area,
- \* 1 - 2270 litre fuel storage tank (empty) in maintenance area,
- \* 1 - 22700 litre fuel storage tank (empty) in maintenance area,
- \* 1 - 4540 litre fuel storage tank (empty) in maintenance area,
- \* 2 - 4540 litre fuel storage tanks (1 is empty, 1 is 80%full of diesel) in trailer camp area,
- \* 2 - 204 litre barrels (full - diesel) in trailer camp area,
- \* 18 - 204 litre barrels (full - diesel) in maintenance area. 9 are located inside the quonset building.

10. 2270, 4540, & 22700 LITRE FUEL STORAGE TANKS AT MAINTENANCE AREA

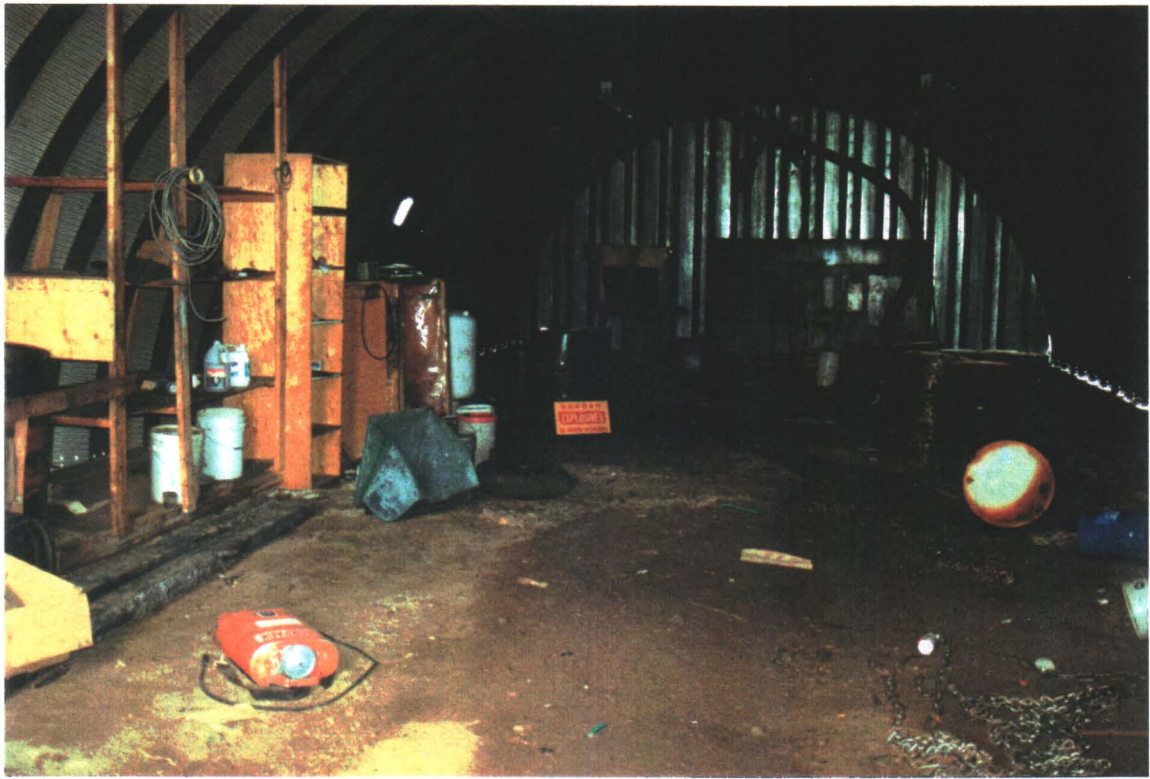
A number of pieces of drill steel are piled in the tent camp exploration area. Approximately 50 - 60m of insulated water line extends from the well to the tent camp exploration site. The quonset is filled with shelving, work benches, hoses, oil pails, and a variety of small pieces of metal waste.

11. INTERIOR OF QUONSET SHED

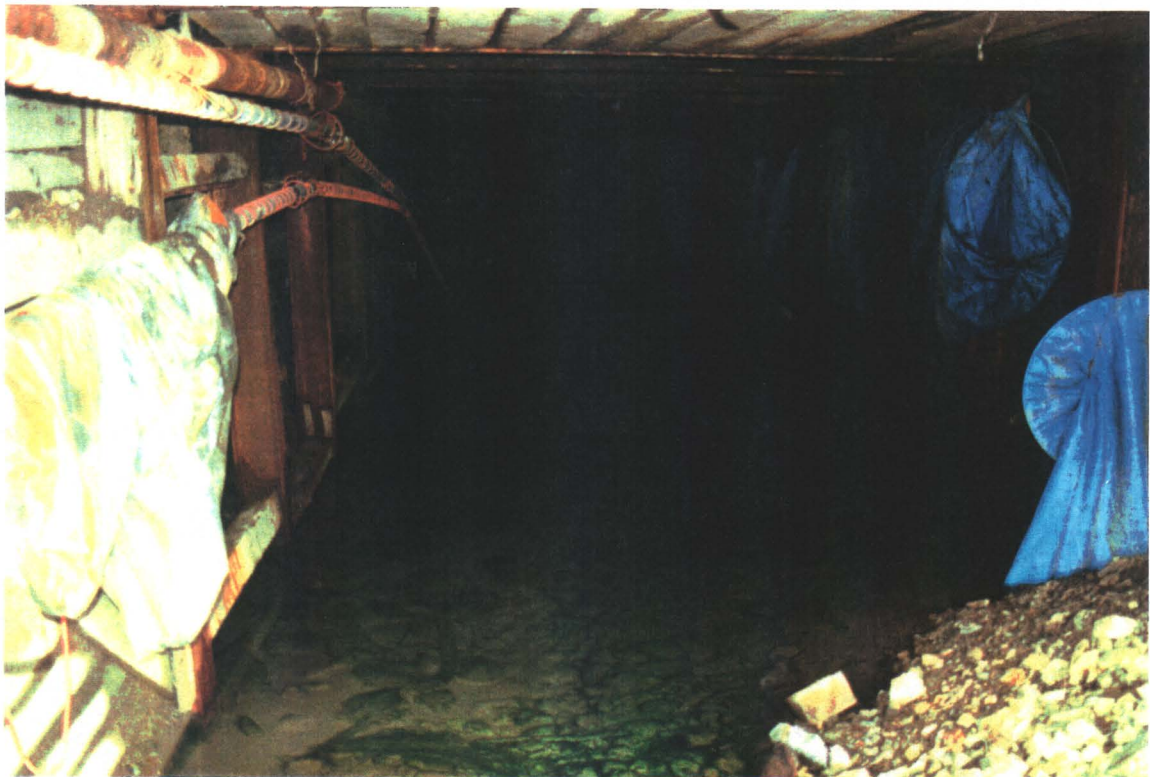
An exploration adit is situated less than 100m below the maintenance workshop area. This adit slopes down into the ground and is full of water. Excess water is overflowing out the entrance of the adit, across the surface, and downslope. It is recorded that one adit and two raises exist at this site. The other locations of the adit or raises could not be found. However it appears that the adit found was the main exploration tunnel with water and ventilation piping installed. Sample piles are marked and situated near the entrance to the adit.

12. INTERIOR OF ADIT

- Properly seal the adit.
- Regrade any unsightly or unsafe slopes after all material has been disposed and removed from the site.

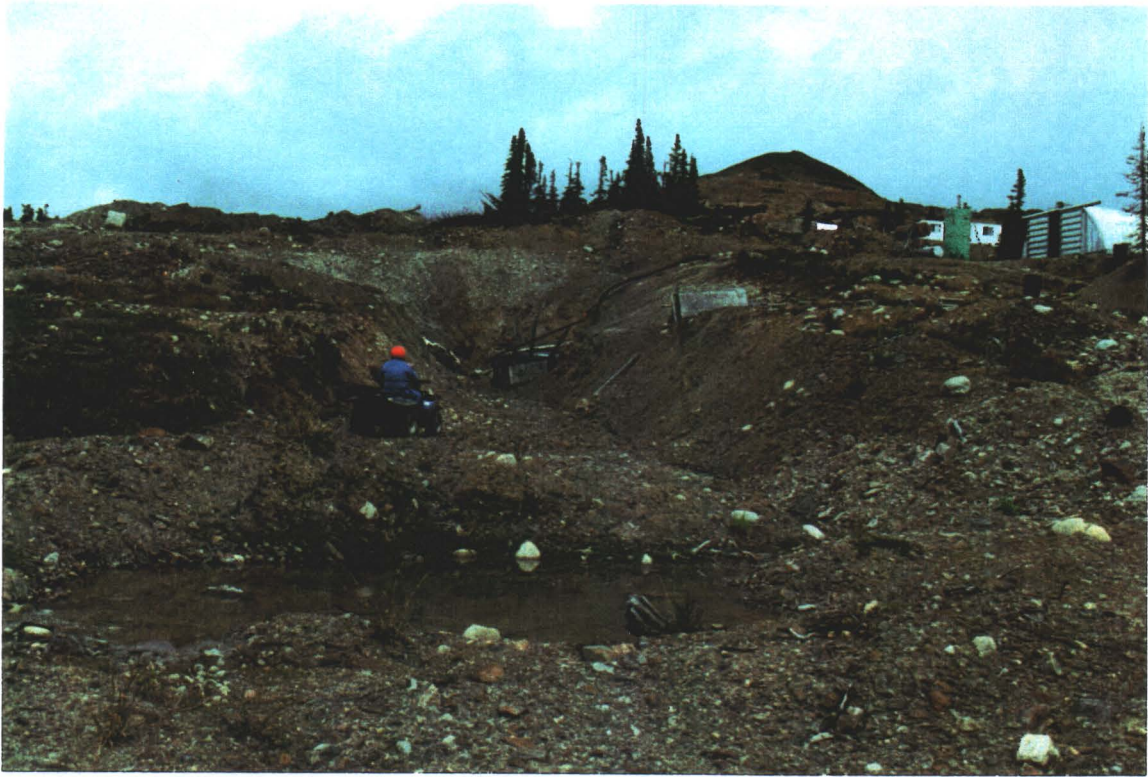
13. EXTERIOR OF ADIT
