**ASSESSMENT REPORT**

**115I-07-1**

**TINTA HILL**

**DIAND TECHNICAL SERVICES**

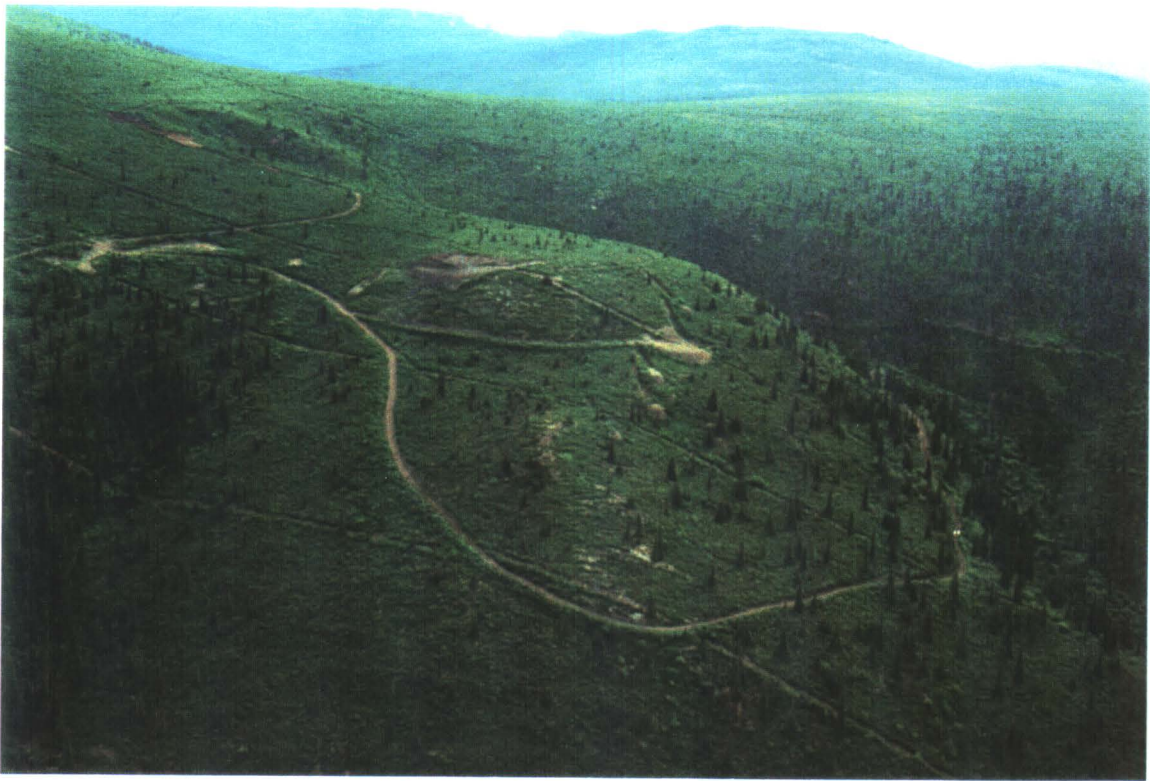
ROAD INTO TINTA HILL SITE

Site remediation of the roads is considered very difficult and costly in this very remote location. Any site remediation would also cause additional damage to the vegetation. No benefits to attempting any slope stabilization is apparent at this site.

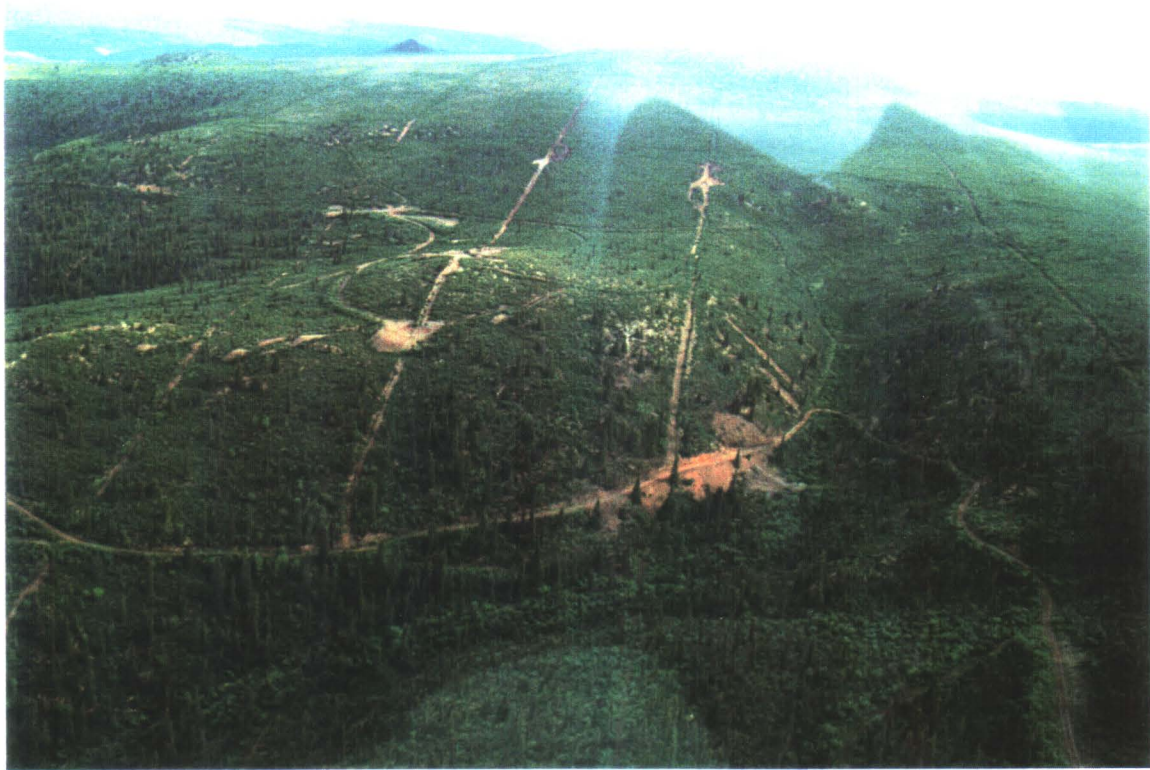
Site disturbance consists of an extensive gridwork of trenching covering several square kilometres. The site has been developed with roads crossing the exploration area and a gridwork of exploration trenching to a depth of up to 3m. The vegetation has been removed wherever road or trenching operations took place. Vegetation is well established over the older parts of the site.

EXPLORATION AREA

Attempting to revegetate the roads and exploration areas would be very difficult. The disturbed areas will eventually revegetate themselves from the local vegetation encroaching into the disturbed areas as is occurring on the older parts of the site. This revegetation process is likely the only practical solution in an area that is remote with a harsh climate.

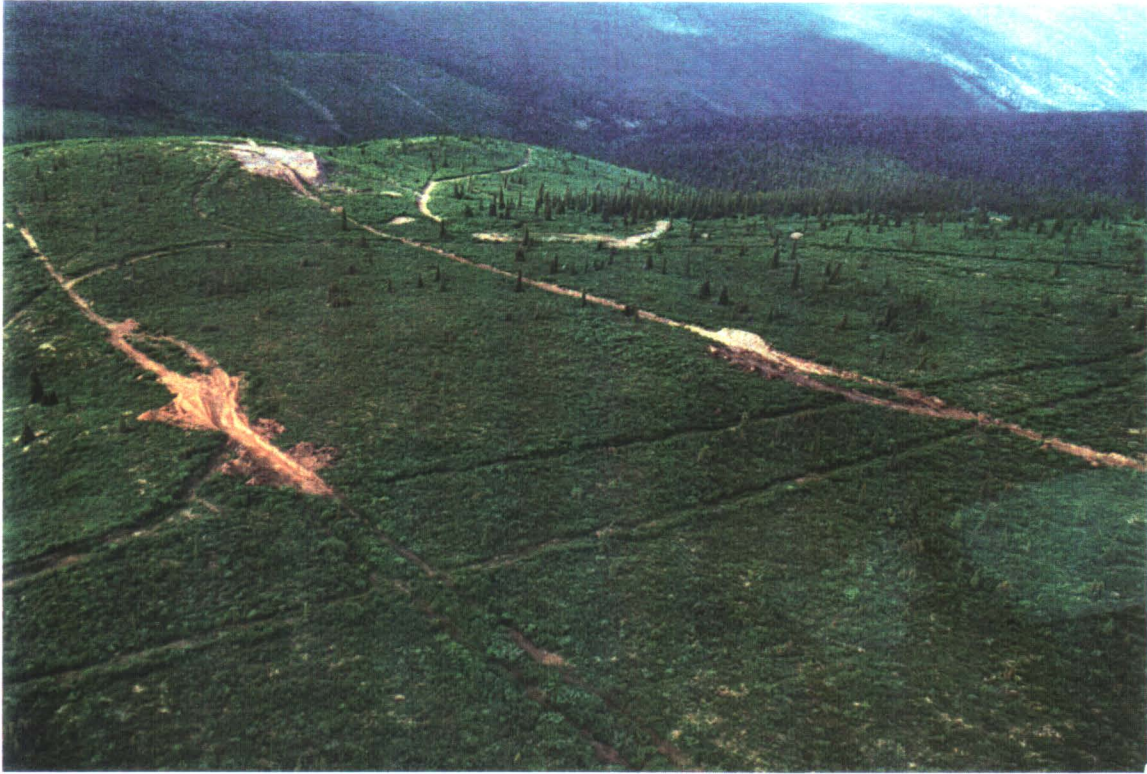
OLD AND NEWER EXPLORATION TRAILS

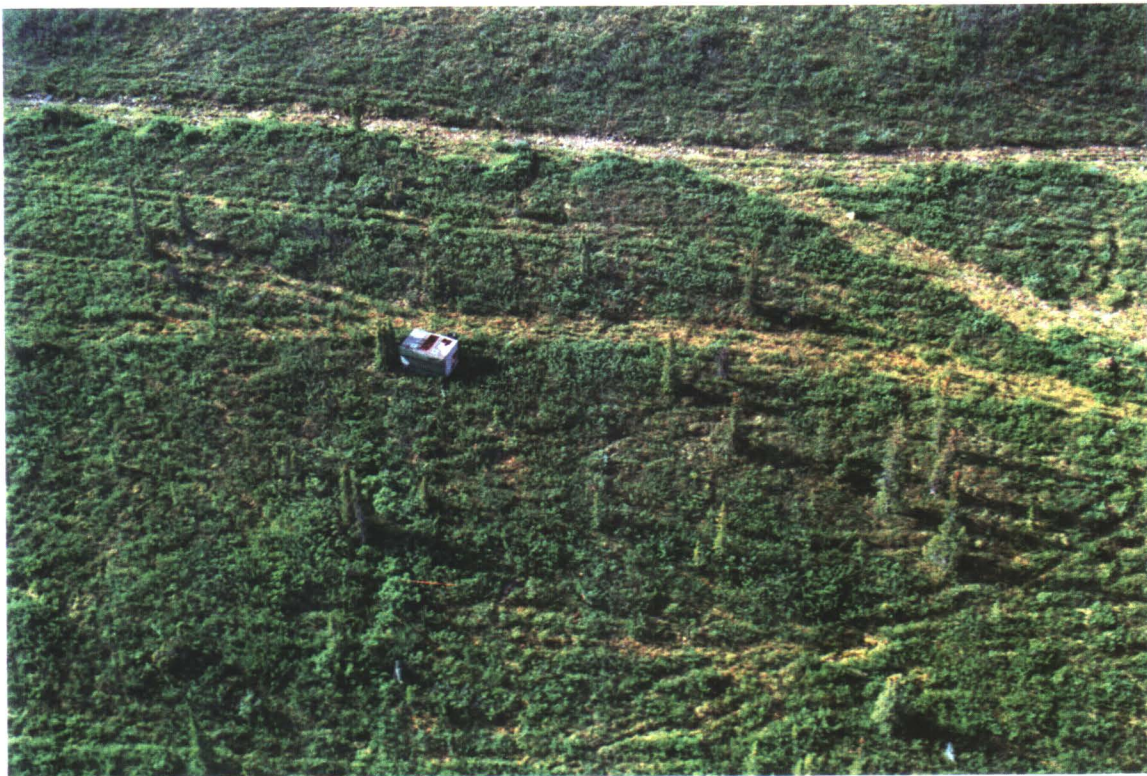
The only remaining infrastructure spotted at the site was one very old trailer.

TRAIL ABANDONED ON-SITE

The old trailer left on-site is not causing any continuing environmental damage and is considered to be a **LOW** priority for clean-up. It is recommended that this trailer be removed only if a general clean-up program is initiated in this area.
