ASSESSMENT REPORT

105G-03-1

TINTINA

DIAND TECHNICAL SERVICES

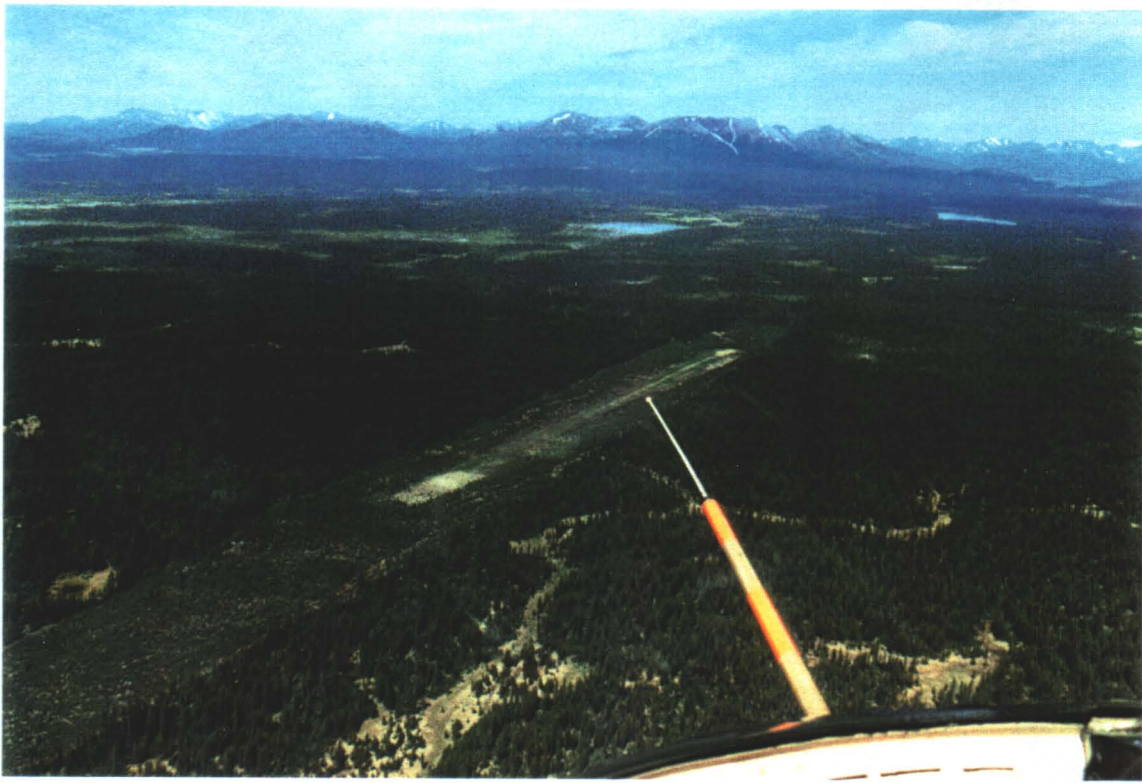
TINTINA AIRSTRIP

The site is remote and can be reached only by helicopter. An airstrip approximately 8 kilometres south of the site was constructed to service the mine exploration. Vegetation is now covering the airstrip, and if not now, will soon be too high to land fixed wing aircraft. A trail extends from the airstrip to the exploration site. According to records, a road was constructed from the Alaska Highway to the site, and pieces of this trail can be seen from the air. However it is obvious that this trail is impassable for vehicle traffic, appears overgrown, and has several large stream crossings between the site and the Alaska Highway.

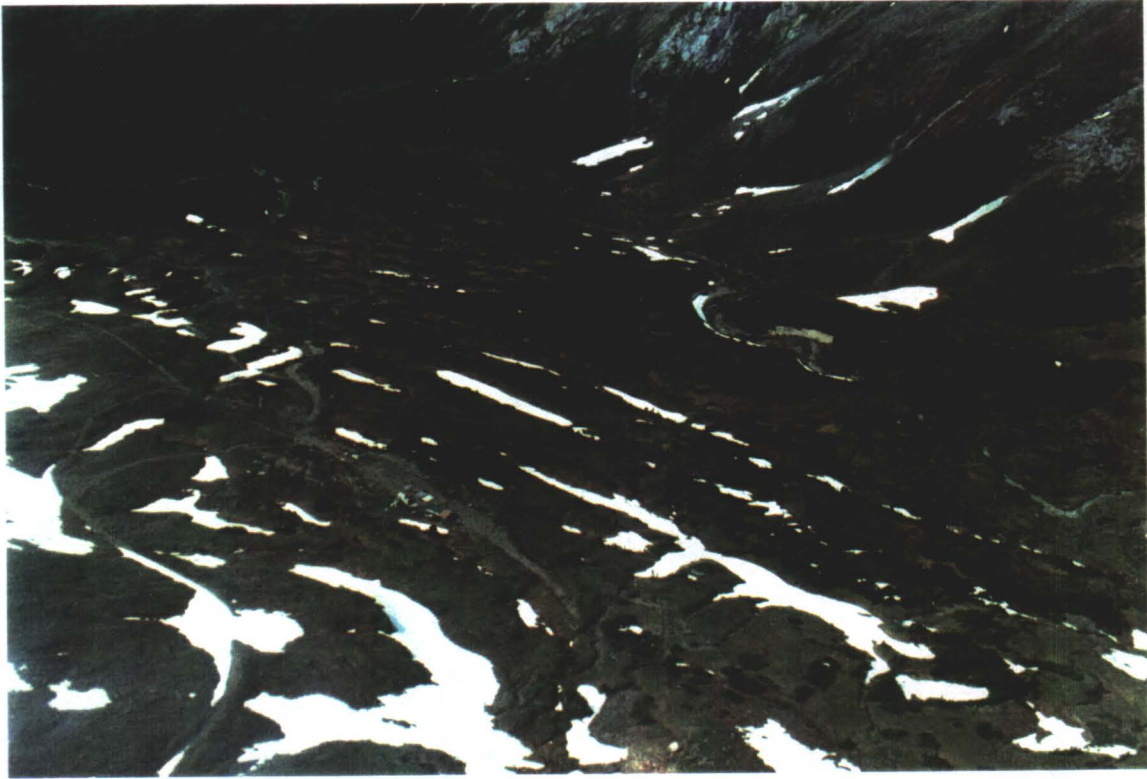
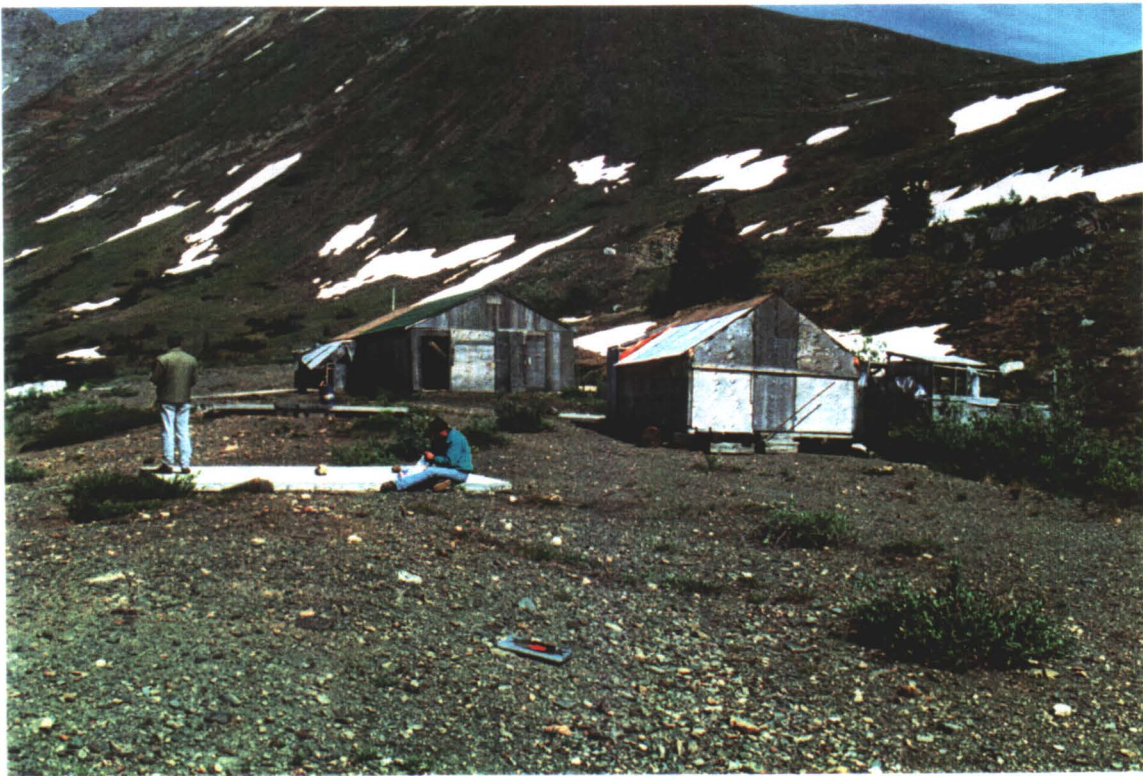
CAMP SITE

- * 1 - 7.6 x 14.6m plywood clad wood framed building used for core storage. This building is full of core, tools, miscellaneous pieces of small equipment, tools, and oil.
- * 1 - 3.7 x 2.7m plywood clad wood frame building used as a camp kitchen,
- * 1 - 2.4 x 3.0m plywood clad wood frame building used as a dining room,
- * 2 - 3.0 x 4.9m plywood tent frame bases,
- * 2 - 3.0 x 3.7m plywood tent frame bases.

- * 12 - 204 litre barrels of diesel,
- * 1 - 204 litre barrel of gasoline (3/4 full),
- * 10 - 6"x6" timbers, and
- * 7 pieces of drill pipe.

The wood structures at the site are beginning to show signs of deterioration which will only worsen with time. These buildings give a visual impact to the environment in this very remote location. It is recommended that these buildings be left untouched unless there is a clean-up program initiated in the area for **LOW** priority sites. If any clean-up is initiated for these buildings the work will need to include;

- cataloguing all worthwhile rock core,
- removing or disposing of the core according to Geological Services recommendations,
- removing all contents from the buildings and disposing in an acceptable way,
- dismantling all structures, piling all wood materials, and burning all wood waste according to acceptable practise, and
- removing all unburned waste from the site.

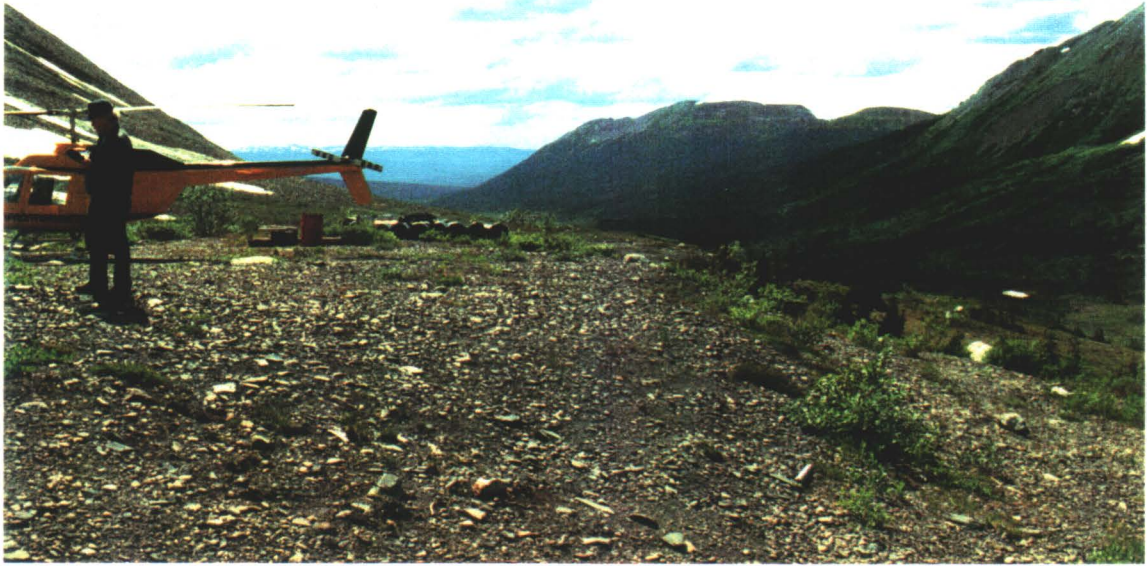
FUEL BARRELS BEHIND HELICOPTER

The twelve remaining barrels of diesel and one remaining barrel of gasoline could potentially leak or be spilled and damage the environment. Removal or disposal of these hydrocarbon products and barrels should be considered a **HIGH** priority.

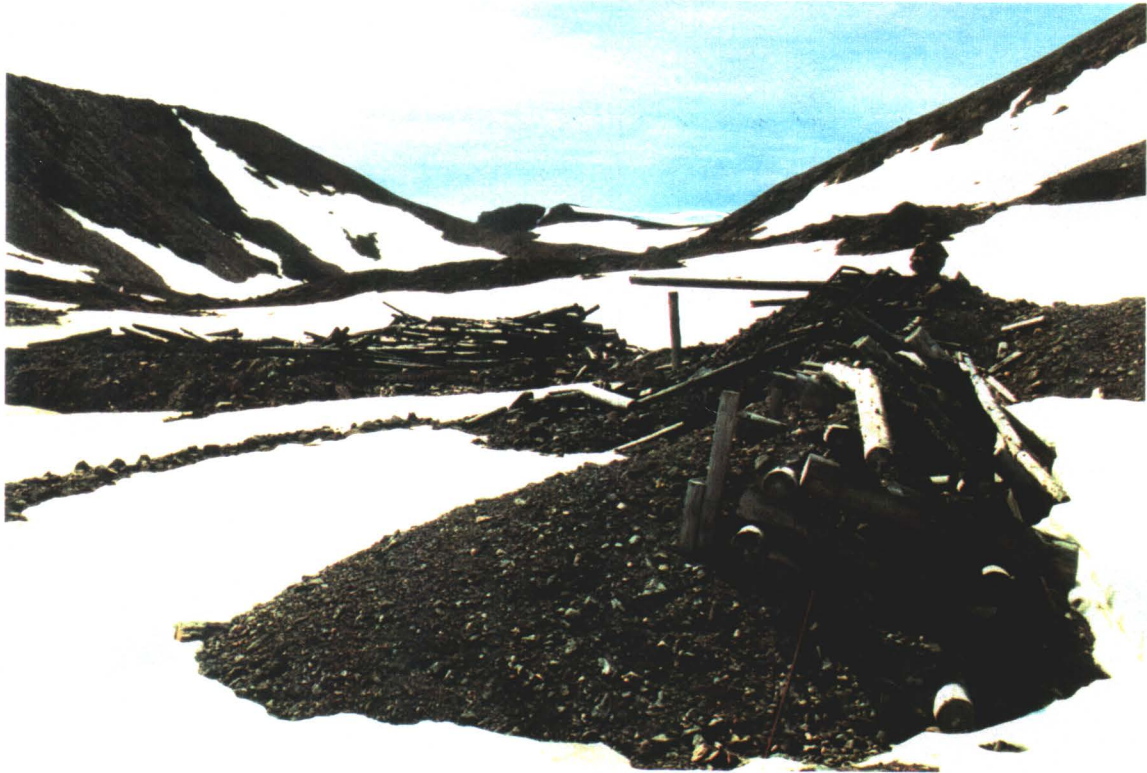
END OF WASTE DUMP, LAGGING ON LEFT

Waste rock has been dumped outside the adit entrance on a gently sloping area. This deposition was completed from ore cars on rails extending from the adit. The rail and track, less than 100m in length, is still in place along with a large pile of locally cut wooden lagging stacked in the same area as the waste rock.

The waste rock from the adit does not appear to have been milled or refined and does not appear to be an environmental hazard. This waste rock should be left alone.

The rail and track to the adit should be removed from the site if a clean-up program is initiated in the area, however this is considered a **LOW** priority. If a clean-up program is initiated for the site, the wooden lagging should also be burned.
