PHASE II ENVIRONMENTAL ASSESSMENT OF THE ARCTIC CARIBOU ABANDONED MINE SITE

**Action on Waste Program
Indian and Northern Affairs Canada**

**Environmental Services
Public Works and Government Services Canada**

March 1997

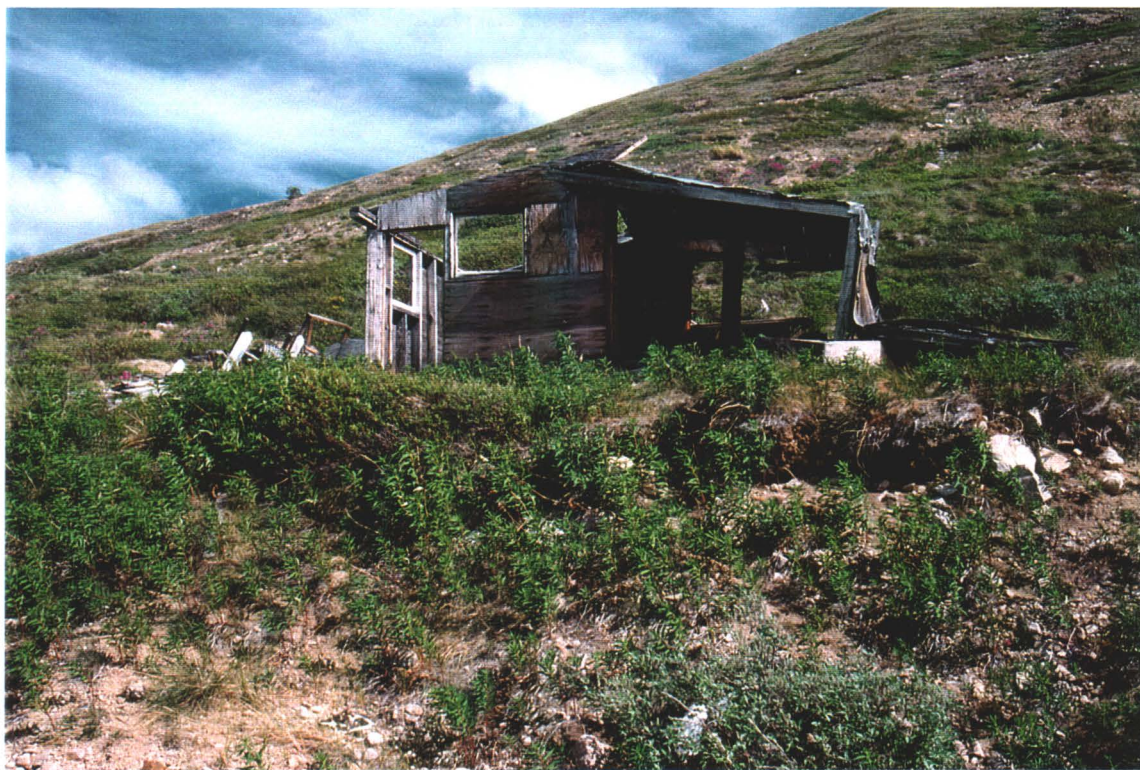
Photo # 2 - Collapsing Shack

Inventoried Material	Number/ Volume	Location	Comments
4.5 m x 4.5 m shack	1	building area below and north of waste rock pile	collapsing wood construction; wood debris inside
5.5 m x 4.1 m living quarters	1	building area	log construction; tin roof; wood debris inside
2 m x 2.8 m shack (outhouse)	1	building area	wood frame and tar paper; wood debris and pails inside
track	100 m	exiting from adit	partially collapsed over eroded waste rock
core sample boxes	10 m x 10 m	building area	poor condition

It is recommended that the buildings be demolished and burned and the ashes buried on site and the rails be demolished and buried on site for aesthetic reasons. These activities can be accomplished using locally available resources and labour and the rails can be buried on-site together with other site debris. Burial can occur by covering waste material with surrounding rock and soil on a clearing adjacent to a rock slope.

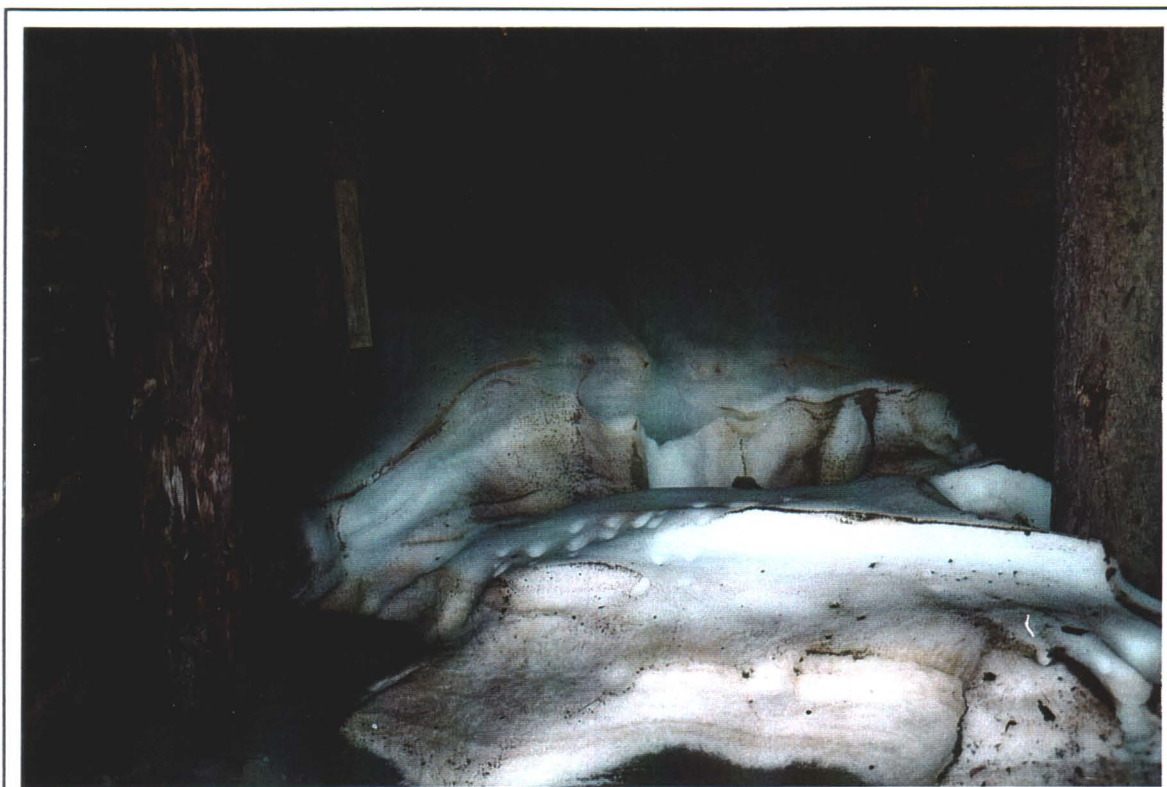
Photo # 9 - Inside Adit

Adit	Location	Drift Length	Condition
1 open adit	approx. 60 m below access road level	697 meters	exposed wooden entrance in satisfactory condition

It is recommended that the mine opening be secured from human and animal access for health and safety reasons. The exposed wooden entrance should be cut back to the original plane of the ground and the adit filled with waste rock.

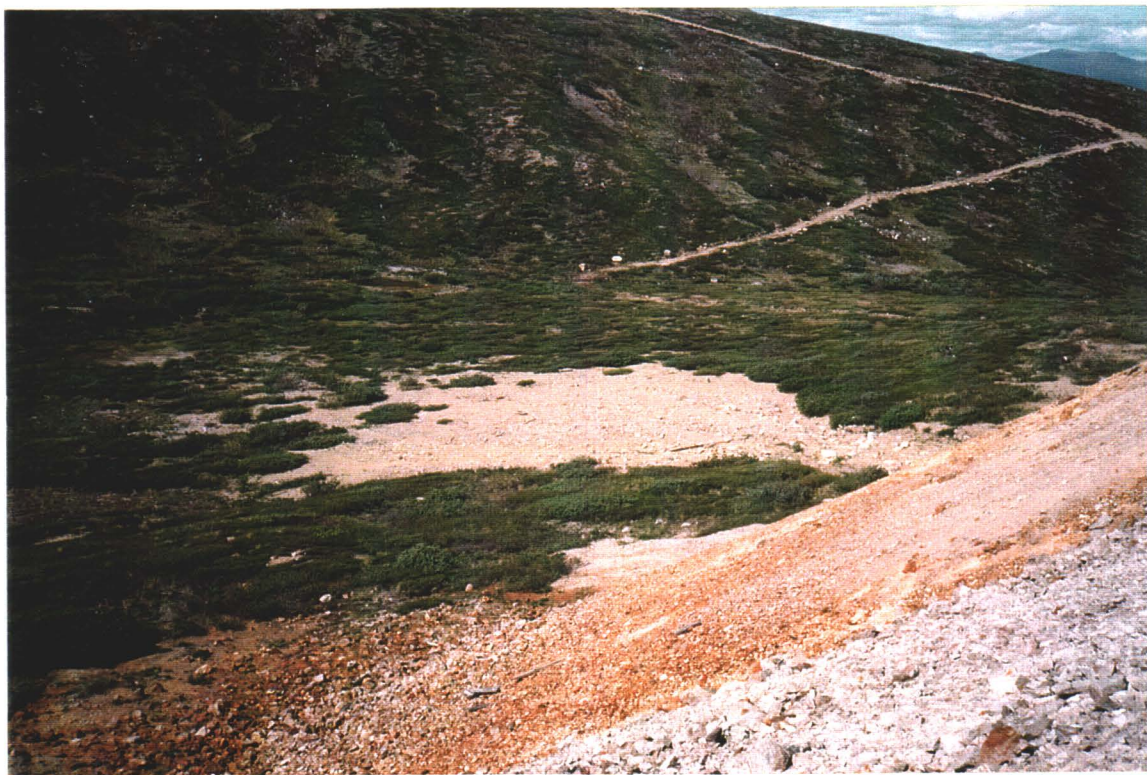
Photo # 20 - Toe of Mineralized Rock Pile

The paste pH values for the unstained mineralized and the development waste rock are neutral to alkaline. The mineralized waste rock that exhibited iron staining had an acidic paste pH, indicating that the material is net acid generating.

The mineralized waste rock exhibiting orange/brown staining is currently generating acidic drainage. The amount of this material is estimated to be between 1,000 and 4,000

No further laboratory test work is recommended on the waste rock. It is anticipated that the mineralized rock that has not yet become acid generating will do so at some future date. This could affect the downstream receiving environment. Therefore, water quality sampling is required to monitor the impact of the acid generating waste on the receiving environment.

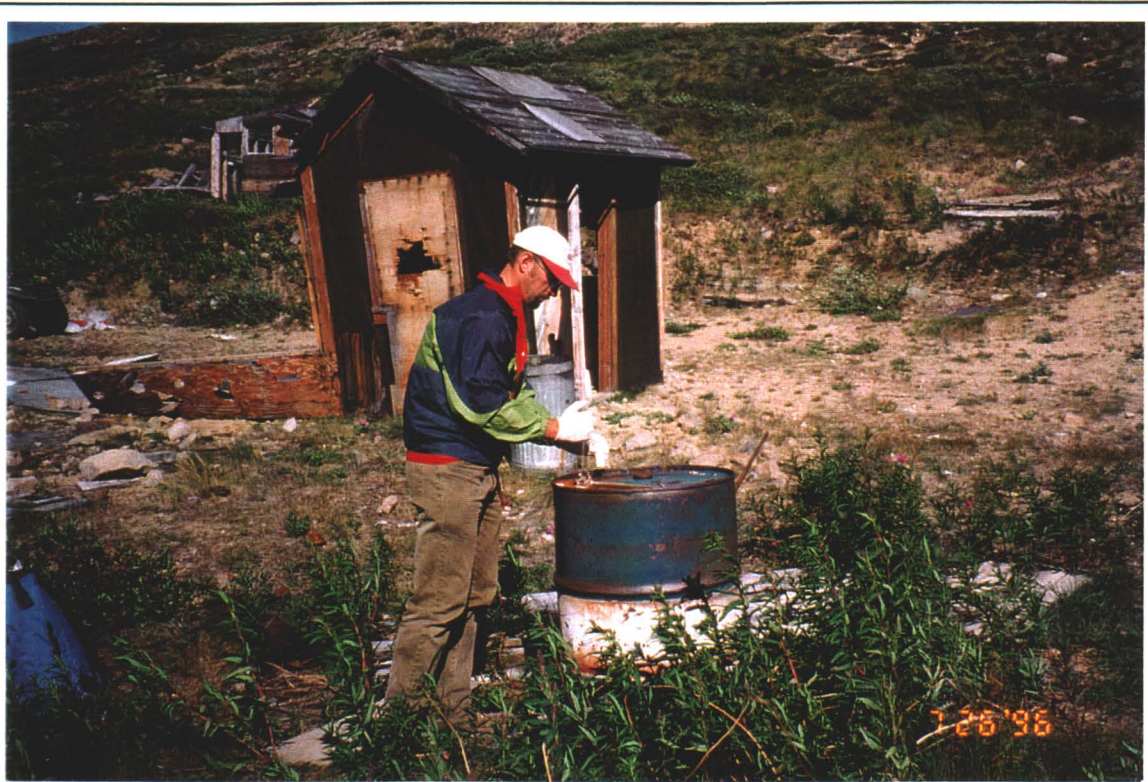
Photo # 23 - 205L Barrel containing Liquid

The only hazardous wastes noted at the site were two 205 L barrels containing significant quantities of petroleum hydrocarbon based liquids and a surface soil stain noted below the adit. Barrel 1, located approximately 5 m south west of the living quarters building was sampled (AC-B101). Barrel 2, located approximately 12 m south west of the first barrel, contained two liquid phases and both were sampled (AC-B102A & AC-B102B).

The two barrels, currently in satisfactory condition, have significant volumes of petroleum hydrocarbons containing concentrations of halogenated organics greater

than established criteria. If left as is, the barrels will degrade with time and eventually result in a hazardous waste spill that may impact on the surrounding environment. As well, hazardous air emissions would be released if the barrel contents were burned.

It is recommended that the two barrels located at the site be transported from the site and disposed of at a suitable hazardous waste disposal facility.
