**PHASE II ENVIRONMENTAL ASSESSMENT
OF THE
BIG THING
ABANDONED MINE SITE**

**Action on Waste Program
Indian and Northern Affairs Canada**

**Environmental Services
Public Works and Government Services Canada**

March 1997

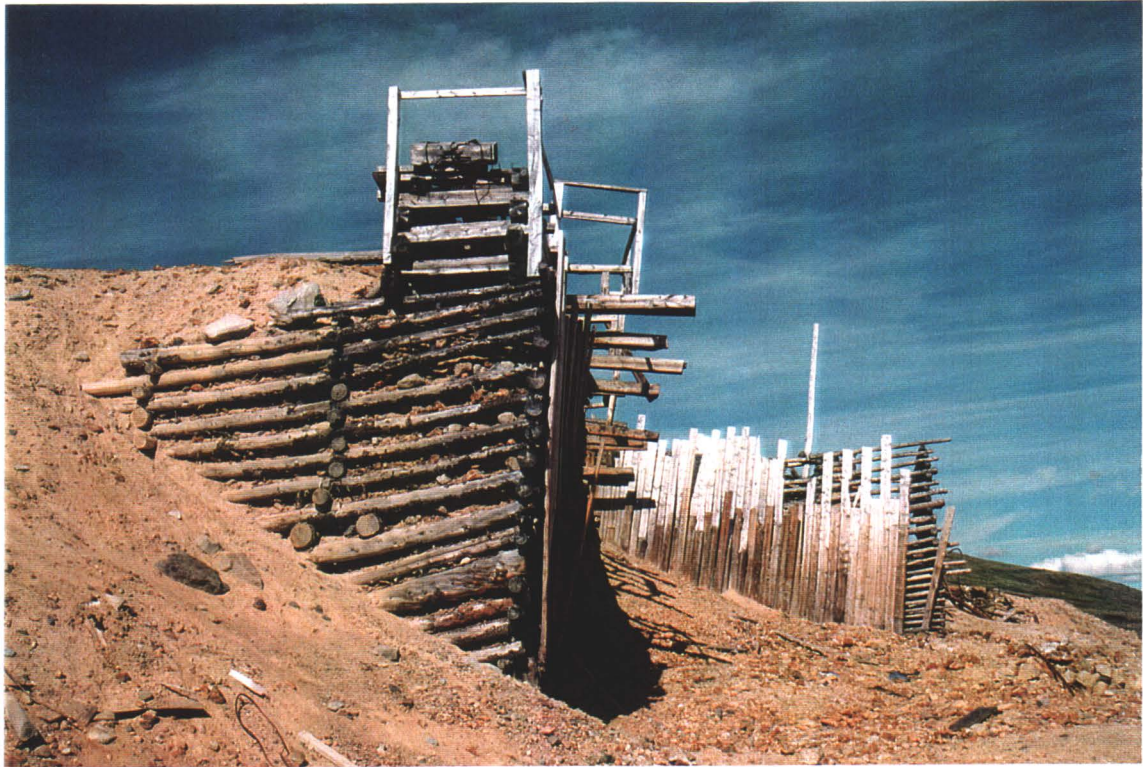
Photo # 9 - Structures Supporting Loadout Facilities, Middle Adit

Inventoried Material	Number/ Volume	Location	Comments
loadout facilities	1	below middle adit	deteriorating wood
trestles	~75 m	adjacent to middle adit	portions in poor condition
abandoned heavy equip.	~2 m ³	slope below middle adit	unusable
retaining wall	60 m	below loadout facilities	remains in satisfactory condition
concrete mill foundation	9 x 24 & 6 x 9 (m)	adjacent to lower adit	not an aesthetic concern
trestle and track	2	from adit to lower loadout facilities	poor condition

It is recommended that the building be demolished and burned on site. The rail track should be demolished, wood waste burned and metal buried in trenches on site. Hoist and heavy equipment should also be buried. The loadout facilities and trestles should be dozed, wood should be removed and burned and the areas restored to the original slopes by dozing. These activities can be accomplished using locally available resources and labour and the rails can be buried on-site together with other site debris. Burial can occur by covering waste material with surrounding rock and soil on a clearing adjacent to a rock slope.

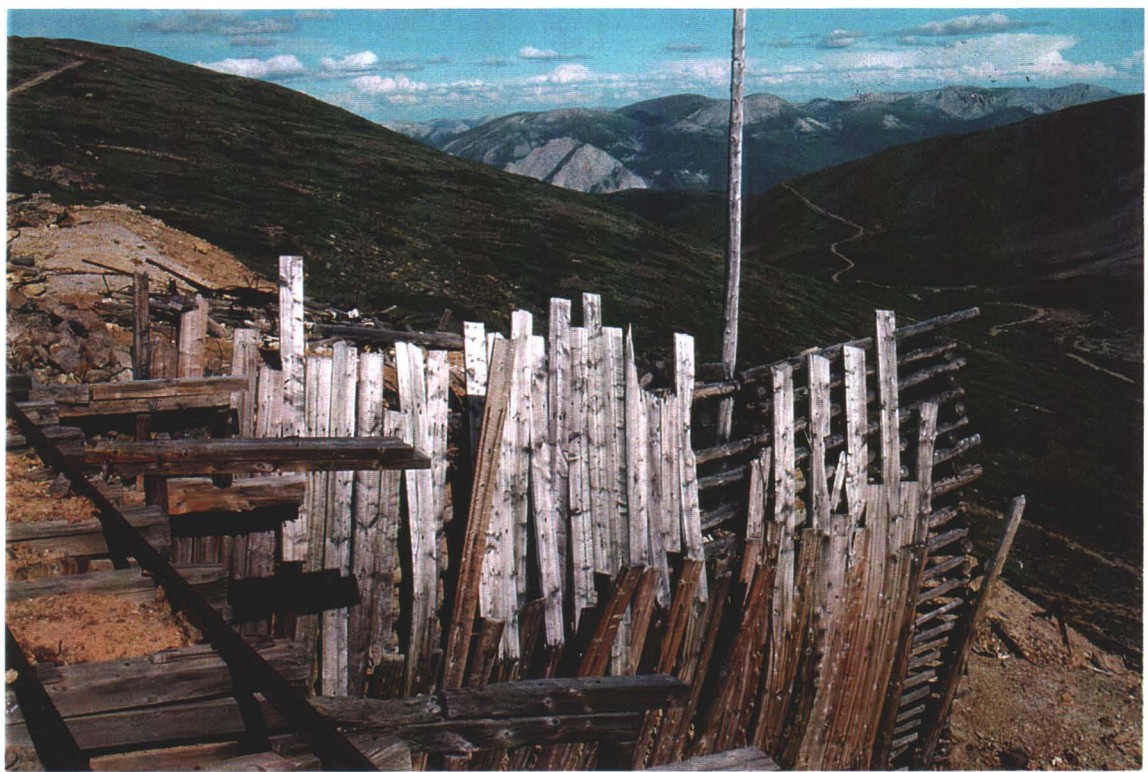
Photo # 12 - Dangerous Conditions - Loadout Facility

The primary concerns at Big Thing mine are the health and safety of humans and wildlife relating to the collapsing mine openings, trestle and loadout facilities and the environmental risk associated with ARD potential from the site. Secondary concerns are the environmental and human safety risk associated with potentially hazardous contents of a single barrel and petroleum hydrocarbon contaminated soils adjacent to the middle adit. Other concerns are the aesthetic appearance of various metal and wood wastes noted throughout the site, particularly the large volume of debris that has been spread down the slope below the middle adit.

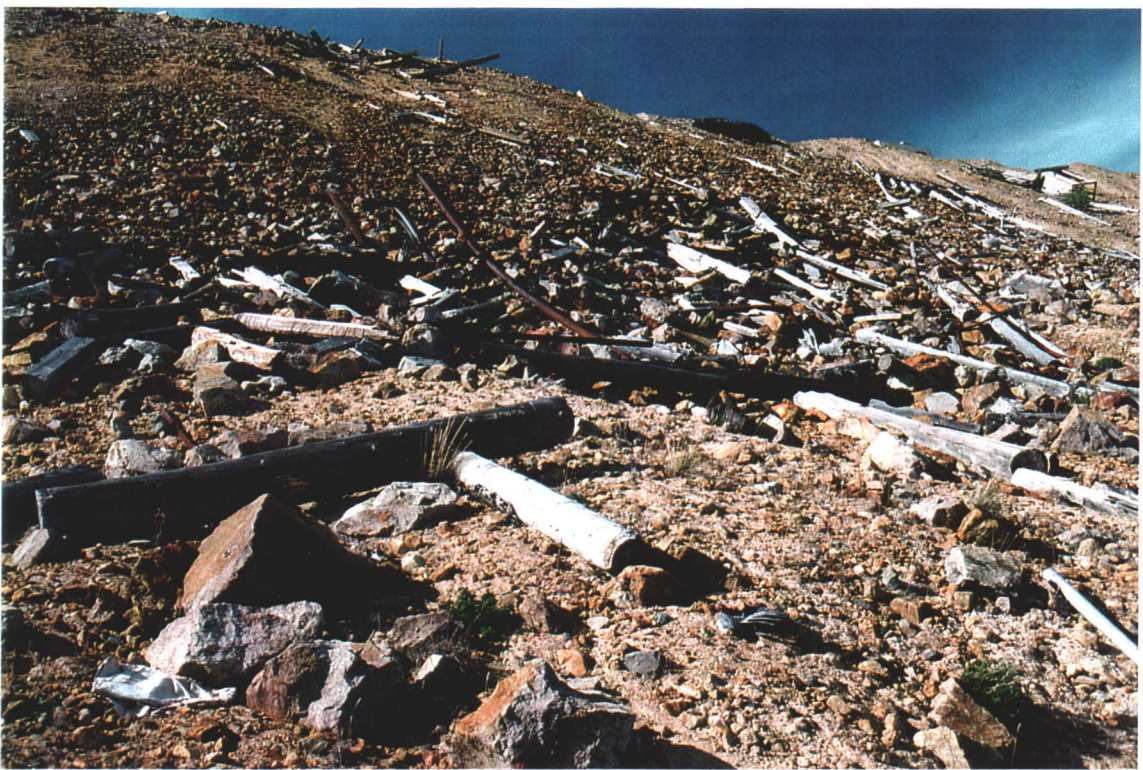
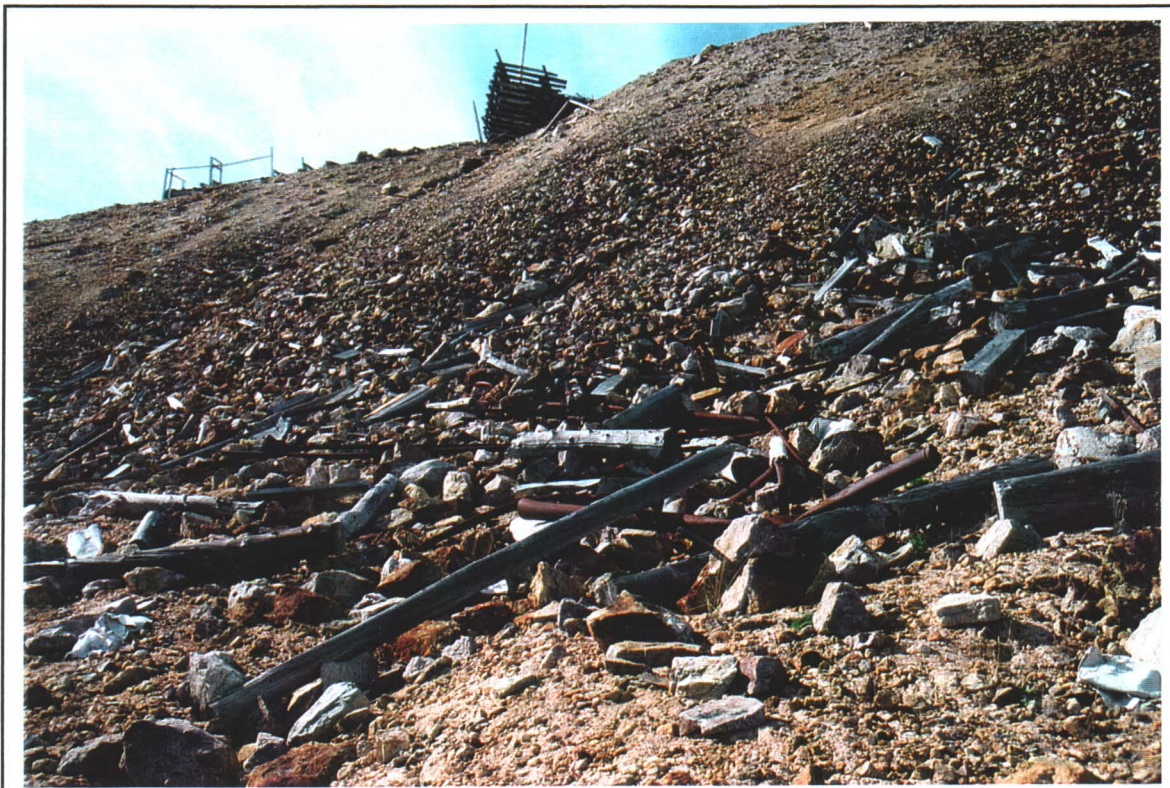
Aesthetic concerns arise from the range of infrastructure, equipment and debris, both metal and wood, noted throughout the site, particularly the large refuse dump which has spread down the face of the waste rock slope below the middle adit.

Photo # 18 - Debris on Slope

Photo # 19 - Debris on Slope

It is recommended that metal and wood site debris, including that noted in the middle adit slope debris pile, be collected and separated. The wood debris should be burned at a designated burn site and metal debris should be buried at a designated area on site using locally available labour and resources.

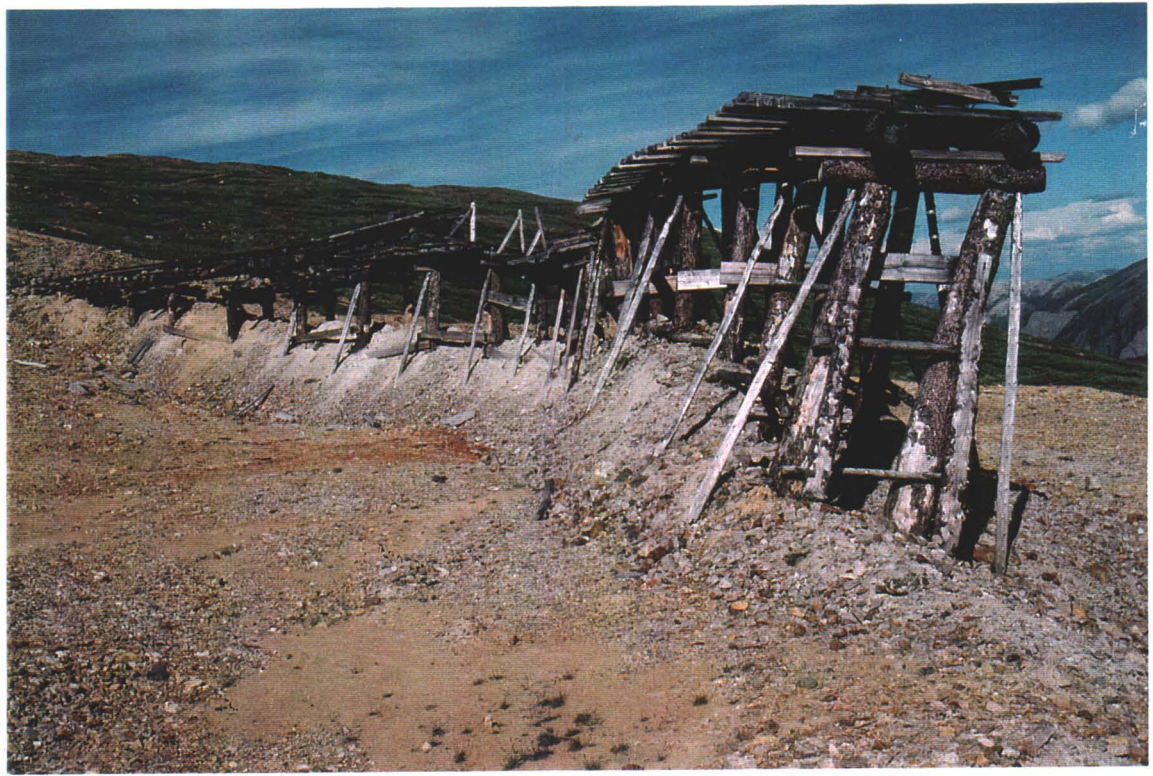
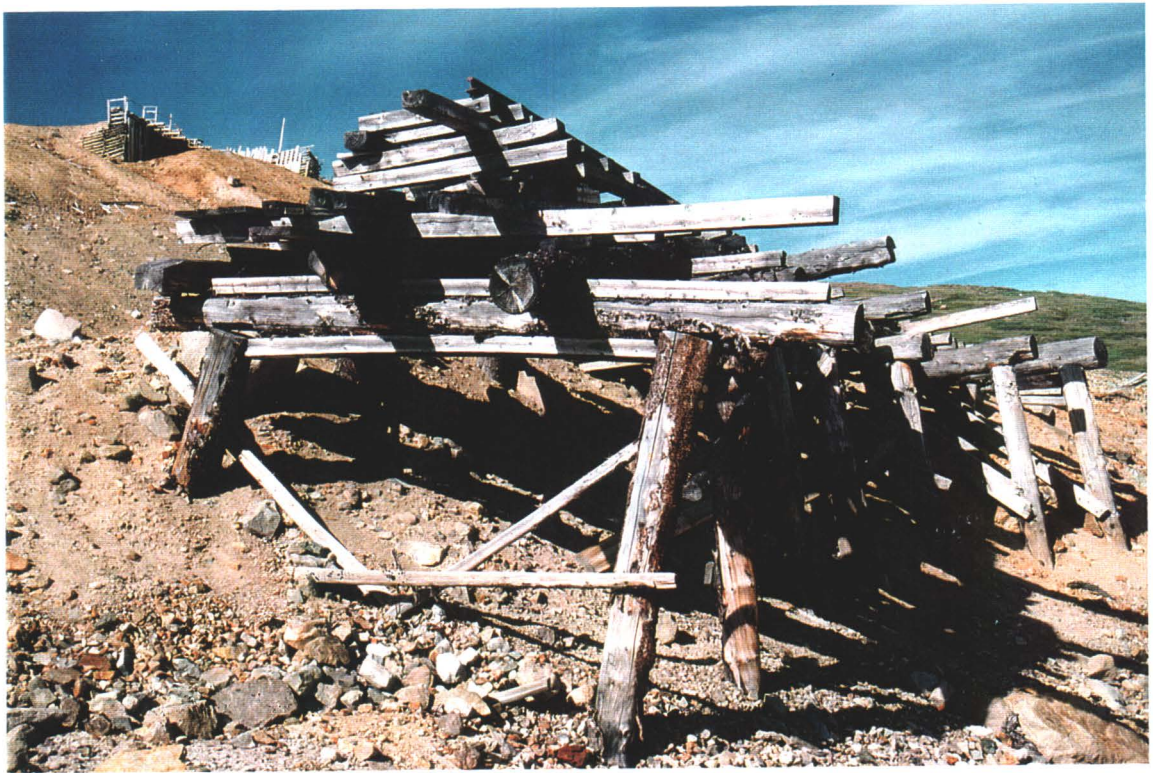
Photo # 25 - Loadout Facility - Deteriorating Condition

Photo # 26 - Loadout Facility - Deteriorating Condition

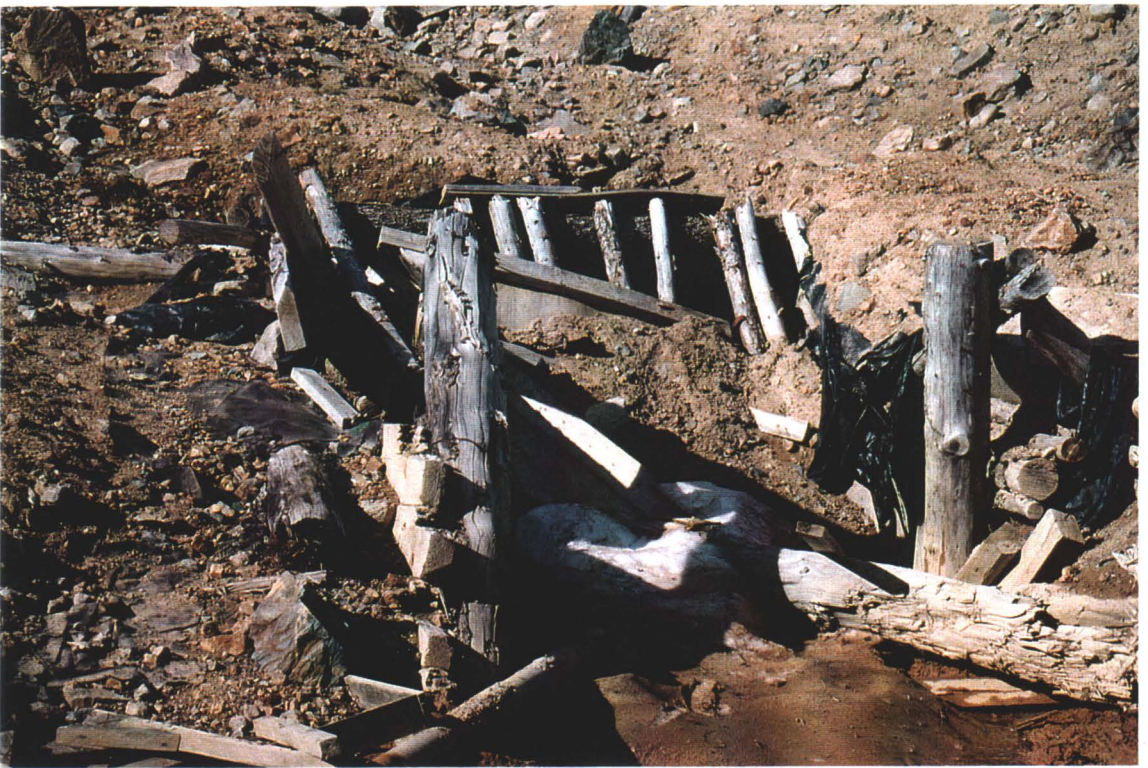
Photo # 30 - Lower Adit, Collapsed

There are two adits and an inclined shaft at the site. The inclined shaft has caved in. Additional failure of the back may be occurring. The upper adit (1705 m Level) is open. The lower adit (1645 m Level) has caved. Table 9 shows the results of the mine openings investigation

Adit	Location	Drift Length	Condition
Inclined shaft	near the mountain peak, approx. 1740 m elev.	137 m	collapsed entrance, possibly unsafe conditions surrounding entrance
middle adit	SW of shaft, 1705 m elev.	unknown	open, wood entrance
lower adit	S of middle adit, 1645 m elev.	707 m	collapsed entrance

The open adit and the unstable area around the shaft openings should be secured from human and animal access for health and safety reasons. It is recommended that all the timber at the inclined shaft be removed, the area collapsed with a dozer and the depression filled by dozing with adjacent materials. All timbers and wood above the slope of the plane at the two adits should be cut and removed. The wood should be removed and burned, the middle adit collapsed with a dozer to the greatest extent possible and the depression filled by dozing.

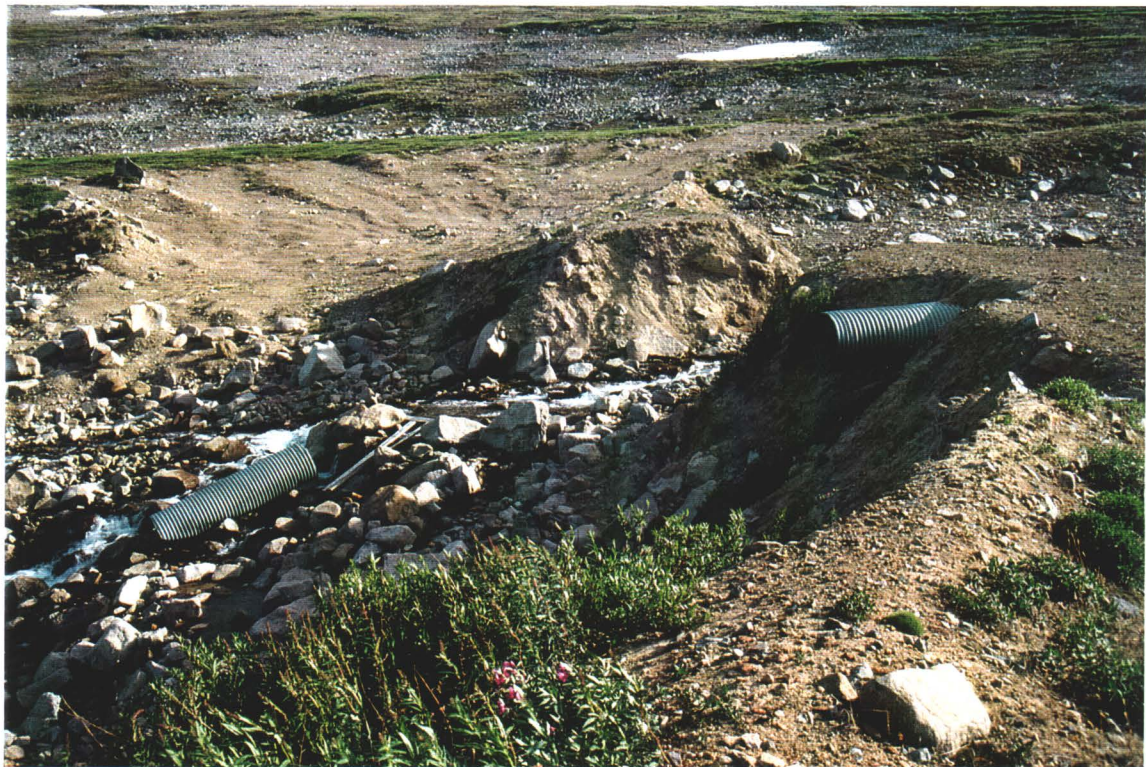
Photo # 39 - Culverts and Collapsed Dam

Big Thing Creek has eroded a passage through the earthen dam and destroyed the metal culvert at the east end of the water reservoir. The dam has caused a narrowing of the creekbed and a steep drop of approximately 3 m. This constriction may restrict downstream movement of fish.

The earthen dam has caused significant changes to creek flow. In its current condition it probably affects local fish population movement, however, removal of the dam would require some disruption of the stream bed.

Culverts at the earthen dam should be removed and buried and the creek bed should be restored to its original configuration. Fisheries and Oceans Canada should be consulted prior to initiating any in-stream work to ensure that fish habitats are not damaged.

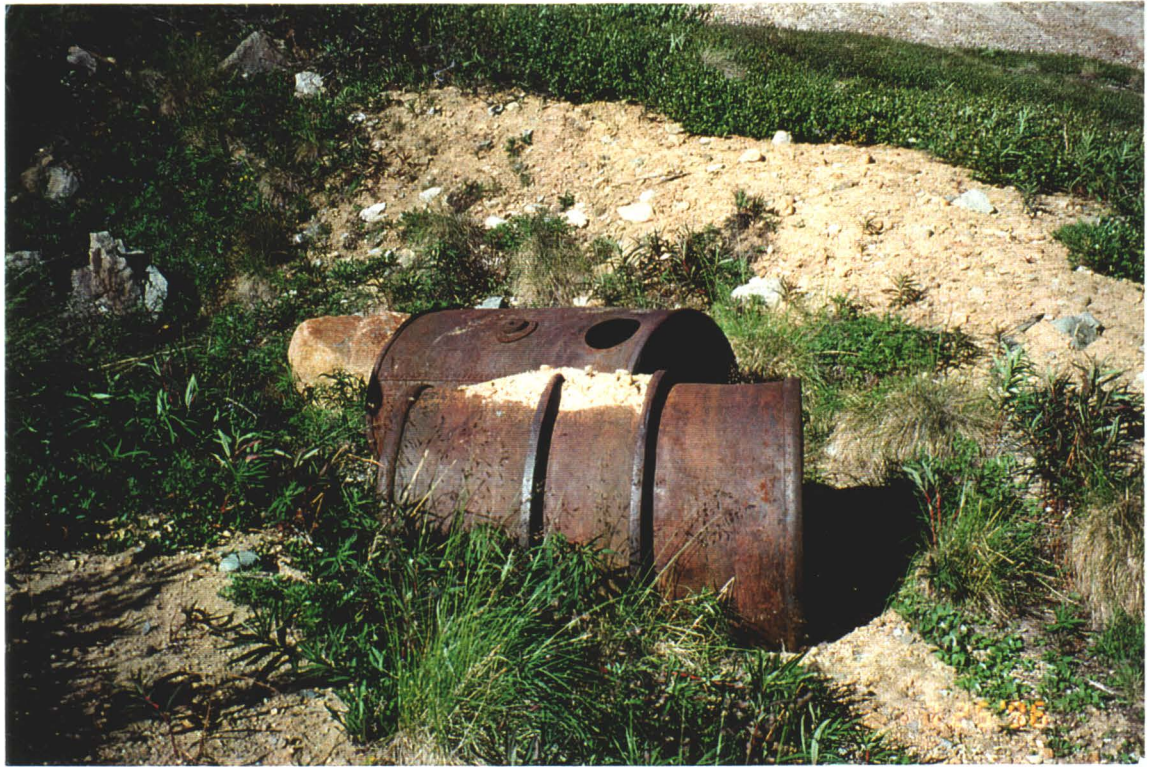
Photo # 40 - Reinforced Barrel adjacent to Old Boiler

The only potentially hazardous materials noted at the site were a sealed barrel with reinforced ribbing and a number of areas where stained soils were noted. The barrel was in satisfactory condition, however, its contents were unknown. The barrel was located near the bank of Big Thing Creek downstream of the dam in an area obscured by vegetation. An attempt to move the barrel by hand was not successful.

The contents of the reinforced barrel, currently in satisfactory condition, are unknown. If left alone, the barrel will degrade with time and may eventually result in a hazardous waste spill capable of impacting on the surrounding environment. There is also a moderate risk to workers moving the barrel since the contents are unknown.

It is recommended that the reinforced barrel be removed from the site, transported to Whitehorse for identification and disposed of at a licensed facility.

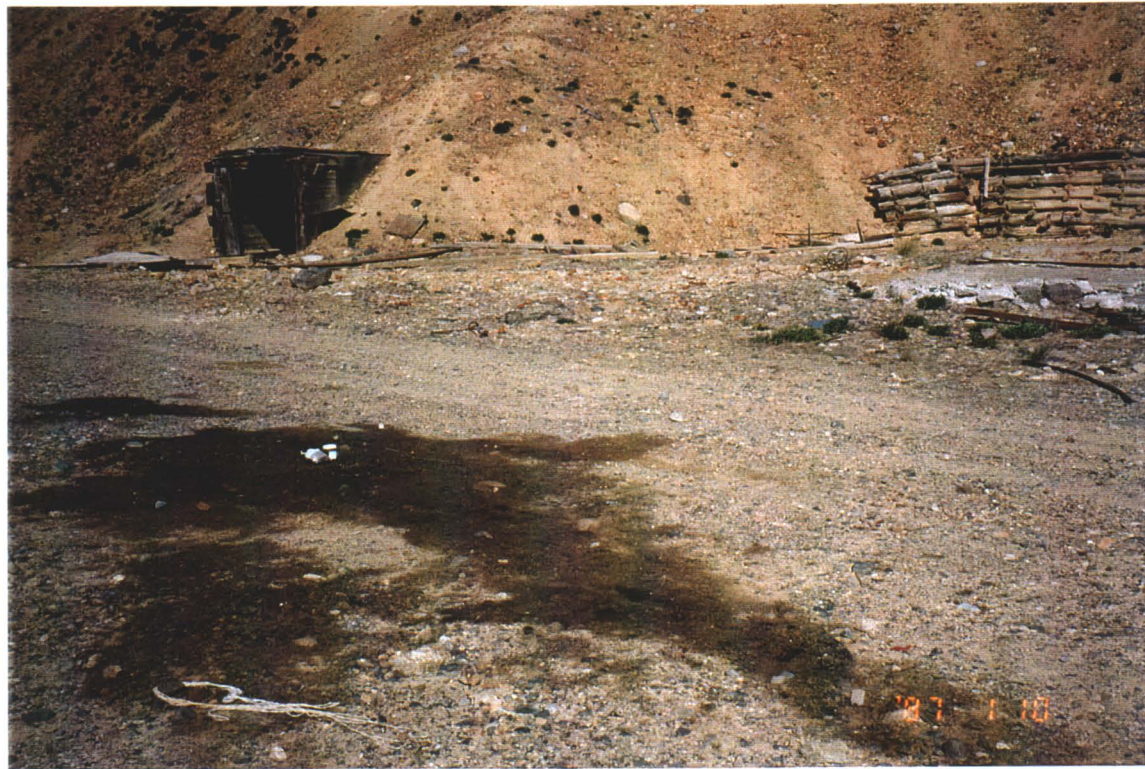
Photo # 44 - Soil Stains adjacent to Middle Adit

The soil stains were small, with the exception of total extractable hydrocarbons no hazardous compounds were noted in any sample, and there were no sensitive environmental receptors in the immediate area of the stains. As such, the stained soils may be left as is and allowed to remediate by natural attenuation.

Sample #	Sample Location	Comments
BT-S201	generator site adj. to middle adit	dark stained area
BT-S202	soil on concrete pad adj. to middle adit	dark stained area
BT-S203	stain approx. 5 m from middle adit	dark stained area
BT-S204	adj. to middle adit	background
BT-S205	drainage below middle adit waste rock/ metal dump	no obvious staining; vegetation stress
BT-S206	drainage below middle adit waste rock/ metal dump	no obvious staining
BT-S207	bottom of drainage path from site approx. 100 m downstream of dam	no obvious staining

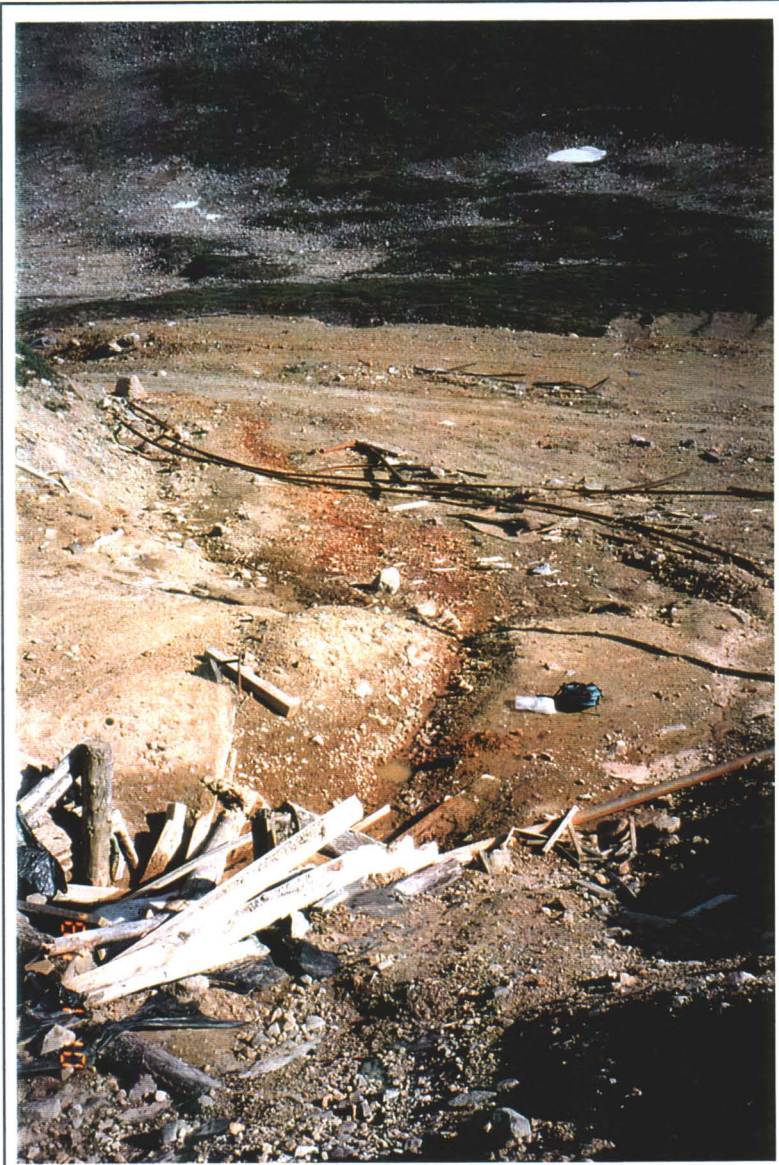
Photo # 48 - Drainage Path below Lower Adit

Low seepage volumes were evident from the lower adit and drain towards the stream. Seepage was also detected from below the ore stockpile at the shaft and the site topography lends itself to seepage through the waste rock piles as a result of site drainage and surface infiltration from precipitation.

Sample BT-WQ-A103 was collected from water discharging from the lower adit. A water sample, BT-WQ-S101, was collected from a seep below the ore stockpile at the shaft. No seeps of water were observed from the waste rock piles below the adits and no water was discharging from the middle adit. Surface run off from the seep and adit are absorbed by waste rock and do not directly enter Big Thing Creek. There is no evidence of ponding of potentially contaminated water that may be used by wildlife. Seep and adit sample locations are included on Drawing 1.

No further test work is recommended on the waste rock. Additional water quality sampling is required to monitor the impact on the receiving environment. Samples should be collected at BT-WQ-STR-101, BT-WQ-STR-102, BT-WQ-STR-104 and BT-WQ-A-103. Any additional seeps observed at the base of the waste rock and ore stockpiles should also be sampled and analysed.

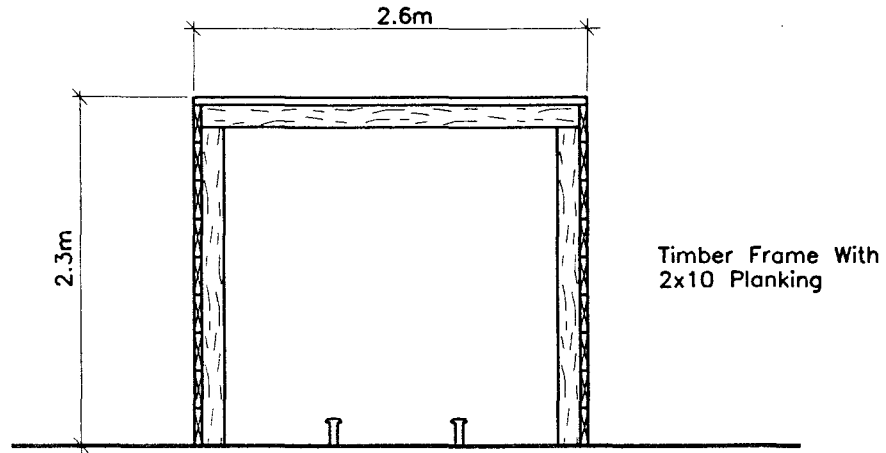
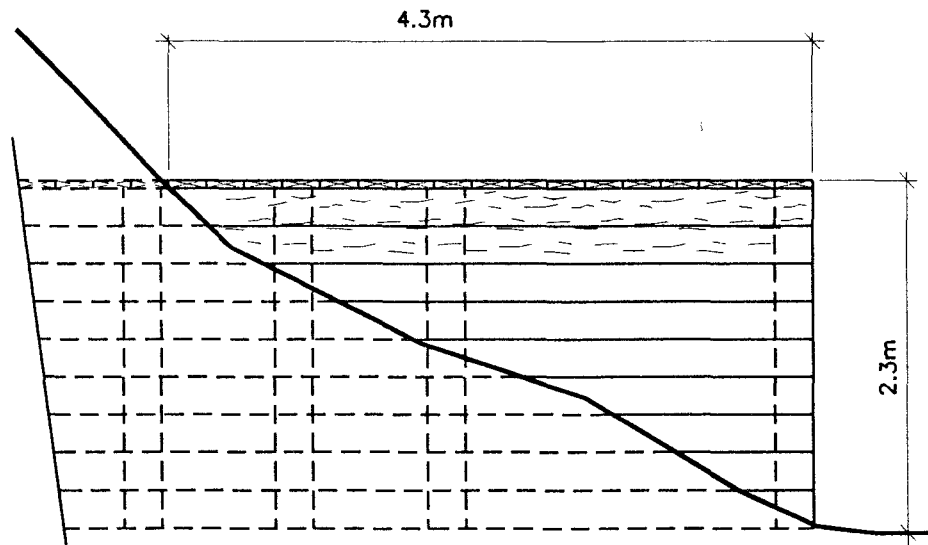
Big Thing Mine
Adit

FRONT VIEW
N.T.S.

- Timber Frame With 2x10 Planking.
- Timbers First At 2.3m Then Approx. 1.0m Intervals.
