**P118401**

**PHASE II ENVIRONMENTAL ASSESSMENT  
OF THE  
CLARK ABANDONED MINE SITE**

**STEFFEN ROBERTSON AND KIRSTEN (CANADA) INC.**

FEBRUARY, 1997

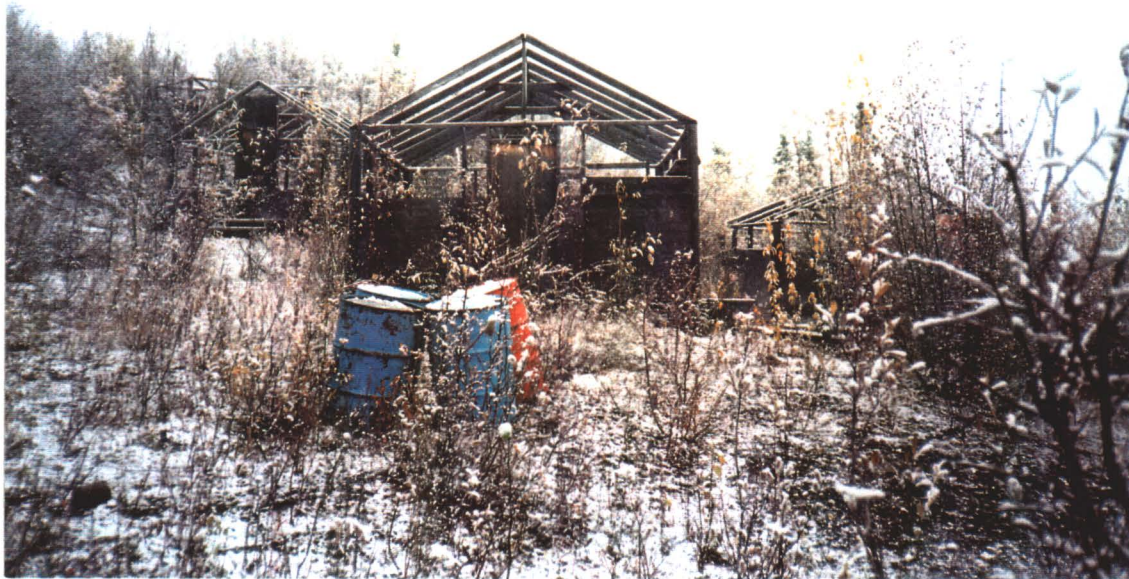
The main camp consists of seven (7) tent platforms with wooden walls and doors (Photo 1). All of the platforms are currently in fair condition, but the wood is starting to rot in the floors and will soon begin to fail. Some of the roof supports are also unstable and could collapse. A core storage area is located at the north end of the camp.

Four unmarked, 205 litre fuel barrels were found standing upright in the main camp (Photo 1). The barrels were inspected and found to be approximately 1/4 full and containing diesel fuel. A sample of one of the barrels was collected (CL/B100) for laboratory analysis to test for organic halogens (solvents) and polychlorinated biphenols (PCBs). The analytical results confirm that this material does not contain significant organic halogens or PCBs. The analytical results are included in Appendix C. All of bungs on the barrels were tightened to prevent possible spillage if knocked over. No signs of soil contamination were observed near the barrels.

Photo 1: Main Camp, tent frames, partially filled barrels - sampled CL/B/B100, looking north. September 19, 1996.

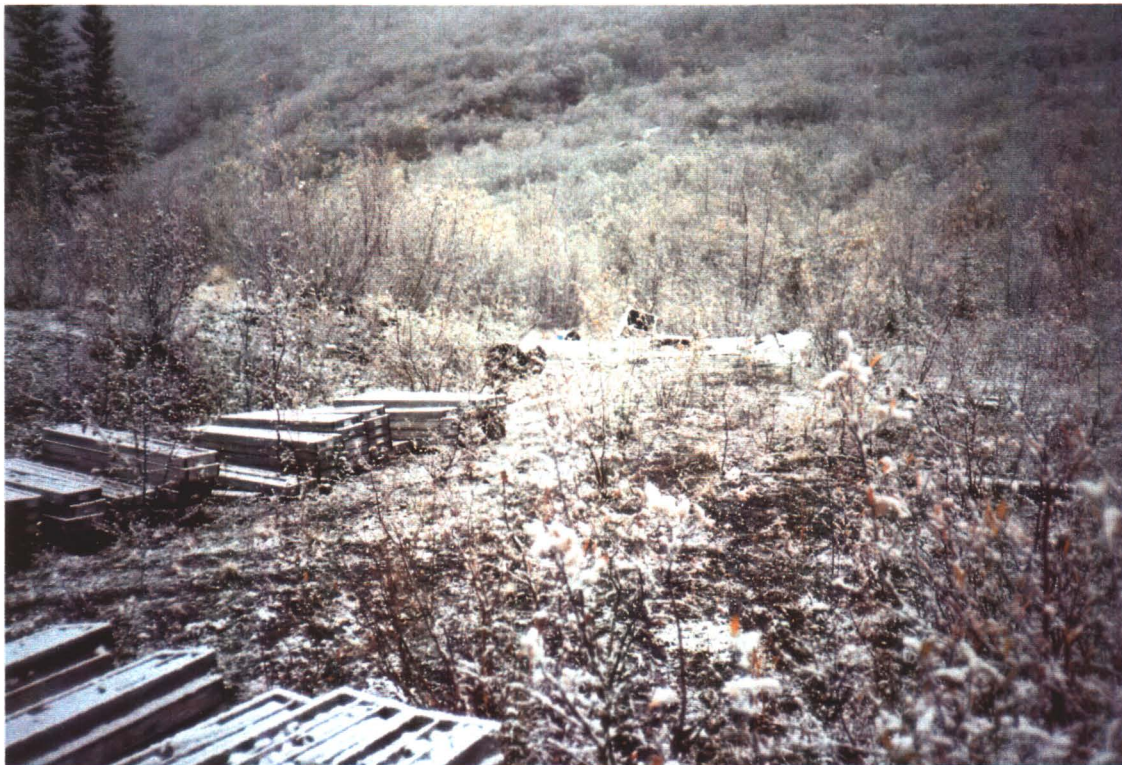
Approximately 75 open core boxes, labelled '1987', are stored at the incinerator site. The burning barrels are filled with burnt tin cans.

Photo 2: Uppercamp: Core storage area and incinerator site, looking south September 19, 1996

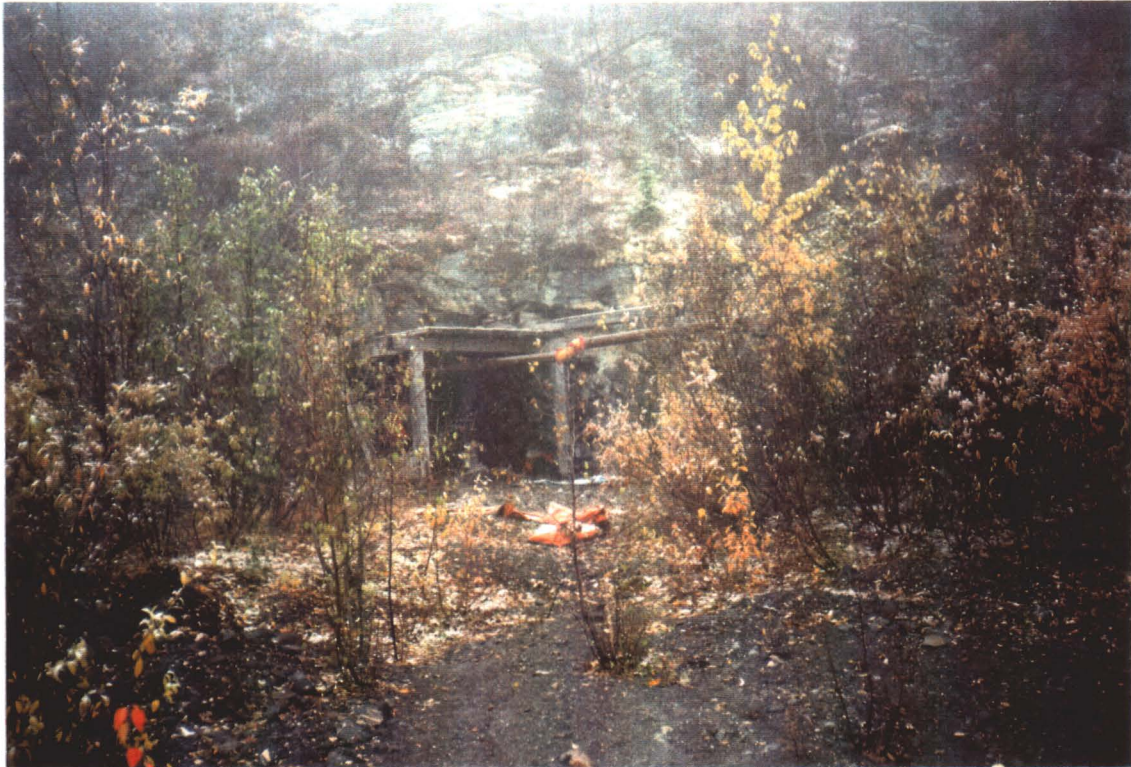
The adit opening consists of heavy timber frame work, in good condition, extending approximately 3 metres out from the opening and 1 metre into the underground workings (Photo 3 and 4).

A portal, 3.7 metres wide and 2.5 metres high, exists at the Clark mine site (Photos 3 and 6). The portal is open and the ground conditions around the entrance appear stable, based on the lack of loose rock on the floor or rock spalling from the back or walls. A 6 inch diameter pipe is secured to the back of the underground workings. The opening is timbered for a distance of 4 metres. Approximately 1 metre of the timber is underground.

Photo 3: Open adit, looking southwest. September 19, 1996

The underground workings at this remote site present a health and safety risk because access is not restricted. While no evidence of loose rock was observed in the first few metres of the adit, the ground near the ore zone is likely very unstable due to the presence of structurally weak rock types such as schist, quartzite and phyllite. Prospectors and geologists working in the area would, therefore, be exposed to a serious health and safety hazard.

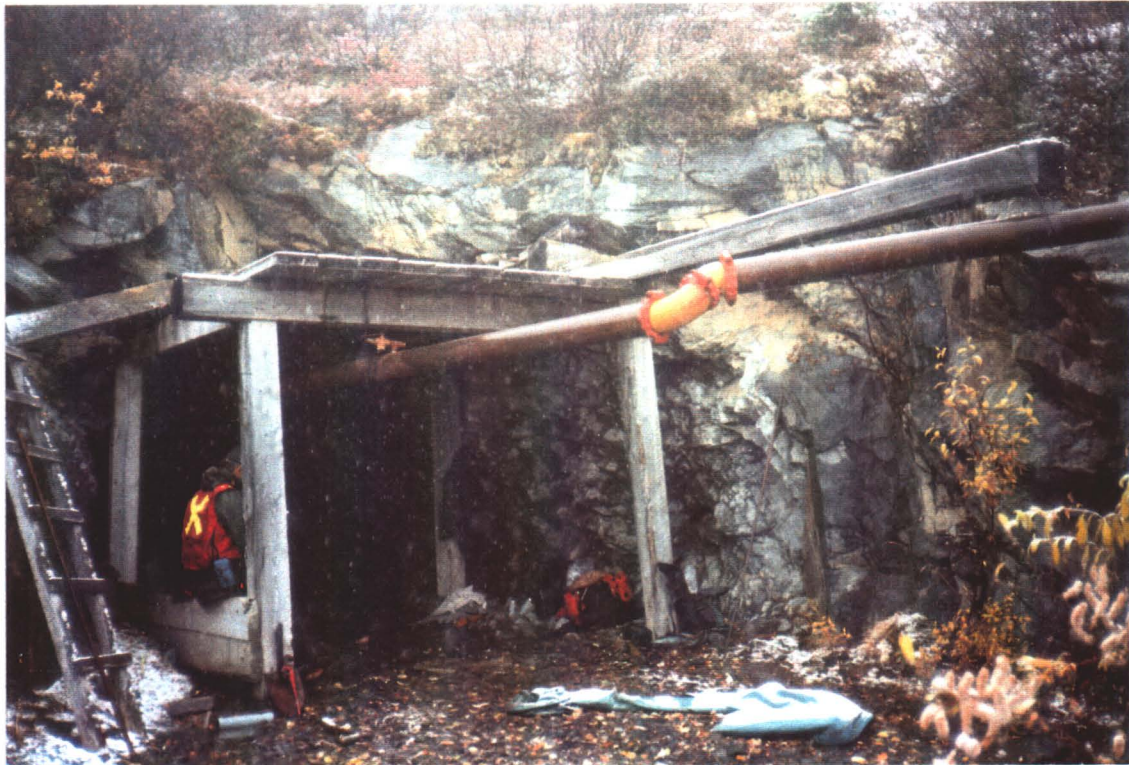
A compressed air pipe consisting of a heavy gauge iron pipe (6" OD) with Victaulic™ clamps linking the compressor station to the adit opening is still in place. The pipe is suspended from by rusting, ductile wire (3 - 4 mm) and therefore is considered to be a potential physical hazard.

Photo 4: Open adit, suspended compressed air pipe, vent tubing in foreground, looking southwest. September 19, 1996.

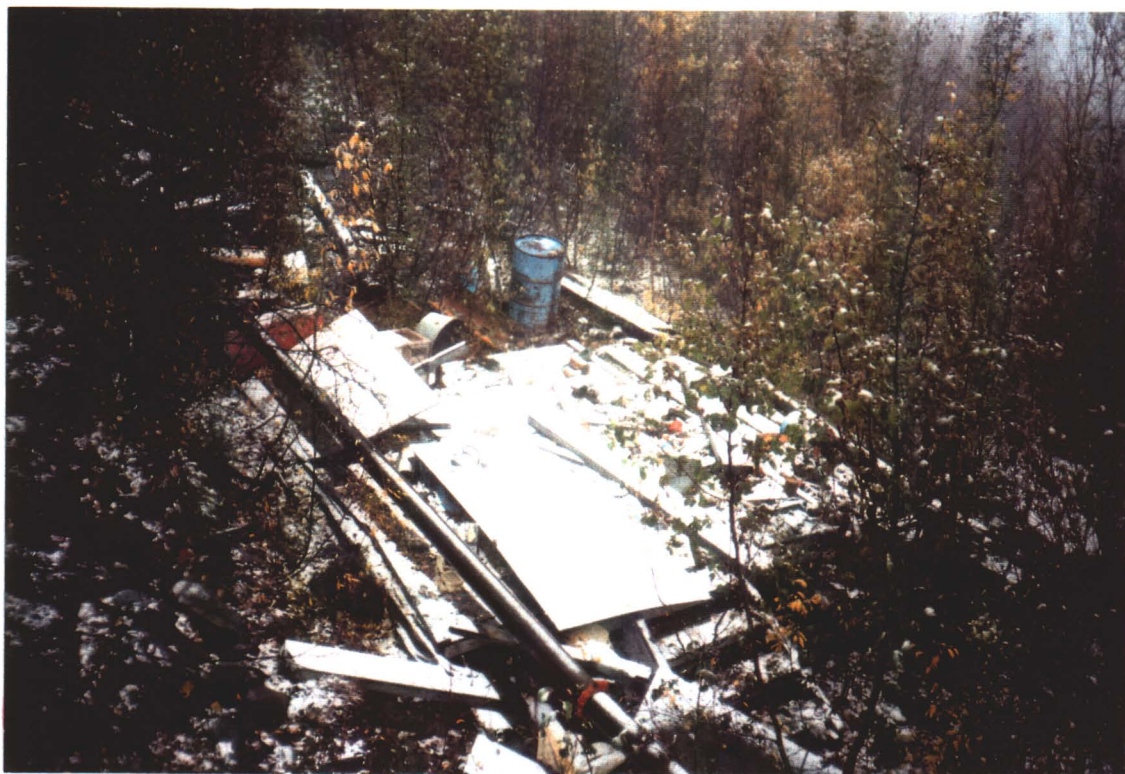
Debris consisting of mining equipment and supplies (air hoses, ventilation tubing, drills, etc.) have been left near the mine opening (Photos 5 and 6). An assortment of debris was found scattered around the bottom of the waste pile. This consisted of torn lengths of ventilation tubing, pipes, oil cans, broken timbers, hydraulic hoses, and other mining debris.

The debris at the demolished compressor station consists of both hazardous and non-hazardous material. The materials include the wall and roofing materials, as well as numerous air and fuel filters, miscellaneous tools (including two air drill/stoppers), air hoses, a broken lead acid car size battery, diesel space heater, and fuel barrels.

Photo 5: Foundation of compressor station/mine services shed, air pipe and assorted debris, looking northwest. September 19, 1996

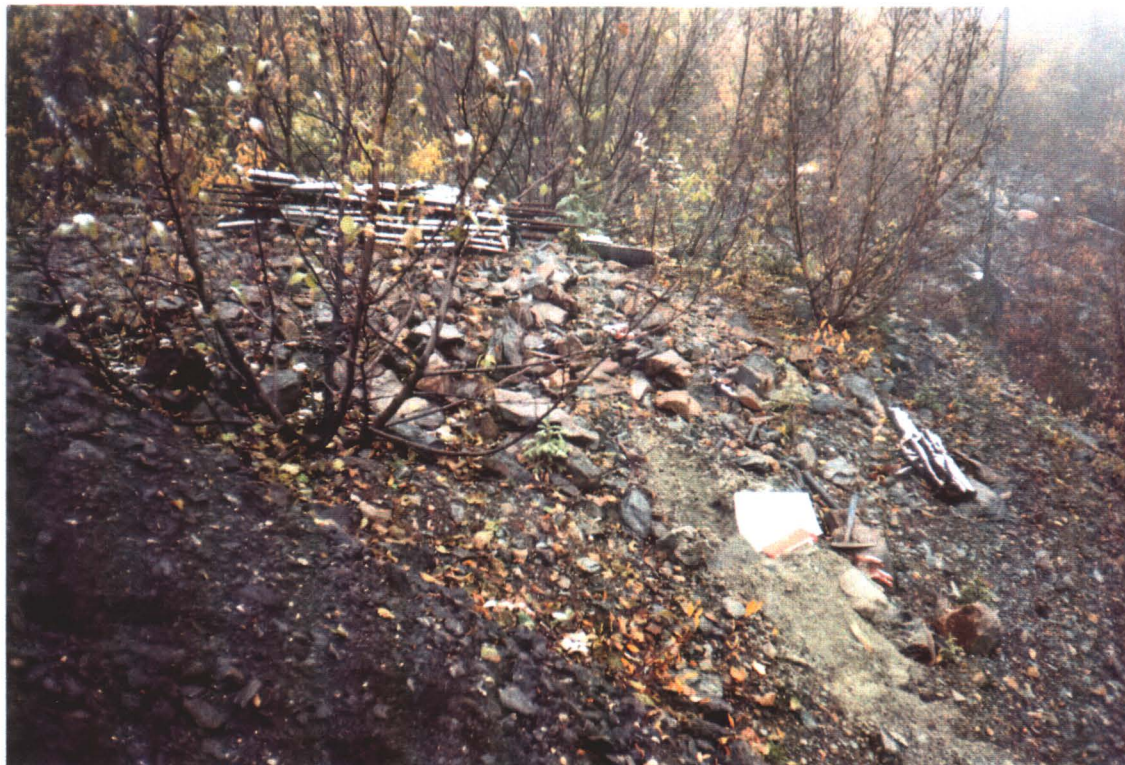
Photo 6: CLWR/P201 sample site 30 metres north of adit in silicified limestone, mineralize rock at lower left, stacked pipe, looking south-southwest. September 19, 1996
