**PHASE II ENVIRONMENTAL ASSESSMENT
OF THE
CONGLOMERATE CREEK
ABANDONED MINE SITE**

**Environmental Services
Public Works and Government Services Canada**

March 1997

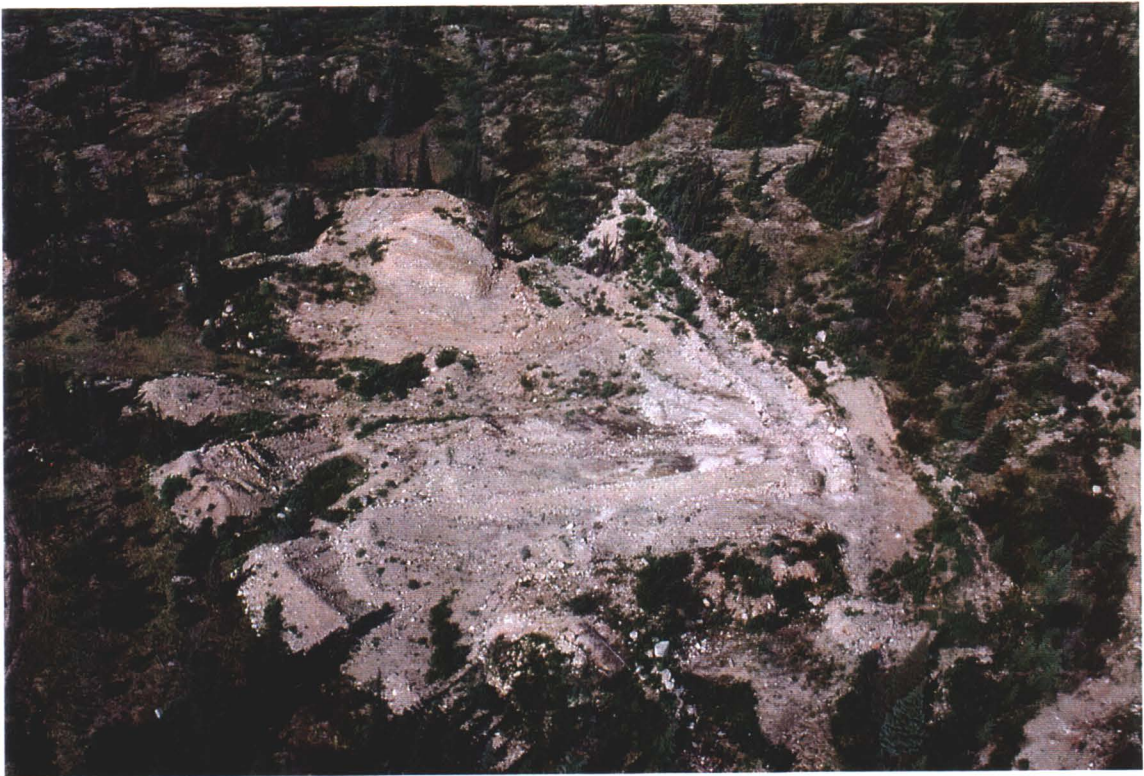
Photo# 2: Aerial View of Trenching

There is no waste rock at the site. Trenching has exposed glacial till overlying granite bedrock. This material contained spotty iron oxide staining and few visible sulphides and, therefore, was not sampled.

Reclamation of the trench areas is not recommended because of the remoteness of the site. Furthermore, recontouring and reseedling of the site would disturb the revegetation that has occurred.

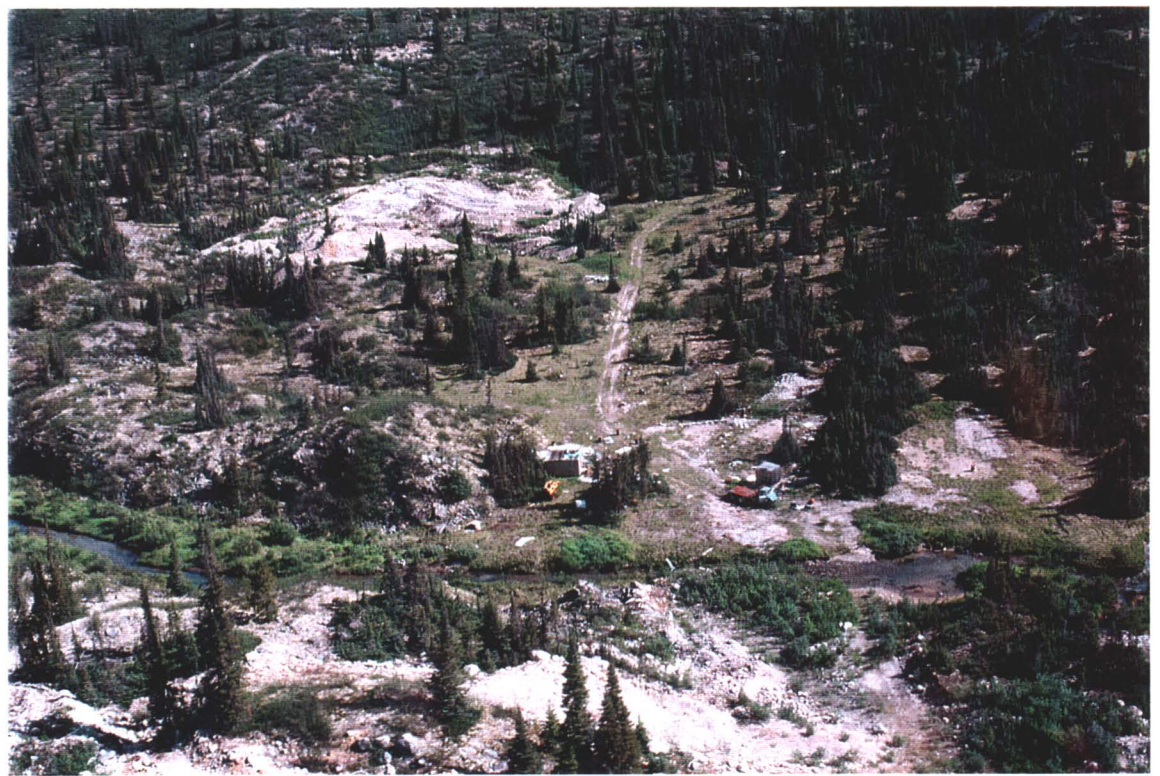
Photo# 4: Camp and Trench Site

Two building structures remain on site and present a potential safety hazard to the public if left unmaintained. Since the site is very remote and practical accesses is achieved by air, the risk is considered to be low.

It is recommended that all buildings be burned and ashes left on site. Waste material that is non-hazardous and combustible can be burned on site.

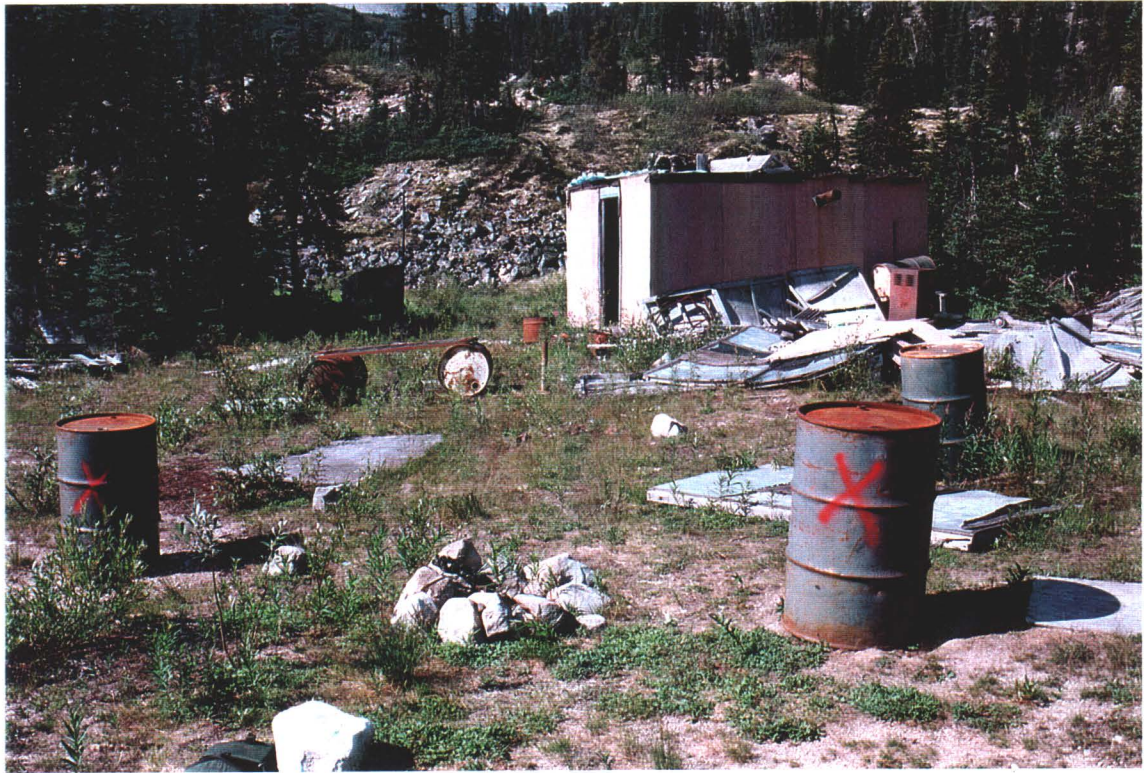
Photo# 5: Site Debris and Barrels

The non-hazardous waste materials observed in and around the site are two demolished sheds and small quantities of wooden timbers, steel rails, 11 empty barrels, and assorted plastic, wood and metal debris.

A minor environmental risk exists as a result the abandonment of petroleum hydrocarbons on site. One barrel, in poor condition, contains approximately 50 litres of a liquid organic waste. Based on laboratory analysis, the disposal of liquid

Waste petroleum products contained in barrels can be use for burning waste debris around the site. Once empty, the barrel should be cleaned and disposed of with along with other non-hazardous waste materials.

It is recommended that the miscellaneous site debris be collected and consolidated.

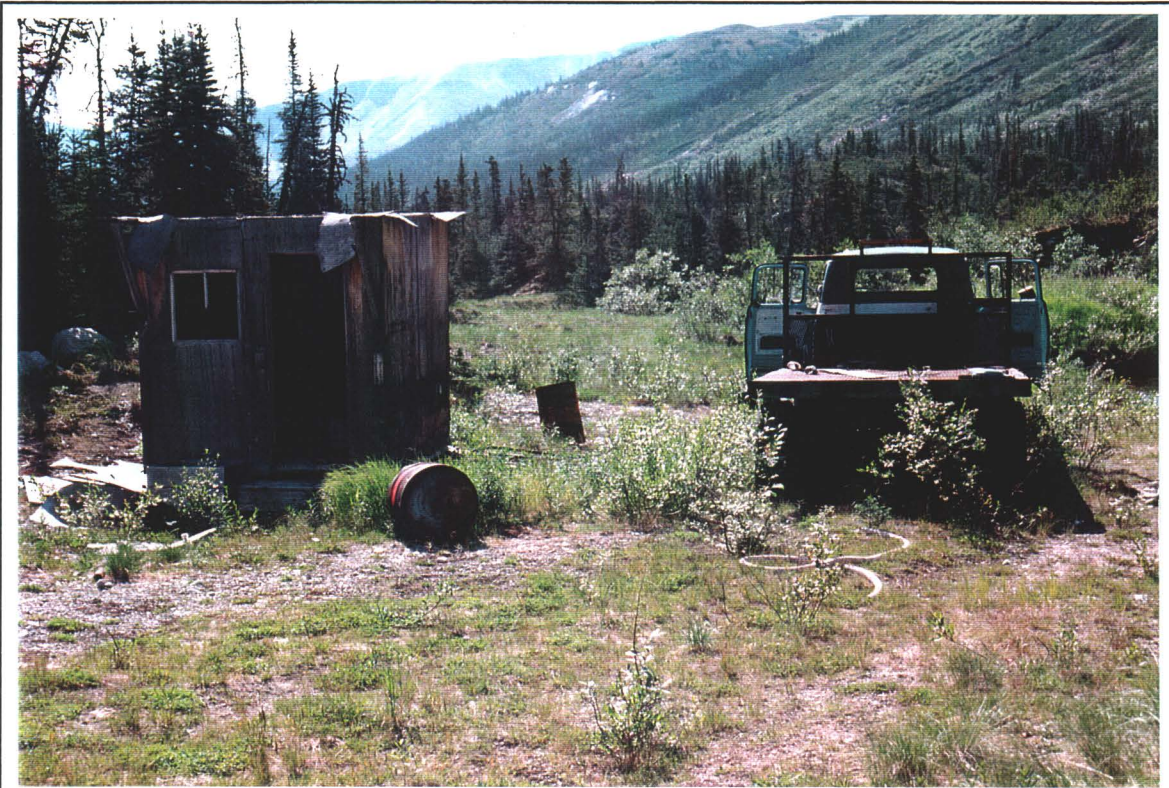
Photo# 7: Site Debris and Shed

Table 1 lists all site buildings and structures by size, construction, and contents. Site observation showed that there were two buildings and three processing structures at the camp site. Structures were all in poor condition and did not indicate any historical value.

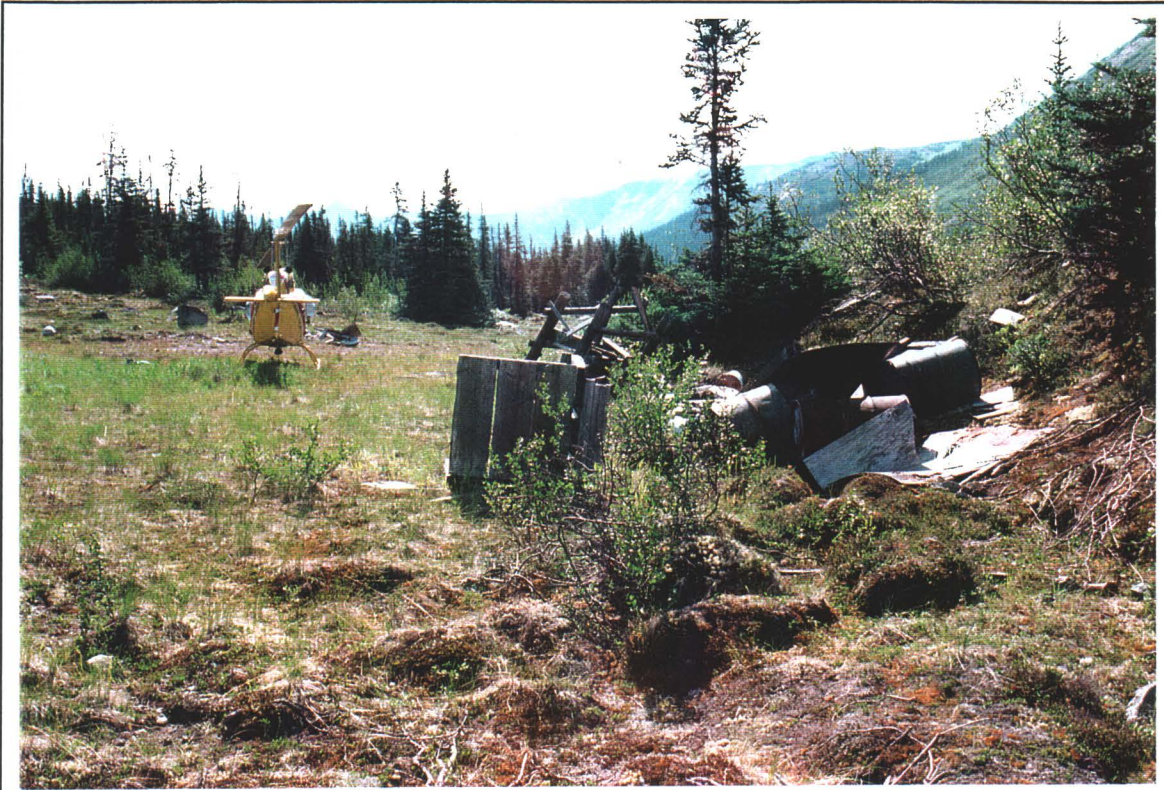
Photo# 9: Site of Hazardous Materials Storage Shed

Two soil samples were collected from stained soils at the site of the former fuel and oil storage site. Samples were analyzed for the presence of lead, total extractable hydrocarbons (TEHs), and Polycyclic Aromatic Hydrocarbon (PAHs).

The concentration of total extractable hydrocarbons (THE) in both samples was above Yukon remediation criteria indicating that petroleum hydrocarbon contaminated soils. Hydrocarbon distributions of both of these samples indicate that contamination is the result of heavy oils, possibly attributable to waste oil spills or leaks. Laboratory results are detailed in Table 3. Complete analytical results are provided in Appendix B. Sample locations are included on Drawing 1.
