PHASE II ENVIRONMENTAL ASSESSMENT
OF THE
DALE
ABANDONED MINE SITE

Action on Waste Program
Indian and Northern Affairs Canada

Environmental Services
Public Works and Government Services Canada

February 1997

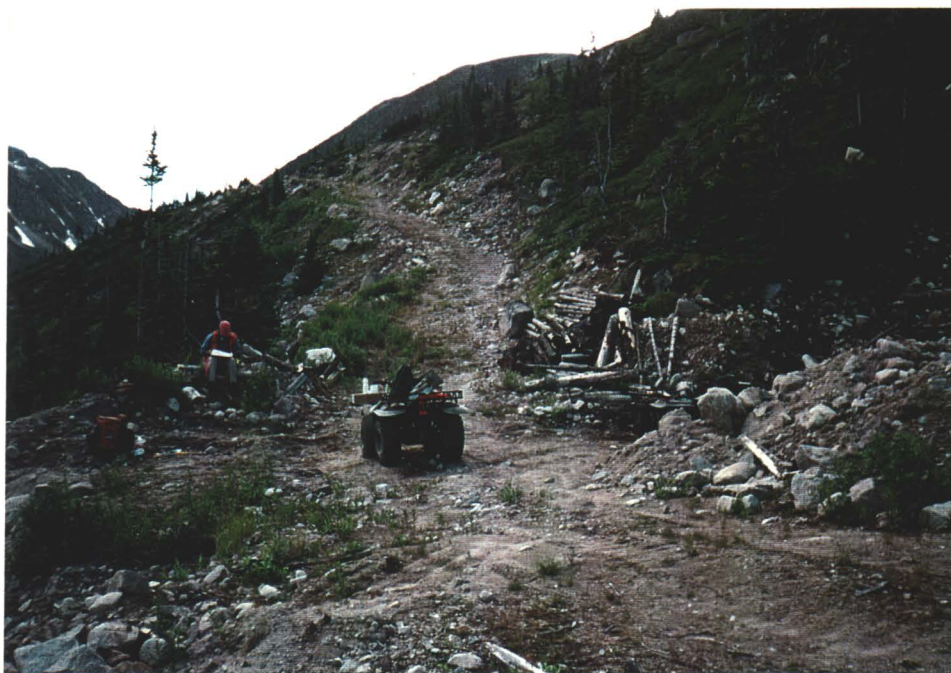
Photo 2. Portal entrance to adit with access road to upper trenching at left (looking north).

The single mine opening should be secured from human and animal access for health and safety reasons. Since site access is good, adits should be covered with surrounding rock and soil using readily available equipment. Timbers and associated wood debris should be burned on site. Should the mine need to be reopened, access to underground workings is achievable with heavy equipment.

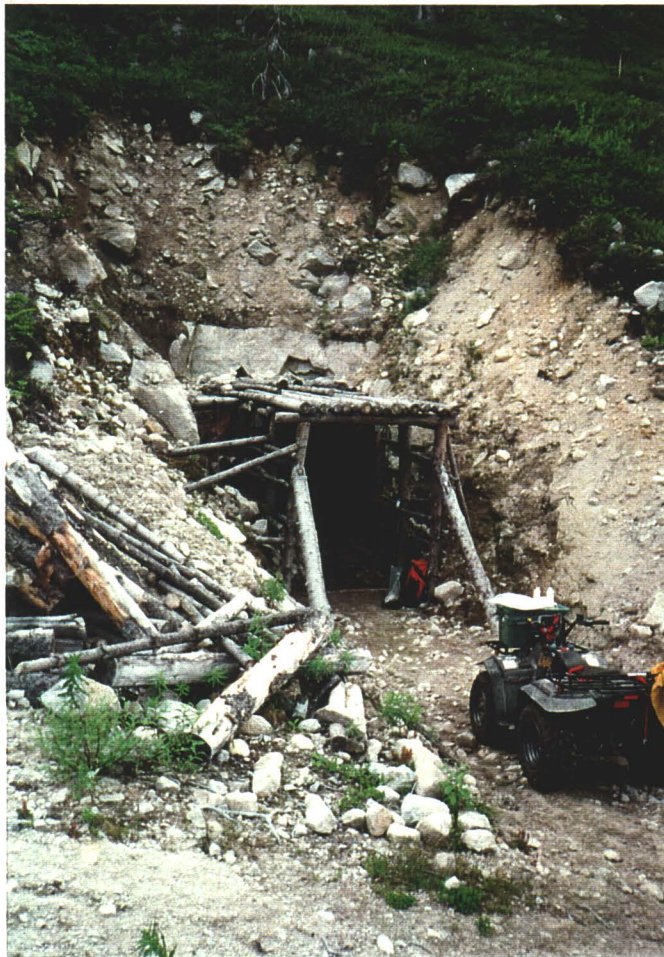
A single adit is located on the Frostbite 2 claim at approximately 1,430 metres elevation and UTM coordinates 6654400 N and 417960 E. The first 6 metres of the portal were re-conditioned in 1994 (MinFile Report 105B 007) with new alpine balsam fir logs 0.15 to 0.30 metres. It extends 5.5 metres out from the rock collar and measures 1.7 metres wide by 2.2 metres high. A total of 7.5 metres of the portal is visible, with the remainder blocked by a screen of chain link fencing at 4 metres and a plastic sheet at 7.5 metres. The adit was partly blocked by a 0.4 metre high pile of frozen snow. The adit is in good repair, but has been underbuilt with the use of undersized timbers and chainlink fencing along its length on both sides instead of horizontal planking.

Adit	Location	Drift Length	Condition
A1	Lower Site, elev. 1430 m	7.5 m	- good condition but underbuilt due to undersize timbers & chainlink fencing rather than horizontal planking

Photo 3. Under built single adit (1.7 m X 2.2 m) built of fir logs.

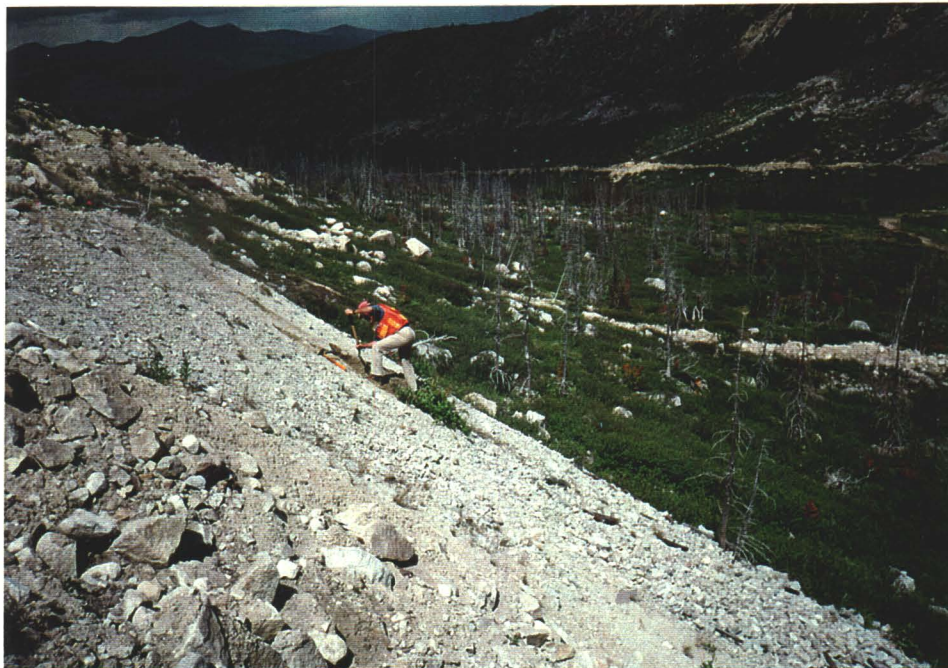
Waste rock from the development of the adit was end dumped 20 metres northeast of the portal area. (see Photos 4 & 8). The material is homogenous, composed primarily of medium grained, equigranular, biotite quartz monzonite of the Cassiar Batholith with no observed vein material or sulphide content. It is angular and is comprised of 50% minus 0.5 cm. material, 30% 0.5 cm. to 3.0 cm. material and 20% 3.0 cm. to 20.0 cm. material.

Photo 4. Excavating waste rock test pit sample hole DL-WR-R1 below (east) of adit entrance.

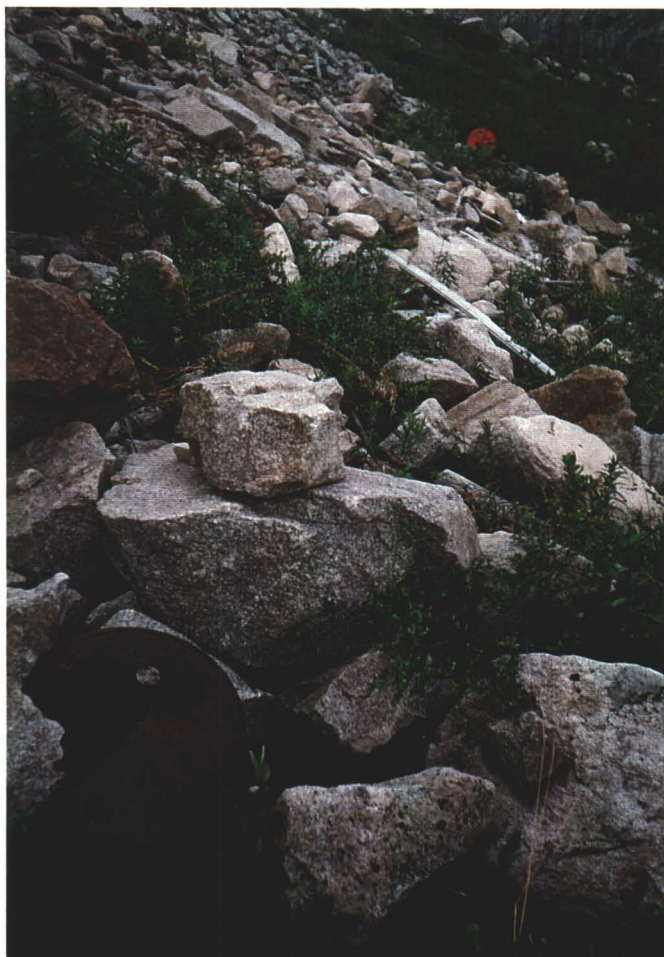
A total of 16 x 205 litre steel barrels were scattered about the site in 2 main areas. Five barrels were identified below the adit location scattered about the waste rock disposal area. A further 11 barrels were scattered across the upper trenching area. Non-hazardous waste materials observed in and around the site are listed in Table 2 below.

Photo 8. Empty 205 litre rusting metal drums on rocky slope below adit entrance.

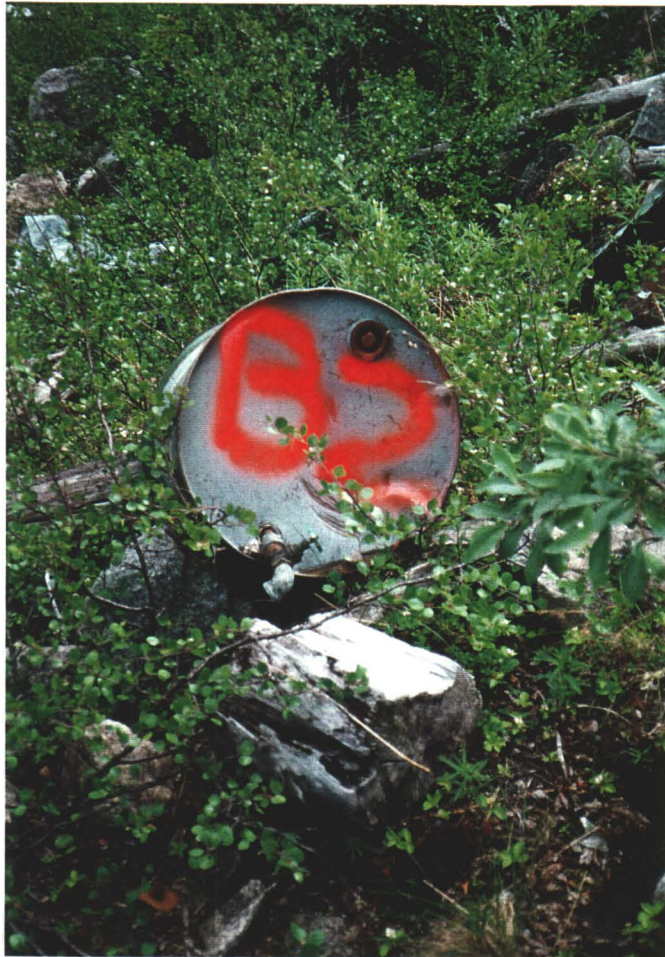
Minor amounts of log and lumber debris, old rail sections, ductwork and 10 rusting 205 l. barrels were identified below the adit (see Photo 9). Numerous barrels scattered about upper trenching area above adit as well as at the exploration camp area below adit (see Photo 10 & 17). Garbage consisting of old equipment and metal waste is strewn about the camp area however, no waste dump, landfill or borrow sites were identified.

No signs of stained soils were observed during the site inspection and no soil samples were taken. Samples of petroleum product were taken from Barrels DLB-2 (30 m northwest and 10 m downslope from adit), Barrel No. DLB-4 (located 50 m east of DLB-2), DLB-7b (upper trenching area barrel cache), DLB-10b (upper trenching area barrel cache), and DLB-12 (at the western extent of upper level trench workings).

Photo 9. 205 litre barrel DL-B2 located on rocky slope below adit entrance.

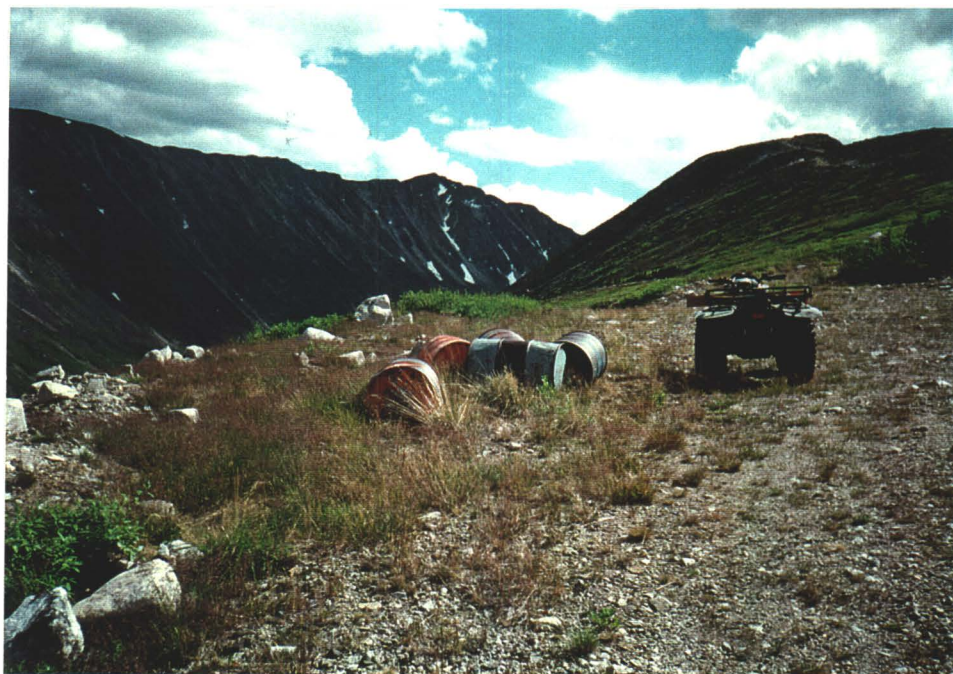
Photo 10. Empty 205 litre rusting metal drums scattered about upper trenching area.

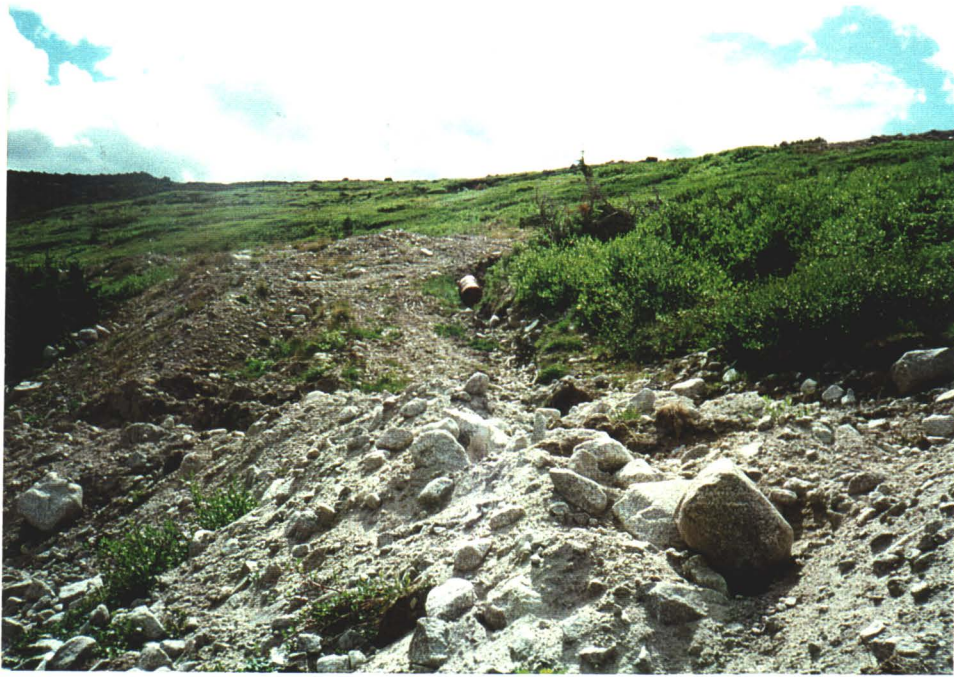
trenches observed between 1540 metres and 1585 metres oriented east-west down the slope and 1 is over 15 metres wide. Two trenches are located end to end over a total length of 250 metres along the east-west trend of the vein and shear zone at the crest of the ridge at 1590 metres elevation. The trenches are 2 to 3 metres deep and were filled with snow at the time of inspection.

Photo11. Detail of trench workings above main adit level.

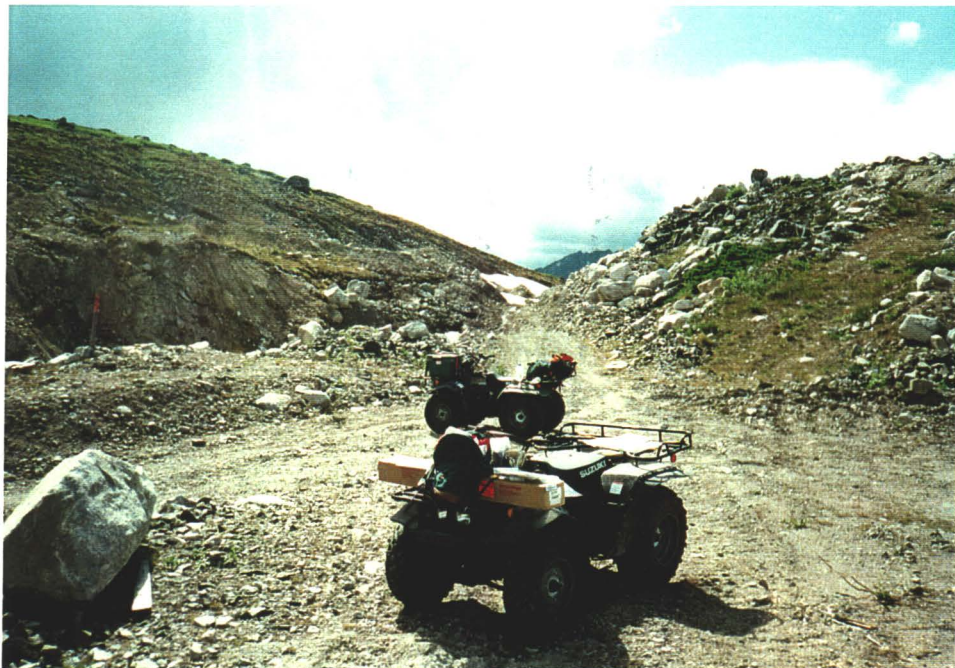
Photo 12. Upper trench workings leading west to snow melt.

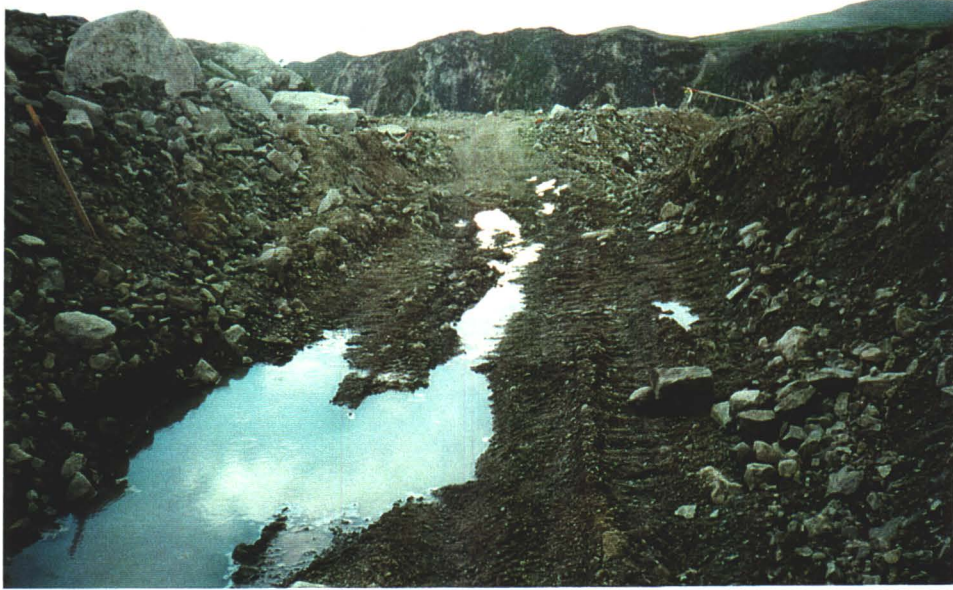
Photo 13. Western extent of upper level trench workings.

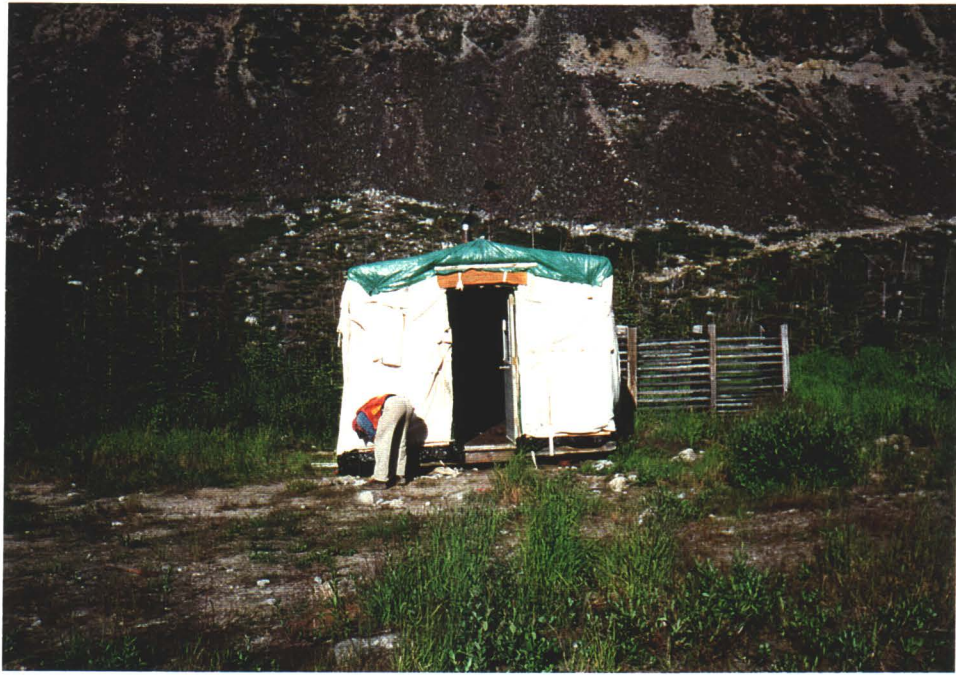
Photo 15. Log structure living quarters covered with tarpaulin (wood floor)

Wood core storage racks in lower encampment area should be retained. Flare off remaining fuel drum behind log cabin, burn log cabin, bury metal roofing of A frame, and burn A frame in place.

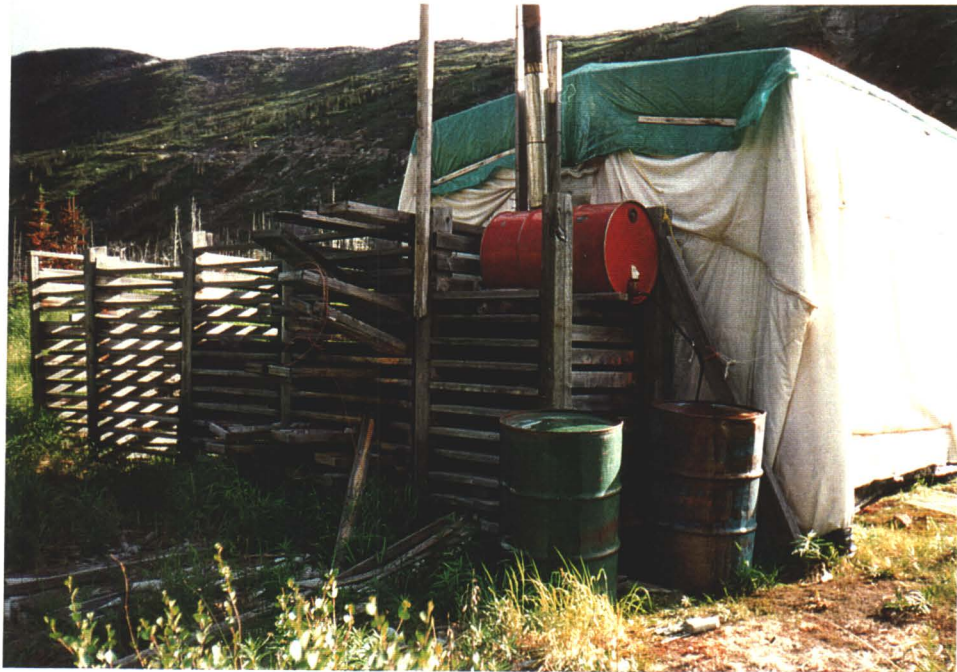
Photo 17. Core racks in rear of living quarters used to support drum for dispensing of fuel oil to stove.

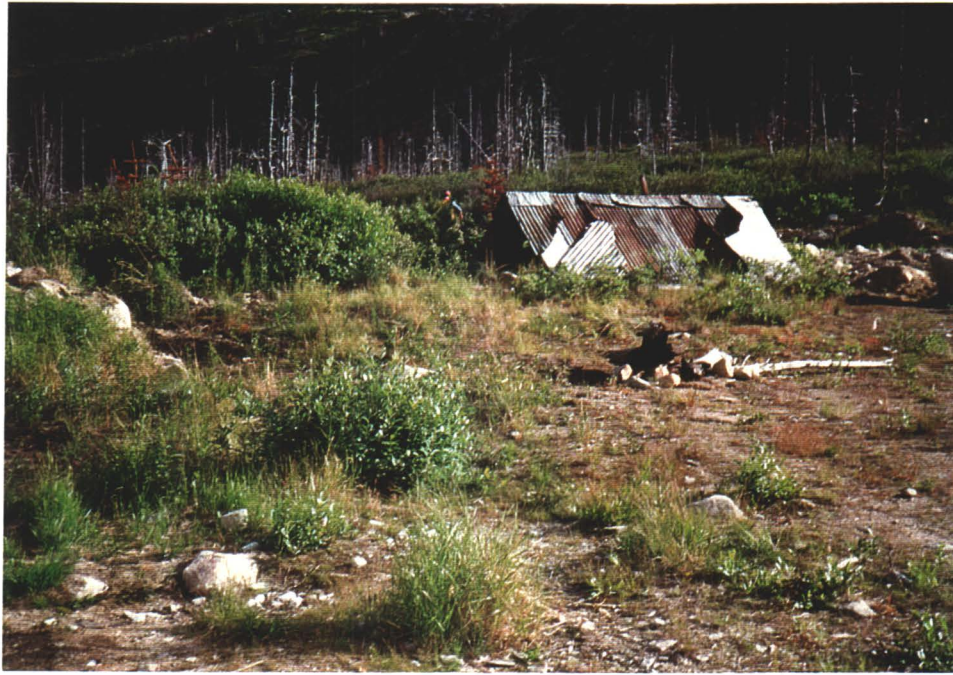
Photo 19. Wood frame metal clad A-frame former roof of log structure used for storage.

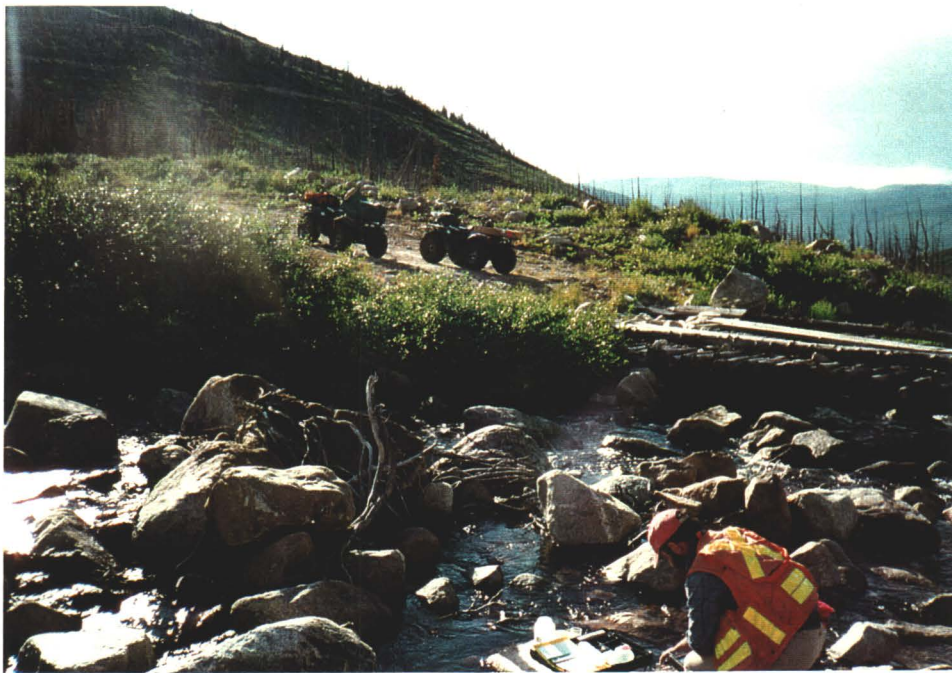
Photo 20. Water quality sample site at access road crossing of unnamed tributary of Freer Creek.
