**PHASE II ENVIRONMENTAL ASSESSMENT
of the
FORMO MINE SITE**

Action on Waste Program
Indian and Northern Affairs Canada

Environmental Services
Public Works and Government Services Canada

February
~~March~~ 1997

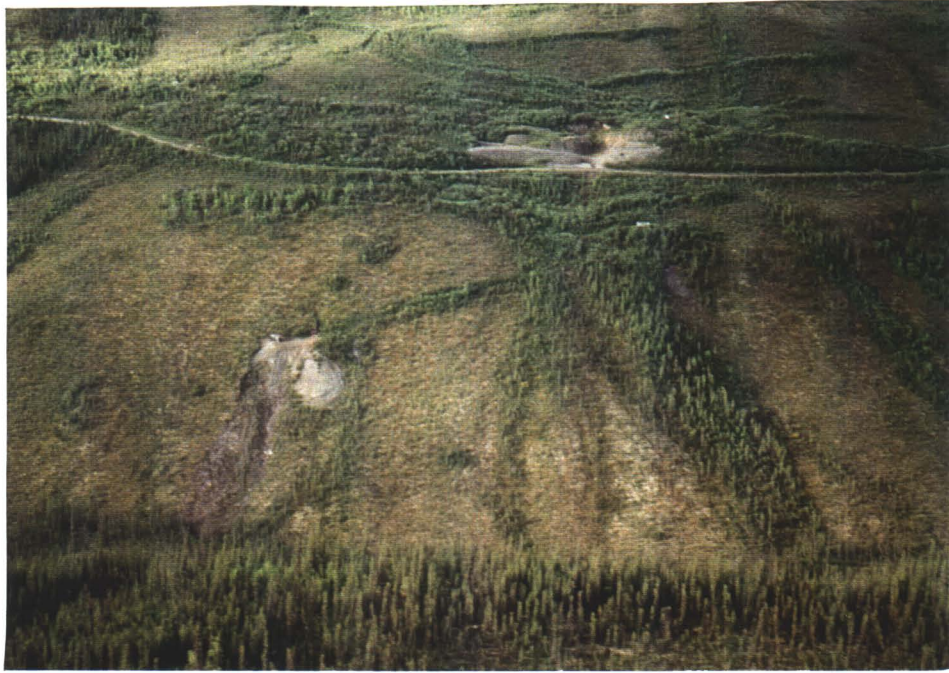
Photo 1. Aerial view of Formo mine site from northeast with lower adit, middle adit and upper workings visible.

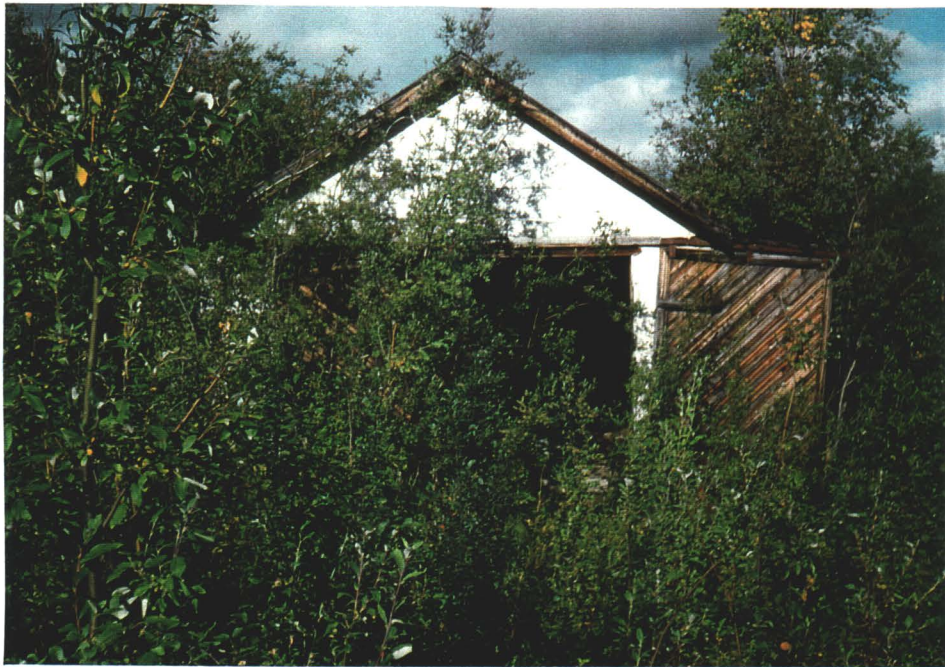
Photo 2. Wood frame wood clad core shed located southwest of upper workings area.

Recommendation 2. All buildings should be demolished by burning in situ. Before burning the core shed, asbestos siding shingles should be stripped off and sealed in heavy-gauge plastic bags. After burning the buildings, bury all residues and the bagged asbestos on site. The recommended burial site for the asbestos is the south end of the upper workings.

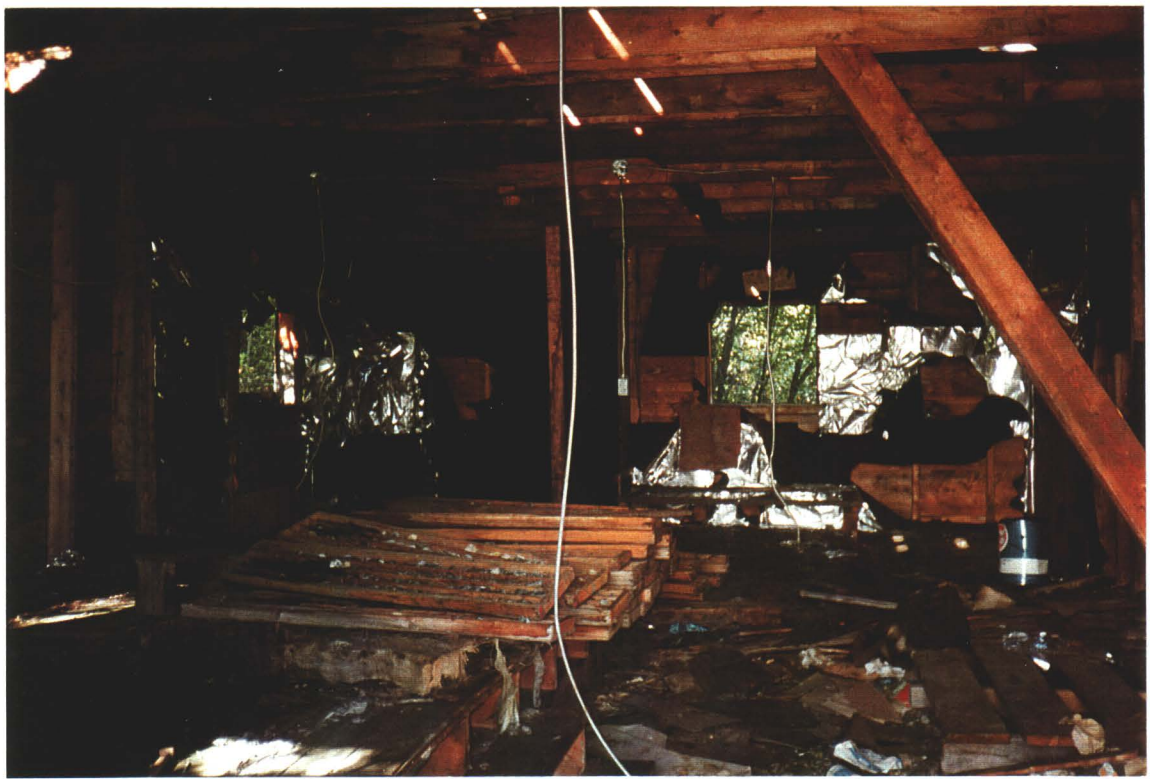
Minor hydrocarbon stains were noted on the soil floor of the core shed. Two samples (FO-SL-201 and -301) were collected from 15 cm depth near the stairs and north wall respectively. Soil from surface to 15 cm depth was typically sandy silt with gravel, and a mild hydrocarbon odour was noted in both samples. Only trace quantities of naphthalene and pyrene were analysed in FO-SL-201 and -301 respectively; these results suggest hydrocarbons in the soil are aged or comprised of heavier lubricating oils which are beyond the PAH analytical range (and for which no CCME criteria exist). Arsenic, cadmium and zinc above CCME C/I levels were found in FO-SL-301.

Photo 3. Interior of core shed; core trays visible at middle left of photo.

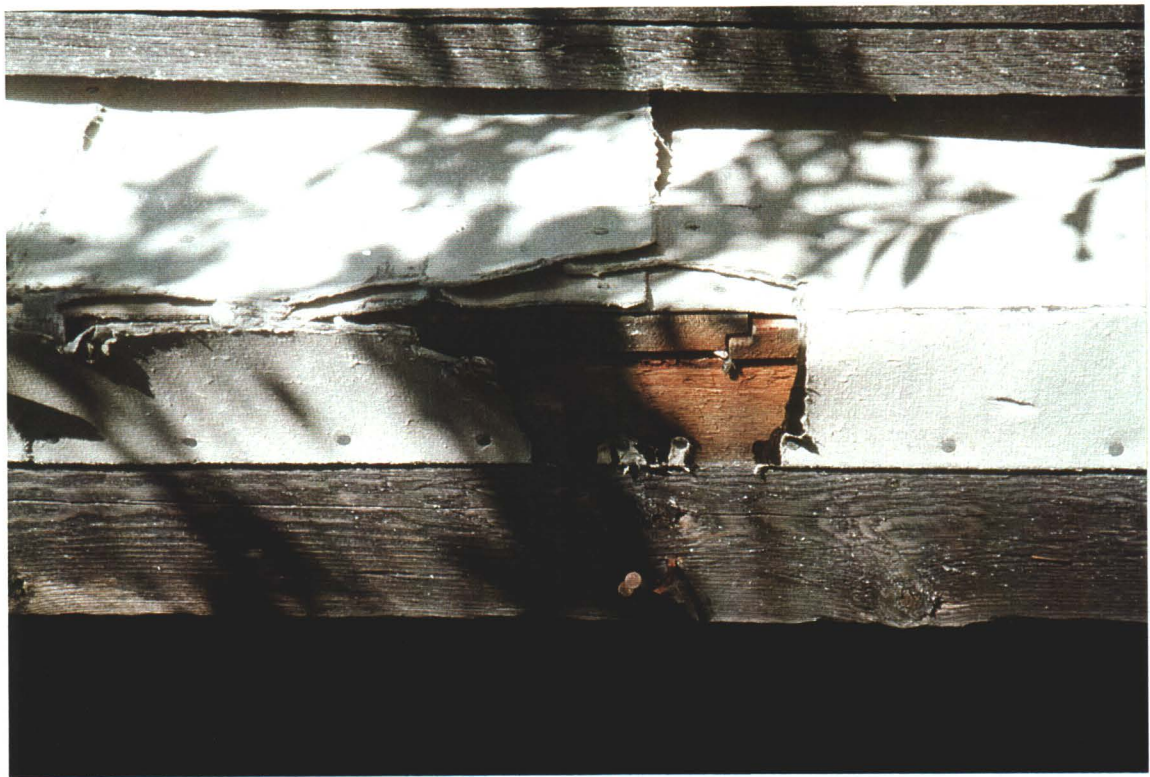
Asbestos-coated siding shingles were observed on the core shed, although the asbestos did not appear friable (Photo4).

Photo 4. Asbestos-coated asphalt shingles on sides of core shed.

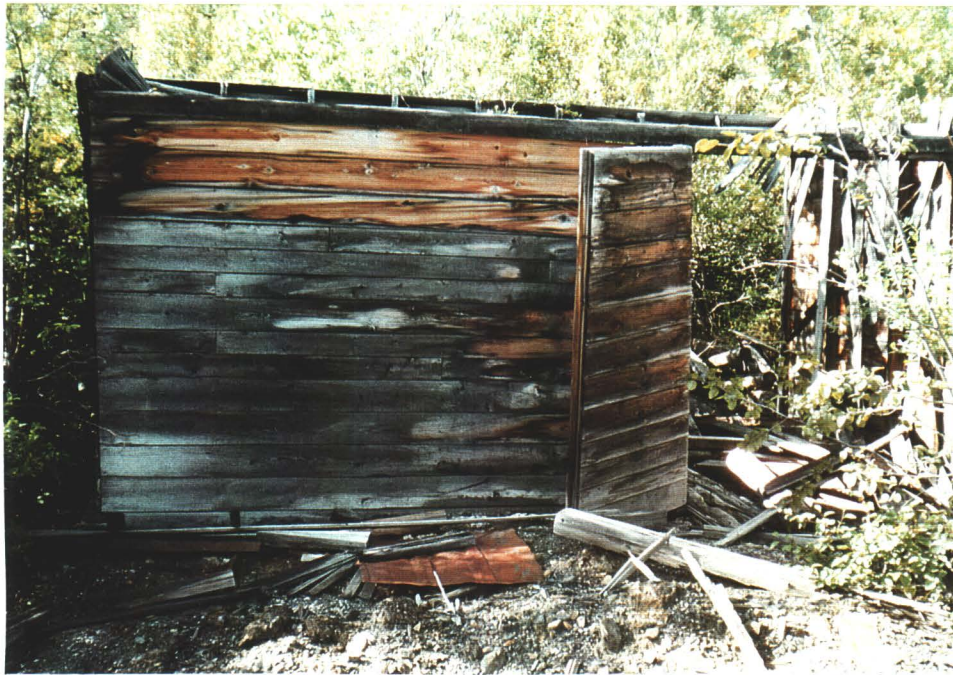
Photo 5. Wood frame wood clad workshop at entrance to lower adit looking southwest.

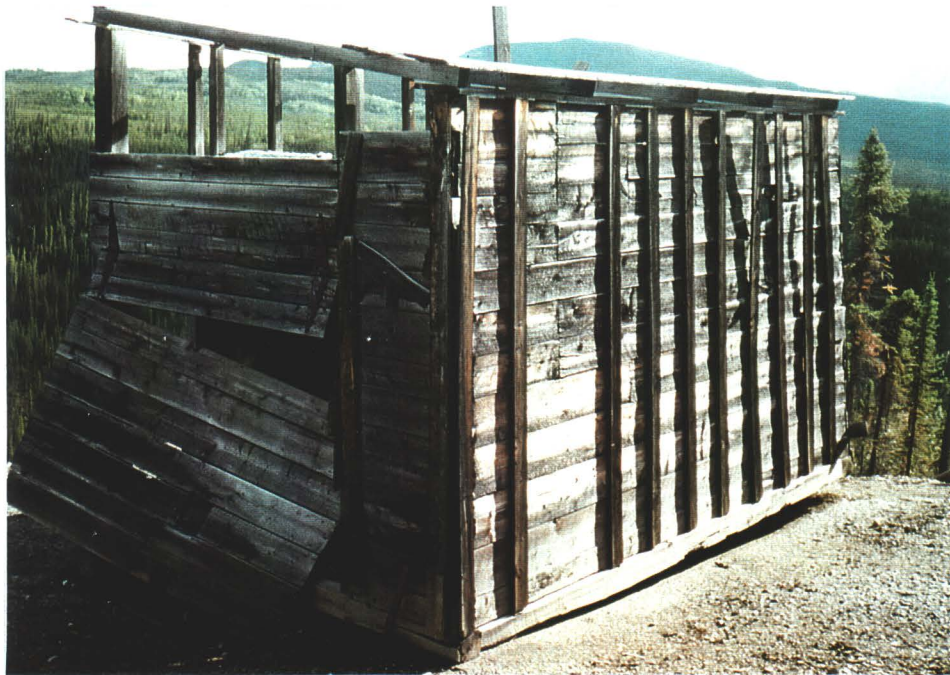
Photo 6. Wood frame wood clad shed at lower adit looking east.

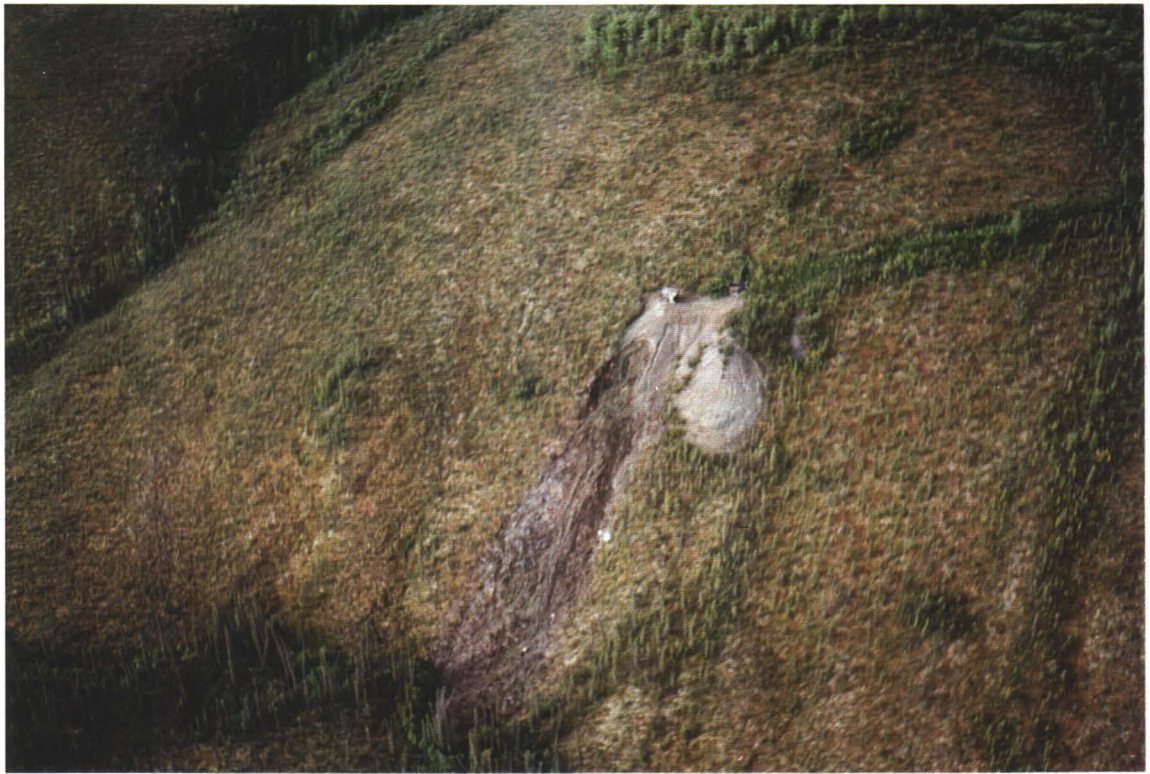
The area of disturbance at the lower workings is approximately 6000 m². The area covered by waste rock was increased by an additional 55% when the eastern lobe failed, causing overburden mixed with waste rock to flow down the hillside into Christal Creek. Waste rock has slumped to within 20 m of Christal Creek, and massive sulphides are evident in the mixed overburden/waste rock slump material. The slope angle was measured to be 45° along the upper parts of the pile. Extension cracks were observed along the top of both lobes and the head scarp of the failure was still evident at the crest of the eastern lobe. Both lobes of the rock pile are undergoing active creep deformation (possibly related to poor drainage and frost action). The western lobe of the waste rock pile is covered with relatively unmineralized rock as compared to the eastern lobe.

Photo 7. Aerial view of lower east waste rock dump. Christal Creek at lower left corner of photo; slumping area evident as brown-colored lobe.

Recommendation 1. To prevent further movement of slumped overburden/waste rock material into Christal Creek, gabion baskets, concrete lock blocks, or some other physical barrier should be placed at the toe of the lower east waste rock dump. Stabilize the upper portion of the waste rock dump by grading to a natural angle of repose. Construct a lined diversion ditch across the top of the dump to reduce surface and near-surface water flows into potential areas of slope failure.

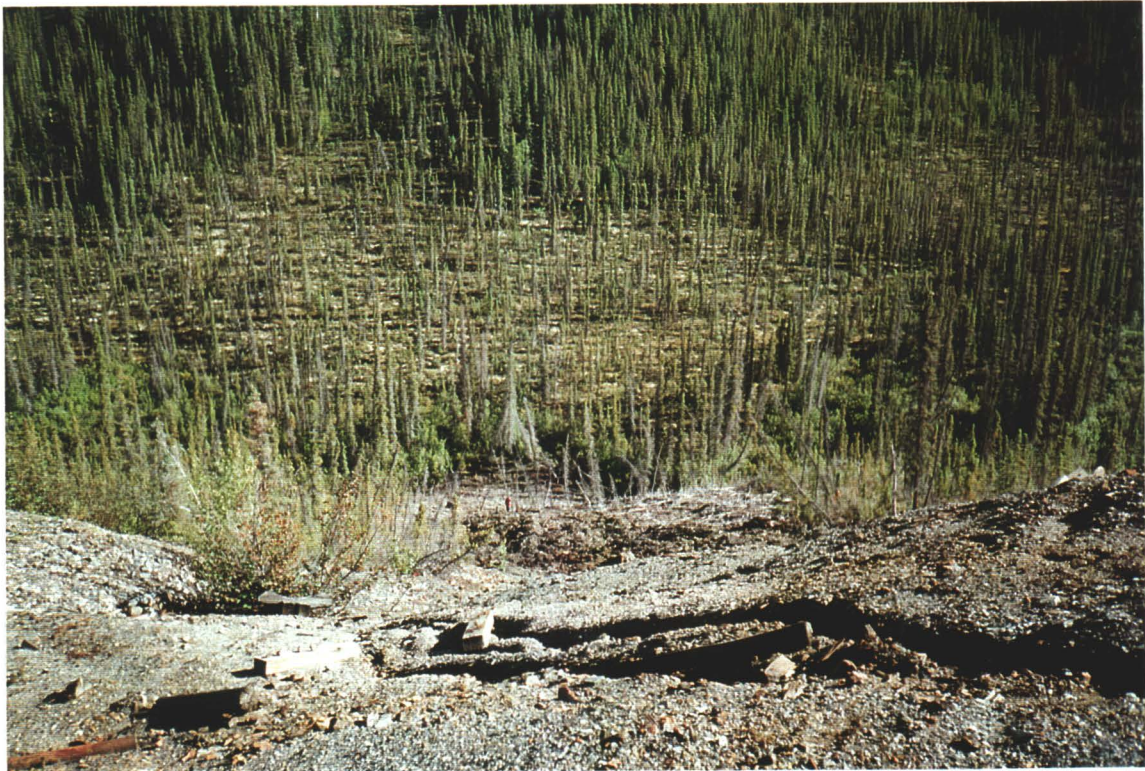
Photo 8. Downhill view of slumped overburden and waste rock, looking toward Christal Creek.

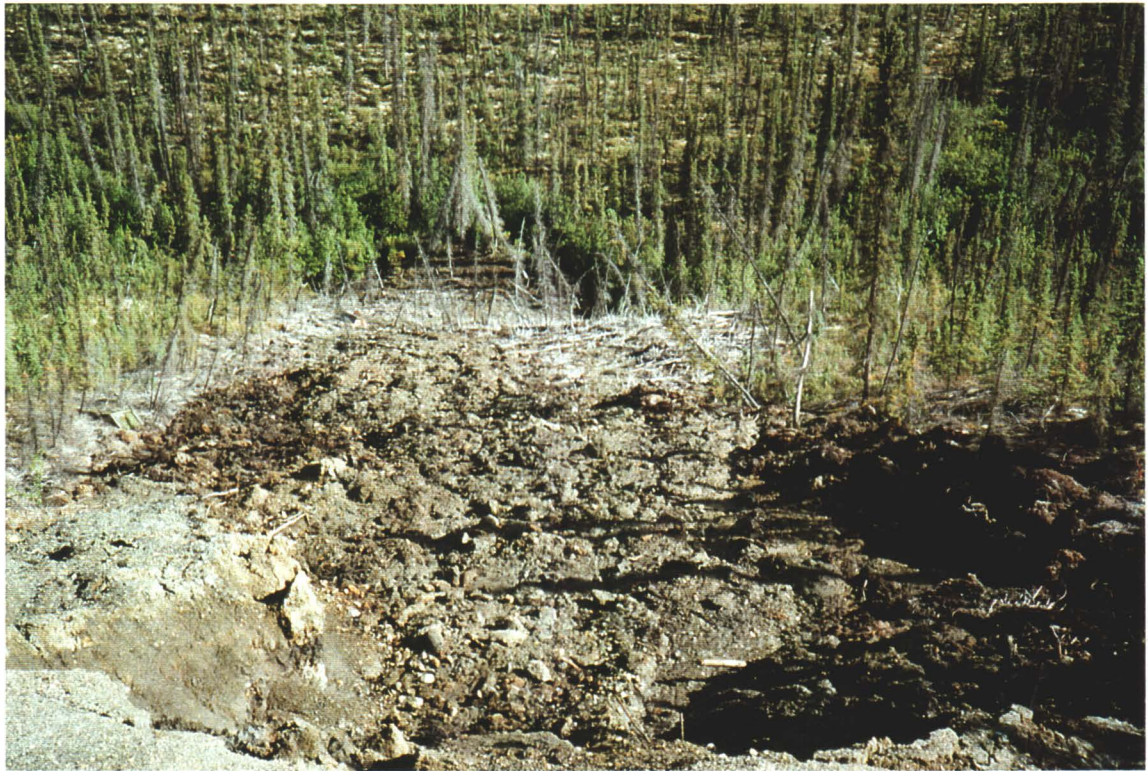
Photo 9. Close-up view of slumped area, lower east waste rock dump. Dead trees visible near toe of slump indicates effects from past slumping.

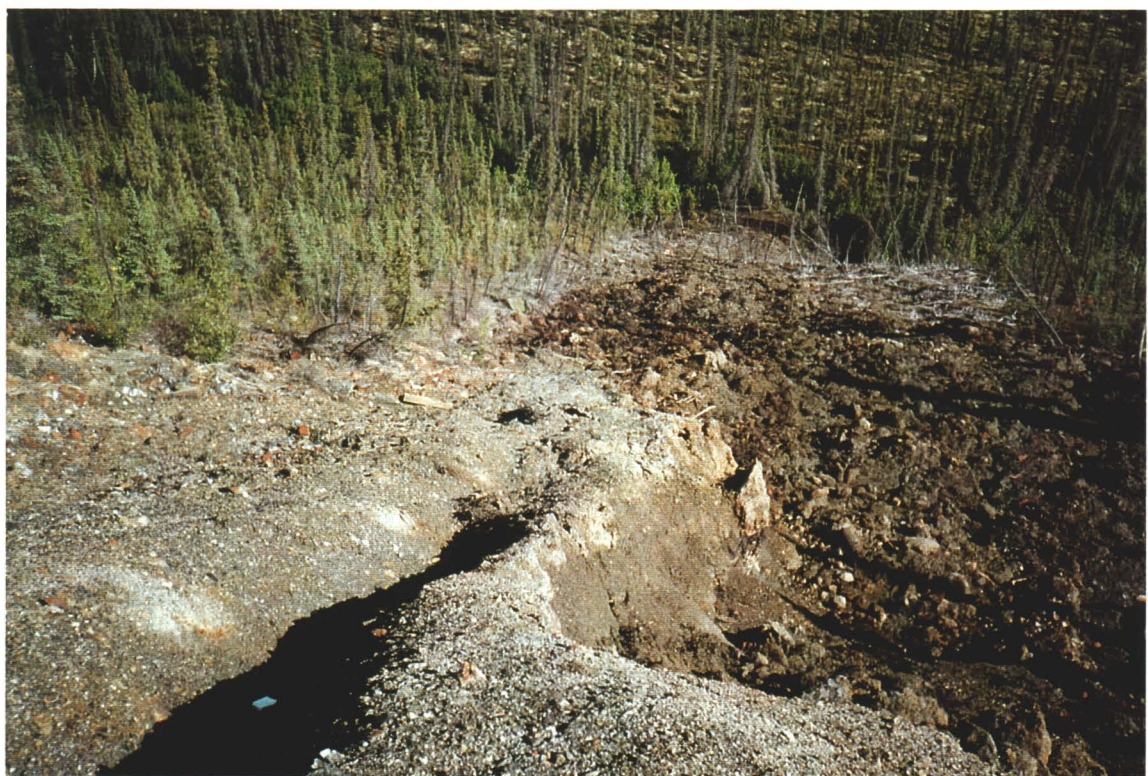
Photo 10. Slumped overburden and waste rock, with recent tension cracks at head of unstable lobe.

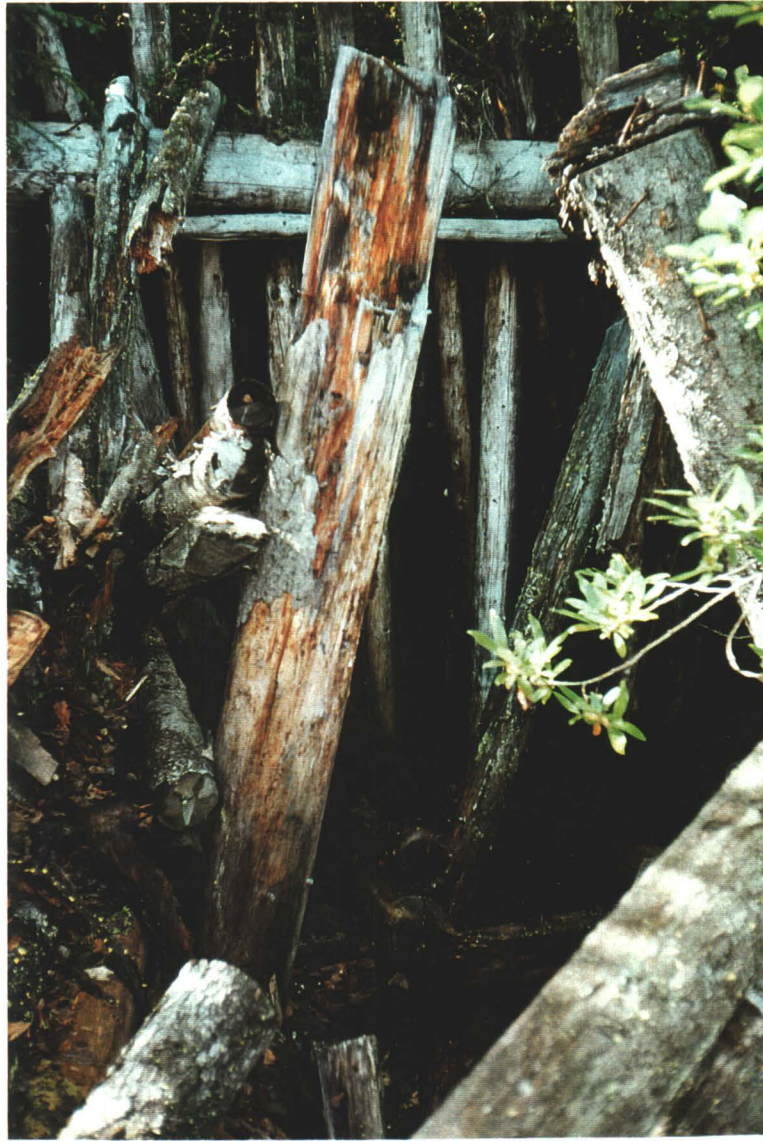
Shallow shafts dug at the upper workings were destroyed during trenching. Two adits were driven at elevations approximately 50 metres and 80 metres below the upper workings at locations. The lower adit is partially blocked by a log retaining wall (Photo 11); however, the logs are loose and rotting, and access to the interior of the adit is possible. Entry to the middle adit has been restricted by a board enclosure, but this adit also is accessible (Photo 12).

Photo 11. Remnants of log and timber barrier at entrance of lower adit.

Recommendation 5. After metal wastes have been placed inside the middle and lower adits, both adits should be sealed by blasting.

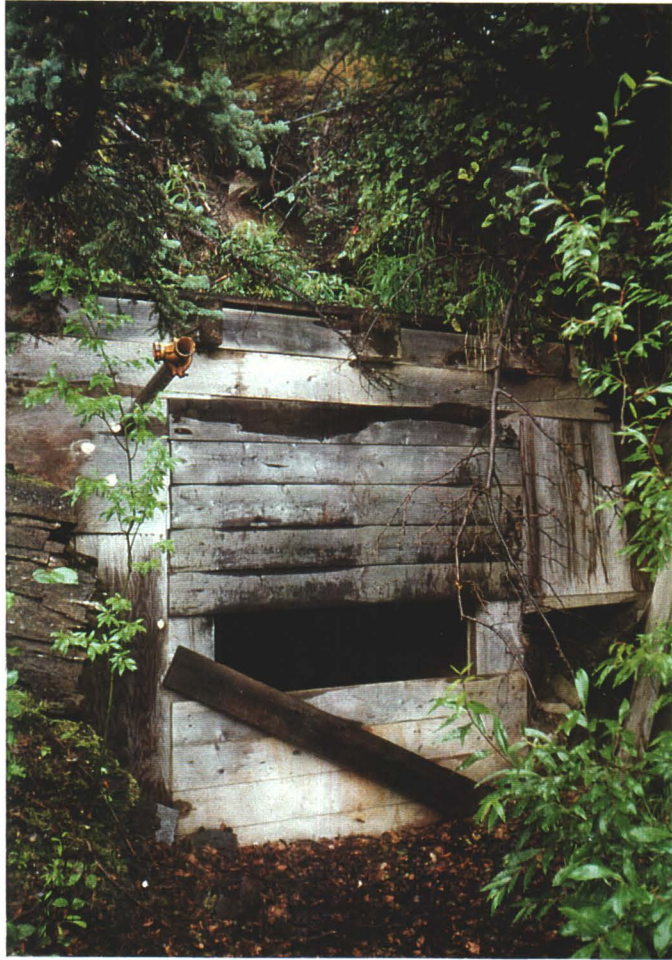
Photo 12. Middle adit enclosure and entrance.
