# Assessment of Abandoned Yukon Mine Sites

## Hayes #85

Prepared for  
Public Works and Government  
Services Canada

February 1997  
GV206.01

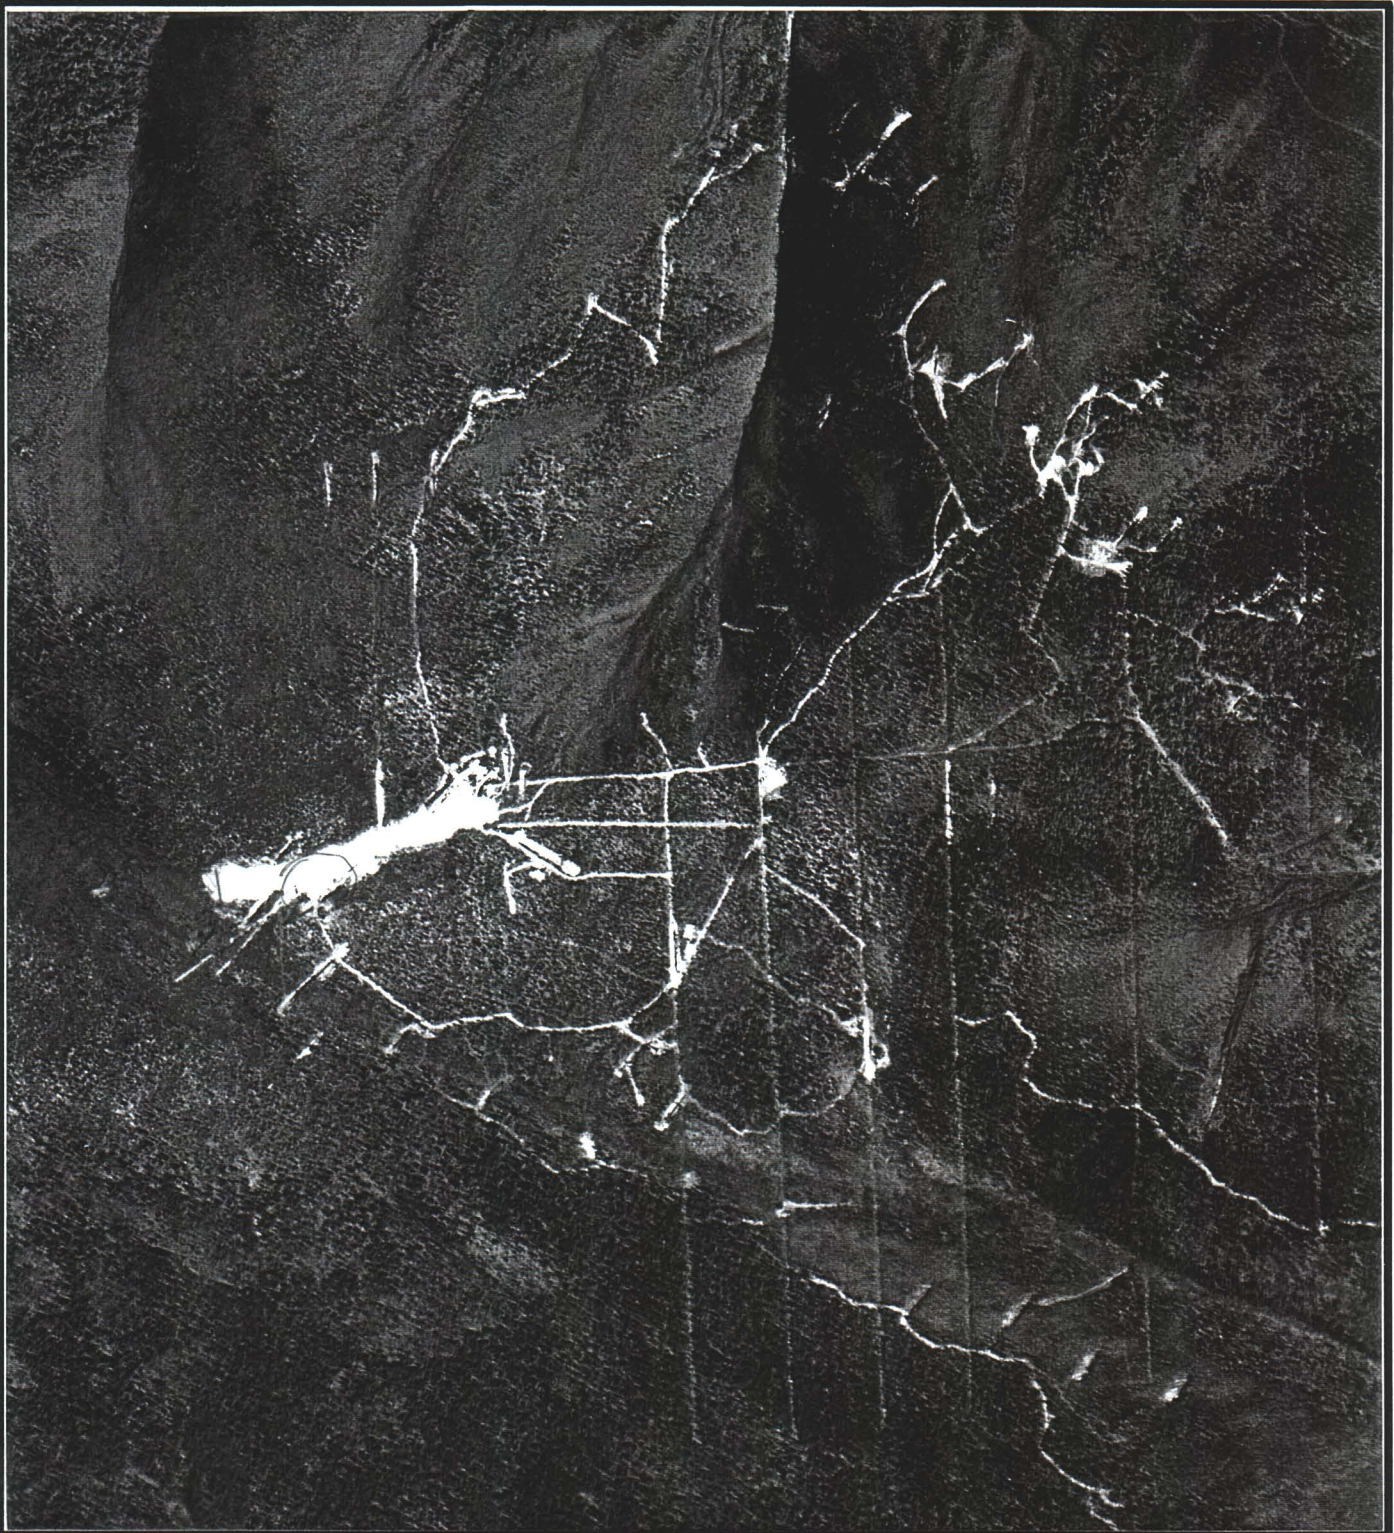
Figure I.3

**Hayes Abandoned Mine Site Air Photo**

Roads, trails and exploration workings are shown in the airphoto presented as Figure 1.3.

The main roadways, airstrip, trails, trenching and excavations are identified on the airphoto (Figure 1.3). The site layout highlighting significant site workings, structures and debris is provided in Figures 5.1 and 5.2. The site and Hayes creek are shown in Photo 2, Appendix A, taken from the air on the day of the site visit.

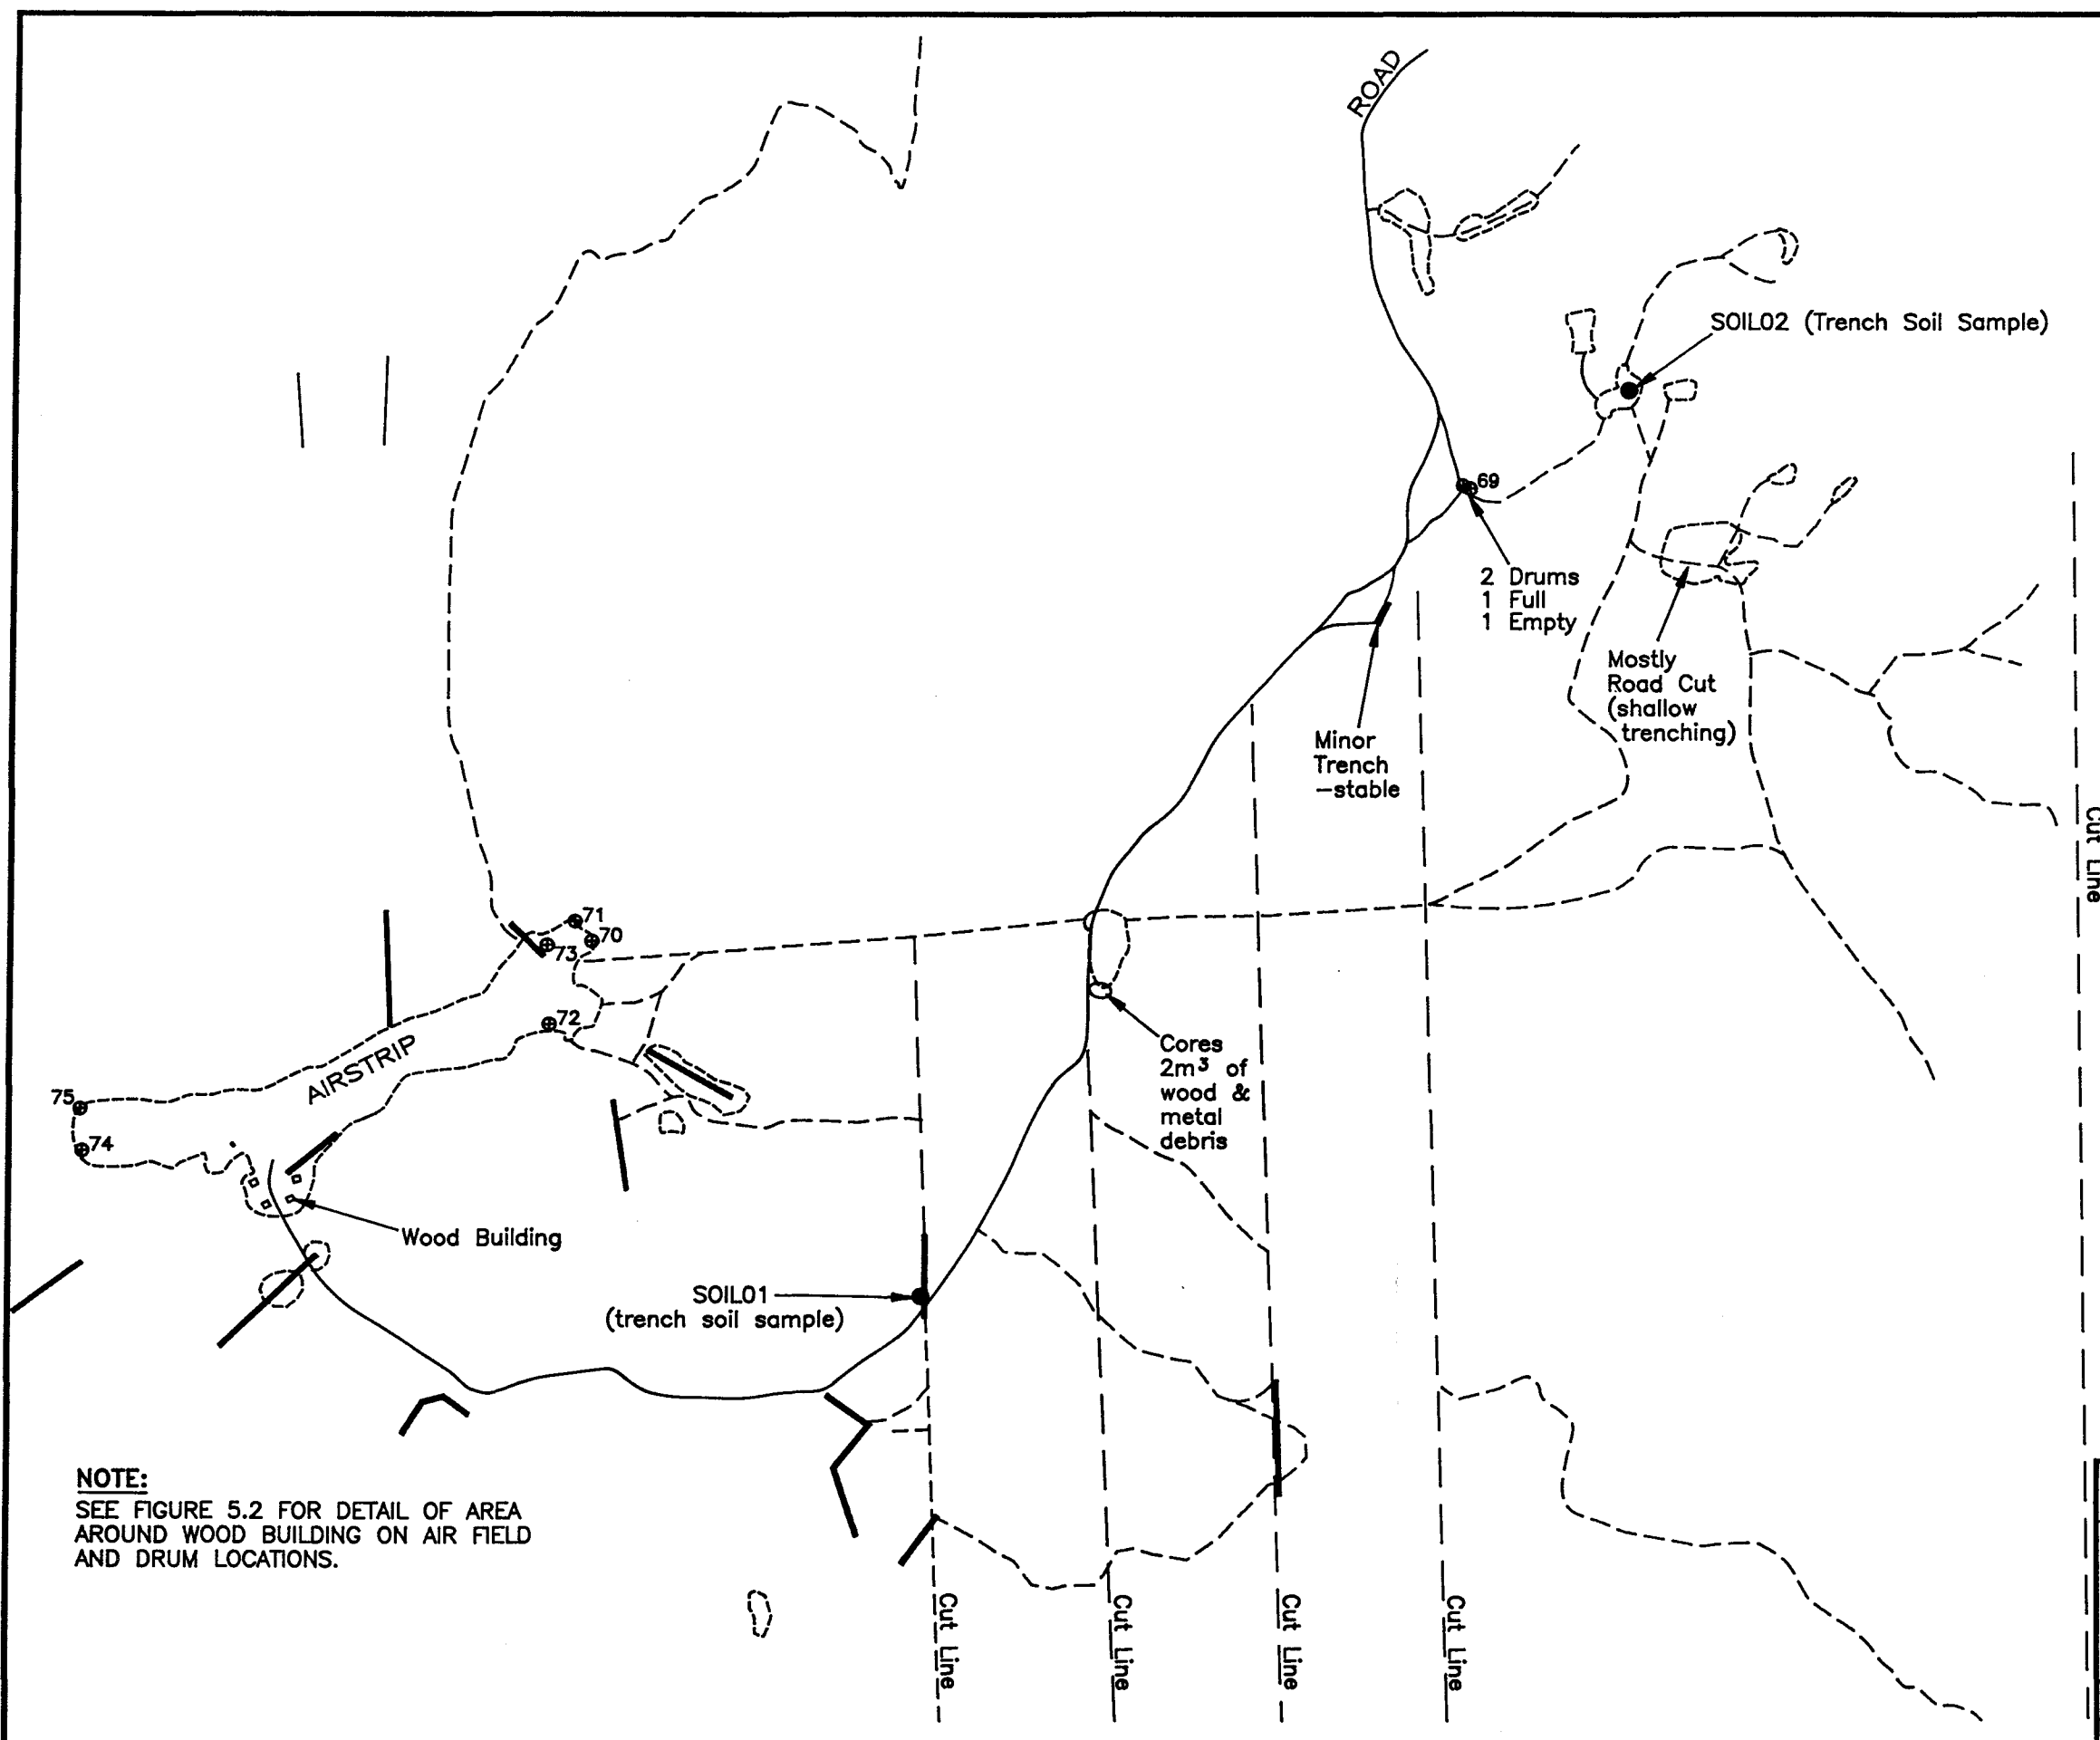
**HAYES EXPLORATION SITE  
 SITE LAYOUT**

**NOTE:**  
 SEE FIGURE 5.2 FOR DETAIL OF AREA  
 AROUND WOOD BUILDING ON AIR FIELD  
 AND DRUM LOCATIONS.

The buildings, infrastructure and equipment discussed in this section are those identified during the site reconnaissance of September 10, 1996. Several buildings, in various states of deterioration, are present. No buildings or structures were identified beyond the main camp area adjacent to the airstrip. Location of buildings, equipment and debris are shown on Figures 5.1 and 5.2.

Four buildings/tent structures were identified at the camp site area located near the southwest end of the airstrip. The layout and location of the buildings are detailed in Figure 5.2. This section details the building construction and material details and debris within the buildings. Names provided for each buildings are given based our best interpretation of use.

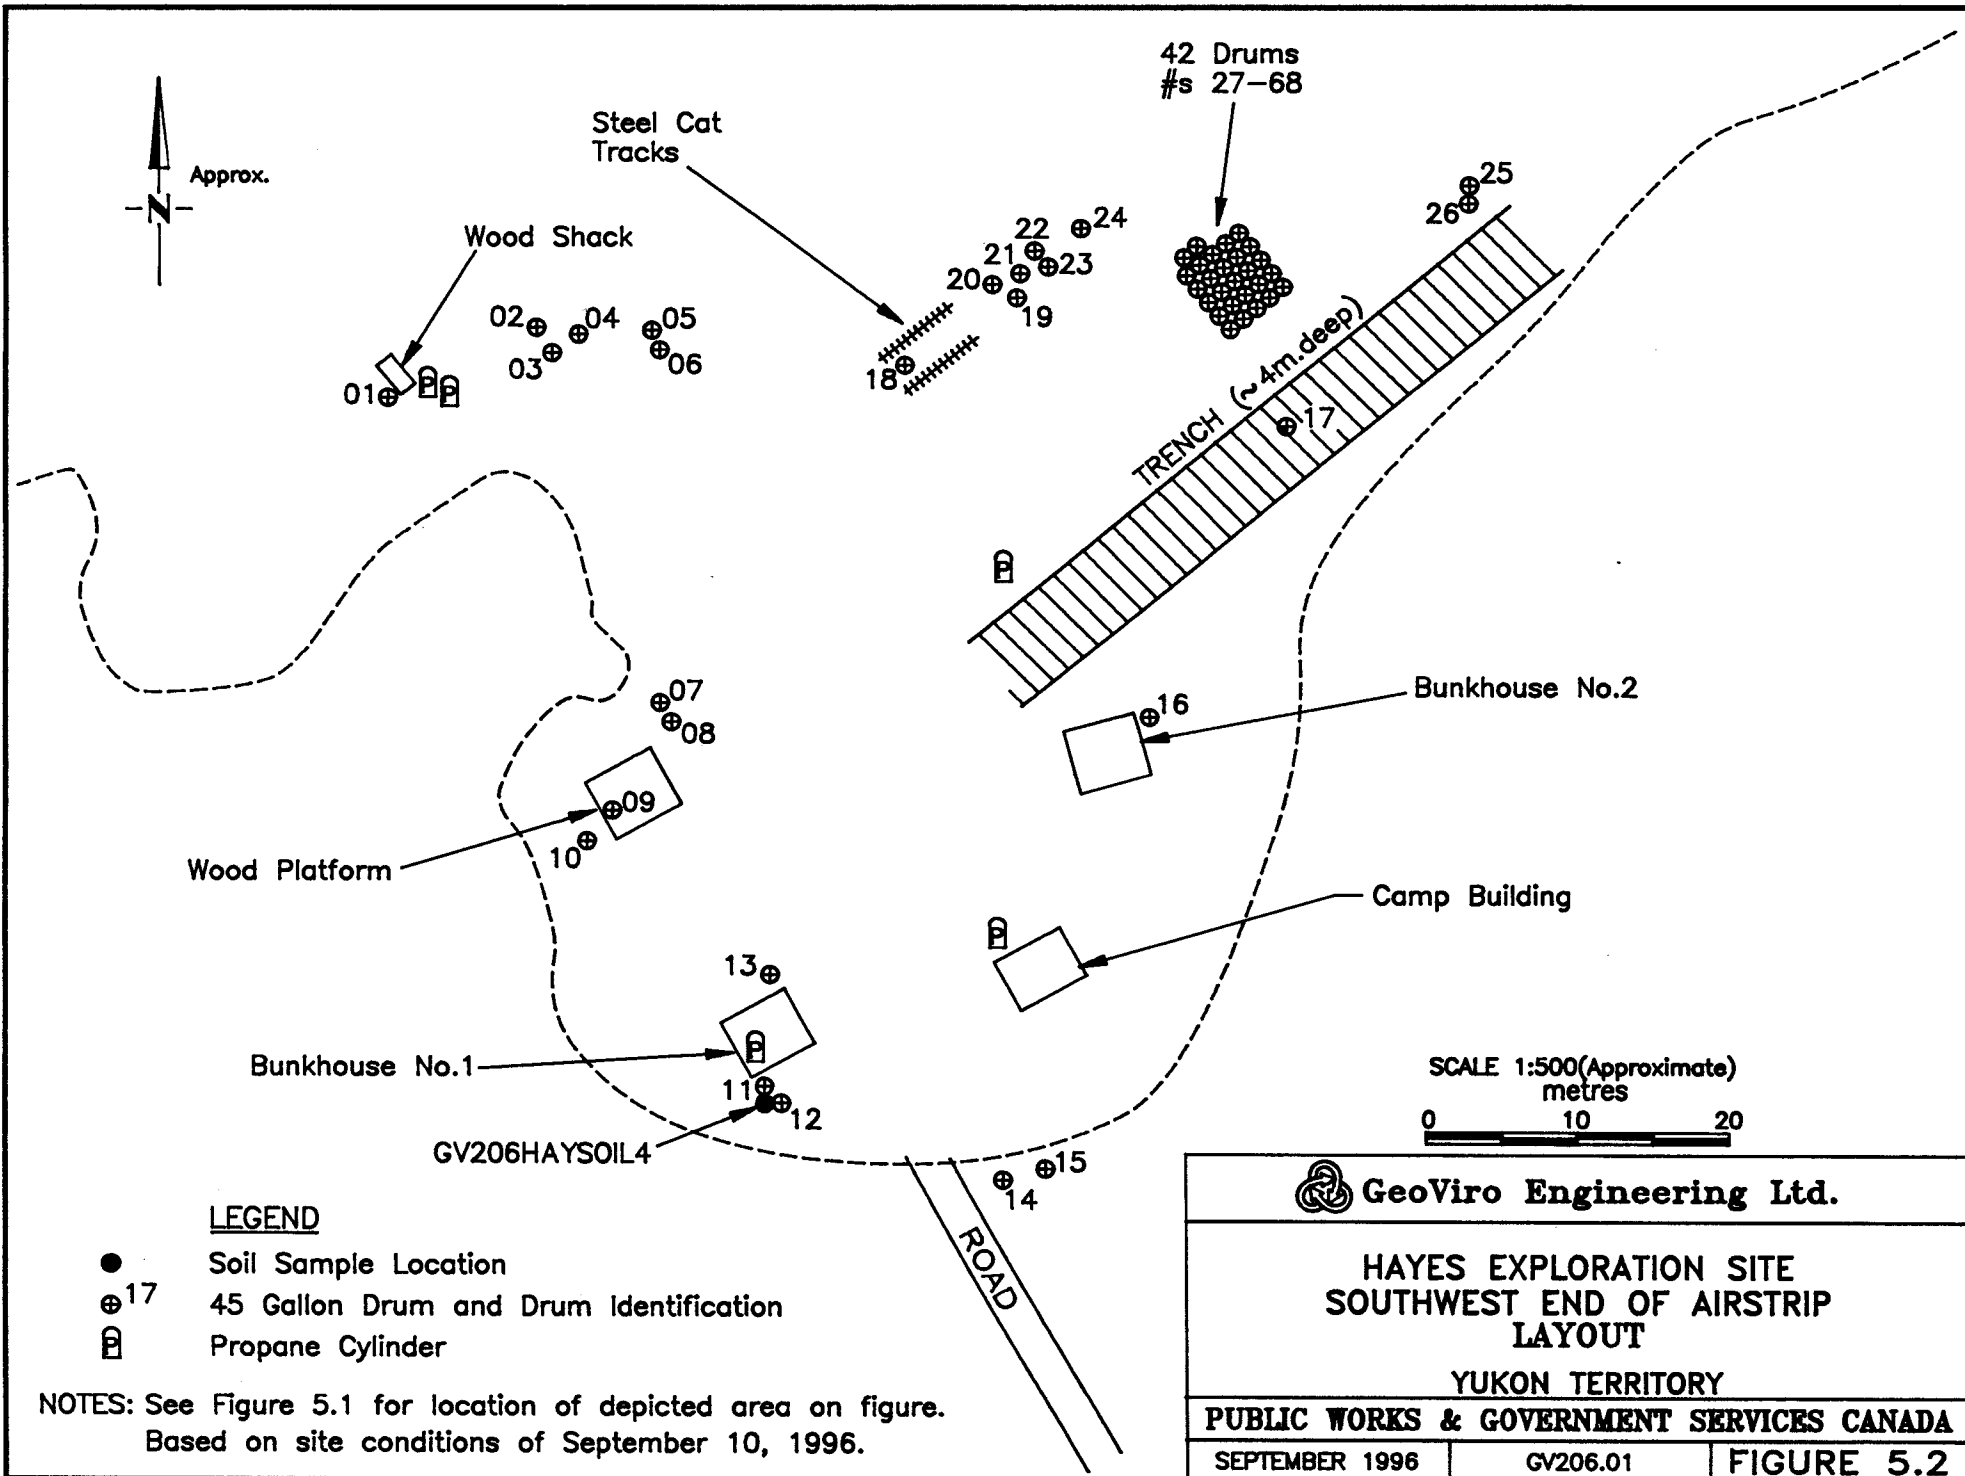
NOTES: See Figure 5.1 for location of depicted area on figure.  
Based on site conditions of September 10, 1996.

Hazardous material identified include the contents in the fuel drums and the propane cylinders. The two propane cylinders beside the wood shack contain a very small amount of propane. The other three cylinders were empty. Table 5-1 lists the drums that contained some liquid, details of the drum contents and results of analysis. Contents of selected drums were analysed for total organic halogens (TOX), polychlorinated biphenyls (PCB) and metals. The drum locations are shown in Figure 5.2. The location of Drum 69 is shown in Figure 5.1.

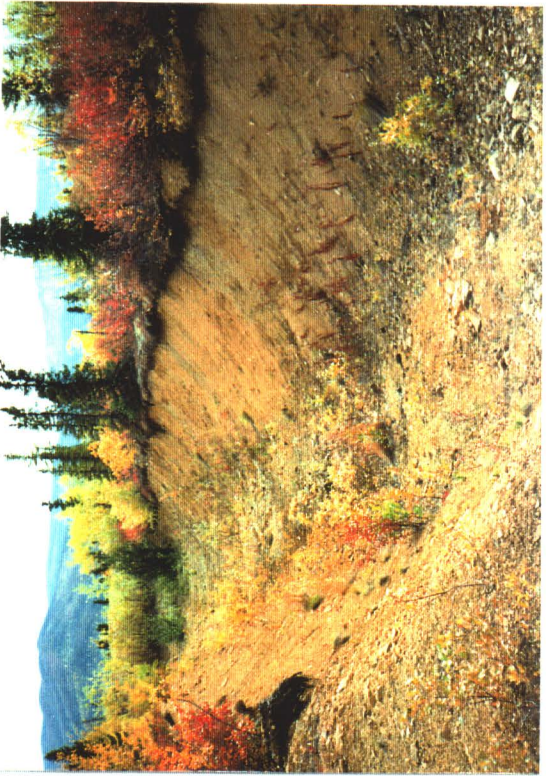
1

- Photo 1: Photo of typical trench, note the slow vegetation growth in the trench and the thin layer of topsoil present at the top of the trench.
- Photo 2: Camp site, airstrip and Hayes creek as seen from the air.
- Photo 3: Camp building.
- Photo 4: Inside camp building.
- Photo 5: Bunkhouse No. 1.
- Photo 6: Bunkhouse No. 2.
- Photo 7: Wood platform.
- Photo 8: Wood shack.
- Photo 9: Debris and cores 350 m east of airstrip.
- Photo 10: Debris, cores and equipment north of bunkhouse No. 1.
- Photo 11: Drums and campsite, pictures taken from edge of airstrip.

The site is covered by sparse vegetation at the top of the eroded ridge to moderate vegetation coverage in more protected areas at lower elevations. The vegetation is comprised predominantly of alder, black spruce and moss. Trails on-site, that are easily identified on the airphoto (Figure 1.3) dated 1968, are now moderately overgrown. Minor vegetation is being re-established in trenches and excavations (Photo 1, Appendix A). The site (other than the eroded peak) is mantled by a very thin layer of topsoil (10 cm) that is underlain by granular rocky material with no organic content; therefore, disturbed areas require a long period of time to re-establish vegetation. The thin layer of topsoil is evident at the top of the trench shown in Photo 1.

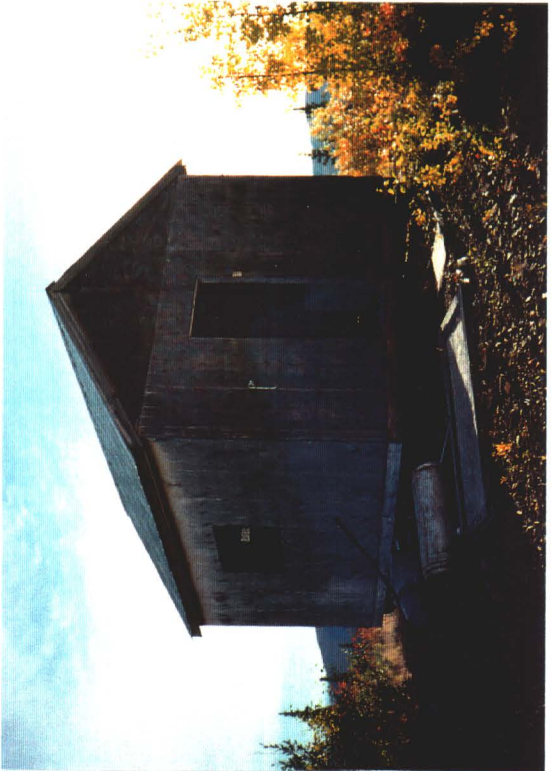
3

The camp building (Photos 3, Appendix A) is of wood construction with a tin roof. The building is 4.9 x 3.65 m in area and does not have any insulation. The building was full of debris (Photo 4, Appendix A) comprising a freezer, camp supplies, tent tarps, tools, kitchen supplies, table, chairs, books and other non-hazardous debris. It appears as though the camp supplies and equipment were stored in this building with the expectation that they would be recovered or used at a later date.

**Buildings** - several building on-site are in various states of deterioration. The camp building is standing and in fair condition. The other buildings do not pose an immediate health and safety hazard. The floor boards on the buildings are slightly deteriorating and in the future may pose a health and safety hazard to people walking on the floors. To prevent a future health and safety issue and to improve the site appearance, all structures should be levelled and non-hazardous and combustible materials burnt in an approved location on-site. Non-hazardous and non-combustible material should be landfilled on site.

Buildings are constructed largely of wood. The buildings should be levelled and all non-hazardous combustible material burnt on-site on the airstrip. As discussed in Section 6.1 the Hayes site is suitable for open burning.

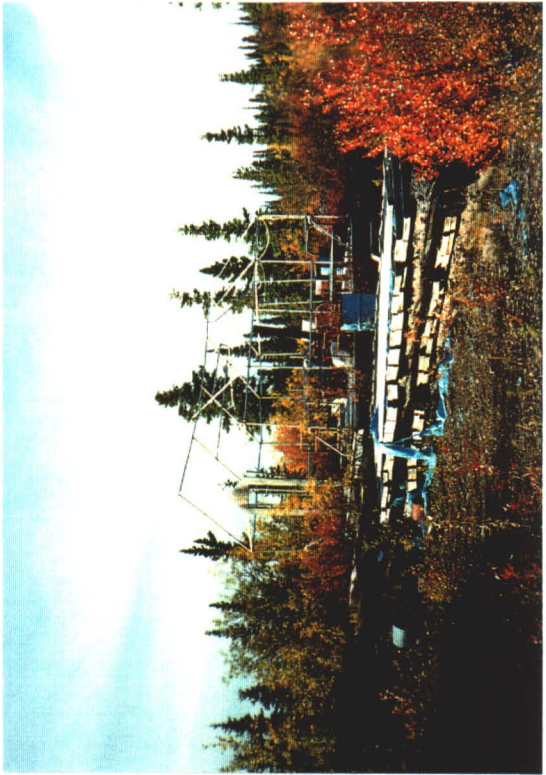
5

A bunkhouse comprised of a wood platform and metal frame (Photo 5, Appendix A) is located approximately 15 m west of the camp building. This bunkhouse is 4.75 x 4.15 m in area and three metal bunks are present on the wood platform.

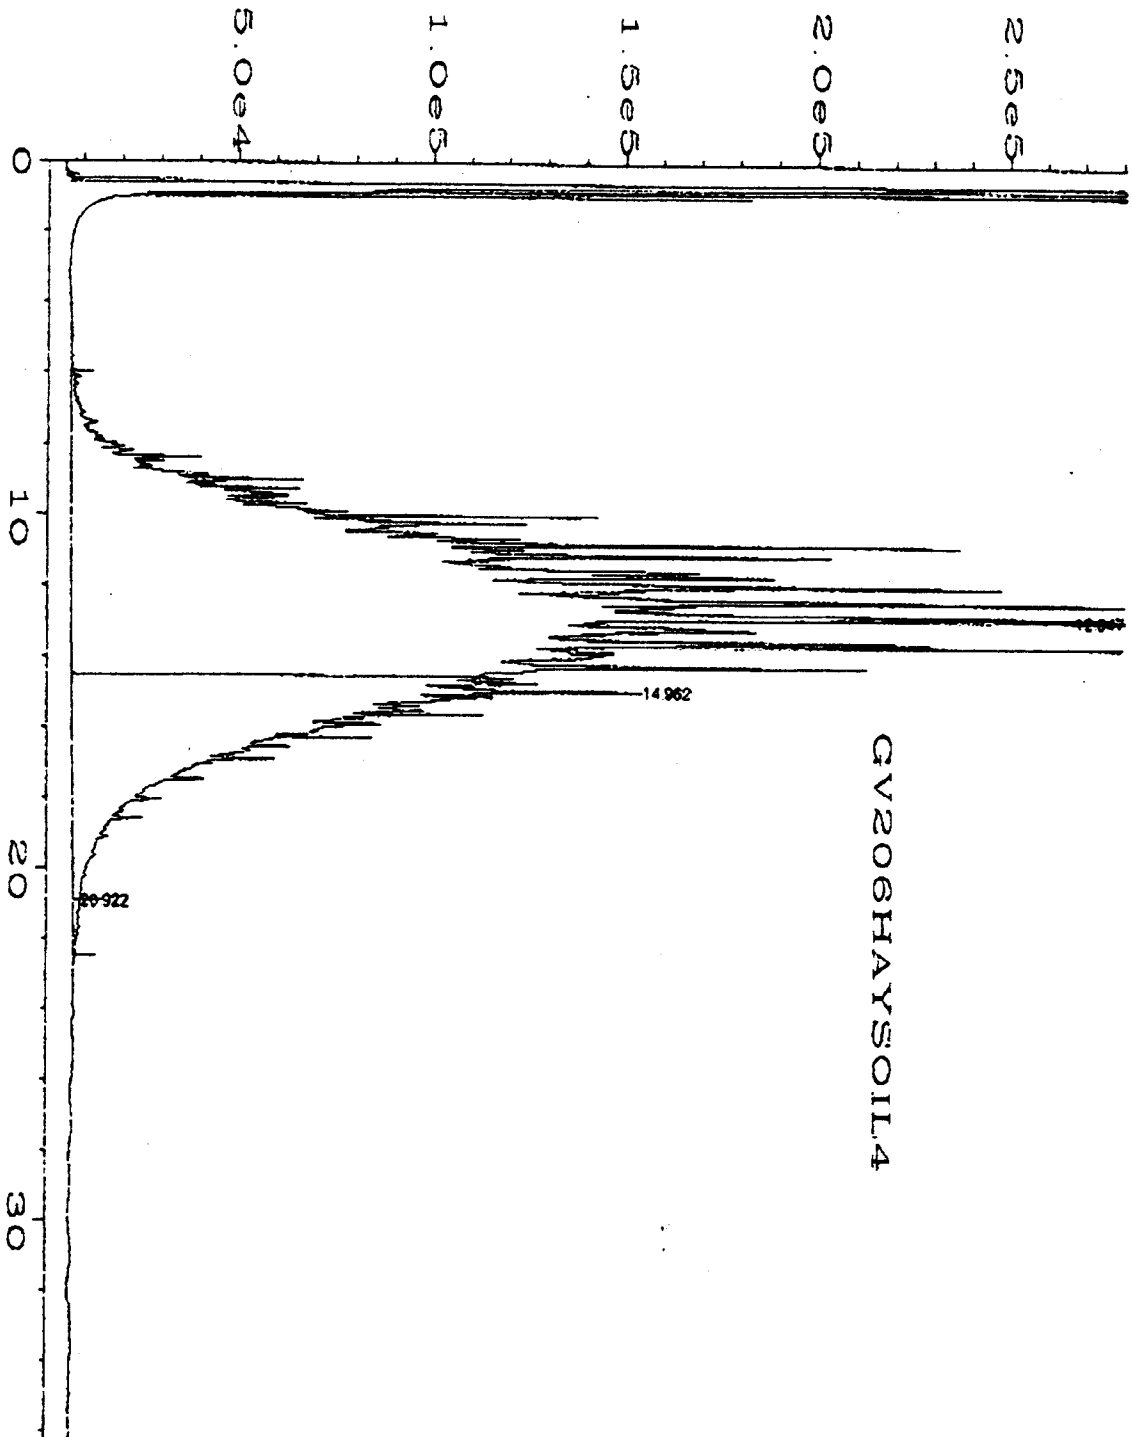
LEPH/HEPH result is expressed as ug/g on an as received basis. The moisture for sample GV206HAYSOIL4 is 72%.

CLIENT SAMPLE IDENTIFICATION:	SAMPLE DATE	CAN TEST ID	LEPH-uncorrected for PAH's	HEPH-uncorrected for PAH's
GV206HAYSOIL4	Sep 10/96	609190046	56000	17000
DETECTION LIMIT UNITS			250 $\mu\text{g/g}$	250 $\mu\text{g/g}$

A soil sample (GV206HAYSOIL4) was collected in a small area of surficial staining adjacent to where diesel drums were placed to provide fuel to the heater in Bunkhouse No. 1. The sample was analysed for light and heavy extractable petroleum hydrocarbon (LEPH and HEPH) concentrations. The results of the analysis indicate that the sample contains 56000 mg/kg LEPH and 17000 mg/kg HEPH. The GC trace of the sample suggests that the hydrocarbon in the soil is a very weathered heating oil (greater than 10 years). These concentrations exceed the CMCS criteria for hydrocarbon contaminated soil and may exceed the

special waste criteria (3% oil and grease). The volume of contaminated soil is less than 0.5 m<sup>3</sup> and in its present state does not pose an environmental or health hazard. Degradation of the hydrocarbon contamination is apparently slow in this environment. The results of the analysis are shown in Table C3, Appendix C and the laboratory report along with the GC trace is provided in Appendix D.

The hydrocarbon staining beside bunkhouse No. 1 does not pose a significant risk to human health or the environment and therefore should be left as is. At the most, we would recommend adding fertiliser and tilling the small volume of stained soil to possibly speed-up the biodegradation of the hydrocarbon.
