**PHASE II ENVIRONMENTAL ASSESSMENT  
OF THE  
HOEY  
ABANDONED MINE SITE**

**Action on Waste Program  
Indian and Northern Affairs Canada**

**Environmental Services  
Public Works and Government Services Canada**

**March, 1997**

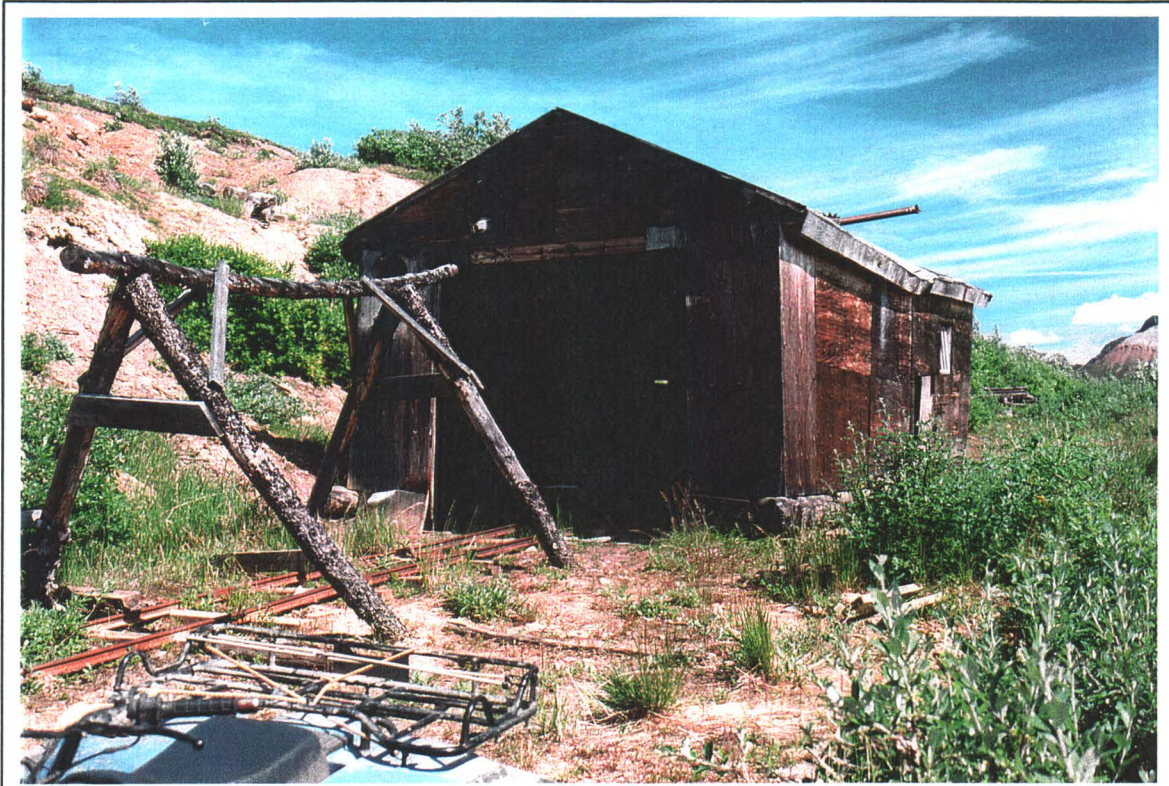
One shack remains on site and presents a potential safety hazard to visitors.

**Photo# 3: Processing Building - Lower Site**

It is recommended that the rails and trestles, shed, and load out ramp be demolished and burned on site for health and safety reasons. This can be accomplished using locally available resources and labour and can be buried on-site together with other site debris. Burial can occur by covering waste material with surrounding rock and soil on a clearing adjacent to a rock slope.

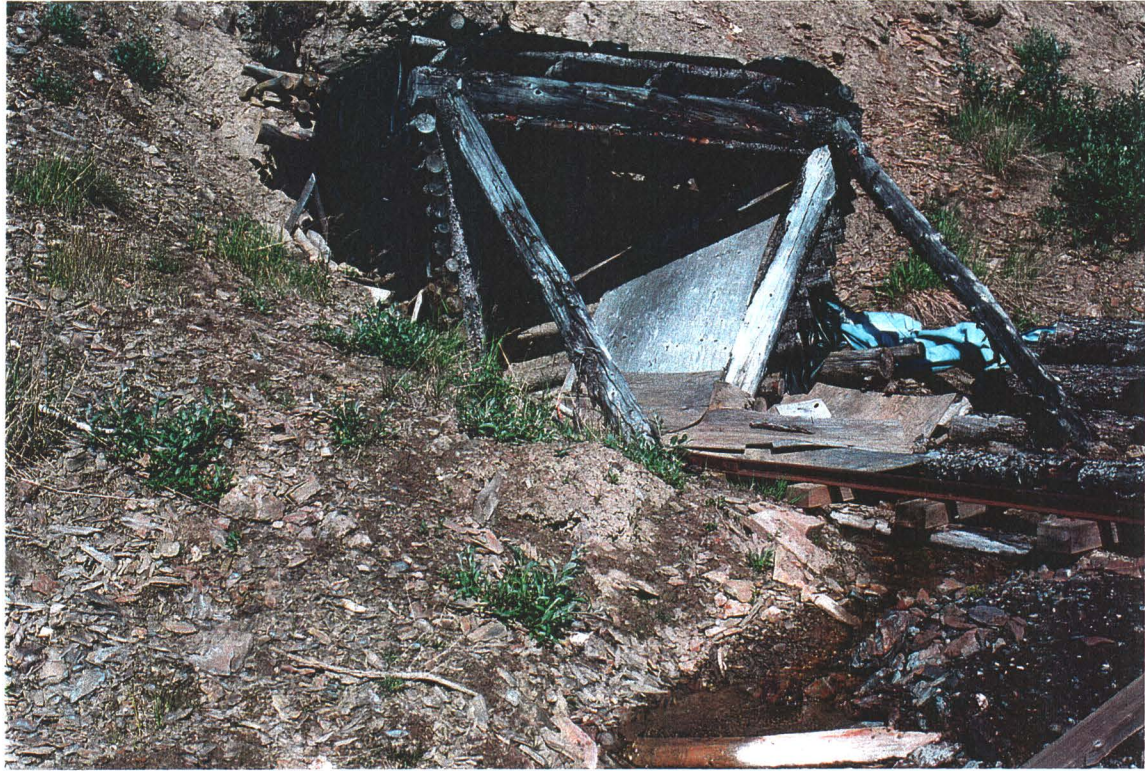
| Adit | Location | Drift Length | Condition |
|---|---|---|--|
| Lower Adit | lower staging area, 1151 m elev. | 67 metres | unstable condition - loose rock above opening, timber structure rotting, 2x6 cladding partially blocking entrance, drift partly collapsed at opening |

**Photo# 5: Lower Adit**

It is recommended that the two mine openings be secured from human and animal access for health and safety reasons. Openings should be covered with surrounding

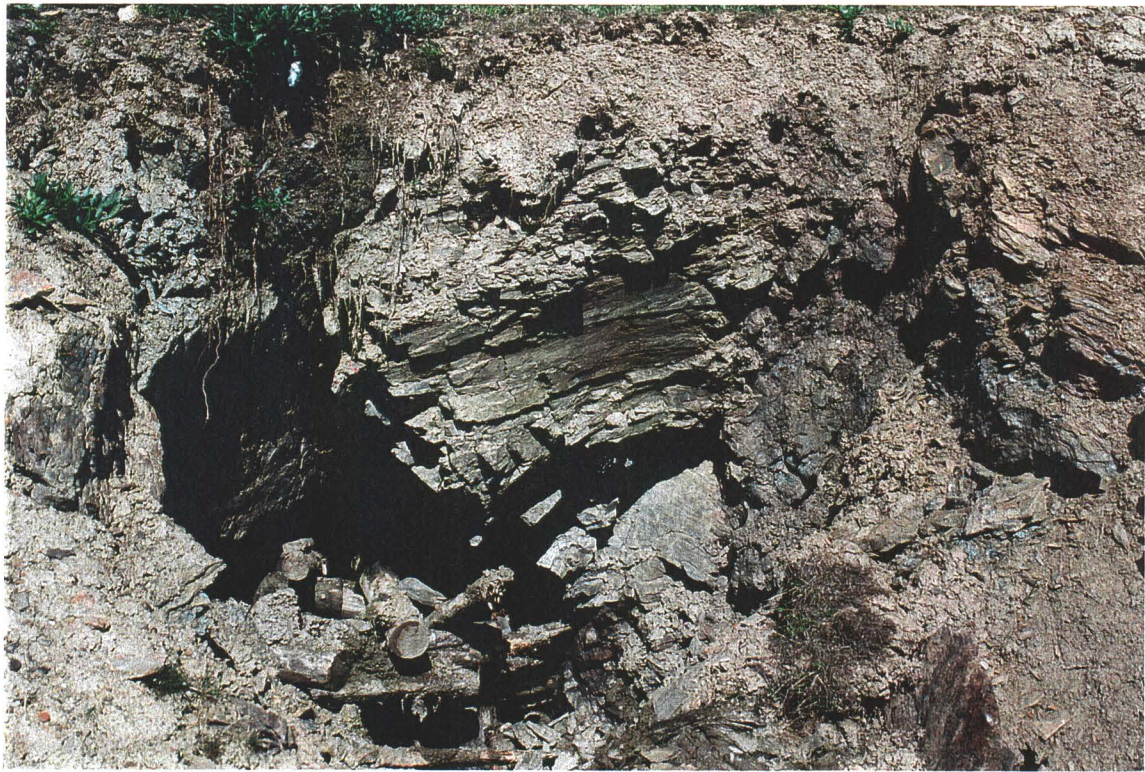
The two mine adits are in unstable condition and are not adequately secured from public and wildlife access. The lower adit is collapsed and remains unstable due both to the rotting supporting structure and surrounding soils and rock. The upper adit remains open and is readily accessible to the public. The unstable supporting structure is collapsed and entrance partly blocked by rotting timbers.

**Photo# 6: Sloughing Above Lower Adit**

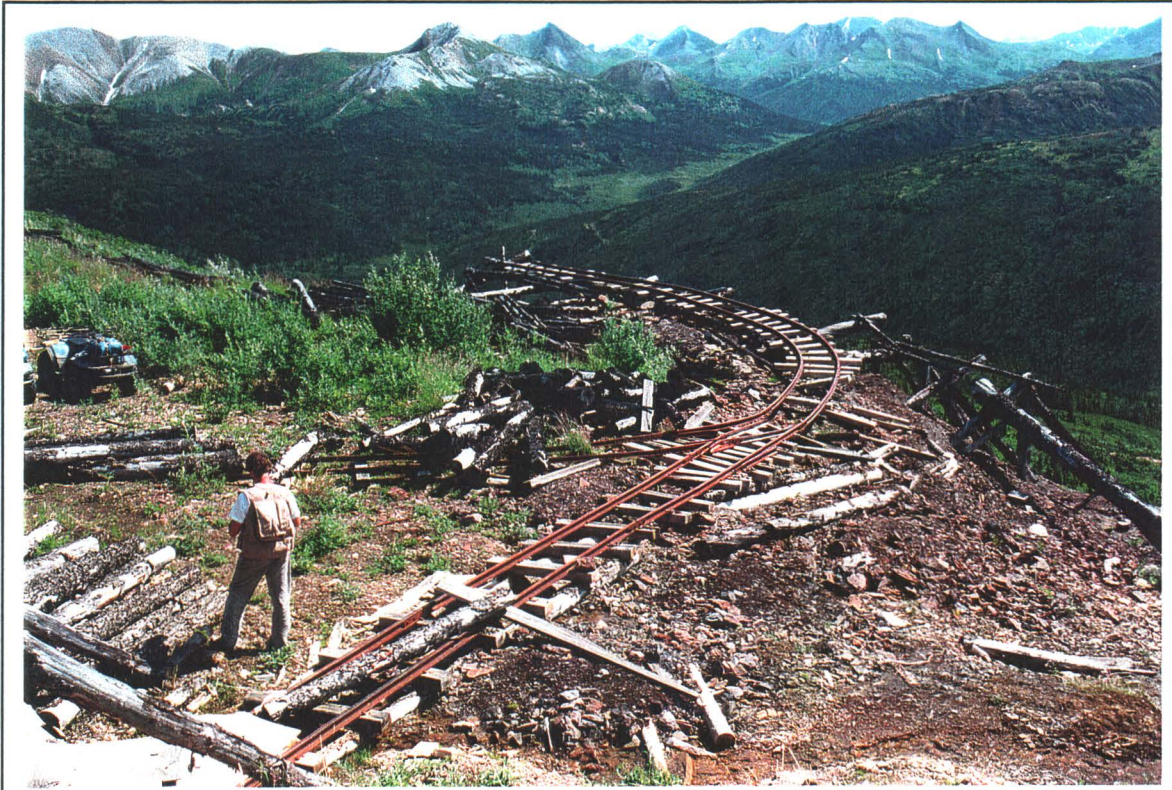
The rails and trestles in front of both the lower and upper adits are physically unstable and pose a health and safety hazard to humans visiting the site. Several large timbers used for loading and transporting ore are left perched and are a safety hazard.

**Photo# 7: Track and Trestle - Lower Site**

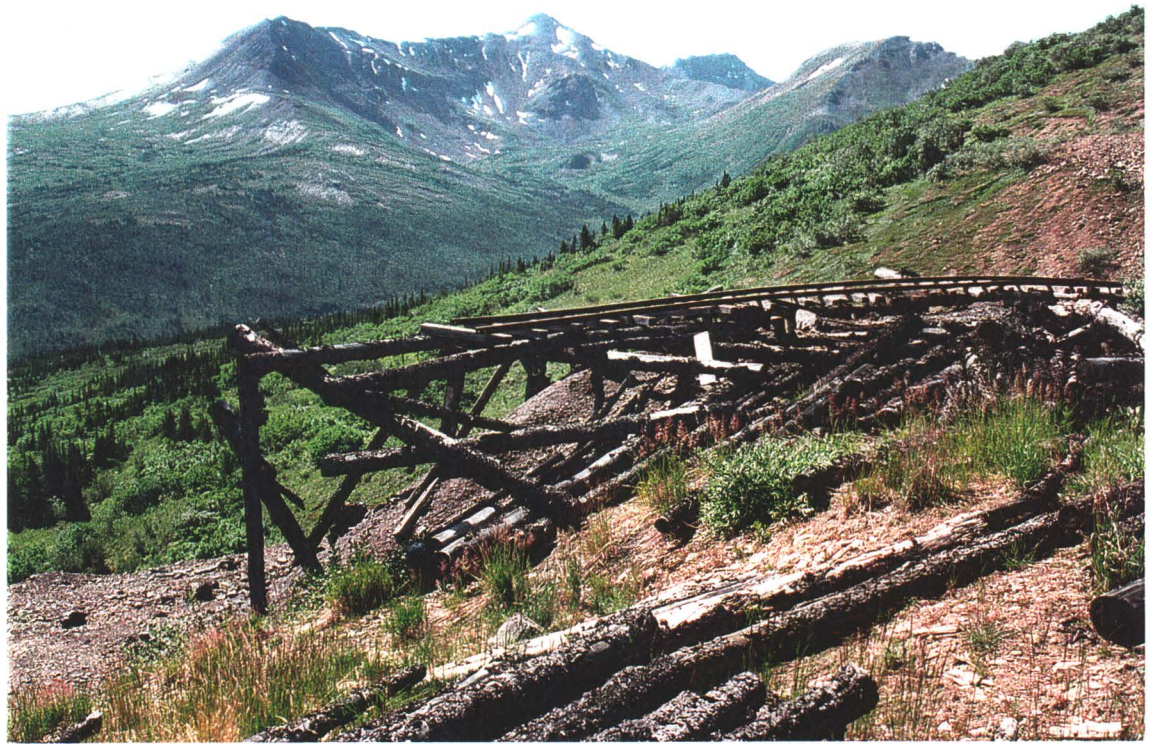
**Photo# 8: Track and Trestle - Lower Site**

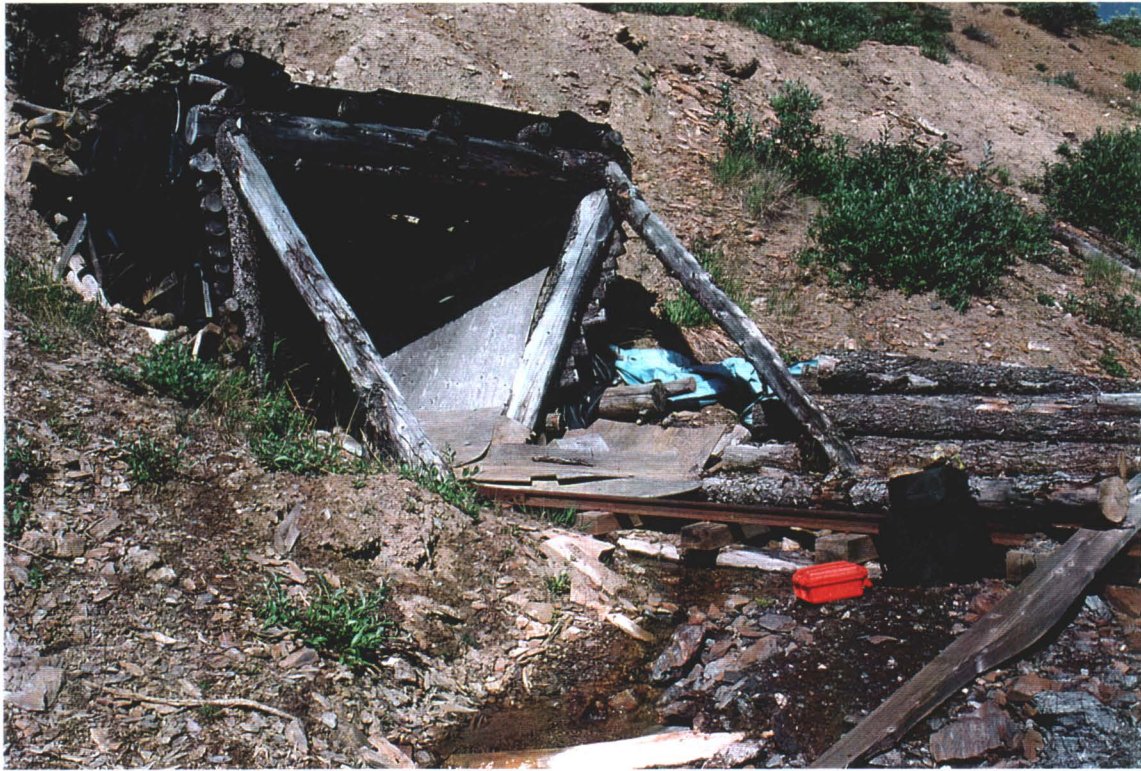
**Photo# 9: Mine Water Seepage - Lower Site**

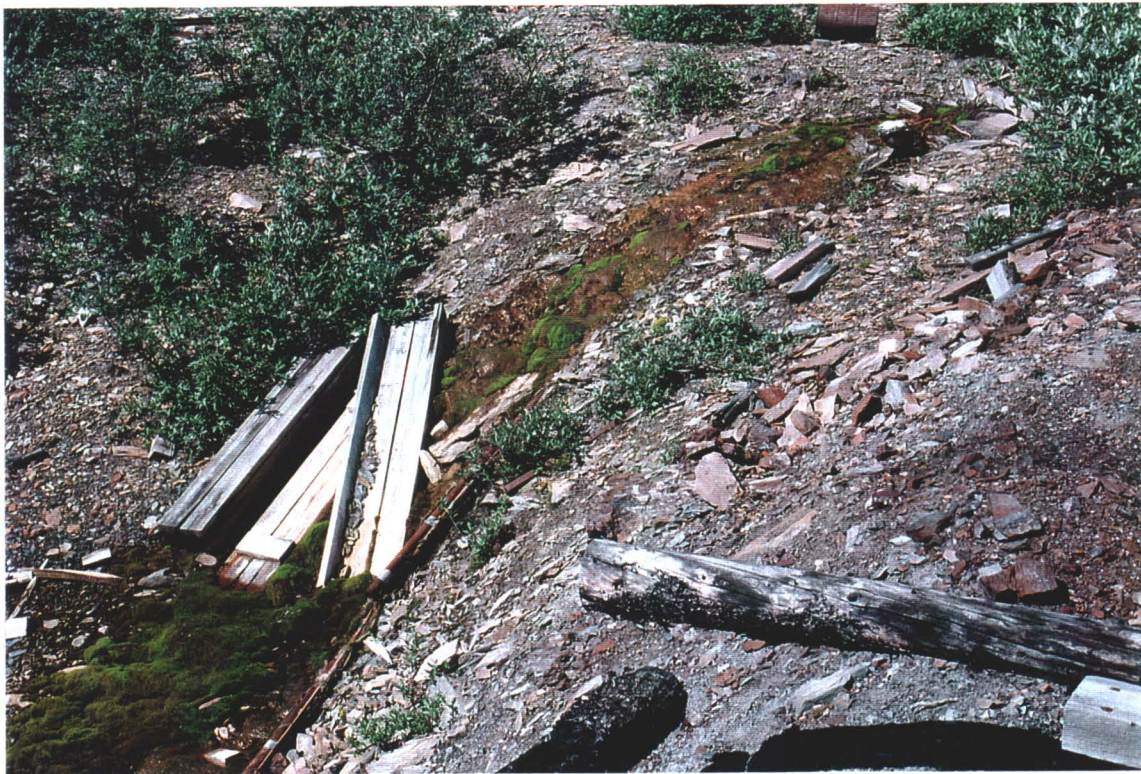
**Photo# 10: Mine Water Seepage and Channel - Lower Site**

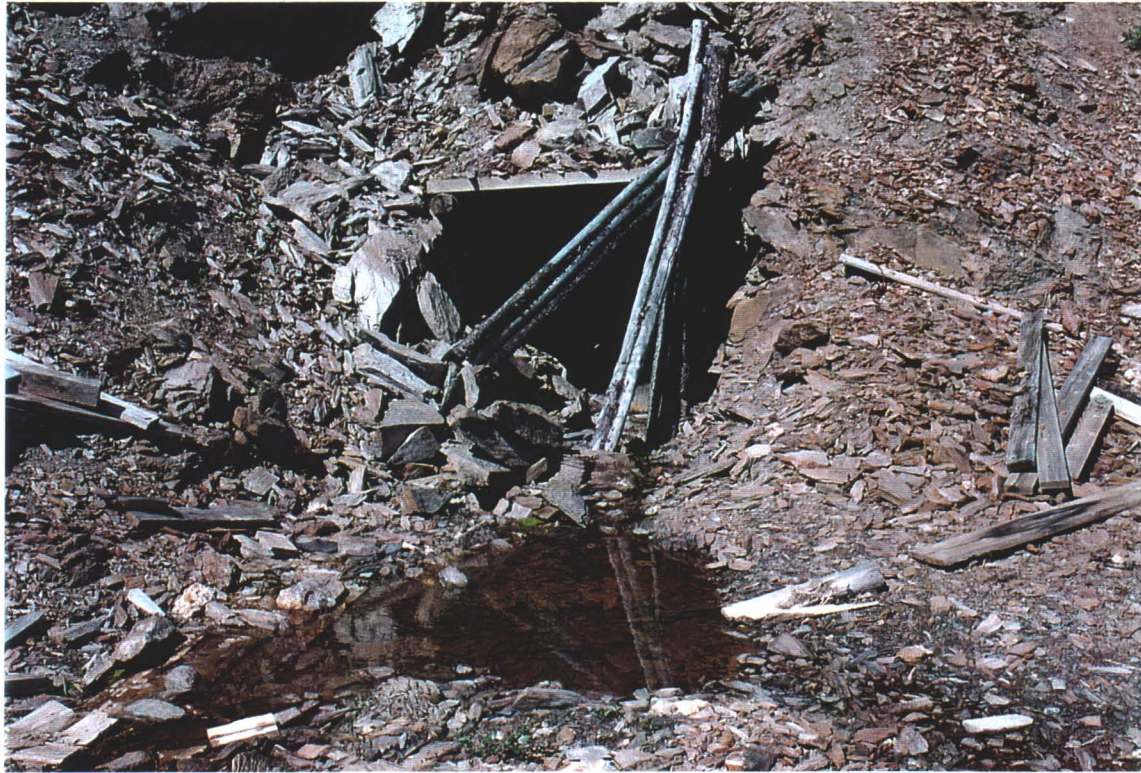
| Adit | Location | Drift Length | Condition |
|---|---|---|--|
| Upper Adit | upper site, 1182 m elev. | Unknown | unstable condition - loose rock above, dilapidated timber support structures |

**Photo# 11: Adit and Mine Water Seepage - Upper Site**

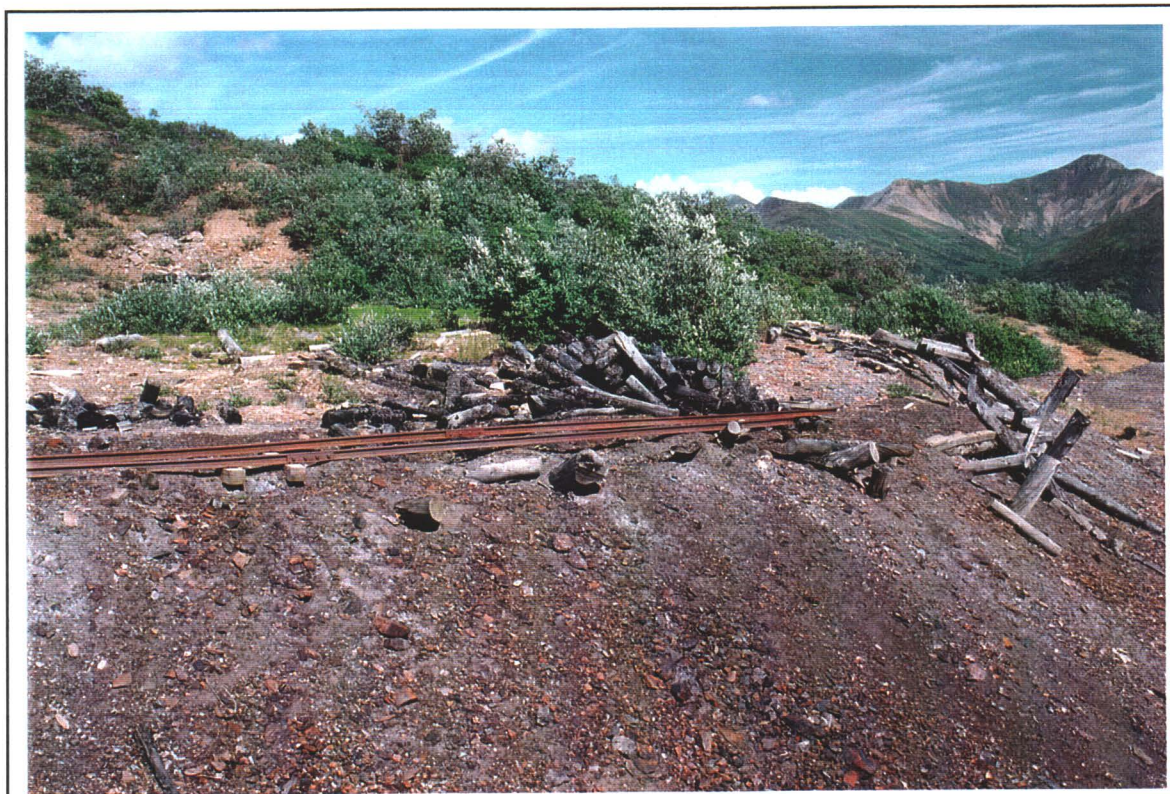
**Photo# 13: Track - Upper Site**

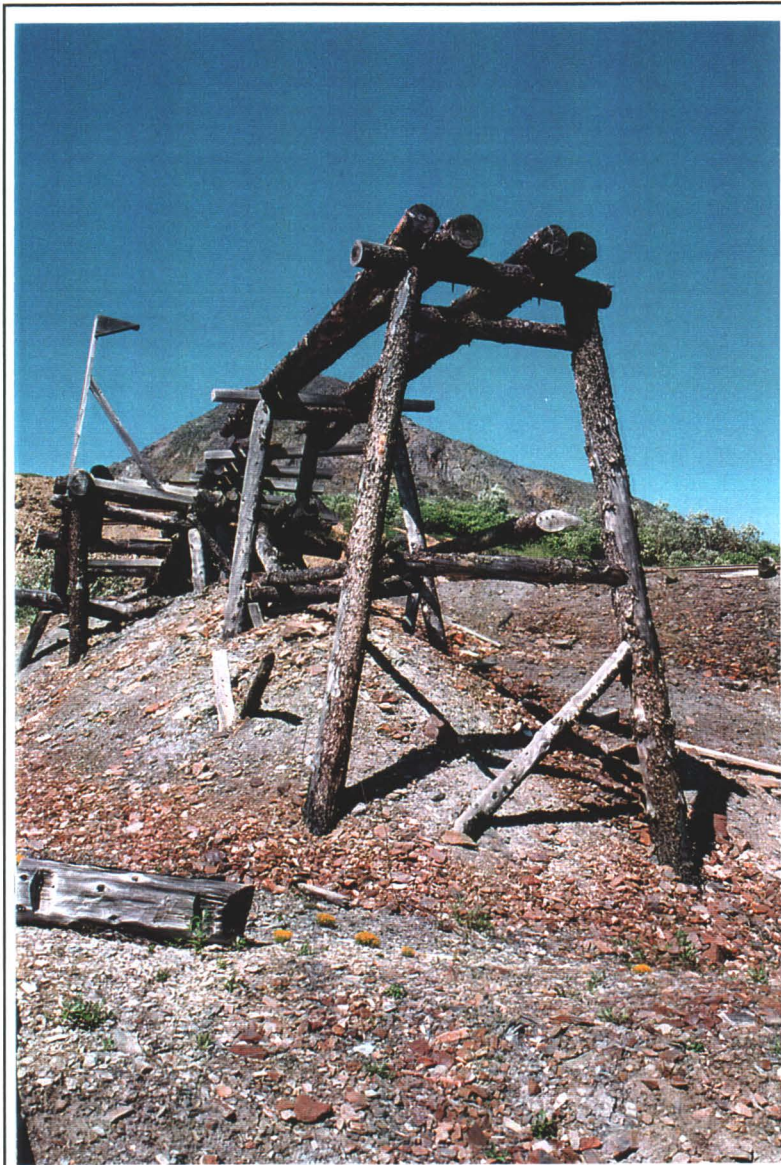
Photo# 14: Trestle - Upper Site

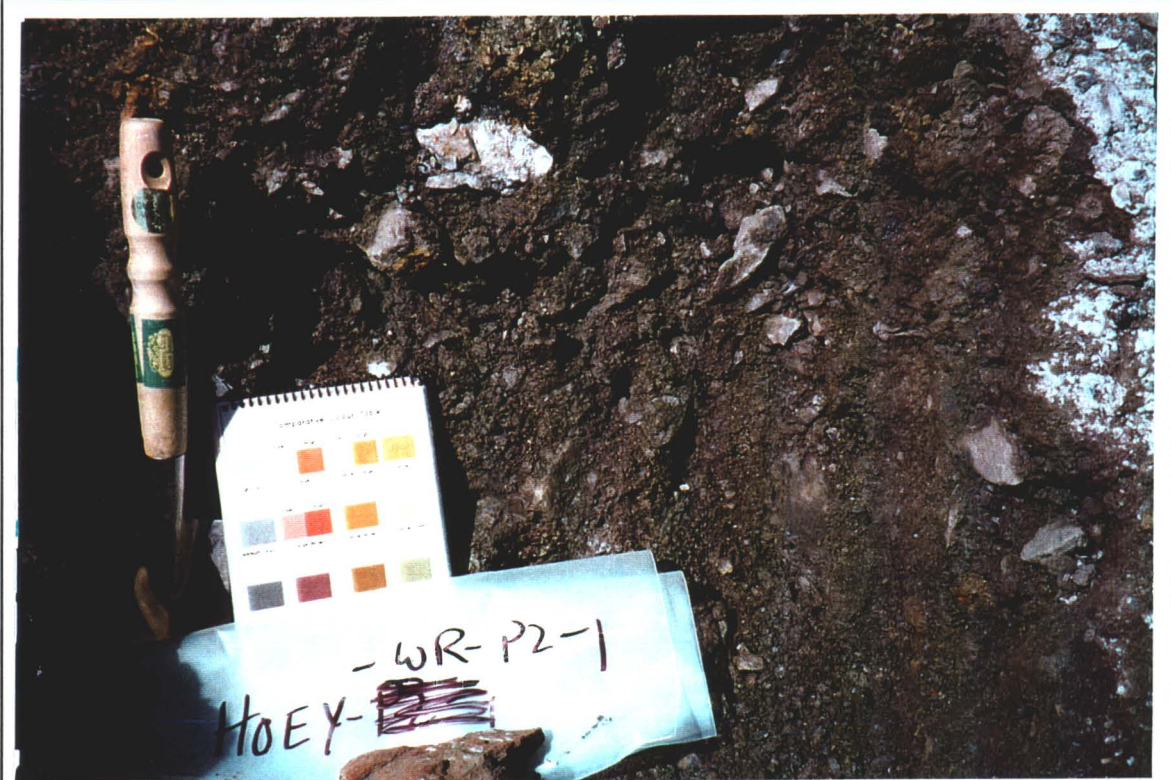
| Sample ID | Sample Location and Description | Discussion of Results |
|---|--|---|
| HOEY/WR/P2/1 | Brown, clayey-sand matrix among clast-supported pebble to cobble sized clasts. Within the top 10 cm there are pockets of limonite staining with some iron oxide cementation of grains. | Potentially acid generating (NP/AP=1.8); high Cu, Fe, P, Pb, Mn; moderate Sb, Co, Ni, Ag. |

Photo# 16: Waste Rock Sample - Hoey/wr/p2/1

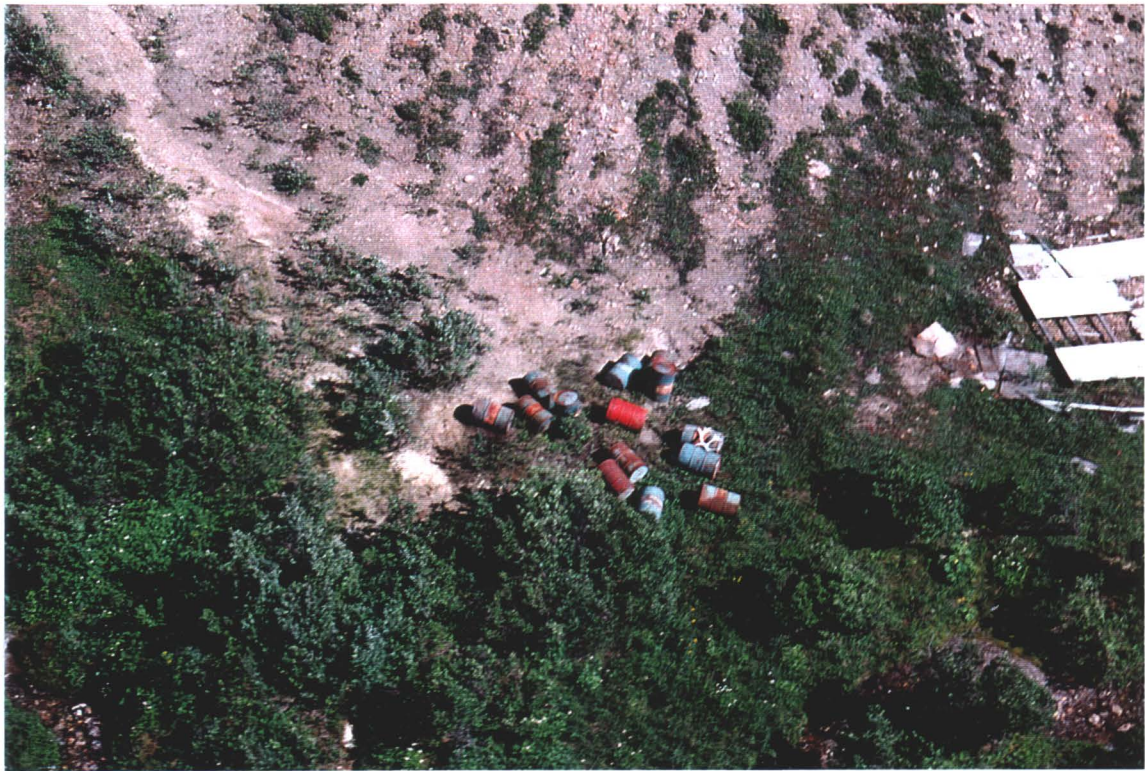
Soil staining was evident in the soils underneath the barrels and sampled for lead, polycyclic aromatic hydrocarbons (PAHs), and total extractible hydrocarbons (TEHs). The concentration of total extractible hydrocarbons (THE) is above Yukon remediation criteria indicating that there is petroleum hydrocarbon contaminated soils. Based on observation, the contaminated area is approximately 25m<sup>2</sup> and 1 m deep. Hydrocarbon distributions indicate that contamination is the result of diesel likely attributable to waste oil spills or leaks. One compound, Phenanthrene, was shown to have a concentration of 20.5 ppm in the surface soils which is above the criteria of 10 ppm. The other 15 PAH compounds were well below criteria. Laboratory results are detailed in Table 4 below. Complete analytical results are provided in Appendix B.

**Photo# 22: Barrels at Camp Site**
