**PHASE II ENVIRONMENTAL ASSESSMENT
OF THE
LEGAL TENDER**

ABANDONED MINE SITE

Environmental Services
Public Works and Government Services Canada

March, 1997

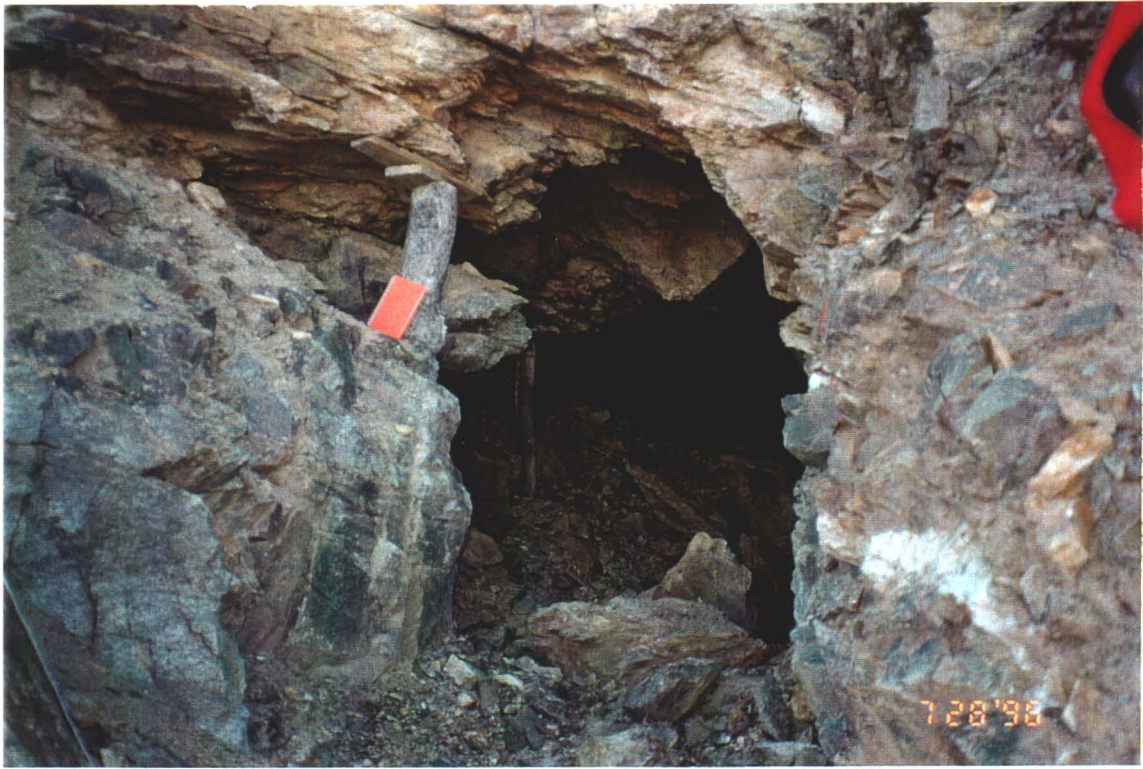
The portal is 2 m (6.5 ft) high by 1 m (3.5 ft) wide and access to the workings are not restricted, other than by its precarious location between avalanche shoots on the side of a mountain. The underground workings themselves appear to be relatively stable compared to the surrounding terrain. A description of the mine opening is presented in Table 3.

Adit	Location	Drift Length	Condition
1 adit	1525 m; ~150 m from peak of Mineral Hill	30 m	open; relatively stable

Photo # 1 - Open Adit in Side of Mountain

The mine adit remains open, however, the health and safety risk associated with the open adit is out-weighed by the risk associated with accessing the site. The site is not readily detectible from Watson River and is not expected to attract the attention of tourists.

There are no recommendations required for this site.

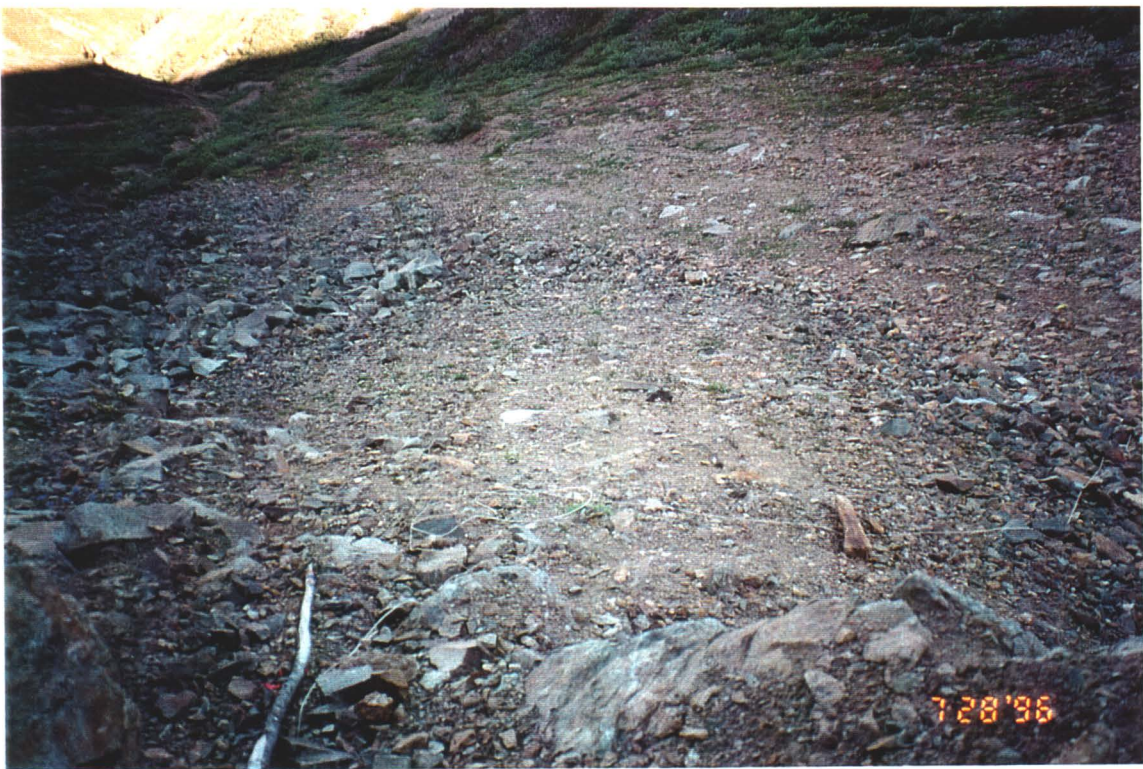
Approximately 175 tonnes (190 tons) of waste rock would have been produced from the underground workings, based on the dimensions observed and a specific gravity of 2.65. A thin layer of waste rock is located below the portal along the slope. Quartz rich waste rock has been piled in a small pile to the west of the adit and represents approximately 25% of the waste observed.

Photo # 2 - Scree Slope below Adit

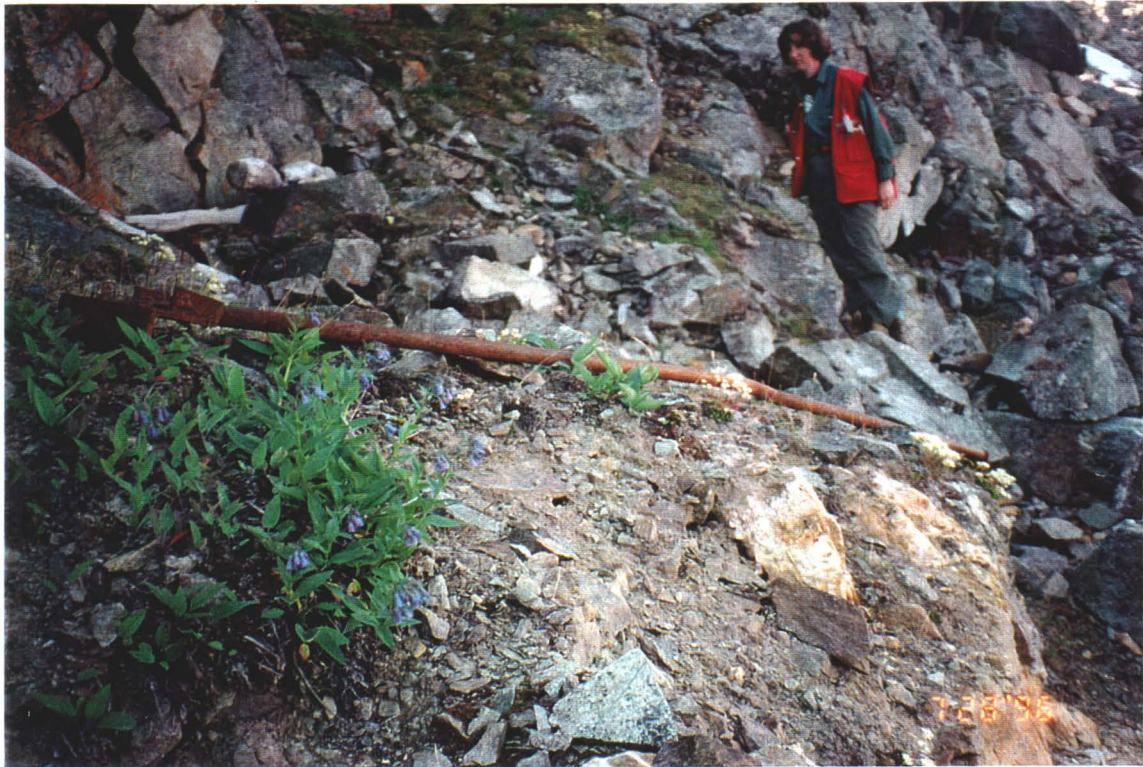
The only materials noted at the site included a 4 m length of metal pipe and a small wooden box.

Photo # 3 - Wood and Metal Debris at Adit

The small volume of waste rock at the site is surrounded by avalanche debris and is therefore not considered a concern from an aesthetic point of view. Minor debris remaining at the site is noticeable only at very short distances.

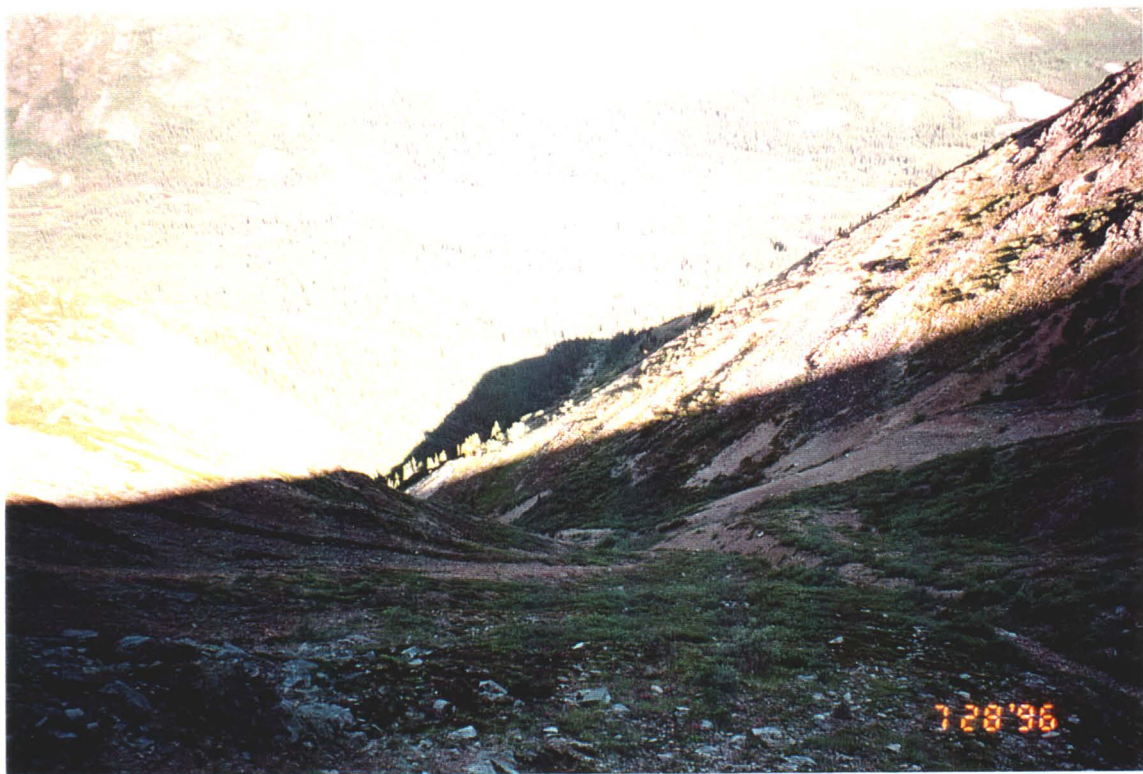
Photo # 4 - Steep Slope below Adit

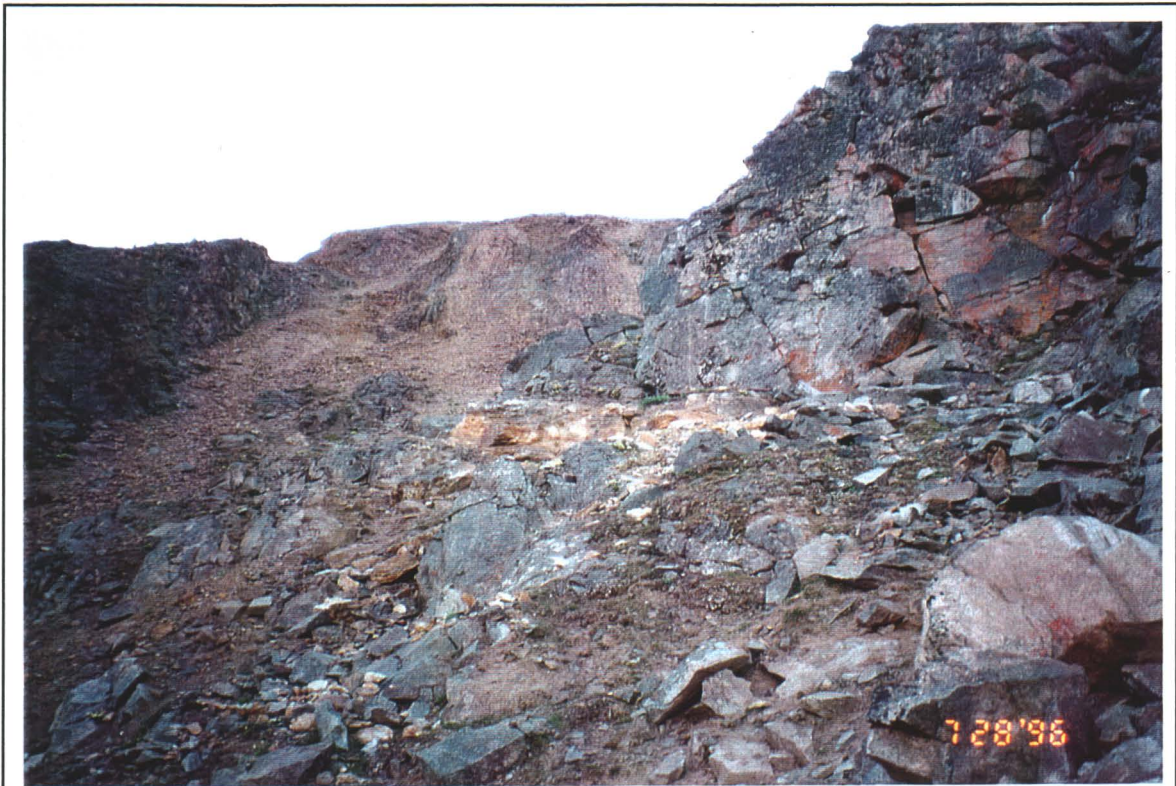
The site is located on the northwest side of Mineral Hill. The valley northwest of the site drops steeply towards the forested area surrounding the broad valley floor surrounding Watson River. The slope on either side above the mine site is a steep rocky slope with two avalanche pathways converging below the site. Directly above the adit is a large outcrop of overhanging rock.

Photo # 5 - Unstable Rocky Slope above Adit
