**PHASE II ENVIRONMENTAL ASSESSMENT  
OF THE  
LOGJAM  
ABANDONED MINE SITE**

Environmental Services  
Public Works and Government Services Canada

**PHASE II  
ENVIRONMENTAL ASSESSMENT  
of the  
LOGJAM MINE SITE**

**March 1997**

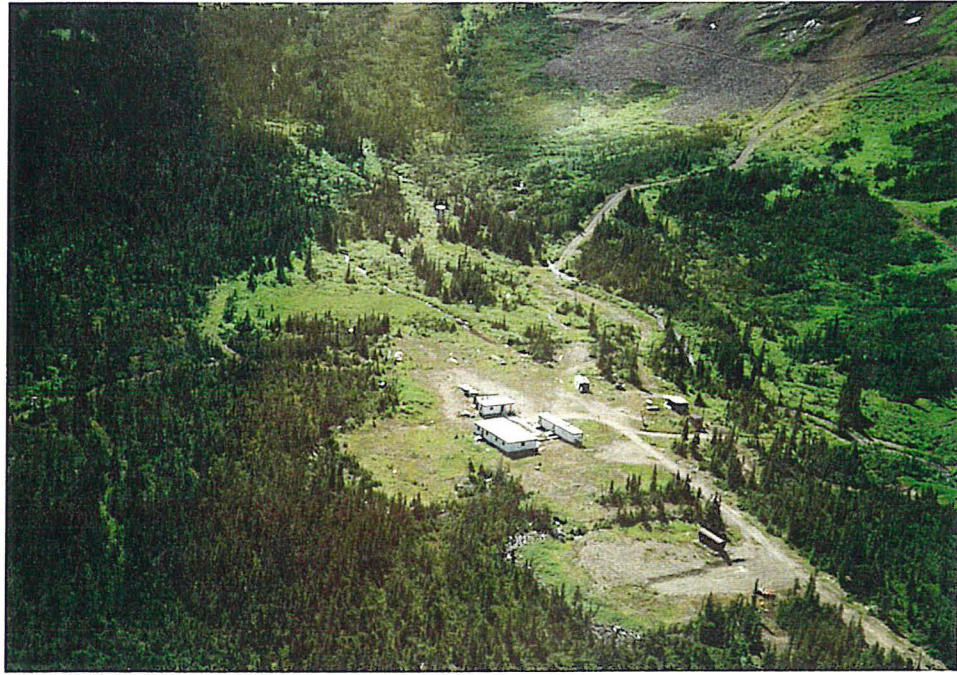
Photo 1. Aerial view of site with camp area (centre), large AST (center rear), secondary tributary of Smart River (right) and access road to adit area (upper right).

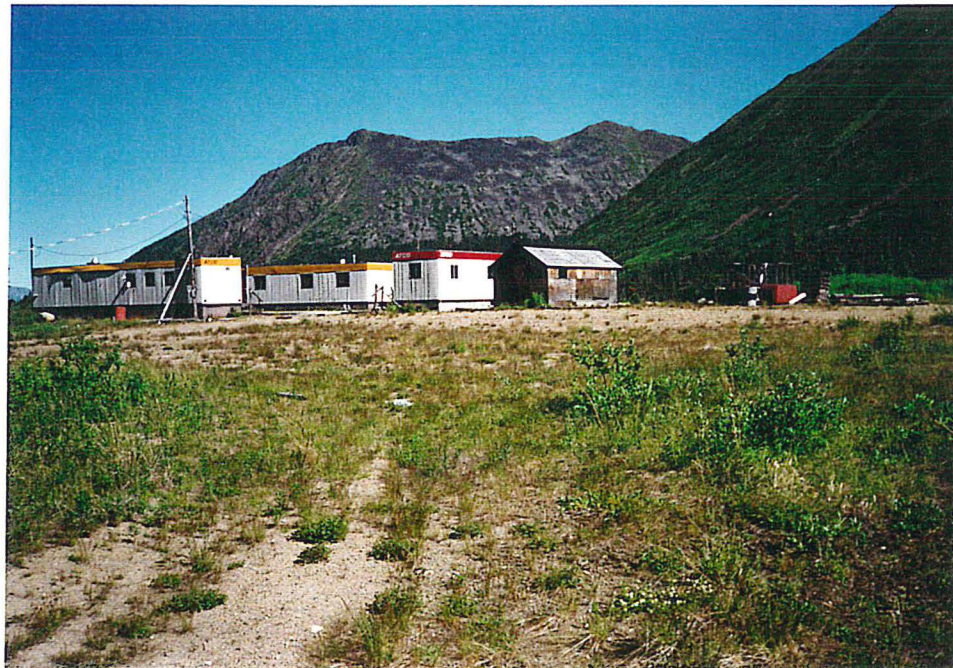
Photo. 2. Atco trailer compound with core storage area, core analysis structure, office trailer, kitchen and sleeping quarters.

Haul out prefabricated trailers off site for salvage. Retain wood core boxes from core sorting structure and burn structure on site. Bury miscellaneous plastic and metal waste in north pit area.

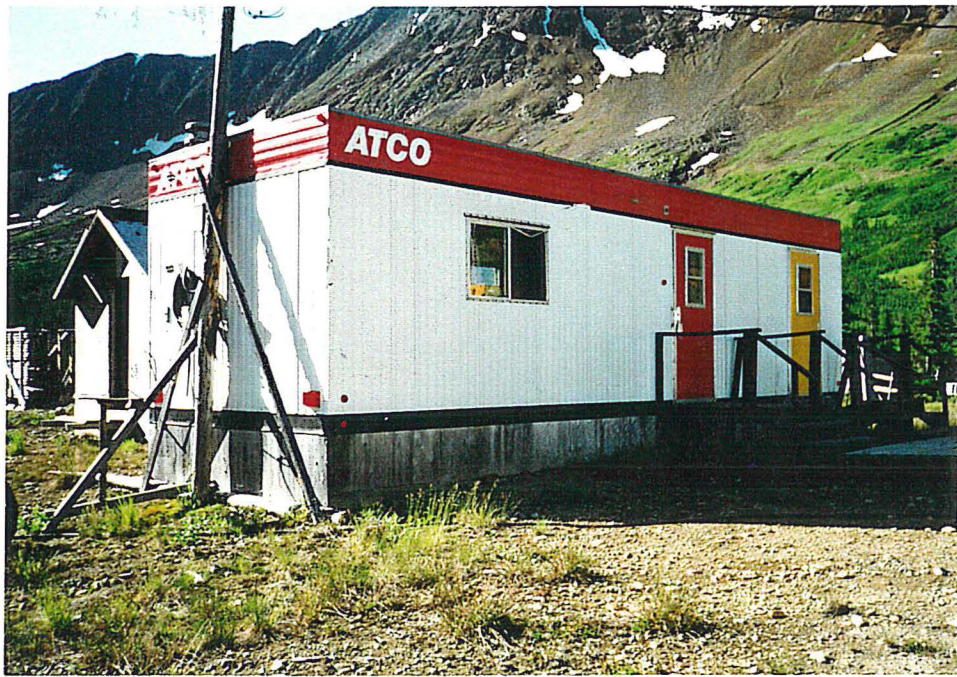
Photo 3. Office trailer with core analysis shed at rear.

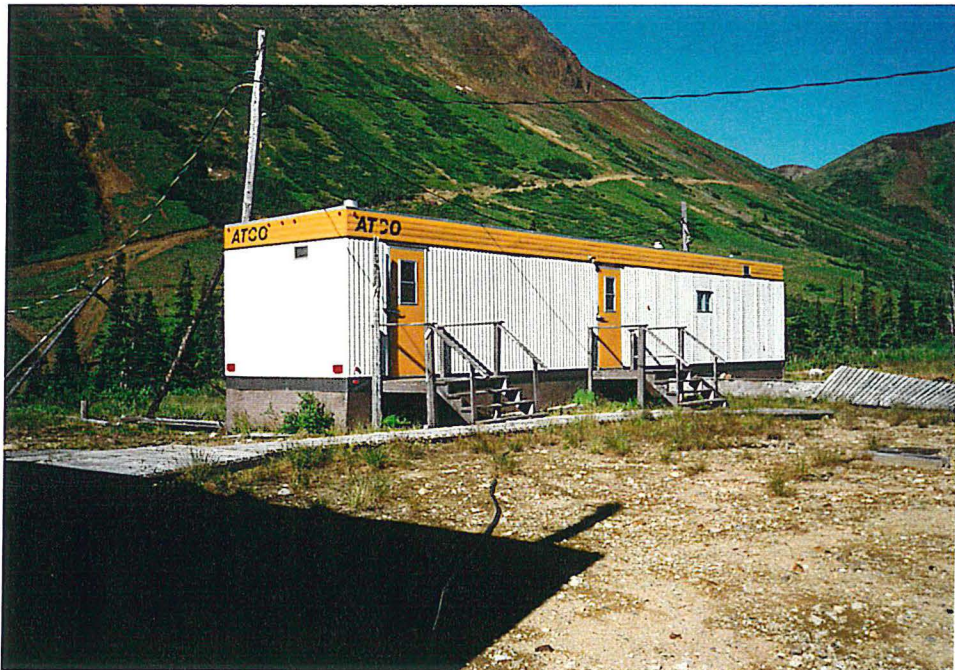
Photo 4. Kitchen trailer with power lines to generator shed.

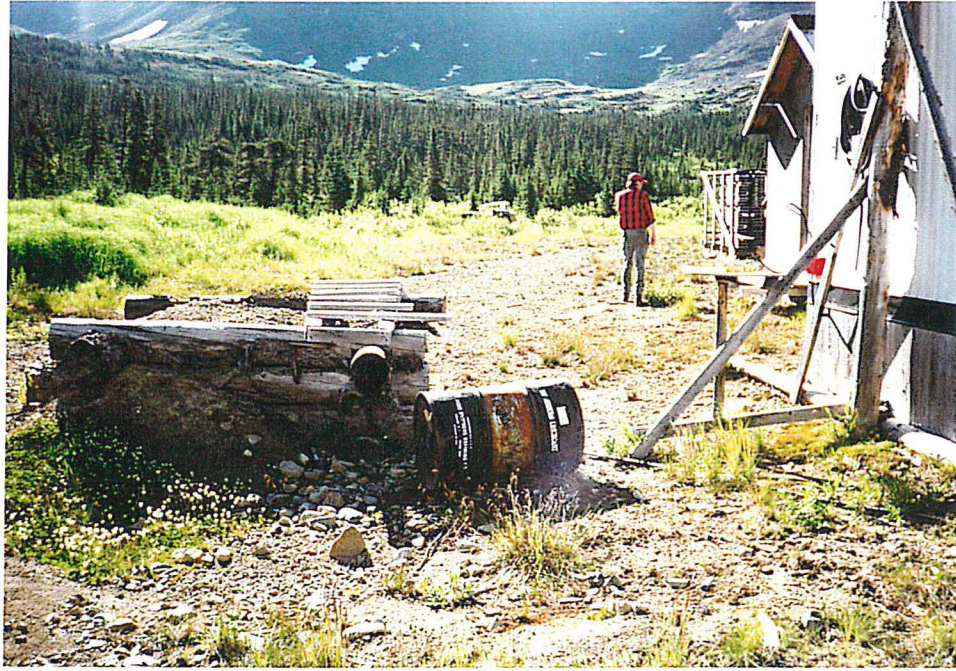
Four additional wood structures were identified on site including a generator shed, tool shed, core sorting shed and maintenance shed, (all in varying stages of repair/disrepair) (See Photos 5, 6 & 7). The only other infrastructure and equipment identified on this site was located at the upper workings area 200 m above the camp area and 50 m above at the 2nd adit. Here, the remains of track and trestles hang precariously from a severe slope from a lower adit and an upper inaccessible adit (See Photo 14).

Photo 5. Small loading facility adjacent to office trailer with empty 205 litre drum.

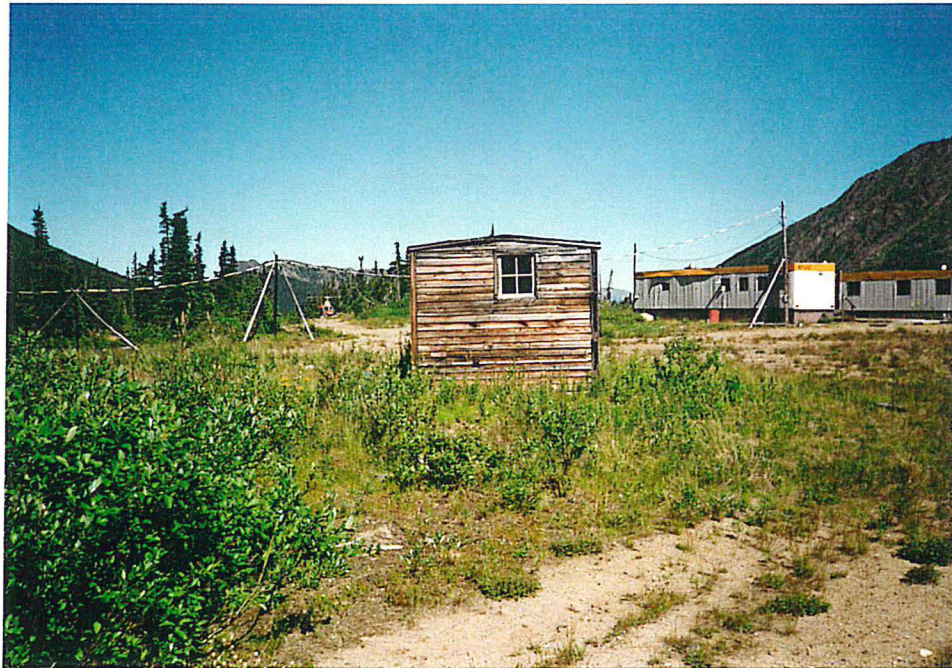
Photo 6. Maintenance shed southwest of trailer compound.

Existing wood frame buildings on site should be demolished and burned on site. Remove core boxes and store on site.

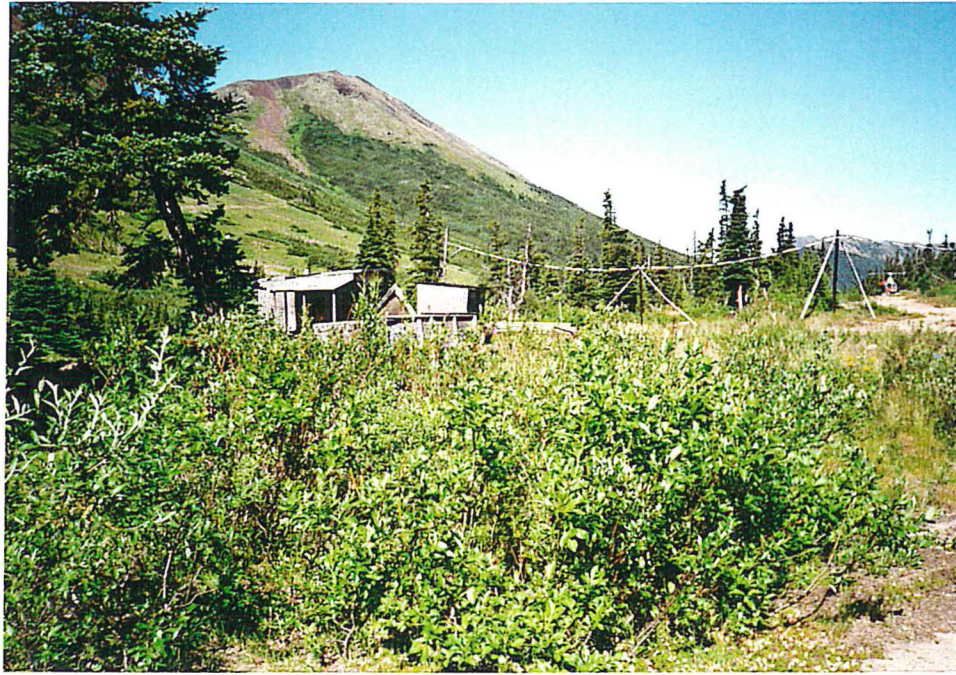
Photo 7. Electrical generator shed with power line to trailer compound visible.

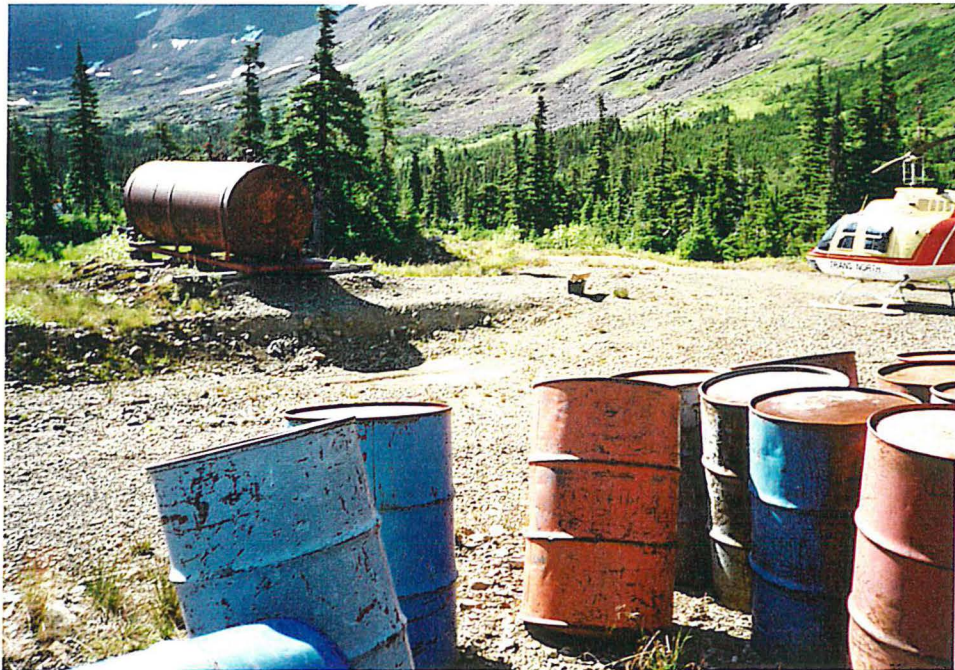
Photo 8. Empty AST with assortment of 205 litre metal barrels previously reported as all empty.

Cut up ASTs and empty 205 litre metal barrels on site, and bury in pit area at north end of camp. Burn waste wood materials at north end of camp in pit area. Bury waste metal materials in pit area.

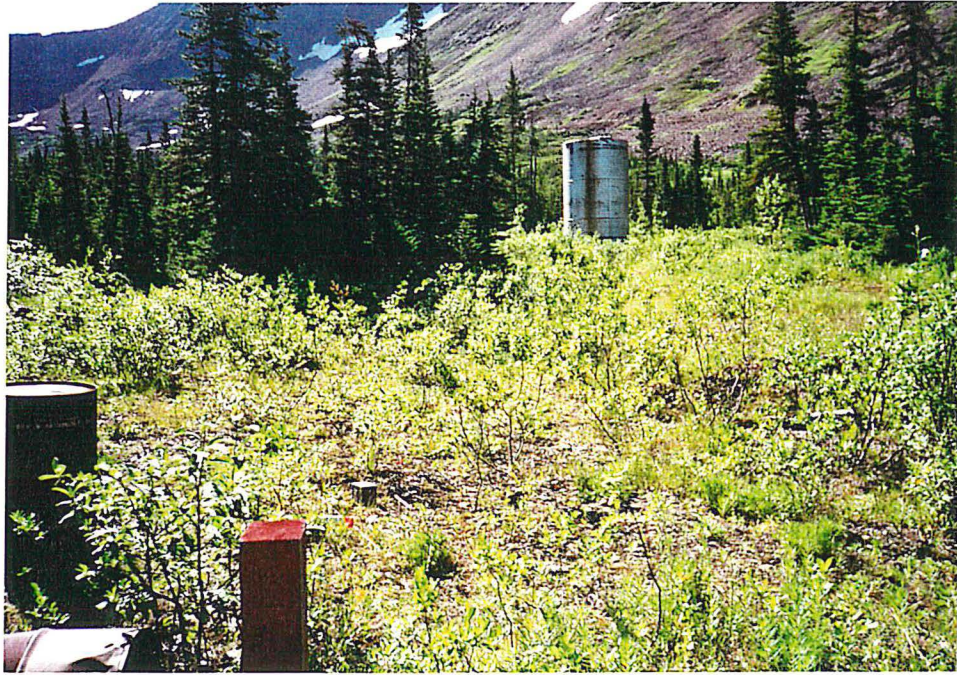
Two above-ground storage tanks (ASTs) were identified: one large vertical AST located 600 m southeast of the camp area and one horizontal AST located 50 m northwest of the camp. Both tanks were inspected and found empty.

Photo 9. Large vertical AST located approximately 600 m south of trailer camp area.

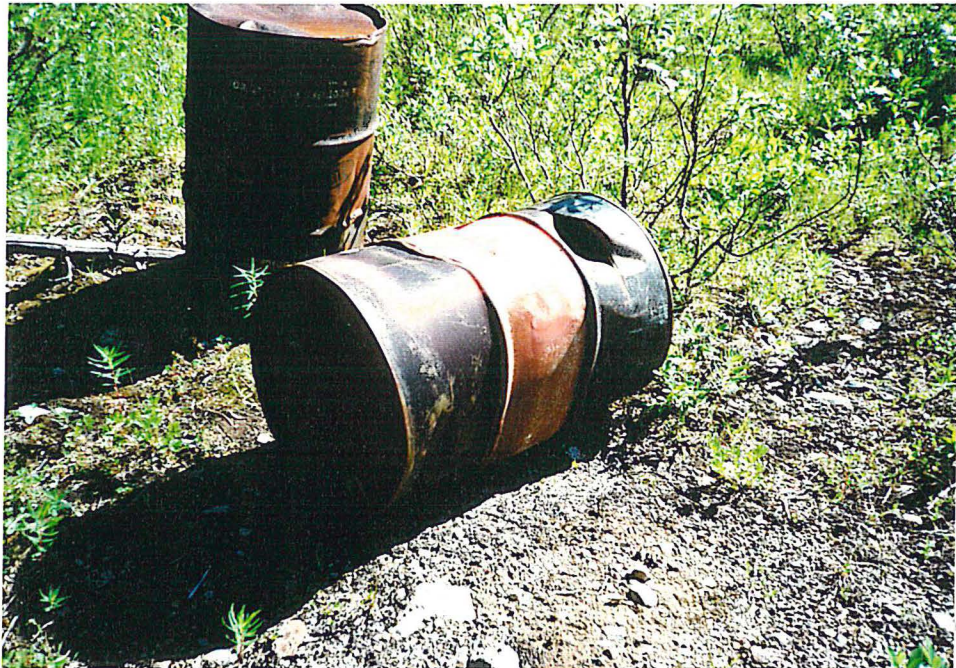
Photo 10. Damaged, rusted and empty metal 205 litre barrels located in vicinity of large vertical AST.

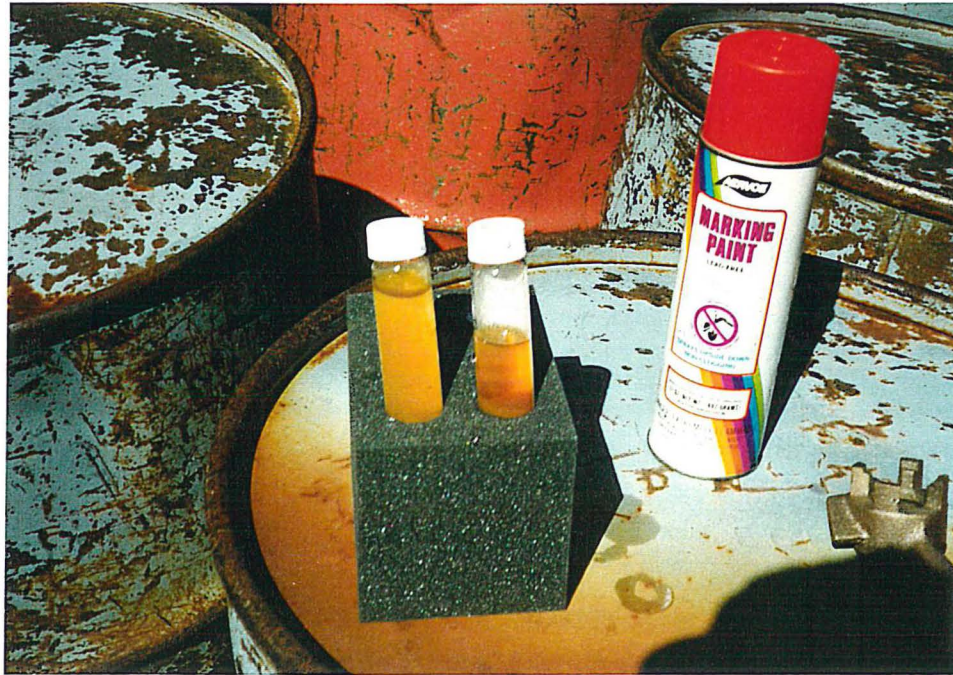
Photo 11. Purge and trap vials (40 ml) used during sampling of product of barrels.

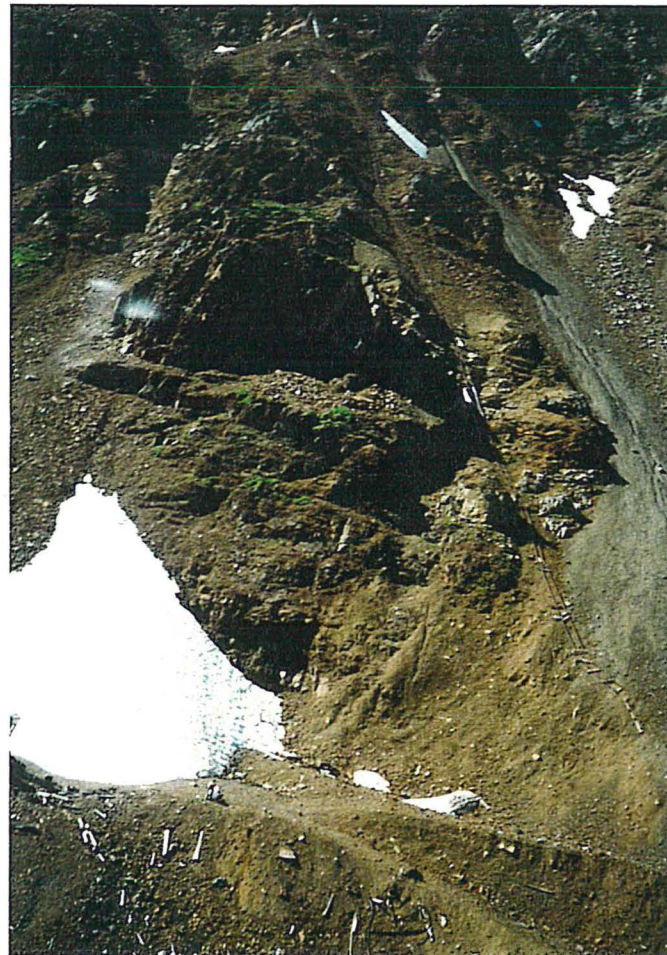
Risks relating to health and safety at the Logjam mine site can be considered medium-low. The 1570 m level portal is caved in by talus material and was completely covered by snow at the time of the site visit (August) suggesting a year round condition (See Photos 12 & 13). The portal at the 1700 m level is relatively inaccessible. Both the inclined track and the horizontally inclined trestle (See Photo 14) are severely deteriorated and could in future be subjected to collapse and further deterioration as a result of weathering and the law of gravity. The 1700 m level could present long term safety problems to humans visiting the site as the trestle and inclined rails become more unstable and begin to fall down the steep face of the cirque. No obvious risks to human health and safety were identified at the exploration camp area

Photo 12. View of typical terrain at Adit A1 (1570 m level). Note geologist below snow accumulation, talus, and beginning of hoist track to upper adit level.

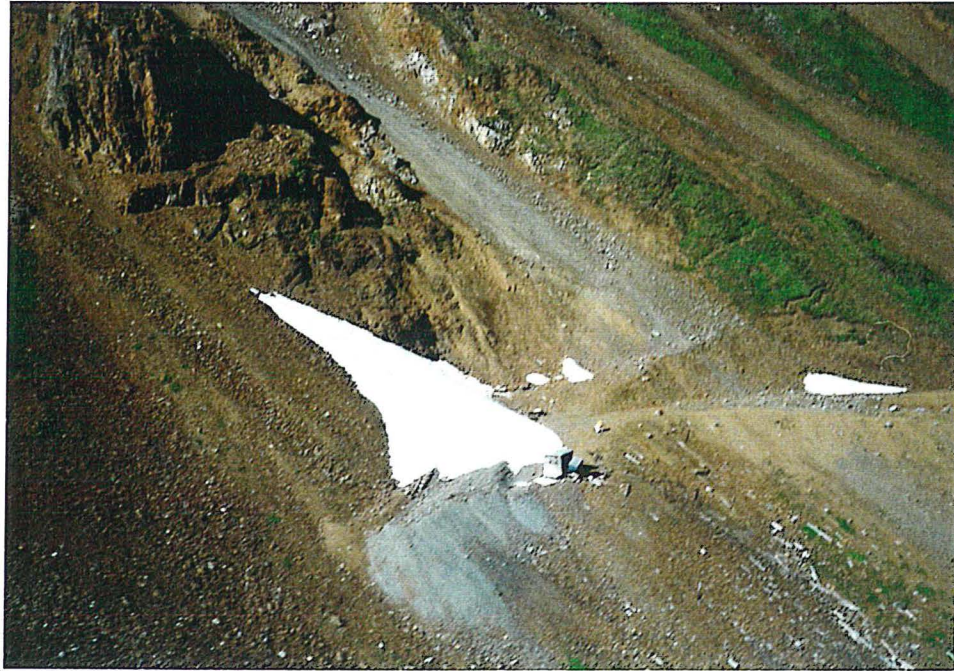
Photo 13. Profile of upper exploration area with Adit A1 (1570 m level) and access road to camp. Note severity of 35° slope.

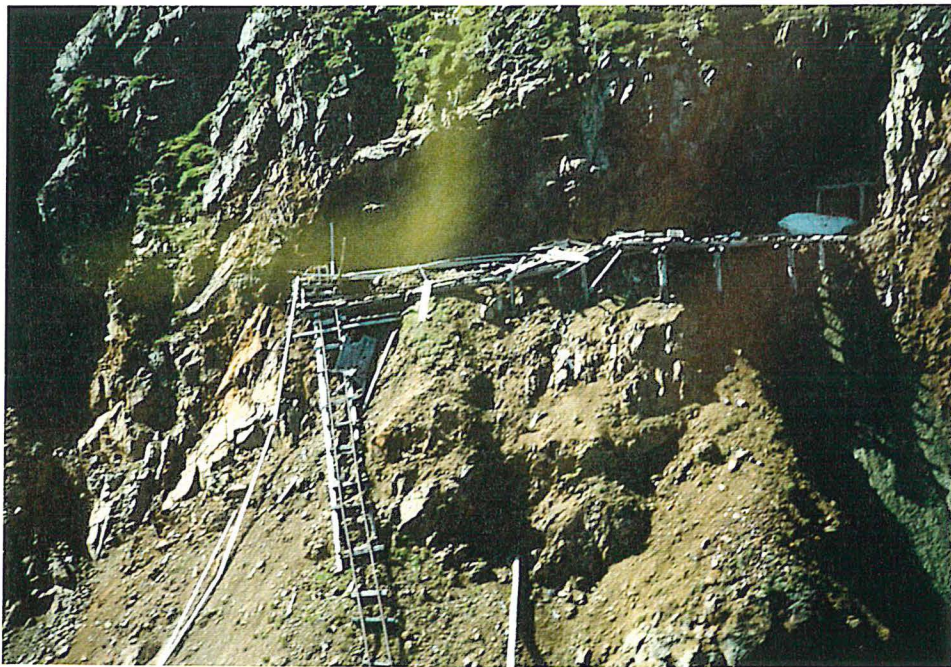
A now dilapidated, 35° inclined rail bed extends down the rock and talus slopes from the south end of a 20 m trestle built into the cliff face at the 1700 m portal to the 1570 m level. The trestle is intact but does not appear sound or operational. The portal is not obstructed and has been left open. No obvious trench sites were observed. A summary of adit features is listed below in Table 6.

Photo 14. Track and trestle at Adit A2 (1707 m level). Note severity of slope, unstable surface and deteriorated condition of trestle and supports.

An attempt should be made to remove the rail and trestle configuration at the upper 1700 m adit level by using a winch off of a tracked vehicle and pulling the structure down slope, burning the wood waste on the slope and burying the metal waste.
