PHASE II ENVIRONMENTAL ASSESSMENT
OF THE
MACTUNG
ABANDONED MINE SITE

Action on Waste Program
Indian and Northern Affairs Canada

Environmental Services
Public Works and Government Services Canada

March 1997

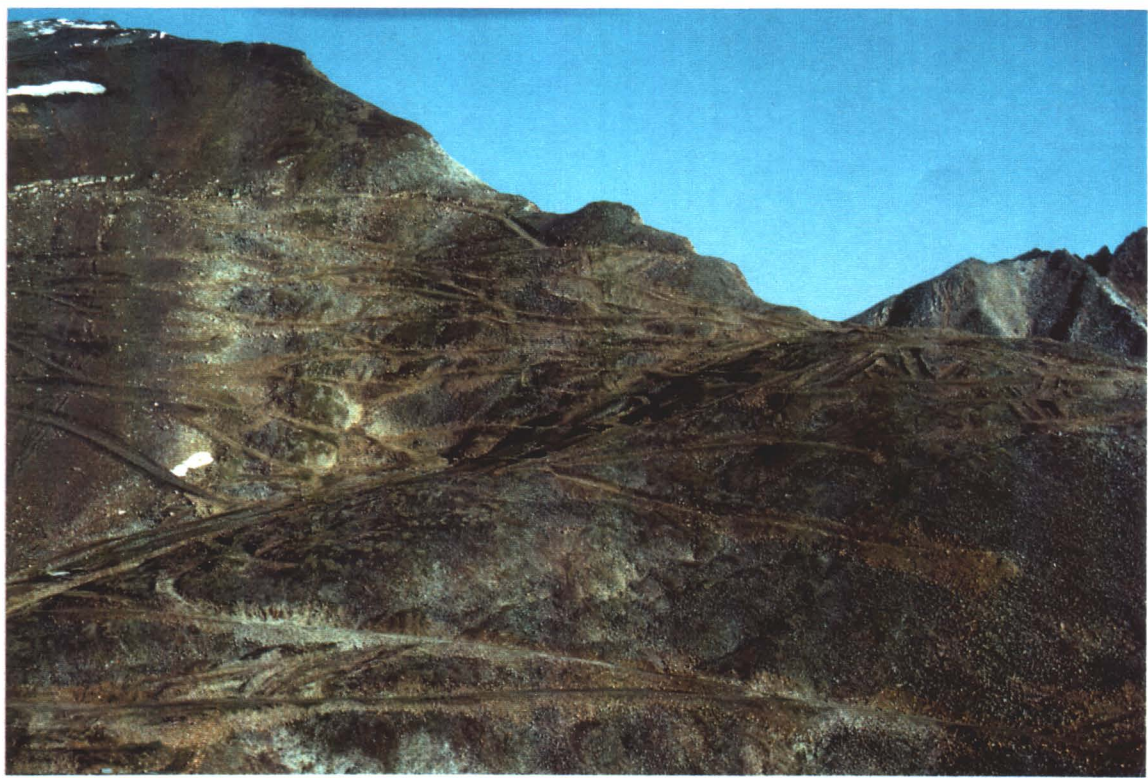
Physical disturbance is limited to the mapped area. Access and drill roads have been constructed on the mountainside west of the underground workings (Photos 1 - 2).

Photo 2. View of trenching and road network immediately north and west of the core storage building.

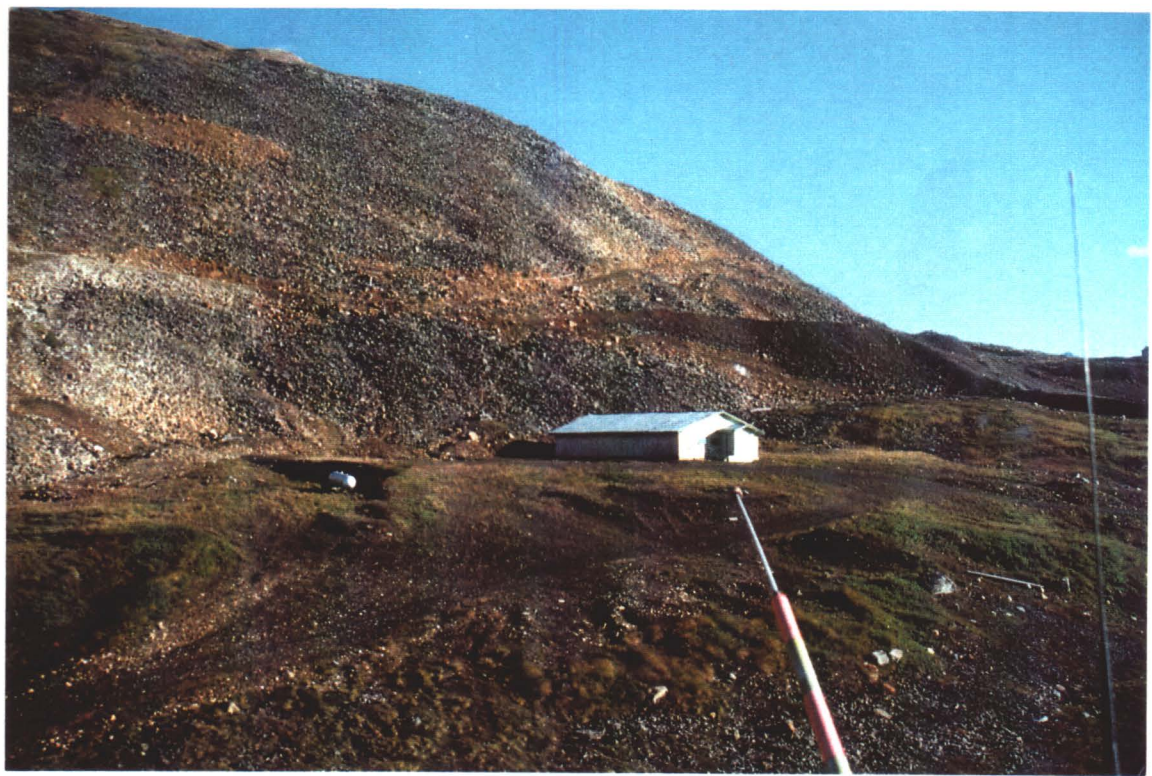
significant structures at the Mactung site (Photos 3 and 4). An ATCO-style office trailer noted in the INAC (1994) report has been removed. Details of construction features and interior contents are summarized in Table 5.1.

Access to the underground workings is still possible, and therefore poses a medium-level hazard to human safety. The former core storage and generator buildings appear to be structurally sound and are not a health and safety risk.

Photo 4. Core shed and propane tank.

Recommendation 2. Until the site is permanently decommissioned, the former core storage and generator buildings should remain standing and accessible. Both buildings are suitable for use as emergency shelters.

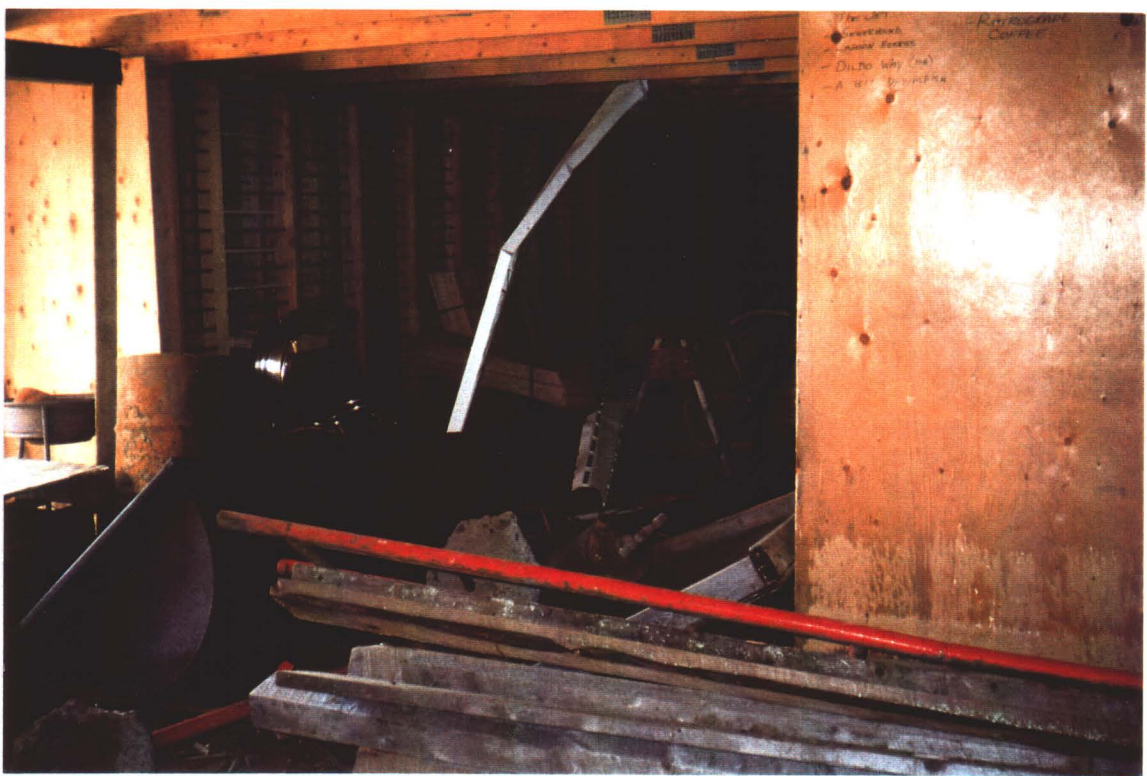
The non-hazardous waste materials are rated a minor aesthetic concern because of the distance of the site from major tourist highways. Generally, the area adjacent to the core shed and generator buildings is relatively free from waste materials; only the steel water pipeline between the adit and trench areas and miscellaneous wastes located near the water dugout pose any aesthetic concern.

Photo 6. Wood and metal wastes, east side of core storage building.

Recommendation 5. Solid waste materials should be consolidated and buried on site

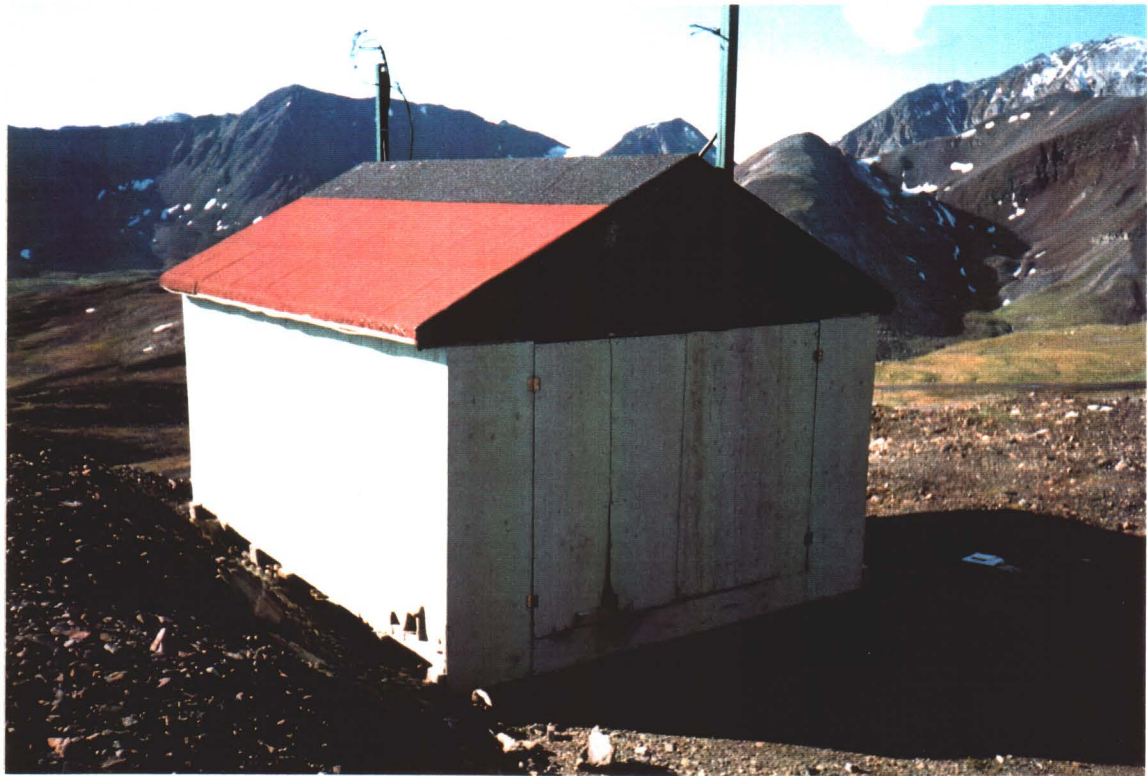
Sample MC-SL-201 was a composite of two heavily-stained patches located 5 and 10 m north of the generator shed on a waste rock, gravel and sandy silt pad. The combined stained area was about 12 m². Areas of heaviest staining were excavated to a depth of 15 cm; excavation was terminated at that depth due to time constraints and the difficulty of digging with hand tools. The soil profile in both excavations consisted of mixed, compacted waste rock (50% >50 mm) and sandy silt to a depth of 15 cm; similar materials appeared to extend past that depth. Staining and oily odour were noted in soil from all levels of the excavation. The coarse granular nature of the pad suggests hydrocarbons have penetrated beyond 15 cm depth. Metal and hydrocarbon analyses identified copper above CCME Commercial/Industrial criteria, but PAH compounds were all within CCME C/I limits.

Photo 7. Generator shed, looking southwest.

Recommendation 4. The areas of staining should be scarified with a front-end loader blade to the depth of visible staining. In-situ bioremediation of residual hydrocarbons can then be enhanced by addition of slow-release fertilizer with an N:P:K ratio approximating 18-3-0.

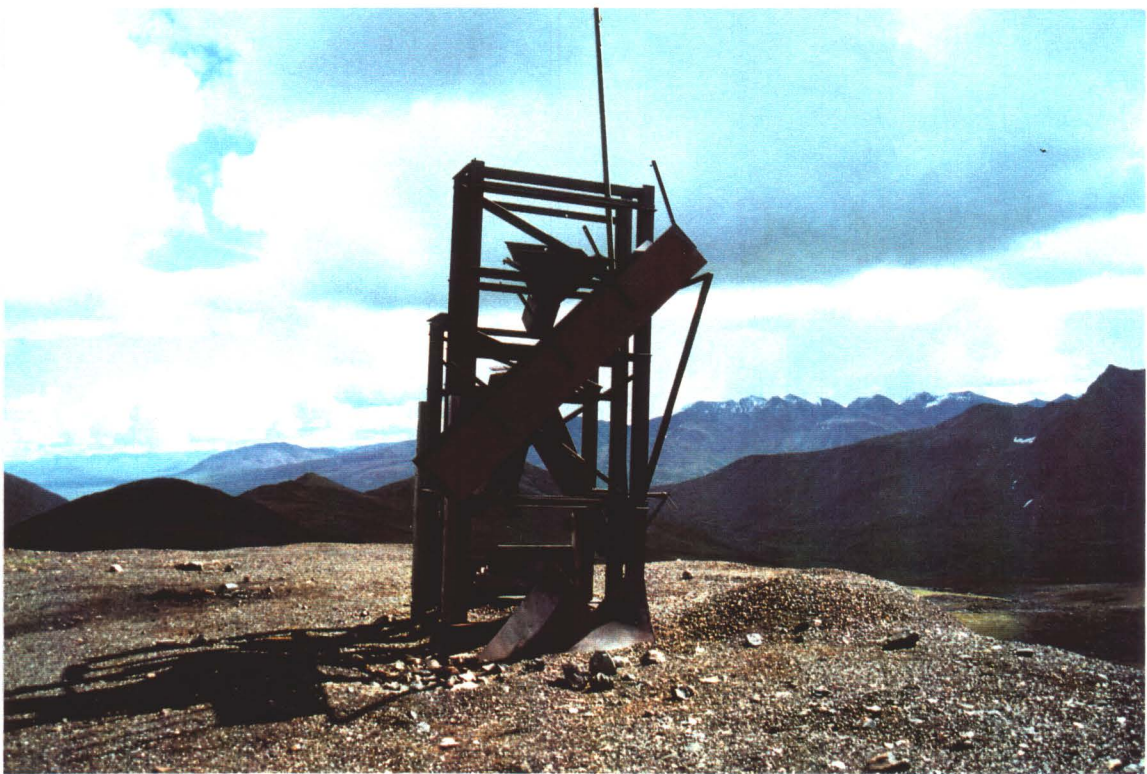
Sample MC-SL-202 was collected from the surface of a heavily-stained 10 m² area located 3 m north of the ore sample splitter on a waste rock, gravel and sandy silt pad. The area of heaviest staining was excavated to a depth of 15 cm. The soil profile was essentially the same as observed near the generator shed. Discoloration and a very strong oily smell was noted at all levels of the excavation. The coarse granular nature of the sampled area suggests hydrocarbons have penetrated beyond the sampling depth. Hydrocarbon analyses showed all PAH compounds to be within CCME Commercial/Industrial limits.

Photo 8. Ore sample splitter, viewed toward east.

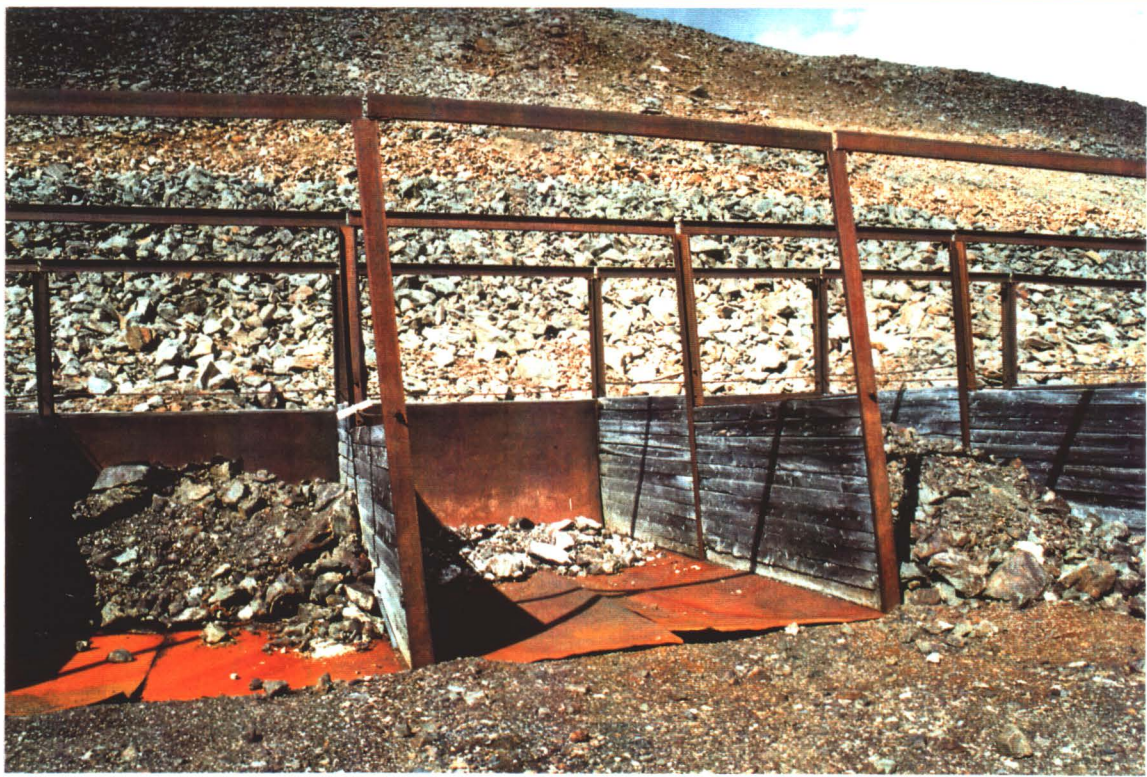
Photo 10. Ore bins constructed from steel I-beams, sheet steel back walls and floors, and timber side walls.

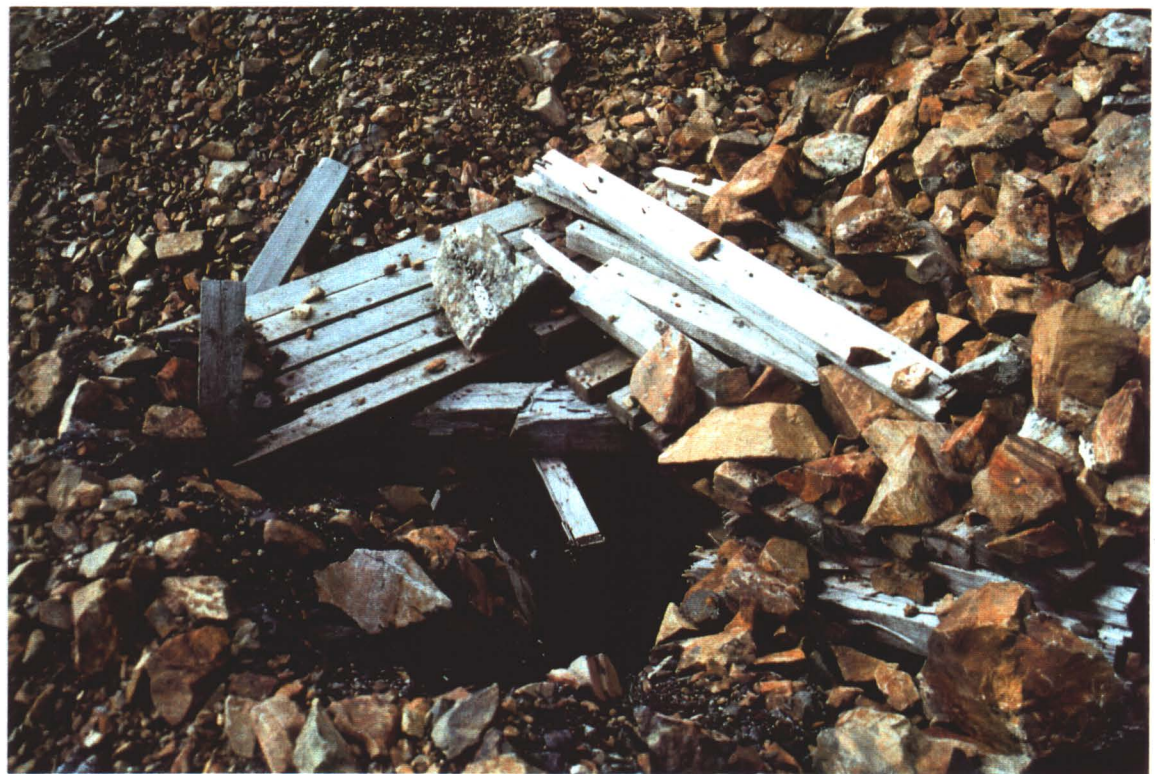
Photo 12. Adit near loading ramp, accessible through opening at lower centre of photo.

Recommendation 1. Assuming no further site development, the adit should be sealed with waste rock. A front-end loader could be used to demolish and deposit available waste rock over the entrance.
