FINAL REPORT

SITE ASSESSMENT REPORT
PADDY CAMP
ELSA, YUKON

PUBLIC WORKS & GOVERNMENT SERVICES CANADA

Job No. 20749-013-310
March 27, 1997

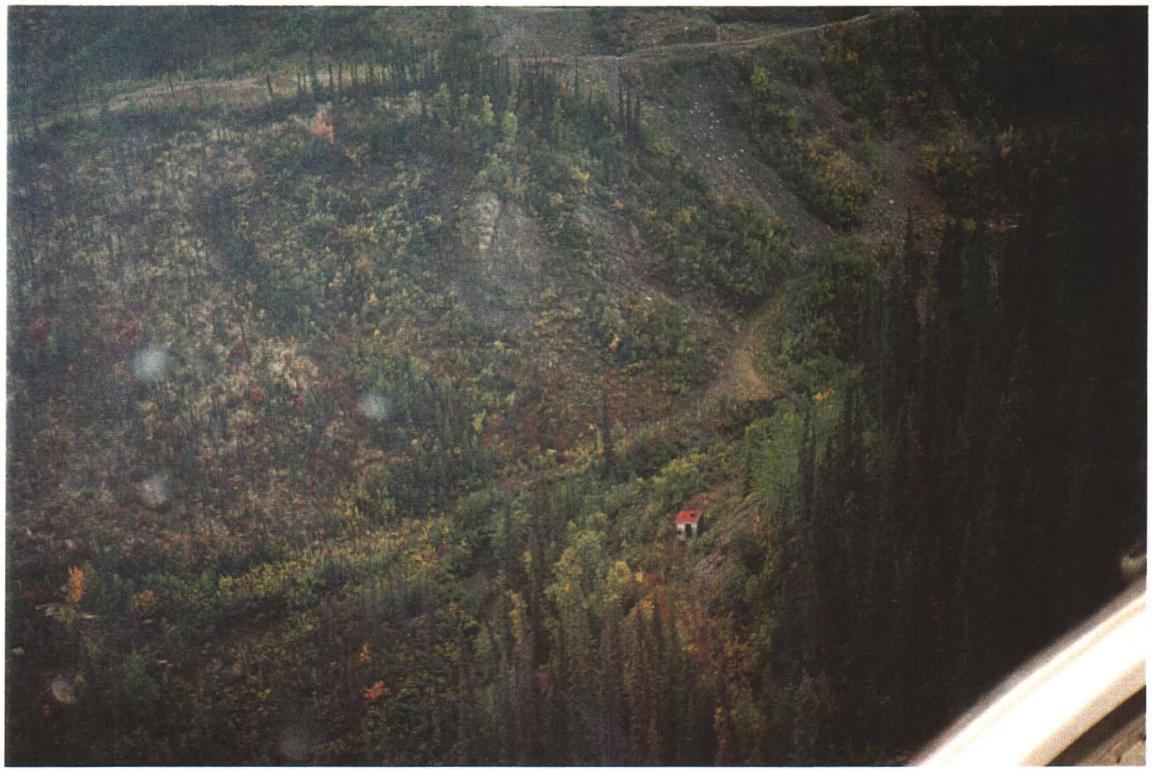
PHOTO 1

Aerial view of main camp including Upper and Lower Roads.

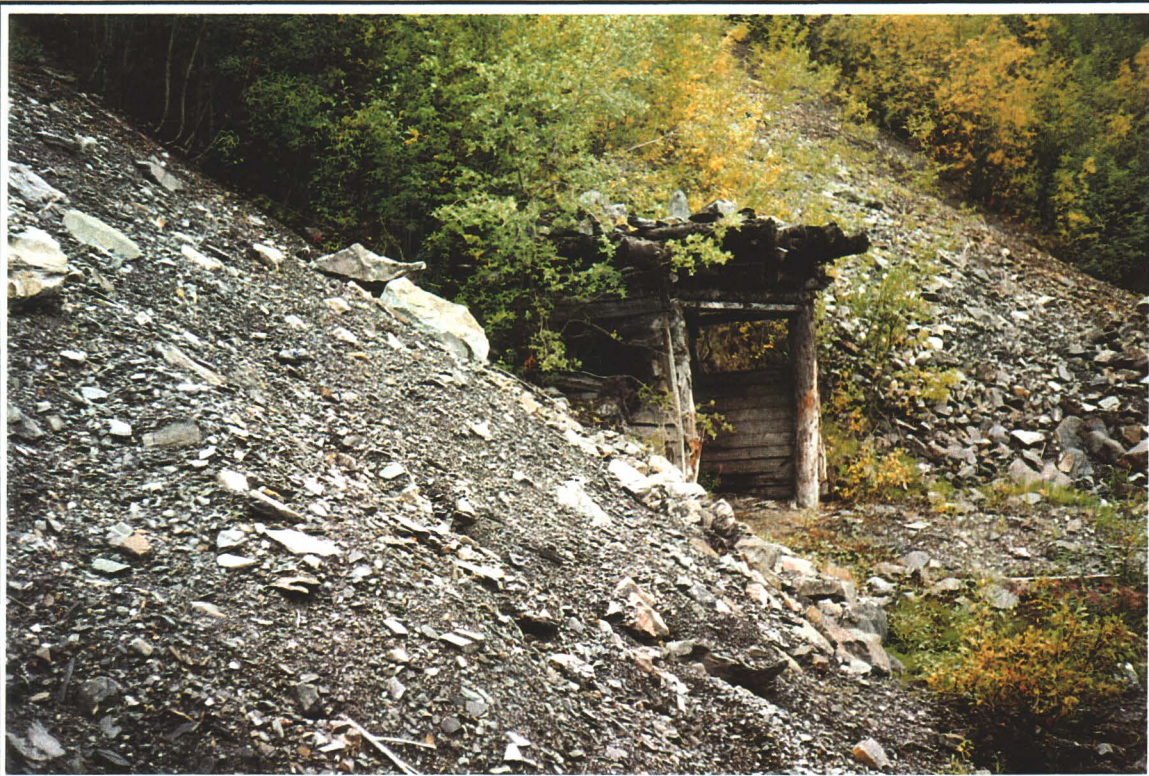
PHOTO 2

An intact adit was noted at the main camp area on the northeast slope above Christal Creek. At the time of the site inspection, surface water was not observed in the vicinity of the adit. The adit was located approximately 100 feet up gradient of Christal Creek on the canyon slope between the upper and lower roads. This feature is shown in Photograph #2.

The initial portion of the adit was in permafrost, and was timbered with local round timber. The timber has rotted, and some of the timber caps are broken. This has resulted in caving at the contact of the overburden with bedrock. The opening is sealed by this caved material, and the workings are inaccessible.

There were no significant mining hazards at this site. The main adit, located on the flank of the Christal Creek valley, is sealed by overburden which has sloughed over the opening due to failure of the portal timber. The adit, located to the north of Highway 11, is covered with waste rock and appears sealed.

View of adit at main camp.

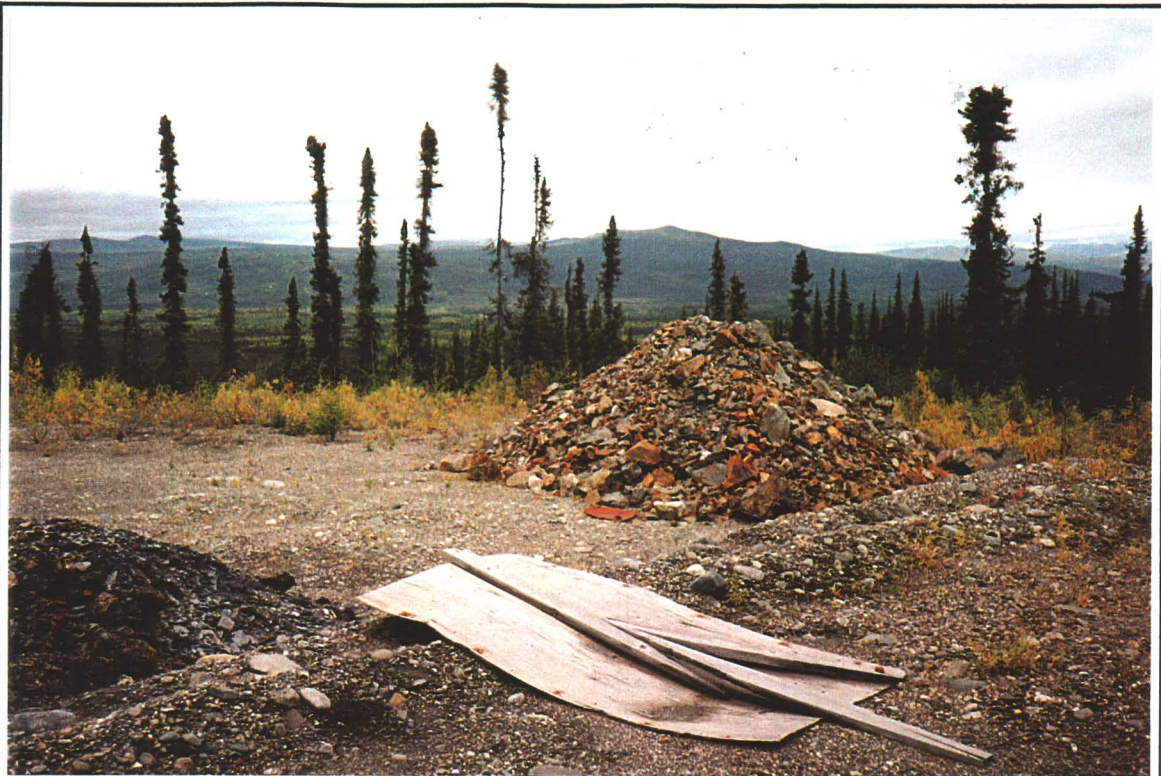
PHOTO 3

The presence of steep slopes within the canyon area of Christal Creek has contributed to the presence of waste rock slides between the upper and lower roads. Due to the extensive slope failure observed at the upper road, waste rock slides have resulted in the destruction of areas of the upper access road. The upper road is therefore only safely accessible by foot.

View of waste rock piles and waste rock road - Upper Road.

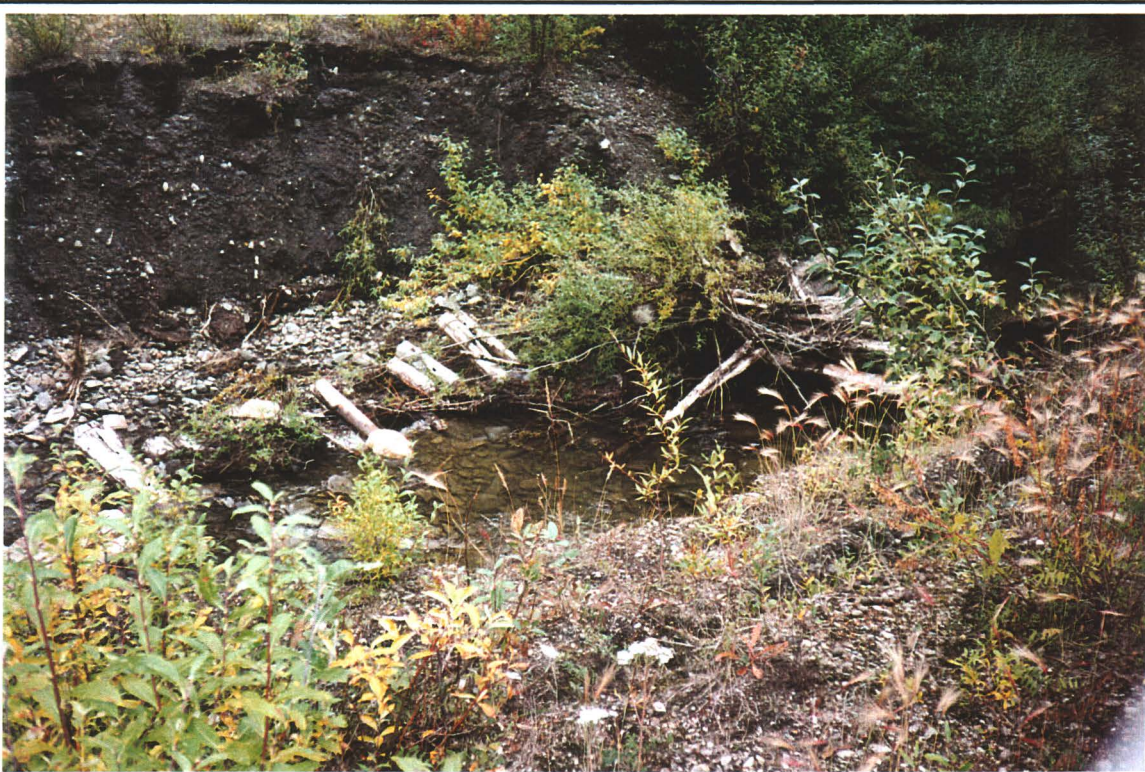
PHOTO 4

Two collapsed bridges were noted at the main camp area in Christal creek. Photograph #4 shows the condition of one of these bridges.

The lower road, adjacent to Christal Creek, is slumping, and will eventually settle into the creek. The effect of this slumping has caused the collapse of the two bridges into Christal Creek. A geotechnical assessment is required to ascertain if the instability of the dumps and road pose a health and safety risks.

The presence of graphitic residual soils along the last 500 metres of the lower access road, in the area of the main camp, has resulted in the localized caving of soil into Christal Creek. Two wooden bridge structures have collapsed into the creek due to the failure of the creek bank. According to a recent study by Access Mining Consultants Ltd. (1996), the presence of the collapsed bridges in the canyon area of Christal Creek appear to have interfered with the migration of fish stocks through the area. An assessment of the impacts of the lower road slope failure/bridge collapse on local fisheries is a component of the geotechnical assessment previously recommended.

View of collapsed road and bridge at Lower Road.

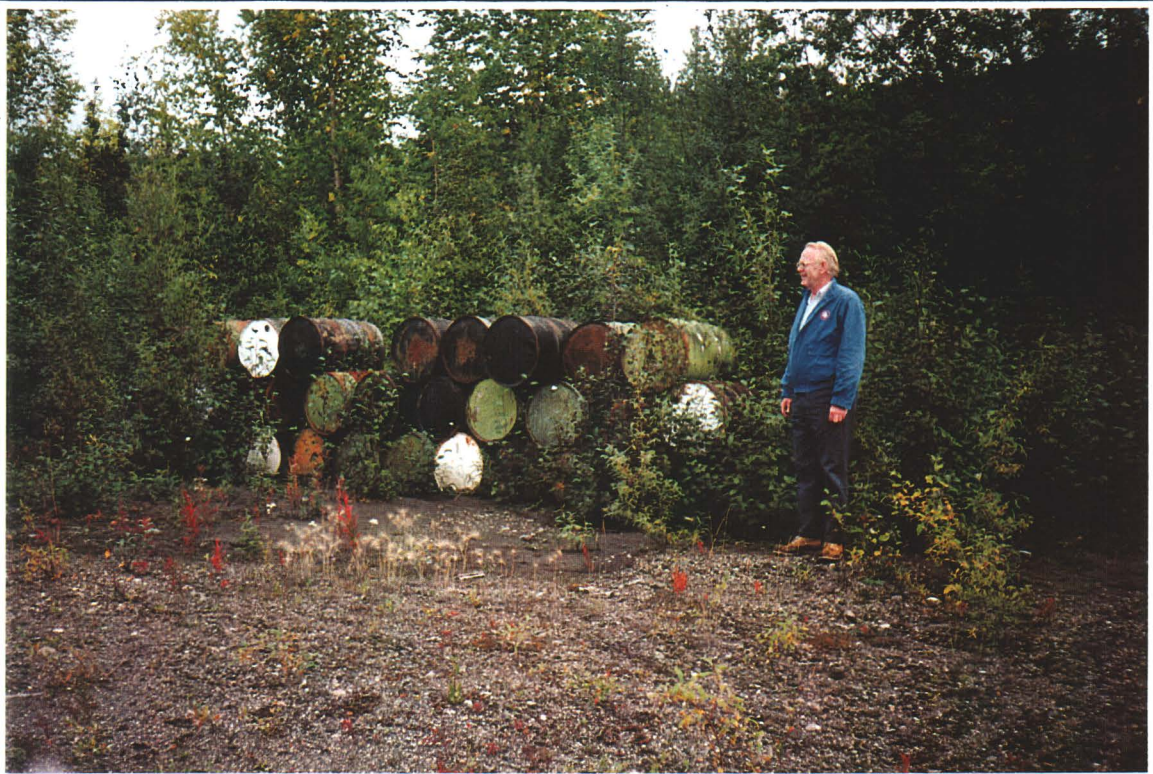
PHOTO 5

Approximately 30 empty fuel barrels were stored at the convergence of the upper and lower roads to the southeast of the main camp. No surface staining was observed at the time of the site inspection. Two soil samples, PS2 and PS3, were collected immediately up gradient and down gradient of the empty barrel storage area and submitted for total metals, BTEX, LEPH/HEPH and VPH analyses. The analytical results for PS2 and PS3 registered within CCME criteria for the total metals and BTEX. As no CCME criteria is available for VPH and LEPH/HEPH, these analyses were performed as a screening process and have been referenced to BC CMCS and New Petroleum Hydrocarbon criteria (July and August, 1995) for commercial/industrial sites. VPH and LEPH/HEPH results were less than the detection limit and were within CMCS criteria. Soil sample results have been presented in Tables 3 through 5. This area is shown in Photograph #5.

Empty barrel storage at convergence of Upper & Lower Roads.

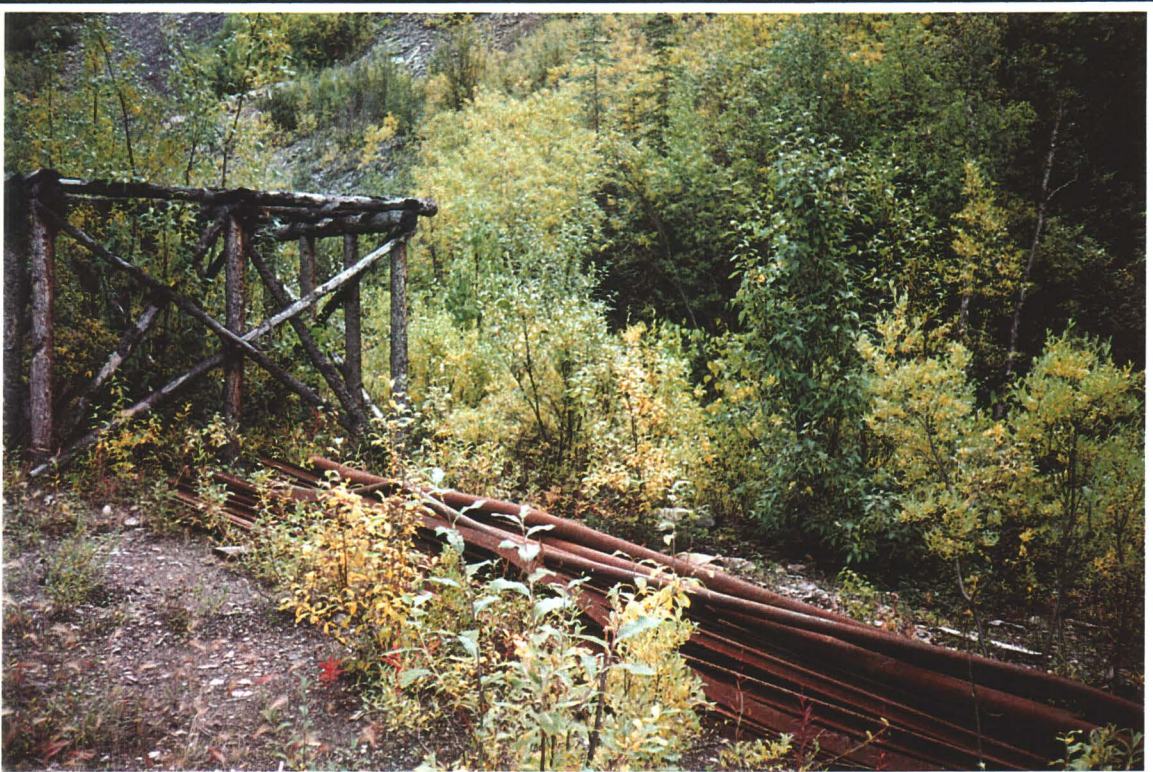
PHOTO 6

In addition to the wood clad building, a wooden support structure, two ore cars, 25 pieces of rail and 8 pieces of pipe were observed on the northwest bank of Christal creek. Approximately thirty empty barrels were also observed in storage at the convergence of the upper and lower roads. These areas are shown in Photograph #6 and #5, respectively.

View of piping abandoned along Lower Road.
