Assessment of Abandoned Yukon Mine Sites

Peso #62

Prepared for
Public Works and Government
Services Canada

February 1997
GV206.01

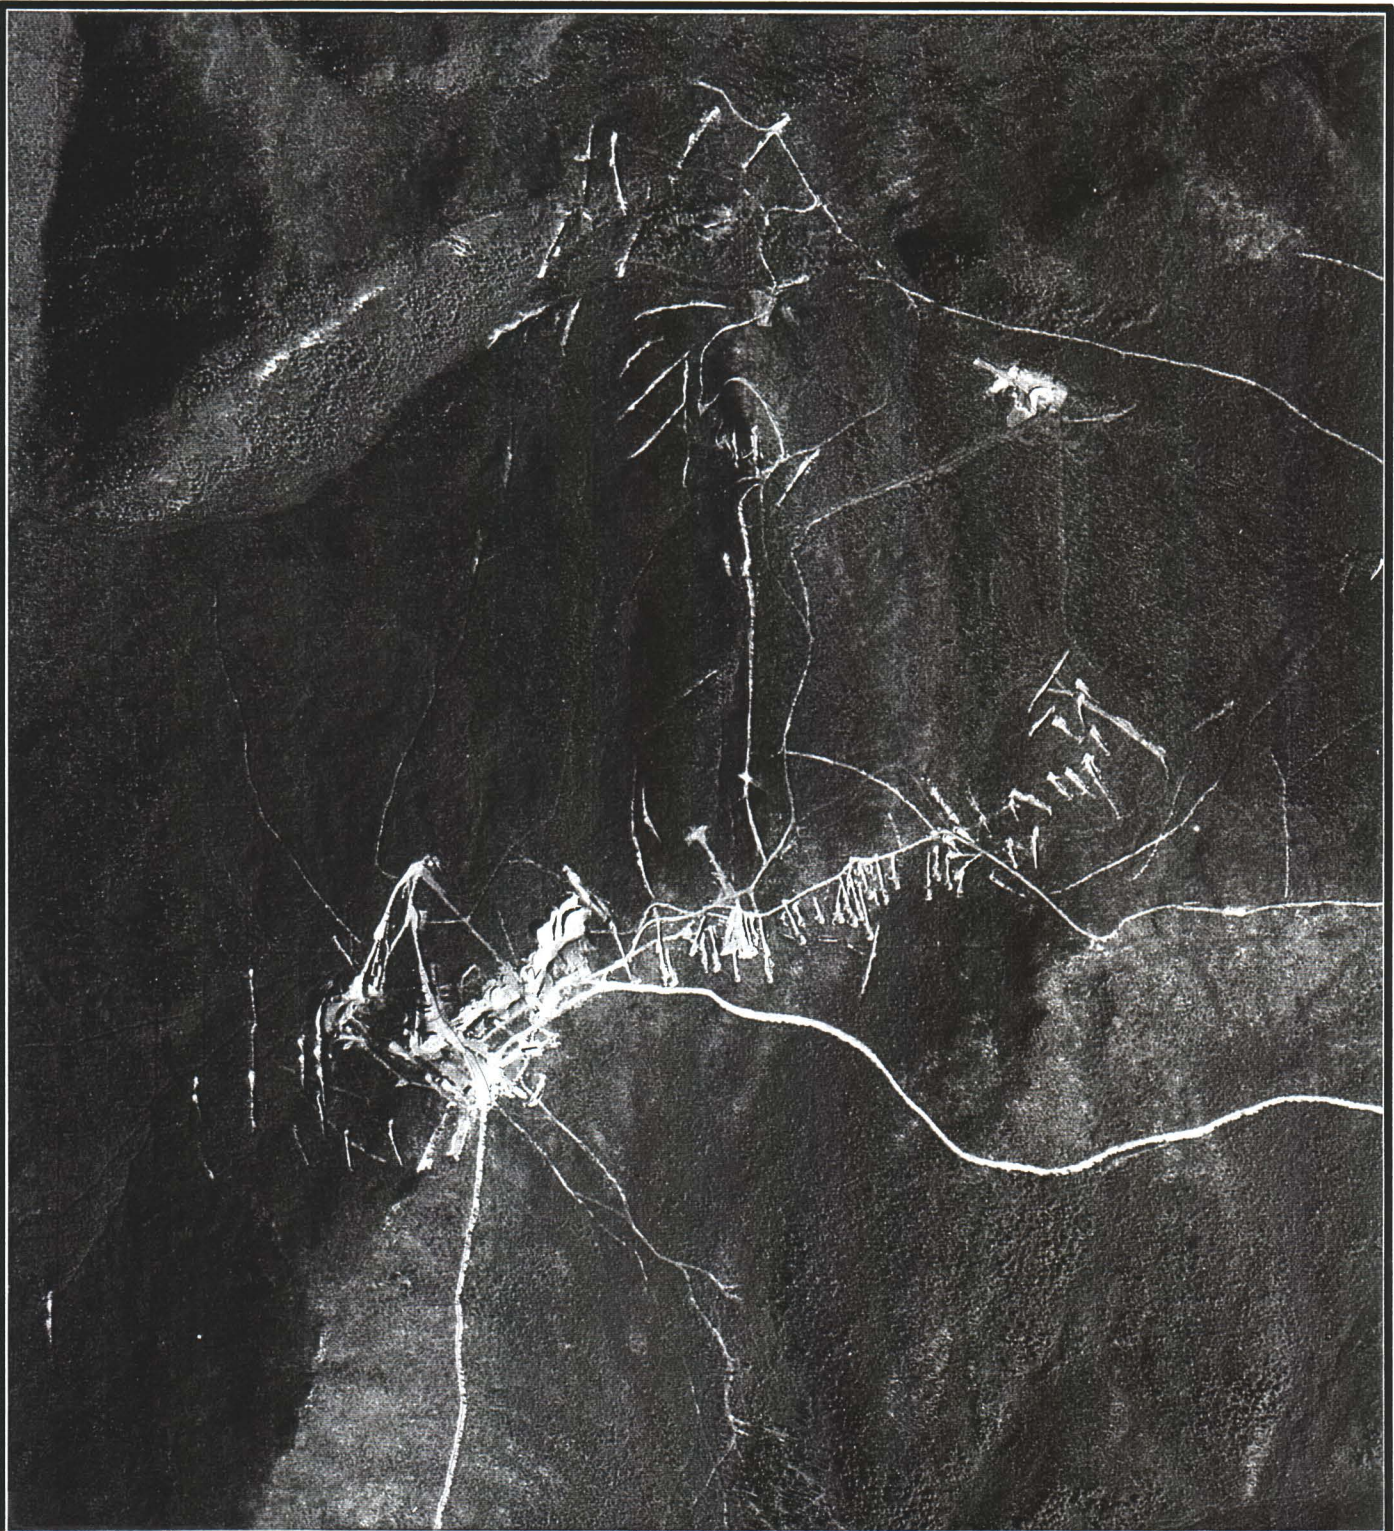
Figure 1.3

Roads, trails and exploration and mine workings are shown in the airphoto presented as Figure 1.3.

Peso Abandoned Mine Site Air Photo

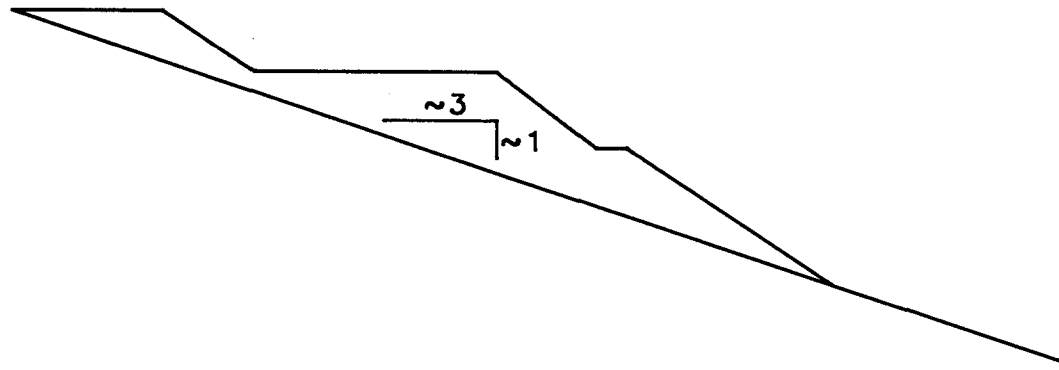
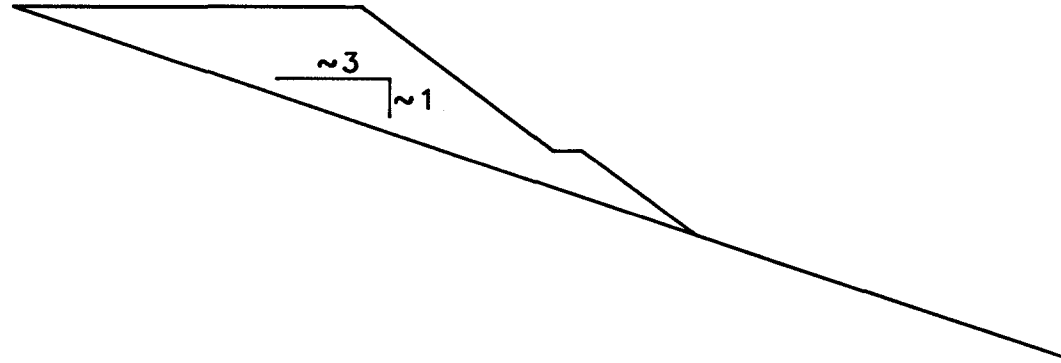
SECTION 1

From a visual inspection, the waste rock is a sand with some silt and gravel, and with a trace of cobbles and boulders. The individual particles are soft, angular, and platy - typical of the chloritic schist in the area. The waste rock appears to have been placed in three lifts about 5 to 12 m thick. Each lift has a face at its angle of repose (about 1.3h:1v or 37 degrees) and is separated from the higher lift by a bench varying in width from 2 to 15 m. The original ground is moderately steep, with an average slope estimated at 3h:1v (18 degrees).

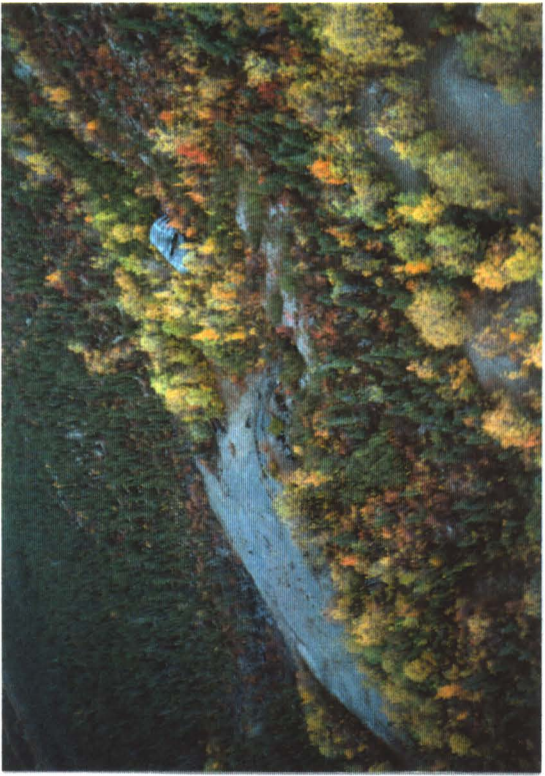
- Photo 1: Waste rock pile and stressed vegetation downgradient of pile.
- Photo 2: Residence building.
- Photo 3: Collapsed wood building No. 1.
- Photo 4: Aerial view of collapsed wood building No. 2, chemical and office buildings, quonset and waste rock pile.
- Photo 5: Inside chemical building.
- Photo 6: Explosive's shack.
- Photo 7: Quonset.
- Photo 8: Debris in Quonset.
- Photo 9: Adit 1 and rail track debris.
- Photo 10: Inside Adit 1 near entrance.
- Photo 11: Adit 2.
- Photo 12: Waste rock pile, viewed from above Adit 1.
- Photo 13: Waste rock pile, viewed from the south.
- Photo 14: Waste rock pile, viewed from below pile.

A less expensive and less effective alternative would be to utilise the relatively soft and fine-grained nature of the waste rock itself to reduce infiltration. After regrading the slopes to 2h:1v so a dozer can operate on the slopes, sufficient lime could be tilled into the top 300 mm of the waste rock to allow grasses and native shrubs to grow. The tilled surface of the waste rock would then be compacted with a dozer to lower the permeability and, hence the surface infiltration. Finally, the area could be seeded to minimise surface erosion.

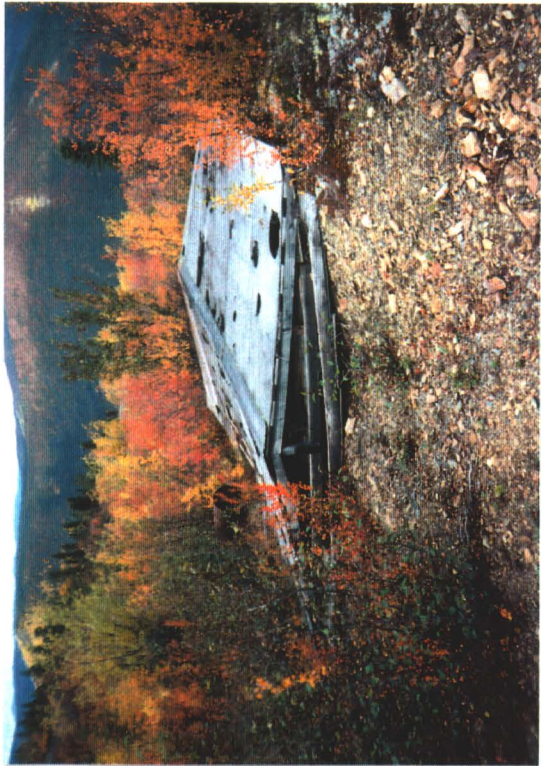
3

This collapsed former buildings (Photo 3, Appendix C) is located approximately 50 m southwest of the residence building. The collapsed wood structure covers an area of 7.5 x 5.3 m. There was no evidence of any materials other than wood, however, other materials may be present within the collapsed structure that could not be investigated due to the hazardous state of the building.

Buildings, other than the quonset, are constructed largely of wood. The combustible building materials should be burned on-site. The quonset should be levelled and landfilled.

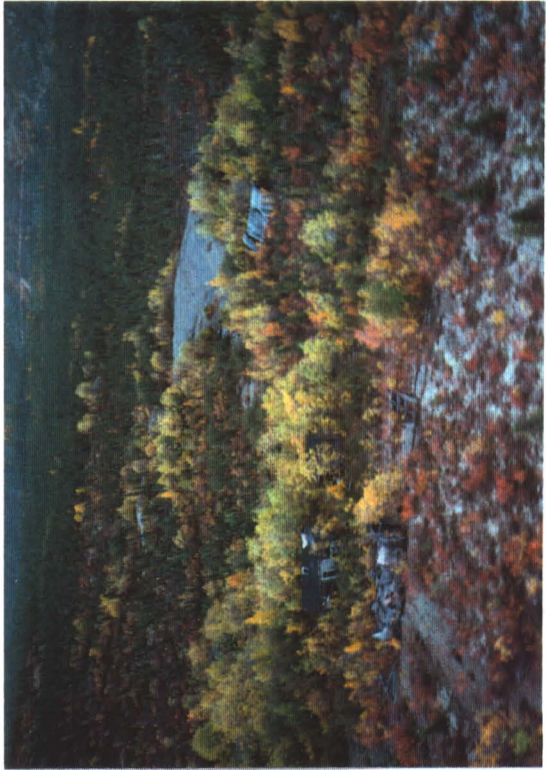
4

This collapsed wood building (Photo 4, Appendix C) is located on the north side of the trail opposite from the chemical and office buildings. The dimension of the wood structure is approximately 11 x 4.5 m. Significant amounts of a fibrous insulation was mixed in with the wood debris. A sample of the insulation (GV206PEINS) was collected and analysed for asbestos content. The results of the analysis (Table D1, Appendix D) indicate that the insulation does not contain asbestos. Laboratory reports are provided in Appendix E.

The chemical building (named because of the presence of approximately five broken Amyl Alcohol bottles and used chemical bottles) is constructed of wood with asphalt shingles on the roof and walls (Photo 4, Appendix C). The building dimension is 8.6 x 3.7 m and the structure is in fair condition, however, floor boards are rooting and may collapse when walked on. Debris within the building consists of one-gas furnace, several bagged soil and rock samples, magazines, wood tables and broken glass (Photo 5, Appendix C).

The office building (Photo 4, Appendix C) is adjacent to the chemical building. The wood building consists of a sleeping area, an office-type area and a small porch. The building dimension is 3.5 x 3.7 m with a 2 x 2 m porch. Debris in the building consists of 4-empty paint cans, a metal box spring, a wooden desk and several books and paper debris. The building structure is in fair condition, however, floor boards are deteriorating.

Buildings on-site are in various state of deterioration. The quonset and collapsed wood building No. 2 are currently unstable. The remaining buildings are either fully collapsed or still standing. The floor boards on some of the buildings are rotting and pose a current or future health hazard. All buildings should be levelled to reduce the risk present from these structures. Combustible non-hazardous materials should be burned on-site and non-combustible non-hazardous materials should be landfilled on-site.

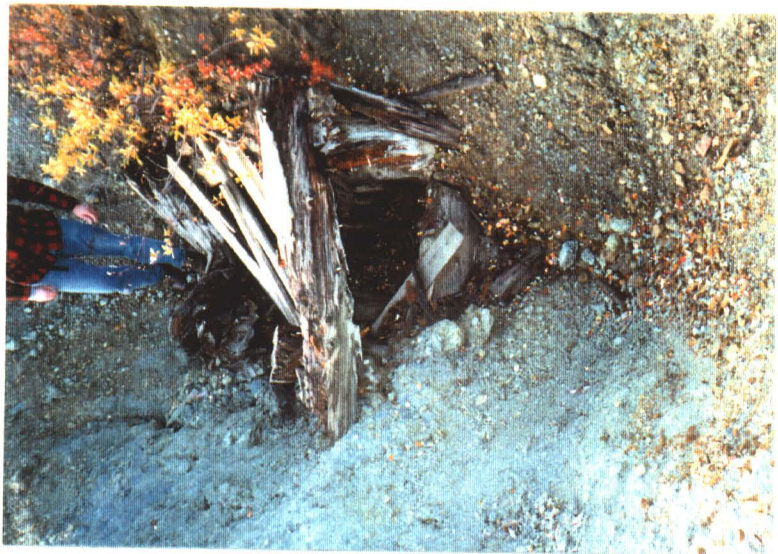
11

Adit 2 (Photo 11, Appendix C) is a near vertical shaft about 1.2 m square. It is filled to within a few metres of the surface with soil and presents only a minor safety hazard as is.

Adit 2 - with very little work and a few cubic metres of adjacent soil, this opening could be completely filled and all safety hazards eliminated.

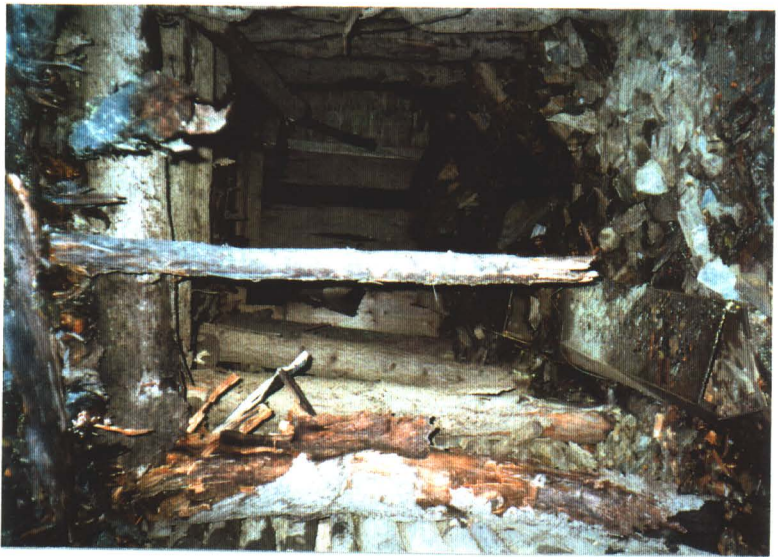
10

Adit 1 (Photos 9 and 10, Appendix C) opening is approximately 2 m² and extends well into the hill. It is not possible to see the end of the drift from the portal. Historic records suggest that the drift could be about 1500 m long; this roughly corresponds with the volume of waste rock on the surface. The portal itself is made of wood cribbing and is starting to decay and collapse. A few boards are nailed across the portal. This site has been identified as being a safety hazard.

Adit 1 - To reduce the hazard, the portal should be closed. If earth moving equipment is mobilised to the site to rework the waste rock pile, the portal can be buried with benign rock or soil. If there will be no earth moving equipment on site, a rock drill can be brought in with a light truck to drill blast holes in the rock around the portal. A qualified blaster could then charge the holes and collapse the entrance to the adit.

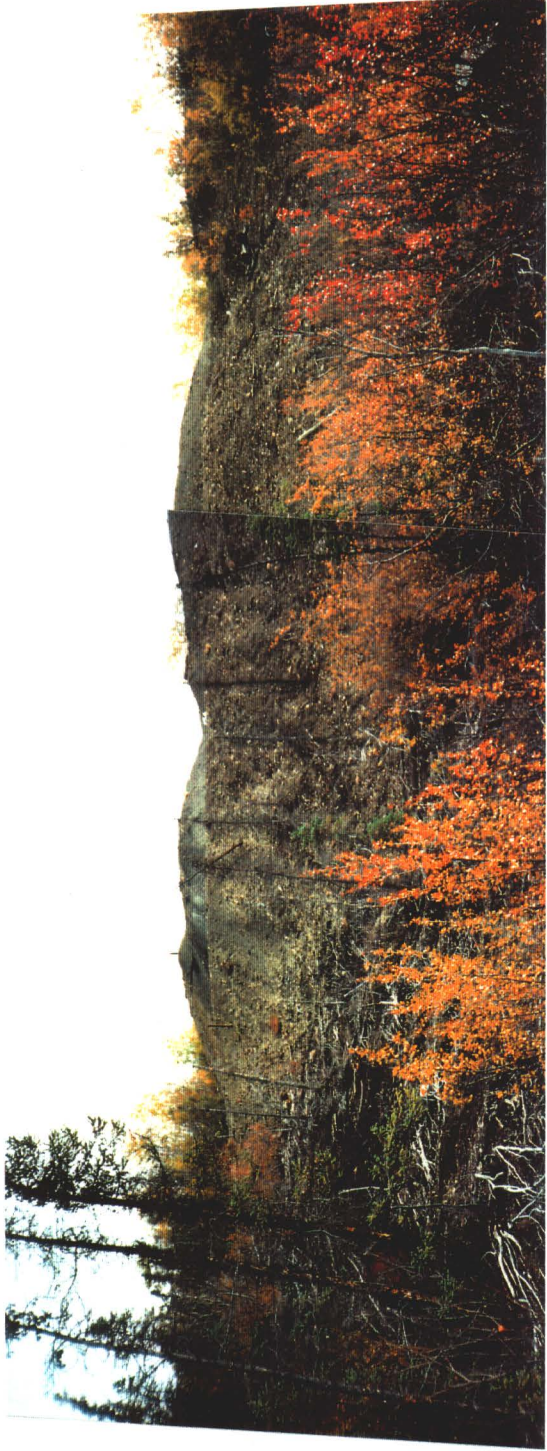
14

There was no evidence of surface slumping or slope failure, nor was there evidence of concentrated seepage along the toe. There was some surface ravelling and fines washing from the slopes, but this did not appear to be degrading the stability of the mass.
